NASA Contractor Report 165677

# Investigation of the Effect of Resin Material on Impact Damage to Graphite/Epoxy Composites

MCDONNELL DOUGLAS CORPORATION  
Douglas Aircraft Company  
Long Beach, California 90846

CONTRACT NAS1-12675 MARCH, 1981

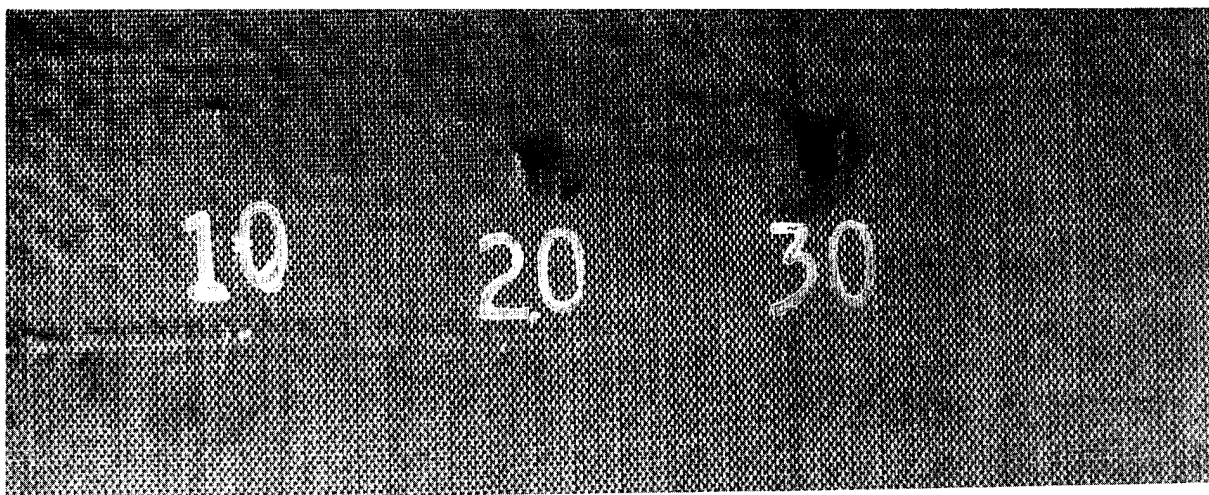
FIGURE 22. COMPARISON OF VISUAL IMPACT DAMAGE VS. NDT INSPECTION FOR U.S. POLYMERIC TOUGH RESIN #1 FOR 3.17 cm (1.25 INCH) SUPPORT AT a. 1.13 JOULES (10 INCH-POUNDS), b. 2.26 JOULES (20 INCH-POUNDS) AND c. 3.39 JOULES (30 INCH-POUNDS)

Visible  
Damage  
Back side

Visible  
Damage  
Front side

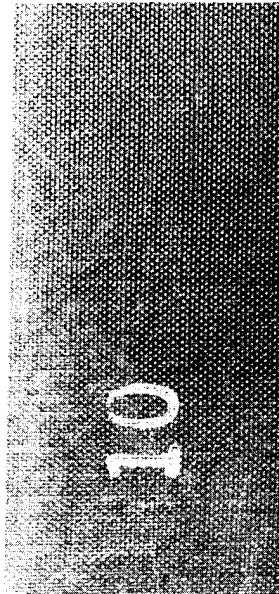
FIGURE 25. COMPARISON OF VISUAL IMPACT DAMAGE VS NDT INSPECTION FOR FIBERDUX 920 FOR 3.17 cm (1.25 INCH) SUPPORT AT a. 1.13 JOULES (10 INCH POUND), b. 2.26 JOULES (20 INCH POUND) AND c. 3.39 JOULES (30 INCH POUND)

Visible  
Damage  
Back side

Visible  
Damage  
Front side

None
