US Army Corps  
of Engineers

USACERL Technical Report 96/15  
December 1995

# Historic Preservation Plan for St. Johns River Lighthouse, Naval Station Mayport, Florida

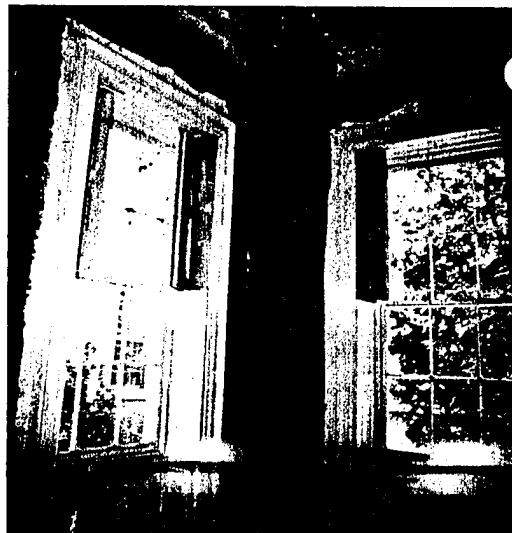
5. The installation of vapor retarders in walls of historic buildings in an effort to contain interior moisture can cause serious damage to historic finishes as shown here. In this example, all the wall plaster and lath have been stripped in preparation for a vapor barrier prior to replastering. Controlling interior temperature and relative humidity can be more effective than adding insulation and vapor barriers to historic perimeter walls. Photo: Ernest A. Conrad, P.E.

To avoid these types of damage to a historic building, it is important to understand how building components work together as a system. Methods for controlling interior temperature and humidity and improving ventilation must be considered in any new or upgraded HVAC or climate control system. While certain energy retrofit measures will have a positive effect on the overall building, installing effective vapor barriers in historic walls is difficult and often results in destruction of significant historic materials (see figure 5).

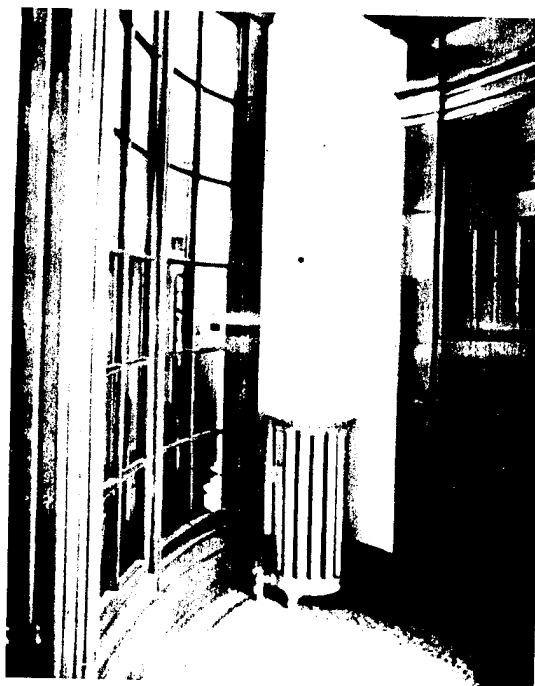
6. A condition assessment during the planning stage would identify this round radiator in a small oval-shaped vestibule as a significant element of the historic heating system. In upgrading the mechanical system, the radiator should be retained. Photo: Michael C. Henry, P.E., AIA.

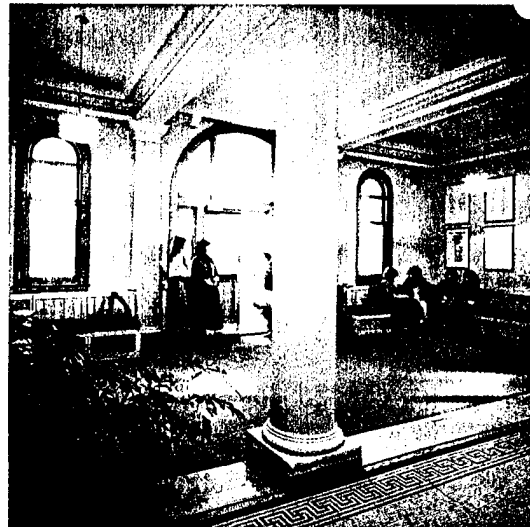
a. Before and after of a circa 1900 school entrance. The radiators have been replaced with a two-pipe fan coil system built into bench seats. The ceiling was preserved and no exposed elements were required to add air conditioning. Piping runs are under the benches and there was no damage to the masonry walls. Photos: Notter Finegold + Alexander Inc. and Lautman Photography, Washington.

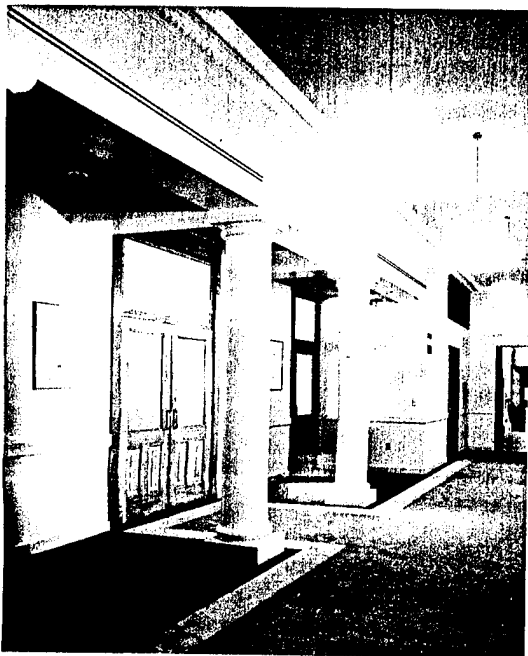
b. Central air conditioning was installed in the corridors of this circa 1900 school building by adding an air handler over the entrance from a vestibule. The custom-designed slot registers provide linear diffusers without detracting from the architecture of the space. Photo: Lautman Photography courtesy of Notter Finegold + Alexander Inc.

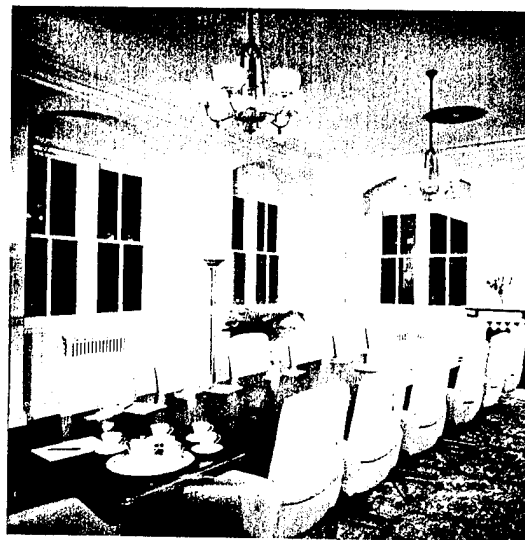
c. Conference room, Auditors Building, Washington, D.C. The historic steam radiators were retained for heating. The cast iron ceiling register was retained as a decorative element, but made inoperable to meet fire codes. Photo: Kenneth Wyner Photography courtesy of Notter Finegold + Alexander Inc.
