Wetlands Research Program Technical Report WRP-RE-12

## **Monitoring Study, Eastern Neck Island National Wildlife Refuge**

**Final report**

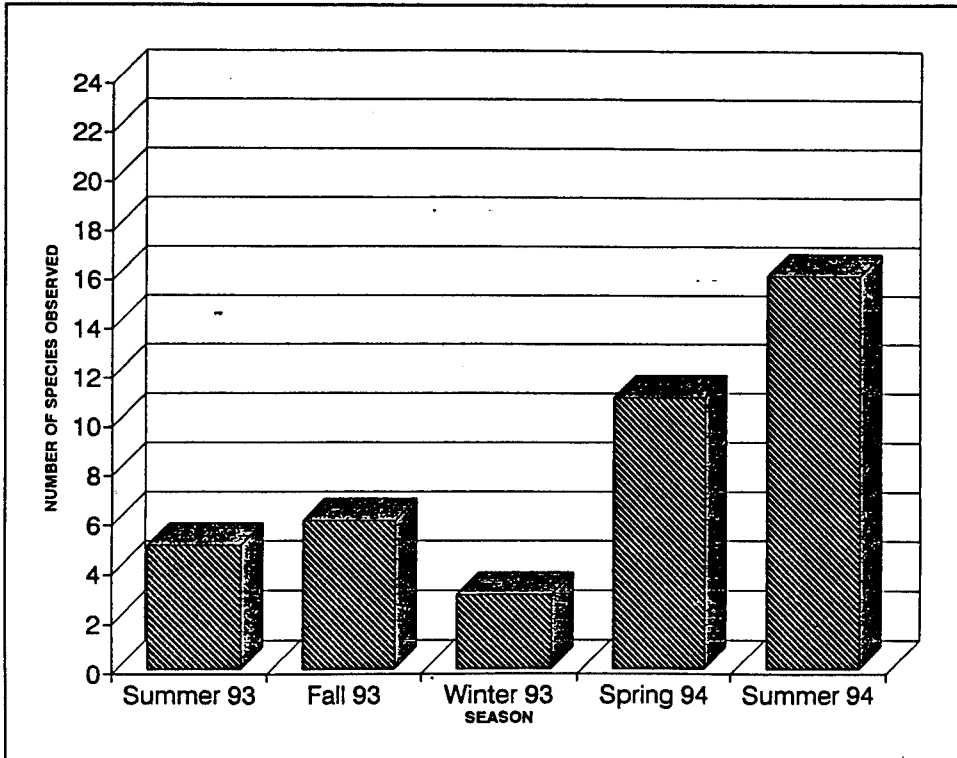
Figure 11. Number of plant species observed in wetland creation study site

Figure 11 depicts the number of plant species observed during the course of the study period. At the beginning the site was rapidly colonized by sea rocket (*Cakile edunata*) and common reed. During the first summer, all common reed invasion was by rhizome extension. During sampling, all rhizome growth encountered was severed from the supporting Phragmites stands. Common reed was a problem the second summer (after herbicide treatment) due to viable seed dispersal. By the end of the second summer the site supported 16 wetland and dune species (Table 4). By frequency of occurrence common reed constituted 1.5 percent, and was treated with herbicide again.

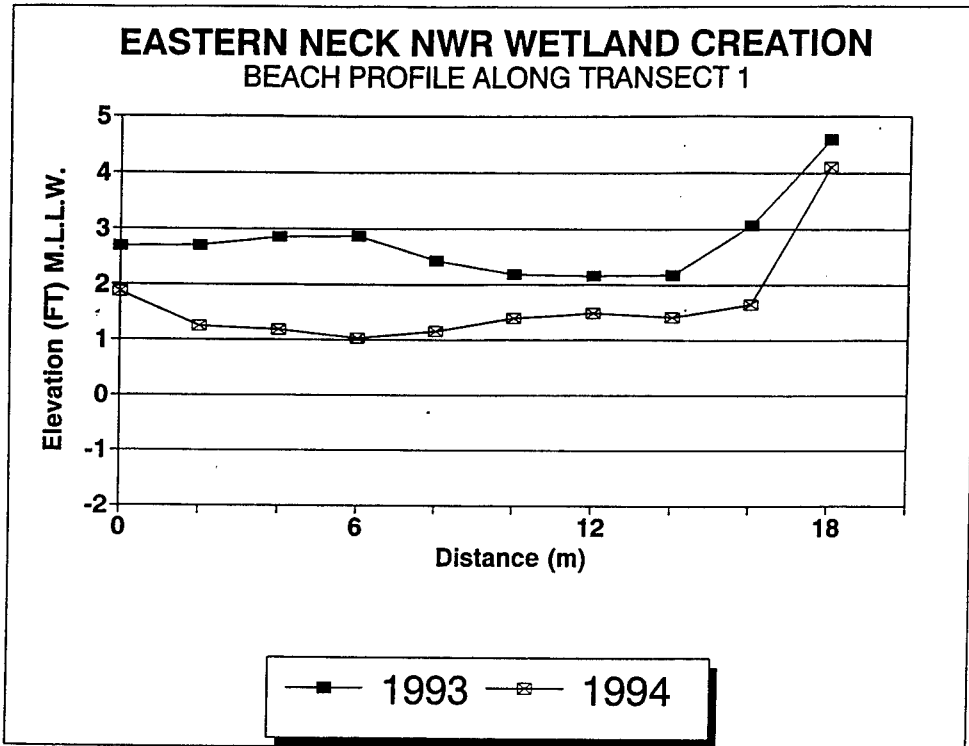
Dredged material beach profiles are presented in Appendix A. Elevations were taken in the summer of 1993 immediately after dredged material placement, and again in the summer of 1994. Measurements are presented by transect. Benchmark D was lost to erosion during the winters of 1993 and 1994; therefore, profiles are missing for Transects 12 and 13. Data are lacking for Transect 9.
