NASA
Technical Memorandum 107008

Microstructural and Strength Stability of a Developmental CVD SiC Fiber

Ramakrishna T. Bhatt
Vehicle Propulsion Directorate
U.S. Army Research Laboratory
Lewis Research Center
Cleveland, Ohio

Prepared for the
96th Annual Meeting and Exposition
sponsored by the American Ceramic Society
Indianapolis, Indiana, April 24-28, 1994

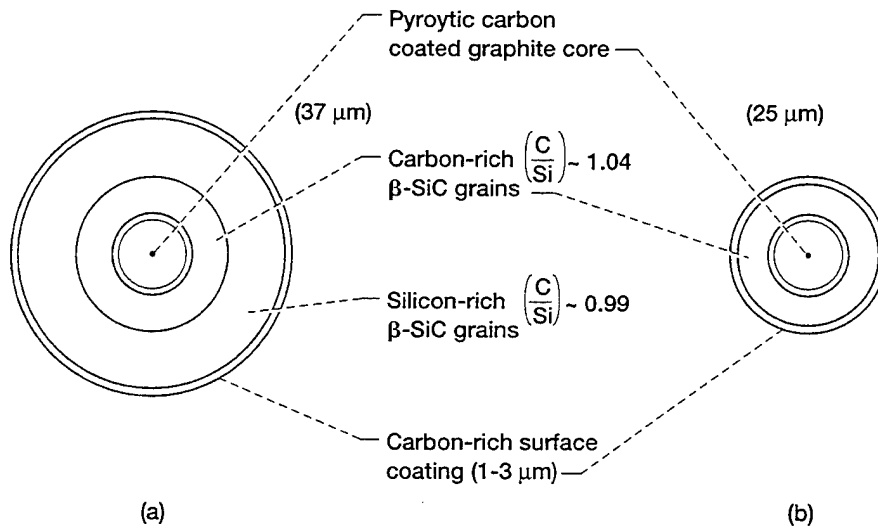
Figure 1.—Cross-section of CVD SiC fibers. (a) Textron SCS-6 fiber (~140 μm).
 (b) Textron developmental SiC fiber (~50 μm).

The 50 μm SiC fiber used in this study was manufactured by CVD of SiC onto a heated pyrolytic carbon-coated ~ 25 μm graphite core in a single stage reactor. Microstructurally, this fiber and the standard grade of CVD SiC fibers (SCS-6) manufactured by TSM are distinctly different. Schematics of the fiber cross-sections are shown in figure 1. The 50 μm SiC fiber contains a single zone of carbon-rich SiC, whereas the SCS-6 fiber contains two zones of SiC having different composition. The C/Si ratio in the SiC sheath of the 50 μm SiC fiber is similar to that of the inner zone of the SCS-6 fiber as determined by electron microprobe. Both fibers had ~ 1 to 3 μm thick carbon-rich coating on the outer surface of the SiC sheath. The coating is used to improve strength and abrasion resistance of the fiber (ref. 4).

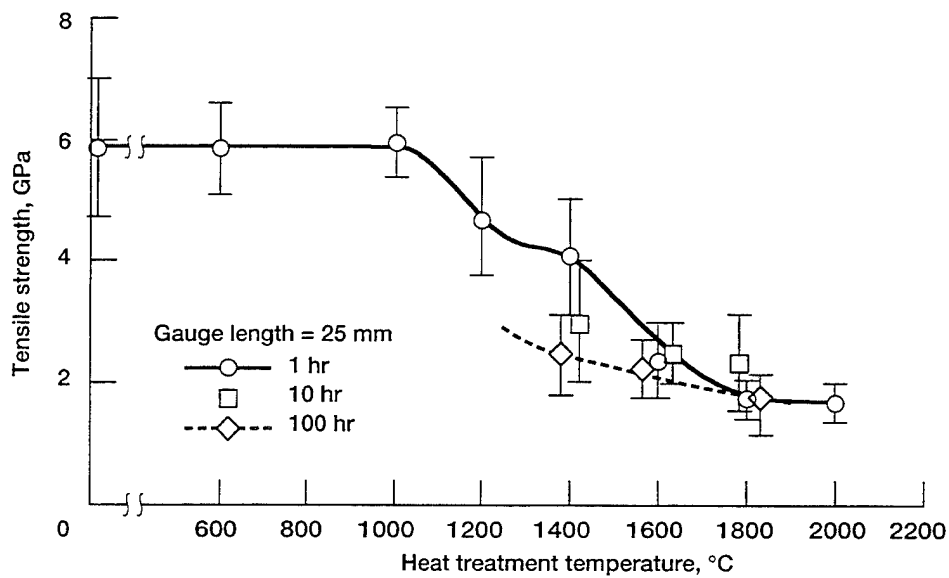
Figure 2.—Effects of temperature on the room-temperature tensile strength of 50 μm SiC fibers heat-treatment in 0.1 MPa argon.

Effects of thermal exposure on the room-temperature tensile strength of the 50 μm SiC fibers after heat treatment in 0.1 MPa argon for 1, 10, and 100 hr from 600 to 2000 $^{\circ}\text{C}$ are shown in figure 2. For comparison, the strength of the as-fabricated fibers (~ 6 GPa) is also shown in the figure. Each data point represents an average of 10 to 15 individual tensile tests and the error bar represents one standard deviation. After one hour heat treatment in argon up to 1000 $^{\circ}\text{C}$, the fibers displayed strength levels similar to that of the as-fabricated fibers. From 1100 to 1600 $^{\circ}\text{C}$, the tensile strength decreased with increasing temperature. In the same temperature range, a slight decrease in strength was noticed with increasing exposure time, but the temperature of exposure had a greater influence on strength degradation than the time of exposure. Beyond 1600 $^{\circ}\text{C}$, the strength approached ~ 2 GPa, and the time of exposure had no significant influence on the strength.

It is evident from this study that the developmental 50 μm SiC fibers show high as-received strength, ~6 GPa, and that even after 1 hr argon treatment between 1600 and 2000 °C, these fibers display high retained strength, ~2 GPa. This value is significantly higher than the strengths of SCS-6 or of Hi-Nicalon fibers after exposure to similar conditions. In argon environment, tensile strength degradation of the 50 μm SiC fibers starts at ~1000 °C and occurs in two stages as displayed by the shape of the tensile strength versus heat-treatment temperature plot (fig. 2): the first stage ranging from 1000 to 1200 °C and the second stage ranging from 1300 to 1600 °C.

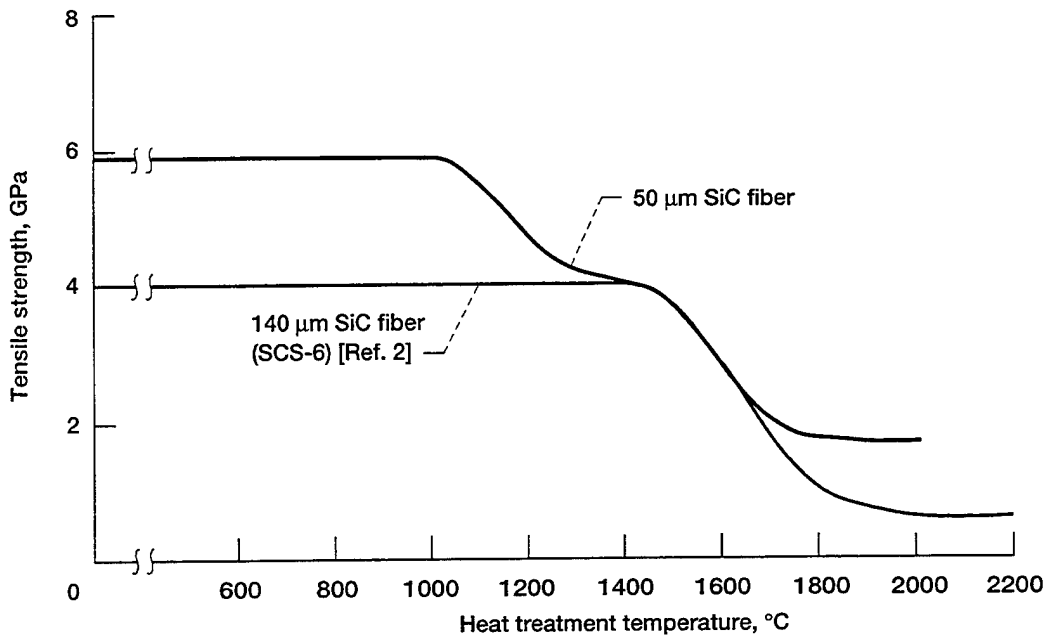
Figure 3.—Comparison of room-temperature tensile strengths of the 50 μm and 140 μm (SCS-6) SiC fibers after 1 hr heat-treatment in 0.1 MPa argon.

In figure 3, the average room-temperature tensile strength data for the 50 μm SiC fibers after 1 and 100 hr exposure in argon between 600 and 2000 $^{\circ}\text{C}$ are compared with the data reported previously for the SCS-6 fibers in the same environment after 1 hr exposure in the same temperature range (ref. 2). Comparison of the best fit data in figure 3 indicates the following: First, the average as-fabricated tensile strength of the 50 μm fibers is higher than

that of the SCS-6 fibers. Second, after 1 hr exposure the 50 μm SiC fibers begin to show strength degradation at a lower temperature than the SCS-6 fibers. Third, the residual strengths of the 50 μm SiC fibers after 1 hr exposure between 1400 and 1700°C are similar to those of the SCS-6 fibers. Fourth, the residual strengths of the 50 μm SiC fibers exposed between 1600 and 2000 °C are generally higher than those of the SCS-6 fibers.

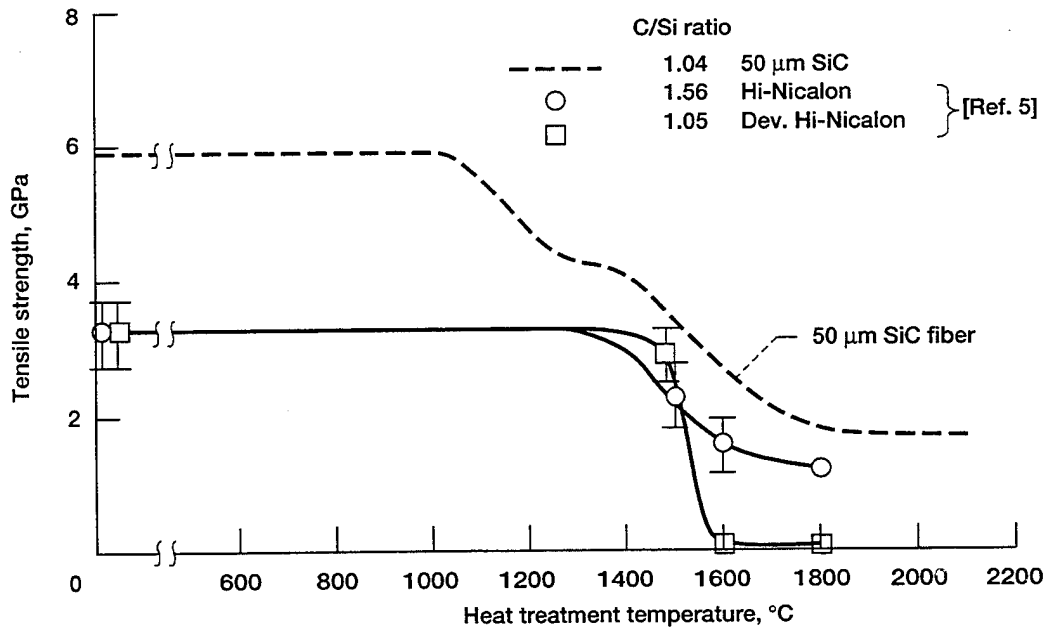
Figure 4.—Comparison of room-temperature tensile strengths of the 50 μm and 14 μm Hi-Nicalon SiC fibers after 1 hr heat-treatment in 0.1 MPa argon.

In figure 4, the room temperature tensile strength data of the 50 μm SiC fiber after 1 hr exposure in argon between 600 and 1800 °C are compared with the data reported for the two types of SiC fibers derived from polymer precursor methods (Commercially available Hi-Nicalon and a developmental Hi-Nicalon) (ref. 5). For comparison purposes, the carbon to silicon (C/Si) ratios of the fibers are also given. The C/Si ratio of commercially available Hi-Nicalon is significantly higher than that of the 50 μm SiC fibers. On the other hand, C/Si ratios of the developmental Hi-Nicalon and the 50 μm SiC fibers are similar. According to figure 4, the 50 μm SiC fiber shows strength degradation at a lower temperature (1000 °C) than both types of Hi-Nicalons. Beyond 1500 °C, the 50 μm SiC fiber displays higher strength retention than both types of Hi-Nicalons. In fact, the developmental Hi-Nicalons have no strength at all after 1 hr exposure in argon beyond 1600 °C.

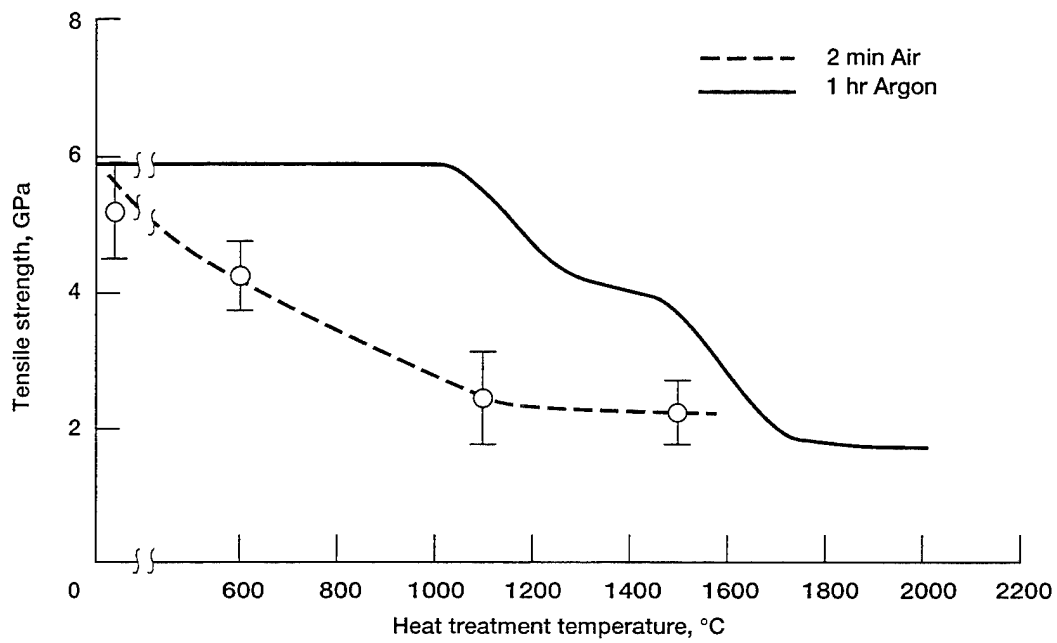
Figure 5.—Effects of temperature on the room-temperature tensile strength of the 50 μm SiC fibers heat-treatment in air.

Influence of oxidation on the room-temperature tensile strength of the 50 μm SiC fibers is shown in figure 5. For this study, fibers were heat treated in air for 2 min between 600 and 1500 °C and then tested at room temperature. Exposure temperatures above 1500 °C were not used to avoid strength degradation due to rapid and thick SiO₂ growth on the fiber surface. Figure 5 shows that with increasing exposure temperature, strength of the fiber decreased continuously and for 2 min in air near 1000 °C attained a level similar to that of the fibers heat-treated between 1500 and 1800 °C for 1 hr in argon.

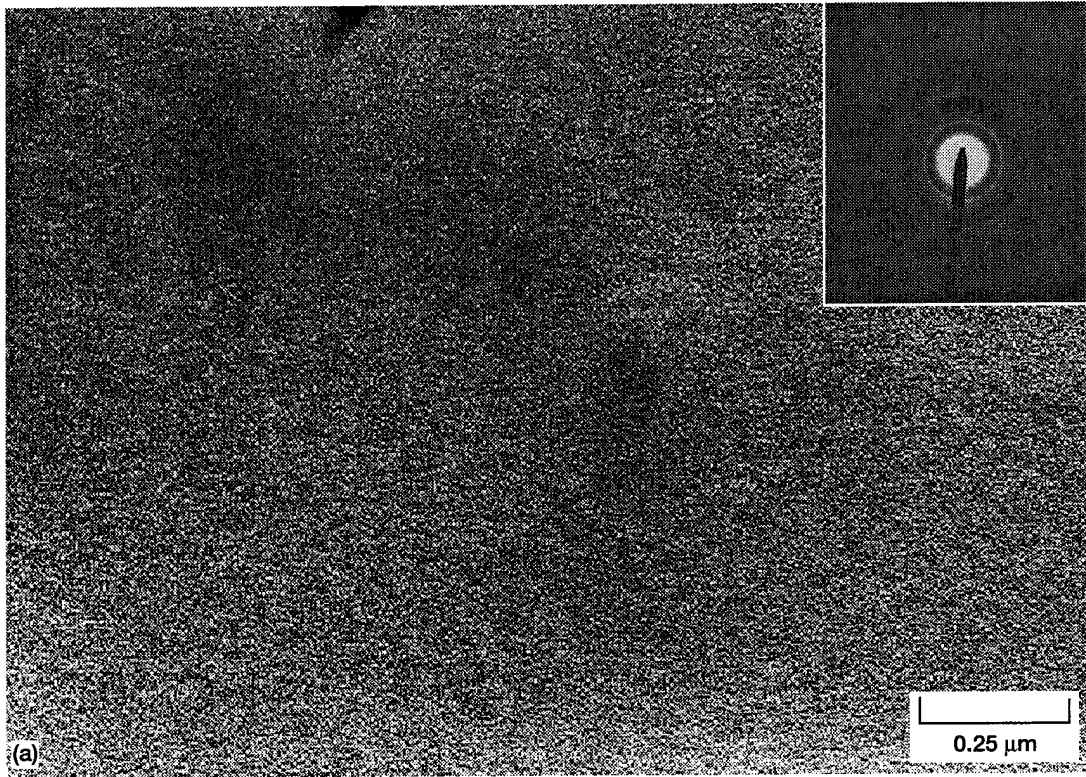
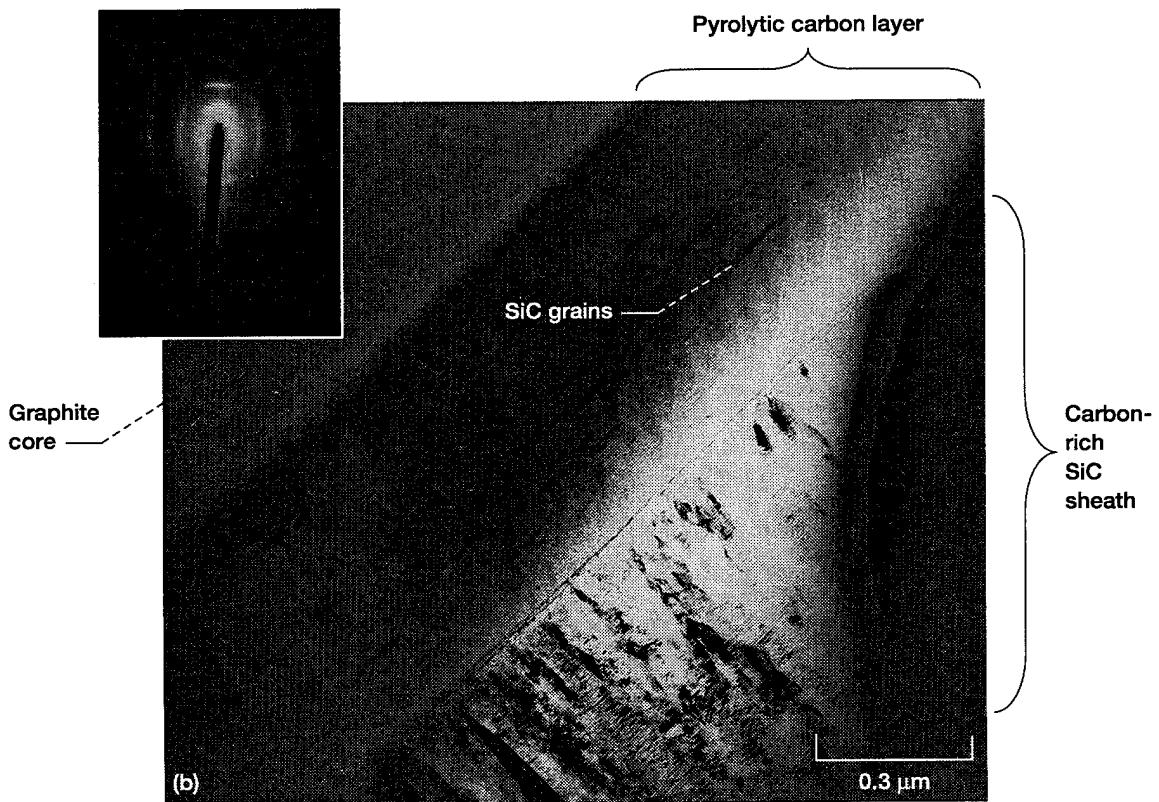
Figure 6.—TEM micrographs and corresponding SADP of different zones of an as-received 50 μm SiC fiber. (a) Graphite core. (b) Pyrolytic carbon layer on the carbon core. (c) Carbon-rich SiC sheath. (d) Carbon-rich surface coating.

To determine argon heat-treatment effects on the microstructure of fibers, TEM analysis was performed on the as-received and heat-treated fibers. In all cases, microstructure of the pyrolytic carbon coated graphite core, SiC sheath, and surface coating were analyzed. Results of this analysis for the as-received fibers are shown in figure 6. The core of the fiber contains randomly oriented turbostratic carbon (TC) blocks (fig. 6(a)). The pyrolytic carbon layer on top of the graphite core consists of TC blocks having a textured orientation. This layer is ~0.6 μm thick (fig. 6(b)) and contains elongated SiC grains that are oriented normal to the radius of the fiber. The aspect ratio of these SiC grains is ~13. The carbon-rich SiC sheath is ~12 μm thick and consists of elongated β -SiC grains running along the radius of the fiber (fig. 6(c)). These β -SiC grains are highly faulted and have an aspect ratio of ~8. The surface coating on top of the SiC sheath has two layers (fig. 6(d)). The first layer adjacent to the carbon-rich SiC sheath consists of textured TC blocks and small elongated SiC grains similar to that present in the pyrolytic carbon layer on the core. The aspect ratio of SiC grains is ~8. The outer most carbon layer consists of textured TC blocks and finely dispersed SiC particulates.

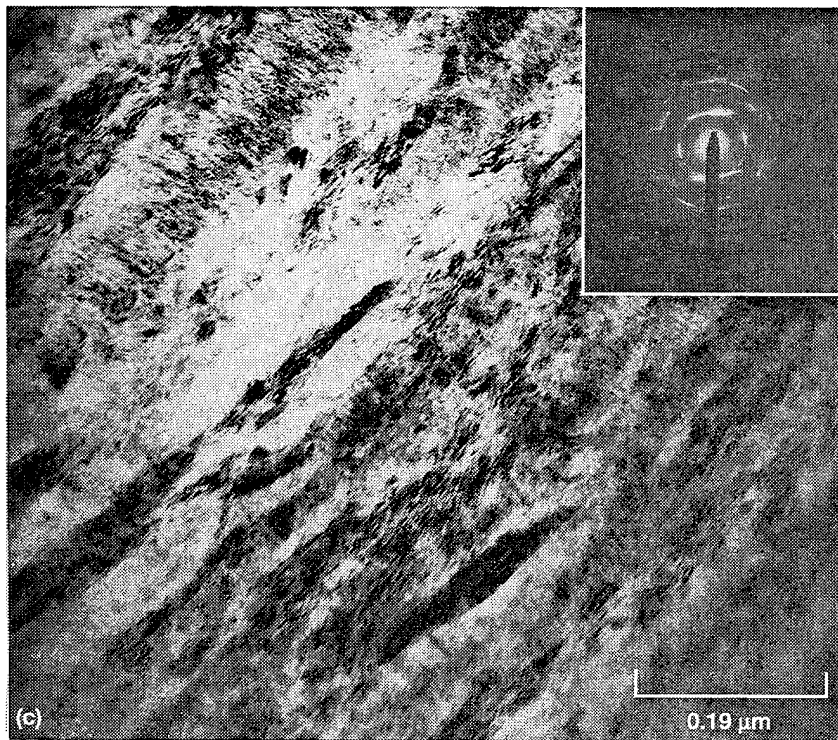
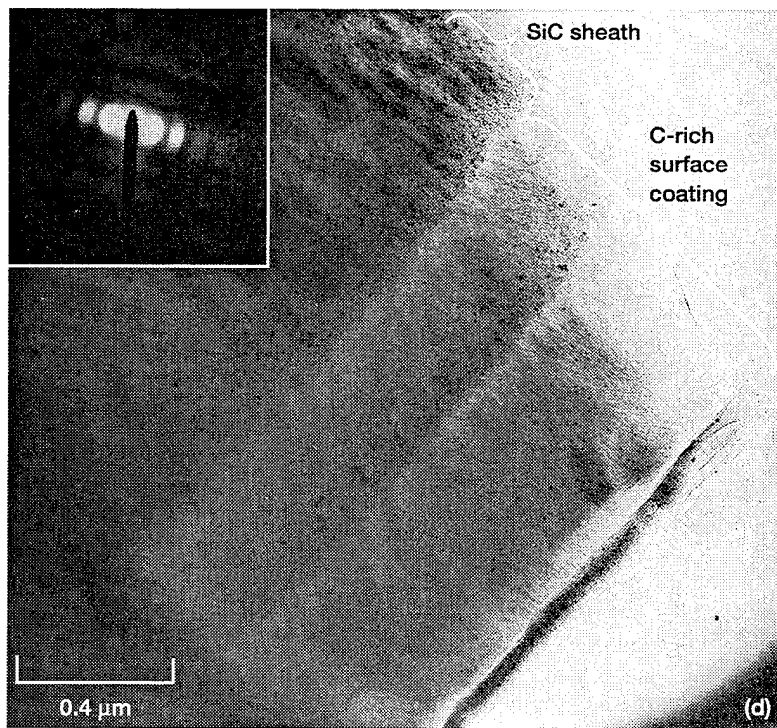
Figure 6.—Concluded. (c) Carbon-rich SiC sheath. (d) Carbon-rich surface coating.

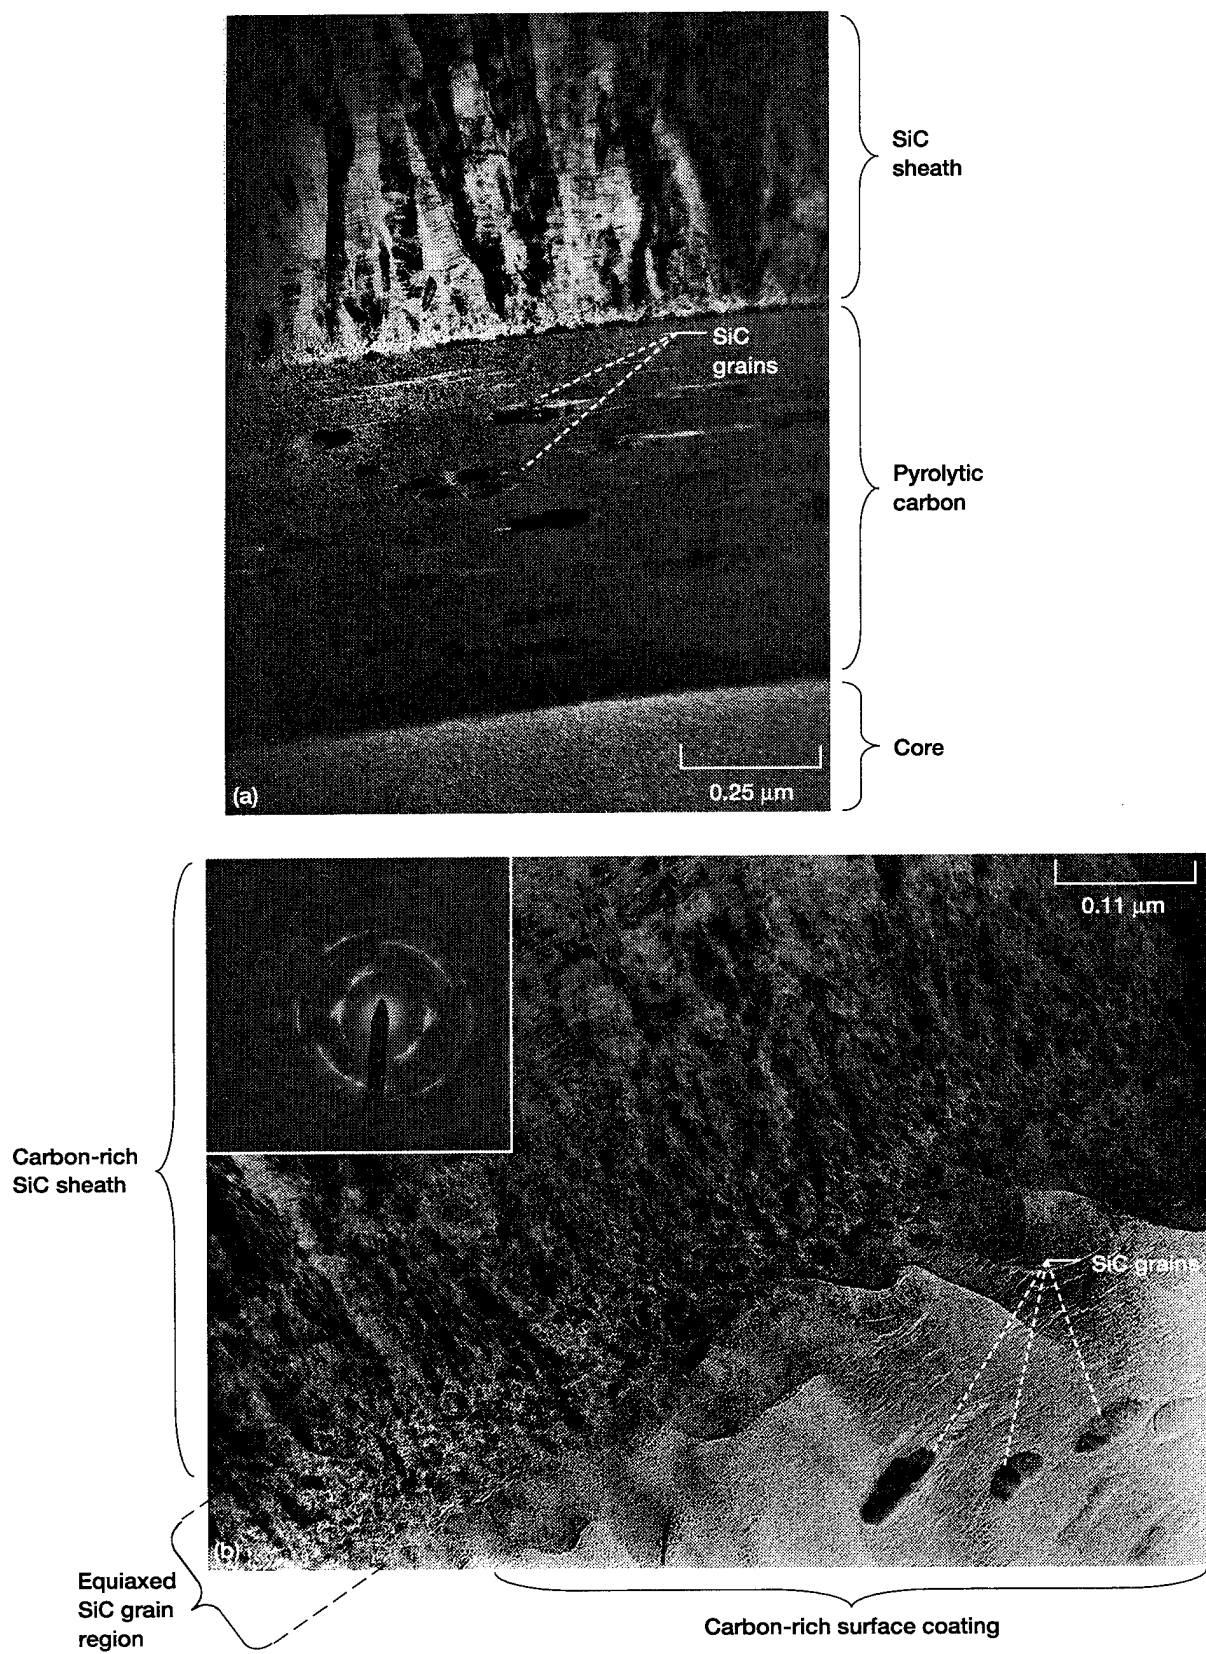
Figure 7.—TEM micrographs and corresponding SADP of a 50 μm SiC fiber heat-treated in argon at 1400 °C for 1 hr. (a) Pyrocarbon layer on the graphite core. (b) SiC sheath and carbon-rich surface coating interface.

One hour heat-treatment in argon at temperatures to 2000 °C had no significant effect on the microstructure of the graphite core and it remained turbostratic, but other zones of the fiber showed microstructural changes after 1 hr heat treatment beyond 1200 °C. With increasing temperature of exposure, spheroidization of SiC grains was observed in the pyrocarbon layer on top of the graphite core, and in the carbon-rich surface coating (figs. 7 and 8). At 1400 °C, a zone of equiaxed SiC grains formed at the interfaces of the SiC sheath and the pyrocarbon layer on the graphite core, and of the SiC sheath and the carbon-rich surface coating (figs. 7(a) and (b)). This zone, however, stopped growing after 1 hr exposure beyond 1600 °C. Typical thickness of the zone is ~100 nm. As the heat treatment temperature was increased, no change in the aspect ratio of the faulted grains in the SiC sheath was noticed, but secondary SiC grains started nucleating and growing along the original grain boundaries and at the intersection of two or more grains (fig. 8). The rate of growth of these secondary grains was slow.

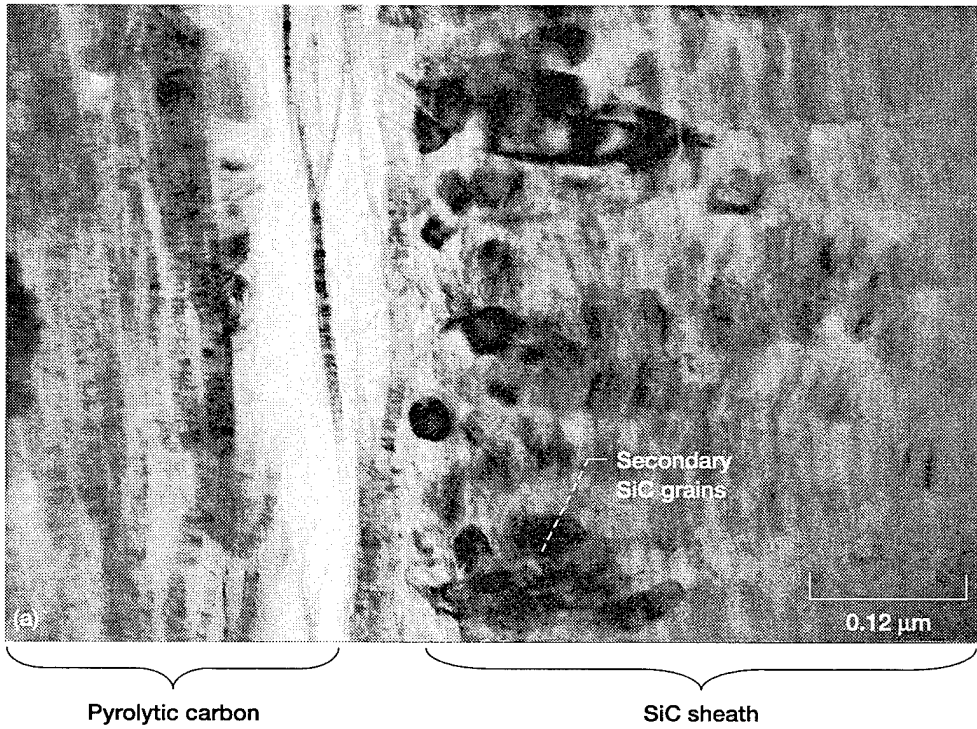
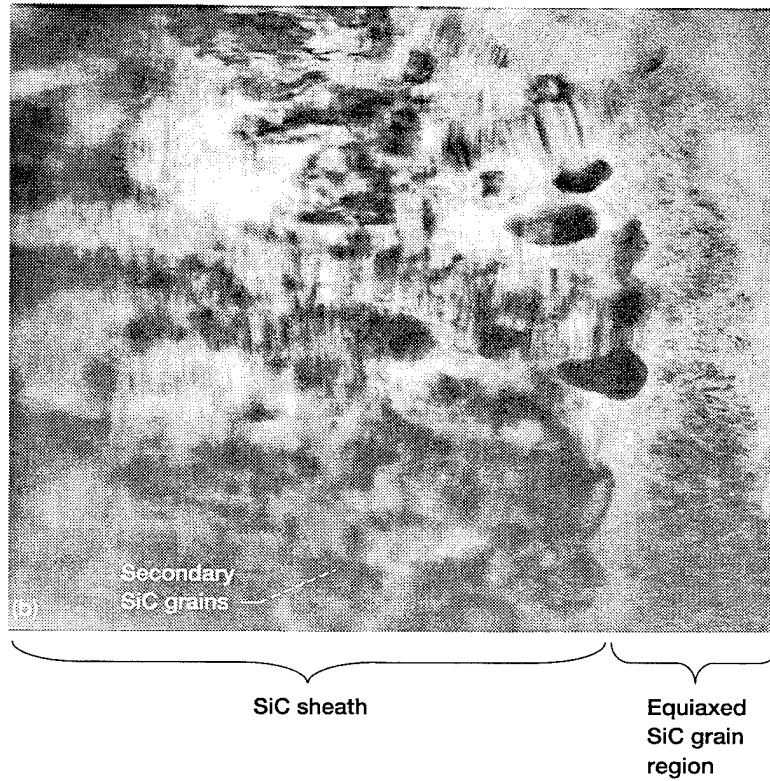
Figure 8.—TEM micrographs of the interfaces of a 50 μm SiC fiber heat-treated in argon at 1800 $^{\circ}\text{C}$ for 1 hr. (a) Interface between pyrocarbon layer and SiC sheath. (b) Interface between SiC sheath and carbon-rich surface coating.

The second stage of strength degradation takes place between 1300 and 1600 °C. In this temperature range, TEM study indicates that this degradation is the result of the flaws created by nucleation and growth of the equiaxed SiC grains in the SiC sheath at the pyrocarbon layer/C-rich SiC sheath, and the C-rich SiC sheath/C-rich surface coating interfaces, and along the grain boundaries of elongated SiC grains of the SiC sheath. The growth of the secondary SiC grains at the boundaries of the original grains is observed only in the 50 μm SiC fibers heat-treated beyond 1300 °C. Such growth was not observed in the heat-treated SiC fibers with Si-rich composition (SCS-6). The slow growth of these equiaxed SiC grains in the 50 μm SiC fibers with increasing time and temperature helps in limiting the size of the flaws. This allows the fiber to maintain the strength levels to ~2 GPa.
