**US Army Corps  
of Engineers**

Waterways Experiment  
Station

Miscellaneous Paper SL-95-5  
December 1995

# **Evaluation of Concrete Seawalls at Perry's Victory and International Peace Memorial**

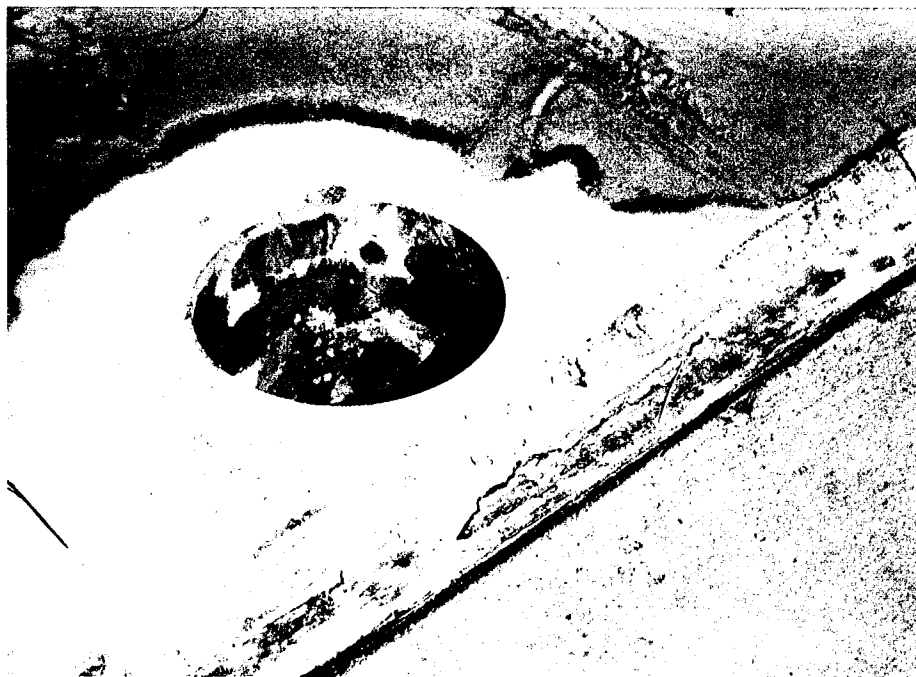
A visual inspection of the north seawall found that most of the distress and deterioration in the concrete was observed at the vertical joints. At a few of the joints, the distress was observed at both corners of the top surface and in the landside face (Figures 1 and 2). Localized distress was observed in the form of hairline cracks with a reddish-brown stain coming from some of the cracks at the ladder recess of monolith N22 (Figure 3). Moisture was retained in some of the aggregate visible in the surface of new borings (Figure 4).

Figure 4. Moisture retained in and around some of the aggregate particles visible in the surface of boring at joint 37/38, north seawall monolith N38

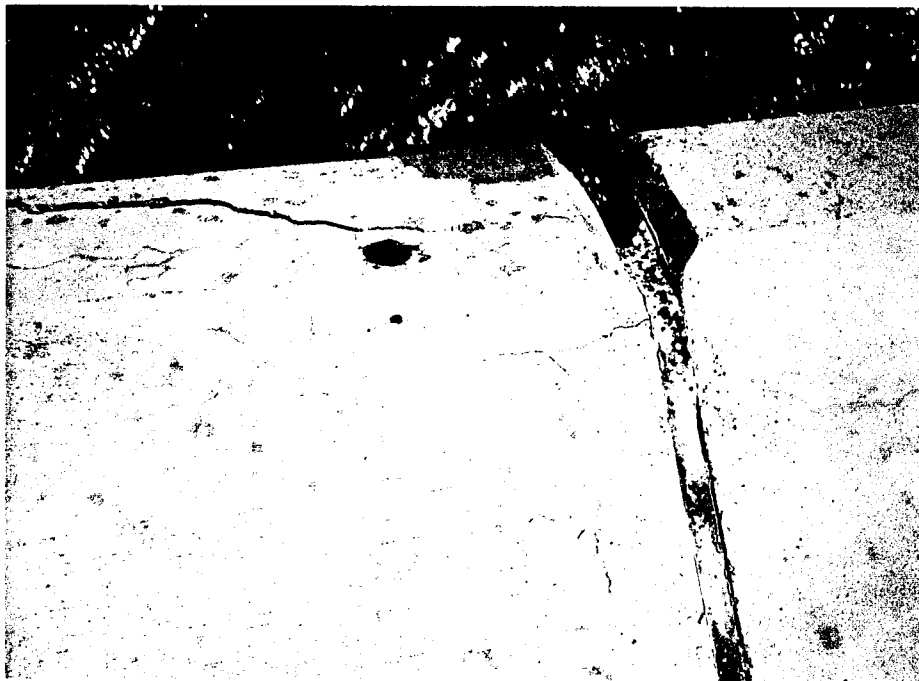
A visual inspection of the south seawall found that most of the distress and deterioration in the concrete was observed along the top-lakeside edges at the vertical joints (Figures 5 - 8). Extensive cracking was observed in the tops of four monoliths, S7, S16, S17, and S20 (Figures 9 -14). Areas of reddish-brown stains were observed coming from cracking along a longitudinal plane in landside (Figures 10 and 11) and lakeside faces of these monoliths.

Figure 8. Cracking along lakeside edge at joint 71/72, south seawall monolith S72

| Monolith | Reference Point | Description of Repair |
|---|---|---|
| S72* | Joint 71/72 | Remove and replace from joint back approximately 610 mm (24 in.) and from top down 380 mm (15 in.) |

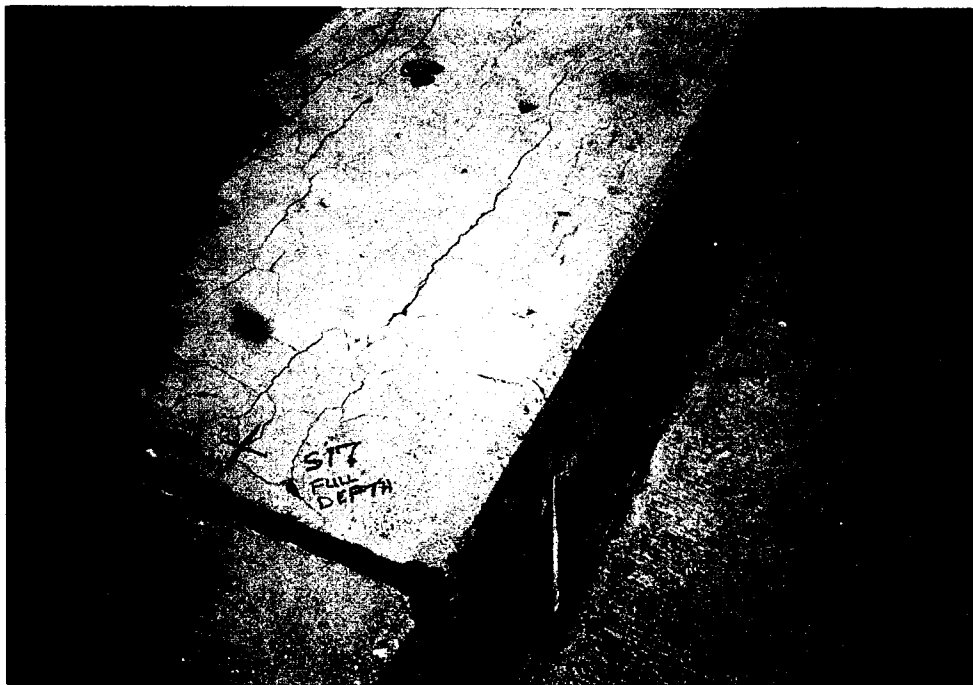
Figure 11. Cracks and stains in faces of south seawall monolith S17 at joint 17/18

Corrosion of the reinforcing steel was indicated in the four south seawall monoliths by areas of reddish-brown stains coming from cracking along a longitudinal plane in landside and lakeside faces. Reddish-brown stains were also observed coming from cracks in the concrete at the ladder recess of north seawall monolith N22.

| Monolith | Reference Point | Description of Repair |
|---|---|---|
| S17* | Entire Monolith | Remove and replace top 460 mm (18 in.) of monolith |

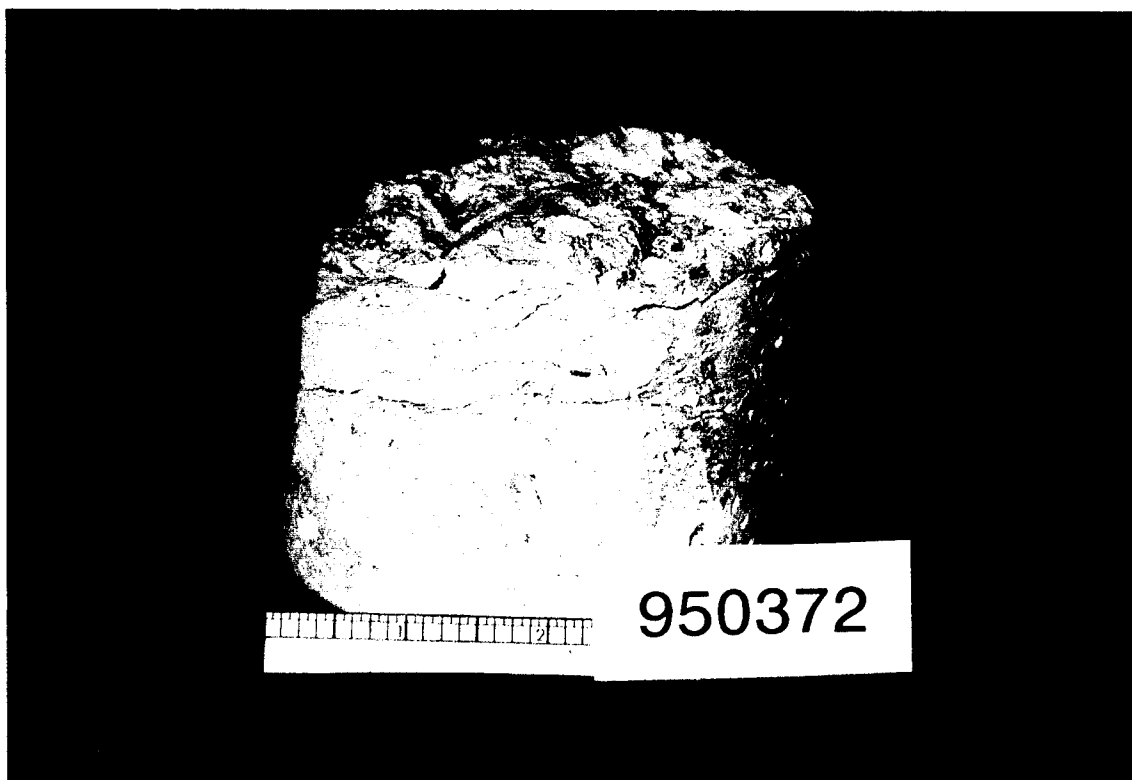
Figure B-29. Cracking parallel to top surface of structure (bottom of photo) occurs several inches below surface and cannot be detected by visual examination

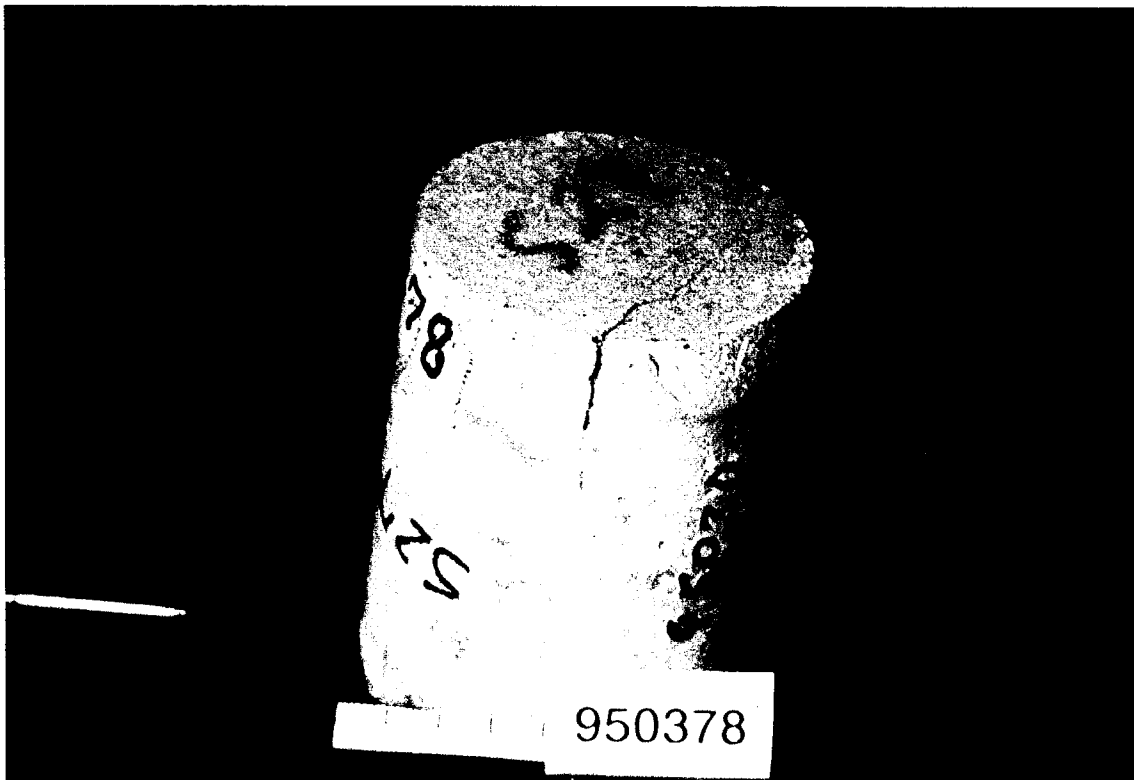
Figure B-30. Vertical crack in sample 950378 goes to the surface of the concrete
