# REPORT NO. 95-19

## HIGH MOBILITY TRAILER (HMT) TRANSPORTABILITY TESTING

Prepared for:  
Commander  
U.S. Army Tank-automotive  
and Armaments Command  
ATTN: AMSTA-TR-E/LTV  
Warren, MI 48397-5000

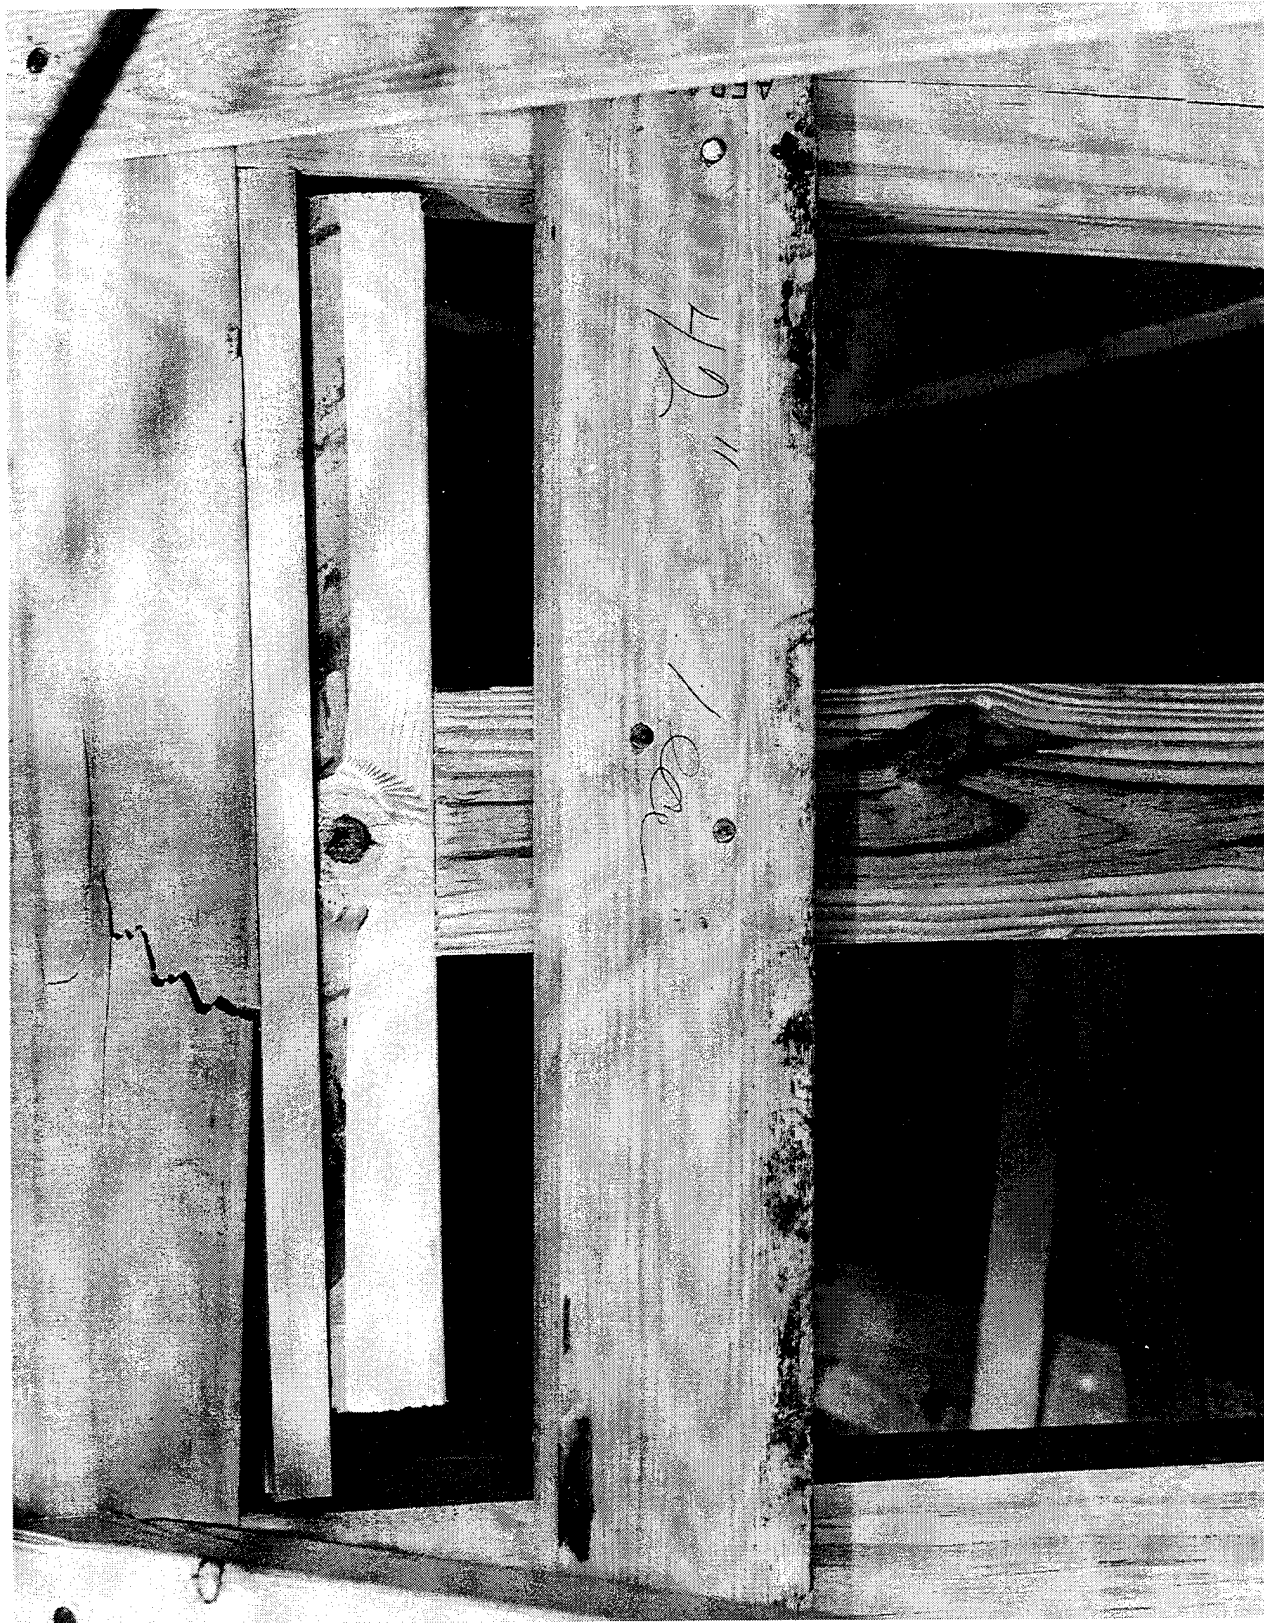
AO317-SCN96-7-291. This photo shows the crack in the stanchion. The stanchion was reinforced as shown.

2. Six 3/8-inch steel wire ropes (cables) were used to secure the loaded trailer to the flatcar, one rope/cable through each of the four trailer tiedown anchors and two ropes/cables through the lunette of the tongue. The trailer tongue was placed on a stanchion and the jack was removed. The stanchion cracked while the HMT was being cabled and was reinforced prior to testing (see photo on page 6-3). The aft end of the loaded HMT was forward for rail impact tests at nominal speeds of 4, 6, and 8.1 mph. The front end wall was forward for the reverse 8.1 mph impact.
