NASA Technical Memorandum 78796

THE EFFECT OF IMPACT DAMAGE AND CIRCULAR HOLES ON THE COMPRESSIVE STRENGTH OF A GRAPHITE-EPOXY LAMINATE

James H. Starnes, Jr., Marvin D. Rhodes and Jerry G. Williams

October 1978

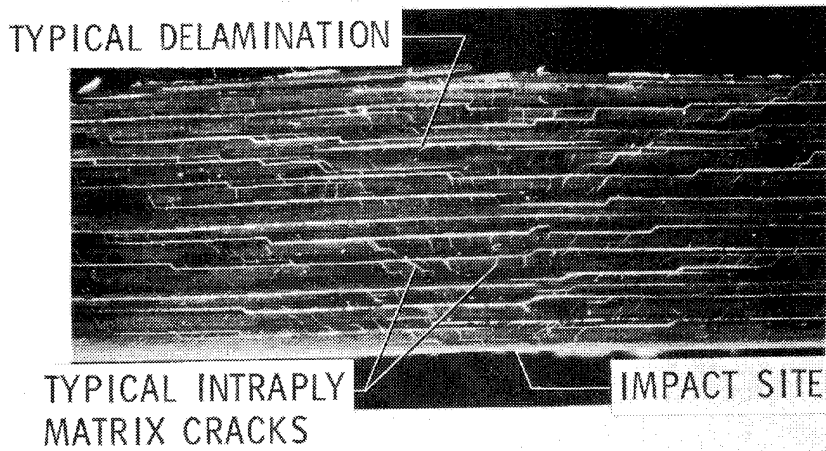
(a) 58 m/s projectile impact speed.

(b) 95 m/s projectile impact speed.

Figure 5. - Photomicrographs of cross sections through the impact site normal to the 0° fibers.

Unloaded specimens were subjected to impact to determine the character of local impact damage. Photographs of the back surfaces of two specimens impacted at 58 and 95 m/s are shown in figure 3. The light colored regions shown in the figure are regions where the brittle lacquer spalled behind the impact location. Radial cracks in the brittle lacquer near the spalled region are also visible. Both the radial cracks and the spalled region indicate that significant deformations have occurred locally due to impact. There is no visible damage to the graphite epoxy on the back surface of the specimen impacted at 58 m/s, but some local surface cracks in the graphite epoxy are visible on the back surface of the specimen impacted at 95 m/s. There is no visible front-surface damage at the impact location of either specimens. Photographs of ultrasonic C scans of the damaged regions of these specimens are shown in figure 4 with the same scale used in figure 3. Each pass of the transducer is represented by a light colored line in the figure. The size of the dark regions indicates the extent of damage in both specimens as a result of impact. The damaged region of the specimen impacted at 58 m/s is smaller and more elongated in the 0° direction than the specimen impacted at 95 m/s. Ultrasonic inspection also indicates that the spalled brittle lacquer provides a qualitative approximation to the size of the damaged region. Photomicrographs of a cross section normal to the 0° fibers through the damaged region of the specimens are shown in figure 5. The photomicrograph of the specimen impacted at 58 m/s shows only a small amount of intraply

cracking and delamination in the impact region. The photomicrograph of the specimen impacted at 95 m/s shows extensive intraply matrix cracking and delamination in the impact region. This cracking and delamination extends 3.4 cm across the width of the specimen. This extensive region of delamination has changed the 48-ply orthotropic laminate into a number of thinner sublaminates in the damaged region that are likely to be anisotropic, thus reducing local stiffnesses and causing local anisotropic coupling. The ultrasonic C scans in figure 4 and the photomicrographs in figure 5 indicate that the projectile used in this study causes substantial internal damage to the laminate with no visible external damage at the impact site for speeds up to approximately 100 m/s.

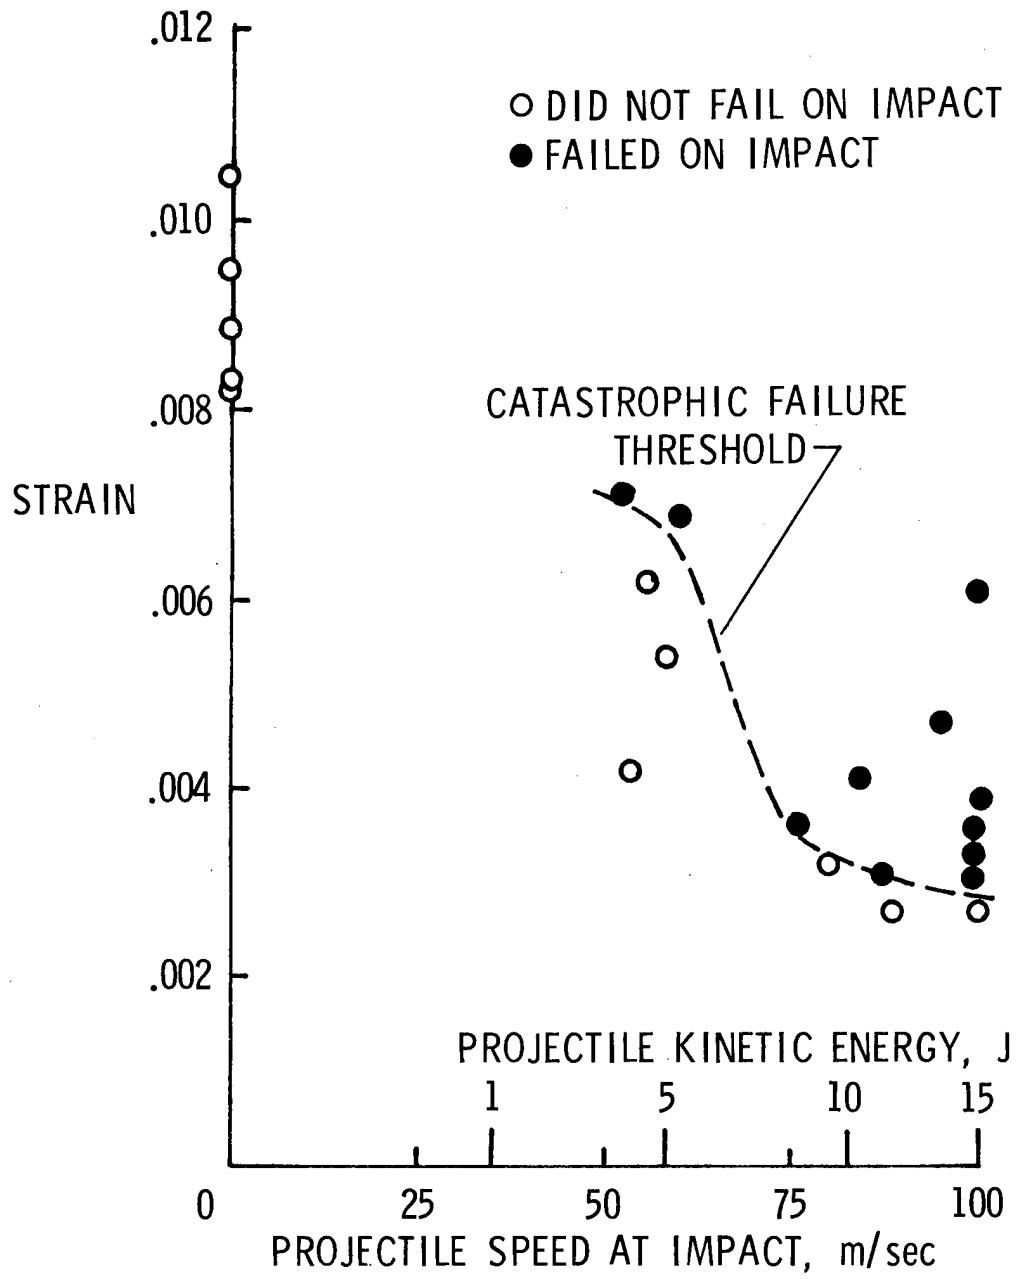
Figure 6. - Effect of projectile speed on catastrophic failure strain.

Impact-damage specimens. - The results of the impact-damage tests are presented in Table 3, and the effect of projectile speed on specimens impacted while loaded to a prescribed axial strain is shown in figure 6. The applied axial strains of the loaded specimens that failed catastrophically on impact are represented by the filled circles in figure 6 and the applied strains of the specimens that did not fail catastrophically on impact are represented by open circles. The results from Table 2 for the undamaged control specimens are shown on the ordinate as open circles for comparison, and the projectile kinetic energy is also shown on the abscissa for reference. The dashed curve in figure 6 represents a lower bound or catastrophic failure threshold separating results of specimens that failed on impact from those that did not. The trend of this catastrophic failure threshold indicates that the compressive strength of these loaded impact specimens is seriously degraded with increasing projectile speed with most of the degradation having occurred by about 80 m/s. A typical failed specimen is shown in figure 7.

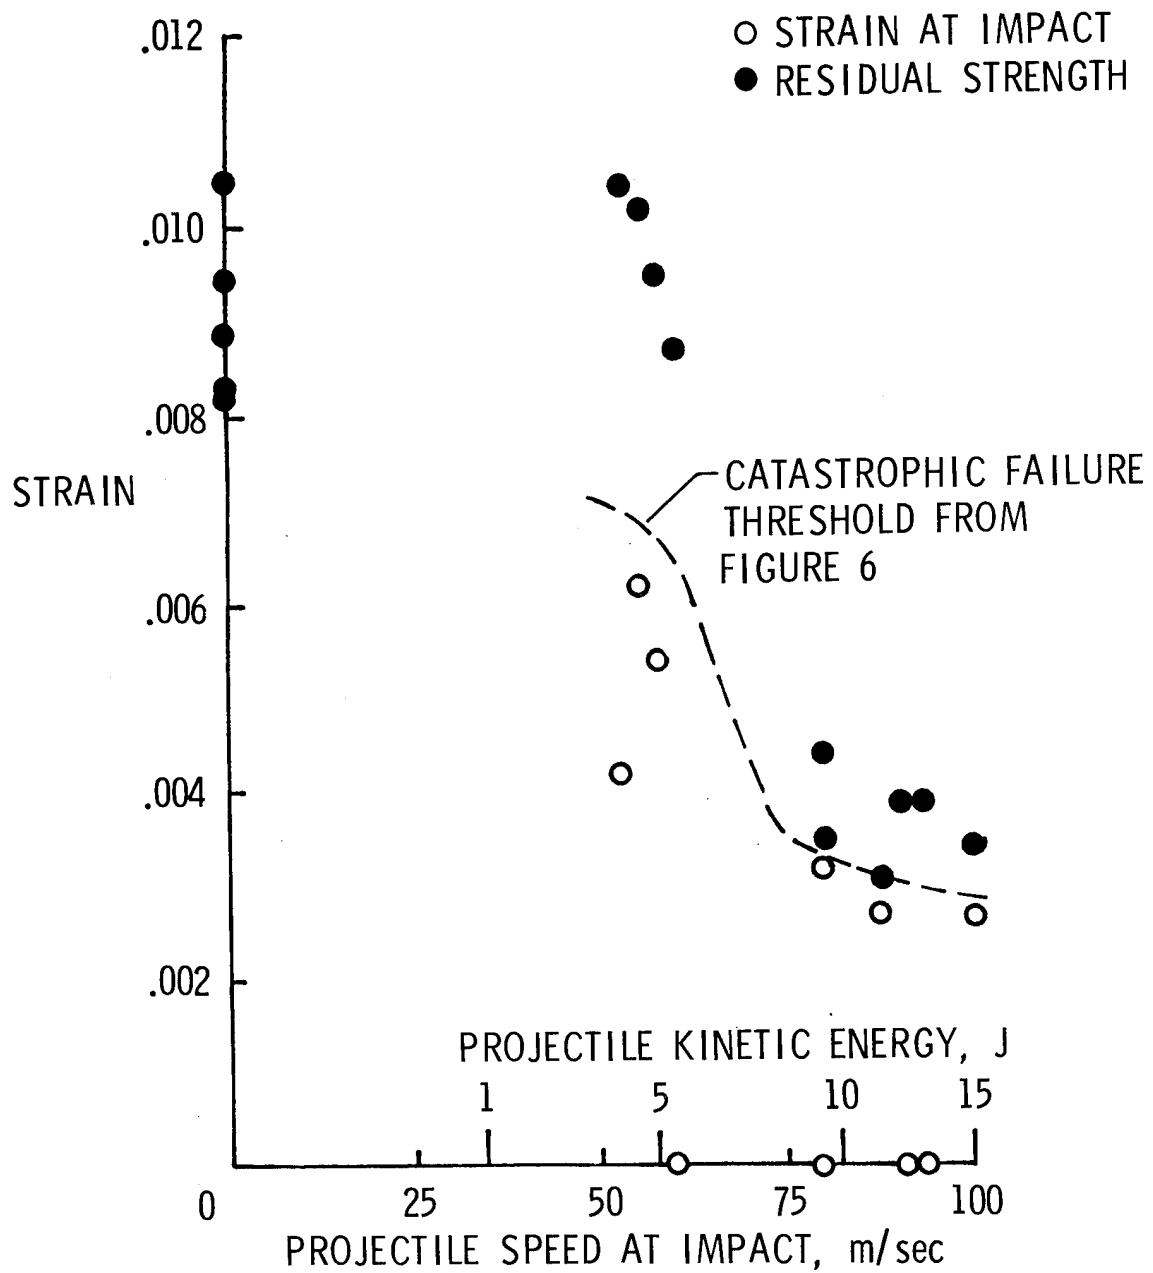
Figure 8. - Effect of projectile speed on residual strength.

The effect of projectile speed on the residual strength of all specimens that did not fail catastrophically on impact is shown in figure 8. The open circles in figure 8 indicate the axial strain the specimens were carrying at the moment of impact, and the filled circles represent the strain at failure measured during residual strength tests. Each open circle in figure 8 has a corresponding filled circle directly above it, and the difference in strain between two corresponding circles represents the additional applied axial strain carried by a damaged specimen. Results from Table 2 for the control tests are shown on the ordinate of figure 8 as filled circles for comparison, and the projectile kinetic energy is shown on the abscissa for reference. The catastrophic failure threshold curve from figure 6 is also shown on figure 8 as a dashed curve for comparison. Specimens impacted in the 50 to 60 m/s range that did not fail catastrophically on impact have residual strengths between 0.0104 and 0.0087 axial strain which is on the same order as the undamaged control specimens. Three of the four specimens impacted in this speed range failed near an end fixture and the fourth failed through the impact site. Specimens impacted in the 80 to 100 m/s range have residual strengths that are only between 0.0044 and 0.0034 axial strain. Specimens impacted in this speed range with no applied axial load fail at higher values of applied axial strain than those impacted while loaded axially and, consequently, have higher residual strengths. Furthermore, a comparison of the residual strength results of figure 8 with the catastrophic failure threshold from figure 6 indicates that catastrophic failure of specimens impacted while loaded axially occurs at applied strains that are slightly below the residual strength results of specimens impacted without applied axial load in the 80 to 100 m/s projectile speed range. However, in the 50 to 60 m/s projectile speed range the catastrophic failure threshold strains for specimens impacted while loaded axially is on the order of 0.002 to 0.003 less strain than the residual strength results for specimens impacted without applied axial load. This difference in loaded and unloaded impact test results indicates that there is an interaction or coupling between the applied inplane load and the local deformations associated with impact. The existence of this coupling is also supported by ultrasonic C scan and cross sectional photomicrograph data. Ultrasonic C scans made before the residual strength tests indicate that damage due to impact for the specimens impacted between 50 and 60 m/s is local and approximately circular with 1.8 to 2.5 cm diameters. These specimens had no visible front- or back-surface damage. Visual inspection of the specimens impacted between 80 and 100 m/s indicated that some local 45° cracks existed on the back surfaces but no front-surface damage was evident. Ultrasonic C scans of these specimens indicate that the local damage due to impact is elliptical. For the specimens impacted without any applied axial strain, the size of the ellipse ranges from 3.6 cm wide by 4.3 cm long to 4.6 cm wide by 5.8 cm long with semimajor axes oriented in the axial direction. For specimen N20, which was impacted at 100 m/s while loaded by an applied axial strain of 0.0027, the ellipse is 5.1 cm wide by 3.8 cm long with its semimajor axis oriented in the transverse direction which is a change in orientation of 90° from the specimens impacted without applied axial strain. Instead of determining its residual strength, specimen N20

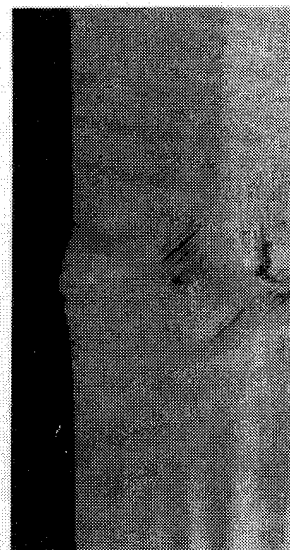
(a) 48 percent of residual strength.

(b) 61 percent of residual strength.

(c) 98 percent of residual strength.

(d) Failed specimen.

Figure 9. - Moiré-fringe patterns during residual-strength test of an impact damaged specimen.

Photographs of successive moire-fringe patterns from the residual strength test of specimen N7 are shown in figure 9. Specimen N7 was impacted at 91 m/s with no applied axial load. The photograph in figure 9a shows the moire-fringe pattern of the damaged region at 48 percent of the specimen residual strength. The small light colored circular region in the center of the specimen is the impact site which is beginning to deform out-of-plane. This deformation is the first observable response of the damaged region to the applied axial load. Subsequent moire-fringe patterns (figs. 9b and 9c) represent local buckling of the impact-damaged region that grows laterally as the applied load is increased. The photograph in figure 9d shows the failed specimen with the damage propagated laterally across the specimen in the same manner as the example shown in figure 7. Examination of the failed specimen removed from the test fixture confirmed that the damage propagated laterally and was confined axially to the region indicated in figure 9d.

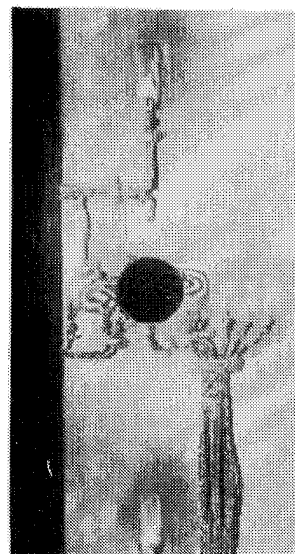
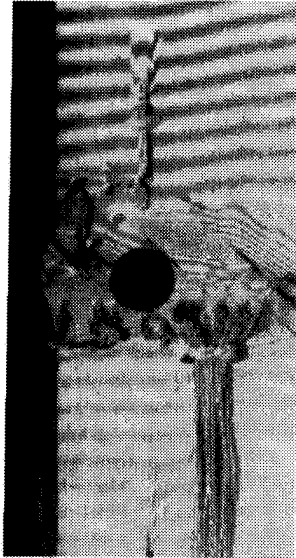
(a) 92.8 percent of ultimate load. No delamination.

(b) 95.4 percent of ultimate load. Delamination to left of hole.

(c) 95.9 percent of ultimate load. Additional delamination to right of hole.

(d) 98.1 percent of ultimate load. Delamination growth.

Figure 12. - Local delamination in hole region and propagation to failure. 1.91 cm diameter hole.

(e) Failed specimen.

A series of photographs of the propagating moire-fringe patterns for a specimen with a 1.91-cm-diameter hole is shown in figure 12 for increasing values of applied load. Figure 12a shows a photograph of the specimen loaded to 92.8 percent of the ultimate failure load and the absence of moire fringes indicates there are no out-of-plane deformations evident. At a slightly higher load (fig. 12b) a small out-of-plane deformation region developed at the left edge of the hole. These results, along with the strain gage results in the hole region and direct visual observations, indicate that a local delamination has developed near the hole. A second local delamination developed at the right edge of the hole (fig. 12c) after another slight increase in applied load. These delaminated regions continued to propagate, first in short discrete increments (fig. 12d), and then rapidly at the failure load (fig. 12e). The failed specimen shown in figure 12e was cut along an axial line passing through the center of the hole. A photograph of the cross section of the specimen in figure 13 shows many local delaminations through the thickness of the laminate. These delaminations extend completely across the specimen width but only extend a short distance in the axial direction.

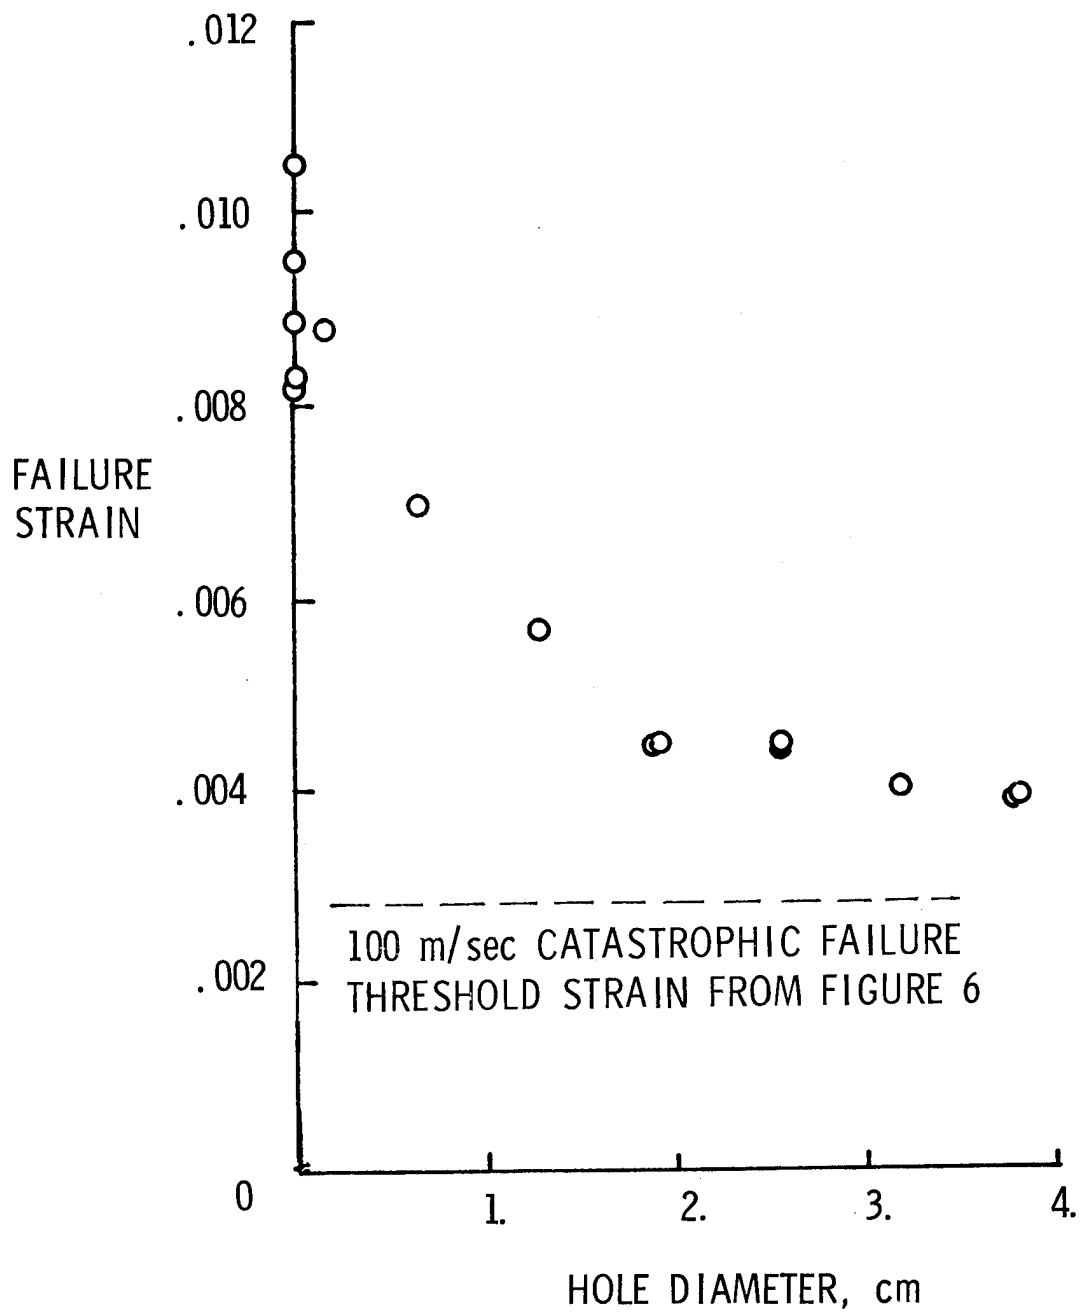
Figure 14. - Effect of hole diameter on laminate compressive strength.

The test results for the hole specimens are presented in Table 4, and the effect of hole diameter on failure strain is shown in figure 14. Results from Table 2 for the control tests are also shown on the ordinate of figure 14 for comparison. Specimen H1 with the 0.16 cm diameter hole failed near an end support fixture like the control specimens and at about the same strain. Thus, local effects associated with the test fixture were more critical than those of the hole for this specimen. All other specimens failed in the hole region at applied strains that decrease as the hole diameter increases. The catastrophic failure threshold from figure 6 for specimens impacted at 100 m/s is also shown in figure 14 as a dashed line for comparison with the hole results.
