## Nondestructive Testing of Graphite Fiber Composite Structures

D. Hagemailer, H. J. McFaul, and D. Moon

McDonnell Douglas Corporation

National Aeronautic and Space Engineering  
and Manufacturing Meeting  
Los Angeles, Calif.  
October 5-9, 1970

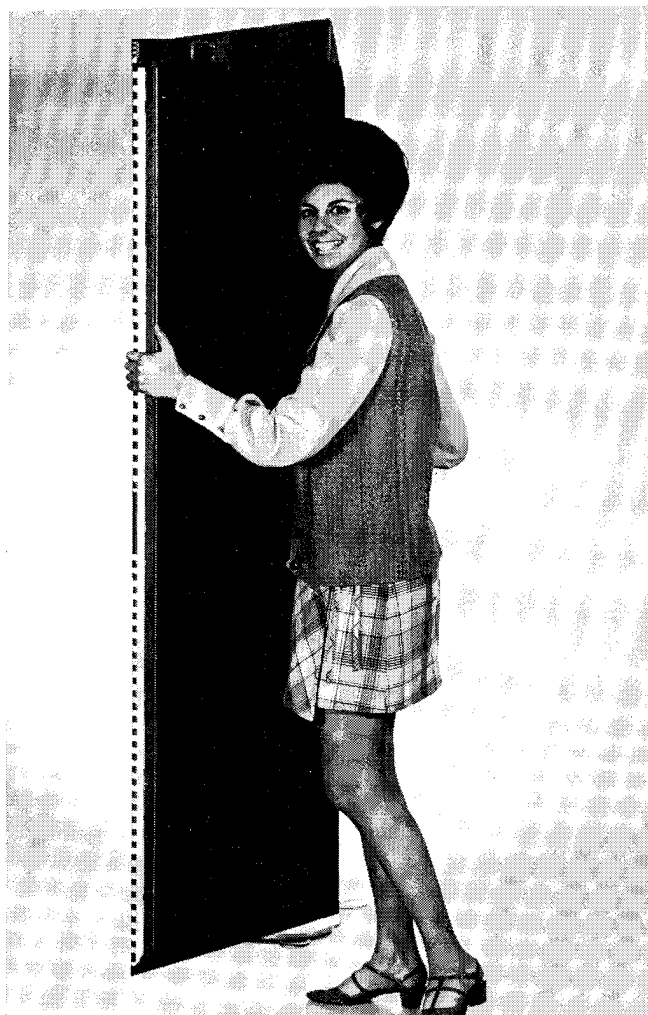
FIGURE 12. A-4 AIRCRAFT, GRAPHITE COMPOSITE/ALUMINUM HONEYCOMB FLAP ASSEMBLY

The A-4 flap assembly shown in Figure 12 was fabricated from Morganite II skins bonded to 5052 alloy honeycomb core by Narmco Metlbond 252. An added feature of the assembly was the successful fabrication of a molded graphite/epoxy actuator rib which is subsequently discussed.

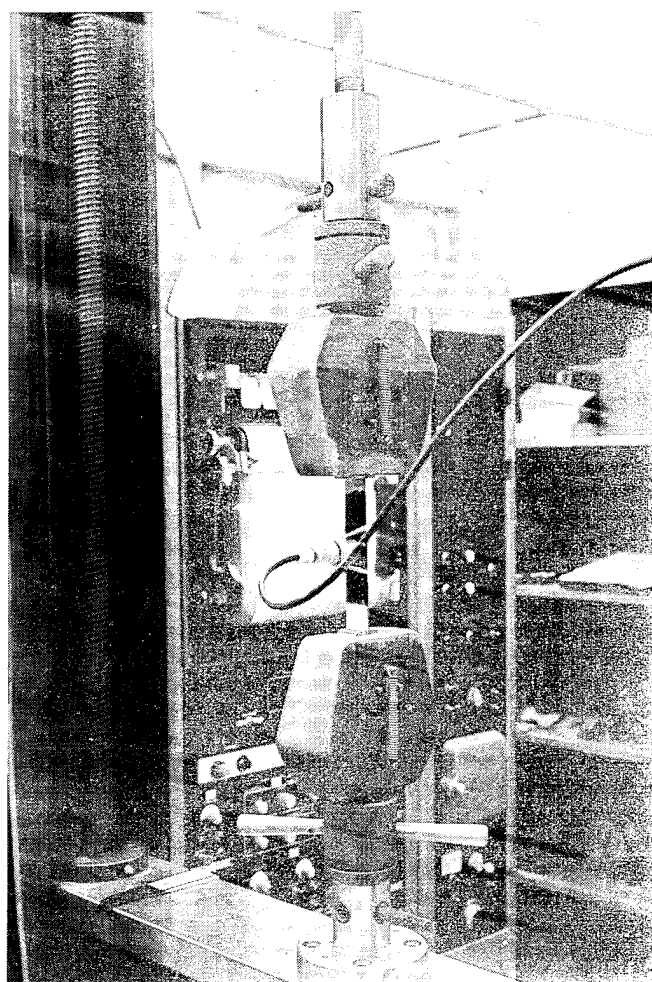
FIGURE 23. ATTACHMENT OF TRANSDUCER TO TYPICAL TEST SPECIMEN AND INSTRON TEST MACHINE

A PZT (lead zirconate titanate) transducer resonant at 150 kHz was taped to the side of the specimen and coupled with a viscous resin. The output of the transducer was amplified and passed through a bandpass filter set to pass frequencies between 120 and 170 kHz. The signals were then fed into a digital counter set to sum all signals counted (accumulation mode). The analog of this accumulated digital data was obtained from a digital-to-analog converter and displayed on the Y-axis of an X-Y plotter. The Dunegan Research Co. acoustic emission equipment is shown in Figure 21. The Bolt Beranek and Newman X-Y plotter is shown in Figure 22. The attachment of the transducer to a typical test specimen and the Instron tensile machine is shown in Figure 23.
