FLIGHT TEST OF HIGH-DENSITY
PHENOLIC-NYLON ON A SPACECRAFT
LAUNCHED BY THE PACEMAKER
VEHICLE SYSTEM

by *William G. Witte*

Langley Research Center

NATIONAL AERONAUTICS AND SPACE ADMINISTRATION • WASHINGTON, D. C. • NOVEMBER 1969

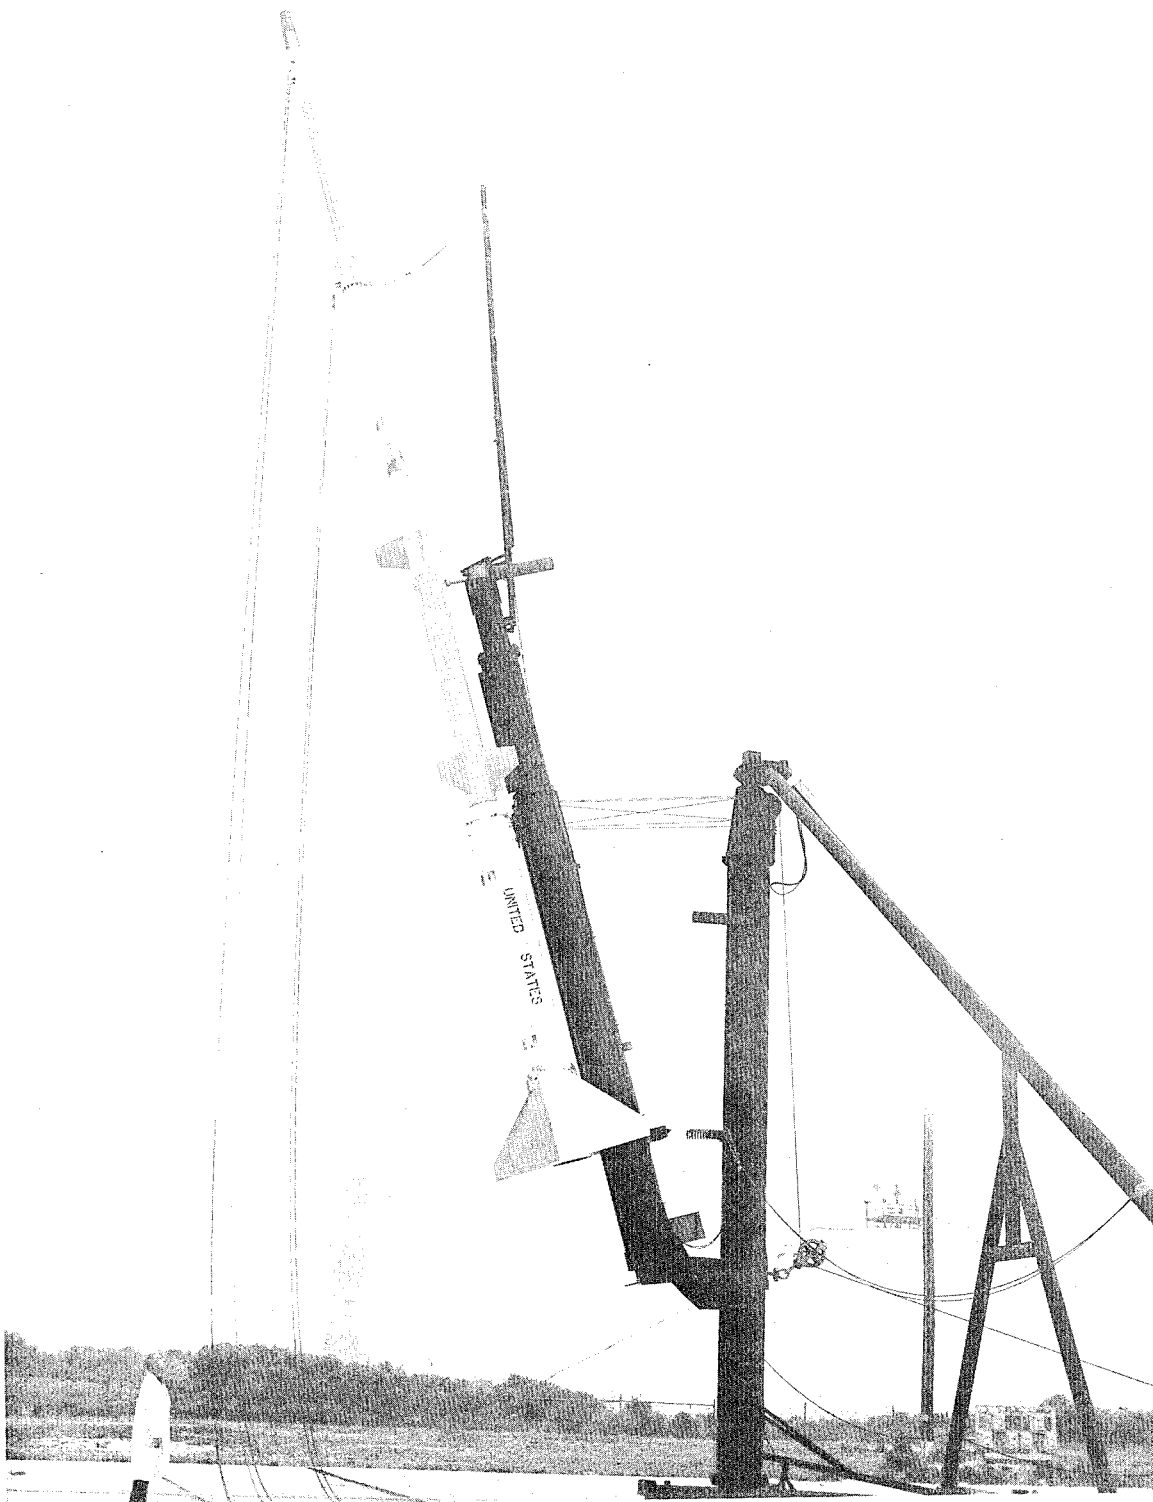
Figure 4.- Photograph of the spacecraft on the launch vehicle.

The Pacemaker launch vehicle and spacecraft in launch position are shown in figure 4. The vehicle was launched June 27, 1968, from the NASA Wallops Station launch facility. It was launched at an elevation angle of 73.3° on an azimuth of 147°.

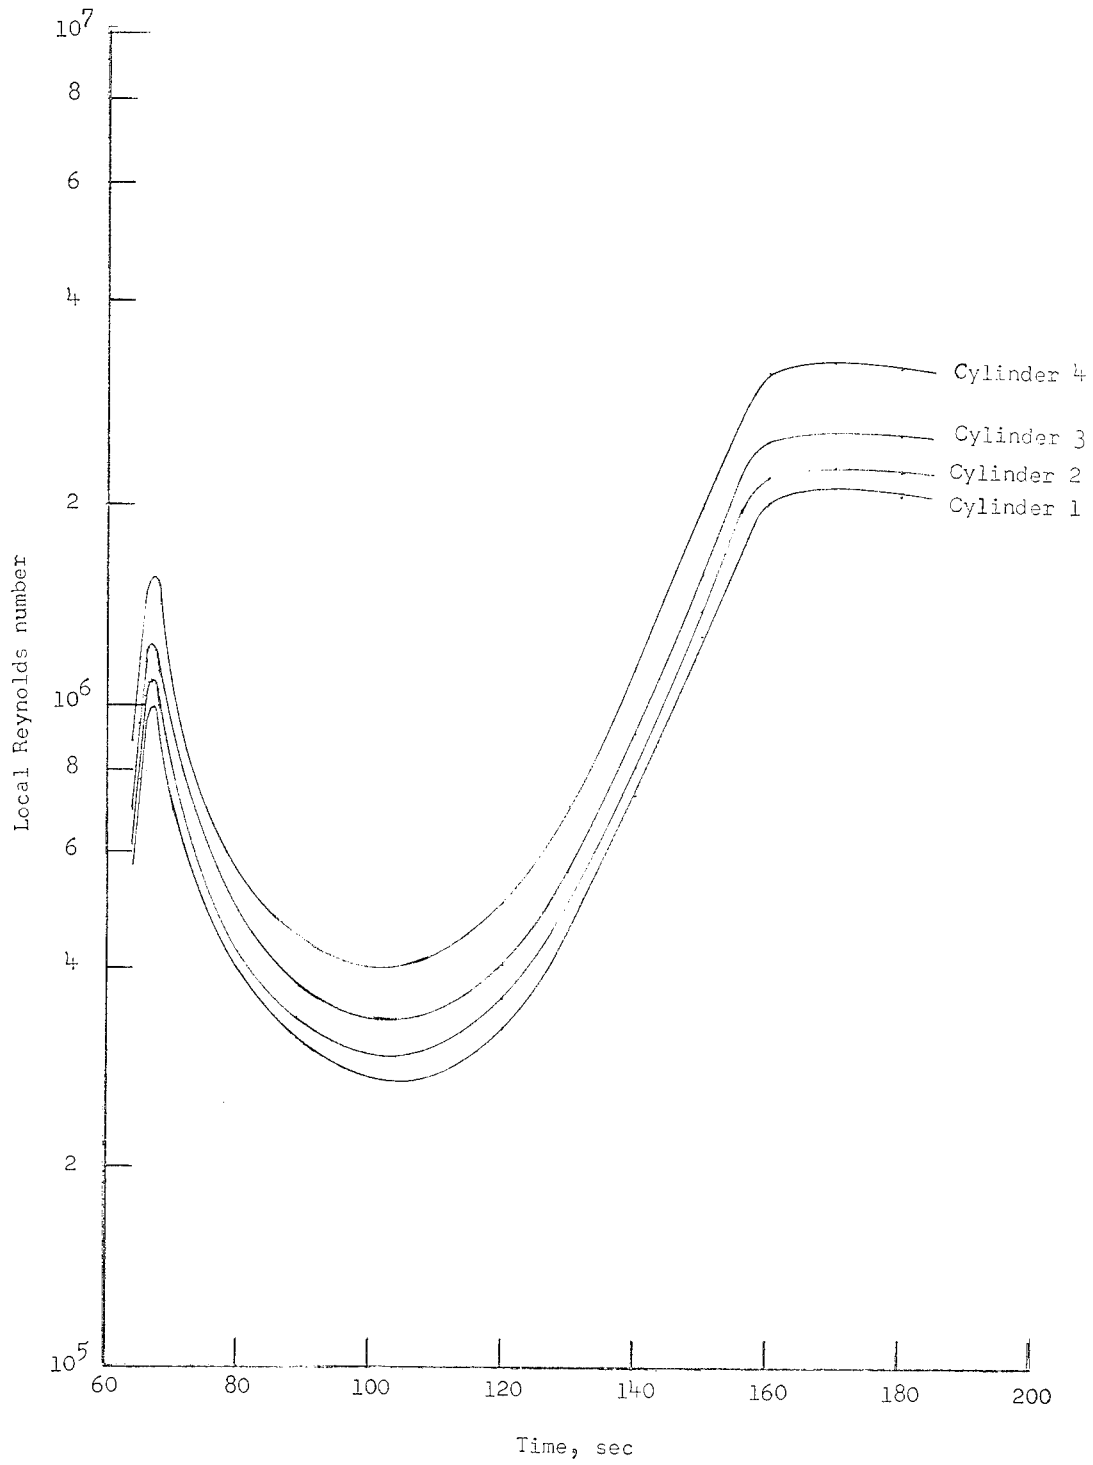
(a) Stations on the hemisphere.

Figure 13.- Computed time histories of local Reynolds numbers.

(b) Stations on the cone.

(c) Stations on the cylinder.

Computed time histories of cold-wall heating rates, local Mach numbers, stagnation enthalpy, local Reynolds numbers, local pressures, and local turbulent shear are presented in figures 10 to 15. These computations were made for the actual flight trajectory by the methods described in reference 6. The wiggles in the initial portions of the local Mach number histories (fig. 11) are due to the rapidly changing conditions during third-stage thrusting as free-stream Mach numbers increase from subsonic to hypersonic values.

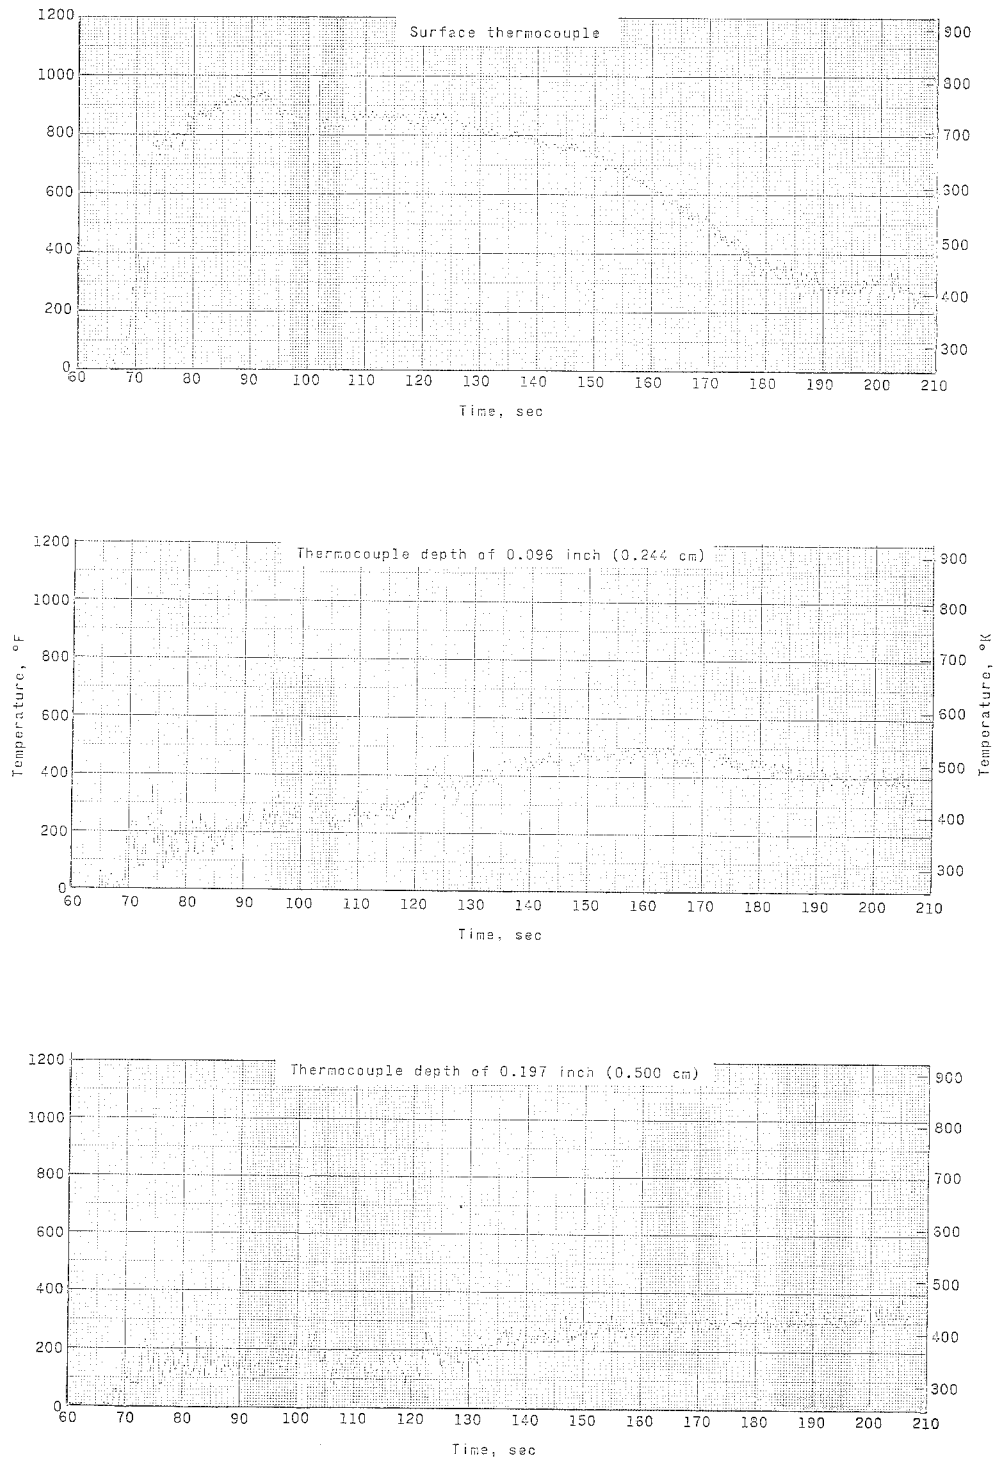
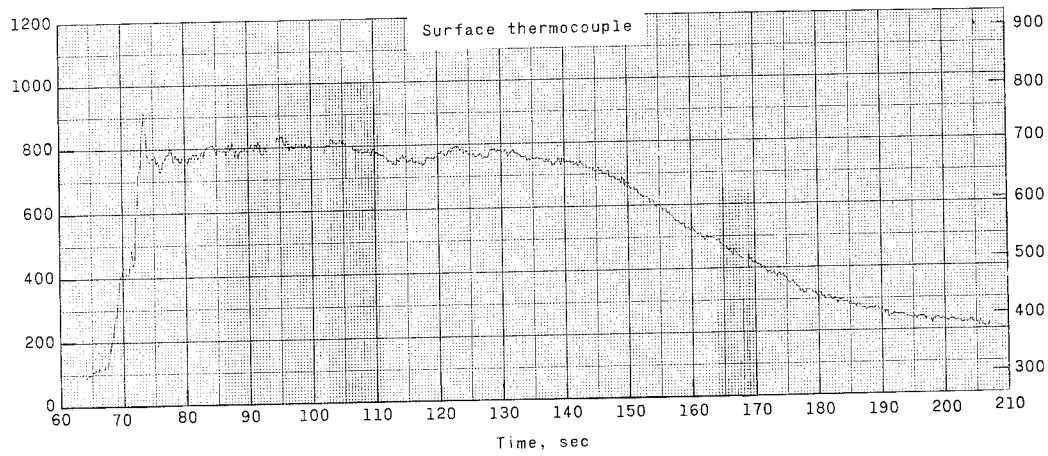
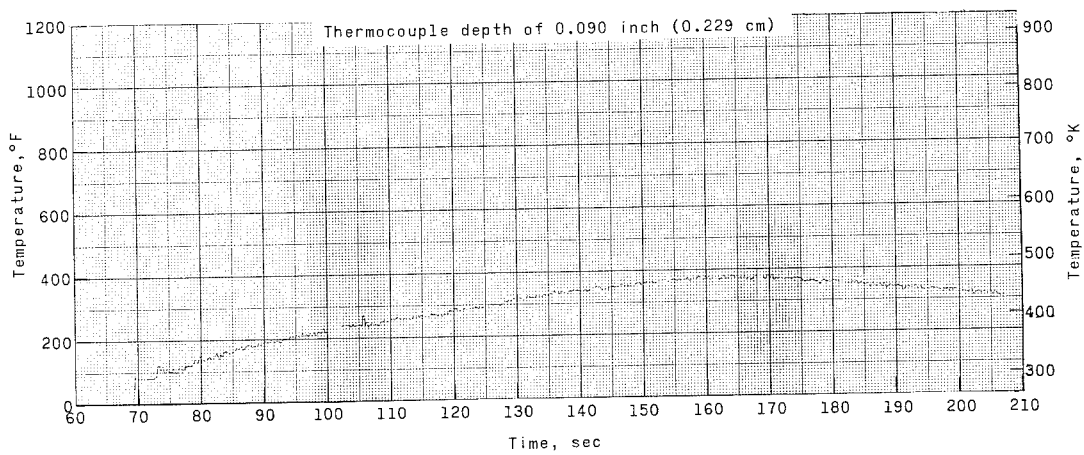
(a) Cone station 1.

Figure 22.- Temperature-time histories obtained from surface and in-depth thermocouples.

(b) Cone station 2.

(c) Cylinder station 1.

surrounding surfaces. Temperature-time histories obtained from the cone and cylinder thermocouples are shown in figure 22. The surface temperatures shown here should be interpreted carefully. They do not rise and fall with the heating rates, as might be expected. Rather, they rise sharply with the heating rate to some value and then level off for the duration of the heating period.
