RESEARCH ON LASER DAMAGE THRESHOLD OF
PHOTOELECTRIC DETECTORS

By: Chen Dezhang, Zhang Chengquan, et al.

Source: Jiguang Jishu, Vol. 19, Nr. 3, June 1995; pp. 135-140

Southwest Institute of Technical Physics
Chengdu 610041

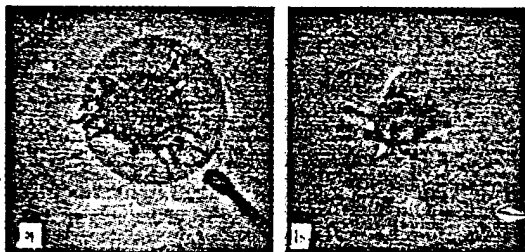
Fig.2 Photograph of the surface of the damaged detector by $1.06\mu\text{m}$, $60\mu\text{s}$ laser pulse ($100\times$)
a - SPD-001 100times b - SPD-005 100times

As experimentally found, for the damage to the photoelectric detector caused by a $60\mu\text{s}$ laser pulse, the regular circular melted pits can be seen on the photosensitive surface. In addition, there is much splash material adhering around the pits, and recrystallized small mounds can be seen in the pits, as shown in Fig. 2. However, in the case of permanent damage to the photoelectric detector caused by a 20ns laser pulse, there are irregular shallow pits on the photoelectric surface, generally appearing as vaporized pits. Many minute mounds are distributed in the pits, possibly due to local vaporization. In addition, loud cracking sounds were heard and cracks appear on the photoelectric surface as shown in Fig. 3. In measuring the I-V properties of the photoelectric detector, the performance deviates quite sharply from that of diodes, with the reverse-

1. The permanent damage to the photoelectric detector by the laser is mainly thermal damage, with phenomena of stress, melting, and vaporization. There are cracks, molten pits, and vaporized pits on the photosensitive surface, in addition to splash material adhering to the surface surrounding the pits. the responsivity of the photodetector is seriously deteriorated,
