BURST TEST OF A FIRST-STAGE POLARIS  
A3 FILAMENT-WOUND CONFIGURATION-X  
CHAMBER

PN D-1971249 SN 71-7041 AGC  
69 STU

Report No. B-235

15 February 1963

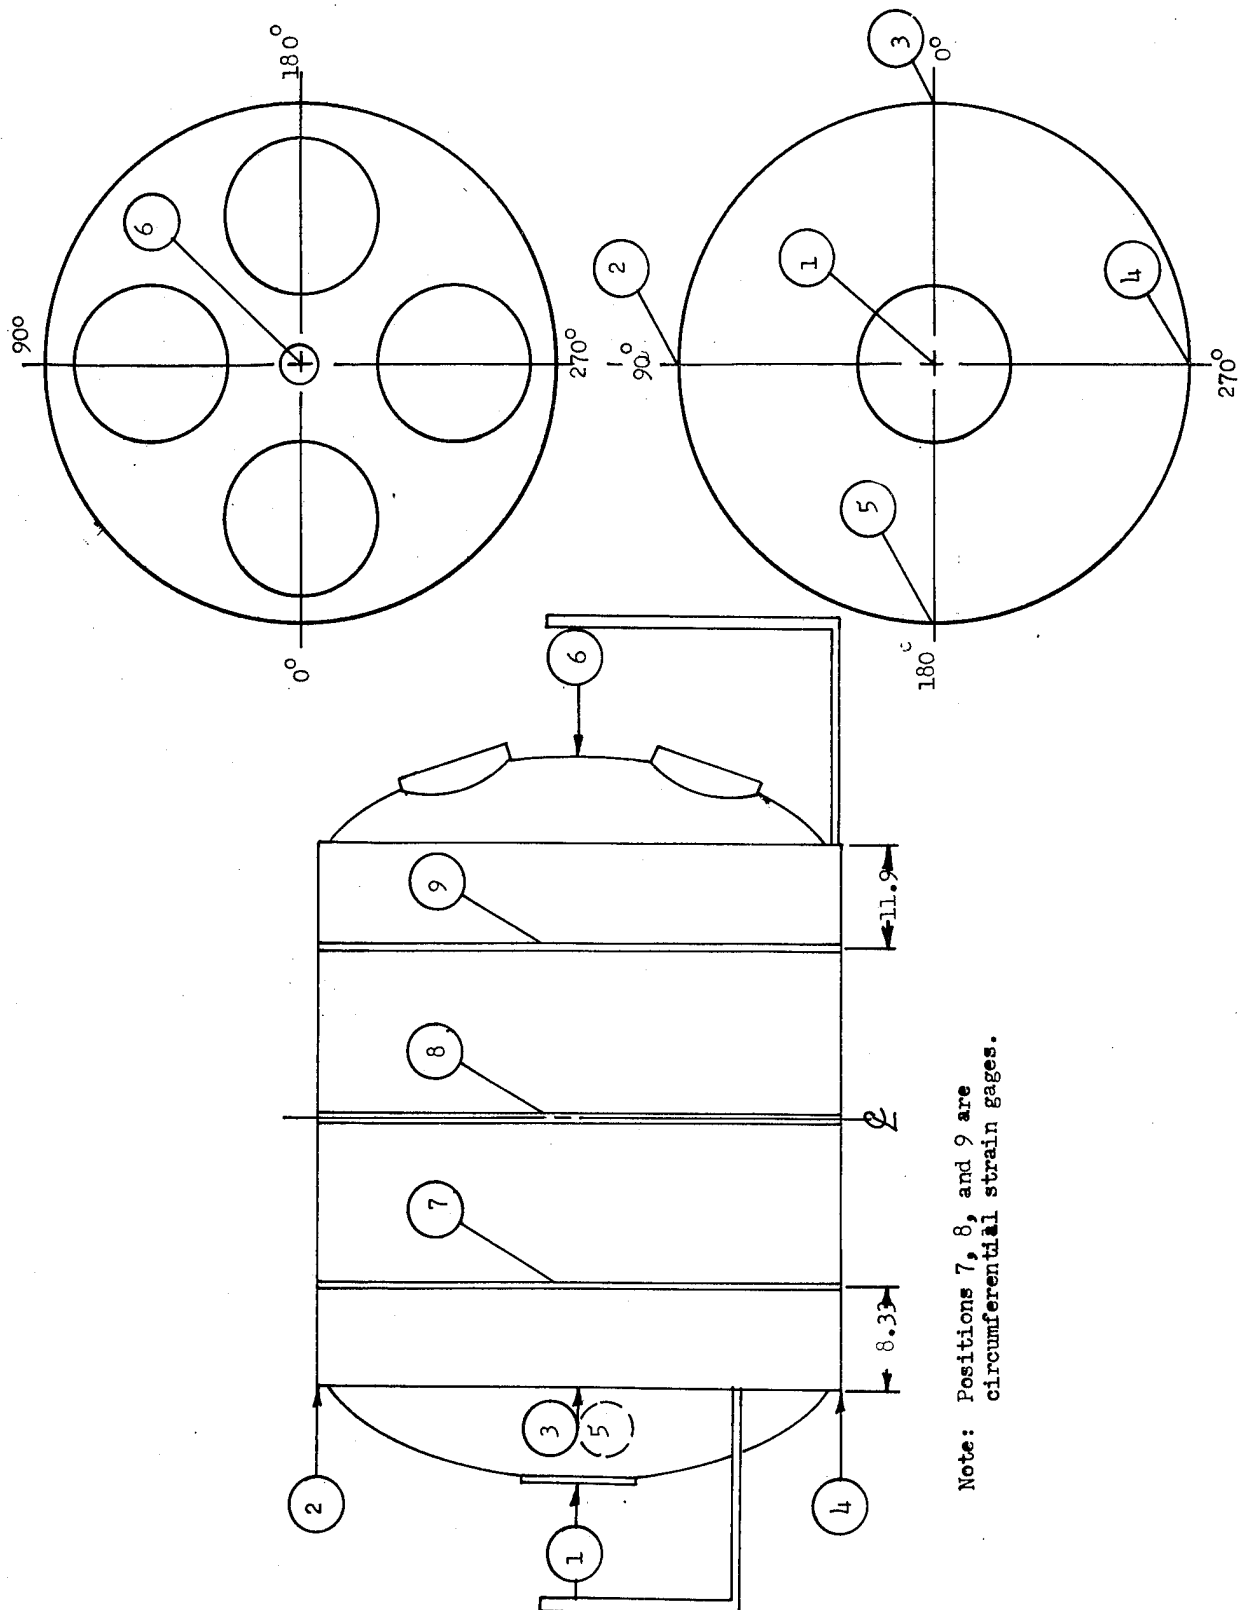
Figure 1

Two contact microphones were placed on the cylindrical portion of the test unit; one microphone was connected to a tape recorder and the other to a sound-level recorder. The chamber was instrumented as shown in Figure 1. All data except the sounds emanating from the chamber were recorded on oscillographic recorders.

Location of Instrumentation

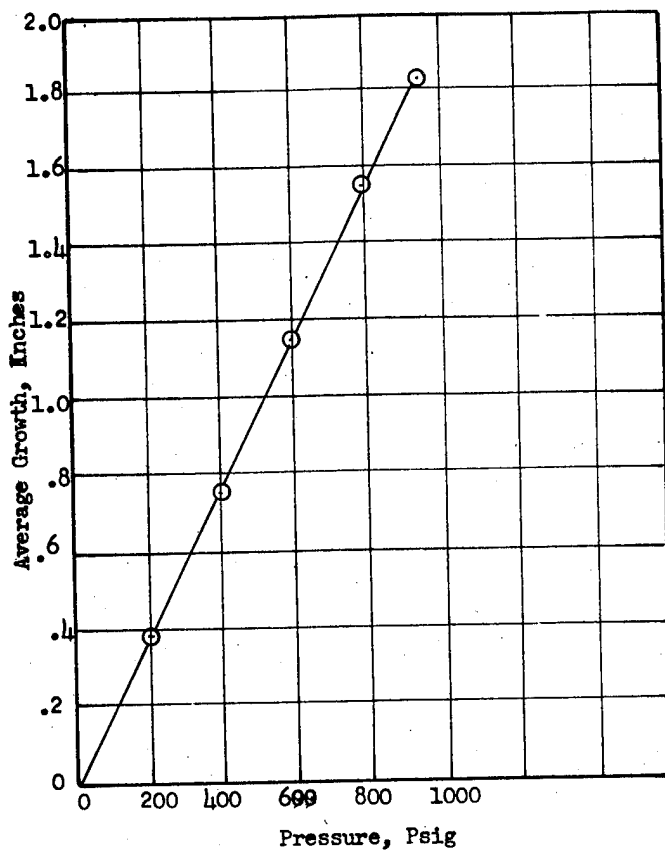
Growth data for the forward and aft domes relative to their skirts are shown in Figures 3 and 4, respectively. The maximum growth of the forward and aft domes was 0.89 and 0.43 in., respectively.

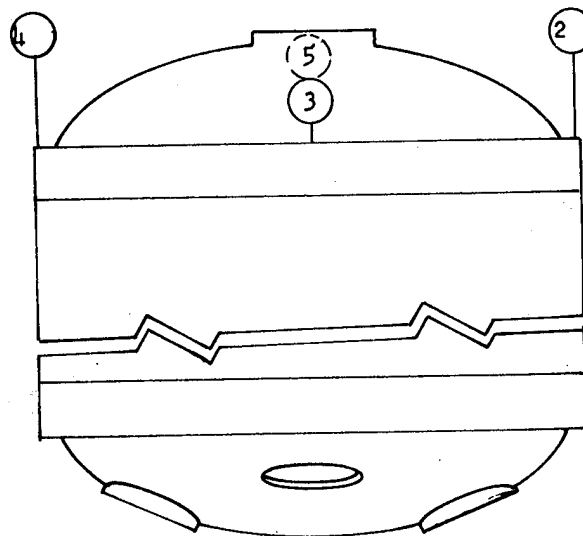
Figure 2

The longitudinal (skirt-to-skirt) growth recorded during the test is graphically shown in Figure 2; a maximum of 1.92 in. was recorded.

Longitudinal (Skirt-to-Skirt) Growth of the Chamber

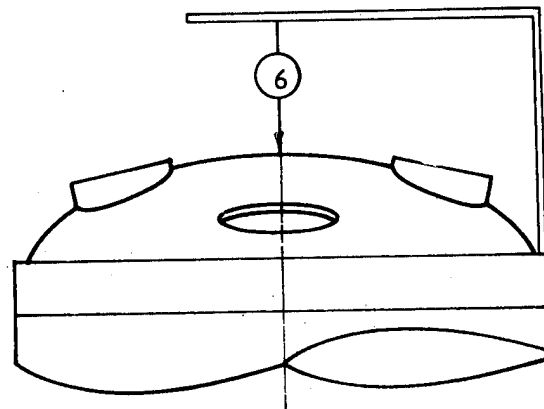
Figure 4

Aft Dome-to-Skirt Growth

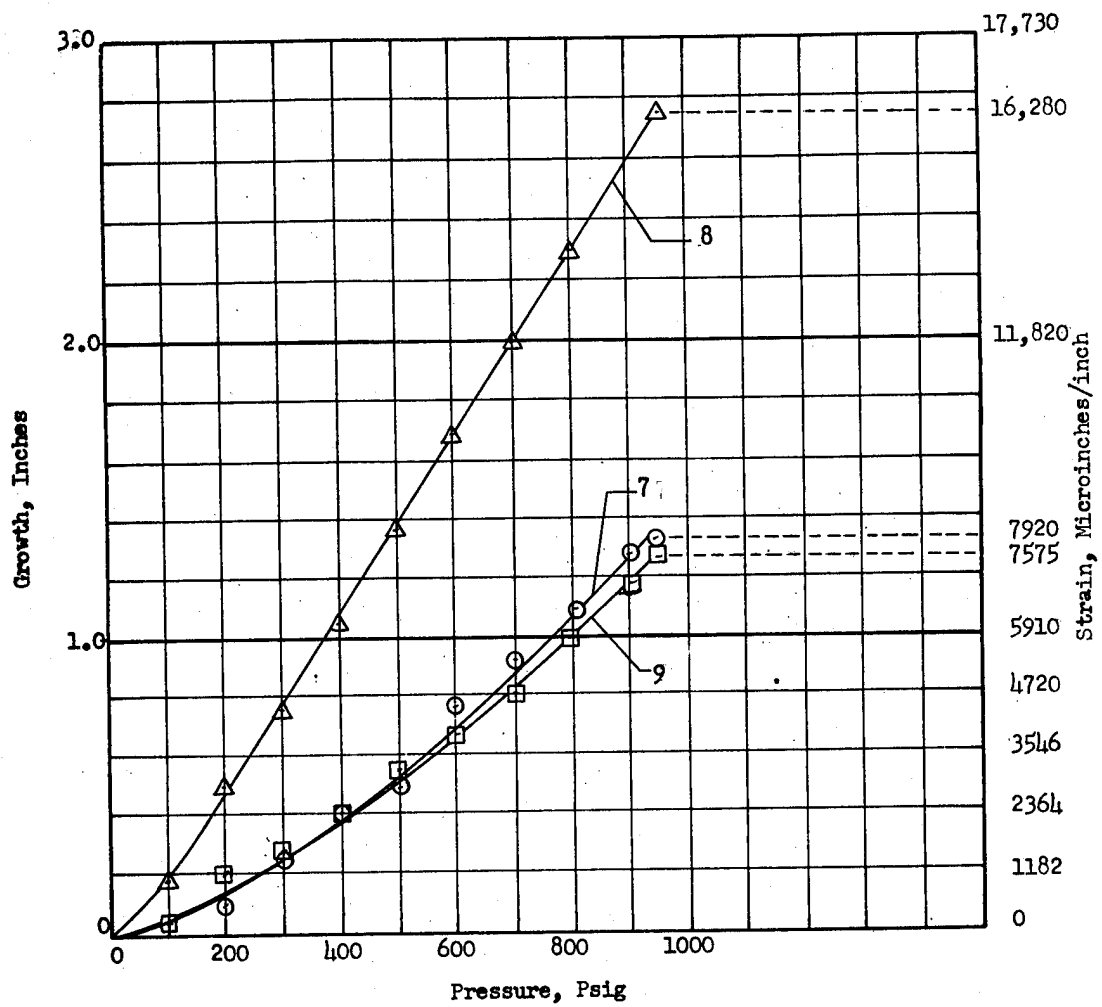
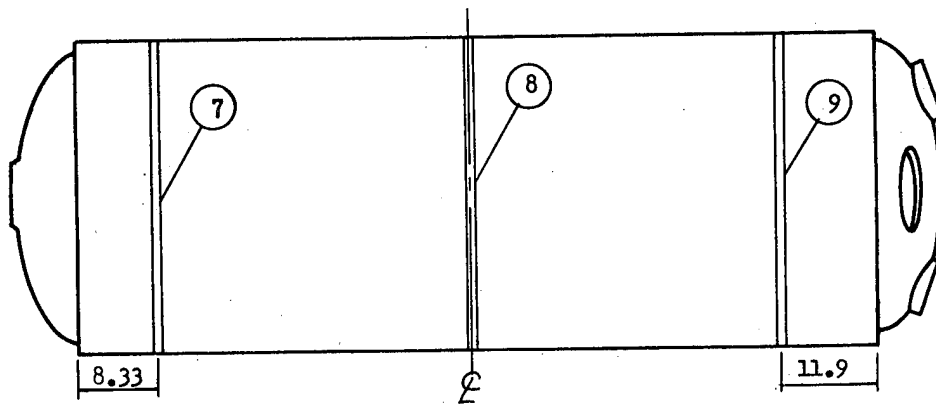
Figure 5

Circumferential growth data, recorded at the forward and aft tangent planes and at the midsection of the chamber, are shown in Figure 5. The maximum growth at the midsection of the chamber was 2.75 in. which corresponds to a strain rate of 8,600 microinches/in./min. No valid sound data were obtained because the recording equipment malfunctioned. A view of the ruptured chamber is shown in Figure 6.

Circumferential Growth Data

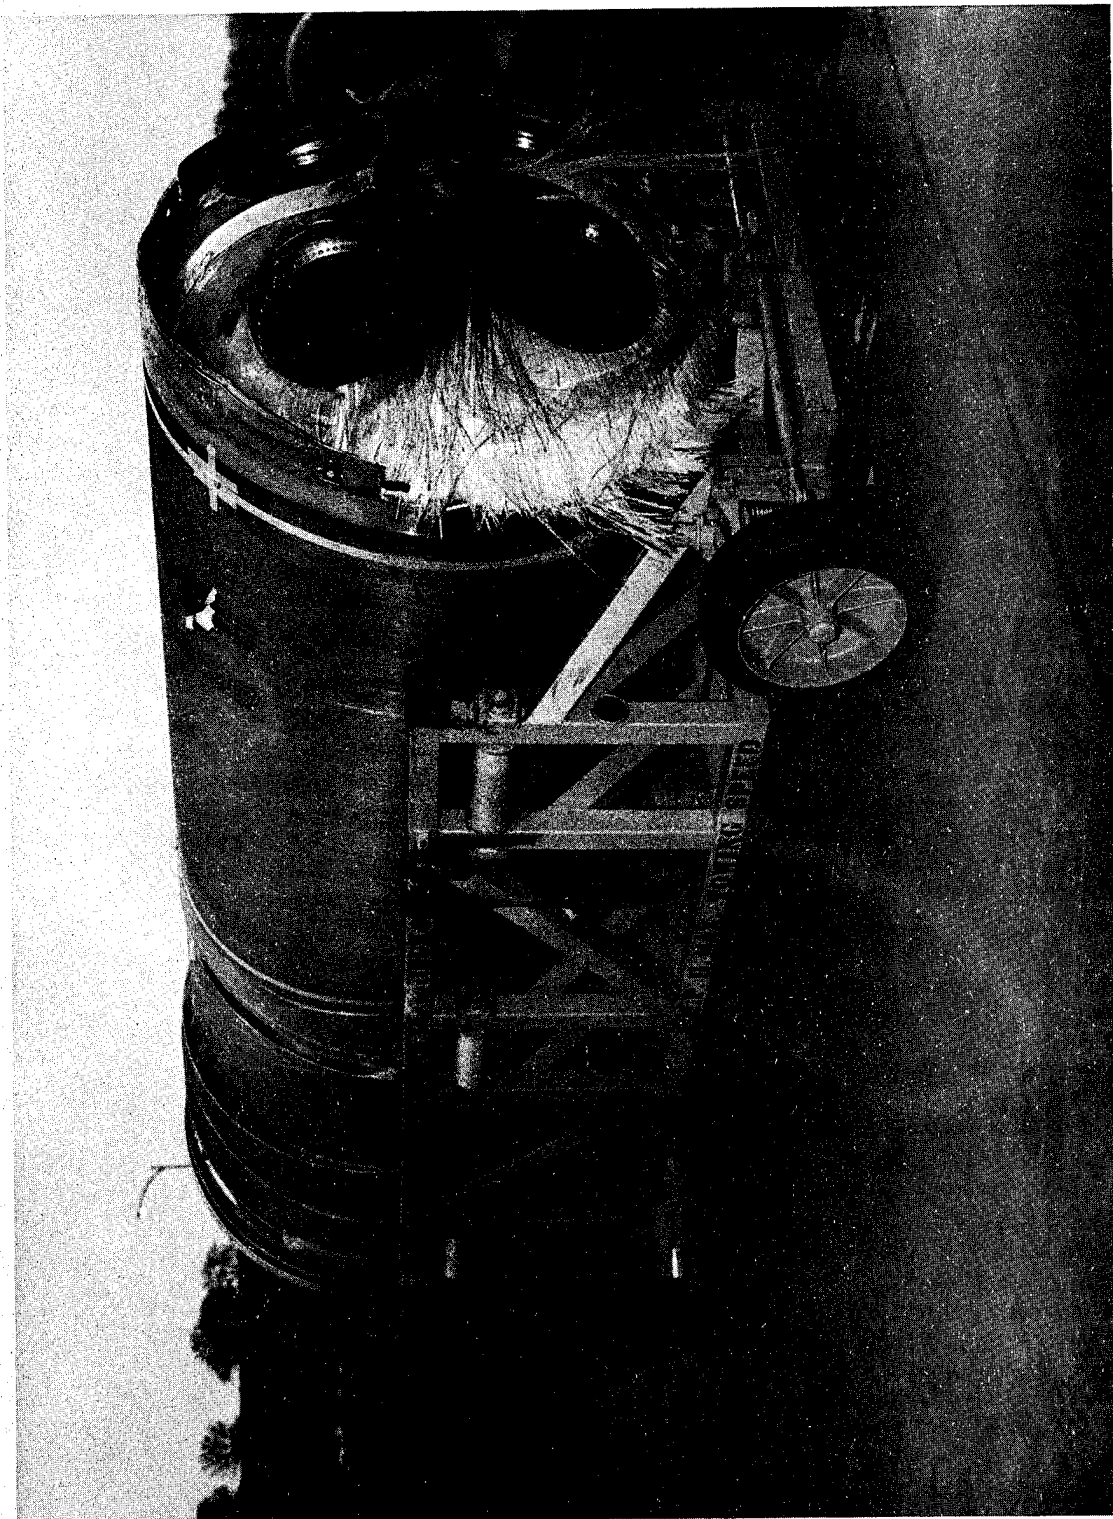
Figure 6

A first-stage POLARIS A3 filament-wound configuration-X chamber was hydrostatically tested to burst to determine the structural strength of the unit and the mode of failure. The test was terminated after 25 sec of a 1-min hold period at 940 psig when the aft head ruptured. The rupture originated at the aft skirt-to-cylinder juncture.

The chamber burst after 25 sec of a planned 1-min hold, at a pressure of 940 psig. The failure originated at the aft skirt-to-cylinder juncture.

Ruptured Chamber (Photograph No. 1-63S 00016)

The burst of the unit during the 1-min hold was anticipated because of the low strand strength exhibited by the roving that had been used in the fabrication of this chamber.
