DOT/FAA/AR-95/47

# Investigation of Fuselage Structure Subject to Widespread Fatigue Damage

February 1996

Final Report

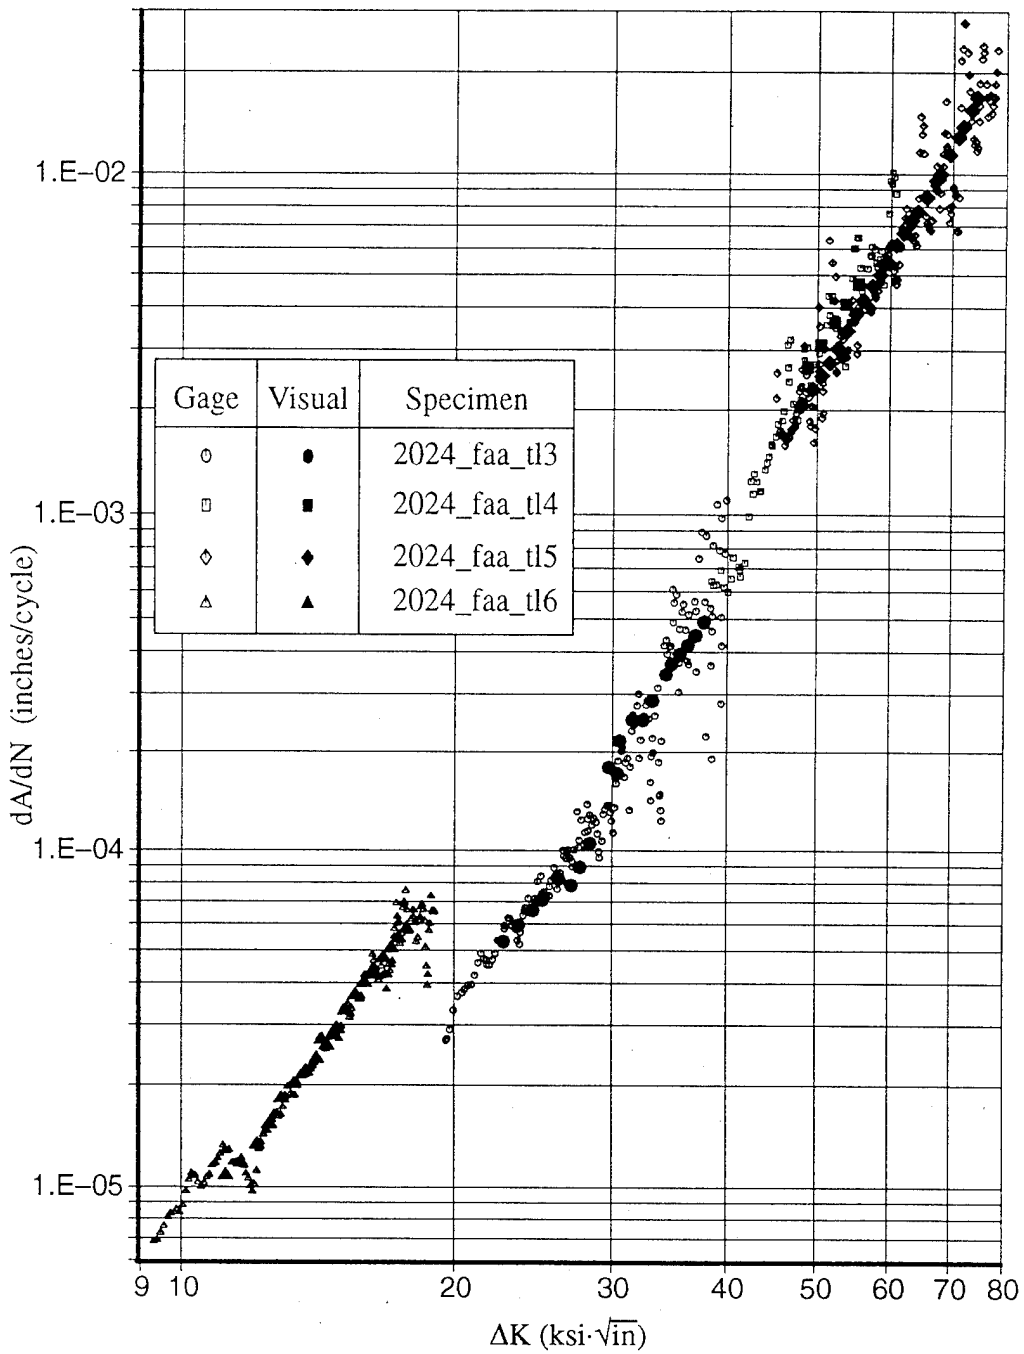
**Figure 5. Crack Growth Rate Data Calculated From Fractomat and Visual Crack Length Measurements**

The  $da/dN$  versus  $\Delta K$  crack growth data calculated from the Fractomat gage readings that is plotted in figure 5 was reduced to  $da/dN$  versus  $\Delta K_{eff}$  data using Newman's crack opening stress equations with  $\alpha = 1.2$ , reference 4. The  $\Delta K_{eff}$  data was then modified back to  $da/dN$  versus  $\Delta K$  data for a stress ratio,  $R$ , equal to zero using the same crack opening stress equations. A stress ratio equal to zero was chosen because it corresponds to the stress ratio applied in the large curved panel tests. The resulting crack growth data is given in figure 6. Examining the reduced crack growth data shows that the data for stress ratios equal to 0.1 and 0.5 have collapsed onto the same curve. Also shown in figure 6 is the corresponding Boeing crack growth data, which is conservative relative to the test data for the lower range of  $\Delta K$ 's where most of the crack growth life occurs. An equation was fit to the test data using least squares and is shown along with the corresponding data in figure 6.

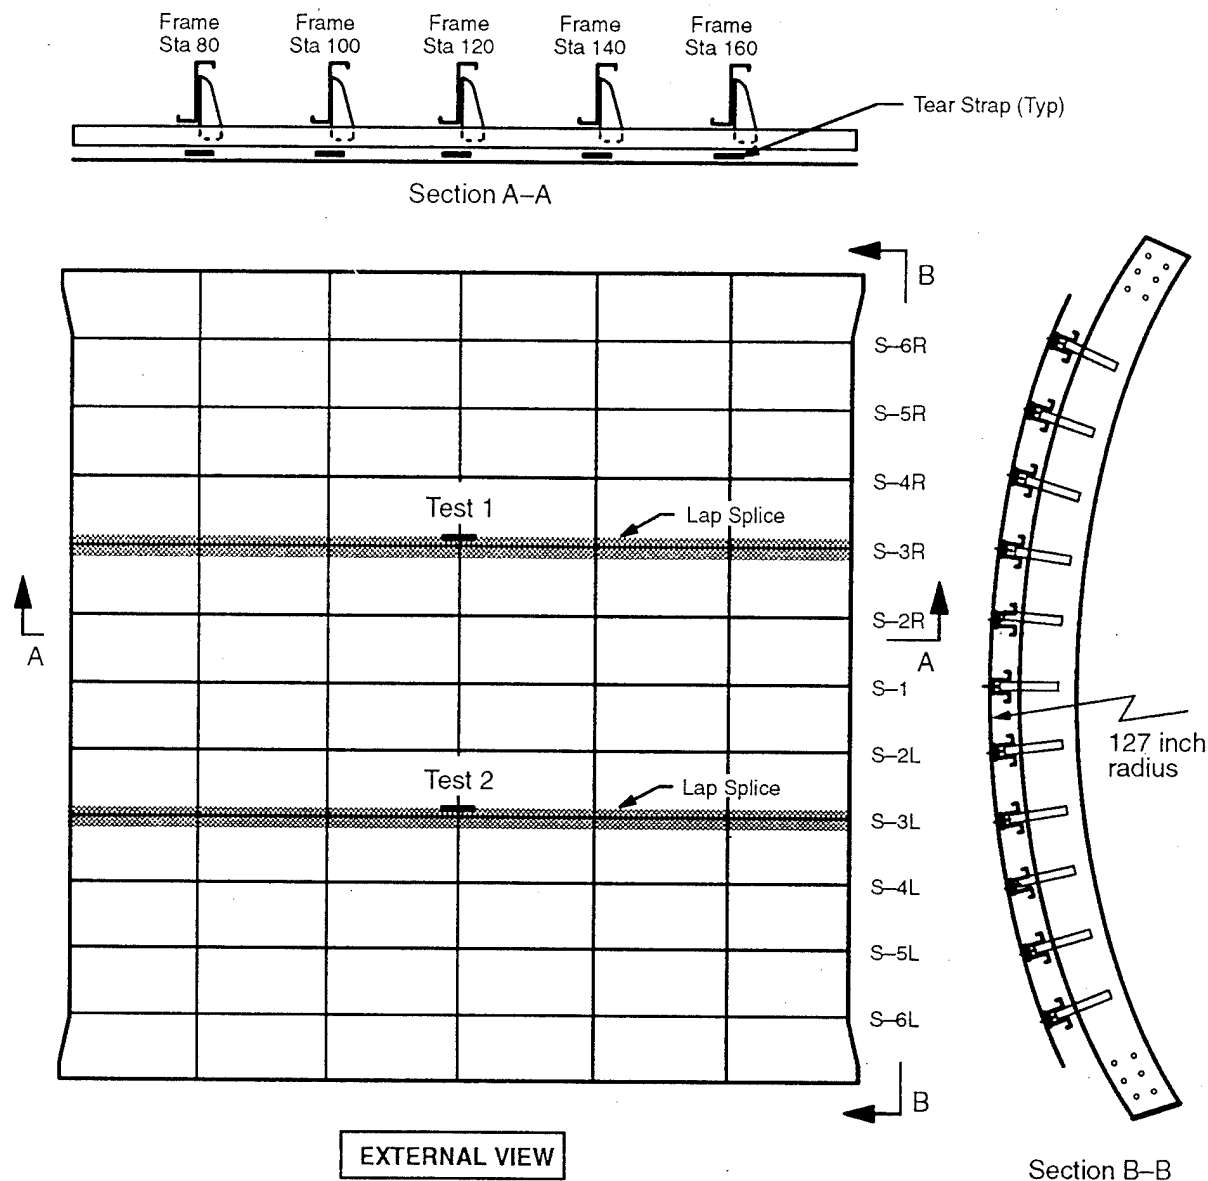
Figure 9. Structural Configuration and Test Locations of Panel FAA 1 and FAA 2

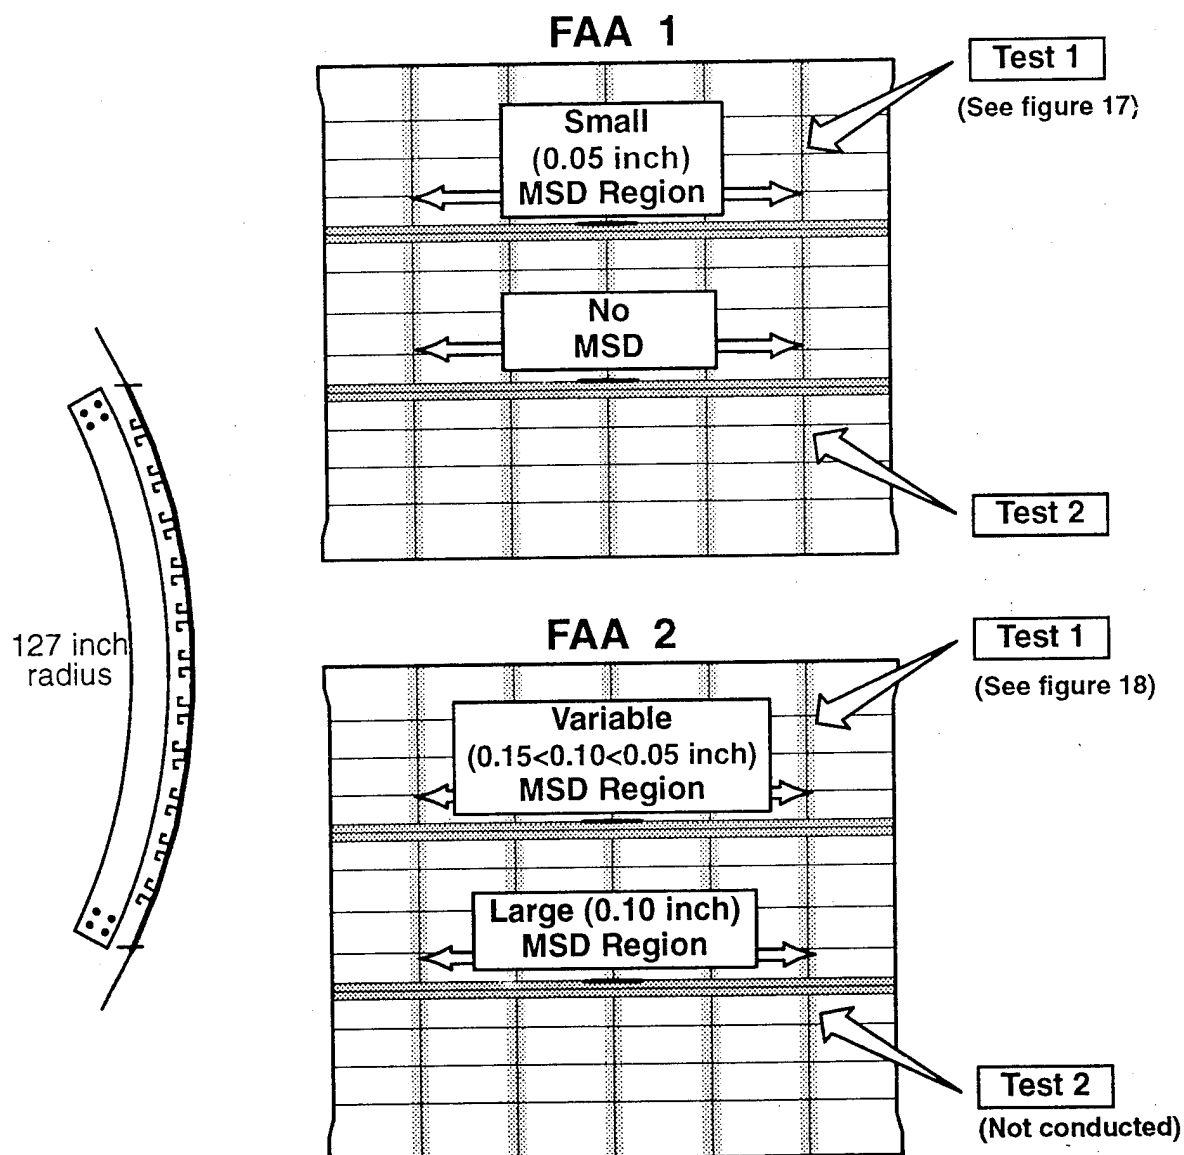
Figure 16. MSD Overview of Panels FAA 1 and FAA 2

Simulated multiple site damage (MSD) was introduced in the upper row of three out of the four lap joints. Saw cuts were made in the outer skin of the lap joints along the upper row of rivets. The sawcuts were oriented out of the fastener holes longitudinally in the 3 and 9 o'clock positions by the use of a modified handsaw producing a 0.006 to 0.008-inch-wide cut. These sawcuts were introduced in the upper skin after the fastener holes had been drilled and countersunk to size, but prior to the application of the fay sealant and rivet installation. Figure 16 shows the 4 bay region (80-inch section) where the simulated MSD sawcuts were installed in both panels with figures 17 and 18 showing further detail.

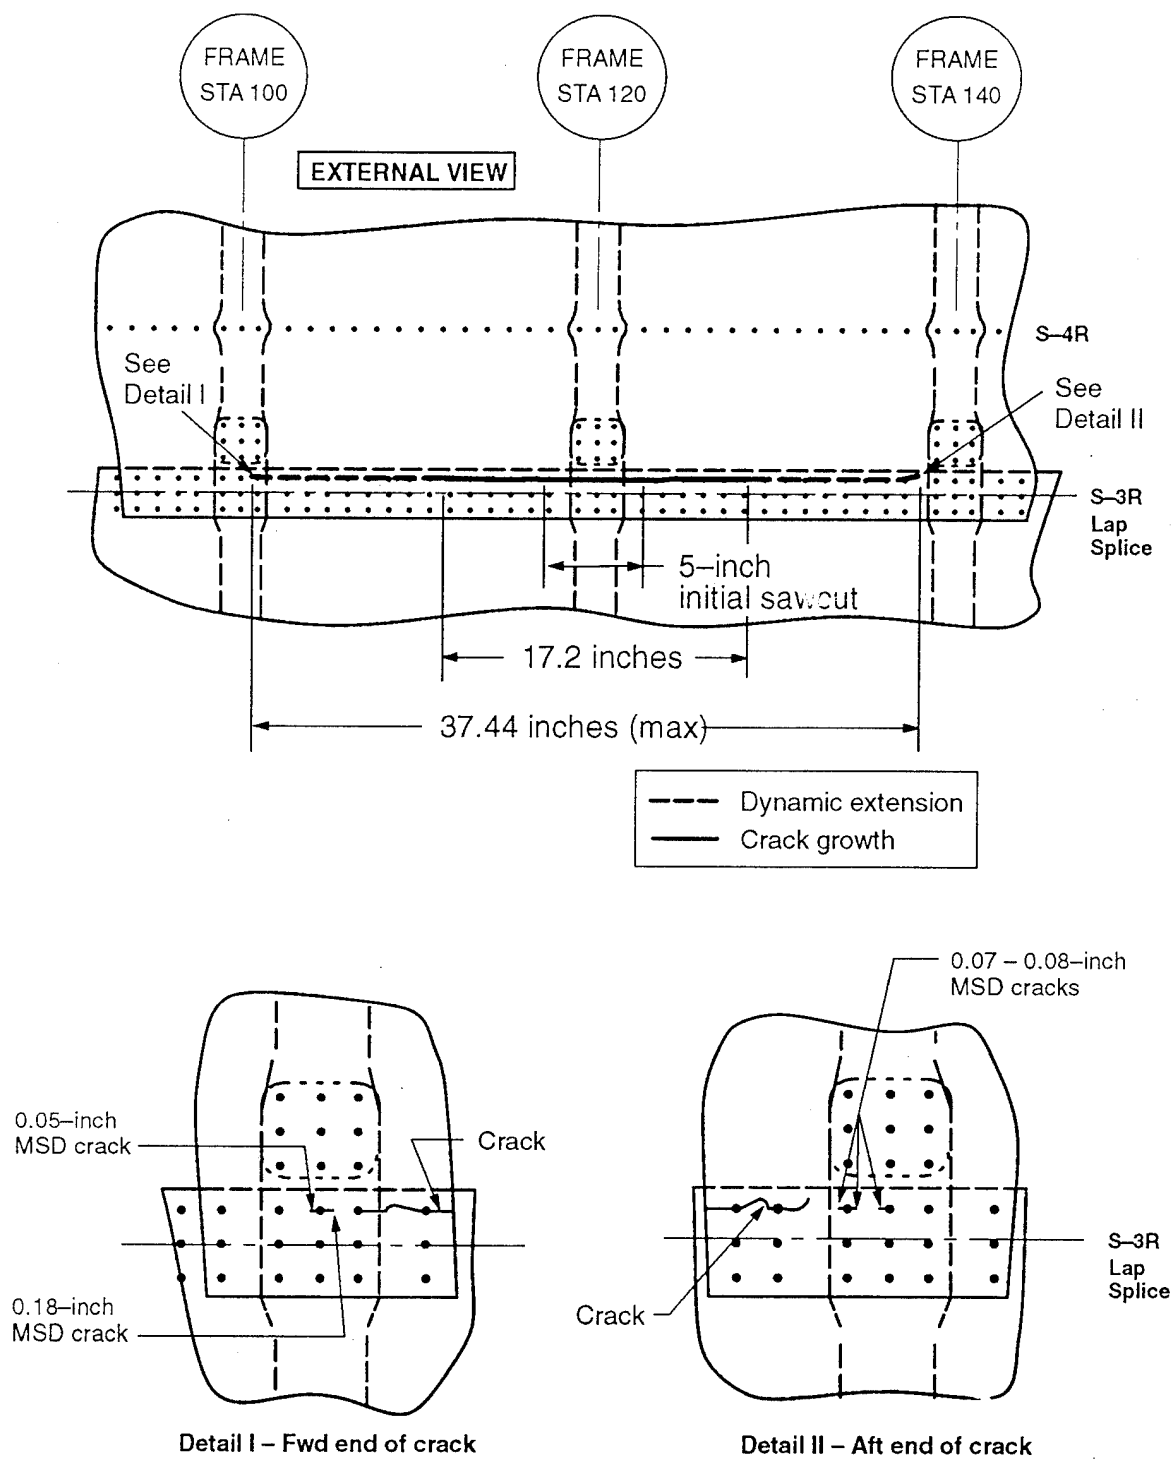
Figure 22. Crack Trajectory of Panel FAA 1, Test 1

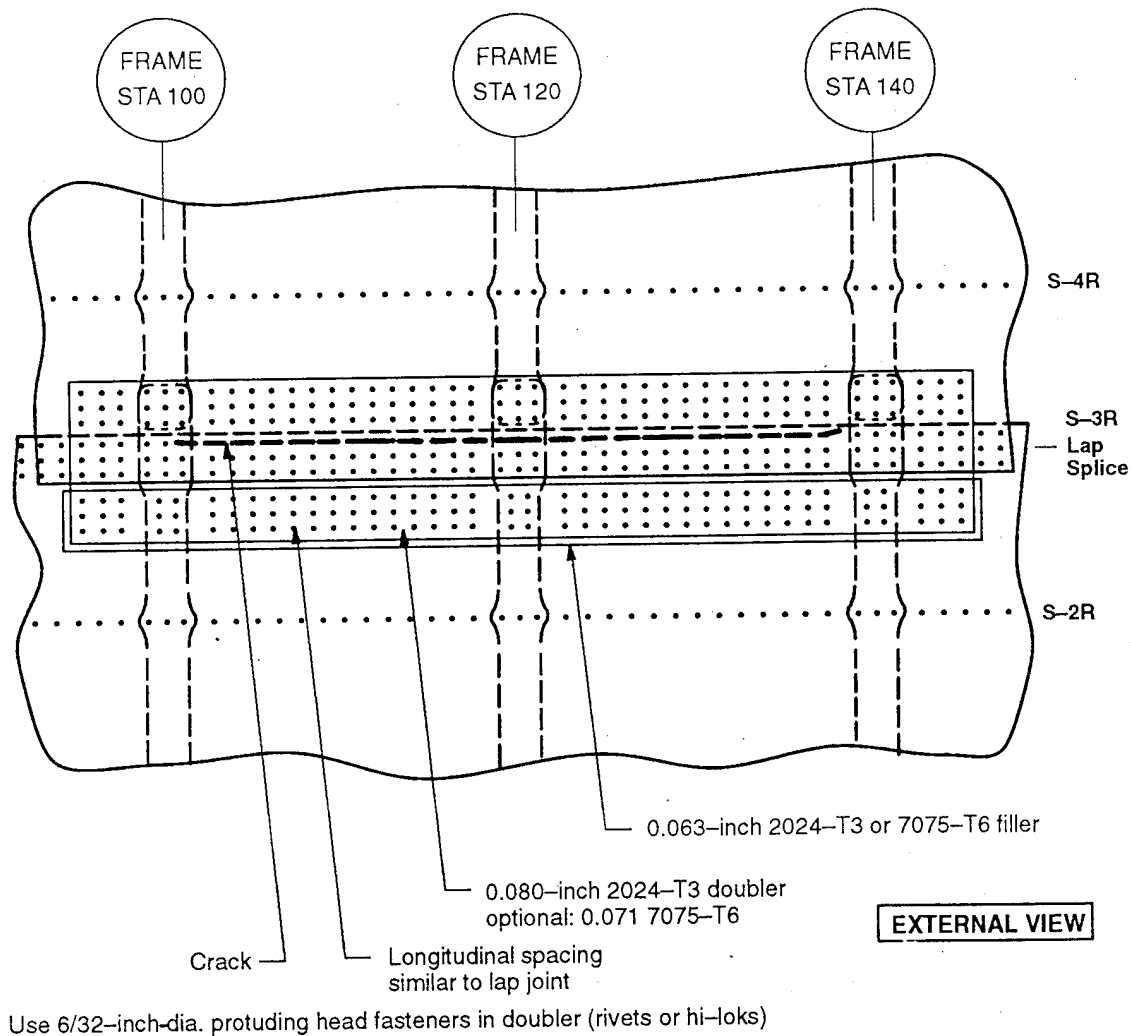
**Figure 24. Panel Repair of FAA 1, Test 1**

The test 1 location was repaired by applying an external doubler as shown in figure 24. The circumferential size of the repair was minimized in order to reduce any influence on the test 2 location.

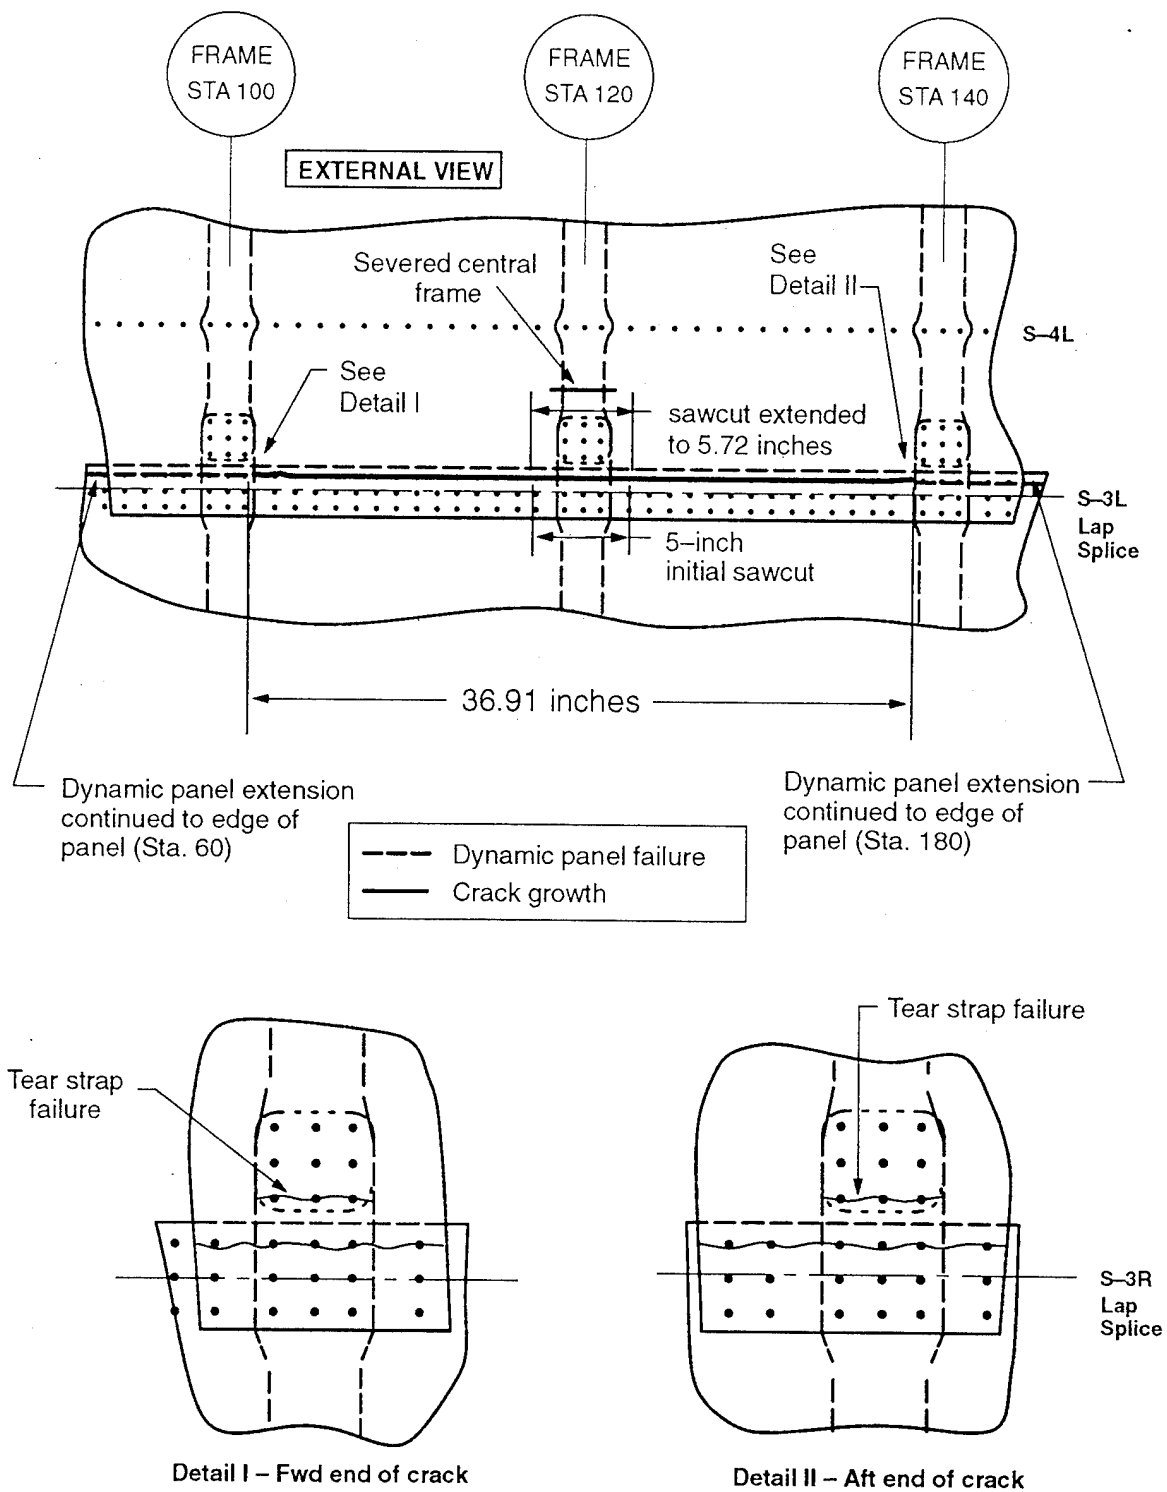
Figure 33. Crack Trajectory of Panel FAA 1, Test 2

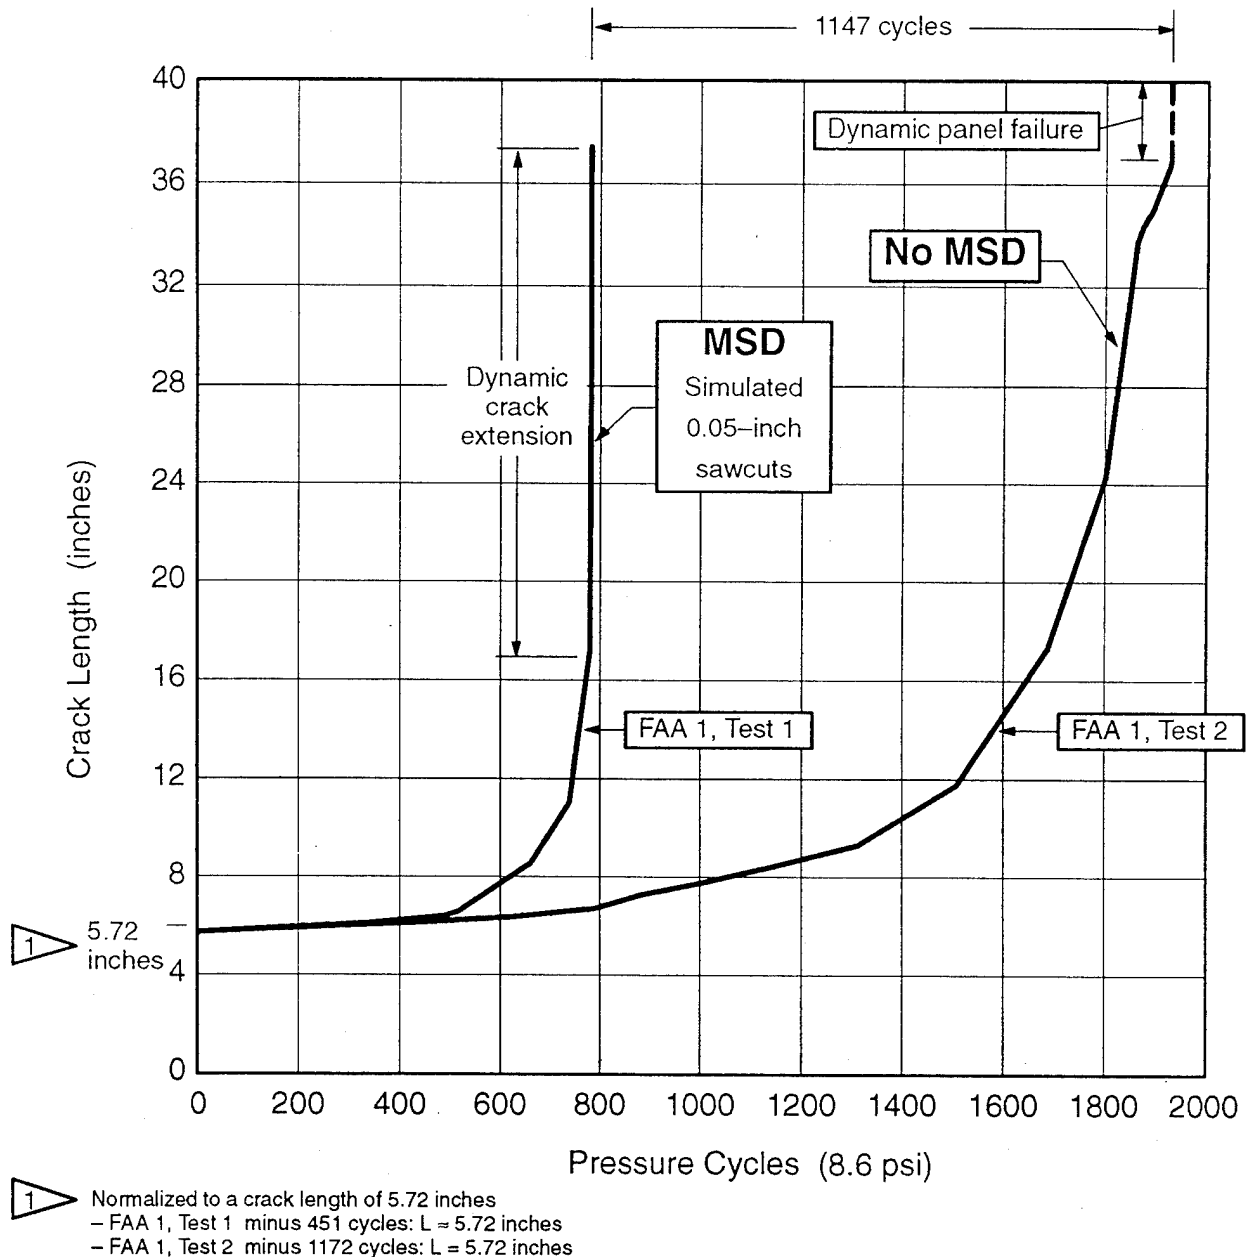
Figure 44 shows a comparison of crack growth data between panel FAA 1, Test 1 vs. Test 2 (simulated MSD vs. No MSD) normalized to an initial crack length of 5.72 inches.

Figure 44. Panel FAA 1, Test 1 and Test 2 Crack Growth Comparison

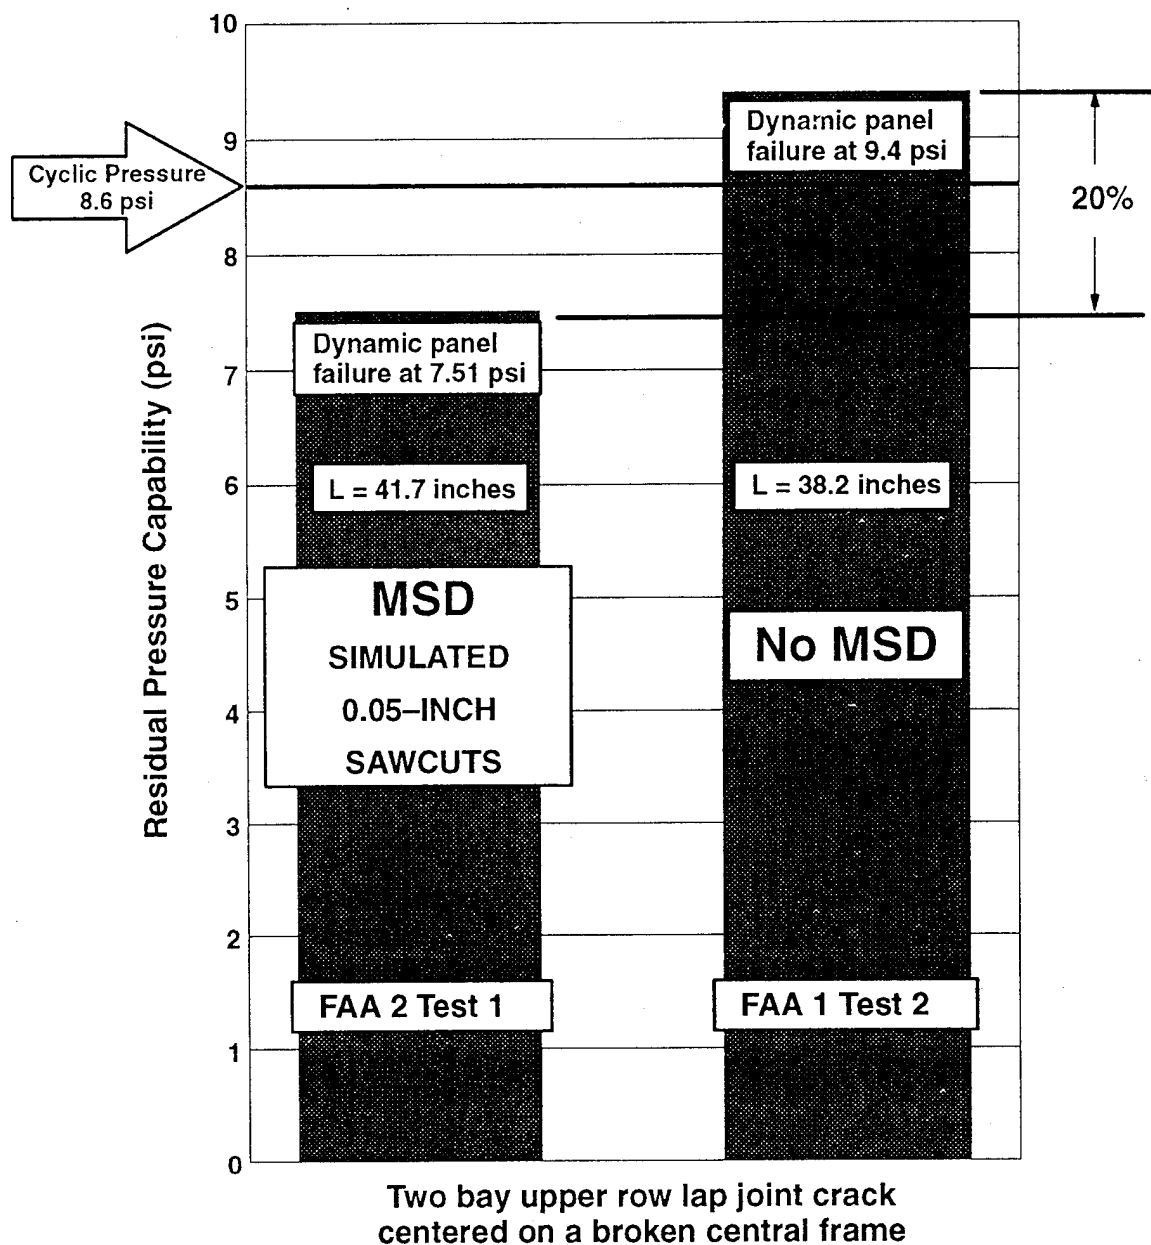
Figure 45 shows a comparison of the residual strength capabilities between FAA 1, Test 2 and FAA 2, Test 1. Note that the panel with MSD had a 3.5-inch larger crack prior to final failure.

Figure 45. Panel FAA 1, Test 2 vs. FAA 2, Test 1 Residual Strength Comparison

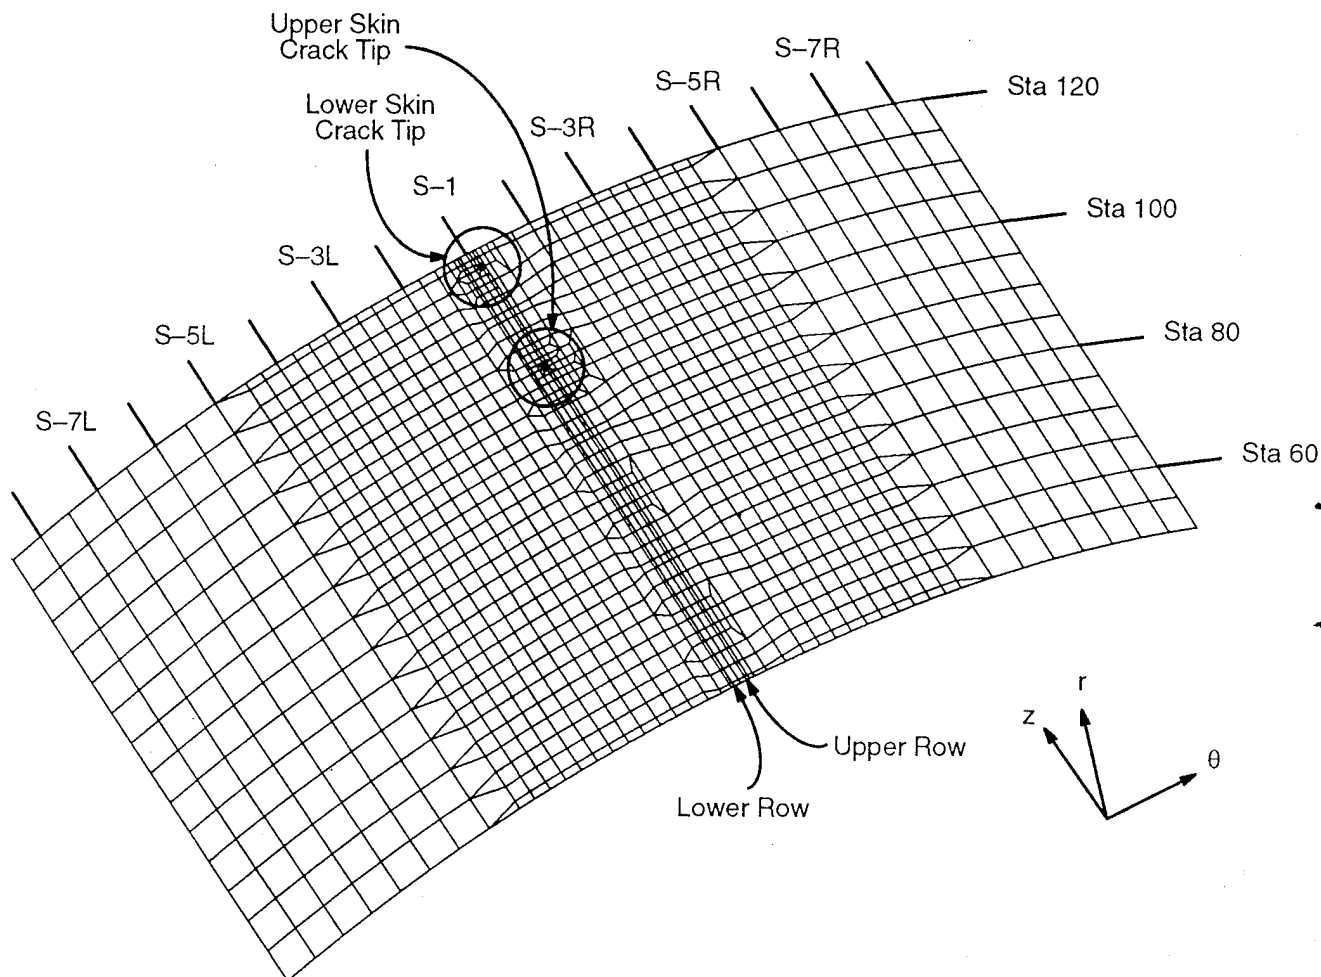
**Figure 46. Skin Mesh**

Figures 46 through 48 show the different layers of the model of a test panel containing a crack in the upper skin. The model was fifteen stringer bays wide ( $\theta=62.6^\circ$ ) by three and one-half frame bays long ( $z=70$  inch). Only the six stringer bays nearest the lap joint were modelled in detail. The remainder of the model was a coarse mesh with rigidly connected structural elements. Extending the model beyond six stringer bays was necessary to prevent warping of the frame at station 120 when that frame was severed for residual strength testing. Because the symmetrical boundary conditions imply that all damage is mirrored across the boundaries, there can be significant interactions if the damage is too close to a boundary.

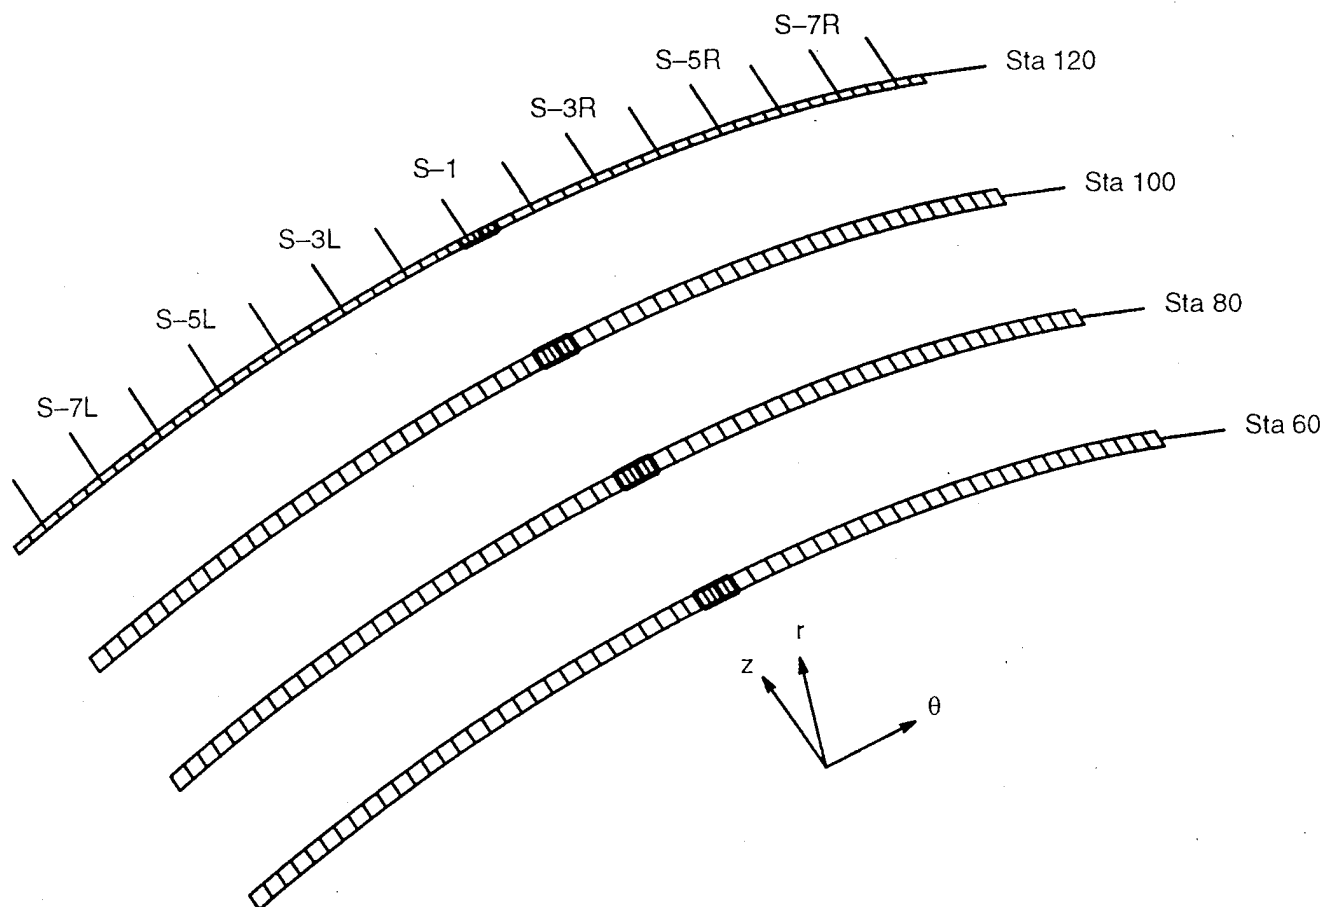
**Figure 47. Tear Strap Mesh**

The sketch in figure 11 details the structure of the test panels. The skins and tear straps were 0.063 inch thick 2024-T3 clad aluminum. The tear straps were 2.4 inches wide and were bonded to the skin except at the lap joints. The stringers and frames were 0.063 inch thick 7075-T6 clad aluminum. The stringers were riveted to the skin. The frames were free-floating and attached to the stringers via stringer clips. The skins and tear straps were modelled with 0.063 inch thick eight-noded shell

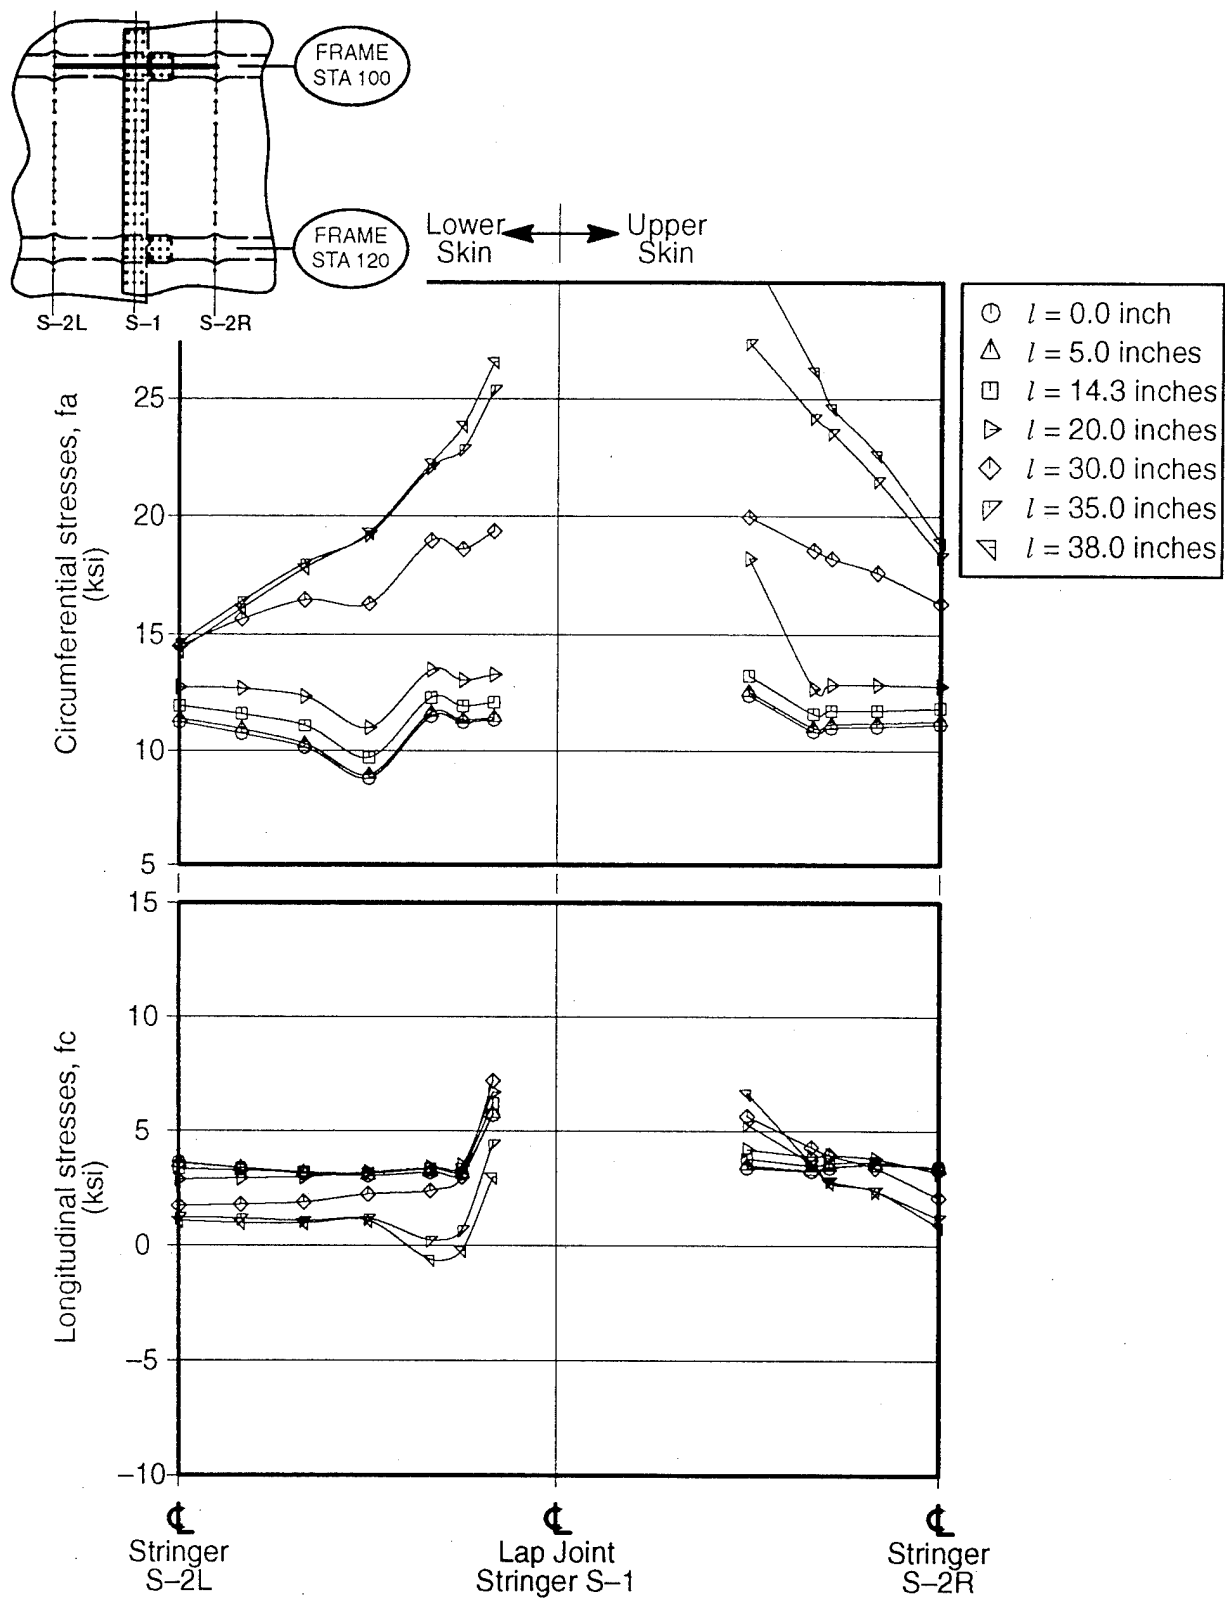
Figure 52. Predicted Midplane Stresses at Station 100

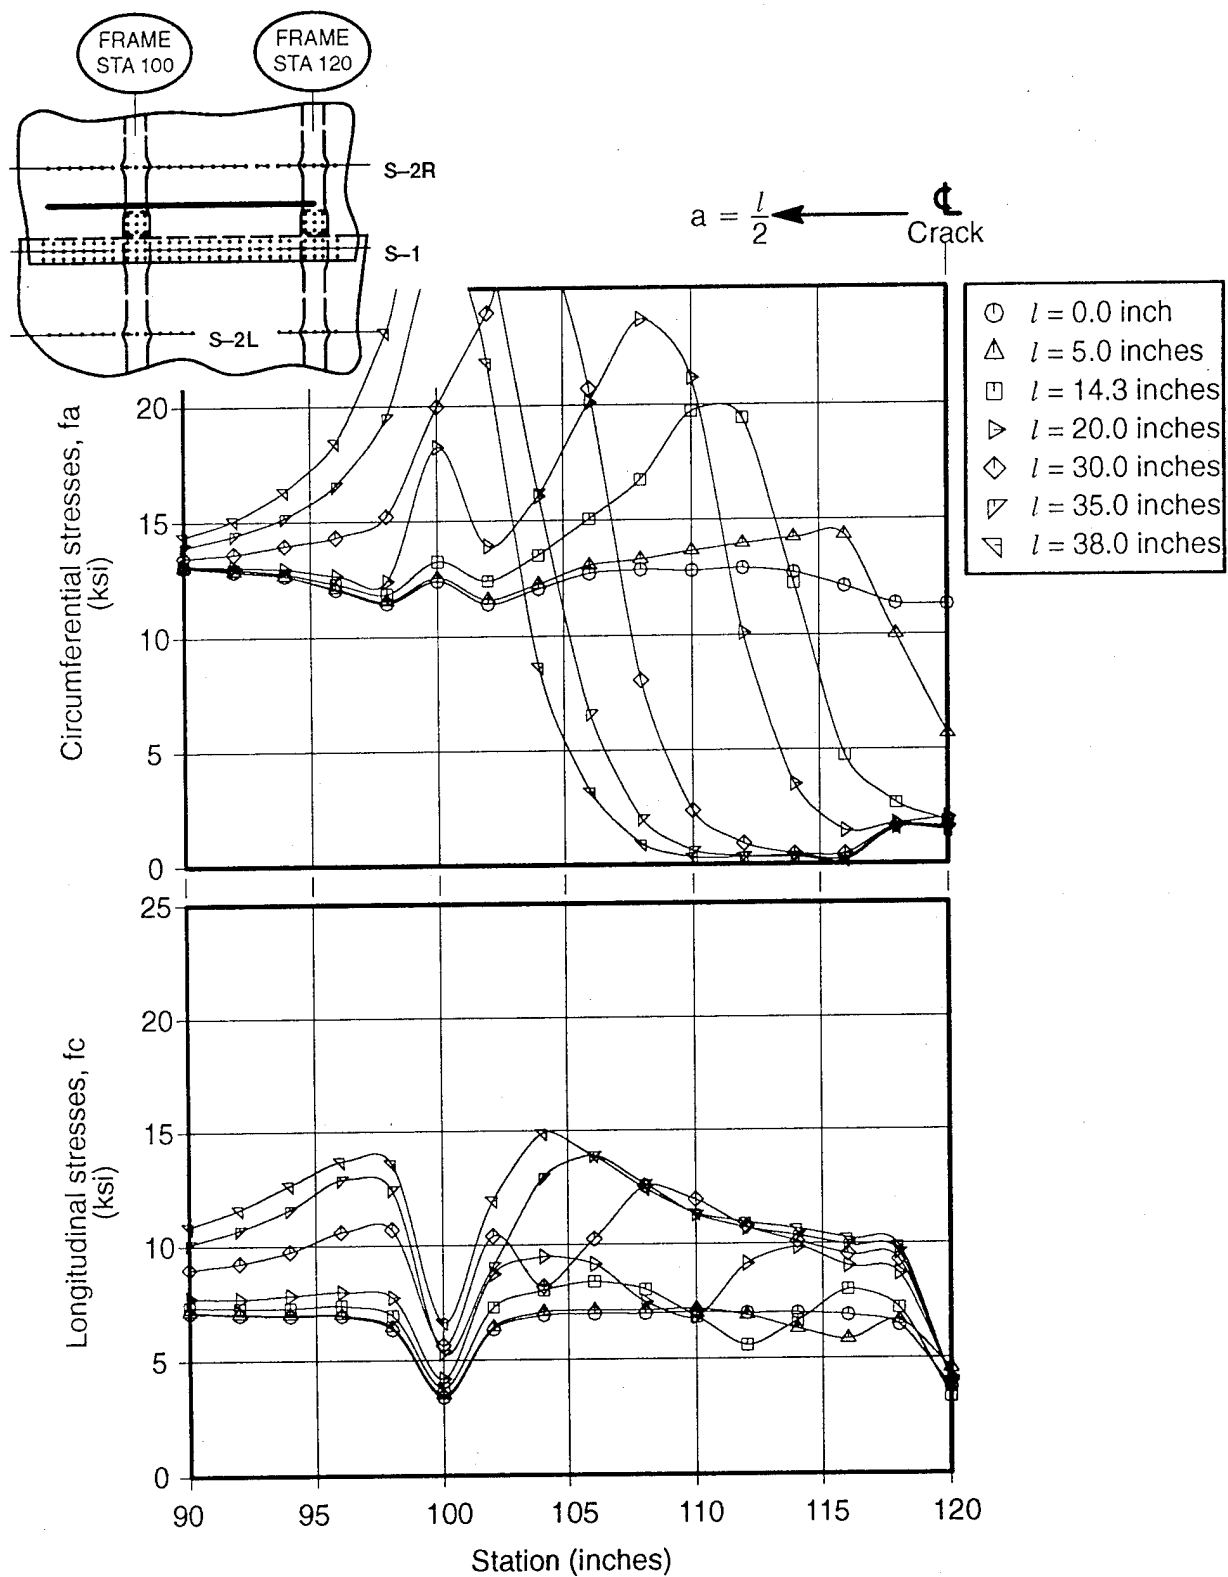
Figure 55. Predicted Midplane Stresses in the Upper Skin 4.6 Inches Right of the Lap Joint Stringer Centerline

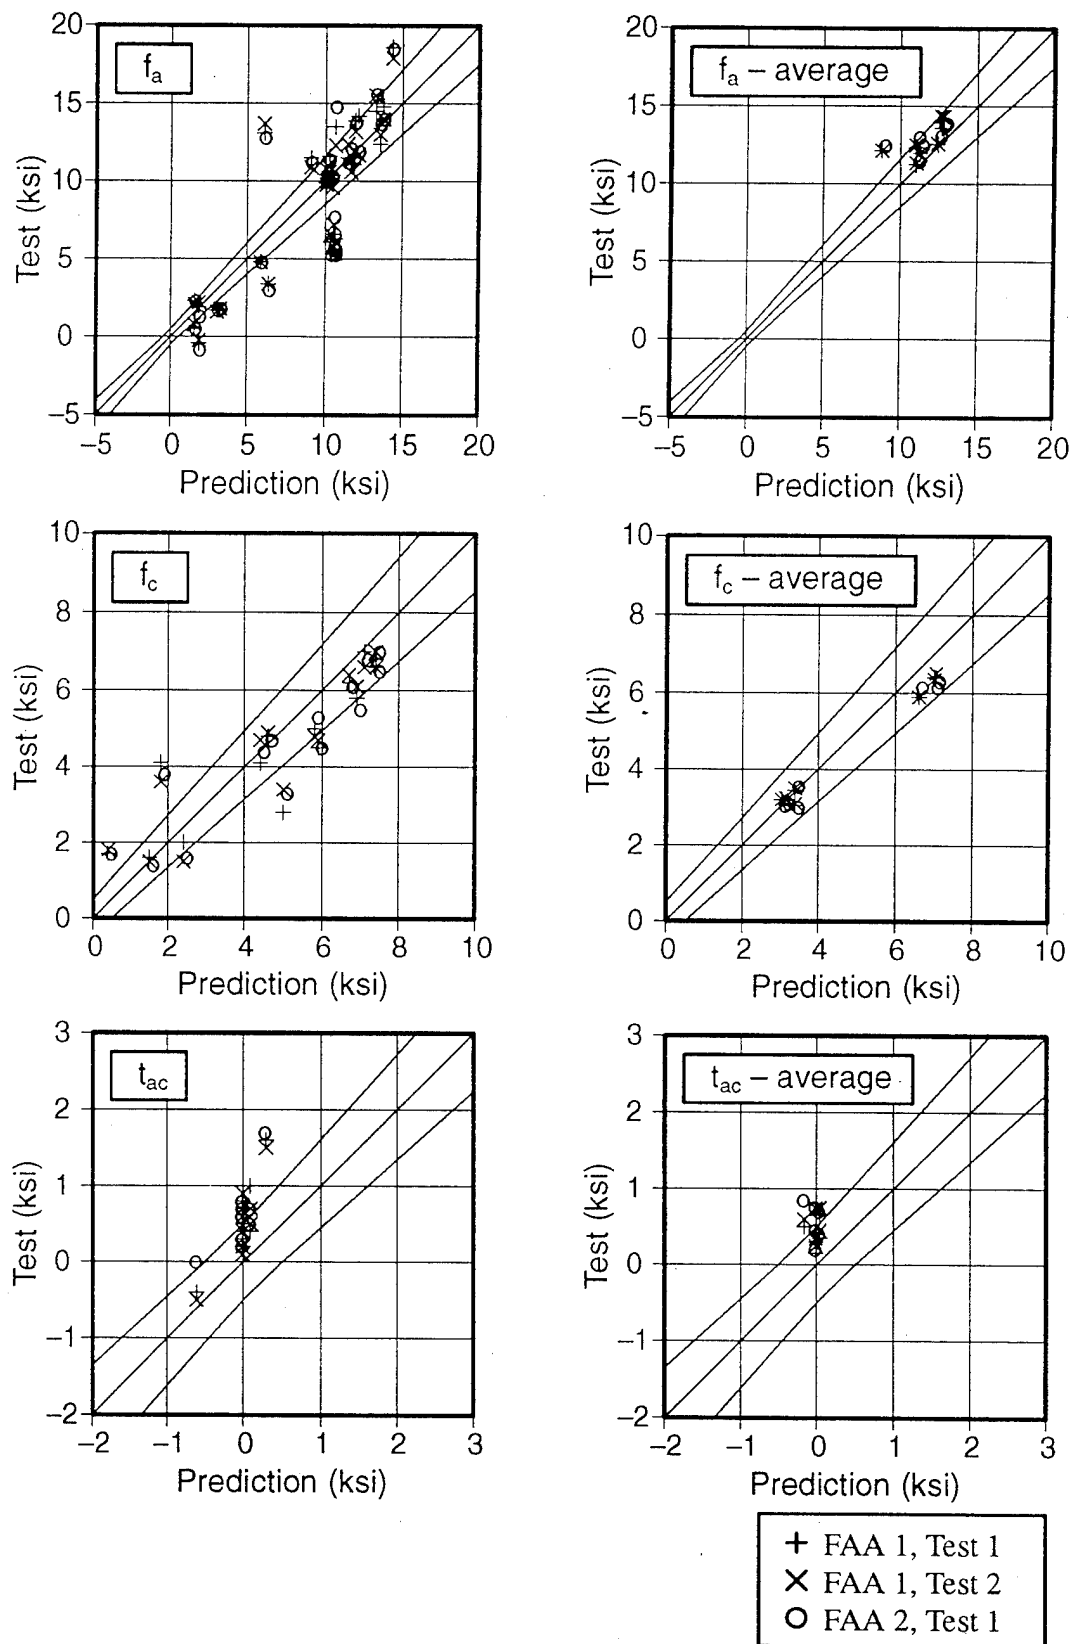
Figure 57. Test / Analysis Strain Gage Correlation for Intact Test Panels

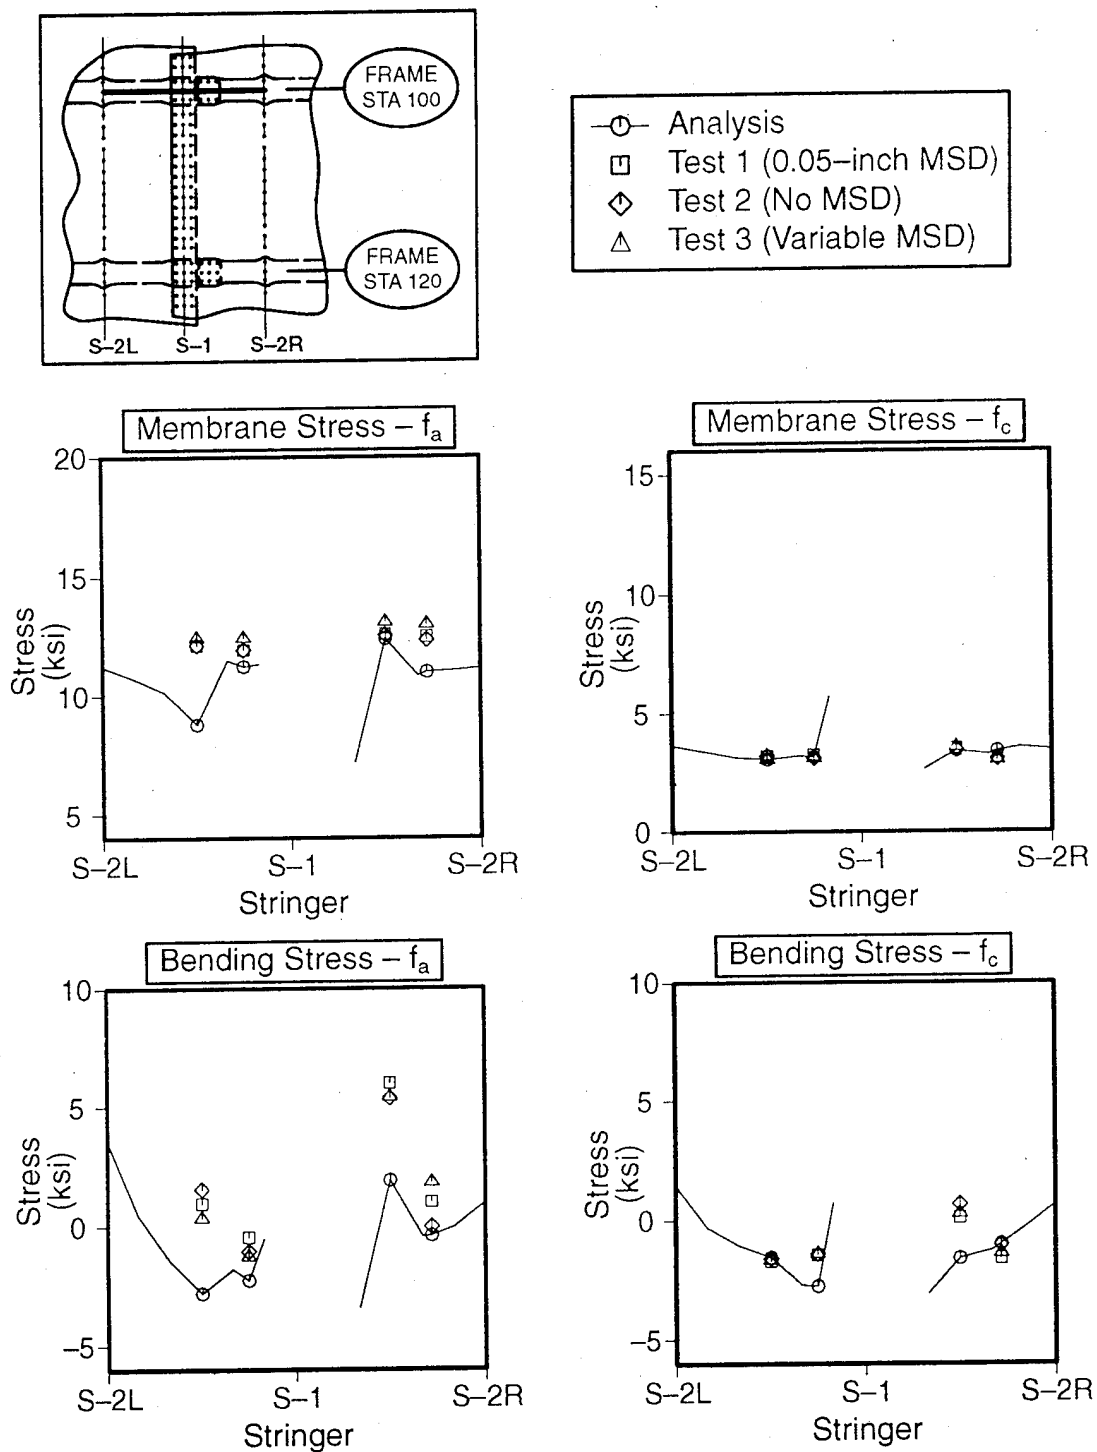
Figure 58. Skin Stress Correlation at Station 100 for an Intact Test Panel

line plots are shown in figures 58 through 63 for the intact test panel and in figures E-5 through E-28 for the test panel containing a crack.
