DOT/FAA/AR-95/47

# Investigation of Fuselage Structure Subject to Widespread Fatigue Damage

February 1996

Final Report

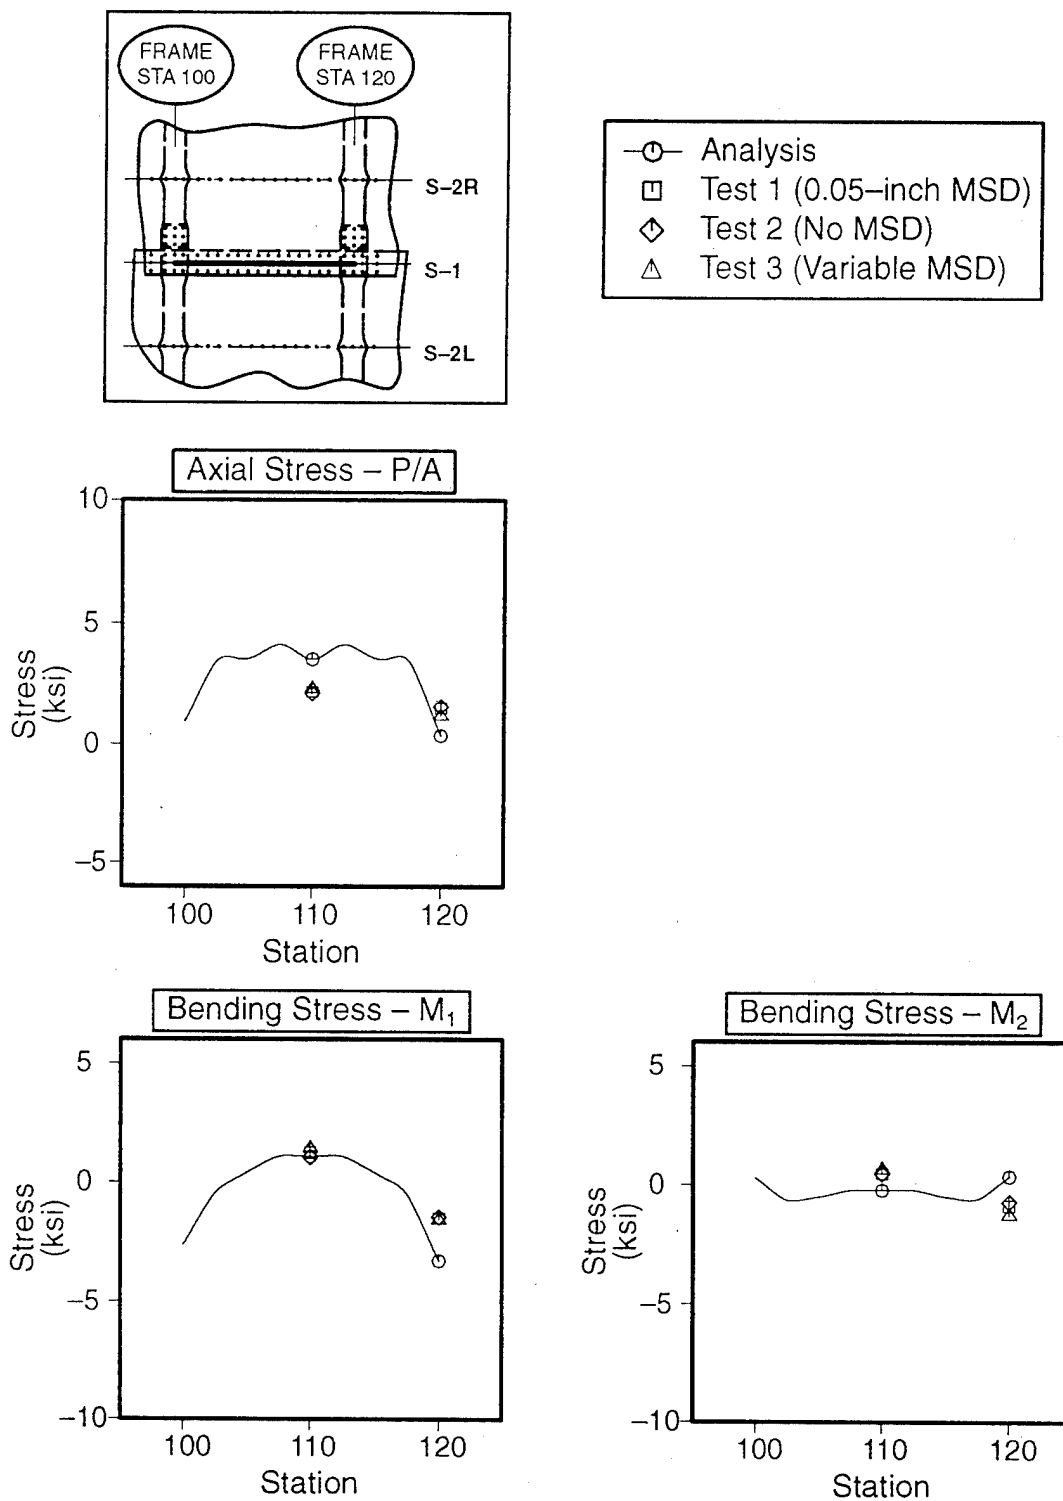
Figure 63. Stringer Stress Correlation at Stringer S-1 for an Intact Test Panel

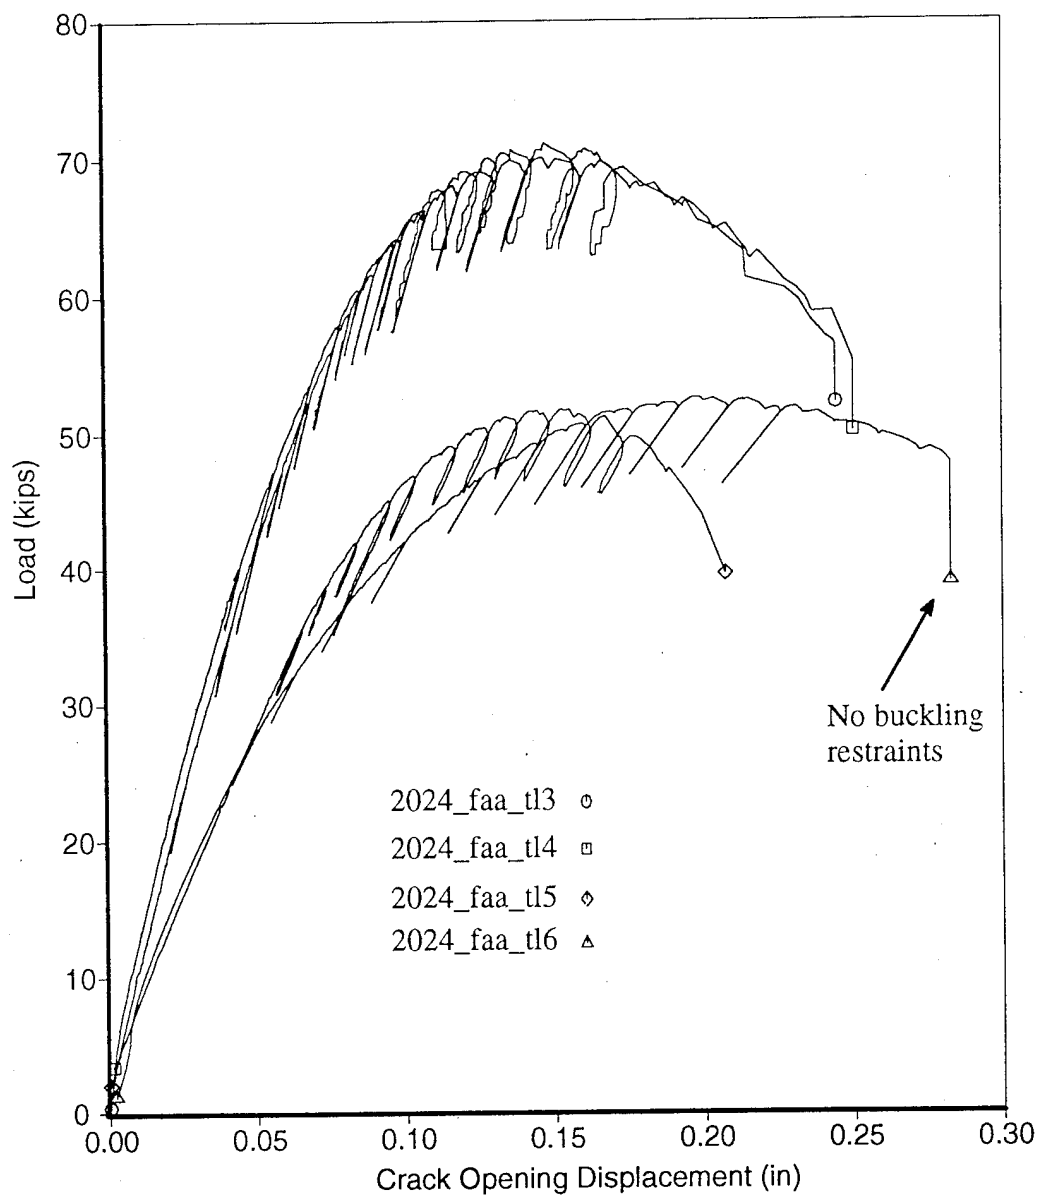
Figure B-1. Load Versus Crack Opening Displacement
