Report for Period: October 1, 1993 - May 31, 1995

**FUNDAMENTAL STUDIES ON THE CORROSION BEHAVIOR OF  
WELDMENTS IN MARINE MICROBIAL ENVIRONMENTS**

Grant No. N00014-92-J-4116

**OFFICE OF NAVAL RESEARCH**

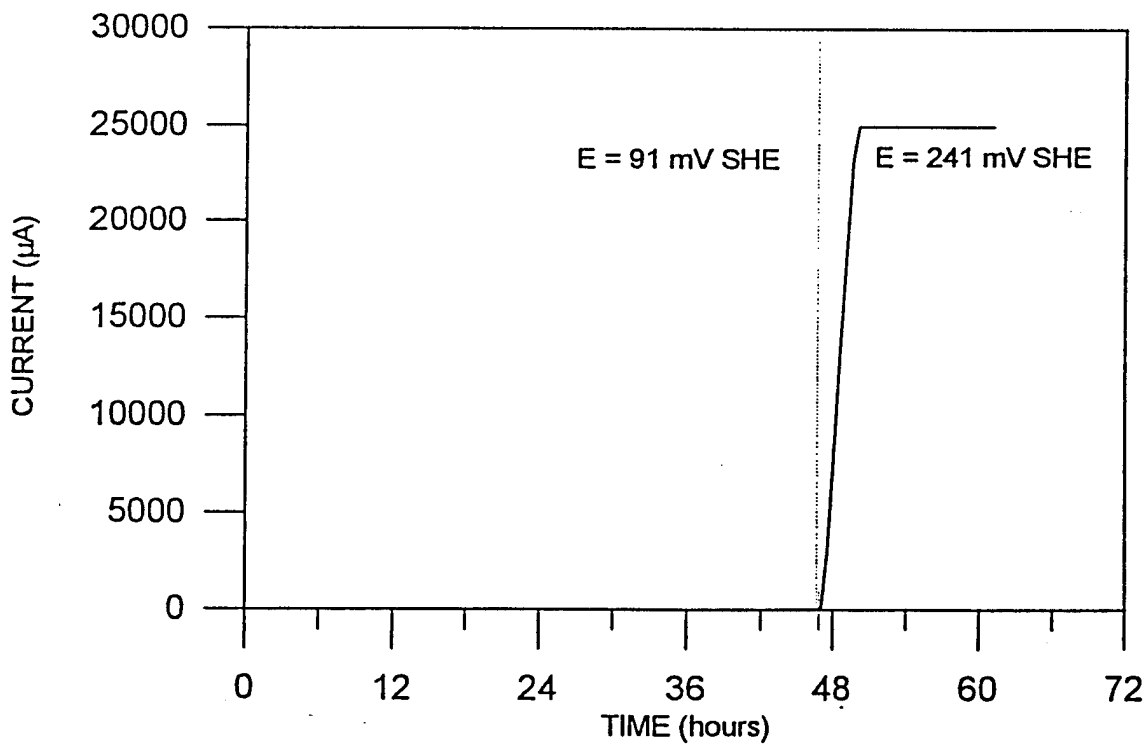
Figure 3. Current vs. time for the bacterial cell.

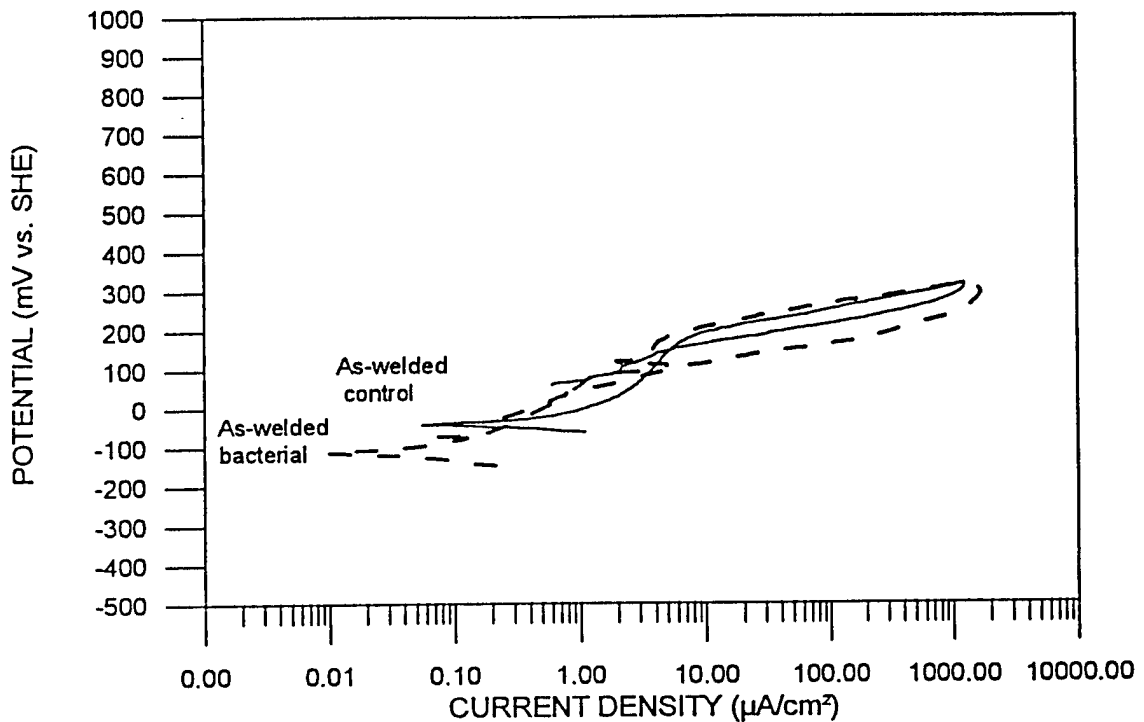
Figure 6. Anodic polarization tests for bacterial and control samples.

In order to avoid randomly trying potentials that would initiate a current increase in the bacterial cells but not in the control cells, anodic polarization tests were run for coupons in the bacterial cell and control cell in order to establish a breakdown potential. Then after having obtained a range of potentials to work with, the applied potential vs. current tests would be run with a better idea of ranges that might show a notable difference in current. However, as shown in Figure 6, anodic polarization tests showed that plots for bacterial and control samples were distinctly similar, with the only apparent difference being the initial potential values. These results suggest that beyond deaeration, indicated by the low  $E_{\text{corr}}$  value, the presence of the biofilm at the surface did not create conditions different from normal conditions. It has repeatedly been documented that biofilms can modify the environment at the biofilm/metal surface interface; however, this was not the case for these tests.

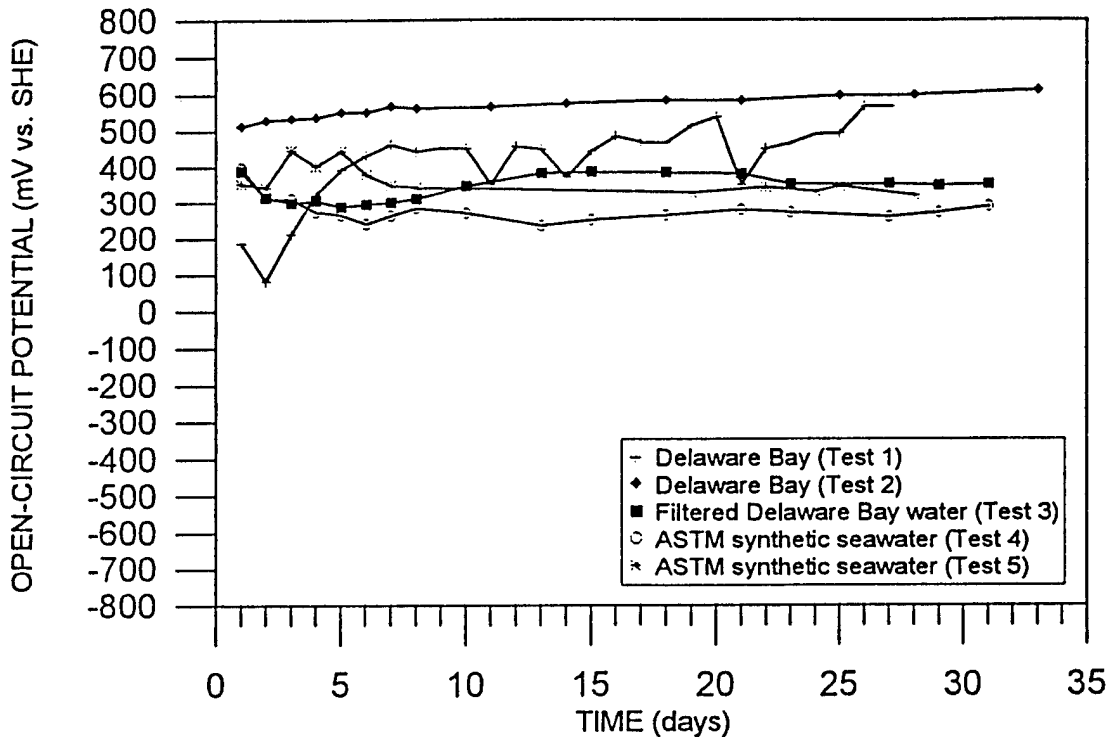
Figure 8. Open-circuit potential vs. time for platinum electrodes.

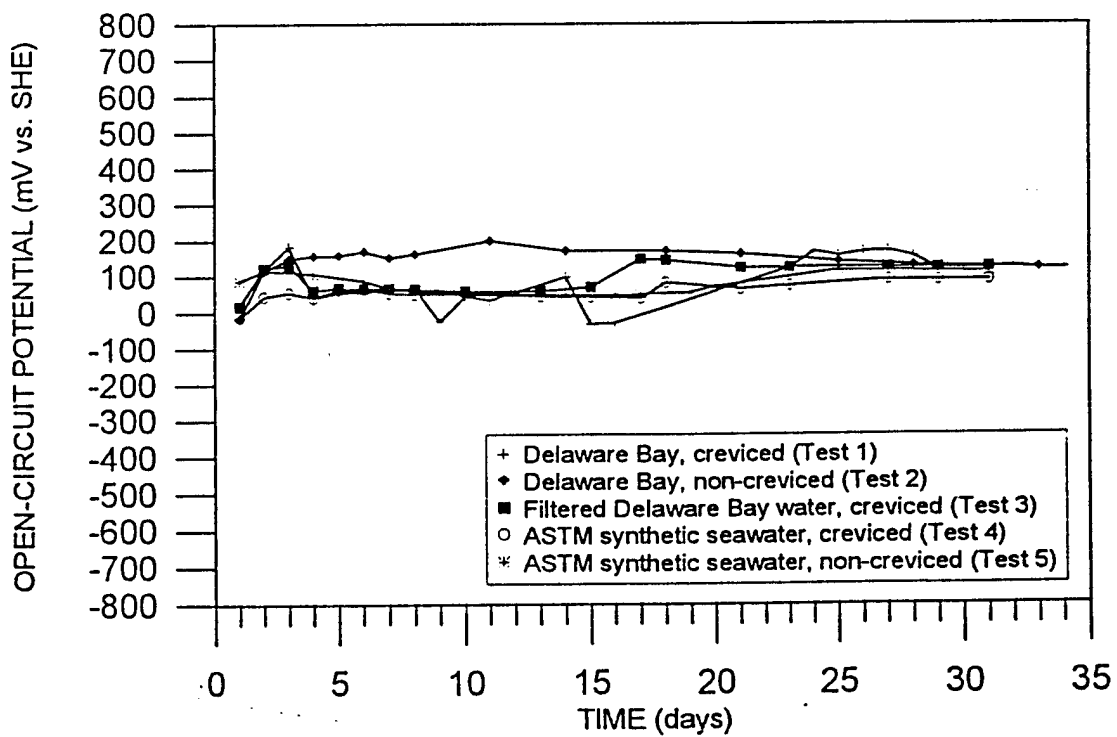
Figure 10. Open-circuit potential vs. time for weldment #1-b (304L/308L, brushed).

OCP measurements for the stainless alloys are shown in Figures 9 through 14. As shown in Figures 9 and 10, values for weldments #1-a and #1-b (304L/308L) of Test 1 (Delaware Bay, creviced) were approximately in the same range as for the laboratory control counterparts of Tests 3 and 4. As expected, because of the intentional crevice, values in Test 1 were lower than in Test 2, which was also conducted in the Delaware Bay, but with non-

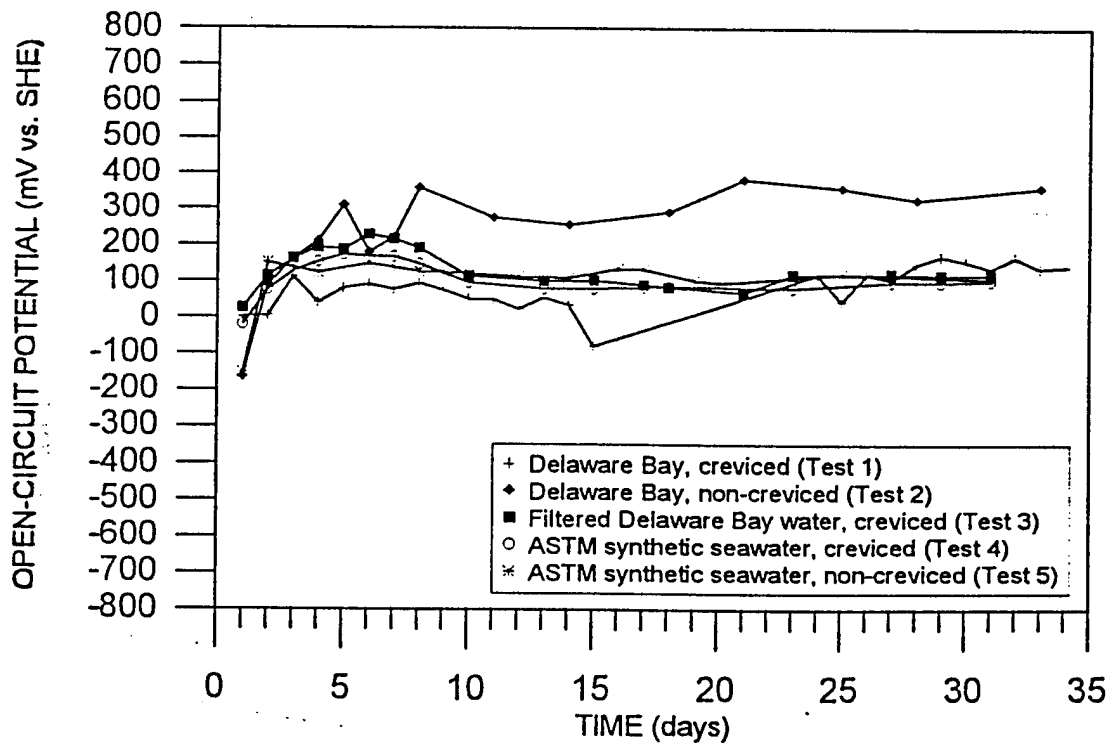
Figure 12. Open-circuit potential vs. time for weldment #2-b (316L/316L, brushed).

OCP measurements for weldments #2-a and #2-b (316L/316L) are shown in Figures 11 and 12. Values for Test 1 were approximately in the same range as for the laboratory control counterparts of Test 3 and Test 4. The differences between creviced and non-creviced values for the same environment were more pronounced with this weldment than they were for weldment #1 (304L/308L). A definite ennoblement was experienced for the coupons in Test 2, showing a 500-600 mV increase from initial potential values. In comparison to Test 5, OCP measurements for Test 2 were approximately 300 mV higher.

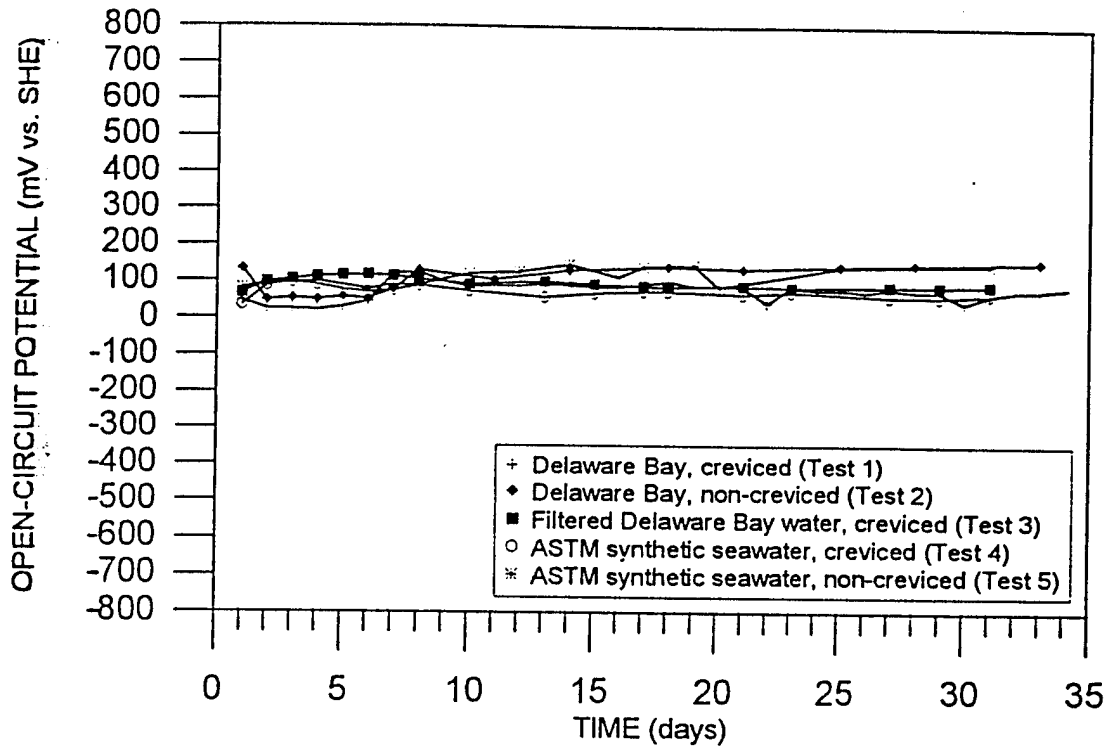
Figure 20. Open-circuit potential vs. time for weldment #7-a (90-10 Cu-Ni/70-30 Cu-Ni, brushed).

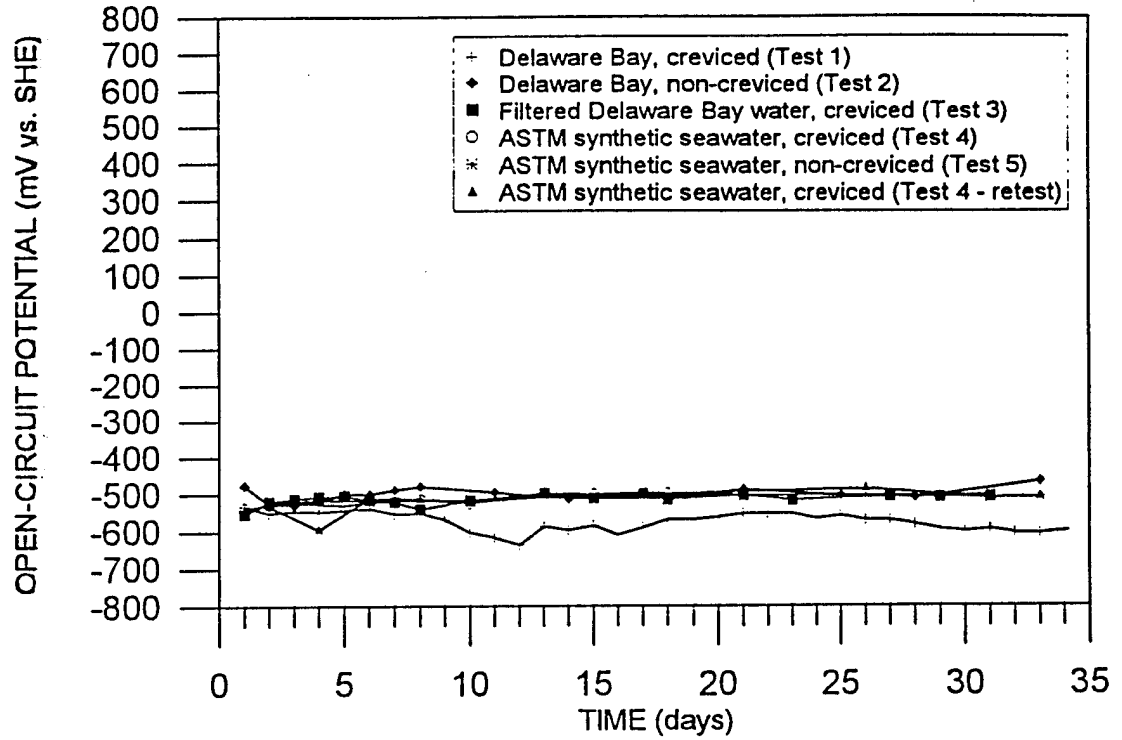
Figure 22. Open-circuit potential vs. time for weldment #8-a (AL 5086/AL 5556, no treatment).

OCP measurements for the aluminum 5086 weldments are shown in Figures 22 and 23. Problems were experienced with regard to testing the aluminum coupons in Tests 3 and 4 (laboratory control tests). Comparison of the results from the first four tests indicated that

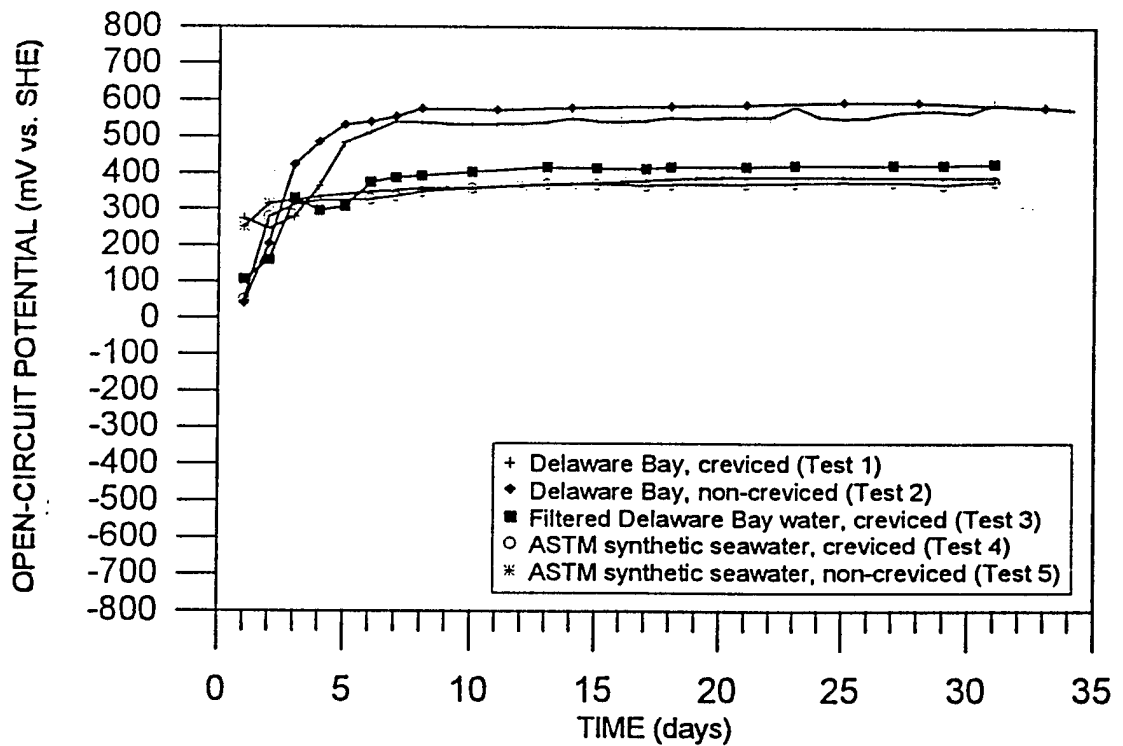
Figure 25. Open-circuit potential vs. time for weldment #9-b (Ti/Ti, brushed).

Open-circuit potential data for the titanium weldments are presented in Figures 24 and 25. All weldments from Tests 1 and 2 (Delaware Bay) ennobled, with about a 200-300 mV difference as compared to values obtained from the laboratory tests. Unlike the stainless alloy weldments, the presence of a crevice did not serve to lower the potential. Similar to results for the platinum electrodes, measurements for Test 3 (filtered Delaware Bay water, creviced) were slightly higher than for Test 4.

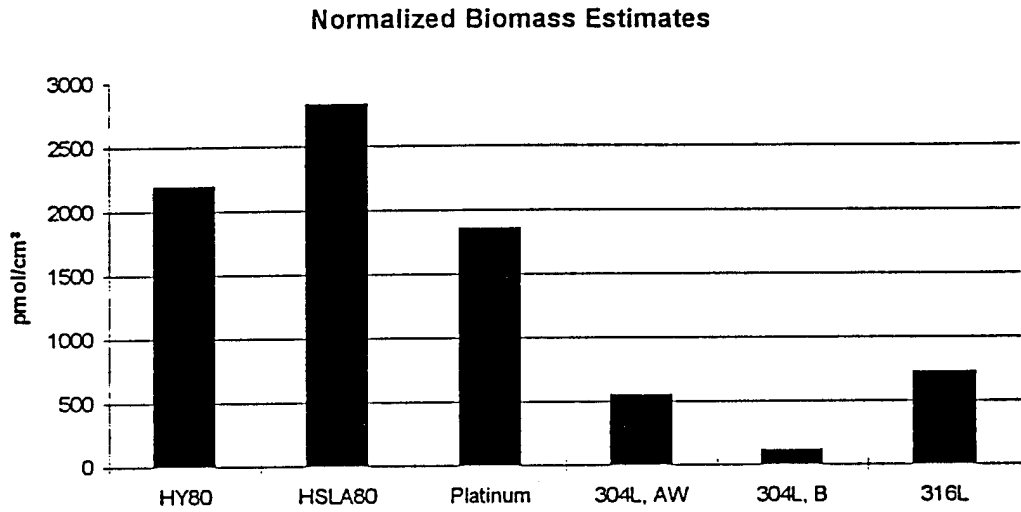
Figure 26. Total biomass estimates for coupons of Test 2 (Delaware Bay, non-creviced).

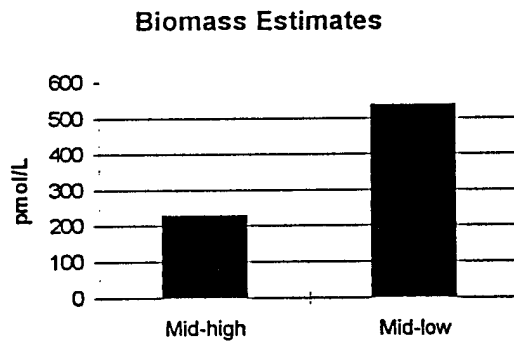
Figure 27. Total biomass estimates for water samples from the Delaware Bay.

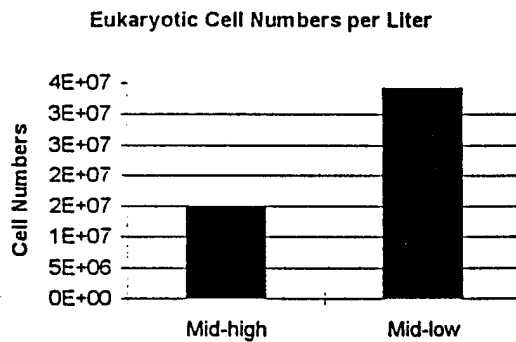
Figure 29. Eukaryotic cell numbers for water samples from the Delaware Bay.

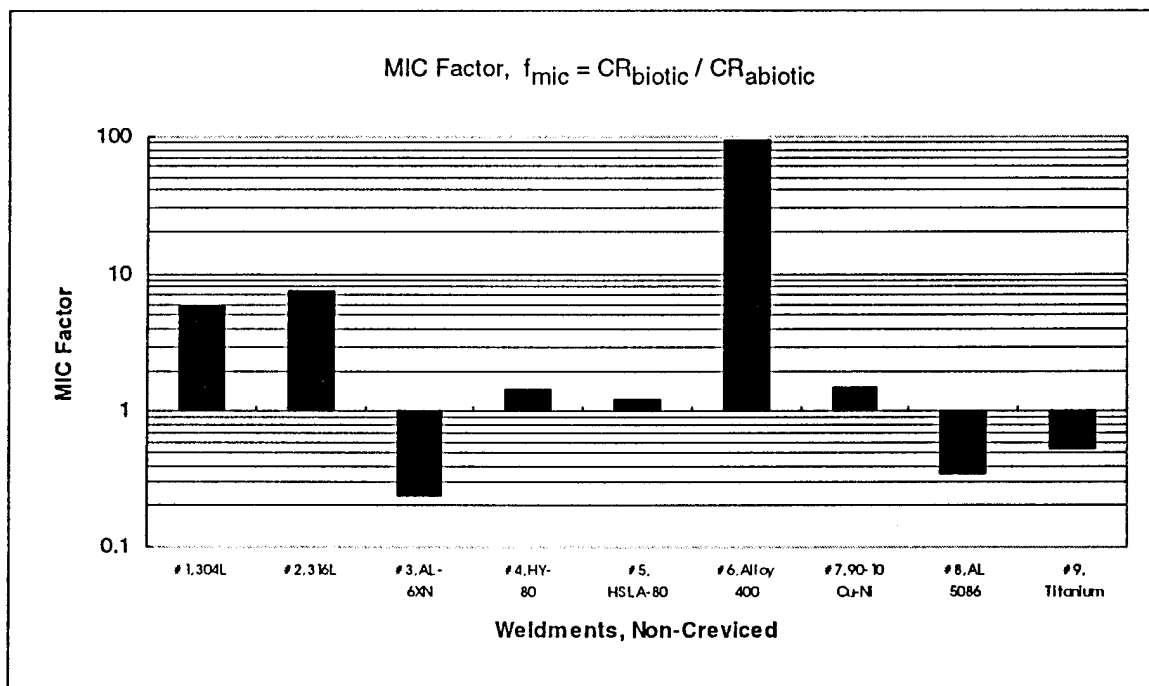
Figure 40. MIC factors for non-creviced weldments.
