# INSTALLATION RESTORATION PROGRAM (IRP) SITE INVESTIGATION

254th COMBAT COMMUNICATIONS GROUP and  
221st COMBAT COMMUNICATIONS SQUADRON  
TEXAS AIR NATIONAL GUARD  
GARLAND AIR NATIONAL GUARD STATION  
GARLAND, TEXAS

APRIL 1995

<b>13. ABSTRACT (Maximum 200 words)</b> Site Investigation Report, Volume I A Site Investigation was performed at one site at the 254th Combat Communication Group and the 221st Combat Communication Squadron, Garland, Texas. The site investigated was the Station Drainage Area and Fence Line (referred to as Site 1). All contamination identified at the site was below State cleanup levels.  The report recommended no further action for the site.	
--	--

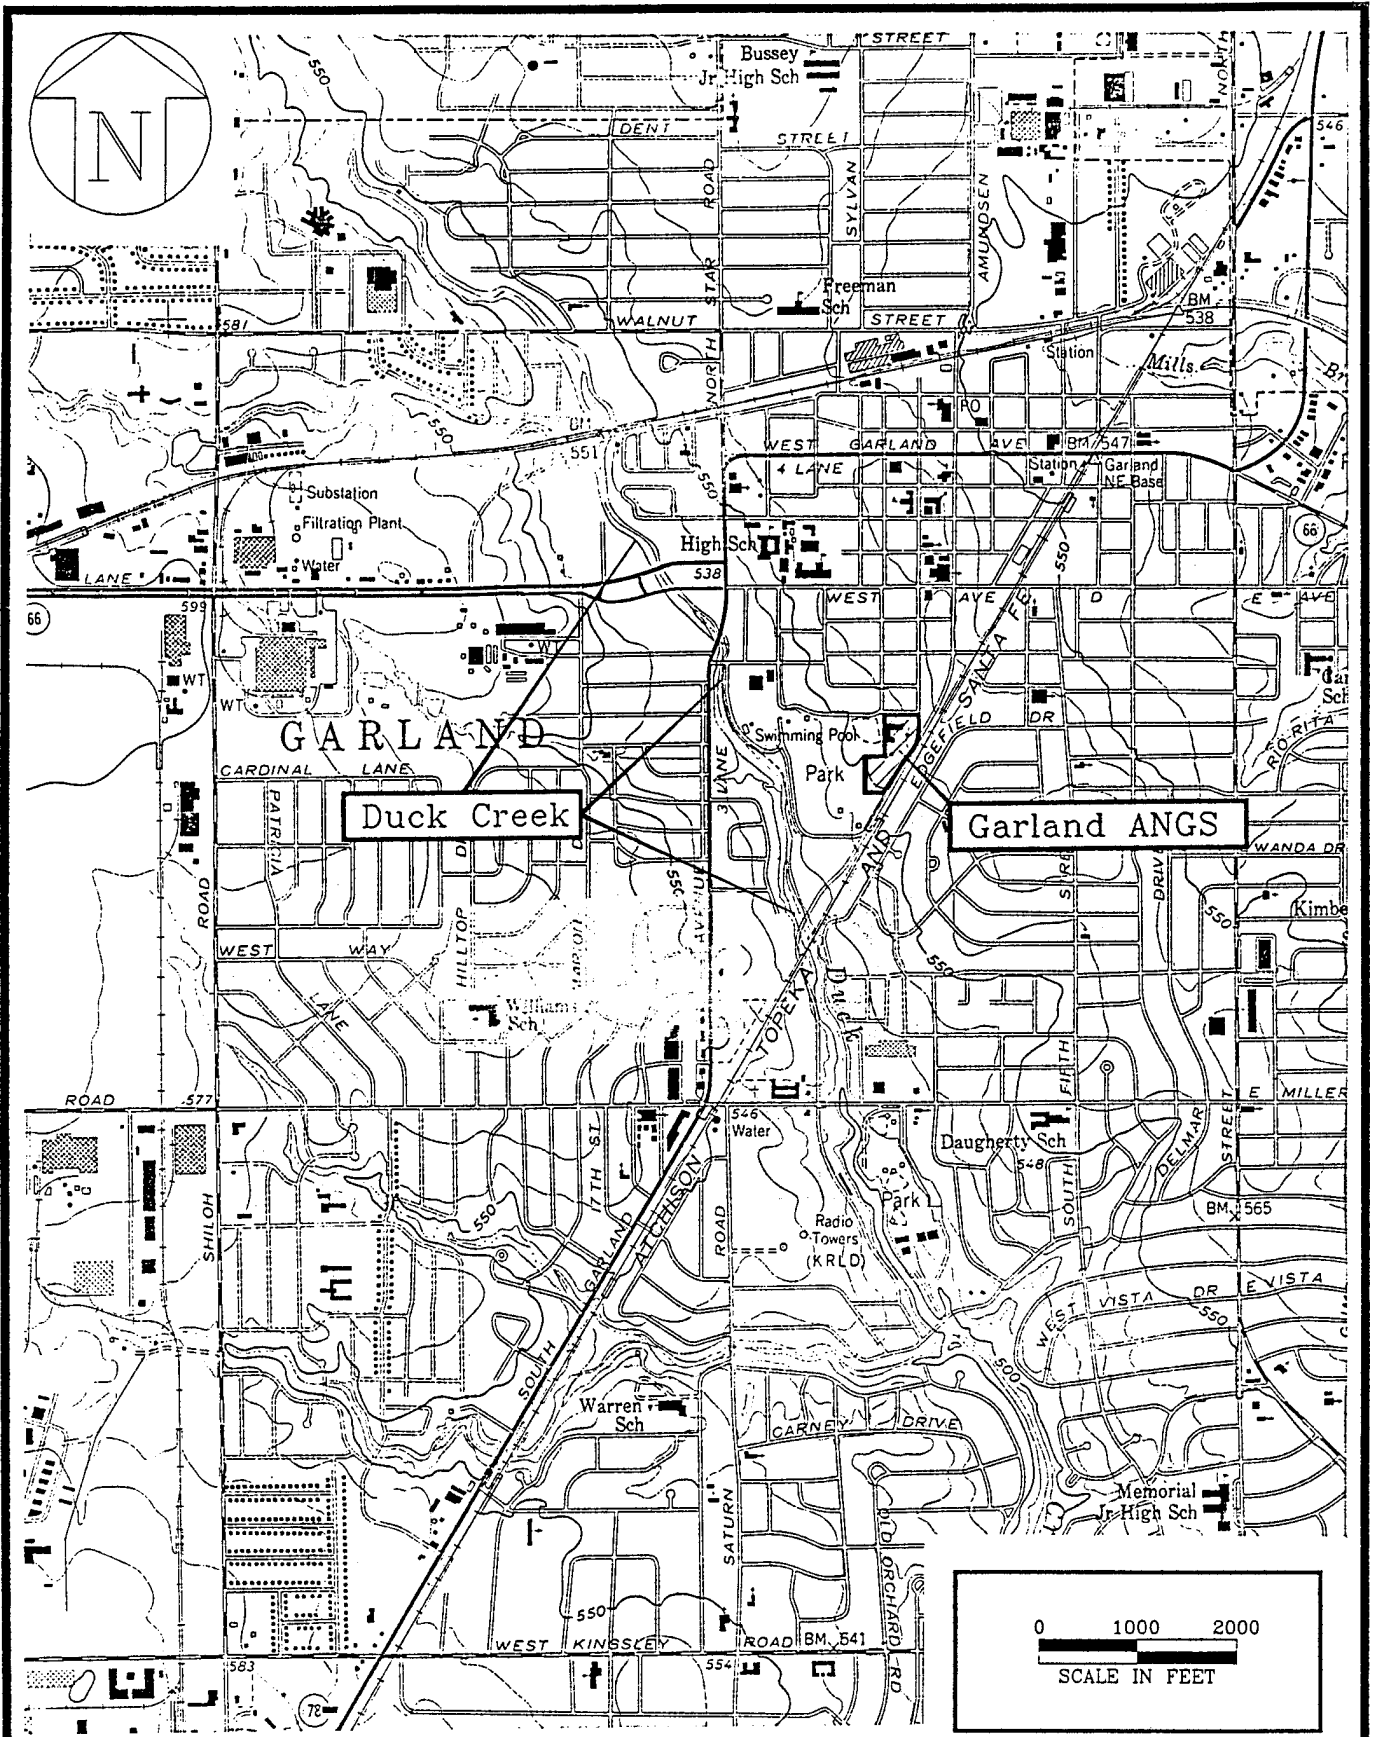
FIGURE 3.2

Garland ANGS is located in Dallas County northeast of Dallas, Texas near the transition zone of the Central Plains to the flat-lying Black Prairies. Figure 3.1 is a Physiographic Map of Texas. The station is located near the escarpment that separates the two regions and has a surface elevation of 560 feet above mean sea level (MSL). Surface topography of the area is illustrated on Figure 3.2. Surface gradients are between 25 and 50 feet per mile toward the southwest.

SOURCE: USGS 7.5 Min. TOPOGRAPHIC MAP, GARLAND QUADRANGLE (1973)

Garland ANGS is located in the Duck Creek drainage basin of the East Fork Trinity River watershed. The location of the Duck Creek drainage basin is shown in Figure 3.2.
