NASA TM X-2504

FLIGHT TEST OF CARBON-PHENOLIC
ON A SPACECRAFT LAUNCHED BY
THE PACEMAKER VEHICLE SYSTEM

by Thomas E. Walton, Jr., and William G. Witte

Langley Research Center

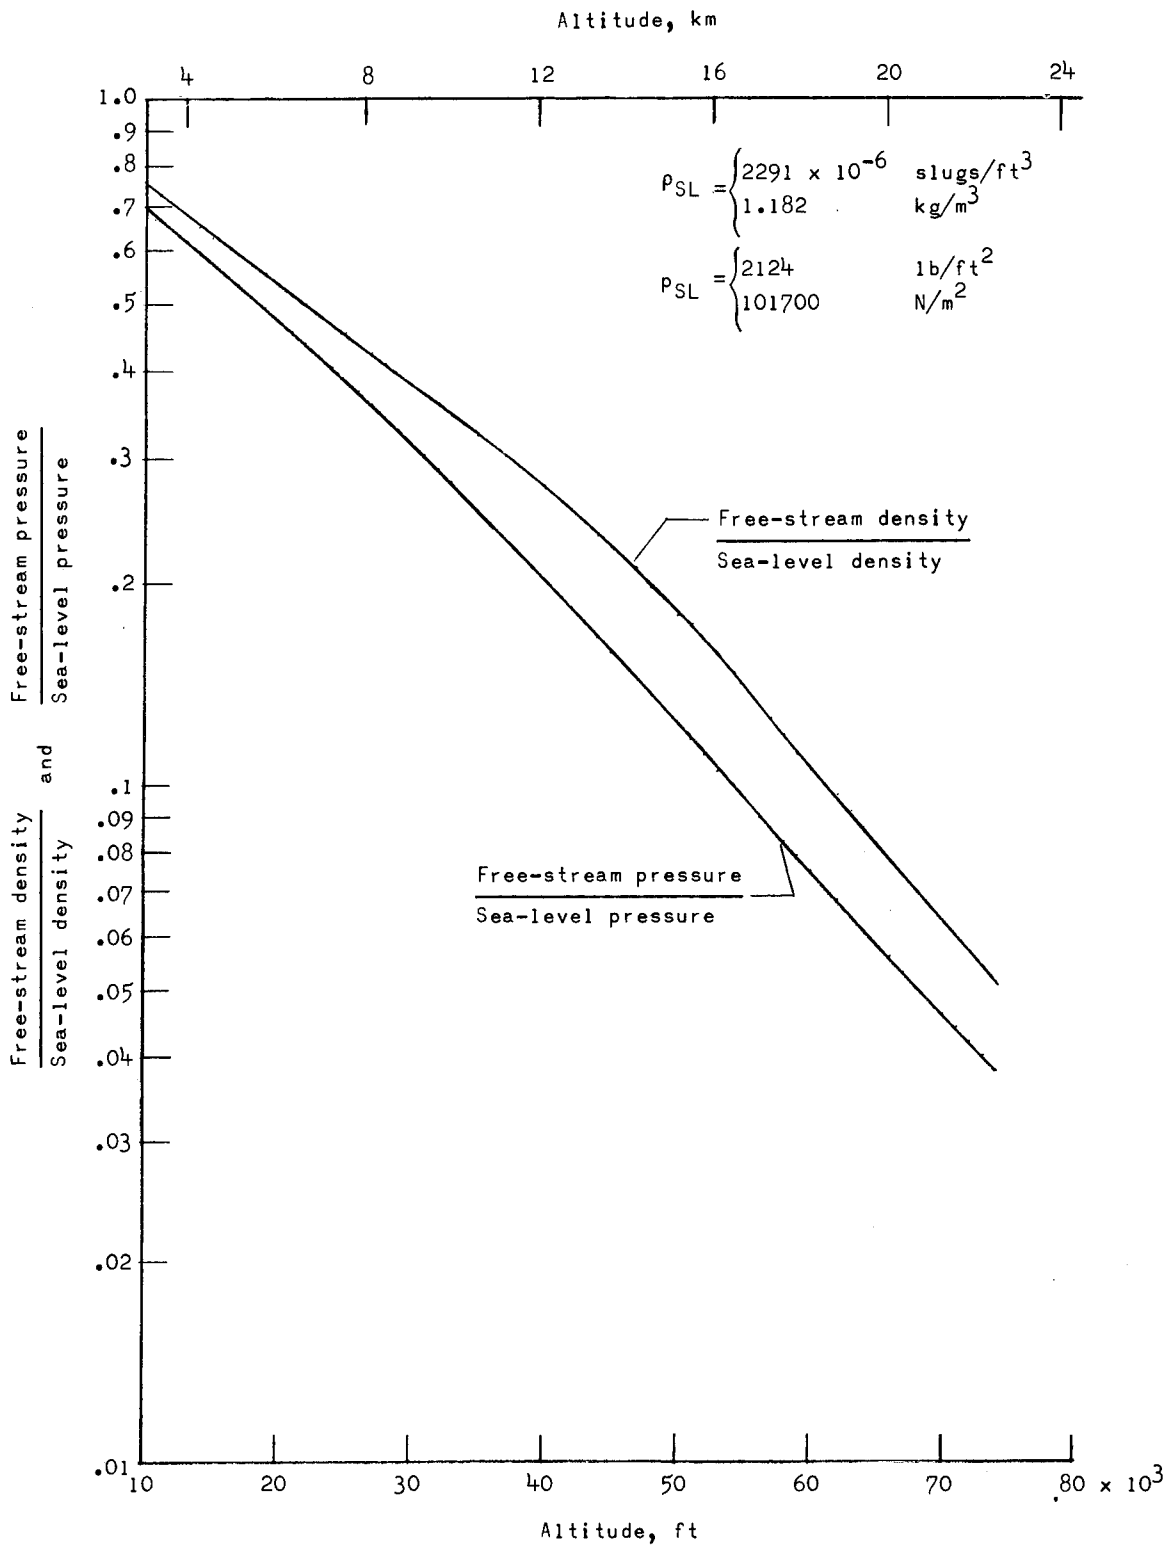
Figure 10.- Atmospheric data obtained from rawinsonde data.

(a) Nondimensional pressure and density variation with altitude.

(b) Temperature variation with altitude.

A rawinsonde launched just prior to flight measured ambient pressure and temperature. Nondimensionalized values of pressure and computed ambient density as functions of altitude are shown in figure 10(a). Figure 10(b) shows the temperature variation with altitude.
