# **Acoustic Thermometry of Ocean Climate (ATOC): Pioneer Seamount Source Installation**

Technical Memorandum

**APL-UW TM3-96**

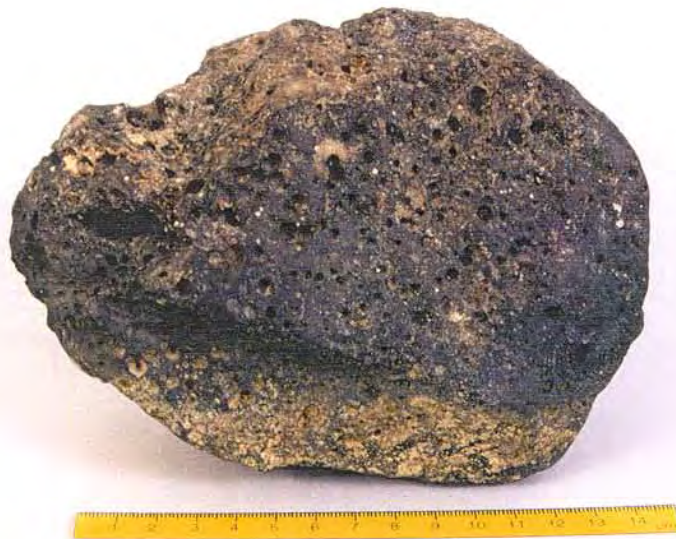
**Figure 12.** Photograph of rock recovered from Pioneer Seamount at  $37^{\circ}20.548'N$ ,  $123^{\circ}26.709'W$  at a depth of 944 m during the ATOC source site survey by DSV 4 *Sea Cliff* on 14 October 1995.

During the dive, some video footage was taken (unfortunately, the deployments of Transponders 2 and 3 were missed) as well as 44 still photographs, one of which is shown in Figure 11. The only physical sample recovered is the rock shown in Figure 12, which was collected next to T3.
