# INVESTIGATION OF THIN FILMS AS FLOATING LINERS FOR FIBER-GLASS CRYOGENIC PROPELLANT TANKS

*by Robert W. Frischmuth, Jr*  
*Lewis Research Center*  
*Cleveland, Ohio*

NATIONAL AERONAUTICS AND SPACE ADMINISTRATION • WASHINGTON, D. C. • JANUARY 1966

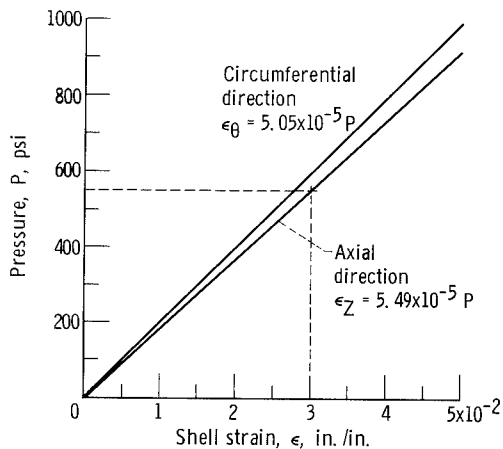
Figure 3. - Calculated shell strain as function of pressure at room temperature.

Using the method outlined in reference 3, the relation between shell strain and pressure  $\epsilon(P)$  can be calculated and is shown in figure 3. Now, the ultimate strain of "E" glass is about 5 percent (ref. 1). However, when fiber glass is used in a filament-wound vessel, the ultimate strain of the glass is reduced due to imperfect packing of the longitudinal fibers as they cross over each other in the vessel domes, and imperfections such as variation in resin content, broken fibers due to handling, nonuniform winding tension, and nonuniform strand distribution. A realistic ultimate shell strain is about 3 percent (ref. 1) which corre-

sponds on figure 3 to a burst pressure of about 550 pounds per square inch. The reason the shell was built this strongly is that there is a practical limit on how thin a fiber-glass shell can be made. Consider the area of the dome at the transition to the cylindrical portion of the tank. Here the surface is not covered by circumferential strands and consequently the wall is thinner here than anywhere on the shell. The dome wall gets thicker as the axis of the vessel is approached due to overlapping of the longitudinal strands. The minimum strand density that can be used in this thin area to adequately support the liner is determined by one layer of adjacent strands. Assuming hexagonal close packing of the individual filaments within the glass strands, the minimum strand density of the type of strand used in this tank is about 370 strands per inch for the longitudinal wrap.

enough to being balanced (see fig. 3, p. 8) that the preceding relation can be used in place of equations (A12) and (A13) (criterion for liner integrity for a shell of unbalanced design derived in the appendix). This simplification will, in this case, introduce a possible error of less than 10 percent which is well within the accuracy of the property data used. The values used in this inequality are as follows:

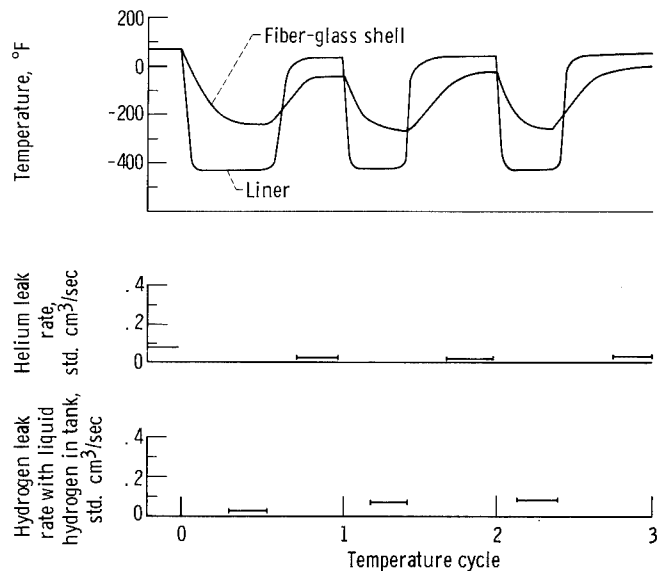
Figure 10. - Temperature cycling liner 5 (Mylar laminate) with liquid hydrogen at a tank pressure of 1 atmosphere.

Liner 5 (Mylar laminate) test results. - The initial helium leak rate was about  $7 \times 10^{-2}$  standard cubic centimeter per second at room temperature and a pressure of 1 atmosphere. The tank was put through three thermal cycles, using liquid hydrogen, without any increase in leak rate (see fig. 10). The temperature of the fiber-glass shell (fig. 10) never approached the temperature of liquid hydrogen ( $-423^{\circ}\text{F}$ ). At 1 atmosphere tank pressure the fiber-glass shell cooled to a steady-state temperature of  $-270^{\circ}\text{F}$ . This was due to the insulating quality of the felt spacer, which was in this case evacuated to approximately the same pressure as the bell jar (average of about  $10\mu\text{Hg}$ ). Thermal conductivity of the evacuated felt spacer was calculated to be  $3 \times 10^{-4}$  Btu per hour per foot per  $^{\circ}\text{F}$ . It should be pointed out that this tank could not be tested in the air since air would be cryopumped into the felt. The saturation of the felt with liquid air would not only be dangerous, but would destroy the insulating quality of the felt.

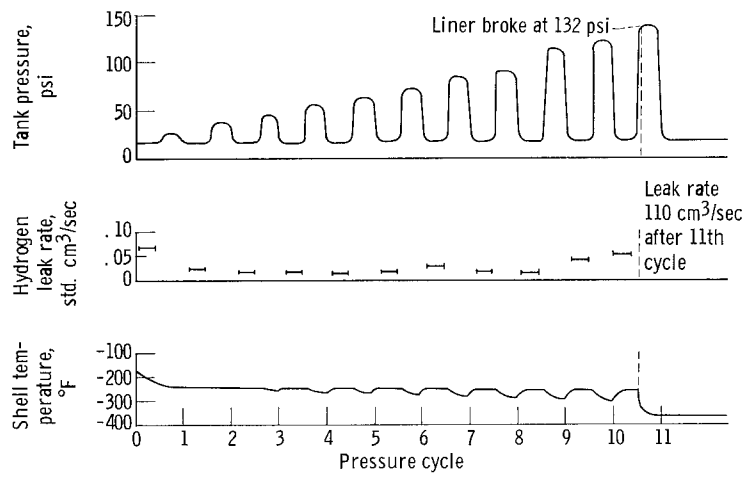
Figure 11. - Pressure cycling liner 5 (Mylar laminate) with liquid hydrogen in tank.

Next the tank was pressure cycled, as shown in figure 11, with liquid hydrogen in the tank. The leak rate, measured after each pressure cycle, was found to be less than  $5 \times 10^{-2}$  standard cubic centimeter per second for the first 10 cycles indicating no damage

to the liner. On the eleventh cycle, when the pressure reached 132 pounds per square inch, the leak rate suddenly increased. After the pressure was dropped back to 1 atmosphere the leak rate measured 110 standard cubic centimeters per second indicating the liner broke. Also at the time the liner failed, the shell temperature suddenly dropped (fig. 11). The felt pad lost its insulating quality due to the loss of vacuum.

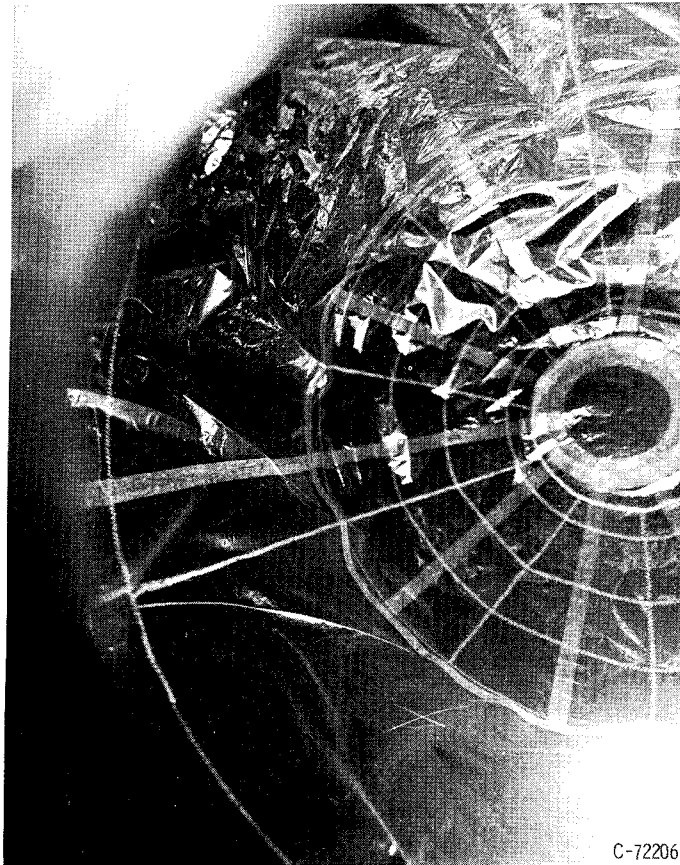
Figure 12. - Liner 5 (Mylar laminate) after failure. Photograph taken with liner in place.

Liner 5 (Mylar laminate) analysis of failure. - Figure 12 is a photograph of the liner after testing, taken through the neck fitting of the tank. As expected, there is some wrinkling. There are several very sharp folds or creases. To further investigate, the liner was removed from the fiber-glass shell.

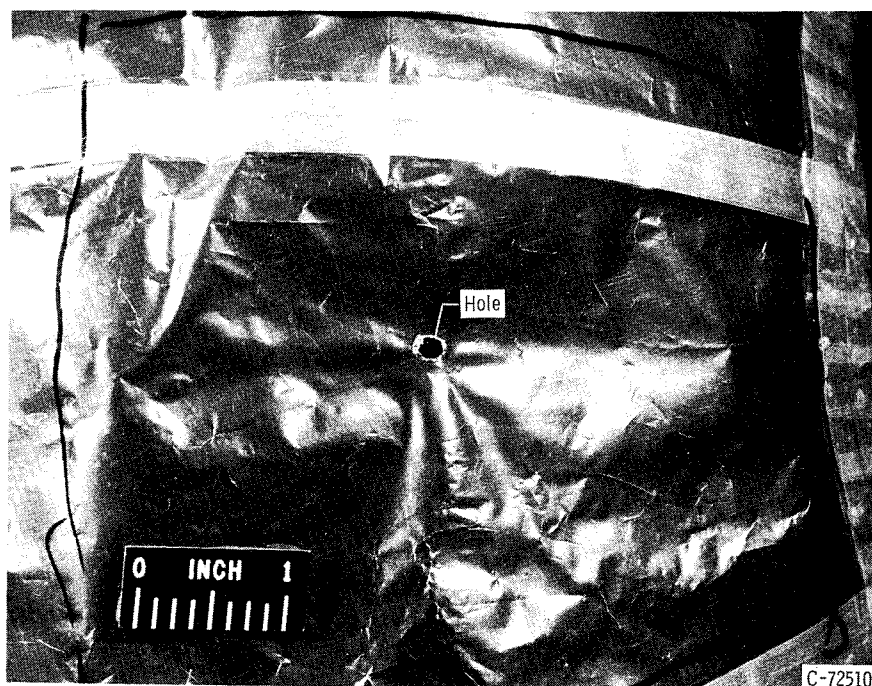
The leak source was found to be three rather large holes. Two of the holes were located in the upper dome (figs. 13 and 14), and one in the cylindrical portion (fig. 15). Also, after a thorough examination, no visible leaks were found in either the adhesive joints or on the sharp folds or creases just mentioned. The holes shown in figures 13 to 15, were believed to be biaxial tensile failures.

Figure 13. - Leak in liner 5 (Mylar laminate) in upper dome.

Figure 14. - Leak in liner 5 (Mylar laminate) in upper dome.

Figure 15. - Leak in liner 5 (Mylar laminate) in cylindrical portion.

Therefore, theoretically the liner should fail in tension at about 118 pounds per square inch. This is in good agreement considering the accuracy of the preceding data with the 132 pounds per square inch at which the liner actually failed, supporting the belief that holes shown in figures 13 to 15 are the results of a biaxial tensile failure. The

reason the appearance of figures 13 to 15 is not typical of conventional biaxial tensile failures such as the bursting of a pressure vessel, is that with the rupturing of the liner there was no sudden release of energy since the tensile load due to pressure was carried by the filament-wound shell.
