EVALUATION OF A SUBSCALE INTERNALLY INSULATED FIBER-GLASS PROPELLANT TANK FOR LIQUID HYDROGEN

*by Laurence J. Heidelberg
Lewis Research Center
Cleveland, Ohio*

NATIONAL AERONAUTICS AND SPACE ADMINISTRATION • WASHINGTON, D. C. • OCTOBER 1965

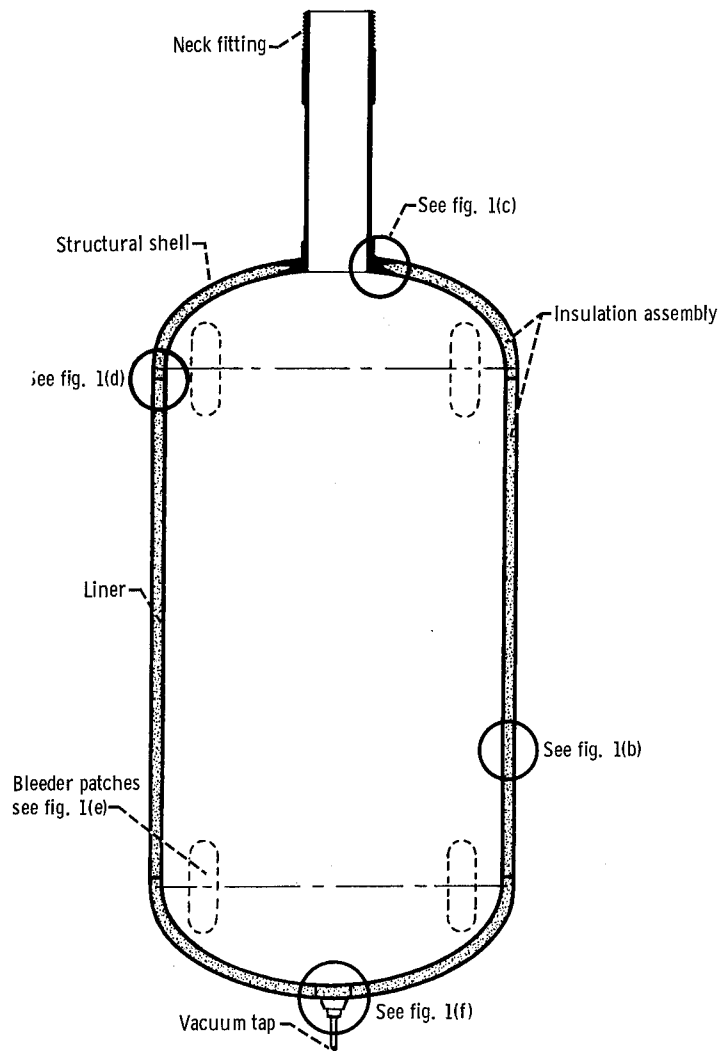
(a) Complete test tank.

Figure 1. - Details of filament-wound liquid-hydrogen test tank. All surfaces bonded except as indicated. (Not to scale.)

An 18-inch-diameter by 36-inch-long pressure-vessel configuration with an approximate capacity of 40 gallons was selected for the test tank. The major components as shown in figure 1 are: (1) a filament-wound fiber-glass structural

shell; (2) a three-piece insulation assembly comprised of a top dome, a cylinder section, and a bottom dome; and (3) a cryogenic liner assembly comprised of two dome ends and a cylinder which are assembled to fit closely against, but not bonded to, the inner walls of the insulation assembly.

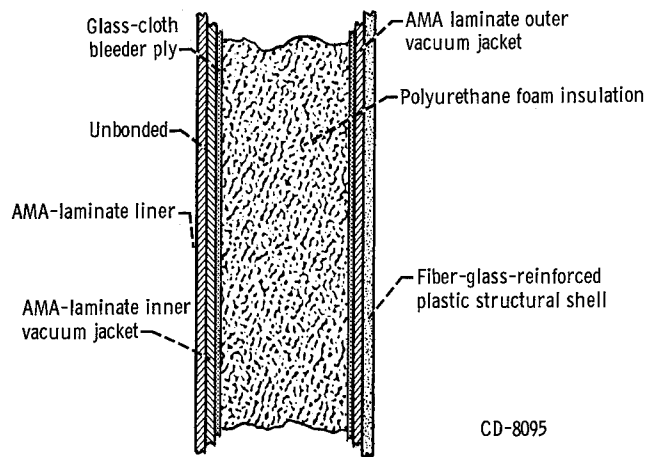
(b) Enlarged typical section through tank wall.

An important feature incorporated in the design of this tank is a glass-cloth layer between the foam to vacuum jackets (see figs. 1(b) and 5). The glass cloth is a bleeder ply (provides a path for gas flow) incorporated to serve the following purposes: (1) facilitate checking the vacuum jackets of each of the insulation components, (2) permit monitoring of the vacuum within the insulation during evaluation tests, and (3) permit rapid detection and vacuum

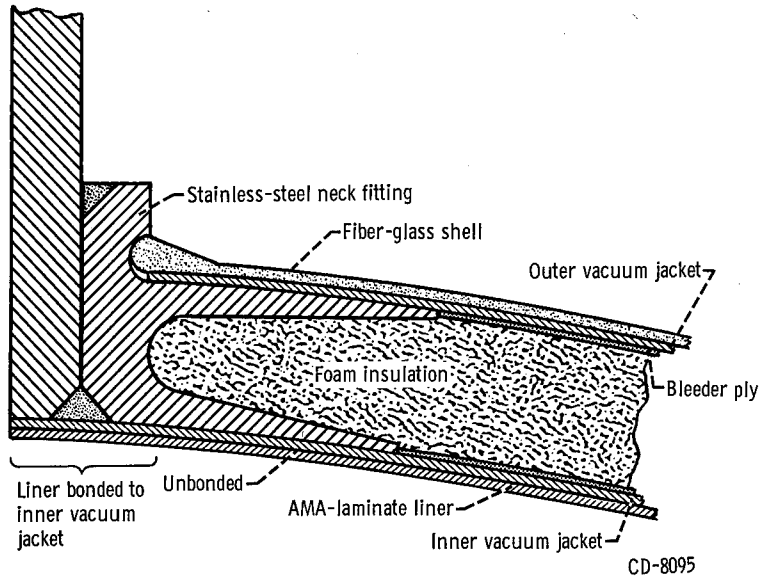
(c) Detail of neck fitting (doublers not shown).

To provide maximum assurance of achieving a leak-tight cryogenic liner and de-emphasize the importance of achieving leak-tight joints between insulation components, the cryogenic liner is designed as a separate unit. The dome portions of the liner are spin-formed 0.005-inch-thick AMA shells. The cylindrical section is a single sheet of 0.0024-inch thick prestretched AMA rolled into a cylinder and joined with one longitudinal lap-joint seam. The upper dome is adhesively bonded to the inner vacuum jacket of the insulation dome only in the area of the neck fitting flange (see fig. 1(c)).

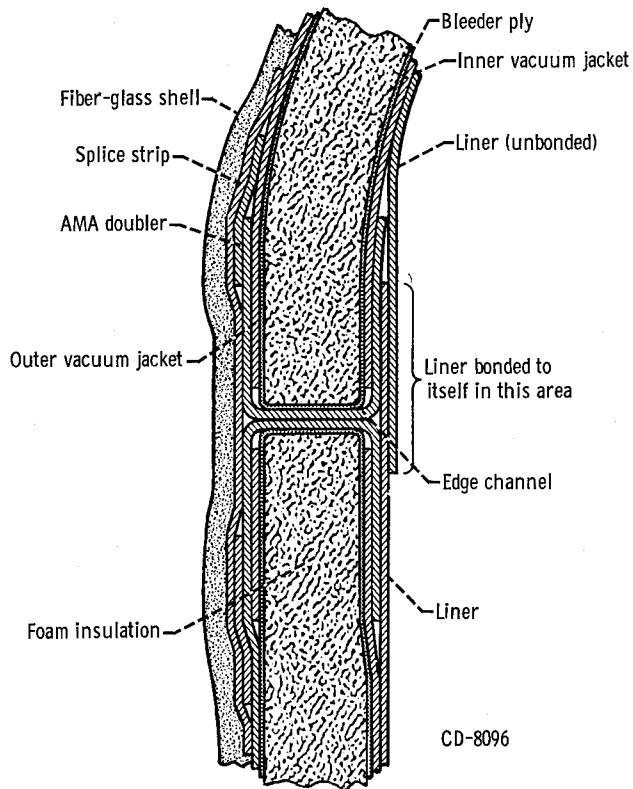
(d) Detail of typical splice between dome and cylinder.

Figure 1. - Continued. Details of filament-wound liquid-hydrogen test tank. All surfaces bonded except as indicated. (Not to scale.)

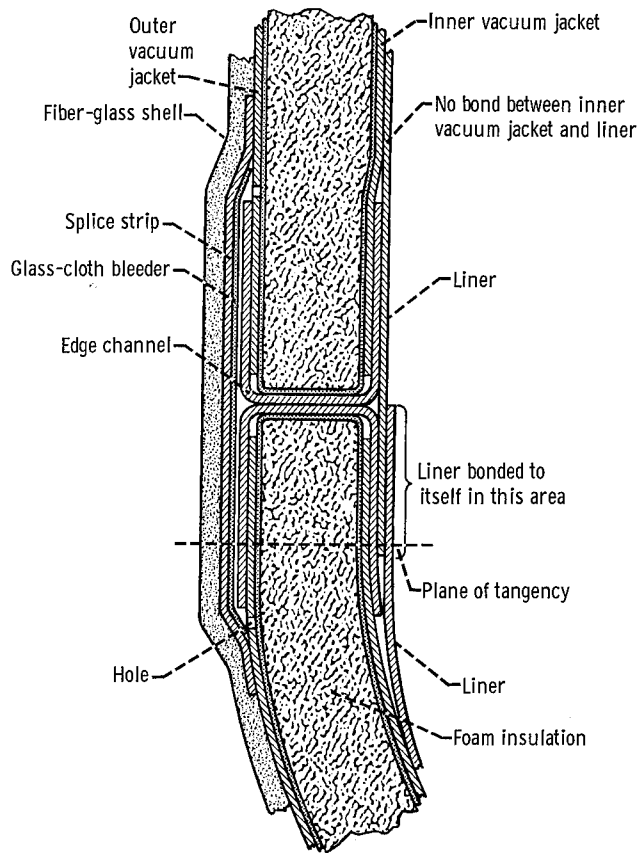
(e) Detail of section through bleeder patch (doubblers not shown).

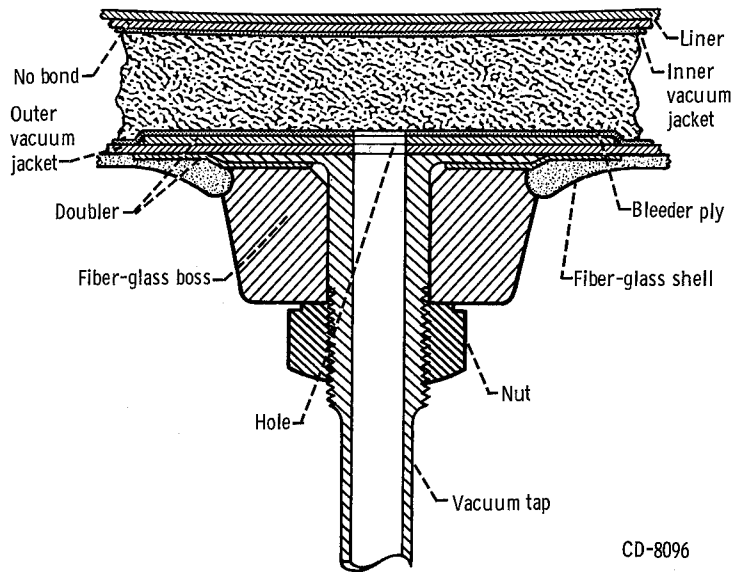
(f) Detail of vacuum tap.

Figure 1. - Concluded. Details of filament-wound liquid-hydrogen test tank. All surfaces bonded except as indicated. (Not to scale.)

pumping of small leaks if they occur in the vacuum jackets during tests. To utilize the bleeder plies, the bleeder plies of each insulation section are connected to the adjacent sections by bleeder patches (see fig. 1(e), p. 6) and vented to a vacuum tap on the outer jacket of the bottom dome (see fig. 1(f)).

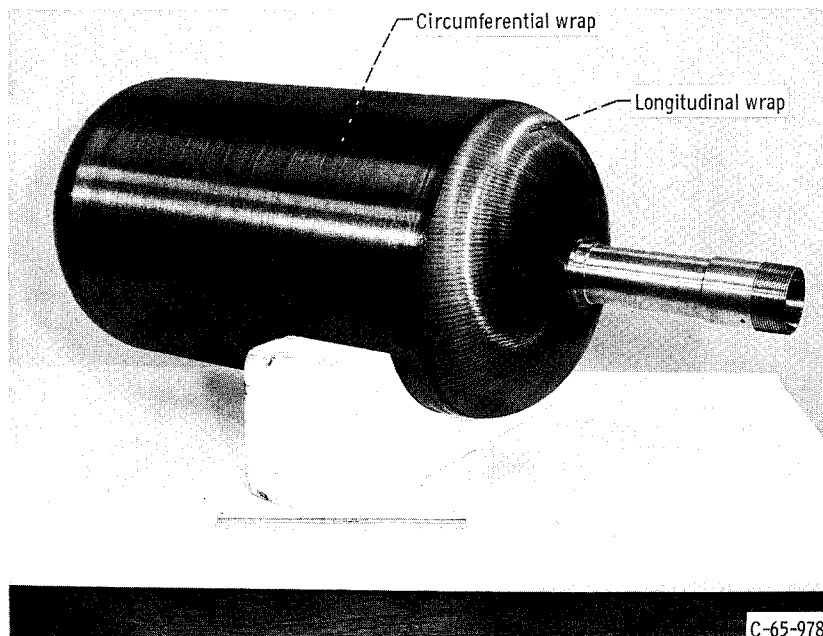
Figure 2. - Completed filament-wound test tank.

The filament-wound shell is of balanced design consisting of two layers of longitudinal wrap (412 total ends per in.) and four layers of circumferential wrap (736 total ends per in.). Roving, consisting of 20-end S/HTS fiber-glass wet impregnated with a low-temperature curing epoxy resin system, was used in winding the shell. Figure 2 shows the completed filament-wound tank.

The completed tank, shown in figure 2, weighs 17.20 pounds. A weight breakdown is as follows:

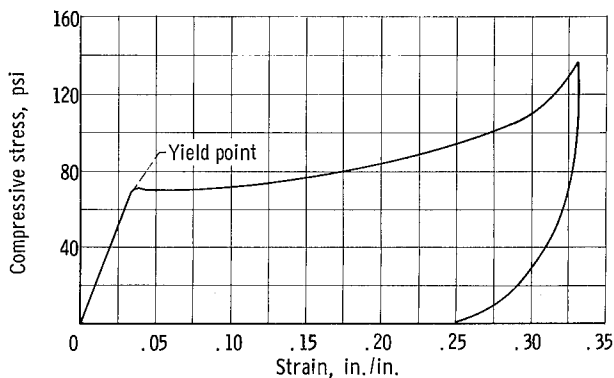
Figure 3. - Typical stress-strain curve for polyurethane foam. Room-temperature compression test; density, 4 pounds per cubic foot; modulus of elasticity, 2500 pounds per square inch.

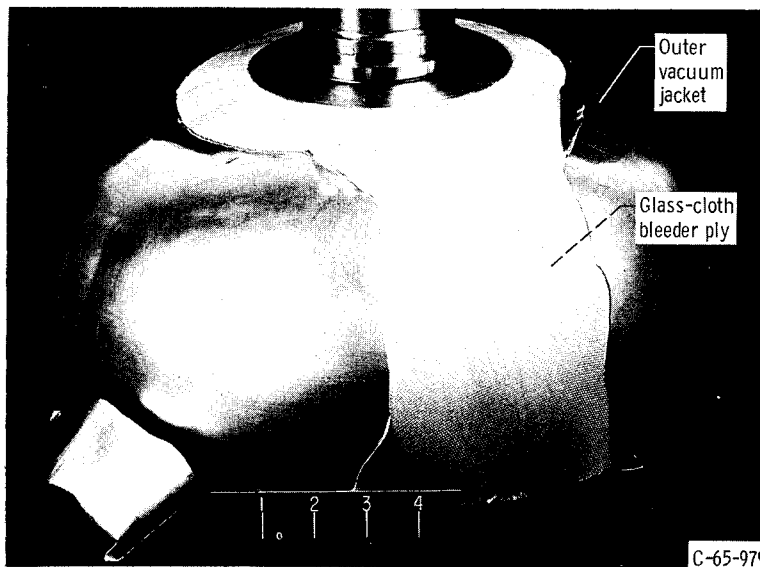
Figure 5. - Top dome insulation (outer vacuum jacket peeled away to expose bleeder ply).

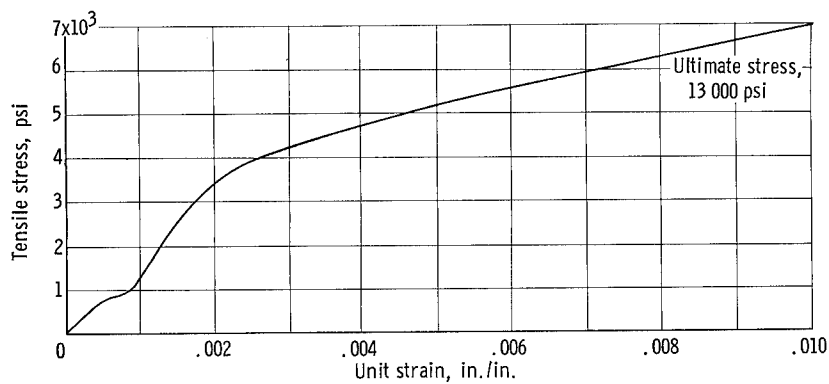
Figure 6. - Room-temperature stress-strain curve for AMA laminate (0.0007 in. aluminum, 0.001 in. Mylar 0.0007 in. aluminum).

A materials-testing program was undertaken to determine the properties of the AMA laminates. Tests were conducted at both room temperature and -300° F. Table I shows the results of these tests. Figures 6 through 9 are typical stress-strain curves recorded during the tests. Figure 6 is a curve of a room-temperature tensile test of the AMA laminate. It should be noted that this curve does not exhibit a yield point but, yields gradually rather than abruptly. When the same test is run at -300° F (fig. 7), the curve shape is the same but the stress values are nearly twice as high for the same strain. It is obvious that a strain of 0.0115 inch per inch is much beyond the elastic limit of this material. Thus, when this material is used as a liner it will be oversized after the first pressure cycle and wrinkles will occur.

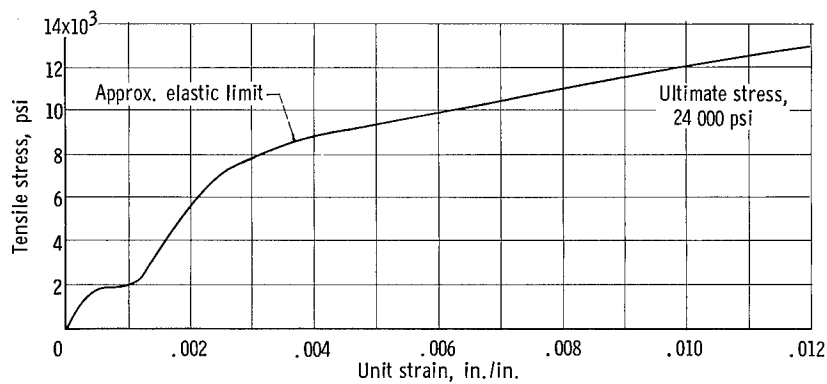
Figure 7. - -300° F stress-strain curve for AMA laminate (0.0007 in. aluminum, 0.001 in. Mylar, 0.0007 in. aluminum).

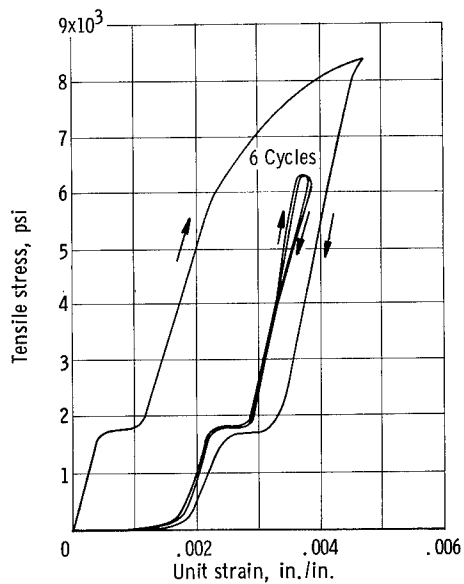
Figure 8. - Stress-strain curve of AMA laminate showing six loading cycles after an initial stress of 8300 pounds per square inch. Temperature, -300° F.

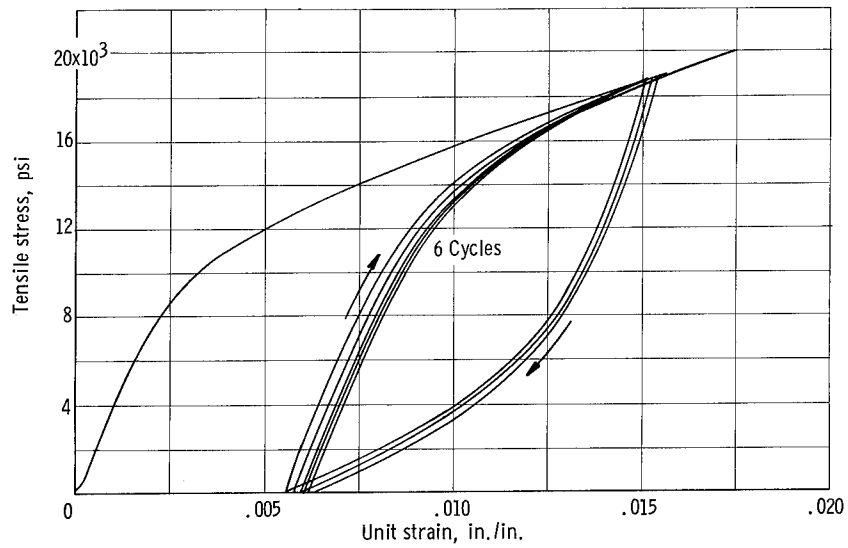
Figure 9. - Stress-strain curve for prestressed (10 040 psi at room temperature) AMA laminate at -300° F.

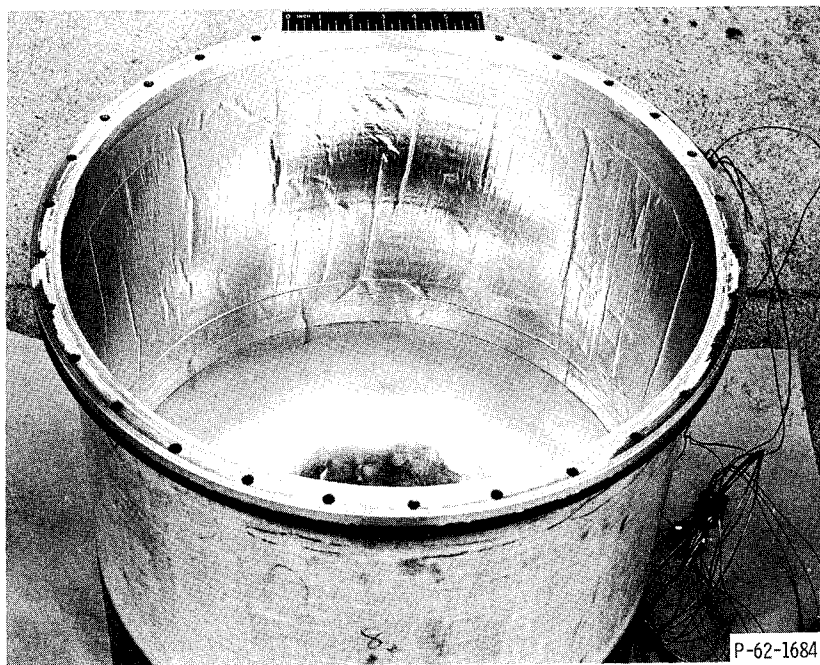
Figure 10. - Uninsulated filament-wound tank with test liner wrinkles after two temperature and pressure cycles.

Prior to fabrication of the test tank, uninsulated but lined filament-wound tanks, similar in geometry to the test tank, were pressure cycled with liquid hydrogen in a vacuum chamber to check the reliability of the adhesive joints with respect to maintaining a seal. The liner shown in figure 10 has gone through two temperature and pressure cycles. After some initial failures a reliable leak-tight adhesive bond was achieved. However, it was decided that some method of reducing the size of the wrinkles in the liner must be found or the resulting sharp creases formed upon repressurization would cause leaks or even breaks. If the liner material is stressed beyond its elastic limit, subsequent loadings to a lower stress produce no further permanent set. This can be seen in figure 8 where the AMA laminate was first stressed to 8300 pounds per square inch and then cycled from 0 to 6250 pounds per square inch six times. It was decided to fabricate the liner and vacuum jackets from 25-pound-per-inch-load (10 040 psi) prestretched AMA laminate to keep the permanent set and, therefore, the wrinkles to a minimum. Figure 9 shows a cycling test of this prestretched material at a temperature of -300° F and a strain of 0.015 inch per inch. It should be noted that most of the strain is within the elastic range. Even with this prestressed material some permanent set was expected when it was used in the test tank. But, it was felt that the bond between the foam insulation and the inner vacuum jacket would stabilize the wrinkles that would occur thus preventing the formation of sharp creases.

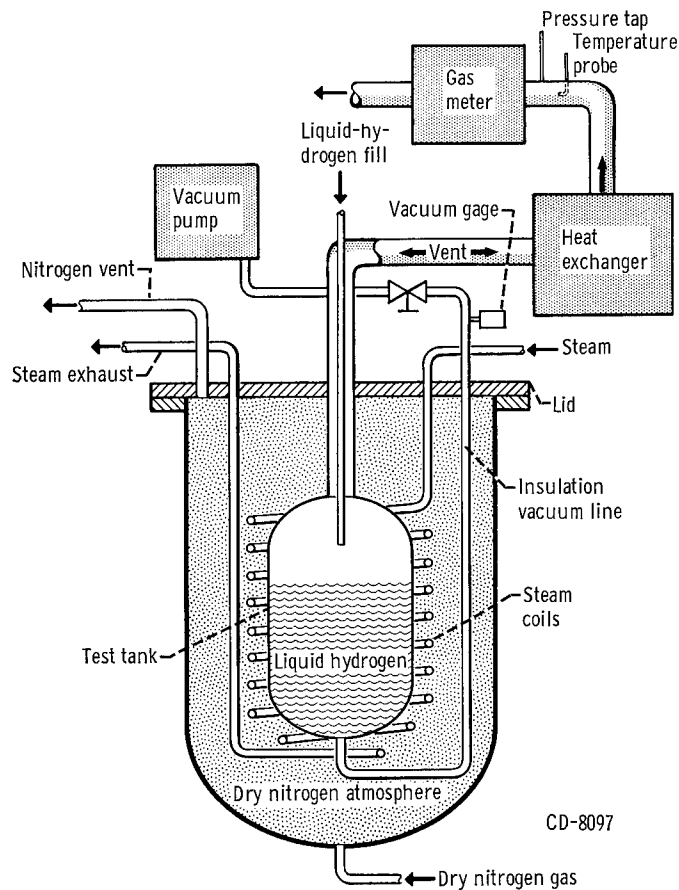
Figure 11. - Controlled-environment test facility.

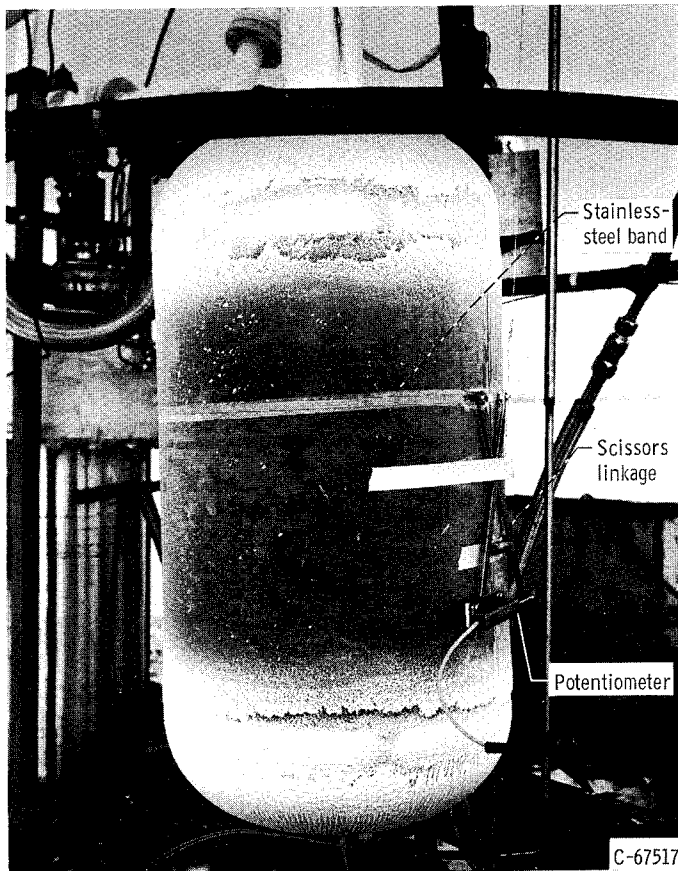
Figure 12. - Strain-gage equipped tank in outdoor test facility.

(2) The occasional breakaway of an area of frost and changes in wind velocity cause a scatter in boiloff data which makes the determination of thermal conductivity more unreliable. Figure 12 shows the frost formation on the tank during a test. Note the areas of frost that have fallen off and that frost only occurs in the vicinity of the heat shorts; that is, the intersections of the the domes with the cylinder.

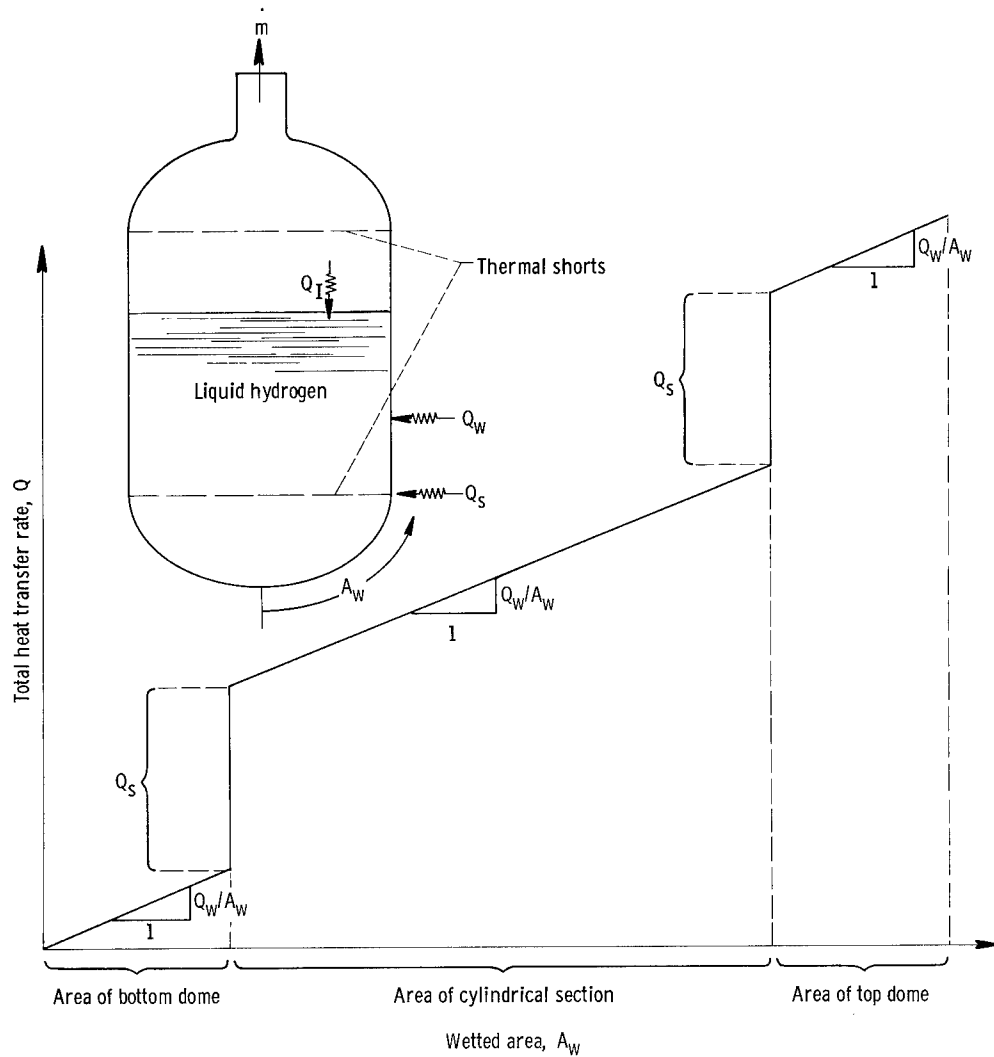
Figure 13. - Idealized curve of heat-transfer rate and wetted area for a liquid-hydrogen tank.

Thus the Q against A_w plot is made and the slope is measured to obtain the heat flux through the insulation. The value for K is then found from this heat flux, the temperature difference, and the insulation thickness. The inside boundary of the insulation was assumed to be at the normal boiling point of liquid hydrogen (-423°F). It was decided to measure the outside tank-wall temperature rather than the outer-insulation boundary due to the simplicity of measuring the former. The error thus introduced is negligible because the thermal resistance of the fiber-glass wall is two orders of magnitude lower than that of the insulation.

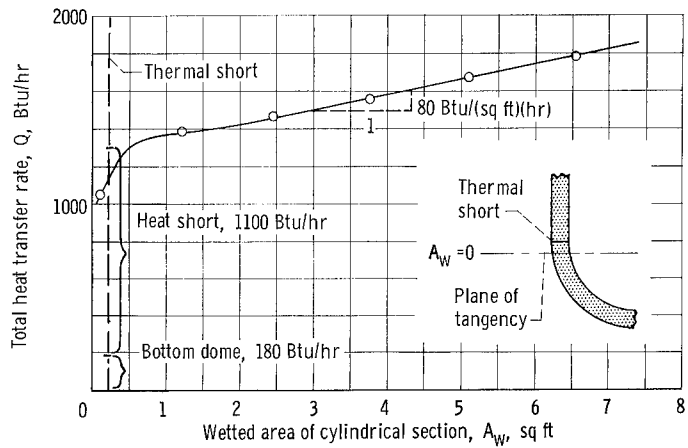
Figure 14. - Variation of total heat-transfer rate with wetted area for liquid-hydrogen test tank in an atmosphere of dry nitrogen at 65° F. Thermal conductivity of insulation, 0.094 (Btu)(in.)/(hr)(sq ft)(°F).

As shown in figures 14, 15, and 16, there is a large heat short at the intersection of the bottom dome and the cylindrical section of the insulation. This heat short is caused by the heavy AMA laminate used on the edge of each insulation section (see fig. 1(d), p. 5). The heat short was calculated to be 1050 Btu per hour, while the value, determined by extrapolating the curve (see figs. 14 to 16) and assuming the heat flux through the bottom dome the same as in the cylindrical section, varied from 1000 to 1340 Btu per hour, depending on ambient conditions. At 75 percent of tank capacity more than 50 percent of the heat transfer was due to this heat short. Calculations show that if Mylar were used instead of the AMA laminate to seal the edges of the insulation sections, the heat short to the liquid would be reduced to approximately 1 Btu per hour.

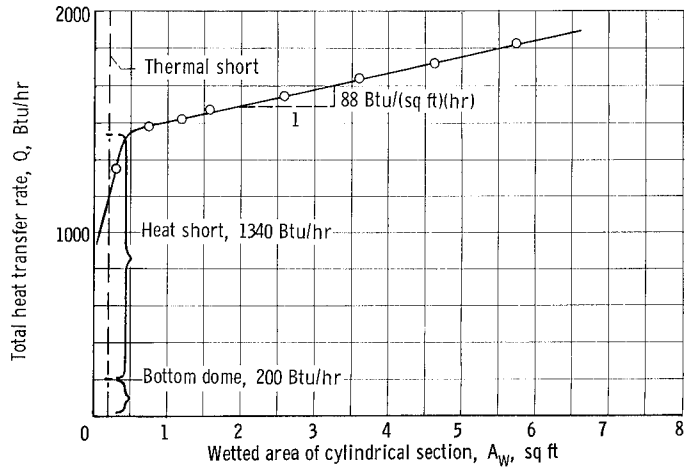
Figure 15. - Variation of total heat-transfer rate with wetted area for liquid-hydrogen test tank in an atmosphere of dry nitrogen at 85° F. Thermal conductivity of insulation, 0.097 (Btu)(in.)/(hr)(sq ft)(°F).

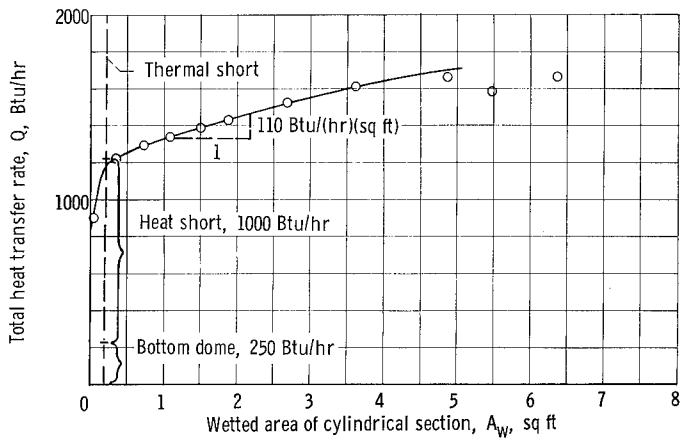
Figure 16. - Variation of total heat-transfer rate with wetted area for liquid-hydrogen tank in outdoor test. Temperature, 60° F, wind speed 17 mph; dew point, 45° F; thermal conductivity of insulation 0.117 (Btu)(in.)/(hr)(sq ft)(°F).

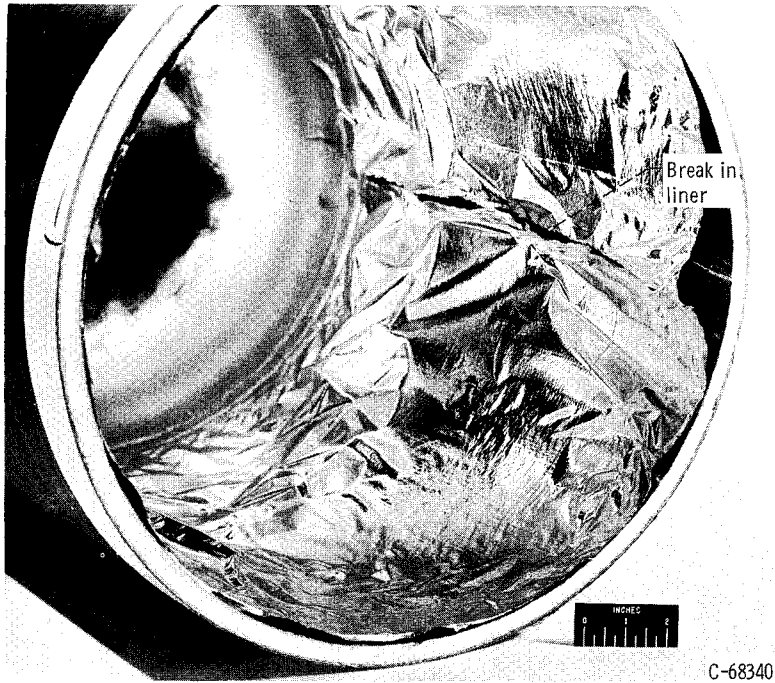
Figure 17. - Inside of tank (showing failure in liner).

Liner failure occurred suddenly with a longitudinal break in the cylindrical section of the tank (see fig. 17). Figure 18 shows the brittle fracture of the Mylar in the liner. Both the liner and the inner vacuum jacket failed at the same place. It should be noted that, even though the liner was highly stressed, all adhesive joints remained leak-tight. Upon examination of the inner vacuum jacket it was discovered that the break occurred along the butt joint of the glass-cloth bleeder ply (see fig. 19). Since the glass-cloth reinforced the vacuum jacket everywhere but at the butt joint where the cloth ends were not spliced, this was the area of highest stress. Instead of the inner vacuum jacket uniformly straining along the entire circumference, most of the expansion occurred over the very small length of this maximum stress area. Thus, the local unit strain was many times higher than it would have been for a uniformly strained material. It is probably the vacuum-jacket failure that initiated the failure in the liner at the same location. It is possible that this failure could have been prevented if the ends of the glass cloth were spliced at the butt joint with a bonded glass-cloth tape.

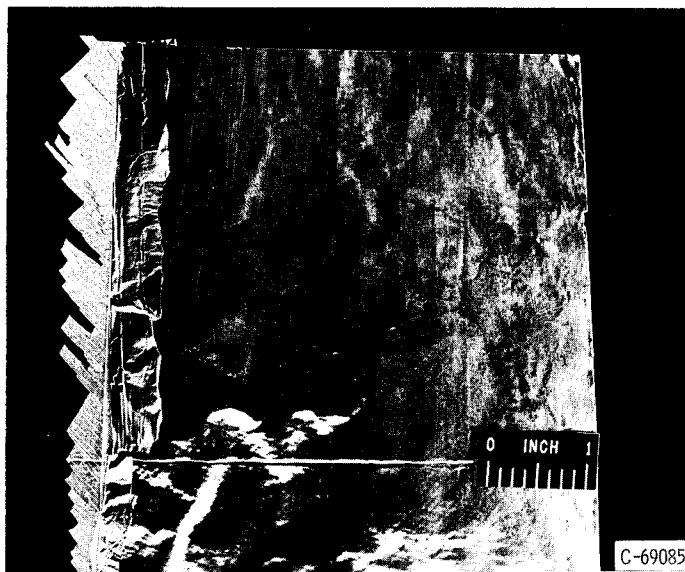
Figure 18. - Section of liner material at break.

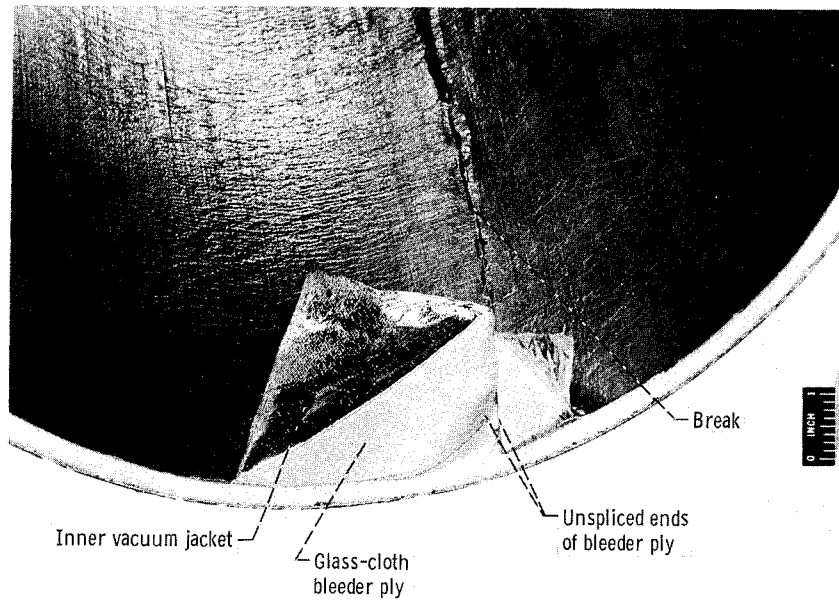
Figure 19. - Failure in inner vacuum jacket (liner removed from tank).

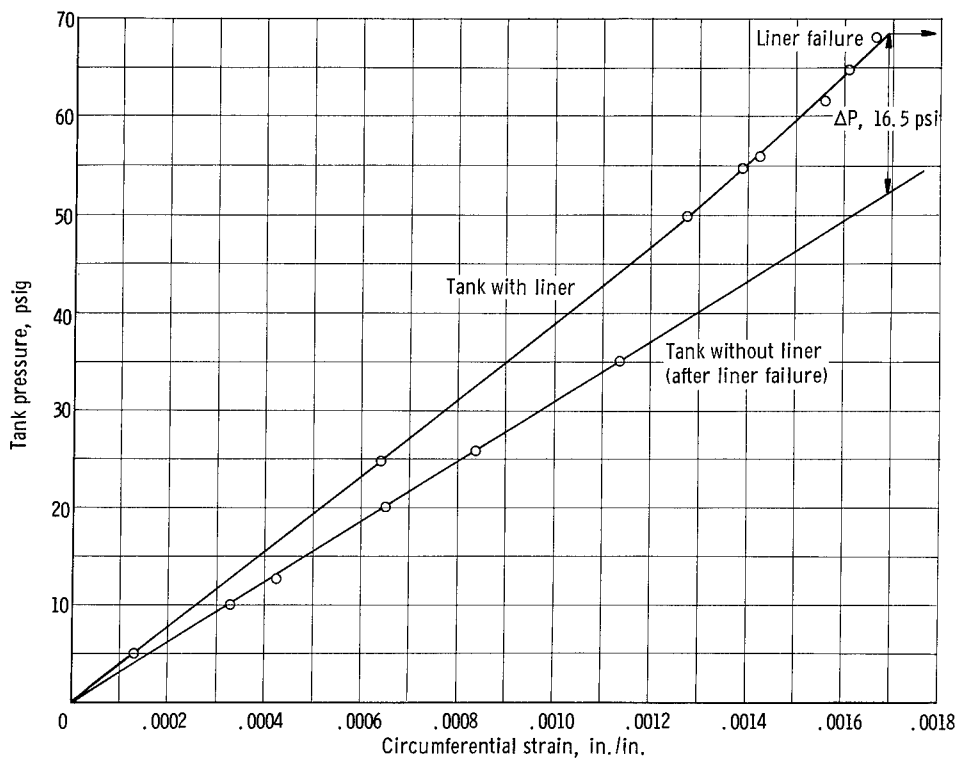
Figure 20. - Effect of liner failure on circumferential strain of tank wall.

The circumferential strain of the fiber-glass shell was measured during pressure tests of this tank both before and after liner failure. Figure 20 shows a plot of this strain against internal tank pressure. When failure occurred at 68.4 pounds per square inch gage, the release of the load carried by the liner and vacuum jacket resulted in increased load on a corresponding strain in the fiber-glass shell. Since the strain at failure, 0.0017 inch per inch, results from a load of only 51.9 pounds per square inch gage after failure, the difference between 68.4 and 51.9 pounds per square inch gage was assumed to be the load the liner and vacuum jacket were taking. Thus, the liner and jacket were taking an internal pressure load of 16.5 pounds per square inch and correspondingly stressed to 29 000 pounds per square inch at failure. This is an increase in tensile strength from the 25 000 pounds per square inch at -300° F listed in table I. The 51.9 pounds per square inch gage carried by the fiber-glass shell results in a composite wall stress of 12 000 pounds per square inch, well below its ultimate of 120 000 pounds per square inch.

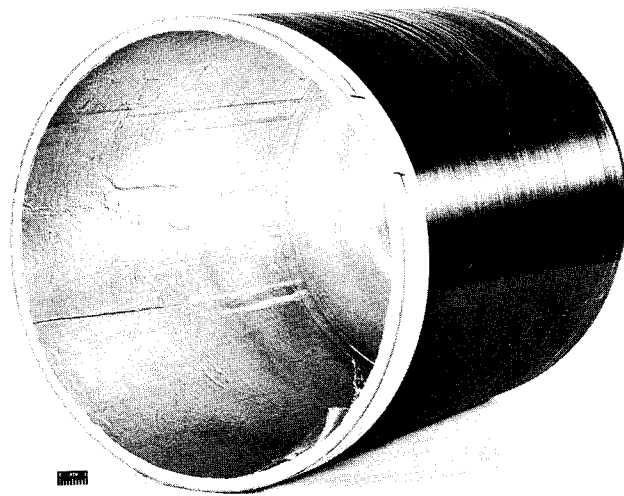
Figure 21. - Inner vacuum jacket after testing.

Final examination of the tank revealed the existence of wrinkles indicating the liner and inner vacuum jacket material has been stressed beyond its elastic limit and thus has taken a permanent set in spite of prestressing the AMA laminate. It was found that the wrinkles in the vacuum jacket (see fig. 21) are not sharply creased as in the preliminary liner tests but rather they are rounded and not likely to be leak sources. It appears that the glass cloth and foam help stabilize the wrinkles and prevent the formation of sharp creases.
