**United States Air Force  
611th Air Support Group/  
Civil Engineering Squadron**

**Remedial Investigation and Feasibility Study**

**Cape Lisburne Radar Installation,  
Alaska**

**ICF Technology Incorporated**

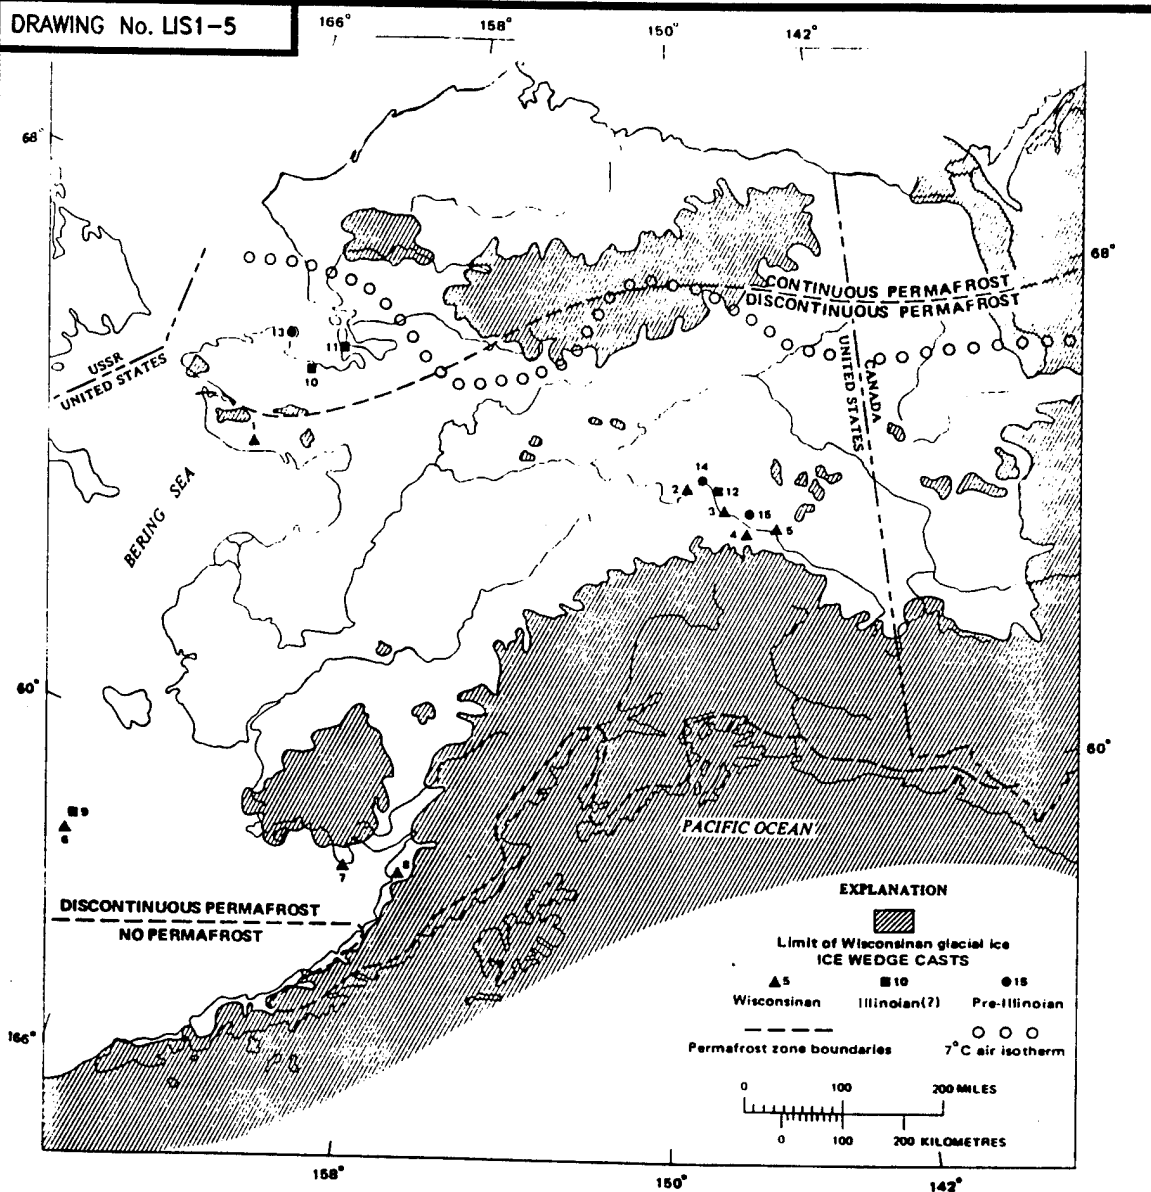
DRAWING No. LIS1-5

PERMAFROST MAP

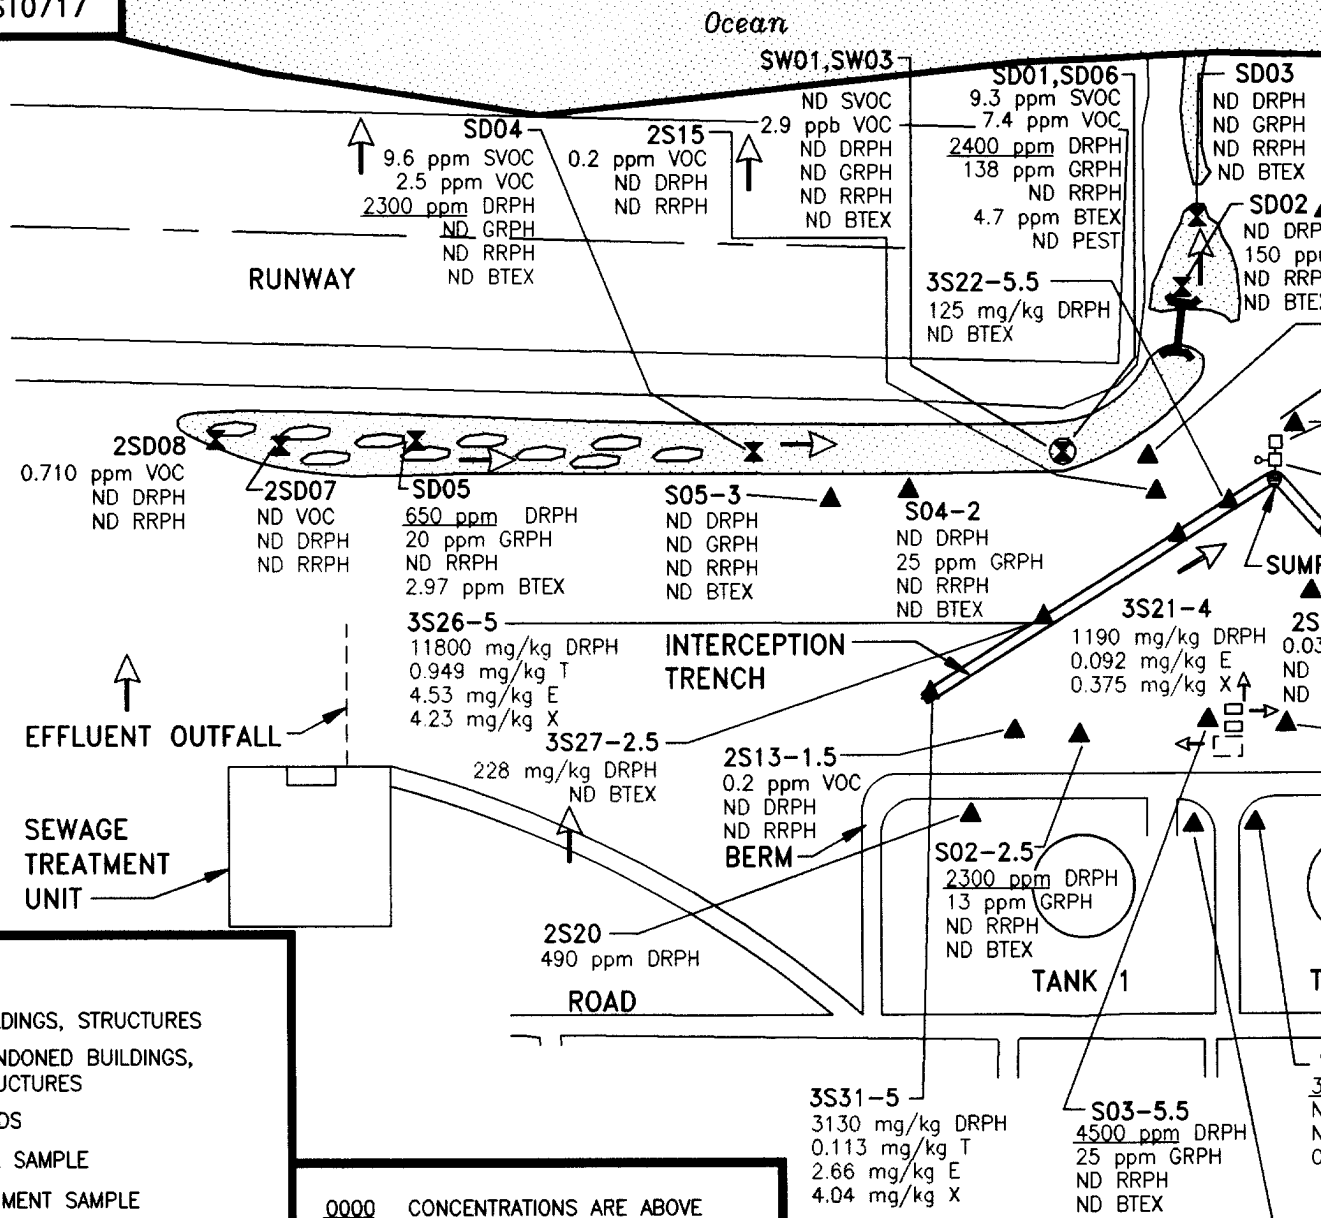
DRAWING No. 94ST0717

Sampling and analyses have determined that the Spill/Leak #3 (ST07) site is contaminated with petroleum hydrocarbons (DRPH) and volatile compounds, most of which are components of diesel fuel. The affected areas at the site include the bermed area adjacent to the POL tanks, the hillside north of the berm, and soils in the man-made drainage ditch.

Levels of petroleum compounds (primarily diesel) detected in soil/sediment at the site exceed ADEC guidance cleanup levels. In addition, site contaminants have migrated downgradient of the site and have impacted gravel areas. Therefore, the site is being recommended for remedial action. The remedial action alternative recommended for the site is enhanced bioremediation. This is in addition to the interception trench and collection and treatment system which was installed in 1994. A complete description and evaluation of the remedial alternatives considered for this site are presented in the FS, Section 5.0, and a complete description of the IRA activities conducted is presented in the IRA Report (U.S. Air Force 1995).

0000 CONCENTRATIONS ARE ABOVE ACTION LEVELS

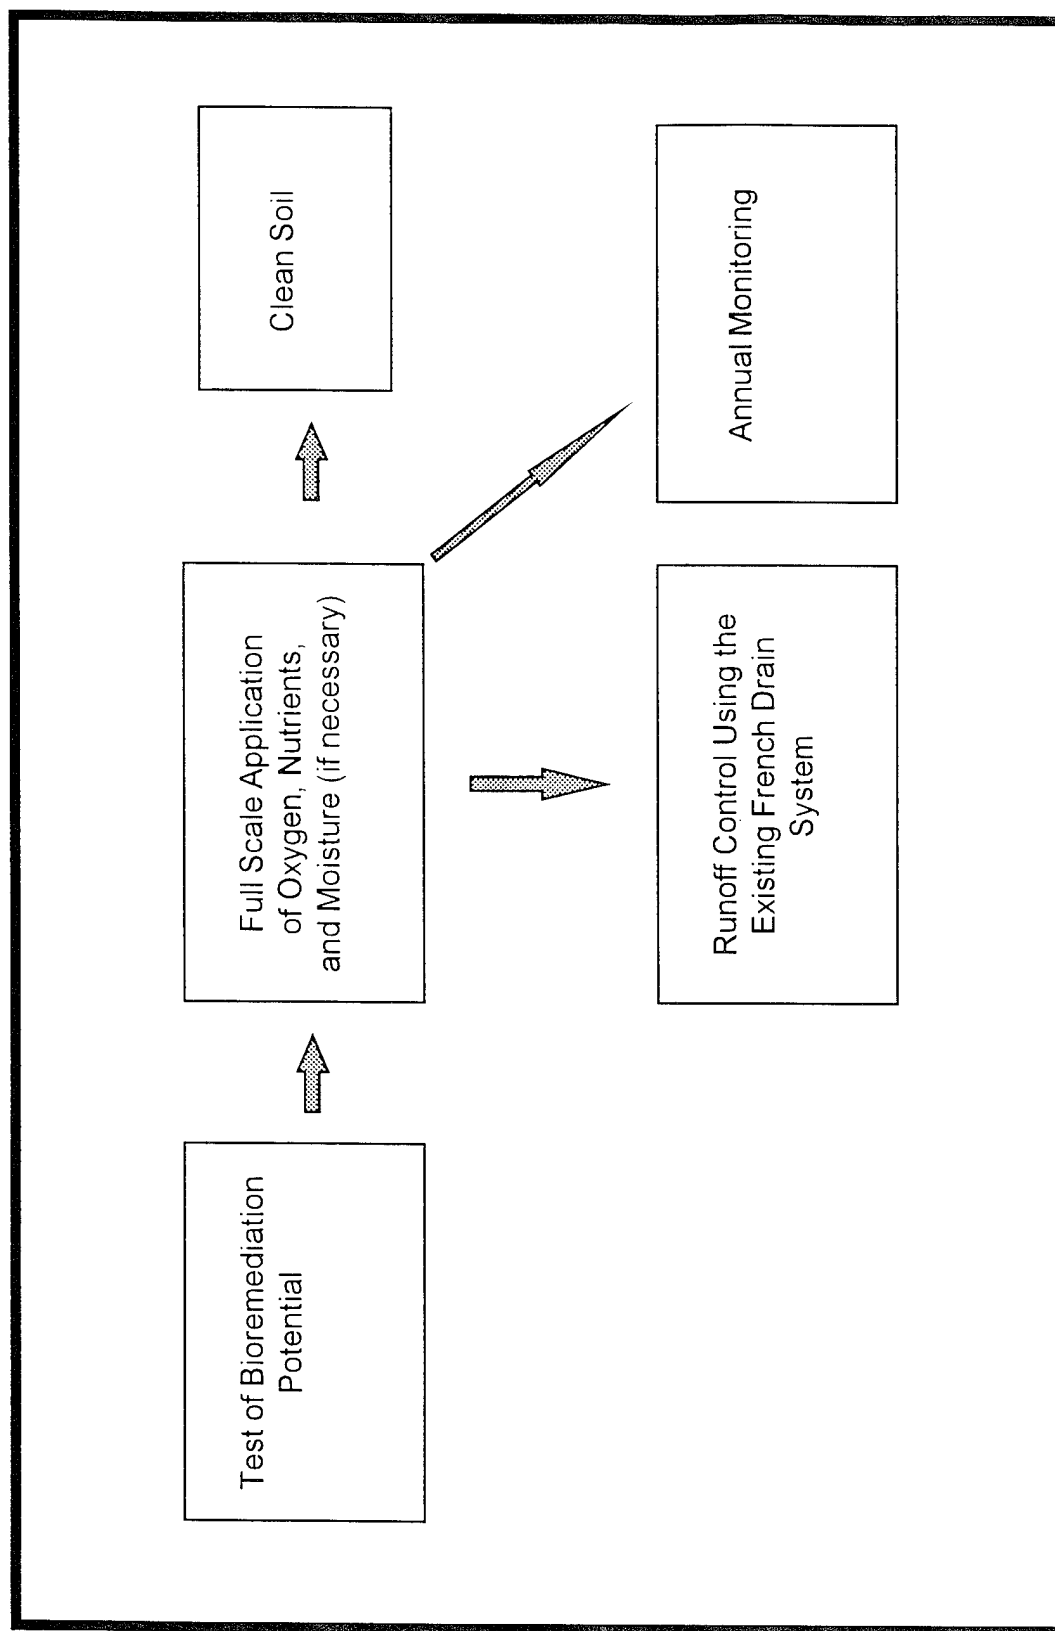
Figure 5-3: Enhanced Bioremediation Process Flow Diagram

treatability study. This process may generate runoff but the existing french drain/treatment system should capture it. Figure 5-3 is a schematic of enhanced bioremediation.

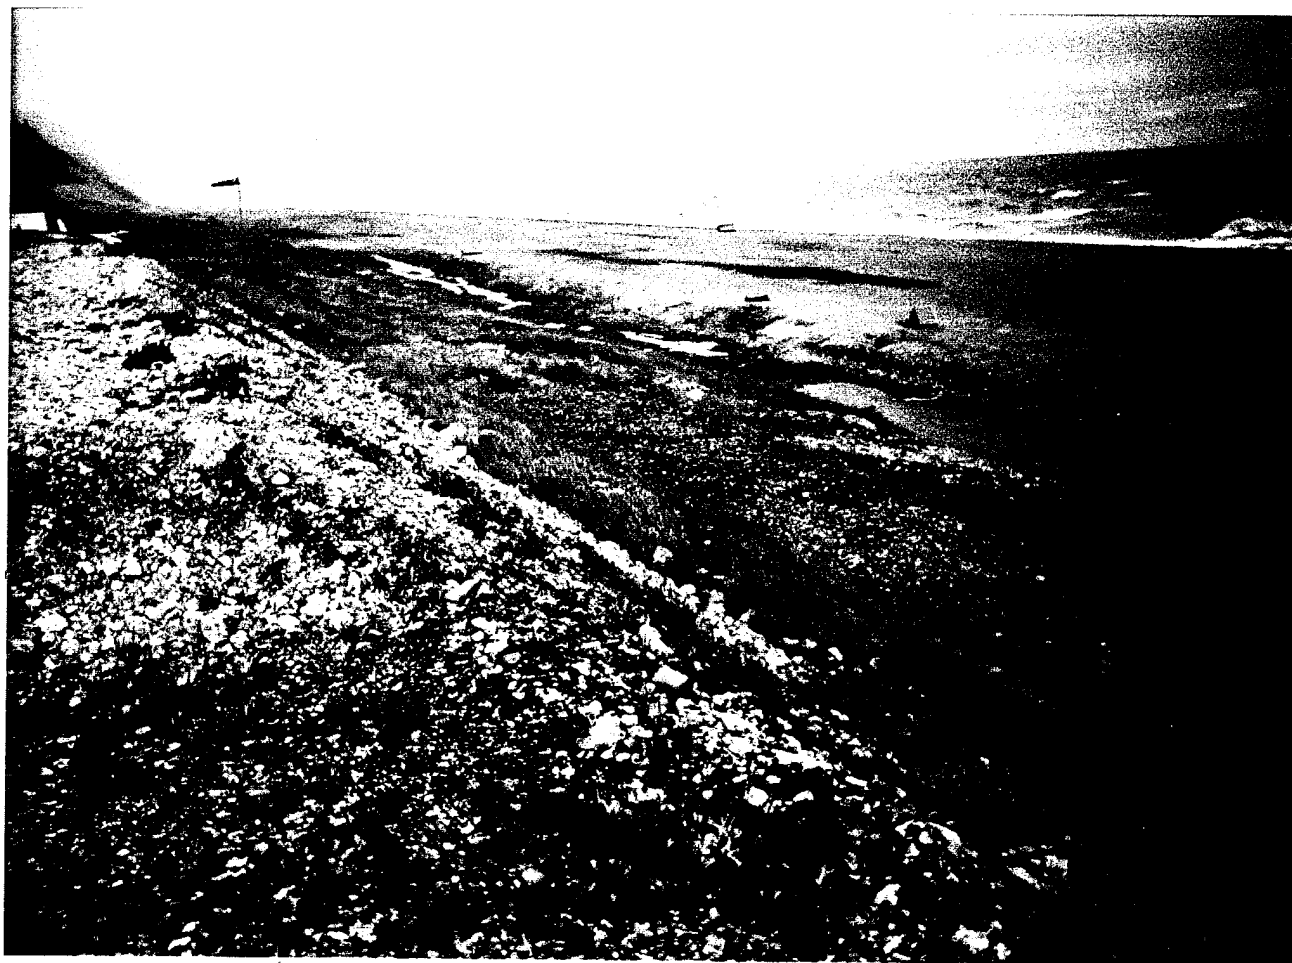
A view to the northeast of the Spill/Leak #3 (ST07) site. Part of the gravel berm surrounding the diesel tanks can be seen to the left.

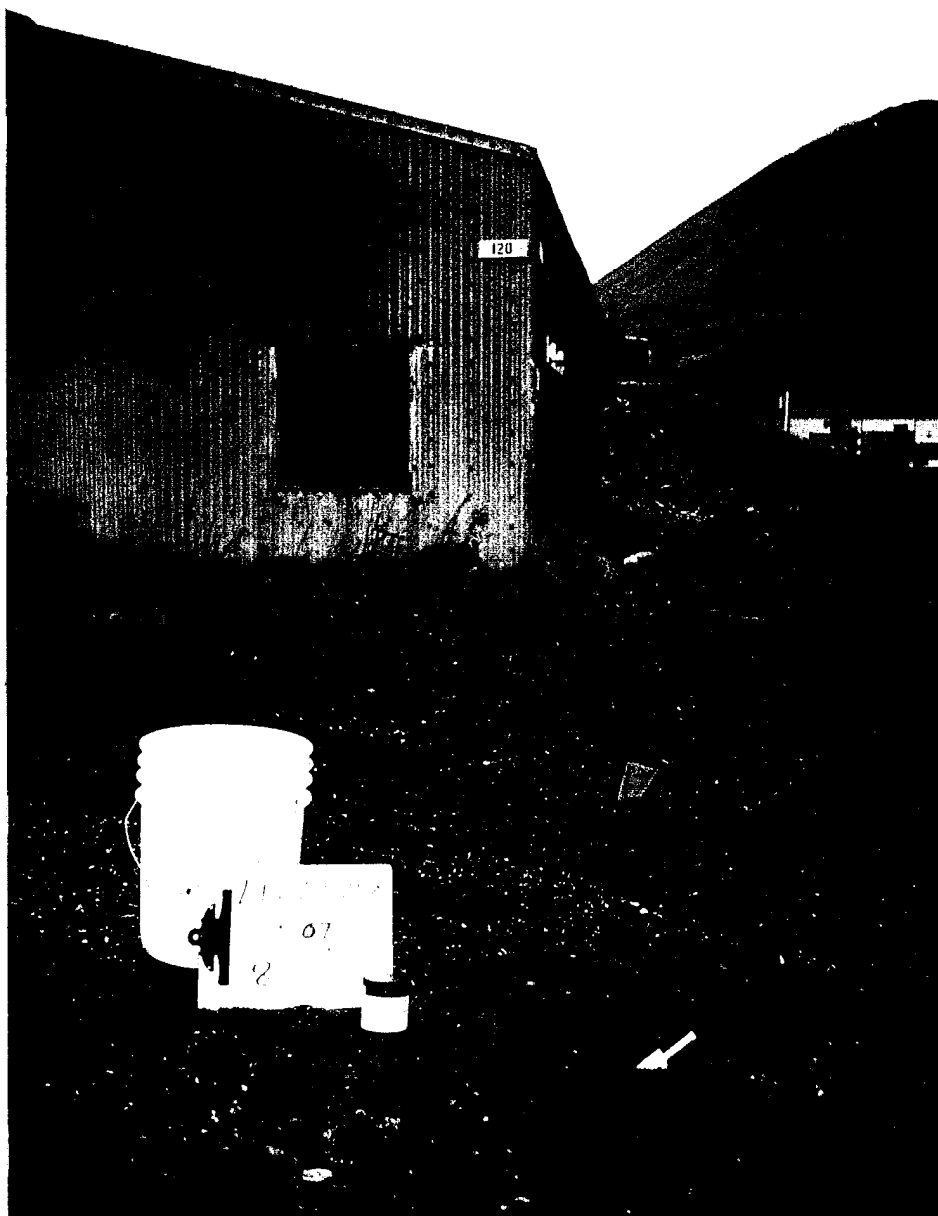
A view to the south of the Lower Camp Transformer Buildings (SS09) site, which is located approximately 100 feet northwest of the main building/living quarters at the station.
