COATED-FABRIC TANK LIFE EXTENSION STUDIES

INTERIM REPORT
TFLRF No. 312

**U.S. Army TARDEC Fuels and Lubricants Research Facility (SwRI)
Southwest Research Institute
San Antonio, Texas**

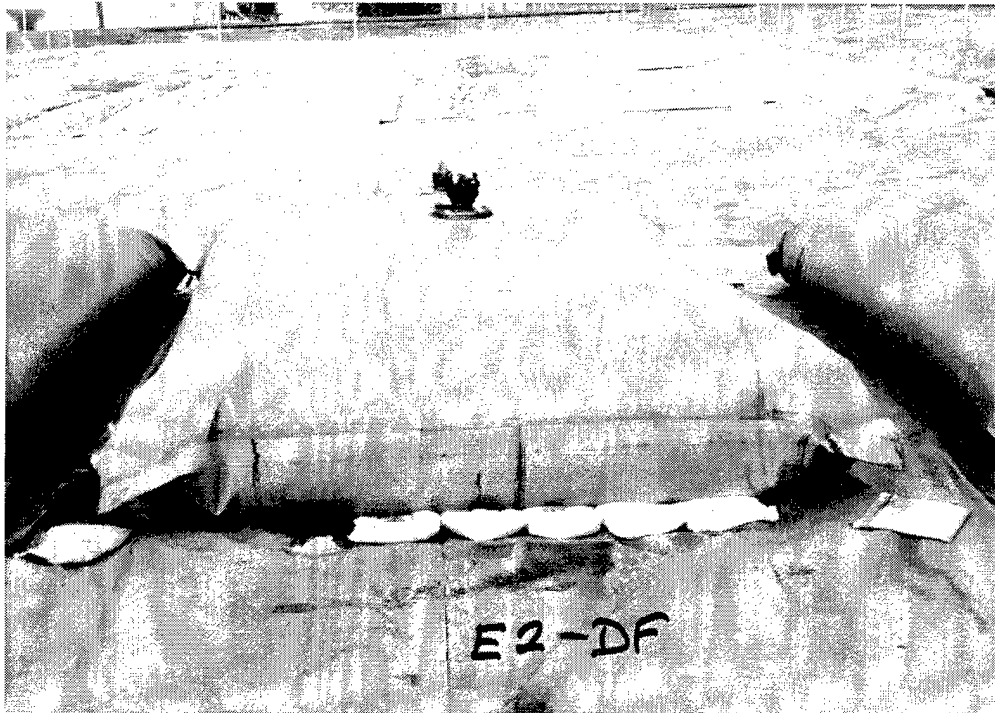
Photograph No. 5. Soiled spill control pillows around E-2 minitank containing diesel fuel

and environmental hazards, the tank was surrounded by "Hazorb" spill control pillows to soak up the puddles of fuel along the periphery of the tank. (These spill control pillows, replaced as needed around the tanks, are filled with inert foamed sand and adsorb acidic, caustic, solvent, and oil spills.) Photograph No. 5 shows the soiled spill control pillows around this minitank. Twenty-four hours later, a stream of diesel fuel was found escaping from this tank, as seen in Photograph No. 6. At this time, the tank was emptied to avoid environmental and safety hazards.

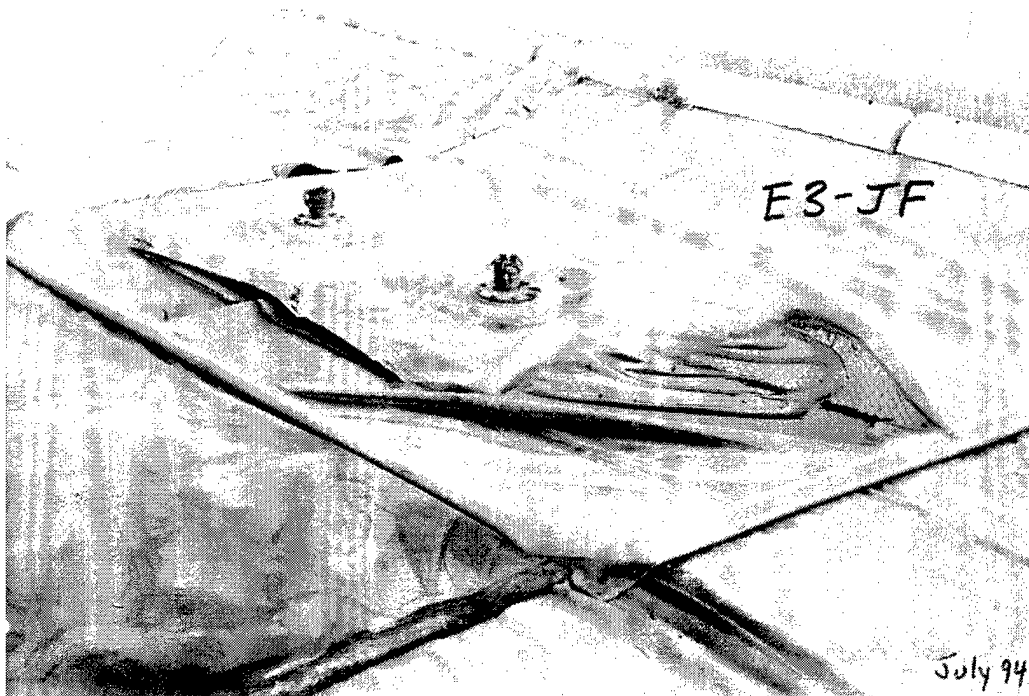
Photograph No. 10. Separated seam section of E-3 minitank containing turbine fuel after 22 months of outdoor exposure

E-3 minitank is shown in Photograph No. 7 immediately after it was filled with diesel fuel. Within two months of storage, this tank had to be emptied and withdrawn from further testing due to excessive fuel leakage at seam areas. Photograph No. 8 illustrates one such area. Minitank of E-3 is shown in Photograph No. 9 one day after it was filled with turbine fuel. Except for minor leaks from the seam areas, this tank survived for 22 months of outdoor exposure before it also had to be emptied of fuel due to an over 100-cm long fully separated seam section, as shown in Photograph No. 10. The empty tank was allowed to remain at the test site. Within one year after this picture was taken, most of the upper surface of this tank suffered from environmentally induced major delamination of the coating material from the nylon fabric, demonstrating full degradation of this material, as shown in Photograph No. 11.

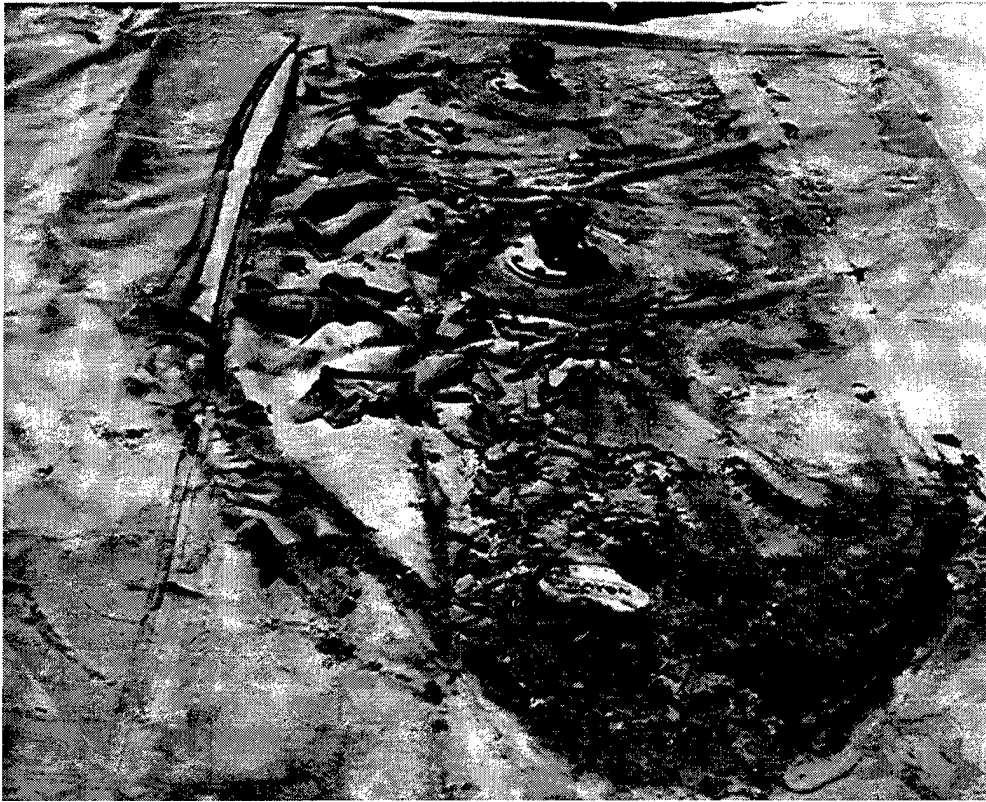
Photograph No. 11. Full degradation of E-3 minitank containing turbine fuel

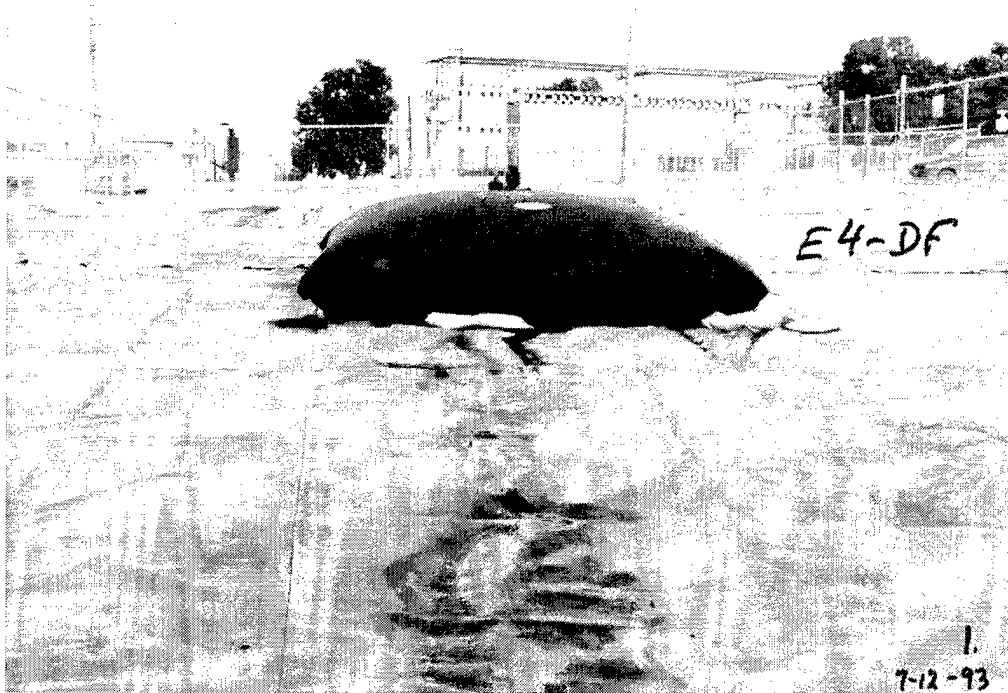
Photograph No. 13. Evidence of seam and corner leakage from E-4 minitank containing diesel fuel

E-4 minitank, filled with the referee grade diesel fuel during August 1992, is shown in Photograph No. 12. This tank failed after 10 months of exposure and had to be taken out of service due to excessive leaking from seam and corner areas, as shown in Photograph No. 13. Note the severe darkening of the outer surfaces of this tank.

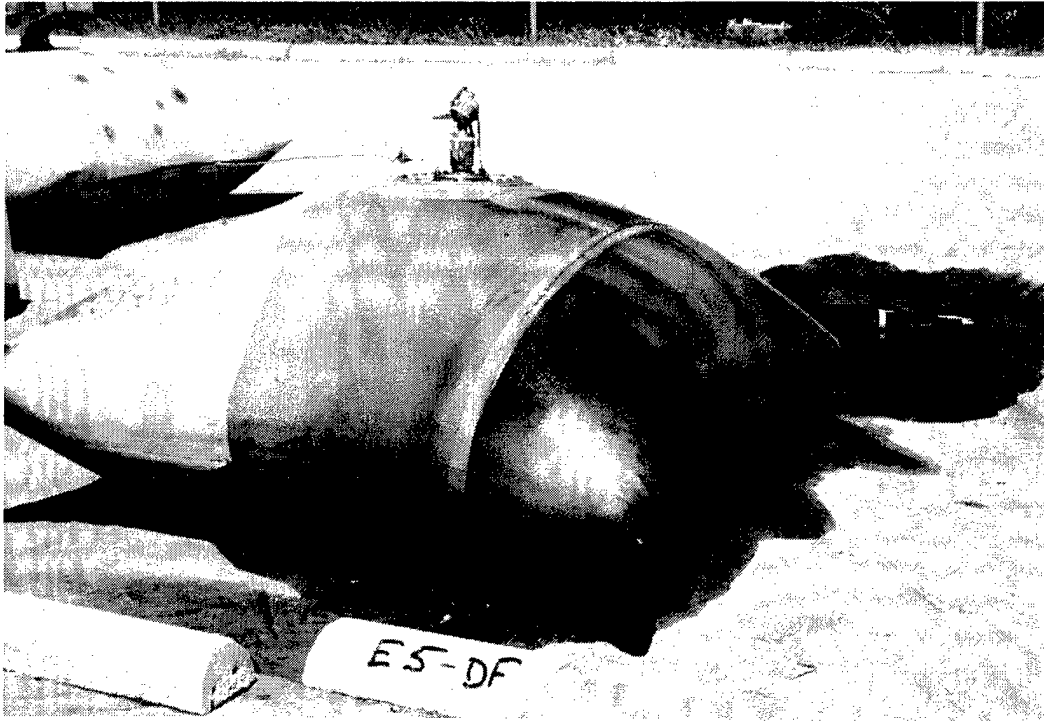
Photograph No. 15. Evidence of E-5 minitank diesel fuel leakage

E-5 minitank was filled with diesel fuel and pressurized using the standpipe system during September 1992. Photograph No. 14 was taken within one week after this tank was placed under test conditions. On July 24, 1995, after approximately 34 months under test conditions, a pinhole developed in the fabric at the upper part of the minitank. Due to the internal pressure, a very small stream of fuel began to spray to the height of 12 to 15 cm (5 to 6 in.). Even after approximately 265 L (70 gal.) of diesel fuel was removed from the tank, the fuel kept oozing from the pinhole. Concurrently, 1- to 2-mm diameter fish scale type blemishes were also observed over the entire surface of the minitank, indicating delamination of the elastomeric

coating from the supporting fabric. The condition of this tank and the escaping large quantities of diesel fuel are shown in Photograph No. 15. Due to the imminent failure of this minitank, for safety and environmental concerns, and because of the excessive cost of potential cleanup, the diesel fuel was withdrawn from the tank.
