NASA
Technical Memorandum 107227

Experimental Evaluation of Face Gears for Aerospace Drive System Applications

Prepared for the
Seventh International Power Transmission and Gearing Conference
sponsored by the American Society of Mechanical Engineers
San Diego, California, October 6-9, 1996

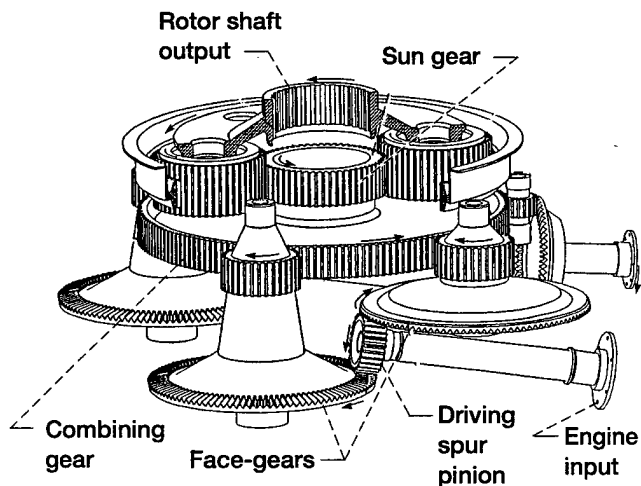
Figure 1.—Helicopter transmission with face gear drives.

The use of face gears in advanced helicopter transmissions was proposed during the U.S. Army Advanced Rotorcraft Transmission Program (Bossler and Heath, 1990; Bill, 1990; and Heath, 1993) and by other researchers from Europe (Hermens and Verschuren, 1989). The arrangement developed under the U.S. Army project is shown in Fig. 1. The use of face gears, as shown in Fig. 1, has the input spur gear pinion driving two face gears. This arrangement would lower the tooth load of the input gear by approximately one-half, assuming that the load was equally split between the two output gears. This design had a very drastic effect on reducing the drive system weight of the proposed transmission. This advantage is of the highest importance in aerospace drive systems.

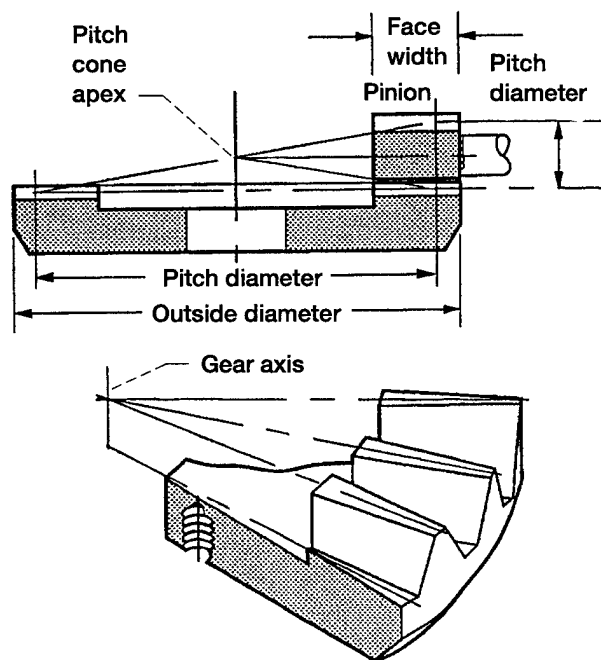
Figure 2.—Face gear terminology.

Face gear terminology is depicted in Fig. 2. A spur gear pinion meshes with the face gear in the arrangement tested herein. The face gear has a radially varying geometry, where the limits are undercutting at the inner radius and tooth pointing at the outer radius (Dudley, 1984). Axial location of the spur pinion is not critical, as in spiral bevel gears, and the pinions are typically made with a wider face width for bending strength improvement. Axial location of the gear is used to achieve the required backlash.

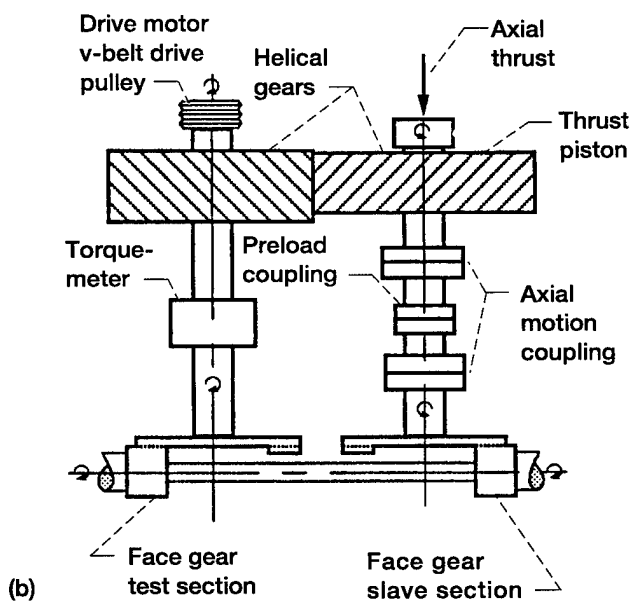
Figure 3.—Facility for face gear test. (a) Spiral bevel gear configuration. (b) Facility layout in gear configuration.

sketch of the facility is shown in Fig. 3(a) and the facility in the face gear arrangement is shown in Fig. 3(b). Rotational motion is provided through V-belts connecting one of the helical gear shafts to the drive motor. The helical gears complete the closed loop. A thrust piston that moves one of the helical gears axially is used to change the loop load during operation. A torque meter measured the loop torque.

Two sets of face gears are tested simultaneously. The left side (test section in Fig. 3(b), operates in the speed reducer mode as would be used in a helicopter main rotor transmission application. The right side (slave section) operates in a speed increaser mode, where the gear drives the pinion. The two pinions are connected via a cross-shaft. A detailed explanation of the operation of the test stand can be found in Handschuh (1992), Handschuh and Kicher (1995); and Handschuh (1995).

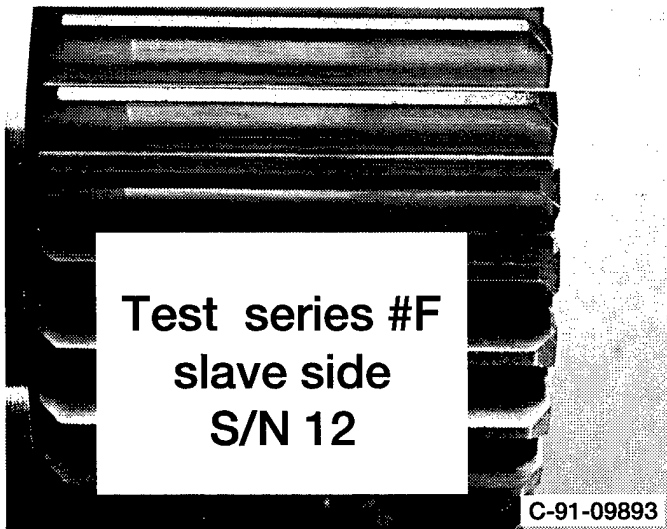
Figure 8.—Pinion from face gear set "A" after 30 million cycles at 100% load and 30 million cycles at 200 % load.

In Fig. 8 the pinion from gear set "A" after testing is shown. The contact location on the pinion is evident from the slight polishing of the surface, however no damage to the surface occurred. This type of pinion condition was typical for all the tests conducted.
