DESIGN OF FLEXIBLE AIRFIELD PAVEMENTS FOR  
MULTIPLE-WHEEL LANDING GEAR ASSEMBLIES

REPORT NO. 1

TEST SECTION WITH LEAN CLAY SUBGRADE

TECHNICAL MEMORANDUM NO. 3-349

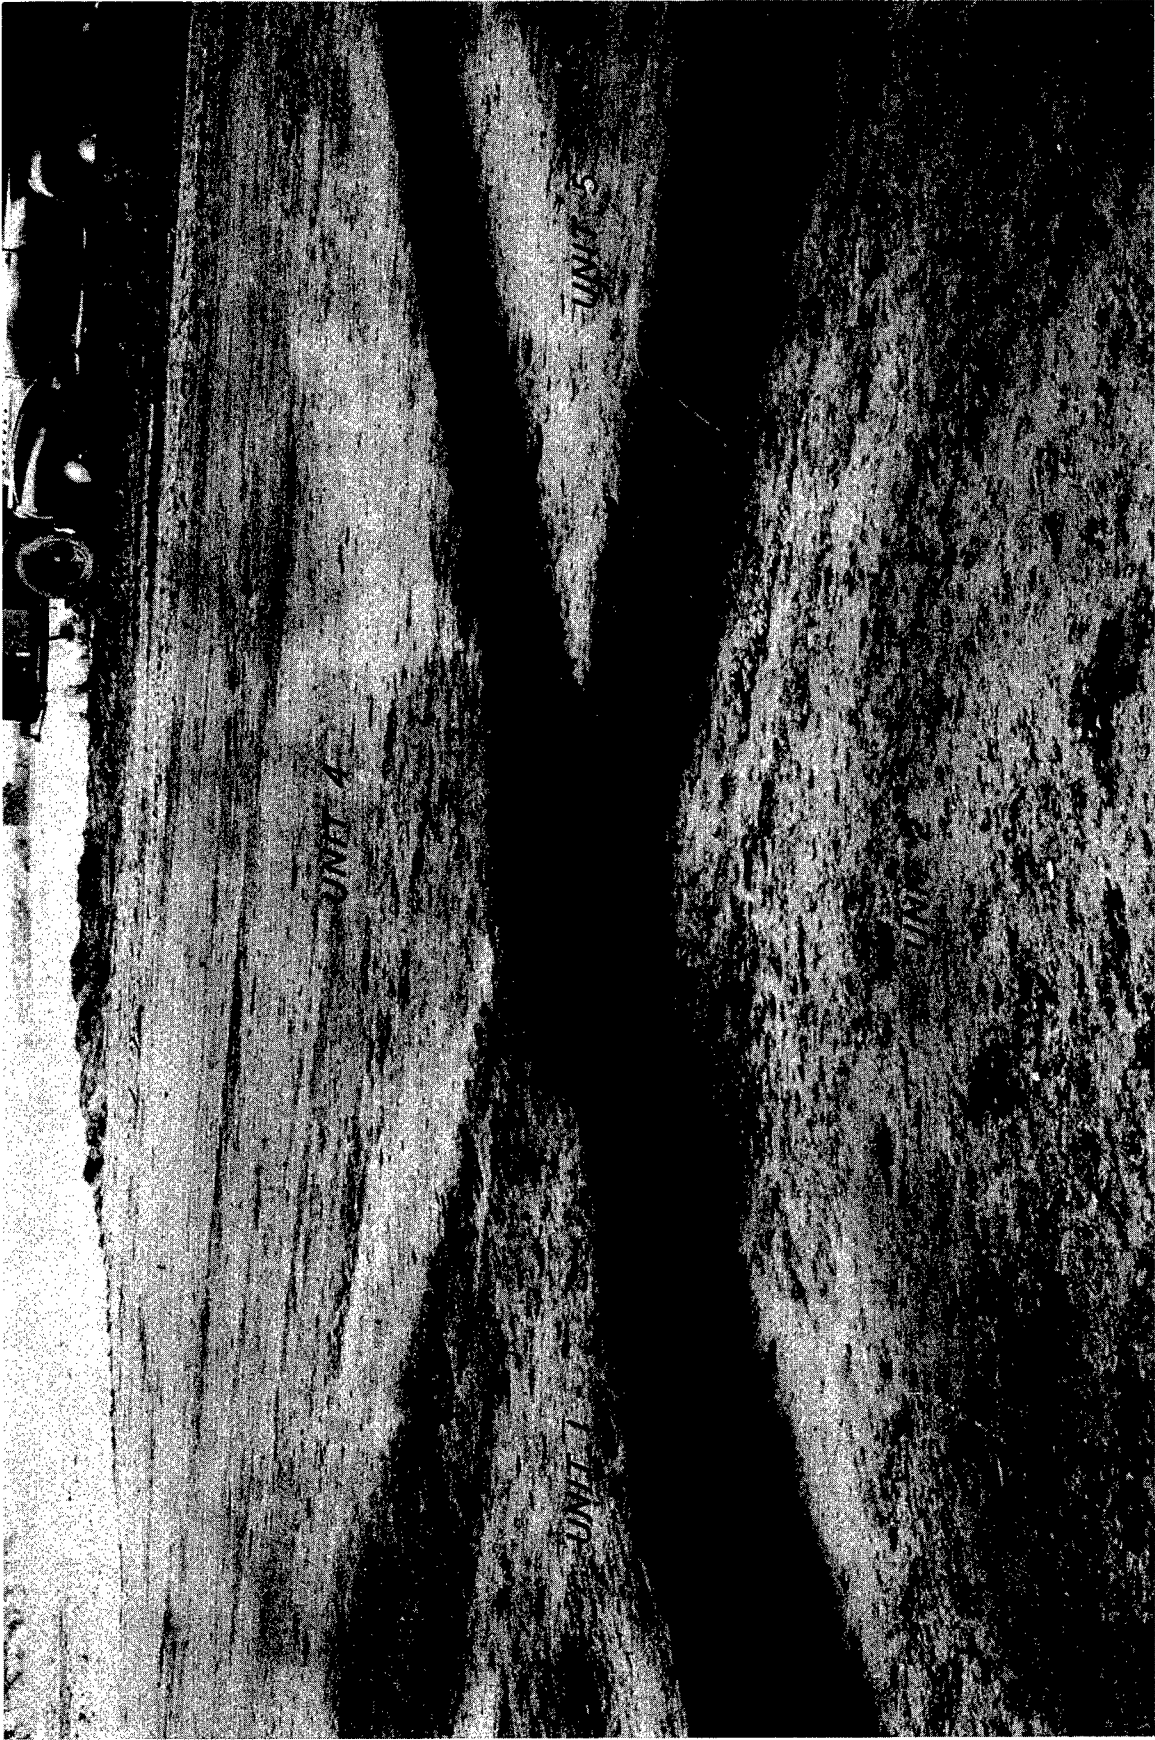
Photograph 1. View of subgrade before placing base

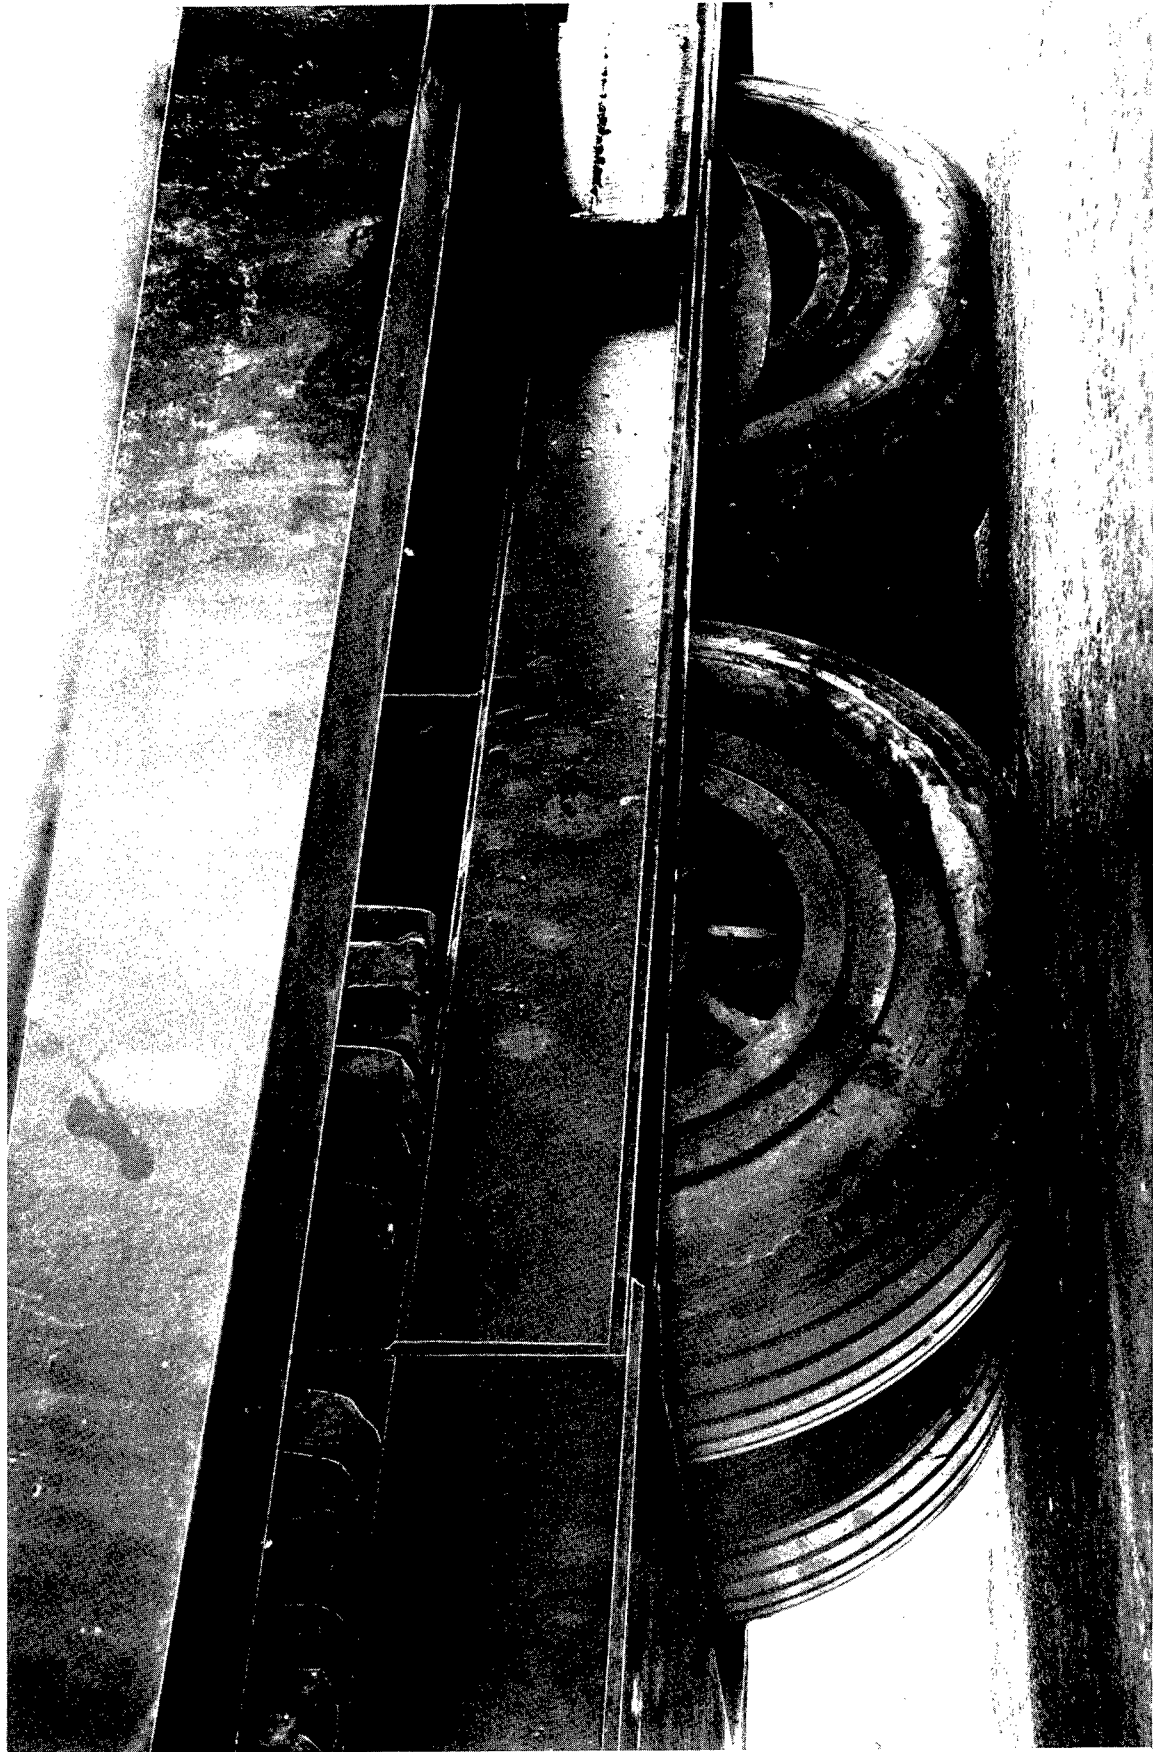
Photograph 6. Close-up of B-36 assembly loaded to 200,000 lb

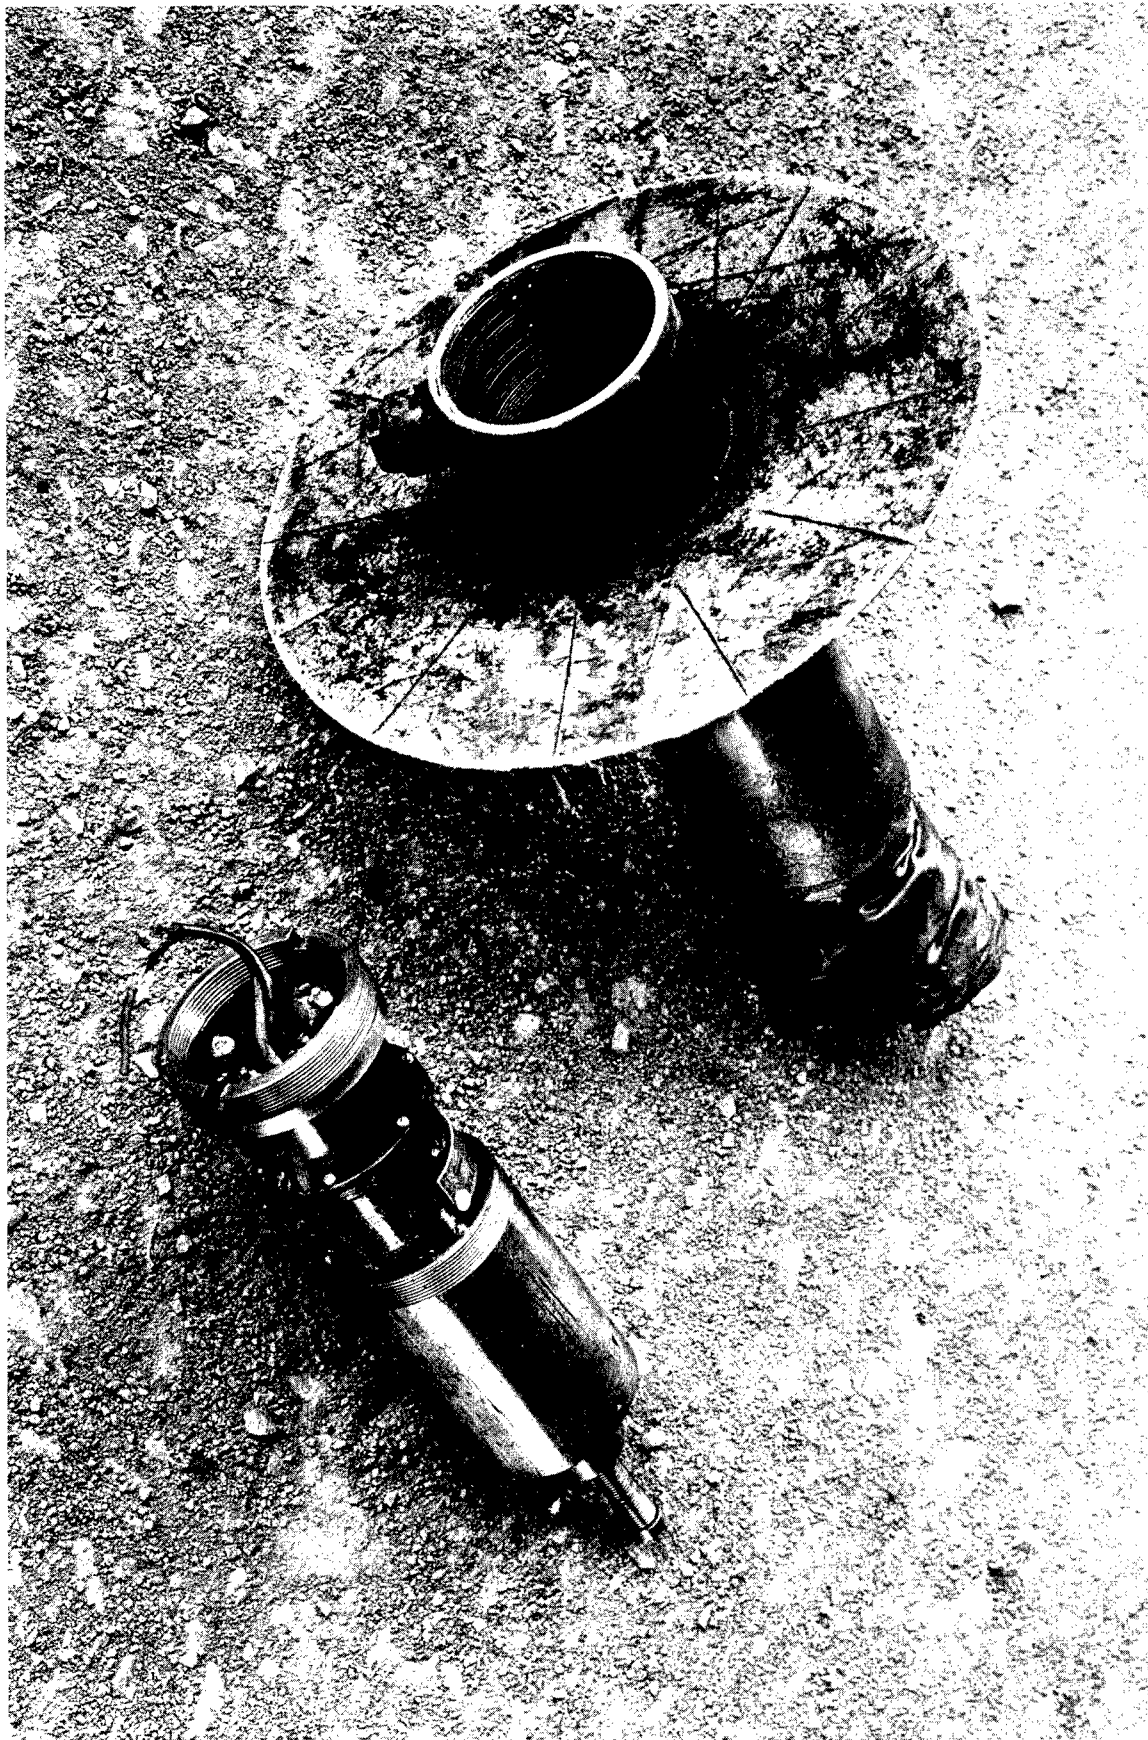
Photograph 7. View of selsyn-motor type deflection gage used in tests

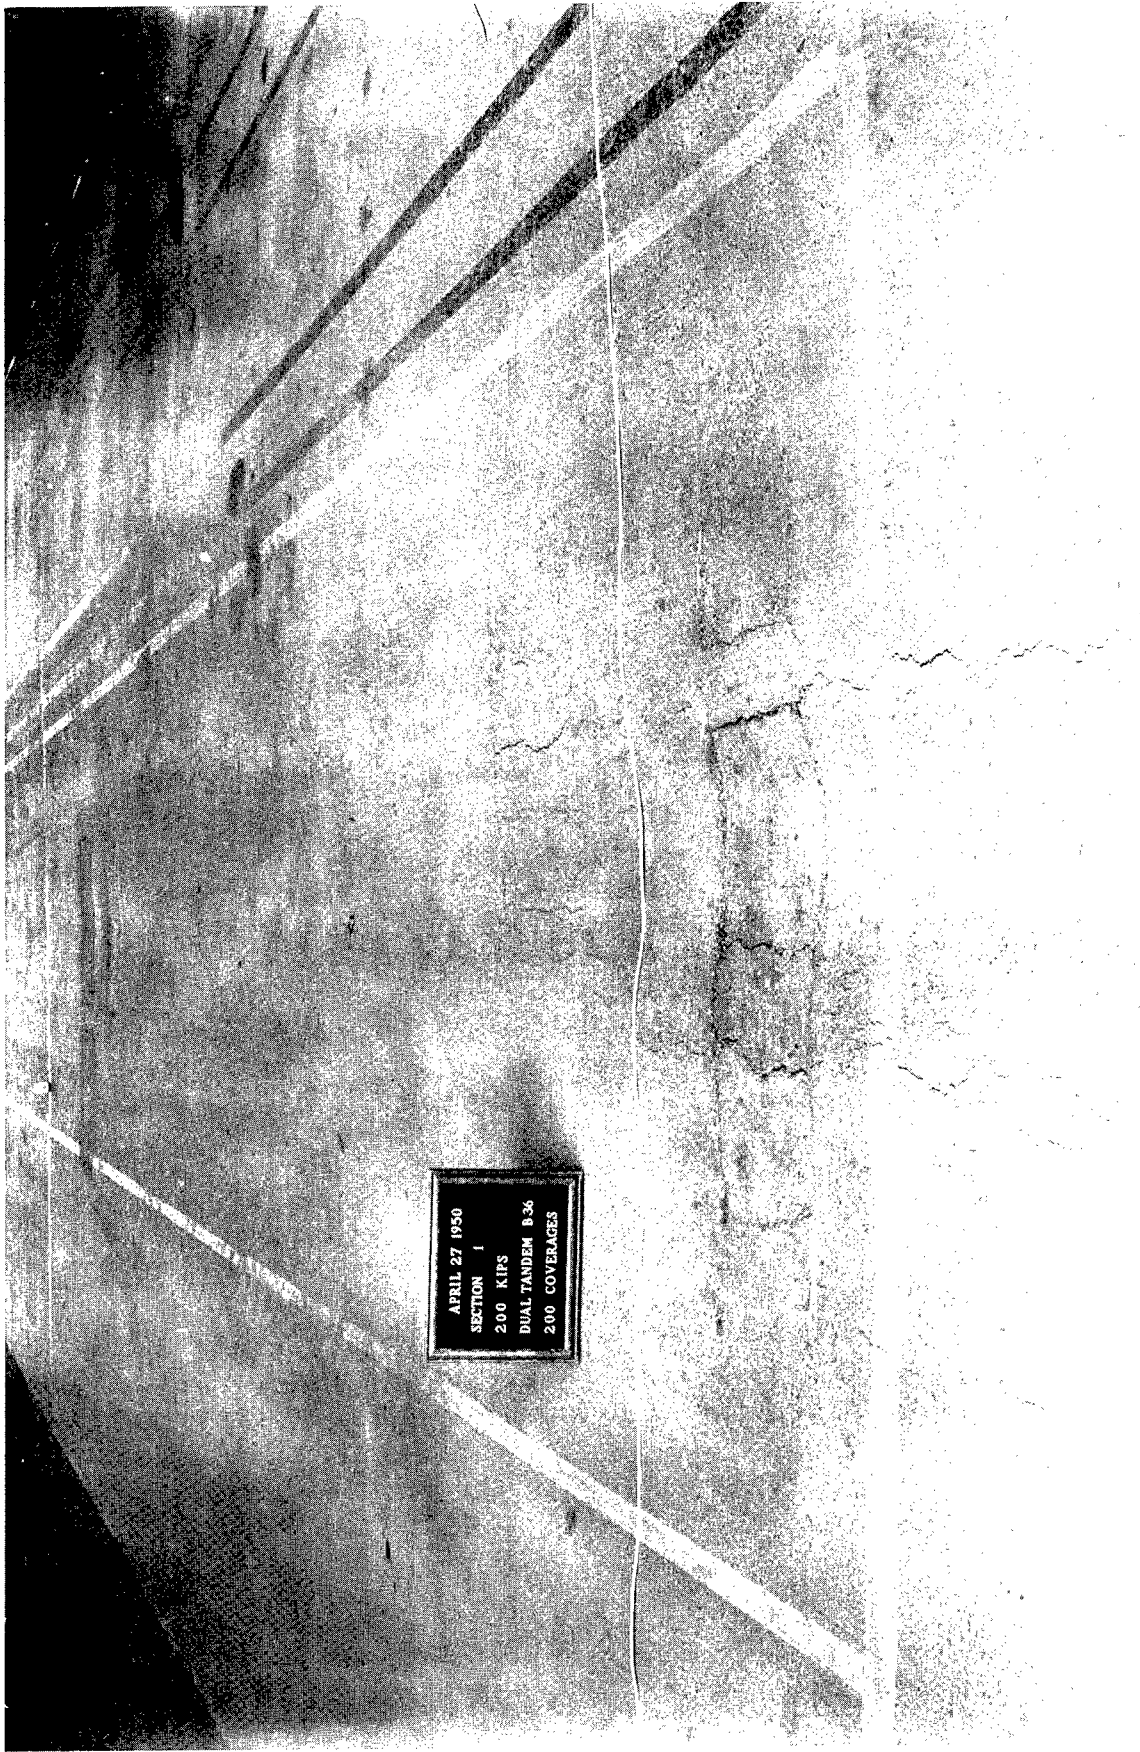
Photograph 10. Unit 1, 14-in. thickness. View showing rutting and failure after 200 coverages with 200,000-lb load on B-36 assembly

Unit 4 of the B-29 lane began to fail after 42 coverages of B-50 traffic and had completely failed after 328 coverages. The failure conditions in these units are shown in photographs 10, 11, 16, and 17. For convenience, the pertinent details of all test traffic are tabulated below:

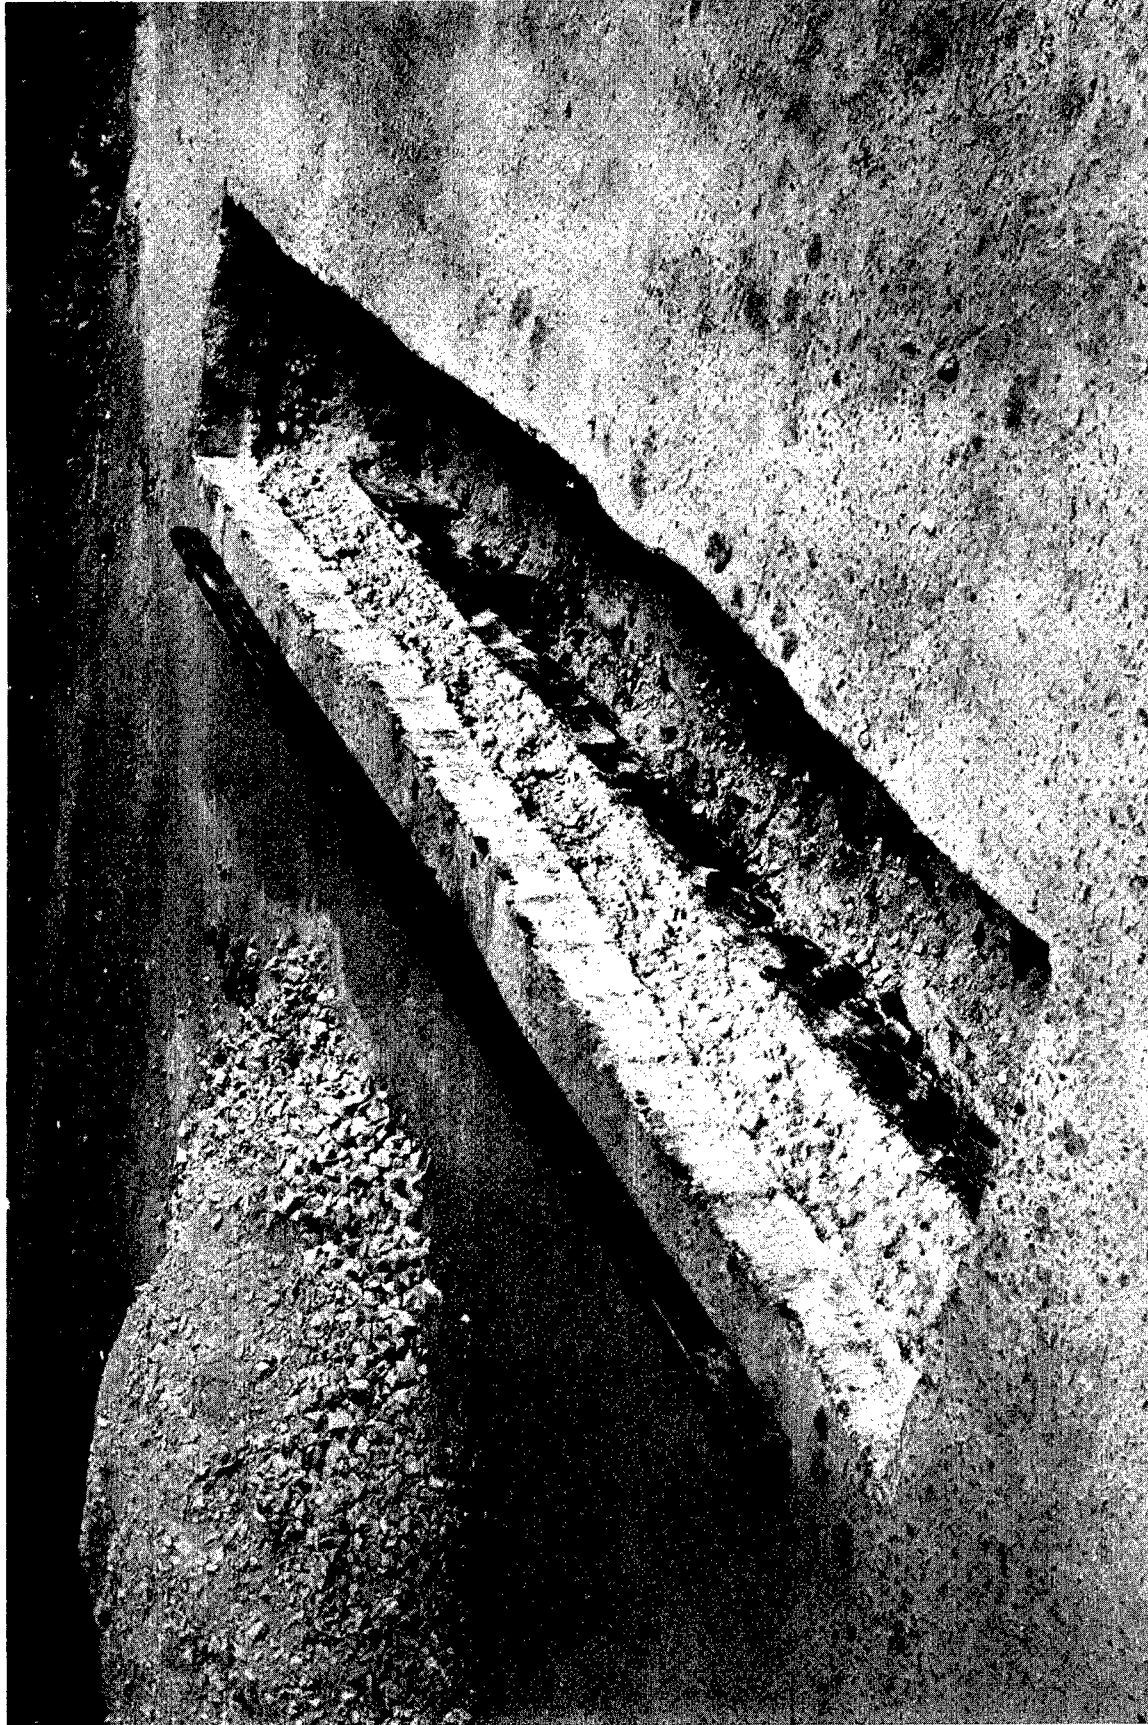
Photograph 15. Unit 4, 10-in. thickness. View of pit 4 after 2,000 coverages with 70,000-lb load on B-29 assembly

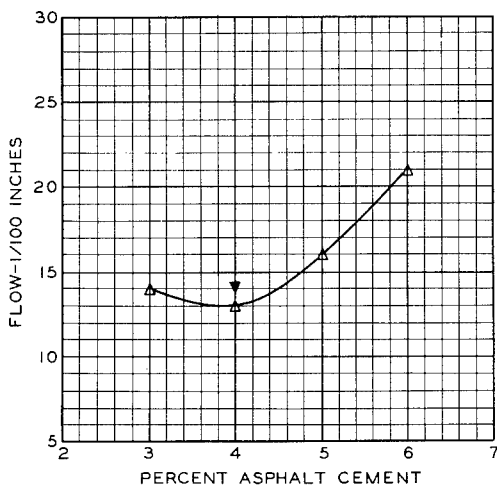
ASPHALTIC CONCRETE  
WEARING COURSE  
MIX DESIGN

▼ SELECTED ASPHALT CONTENT

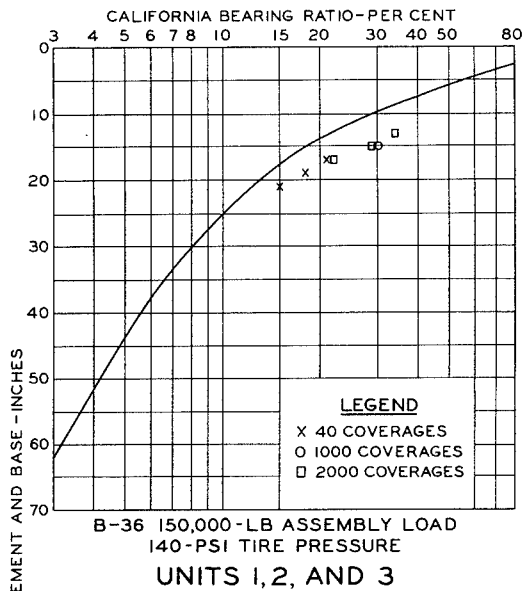
### DESIGN THICKNESSES BASED ON EQUIVALENT SINGLE WHEEL LOADS

NOTE: CURVES ARE PRESENT DESIGN CURVES FOR THE LOADING INDICATED. POINTS INDICATE THICKNESS REQUIRED FOR EQUIVALENT SINGLE WHEEL LOAD, COMPUTED BY EQUATING DEFLECTIONS BENEATH SINGLE AND MULTIPLE LOADS.
