Technical Report EL-96-17  
November 1996

# **Site Characterization and Analysis Penetrometer System (SCAPS) Field Investigation at the Building 4020 Site, Aberdeen Proving Ground, Maryland**

**Final report**

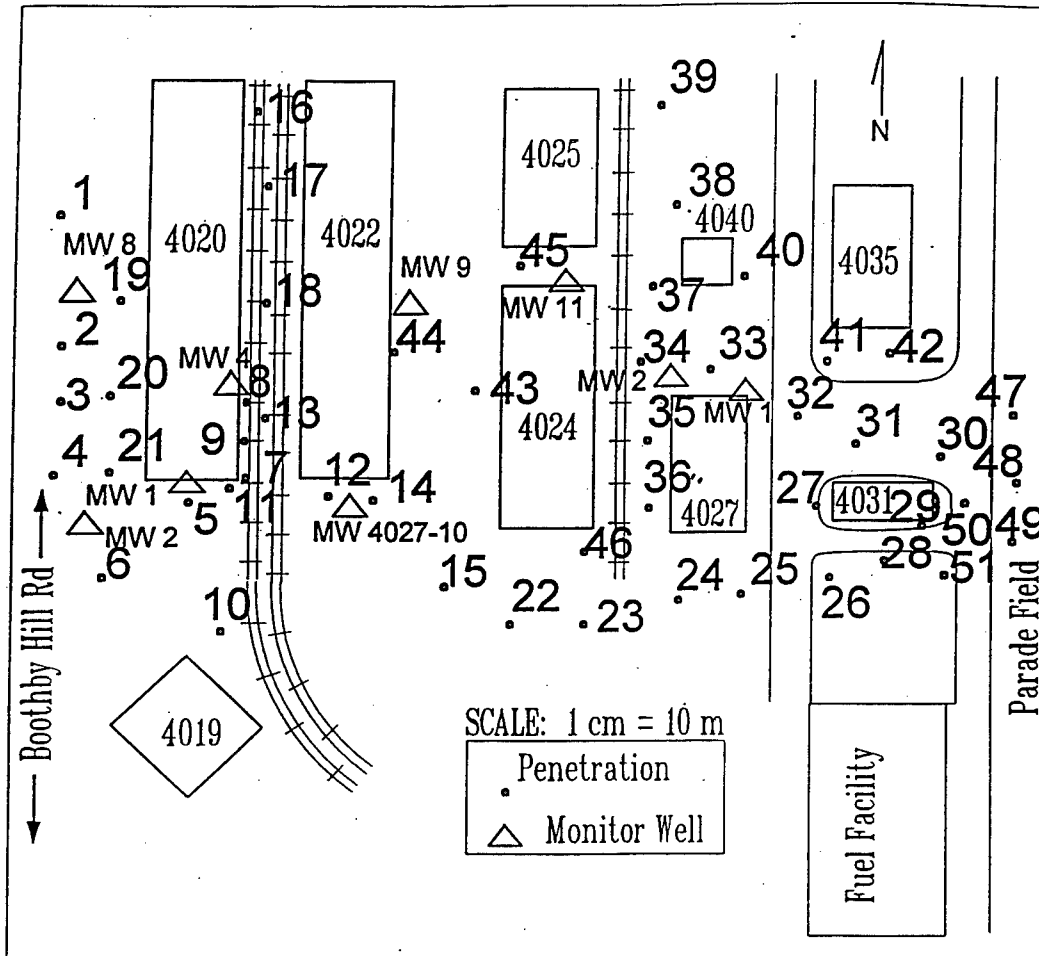
Figure 2. SCAPS investigation site near Building 4020

The SCAPS APG field investigation site is shown in Figure 2. The scope of the investigation initially focused on the area adjacent to Building 4020 and was expanded as the investigation progressed. Previous site investigations have been performed, monitoring wells have been placed, and remediation activities have been accomplished at this site (ENSAT Corporation 1992a,b). The previous investigations identified significant POL contamination near the location of a UST located at the east end of Building 4020.

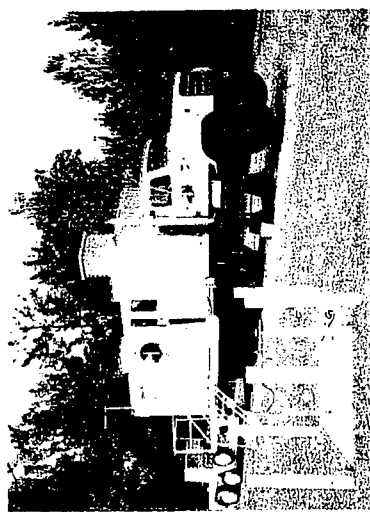
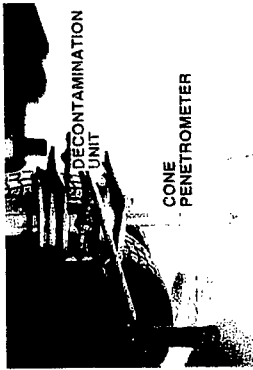
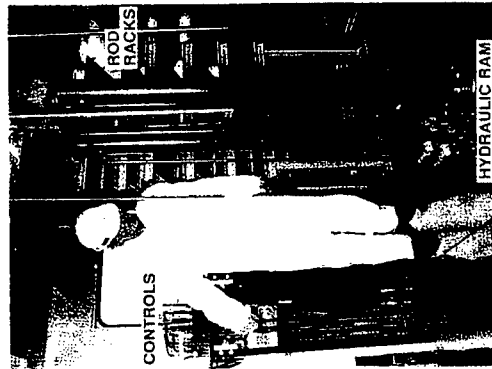
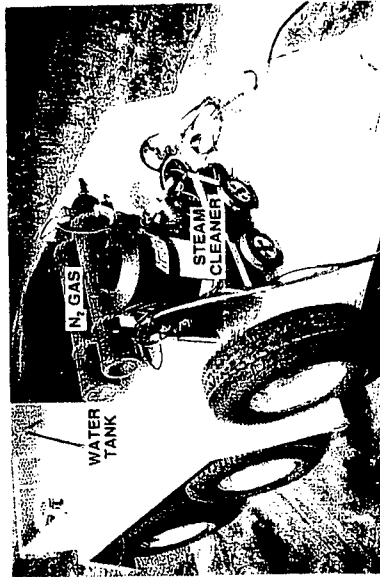
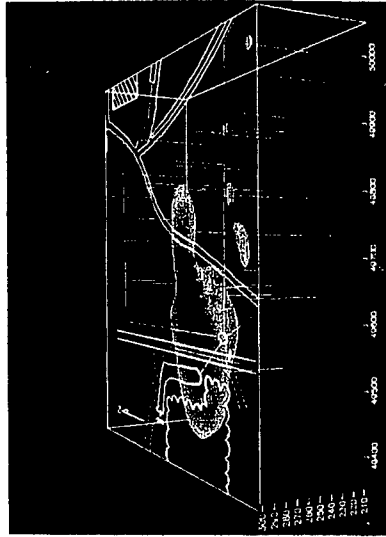
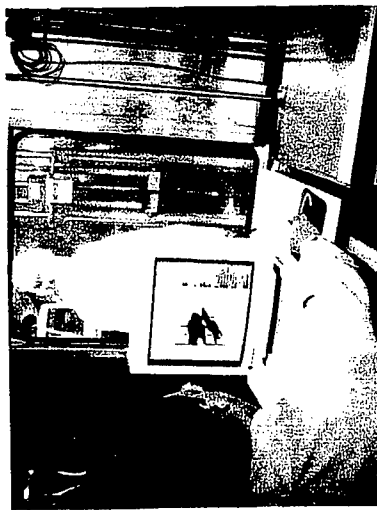
**Figure 3. The SCAPS system**

SCAPS consists of the cone penetrometer truck, enclosed support trailer containing the decontamination wash water system and grout pumping system, and a mobile analytical laboratory van. Figure 3 shows the SCAPS vehicle and support trailer. The SCAPS sensors used at APG were the soil classification sensor and the laser-induced fluorescence (LIF) sensor combined to form the POL sensor. It should be noted that the soil classification sensor used in the SCAPS is operated in accordance with procedures described in American Society for Testing and Materials (ASTM) Method D3441 (ASTM 1995). For more details, the reader is referred to previous descriptions (Olson and Farr 1986; Lee et al. 1993).

**SCAPS Truck and Grout Trailer  
(Monitoring Well in Foreground)**

**Cone Penetrometer  
With Sensor Package**

**Hydraulic Operations  
Compartment**

**Grout Trailer**

**Three-Dimensional Contaminant  
Visualization**

**Data Acquisition/Processing  
Compartment**

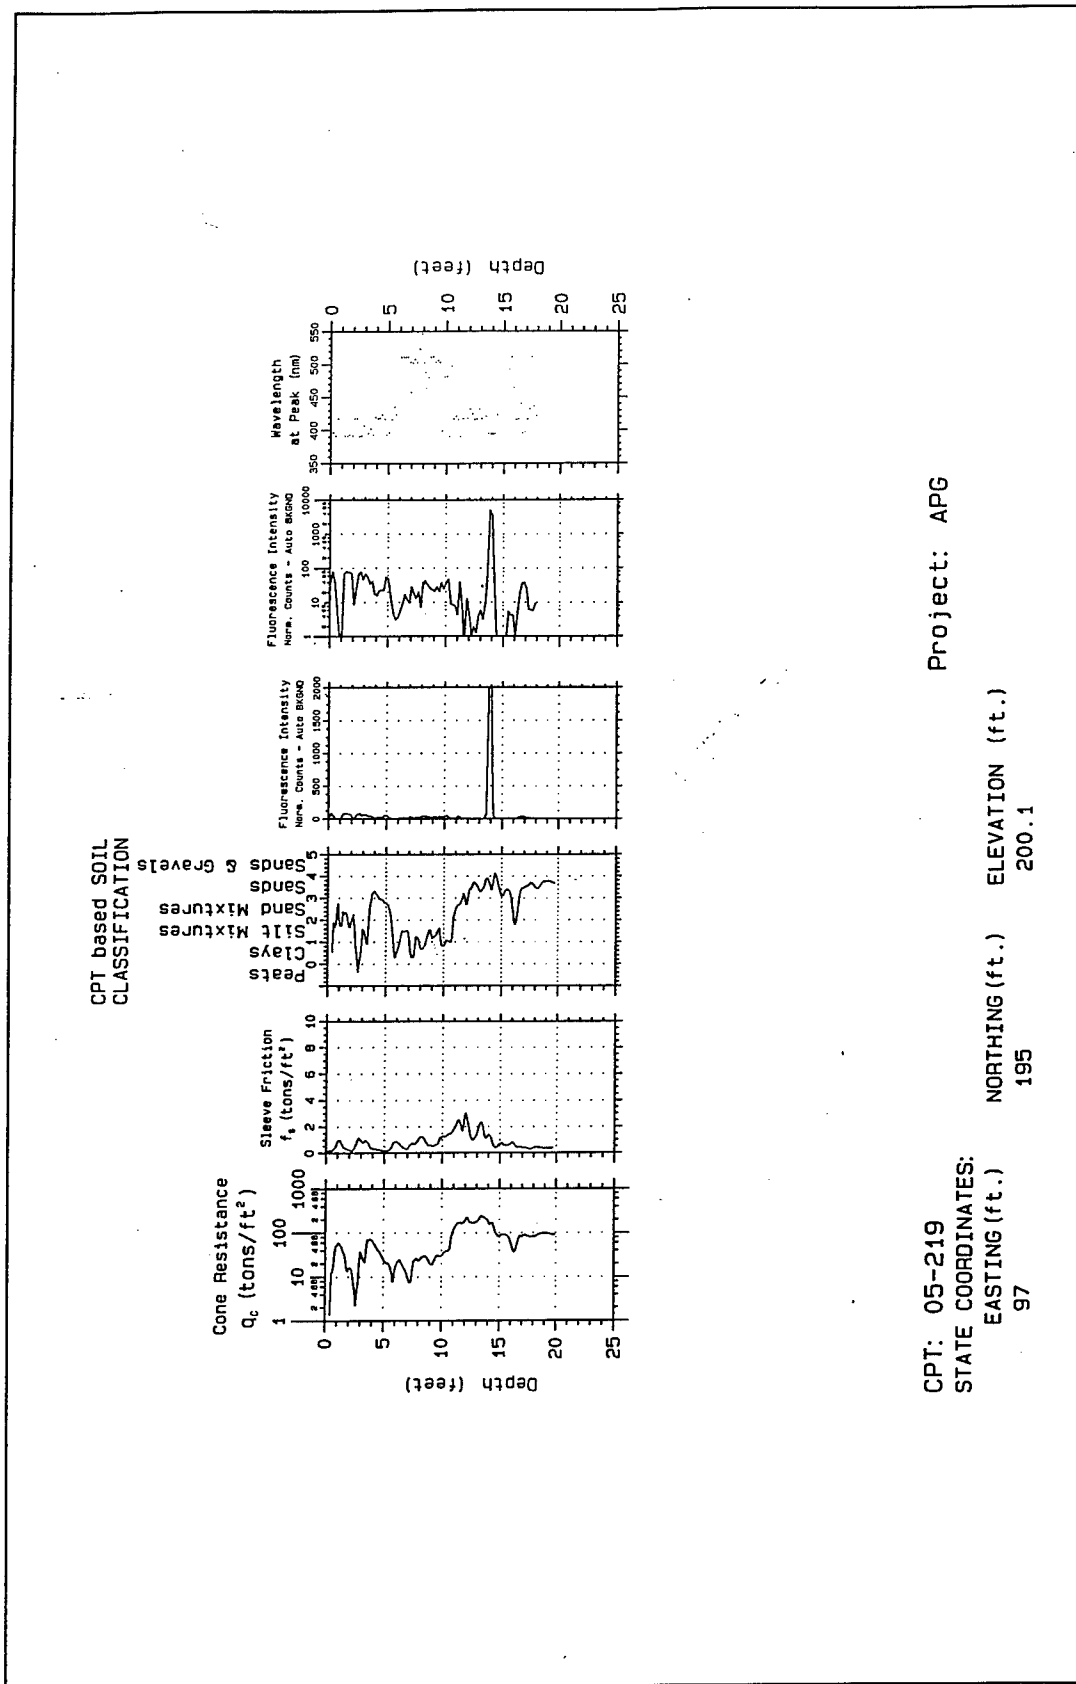
Figure 4. Typical SCAPS panel plot (from penetration #5 near Building 4020)

Real-time sensor response for the soil classification and LIF sensors is plotted during each penetration. These data allow the operator to observe the soil classification and fluorescence response as the sensors are advanced into

the soil. The sensor data were then plotted as a function of depth for informative visualization (Figure 4).

SCAPS penetrations in the areas around MW-1, MW-4, and MW-8 confirmed the previous findings (Appendix A, Figures A5, A8, and A19). SCAPS penetration #5 detected a narrow band of intense fluorescence response approximately 14 ft BGS, consistent with the previously reported free product detected in MW-1. Bands of less intense but significant fluorescence response was detected by penetration #19 (adjacent to MW-8). The SCAPS data indicated low level fluorescence from the surface to 5 ft BGS, and contamination appeared again at 7.5 ft BGS and continued to approximately 20 ft BGS. The OVA analyses performed during the installation of MW-8 indicated elevated readings from 4 to 21 ft BGS.

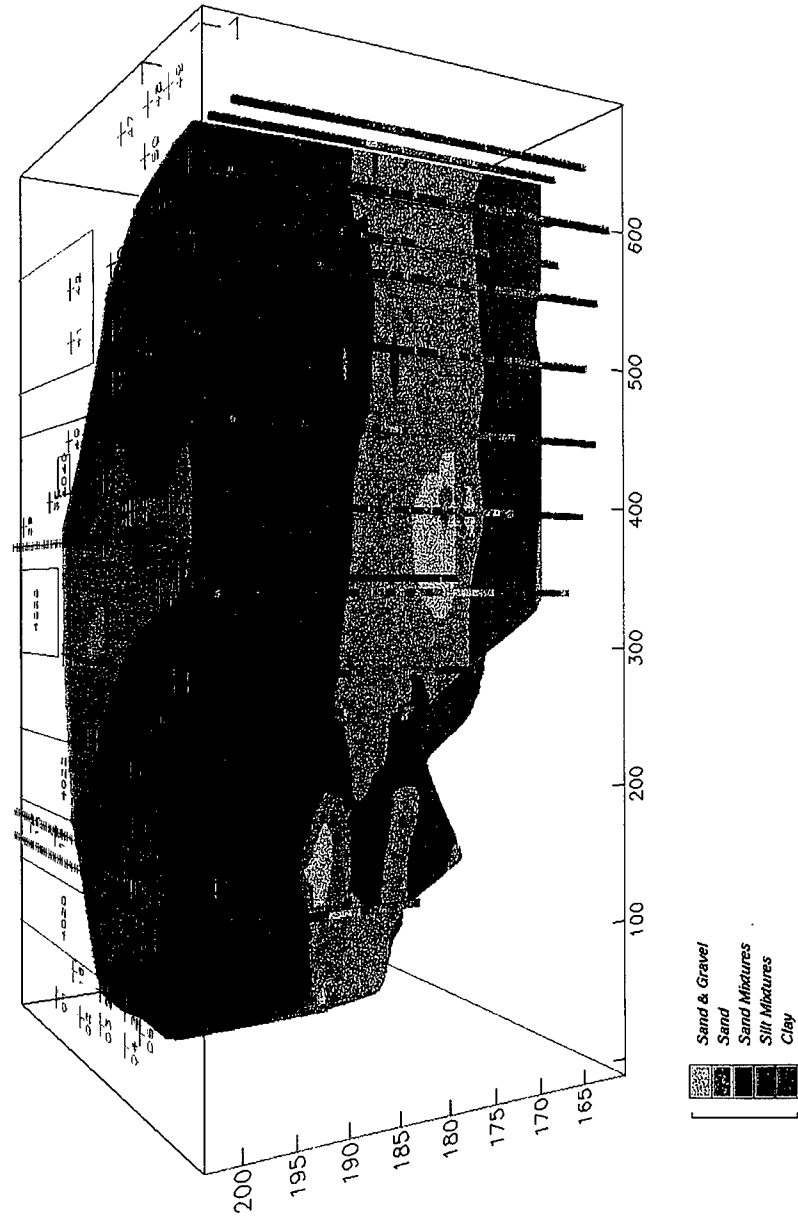
Figure 5. View of site soil stratigraphy

The site soils consist of gravels, sands, clays, and silts, all highly interbedded. The soil classification sensor data agreed with the soil classification and lithology determined previously (ENSAT Corporation 1992a,b). In general, the fine-grained material to a depth of 15 ft below ground surface (BGS) was underlain by coarse-grained material approximately 15 to 20 ft thick. Below that was another fine-grained material, which appears to be an aquitard based on visual identification of soil sample moisture content. The top of that fine-grained layer (approximately 35 to 38 ft BGS) contains partially decomposed woody material (tree stems) that was not water saturated. The woody material was initially noticed from the amplified LIF response as the probe penetrated the material and was confirmed with subsequent verification soil sampling analyses.

The soil classifications assigned using the SCAPS sensor are those designated in ASTM Method D3441. The soil classification data were plotted as a function of depth and used to generate a 3-D computer model of the site stratigraphy. The site stratigraphy generally conformed to the soil classification and lithology determined from the previous soil borings. However, it should be noted that the SCAPS soil classification sensor stored a data point for every 4 cm the sensor advanced. The high density of data points for each SCAPS push and the large number of penetrations achievable (e.g., six per day) provide much higher resolution stratigraphic mapping than conventional soil boring techniques (EPA 1995).

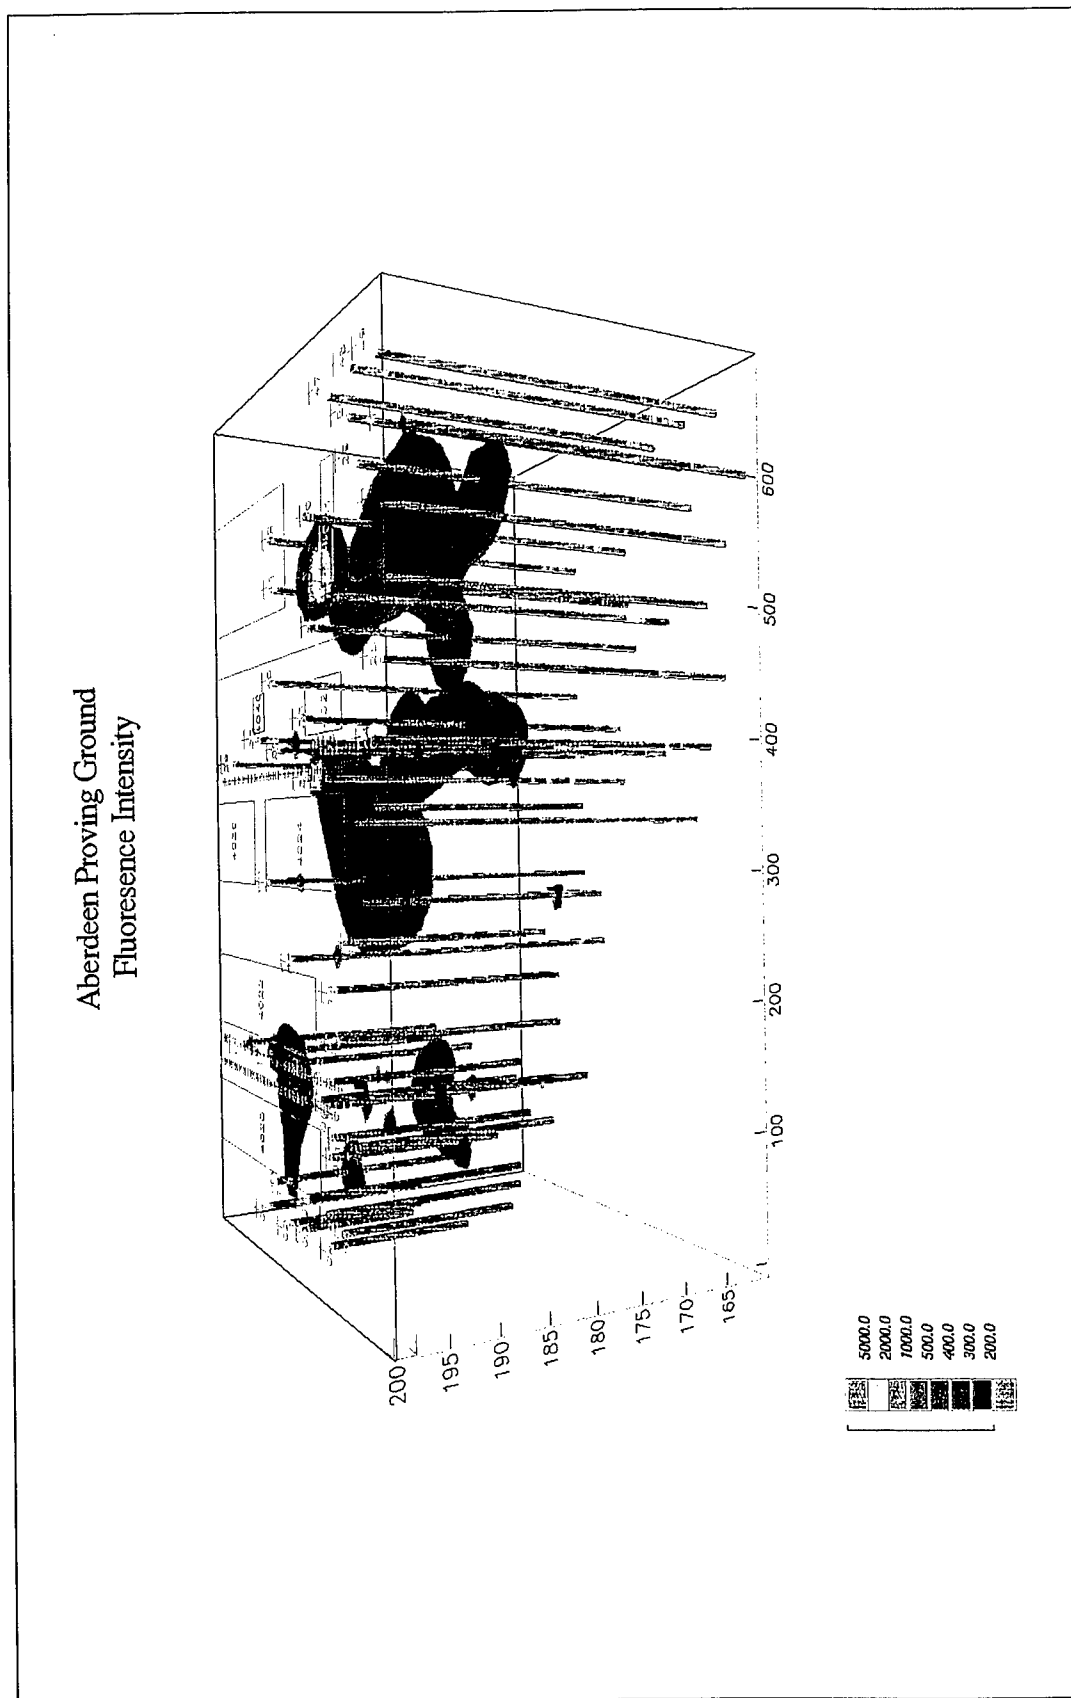
Figure 6. View of SCAPS POL sensor response, low intensity

A total of 51 POL sensor penetrations were completed over 12 days. During the same time period, 10 soil sampling penetrations were completed, with 20 verification soil samples retrieved. Three-dimensional (3-D) computer models of both the soil stratigraphy and POL sensor response were generated during the final 3 days of data collection, enabling onsite 3-D visualizations of subsurface site conditions (Figures 5, 6, and 7). The data for Figure 7 are the same as for Figure 6, but replotted to enhance the high-intensity areas.

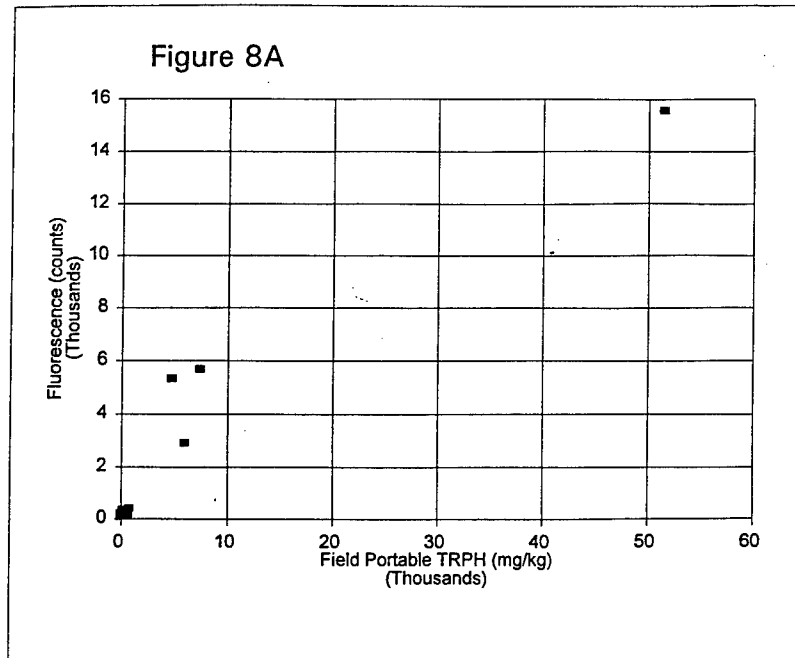
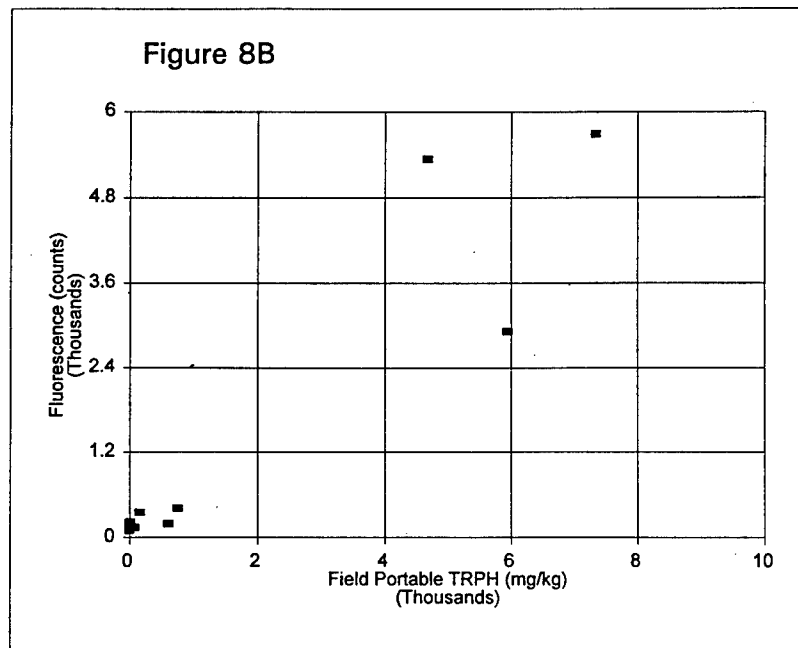
Figure 8. Comparison between TRPH and POL sensor response (8A contains all data presented in Table 1; 8B is an expanded view of the low concentration region of 8A)

The results show strong correlations between the fluorescence response of the samples, the TRPH (Figure 8), and the total PAH minus naphthalenes (NAPH) (Figure 9). The POL sensor response results from fluorescence emission of the PAH components heavier than naphthalene present in petroleum products (Aptiz et al. 1992). Therefore, it is expected that the strongest correlation would be between the PAH components heavier than naphthalene. For a particular petroleum product, there is a correlation between the TRPH for that product and the PAH concentration (Lee et al. 1994; Davis, Jones, and Porter 1995). Thus, a site contaminated with a single POL product should exhibit a correlation between the TRPH and the POL sensor response.

The influence of the heavier PAHs can be seen in the results of the validation samples collected during the investigation at the APG site (Table 2). The results indicated that the strongest correlation between POL sensor fluorescence response and other POL measures was observed for the total PAH minus NAPH ( $r^2 = 0.92$ ). The correlation between the total PAH (including NAPH) and POL sensor response is much weaker ( $r^2 = 0.79$ ) and is even weaker for NAPH alone ( $r^2 = 0.69$ ). The correlations between both TRPH measures and the POL sensor response were strong ( $r^2 = 0.91$  for EPA Method 418.1,  $r^2 = 0.89$  for field portable method, Table 2). There is a very strong correlation between the EPA Method 418.1 and the field portable method TRPH ( $r^2 = 0.99$ ) (Davis, Jones, and Porter 1995).

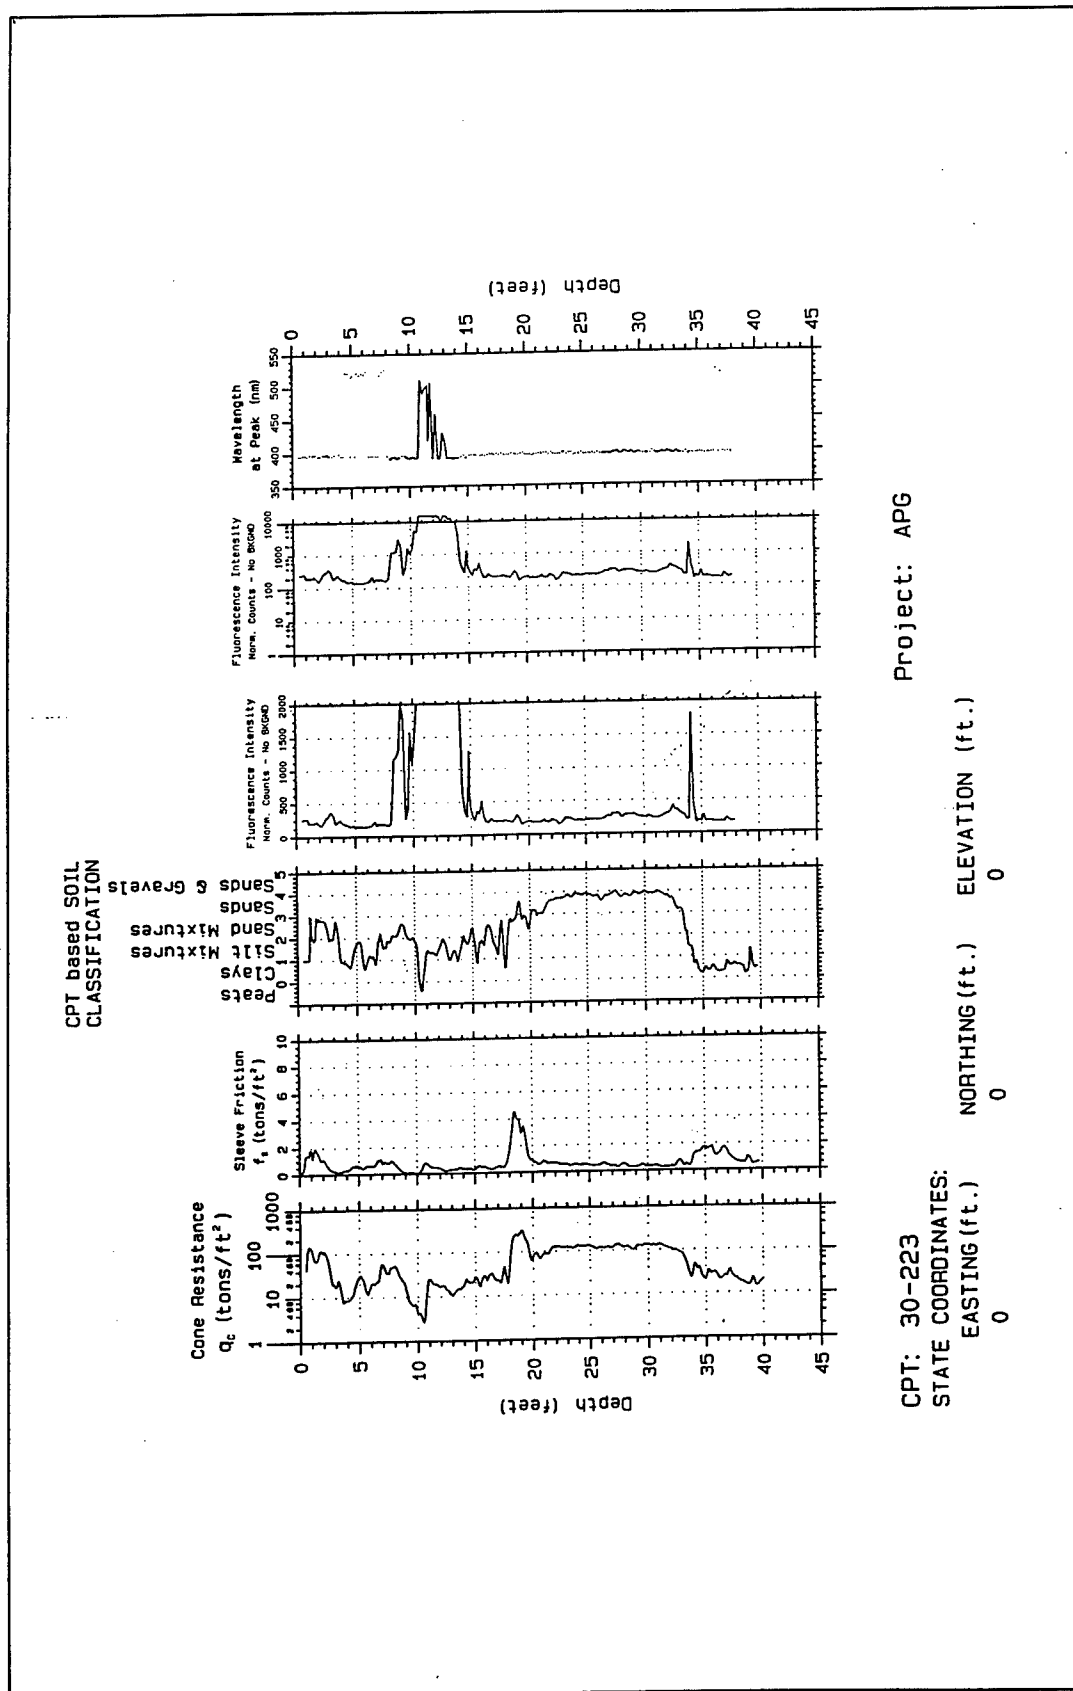
Figure A30. CPT 30-223, Aberdeen Proving Ground

The third area investigated was east of Building 4027, south of Building 4035, and all around Building 4031. That area was investigated because significant fluorescence response was noted during SCAPS penetration #30 (Appendix A, Figure A30). The data indicated a very intense band of POL contamination from 10 to 15 ft BGS. Penetration #30 was performed to investigate the possible down-gradient migration of free product from the UST that had been located north of Building 4027. However, the low levels of contamination detected in the areas investigated around building 4027 and high contaminant levels detected in penetration #30 suggested an alternate source of contamination.

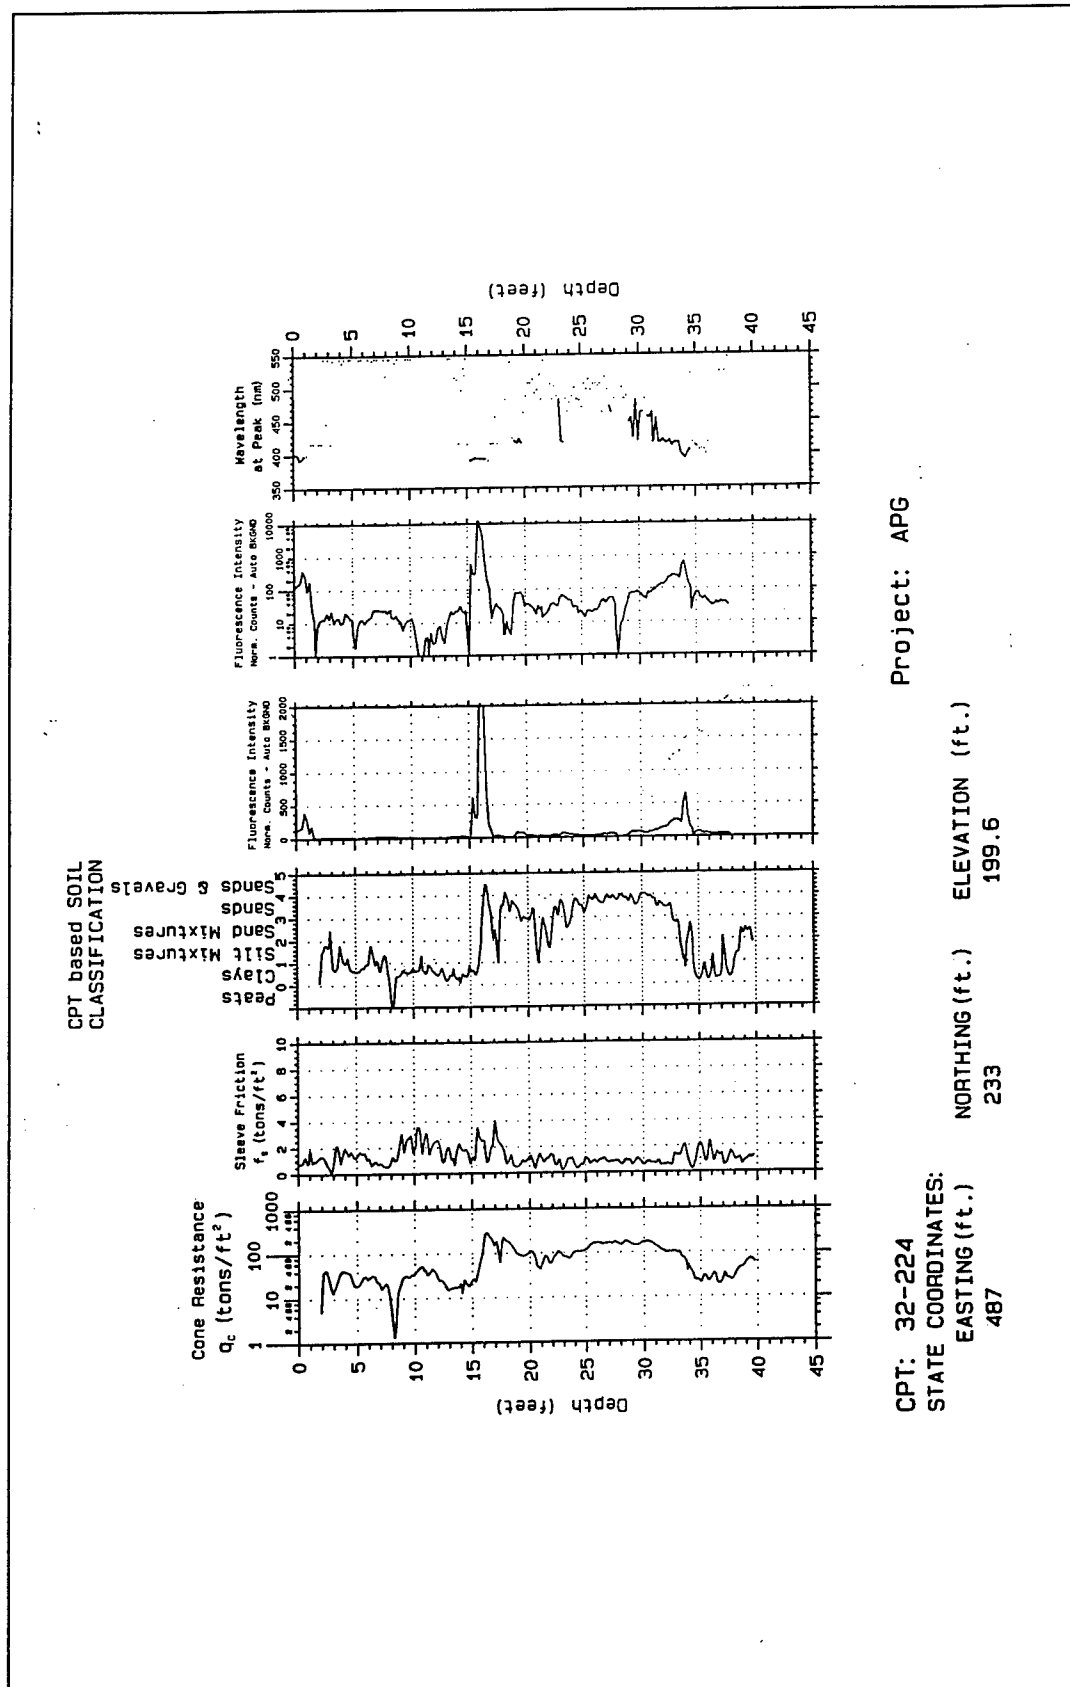
Figure A32. CPT 32-224, Aberdeen Proving Ground

Based on the results of penetration #30, the area of the parking lot to the north of Building 4031 was investigated. The suspected source appears to be in the vicinity of SCAPS penetration #31 (just west of penetration #30). That penetration revealed high fluorescence from the surface down to about 15 ft BGS (Appendix A, Figure A31). Subsequent penetrations around Building 4031 delineated the extent of POL contamination in the area (visualized in Figure 5). Penetration #29 was located to the south of Building 4031 and detected significant fluorescence response in a sandy layer from 13 to 14 ft BGS. Similar levels of contamination were also detected northwest of the building in a sandy layer 15 to 17 ft BGS during penetration #32 (Appendix A, Figure A32).

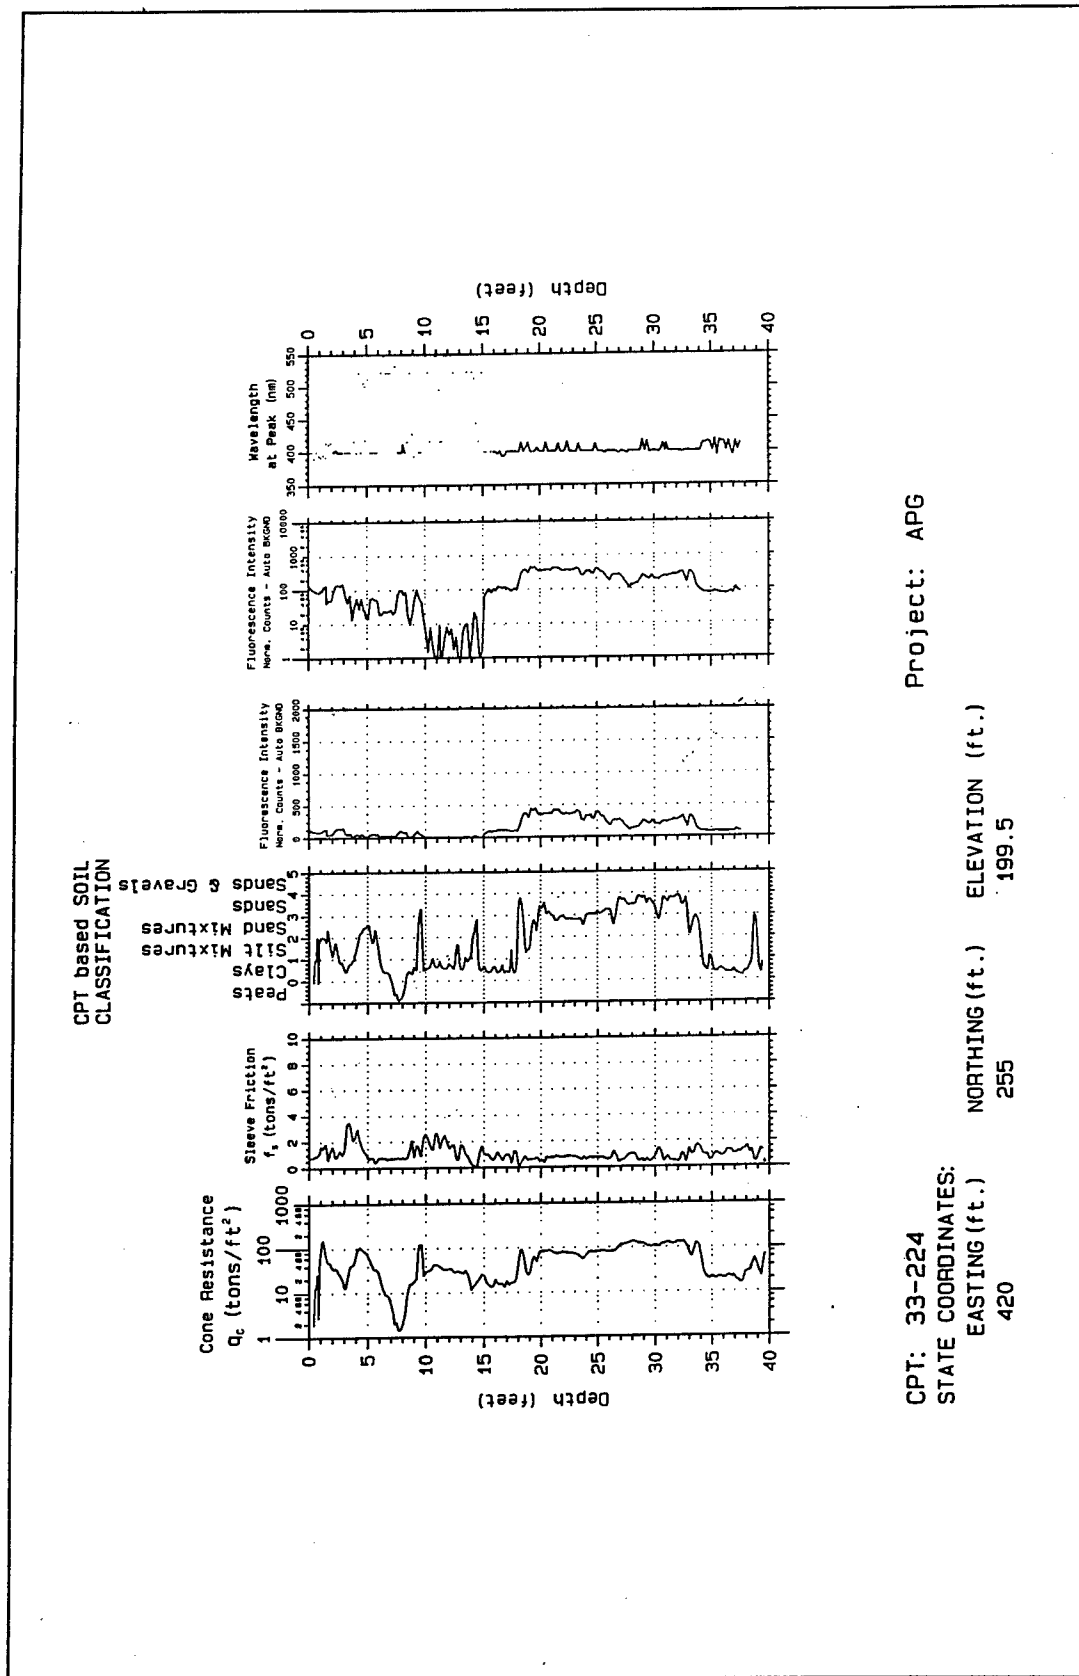
Figure A33. CPT 33-224, Aberdeen Proving Ground

Corporation 1992a). The SCAPS POL sensor penetrations in the area indicated very low or nondetectable POL contamination (Appendix A, Figure A33). However, penetration #45 (near MW-11) on the north end of Building 4024 detected extremely high level POL contamination from 12 to 17 ft BGS (Appendix A, Figure A45). These data are consistent with previous investigations that identified free product in this area.
