STATIONWIDE  
ENVIRONMENTAL BASELINE SURVEY AND  
RELATED ENVIRONMENTAL FACTORS  
ONTARIO AIR NATIONAL GUARD STATION  
CALIFORNIA  
November 1996

**STATIONWIDE ENVIRONMENTAL BASELINE SURVEY**  
**ONTARIO AIR NATIONAL GUARD STATION, CALIFORNIA**

**NOVEMBER 26, 1996**

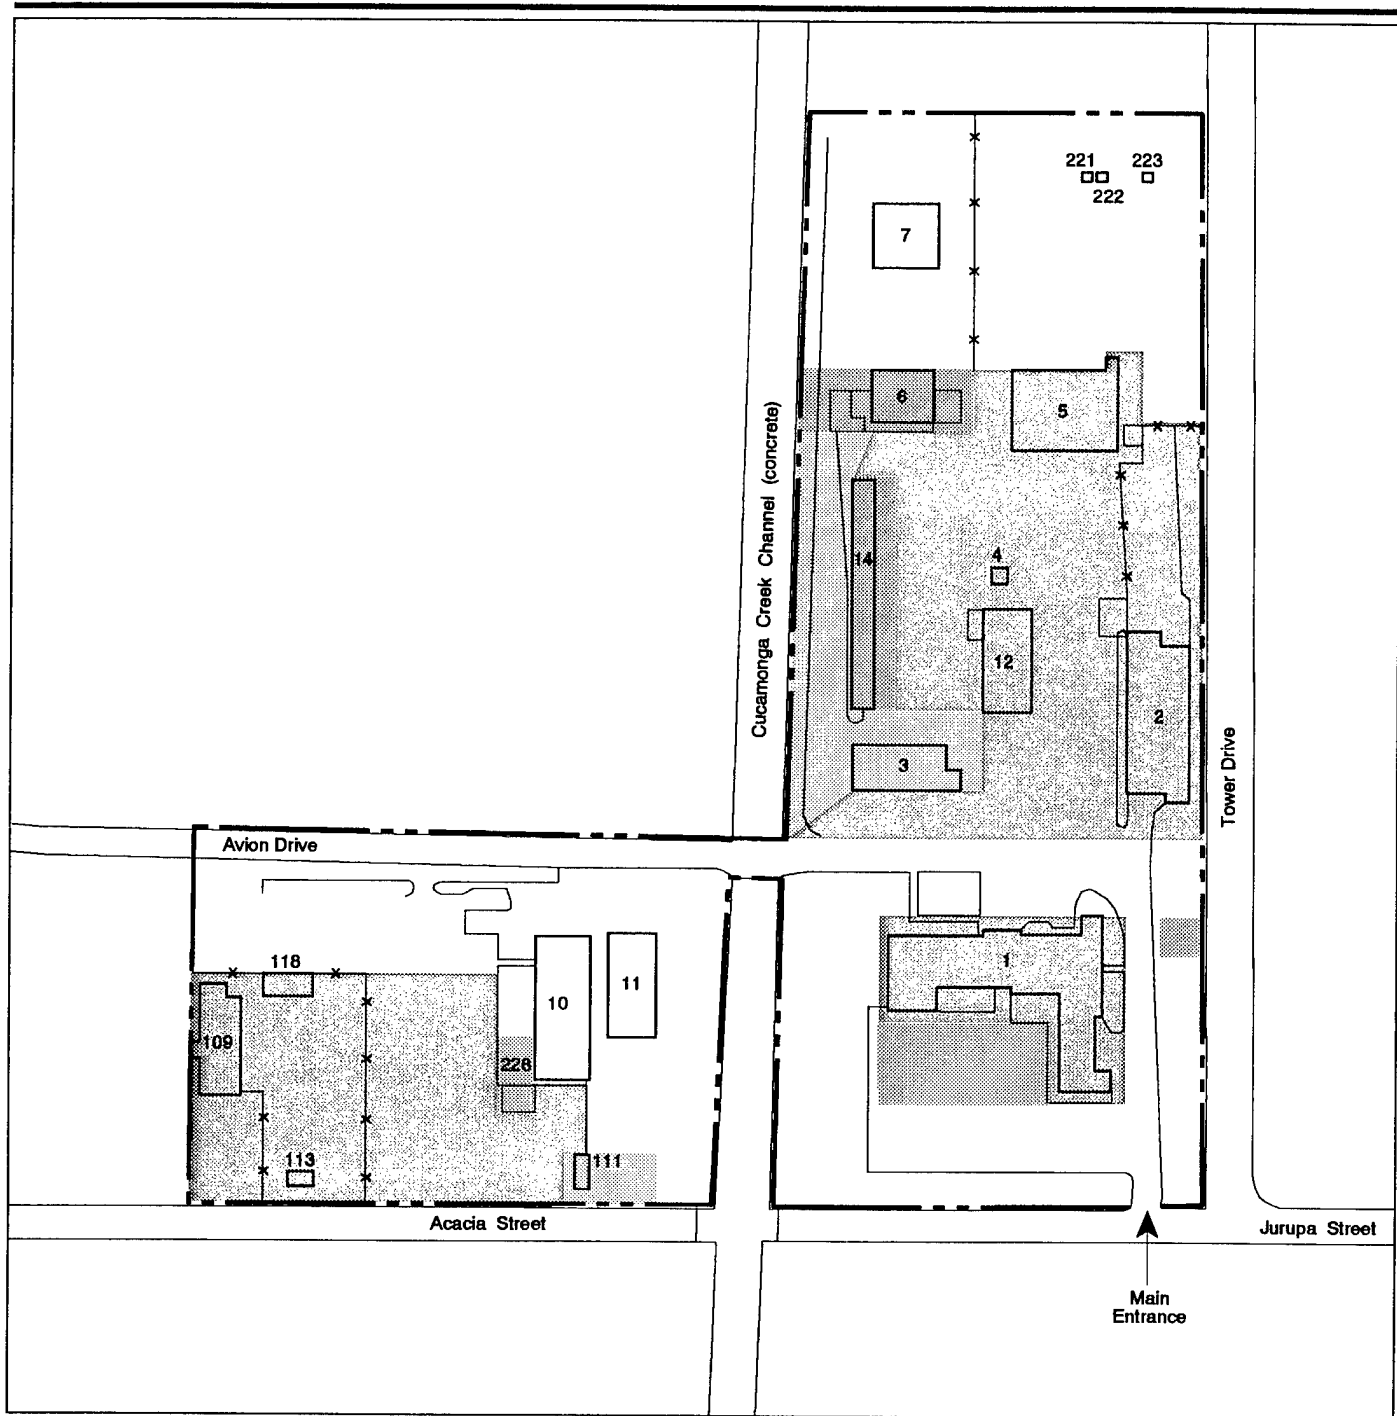
**S.2.1.2 Property Categorization.** As described above, property on Ontario ANGTS was classified into one of eight categories based on the findings of this EBS (Figure S-1). Category 1 properties generally occur in the vehicle parking area for Building 1, the northern portion of the station where munitions storage activities once took place, and around the administration and dining hall west of Cucamonga Creek. Category 2 properties occur throughout the central portion of the station including Buildings 1, 2, 4, 5, and 12, and most of the area west of Cucamonga Creek. Category 3 property is associated with IRP Sites SS-01 and ST-03. Portions of the storm drain system are also considered Category 3 as a result of past disposal activities. No Category 4, 5, or 6, properties were identified. Category 7 properties include Buildings 6 and 14 where subsurface soil conditions at OWSs are unknown. A grease trap (Facility 228) located adjacent to Building 10 is also considered Category 7 due to unknown subsurface soil conditions. The septic tanks and leach fields associated with

Buildings 2 and 6 may have received hazardous substances and are considered Category 7. An area located south of Building 1 may have been utilized as a burn pit in the mid-1940s and is considered Category 7. IRP Site ST-02 is considered Category P<sub>R</sub> as a result of past releases from fuel oil USTs, but is not shown on the figure because other factors contribute to the property, which outweighs Category P<sub>R</sub>.

- OWS and grease trap locations have unknown subsurface soil conditions and may require further investigation.
- Septic tanks and leach fields associated with Buildings 2 and 6 may have received hazardous substances and require further investigation.
- Facility-specific information regarding hazardous material storage was not available.
- Facility-specific information regarding hazardous waste generation was not available.
- The area south of Building 1 that may have been utilized as a burn pit may require further investigation.

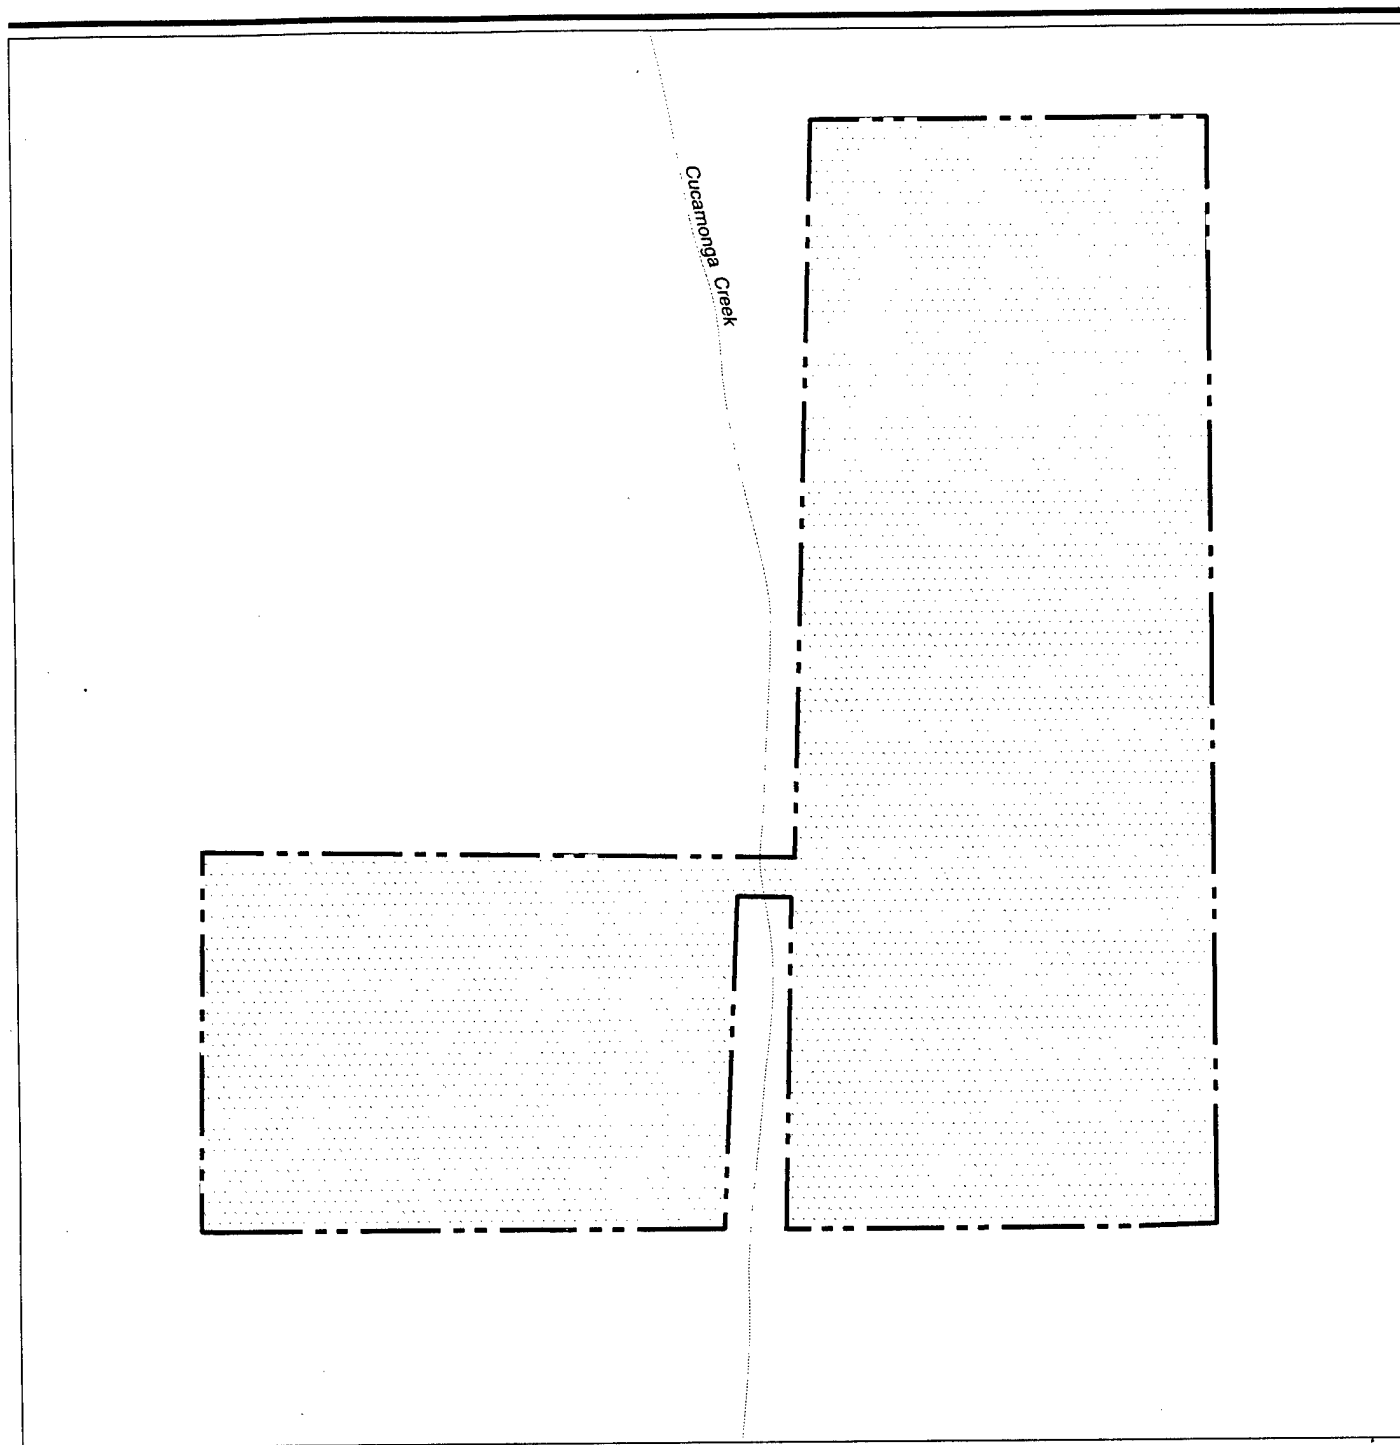
Figure 3-1

Prior to the 1940s, the area for the future site of the Ontario International Airport and Ontario ANGTS was primarily agricultural (Figure 3-1).

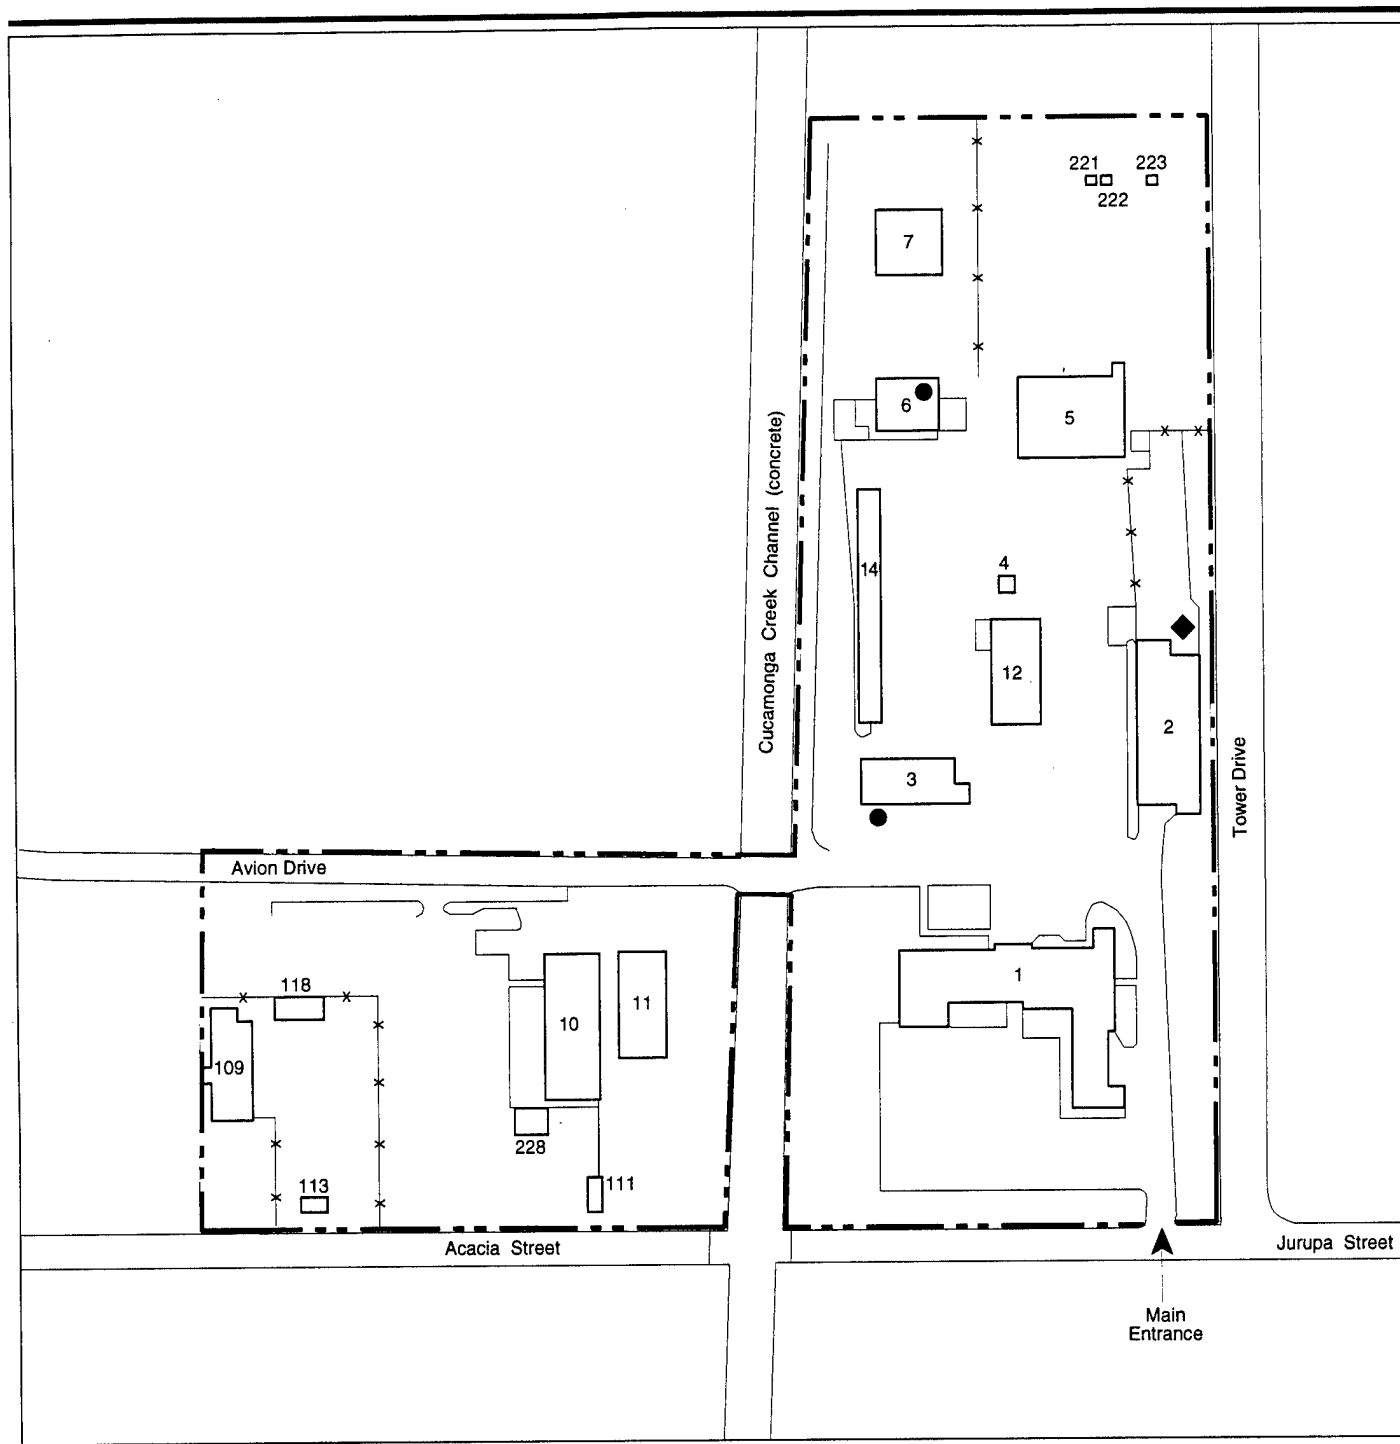
## Hazardous Waste Storage Locations

**3.3.1.2 Hazardous Waste and Waste Petroleum Products.** Station records dating from 1993 were reviewed to identify quantities and types of hazardous wastes and petroleum wastes generated or stored in station facilities. Hazardous wastes and/or waste petroleum products were stored at Buildings 2, 3, and 6. Appendix C, Table C-2, provides an inventory of Hazardous Waste and Waste Petroleum Product Storage Areas. Hazardous waste manifests were reviewed for information on types and quantities of hazardous wastes or waste petroleum products stored by facility. The review of the hazardous waste manifests did not yield any usable information. Figure 3-6 shows the locations of facilities in which hazardous wastes or petroleum wastes were stored.

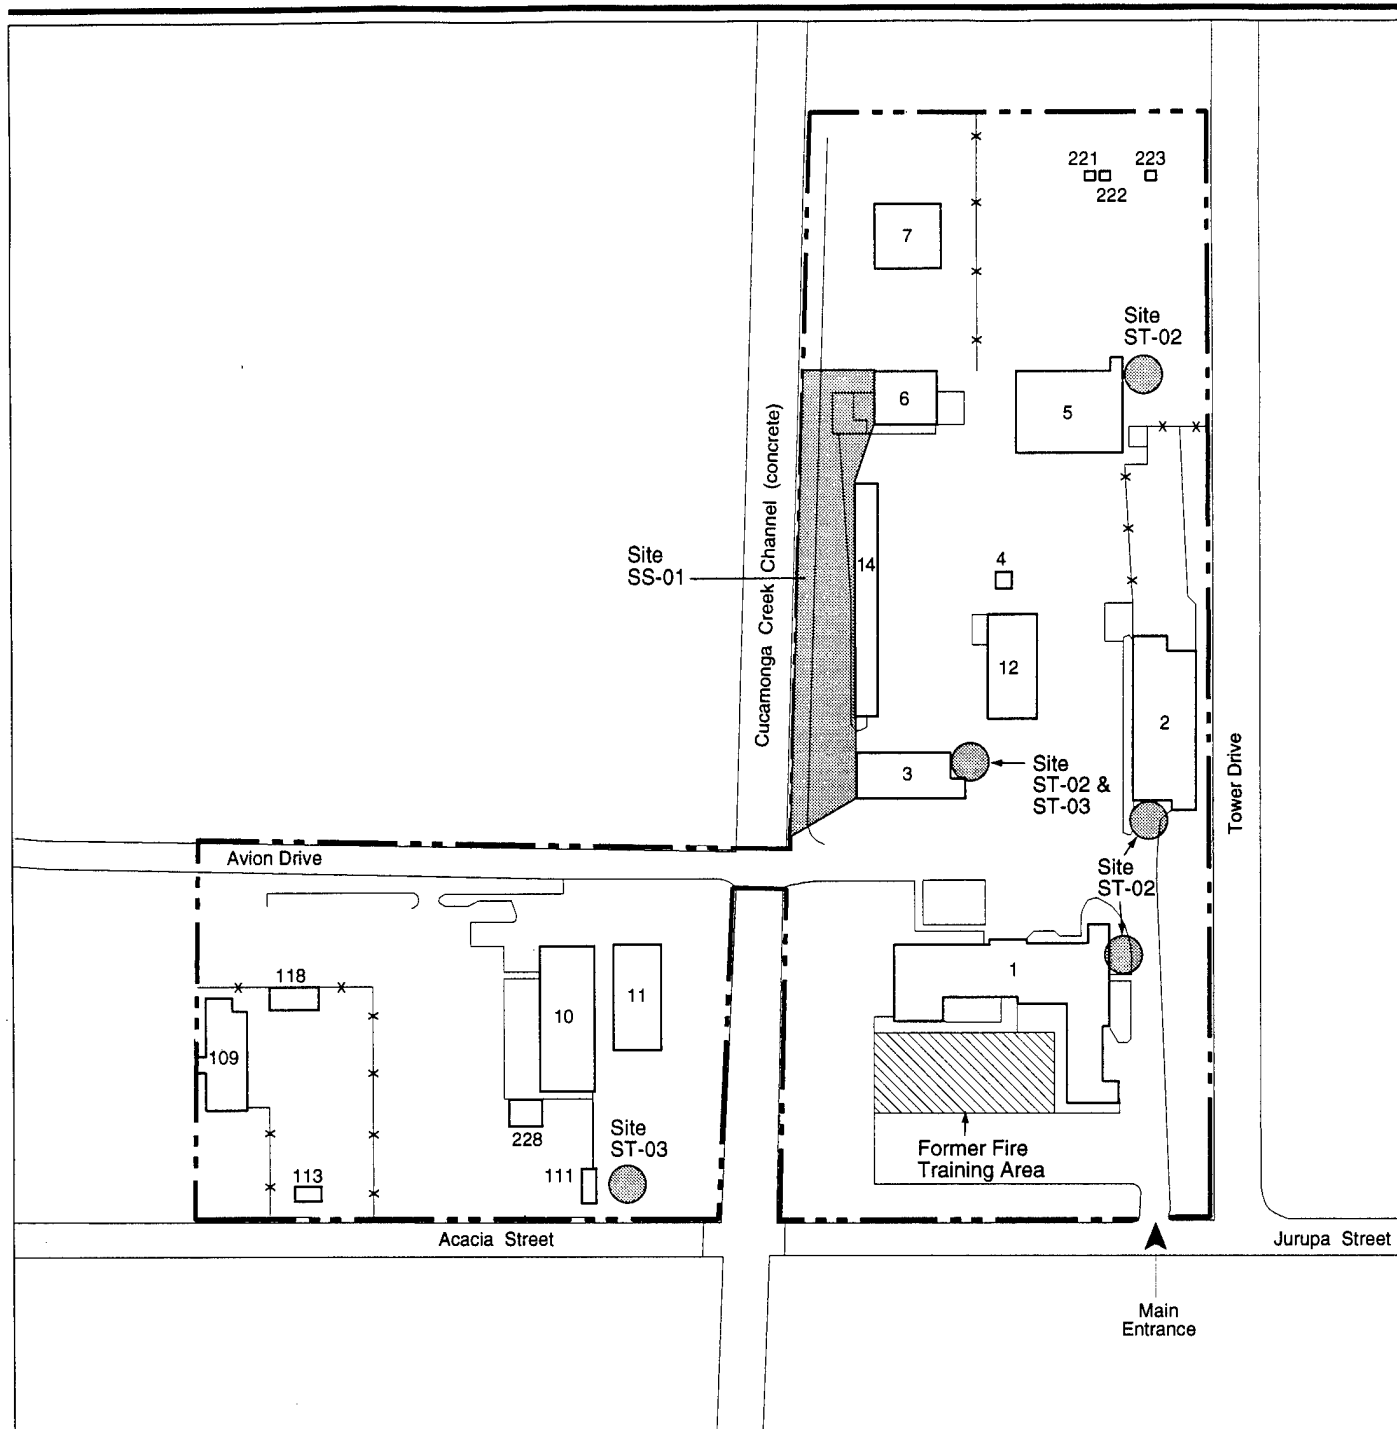
**3.3.2.2 IRP History.** The Air Force began the IRP process at Ontario ANGTS in 1990 with a PA. It initially identified three areas of possible contamination (Figure 3-7). Of these sites, one (IRP Site SS-01) was

| Study Area | Site No. | Site Name | Status | Description | Category |
|---|---|---|---|---|---|
| A | NA | Former Fire Training Area | Further investigation recommended | In the mid-1940s, the area south of Building 1 was used as a fire training area. Specific activities conducted are unknown. | 7 |

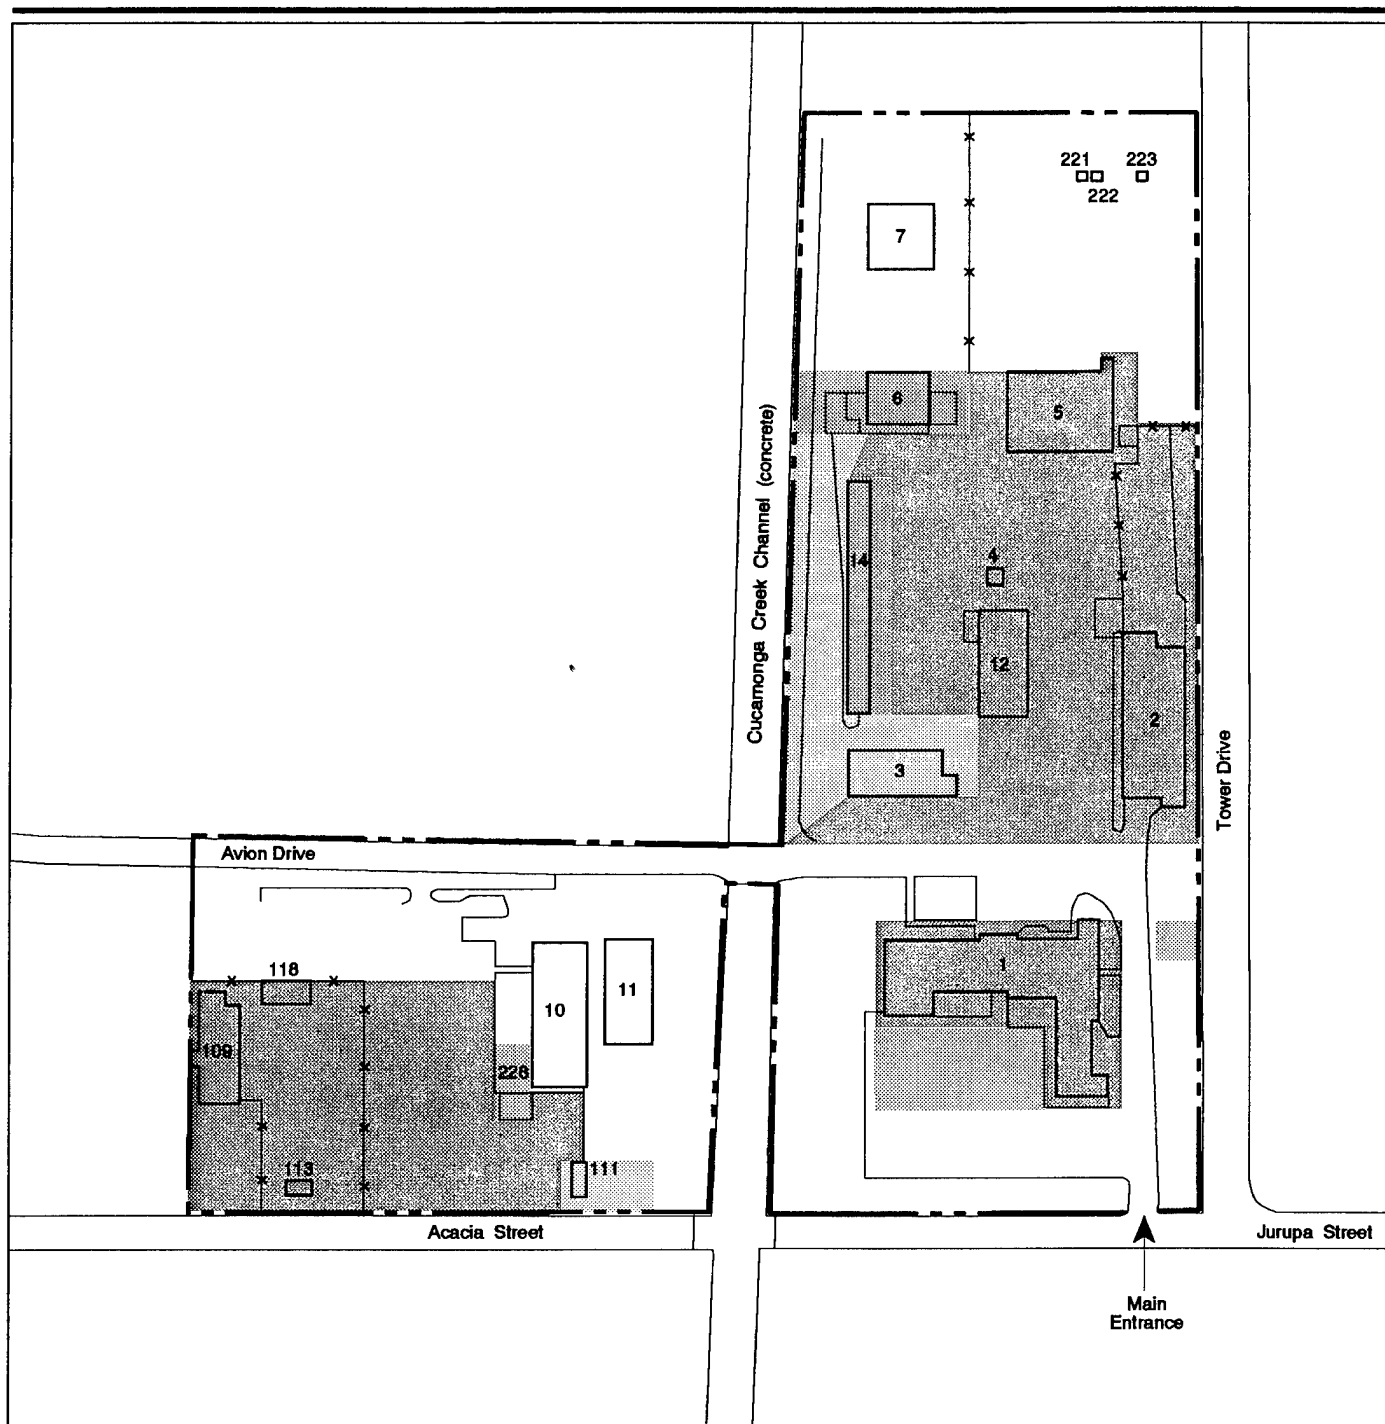
Figure 5-2

- Uncontaminated Property (Category 1)
- Hazardous substance stored - no release (Category 2)
- Hazardous substance release, below action levels (Category 3)
- Hazardous substance release, all actions have been taken (Category 4) \*
