Biological Report 86(6)  
June 1986

**MITIGATION OPTIONS FOR FISH AND WILDLIFE  
RESOURCES AFFECTED BY PORT AND OTHER  
WATER-DEPENDENT DEVELOPMENTS IN  
TAMPA BAY,  
FLORIDA**

R. Steve Dial and Donald R. Deis  
Continental Shelf Associates, Inc.  
759 Parkway Street  
Jupiter, FL 33477

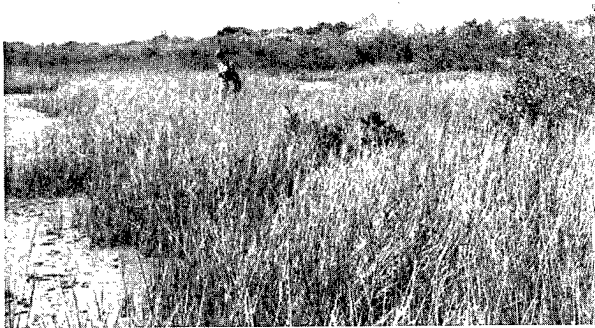
at 1130 hours (approximately low tide), 6 years after planting. Overall, Sunken Island was the most diversified restoration project visited during this survey due to the combination of many different kinds of habitats found there (i.e., S. alterniflora marsh, mangroves, upland, open sand beach, shallow intertidal, and subtidal) (Figures 22, 23, and 24). The S. alterniflora plugs had coalesced into a marsh and R. mangle, A. germinans, and L. racemosa seedlings had recruited and reached 0.5 to 1.5 m in height (Figure 22).

**Figure 22.** Sunken Island restoration area, 28 November 1984, with band of Spartina alterniflora and higher marsh of Avicennia germinans, Laguncularia racemosa, and Paspalum vaginatum.

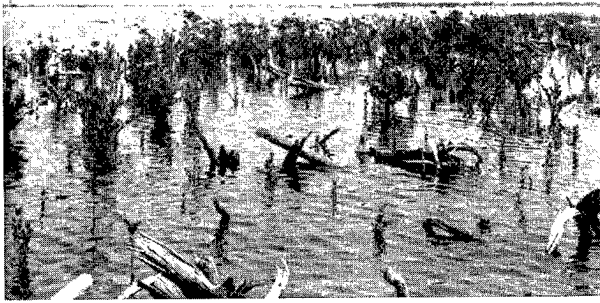
**Figure 27.** Frandorson property 9 months following restoration. Majority of seedlings are white (*Laguncularia racemosa*) or black (*Avicennia germinans*) mangroves from natural recruitment or new growth from remaining root stock.

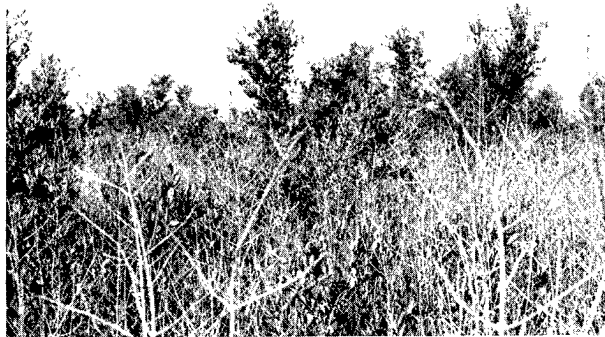
**Figure 29.** Mangrove habitat at east end of transect, 28 November 1984, 10 years after illegal clearing. Freeze-damaged white (*Laguncularia racemosa*) and black (*Avicennia germinans*) mangroves in foreground and taller red (*Rhizophora mangle*) and white (*L. racemosa*) mangroves in background.

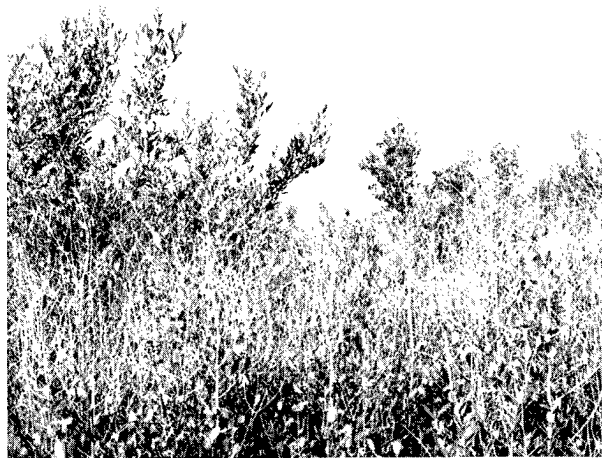
**Figure 30.** Mangrove community at west end of transect, 28 November 1984, dominated by red (*Rhizophora mangle*) mangroves in foreground and dense black (*Avicennia germinans*) and white (*Laguncularia racemosa*) mangroves in background.

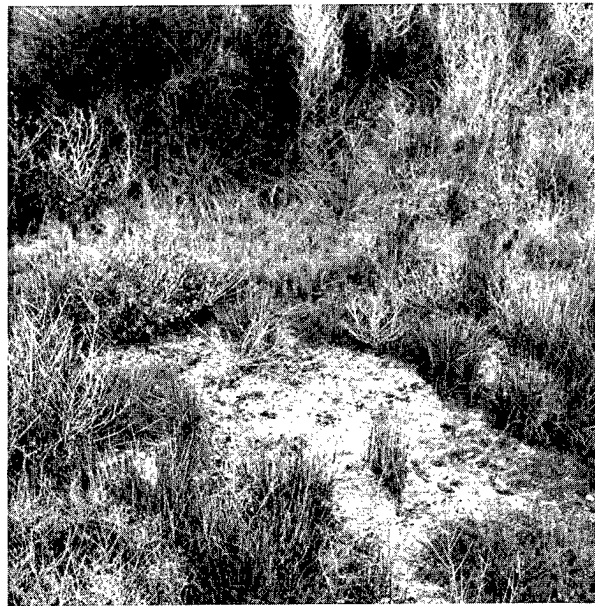
**Figure 35.** Area of unsuccessful Juncus roemerianus restoration, dominated by Salicornia virginica, Paspalum vaginatum, and stunted J. roemerianus.

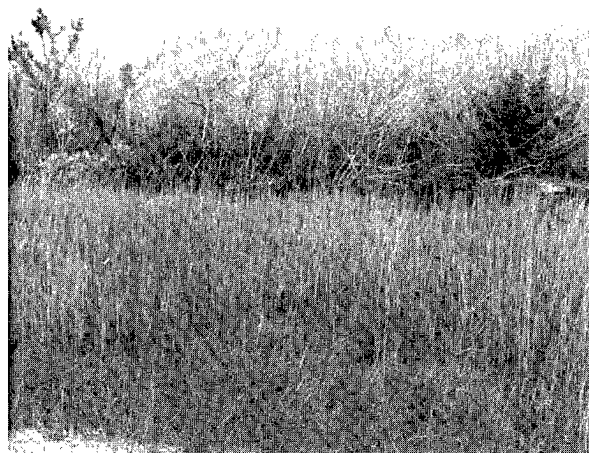
**Figure 37.** Transect 4 in the area previously restored in May 1983 (*Spartina alterniflora*, *Paspalum vaginatum*, and *Salicornia virginica*) at Feather Cove; adjacent mangrove habitat in background.

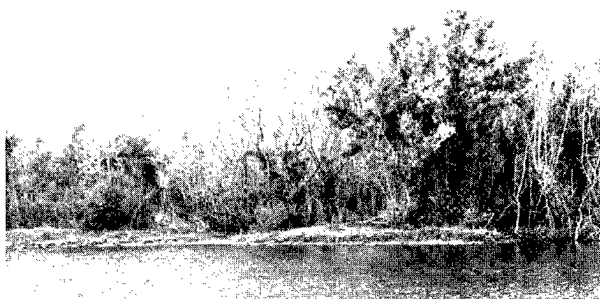
**Figure 38.** Area (Transect 1) planted with Spartina alterniflora 12 May 1984, as observed on 29 November 1984. Mangrove habitat in background shows existing habitat prior to unauthorized clearing.

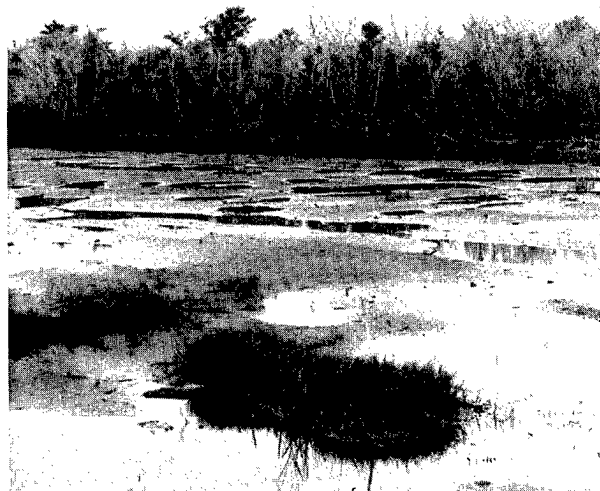
**Figure 39.** Area (Transect 2) planted with Spartina alterniflora 12 May 1984, as observed on 29 November 1984. A few sprigs are noticeable in the background, with Paspalum vaginatum in higher area.

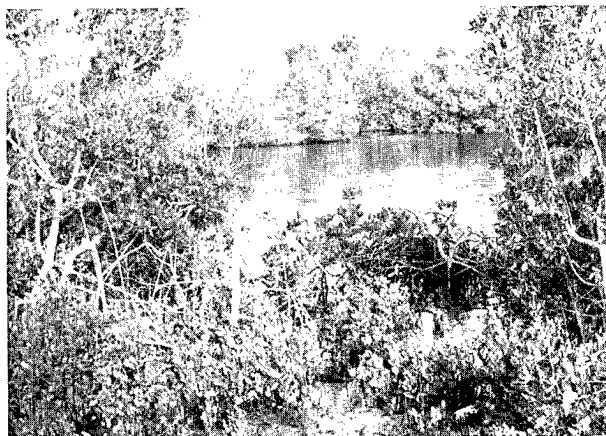
**Figure 44.** Illegal mangrove trimming by private homeowner; north shoreline of Harbor Island's mitigation area.

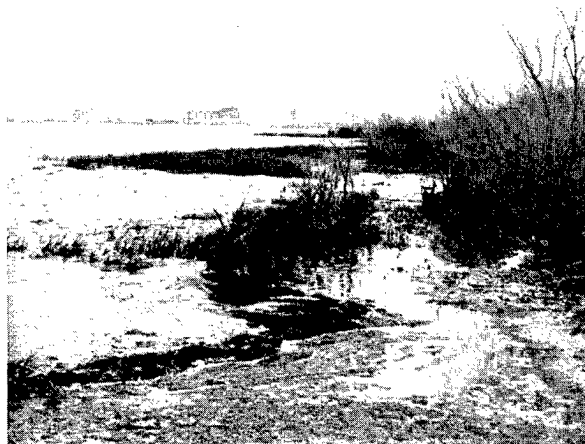
**Figure 72.** Shoreline near Gardinier, Inc. gypsum pile with fringing *Spartina alterniflora* marsh, drift algae (*Ulva* sp.), and freeze-damaged mangroves.

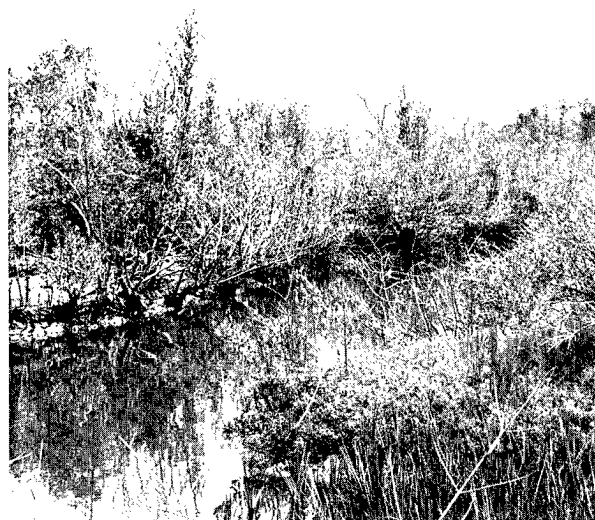
**Figure 95.** Interior tidal creeks at Booth Point showing freeze damaged mangroves, *Juncus roemerianus*, *Salicornia virginica*, and upland vegetation on spoil mounds.

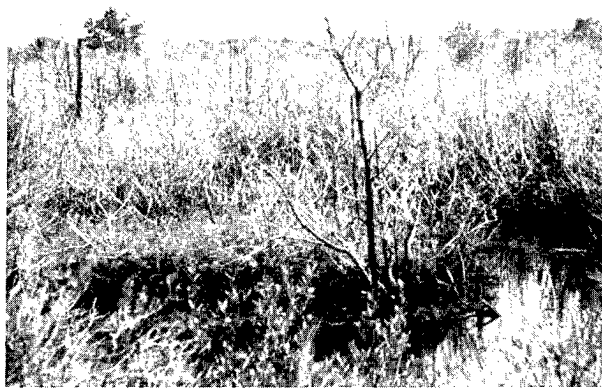
Freeze damaged mangrove habitat at Booth Point site.
