EMI Leakage into the Radio Frequency Distribution System of a Receiving Site

Wilbur R. Vincent
Richard W. Adler
Hugh J. Myers

January 1997

Prepared for: COMNAVSECGRU, N-44

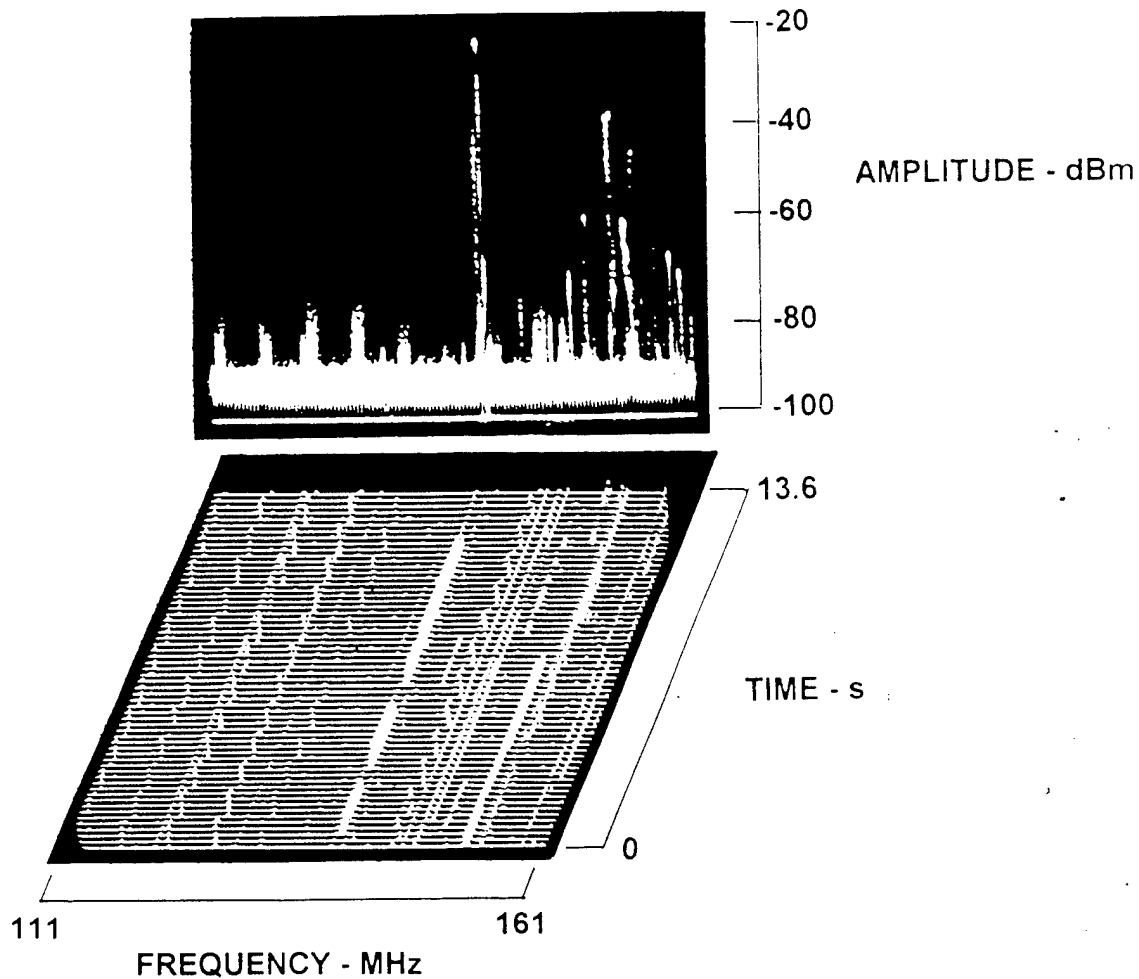
960924 0945
 GTMO. OPS. LPA3-V
 136 MHz, 50 MHz, 30 kHz, 200 ms
 0, 0, -20
 Vss Interference
 4.71 to 4.77 MHz basic sweep frequency

A third example is provided to show that the internal EMI problem also extends upward into the VHF and UHF bands. Figure 2-3 (960924 0945) shows EMI at the input terminals of a receiver in the upper part of the VHF band. Bands of EMI are spaced about 1.6-MHz apart across the entire width of the frequency range examined. Excessive levels of EMI were found from the lower end of the HF band upward into the UHF band. The source was traced to the synchronizer unit of the site's video security system (VSS).

Figure 2-3
Example of the Adverse Impact of Site-Generated EMI
on Signal Reception at a VHF/UHF Site

One aspect of the VSS example should be noted. Due to the high signal environment, a preamplifier could not be used to lower the noise figure of the measurement system to that of the receiving system. The noise floor of Figure 2-3 is more than 20-dB higher than the receiving system. Thus the impact of the EMI on the receiving system is much greater than implied by a casual glance at the measured data.

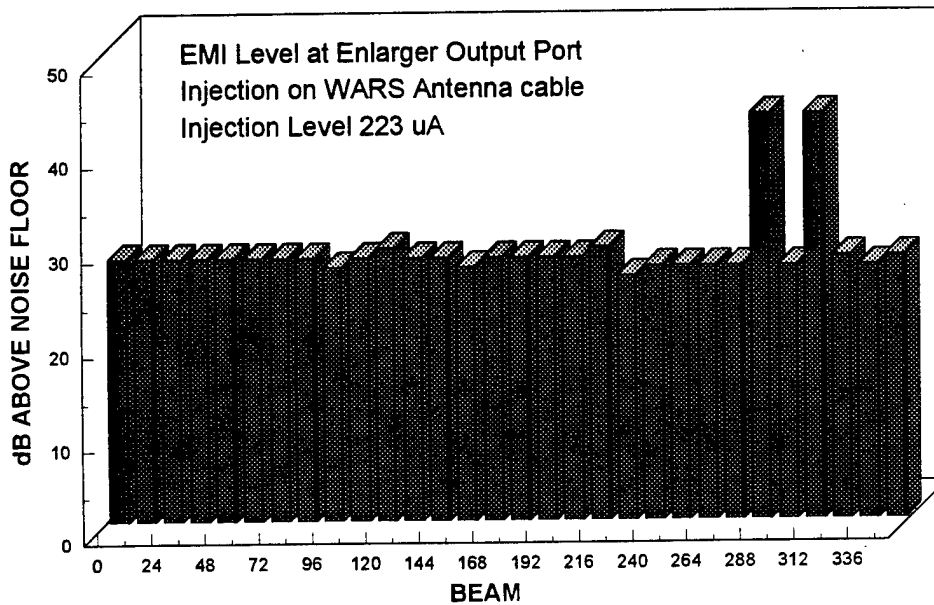
Figure 3.2-1
EMI Leakage from Initial Test

Leakage into the RF path provided for the test receiver in the RF Room is shown. The amplitude of the leakage signal is provided in dB above the receiver noise floor when the noise floor is measured in a 3-kHz gaussian shaped bandwidth. The actual leakage level can be reconverted into dBm by subtracting 130 from each value shown in the figure.

One primary aspect of the data is evident from a cursory examination of the example. Excessive test-signal leakage was found for Beams LBM-288 and LBM-312. Leakage for these two beams was 15-dB higher than that of all other beams. This leakage was quickly traced by NRaD personnel to faulty coaxial connectors in RF paths for the two beams. The connectors were repaired before starting the sequence of measurements described in Sections 3.3 through 3.7. The example is shown to demonstrate the destructive impact on signal reception from improperly assembled and defective coaxial cables and connectors in the RFD. EMI current will efficiently seek such weak spots in the RFD and appear as harmful and destructive interference at the input terminals of a receiver.

A second factor of high interest is also shown in Figure 3.2-1. The injection current of 707 μA (a value of EMI current often found on the WARS RF cable at CDAA sites) produces interference levels about 30-dB above the noise floor in the RF path feeding the test receiver in the RF Room. This is a very high level of interference. It indicates that the RF paths are poorly isolated from site-generated EMI current flowing on the WARS antenna cable and probably from site-generated EMI current flowing on other conductors.

One can assume that if the EMI current is reduced in level by 30 dB, the interference level should be reduced to the noise floor. This suggests that the maximum EMI current that can be tolerated is about 22.4 μA . This is much lower than the EMI current levels found on the WARS antenna cable in most sites and lower than the EMI current levels found on many other conductors in a receiving site.

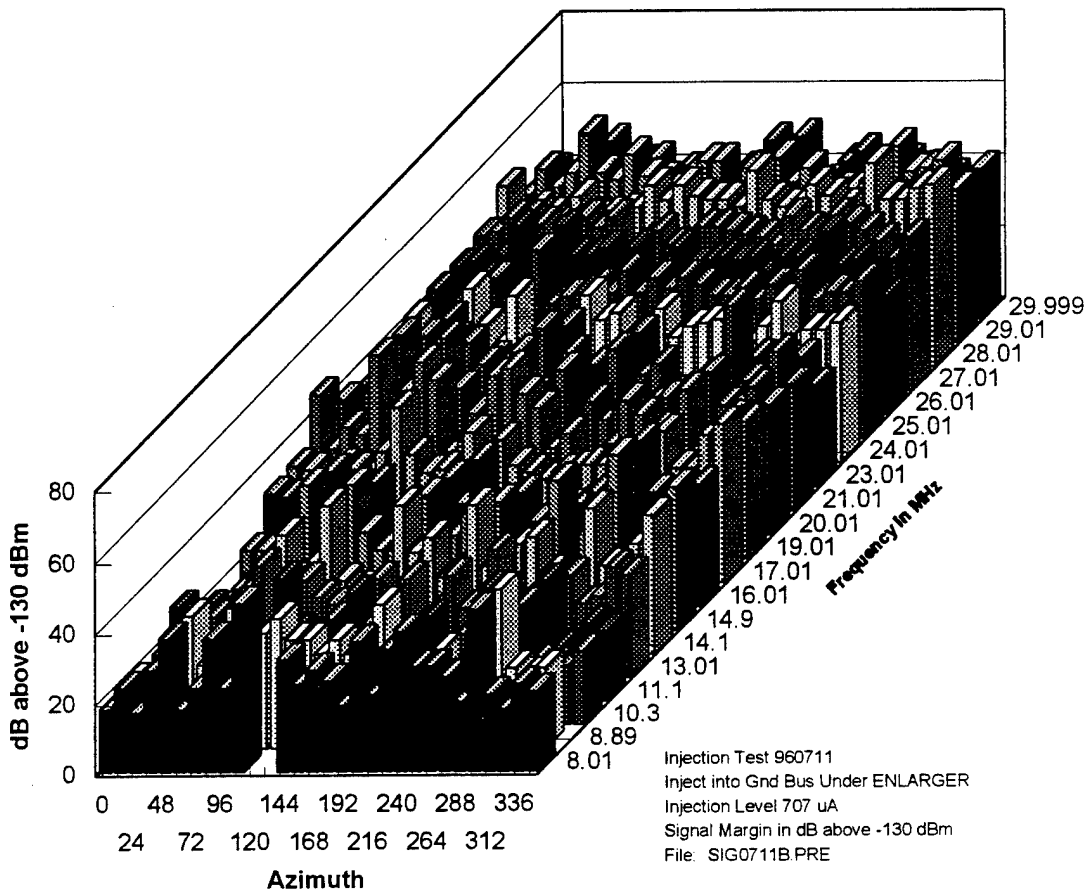
**Figure 3.4-3
 High-Band EMI Leakage, Test 2**

The maximum high band leakage was 59 dBm. This indicates that the EMI current must be reduced to 0.8 μ A to be at the noise level of the primary multicouplers for a 3-kHz detection bandwidth.

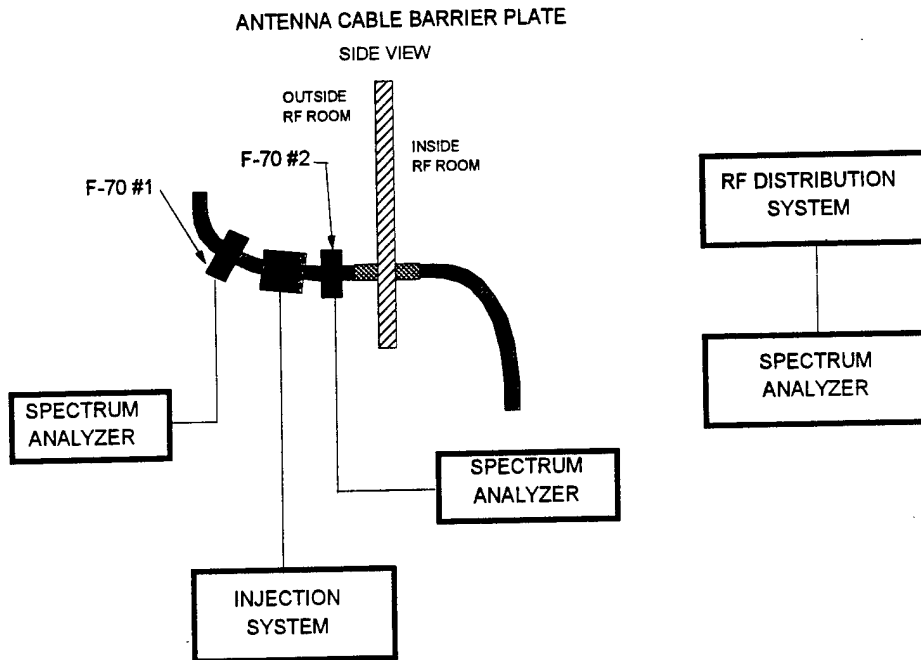
WAH96077-12AM

Figure 3.5-1 shows a sketch of the measurement configuration for Test 3. The test signal was injected into one of the RG-85 cables leading from the RF Room to the antenna elements. The injection probe was located outside the RG-85 cable termination plate.

Figure 3.5-1
Block Diagram for Test 3

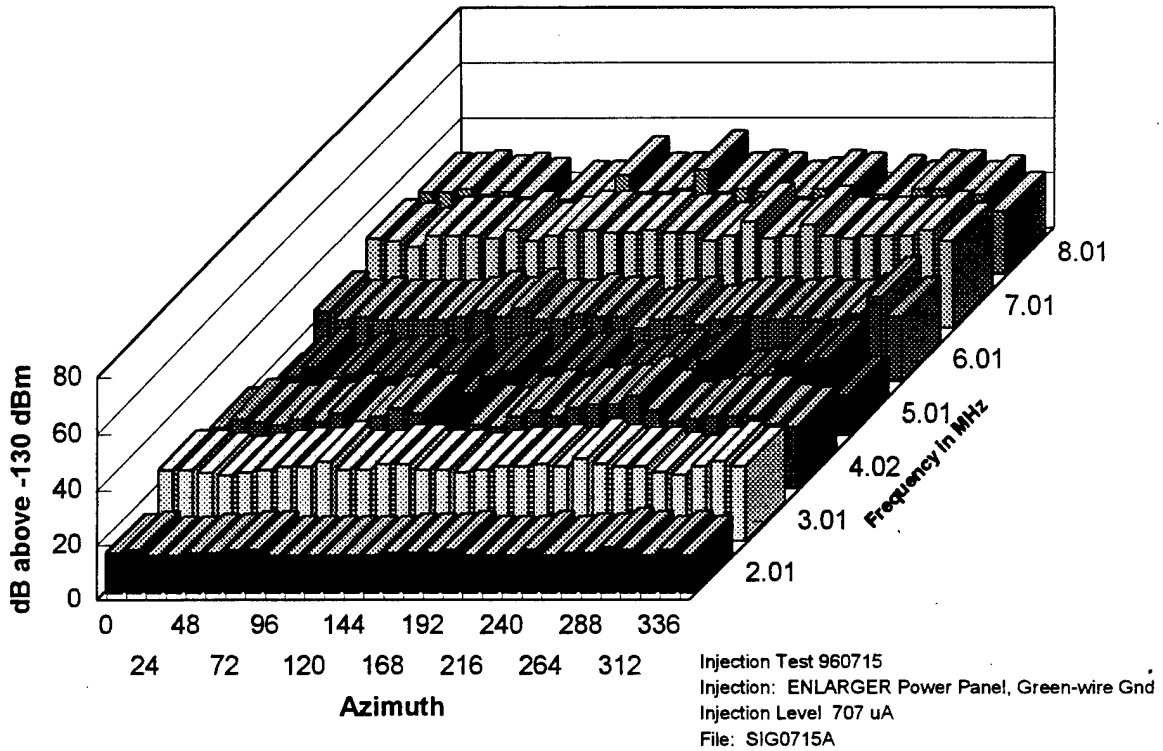
Figure 3.7-2 shows the EMI leakage from the green-wire ground conductor into the RFD for the low band.

Figure 3.7-2
Low-Band EMI Leakage, Test 5

The maximum low-band leakage was 38-dB above the noise floor. The leakage was fairly uniform from beam to beam on many of the test frequencies. A few significant variations in leakage were found at some test frequencies, indicating the presence of a few resonance conditions. The data suggests the maximum tolerable EMI current in the green-wire power conductor is about 8.9 μ A for the low-band beams.

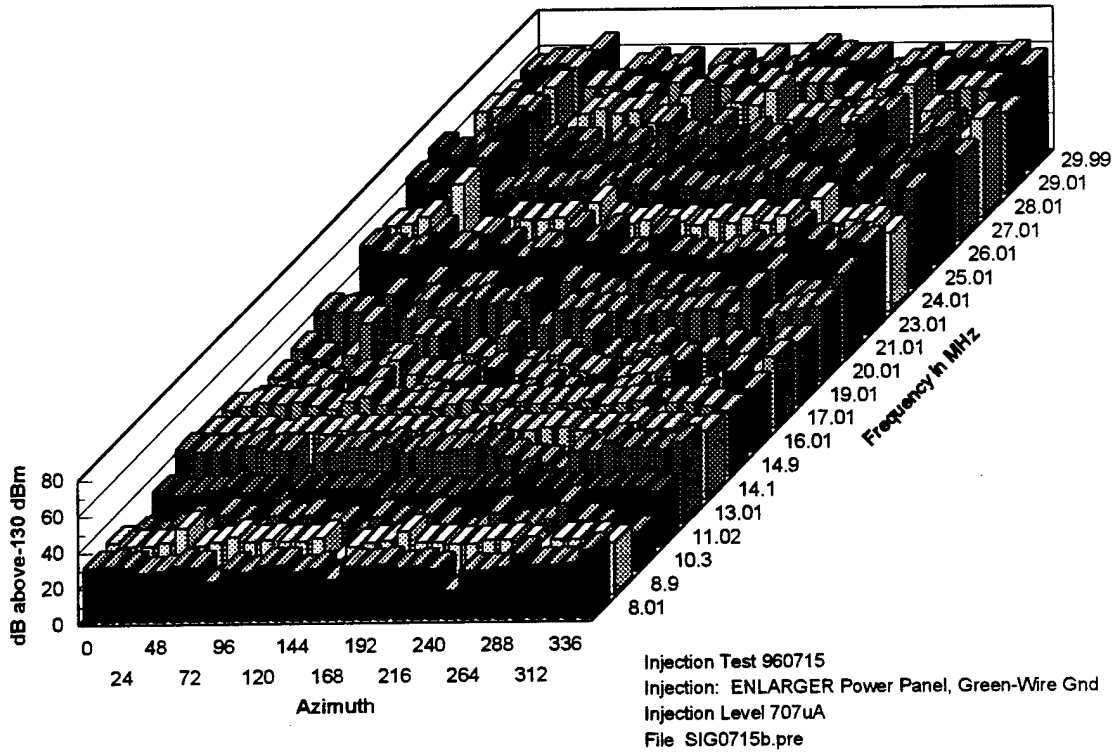
The companion high-band data for Test 5 is shown in Figure 3.7-3.

Figure 3.7-3
High-Band EMI Leakage, Test 5

The maximum high-band leakage from the green-wire conductor in the power panel varied from about 20-dB to as high as 60-dB above the RFD noise floor. This suggests that the maximum tolerable EMI current for the high band is about 0.7 μ A. It is curious that the leakage from the green wire into the RFD is greater for the high band than for the low band. This is the opposite of the prior example. However, this finding is consistent with prior observations of high levels of the ENLARGER Beam-Path Verification signal (near 32 MHz) on conductors in its power panel. These two results suggest that some aspect of the high-band signal paths of the RFD lack electromagnetic isolation from the power conductors. These findings also suggest that the EMI leakage mechanism between the RFD and the power conductors is different from those associated with coaxial cable shields and grounds. It further demonstrates the need for the complete shielding and isolation of all RF paths.
