Contract Report CHL-97-1  
March 1997

# Interaction of Seawalls and Beaches: Eight Years of Field Monitoring, Monterey Bay, California

*By Gary B. Griggs, James F. Tait, Laura J. Moore, Katie Scott,  
Wendy Corona, Deborah Pembrook,  
University of California, Santa Cruz*

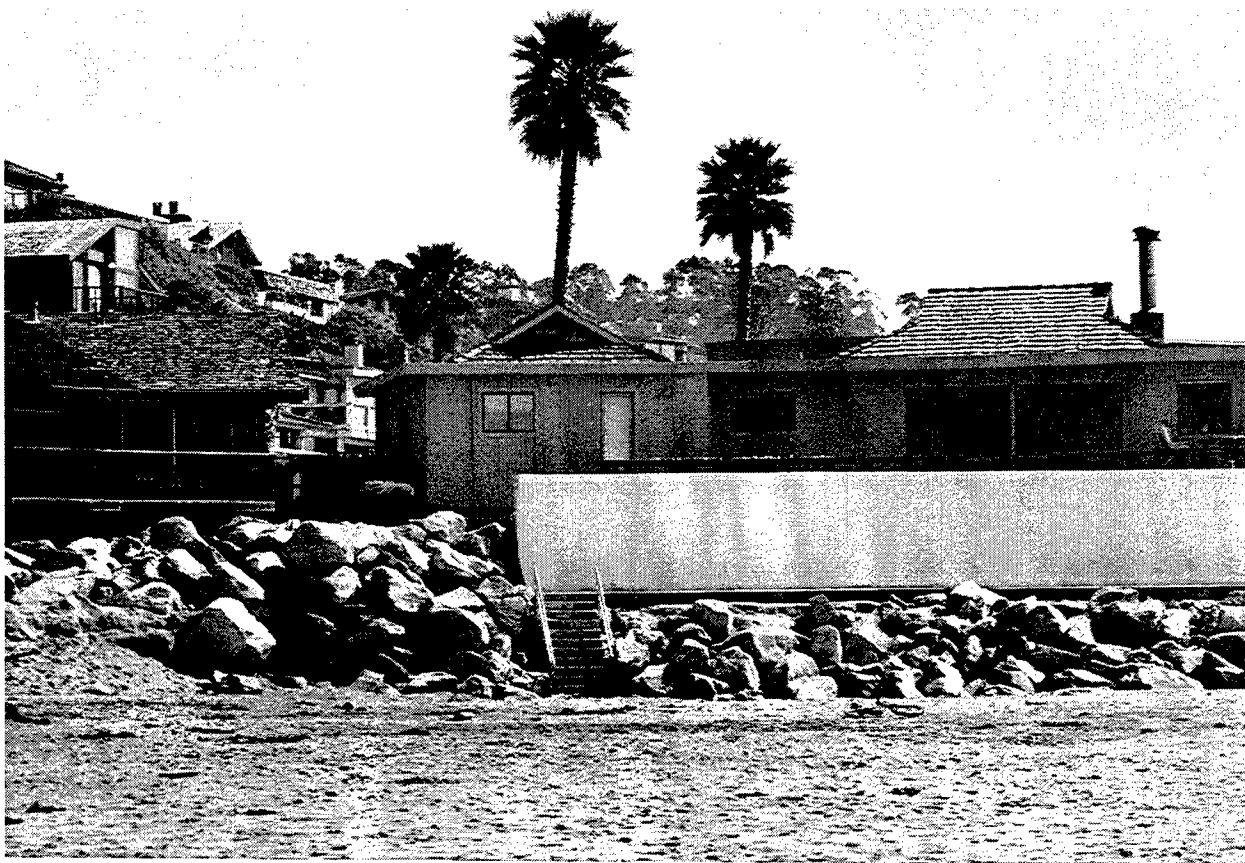
Figure 13. Stairs at north end of Aptos Seascape seawall after the storms of January 1995

**Profiles.** At the Aptos Seascape seawall study site, the primary beach responses to the storms of 1995 were a rapid change in profile shape, a significant decrease in beach elevation due to frontal scour, and erosion of approximately 115 m<sup>3</sup> of sand for every alongshore meter of beach. Several indicators of substantial beach elevation change were apparent to observers familiar with the study site. For example, the stairs on the northern flank of the seawall, usually buried in the beach, were completely exposed as the beach eroded (Figure 13). In addition, the access stairs fronting the seawall, which usually extend below sand level, were left dangling meters above the newly scoured beach (Figure 14).

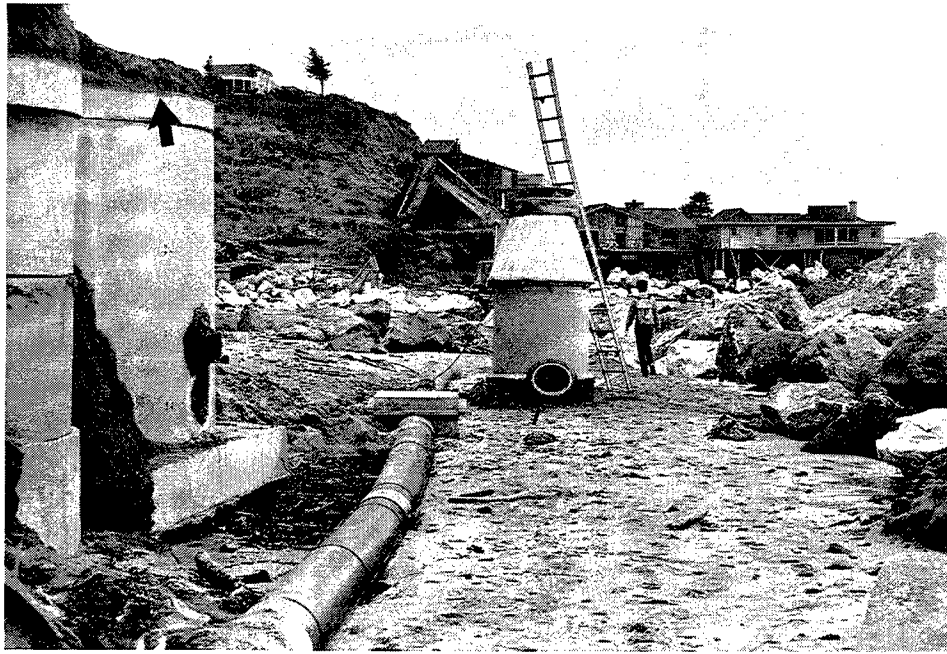
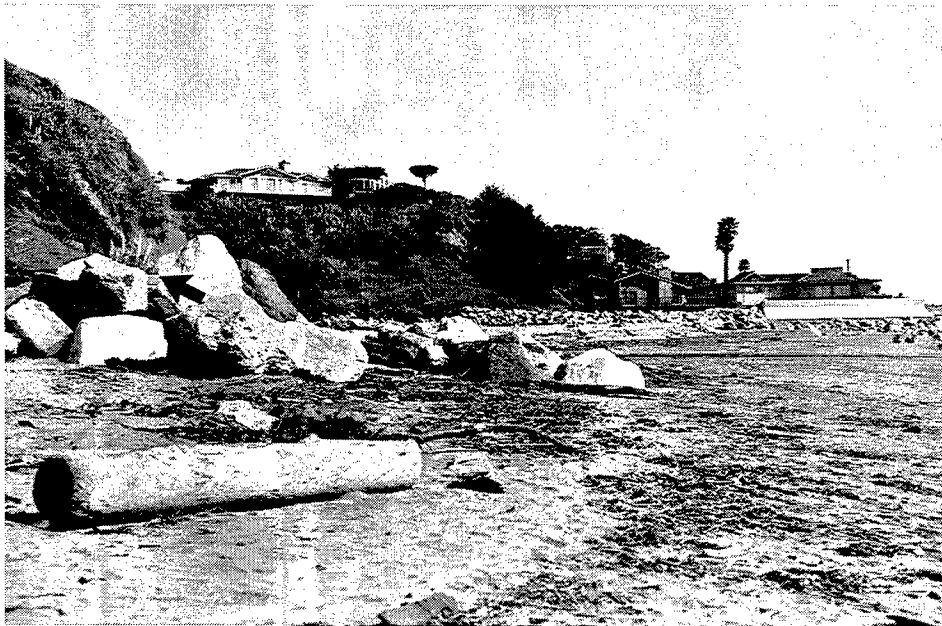
Figure 15. Comparisons of beach scour at north end of Aptos Seascapes seawall. Photo scales differ; the seawall was under construction in 1983 and the sewage manholes (tops indicated by arrows) have been protected by riprap. Despite these differences, photos demonstrate that relative to the top of the manholes, the beach was significantly lower in elevation after the 1983 storms as opposed to the 1995 storms

These extreme changes in beach level were reminiscent of the changes associated with the 1983 winter storms. However, despite obvious erosion, photographic comparison of the north control beach after the 1983 and 1995 events reveals that sand loss in 1995 (Figure 15b) was significantly less than it was in 1983 (Figure 15a).
