Management and Maintenance Manual
The Old Hospital Complex
Fort Carson, Colorado
(5EP1778)

James Schneck

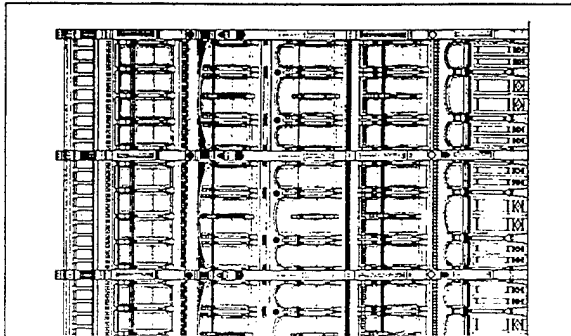
Finally, this illustrated version of the Guidelines for Rehabilitating Historic Buildings has been designed to enhance overall understanding of basic preservation principles. Showing specific examples of appropriate treatments as well as the consequences of inappropriate treatments is just another aspect of a sustained effort to encourage the most respectful approaches possible in rehabilitating our nation's irreplaceable historic properties.

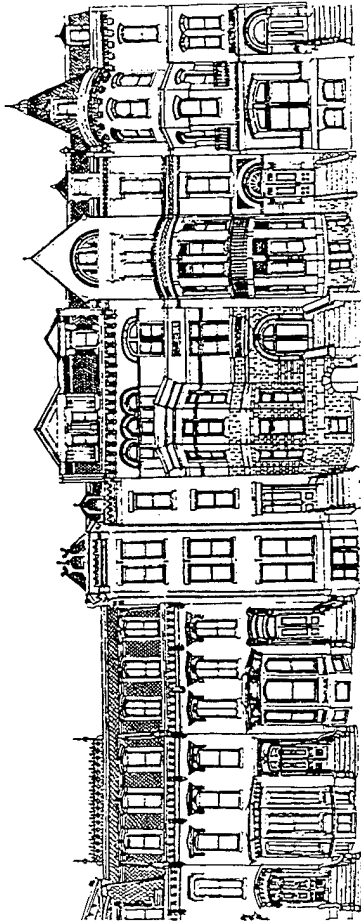
drawing: Nicholas Satterlee

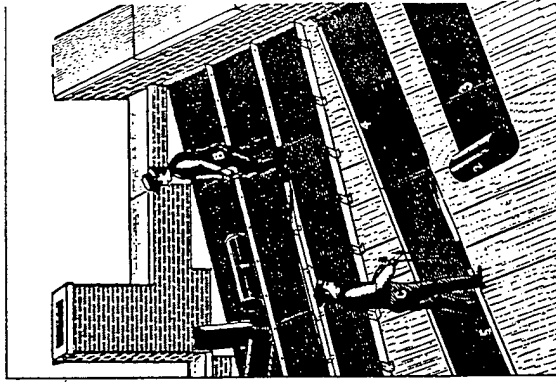
ments such as rust removal, caulking, limited paint removal, and re-application of protective coating; the cyclical cleaning of roof gutter systems; or installation of fencing, protective plywood, alarm systems and other temporary protective measures. Although a historic building will usually require more extensive work, an overall evaluation of its physical condition should always begin at this level.

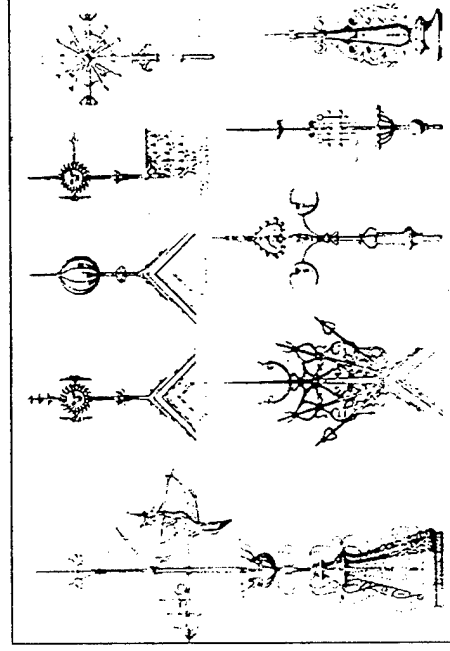
character-defining feature with new material because the level of deterioration or damage of materials precludes repair (for example, an exterior cornice; an interior staircase; or a complete porch or storefront). If the essential form and detailing are still evident so that the physical evidence can be used to re-establish the feature as an integral part of the rehabilitation project, then its replacement is appropriate. Like the guidance for repair, the preferred option is always replacement of the entire feature in kind, that is, with the

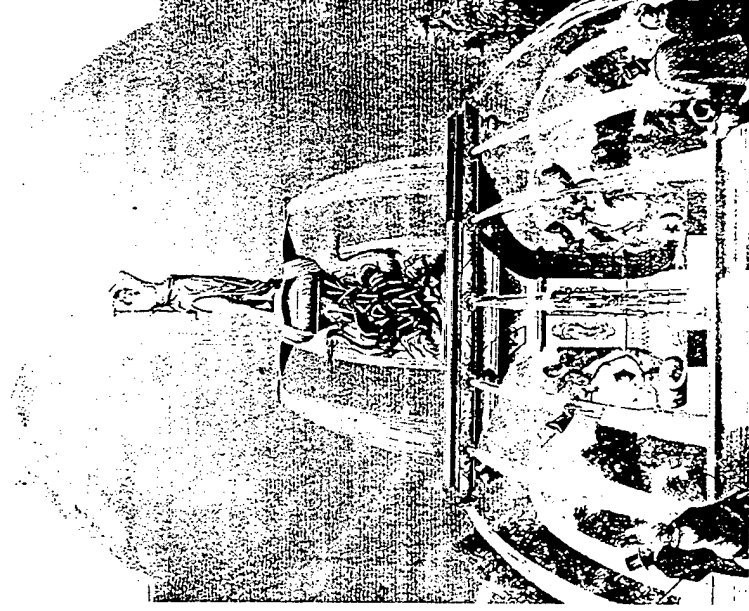
new design that is compatible with the remaining character-defining features of the historic building. The new design should always take into account the size, scale, and material of the historic building itself and, most importantly, should be clearly differentiated so that a false historical appearance is not created.

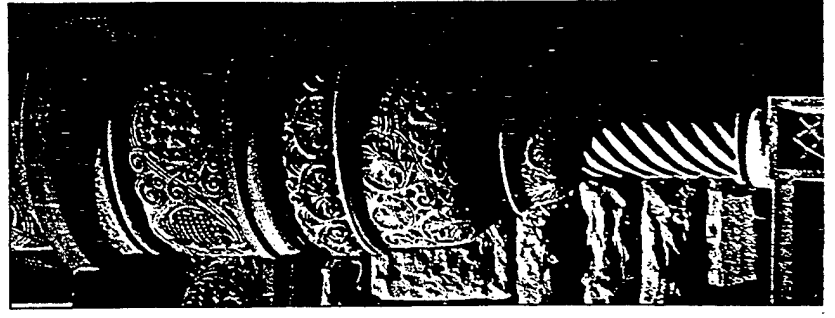
While masonry is among the most durable of historic building materials, it is also very susceptible to damage by improper maintenance or repair techniques and harsh or abrasive cleaning methods.

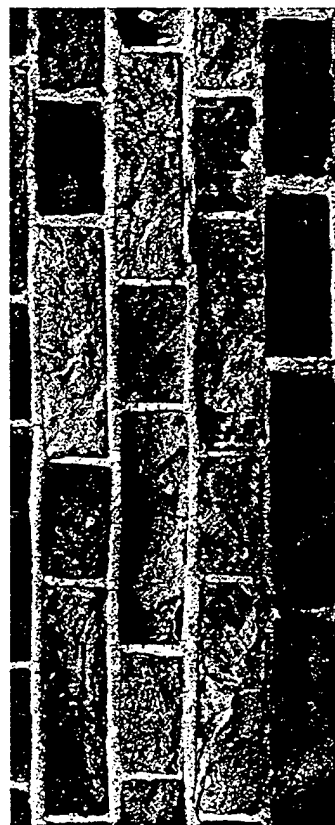
Photo: Jack E. Boucher, HABS

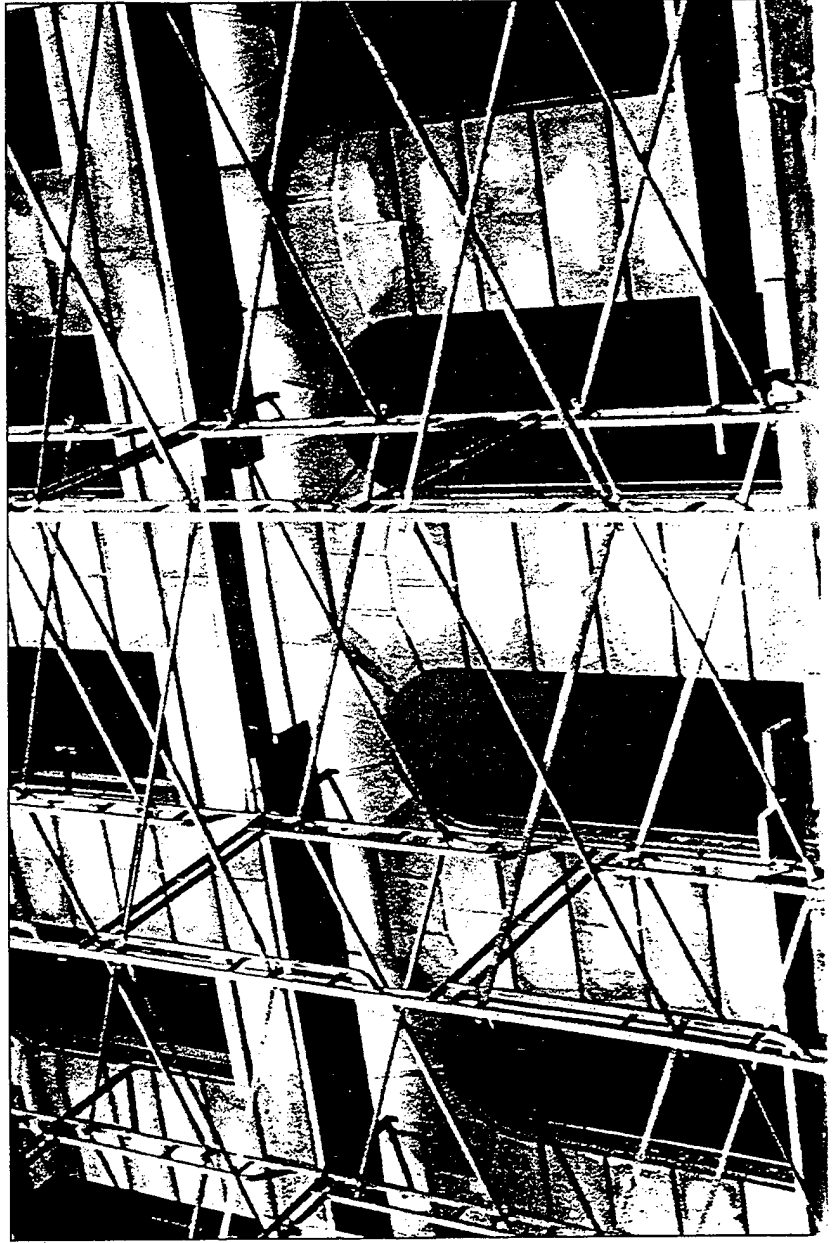
Composite patching with a cementitious mixture is being used to repair eroded areas of this sandstone facade.

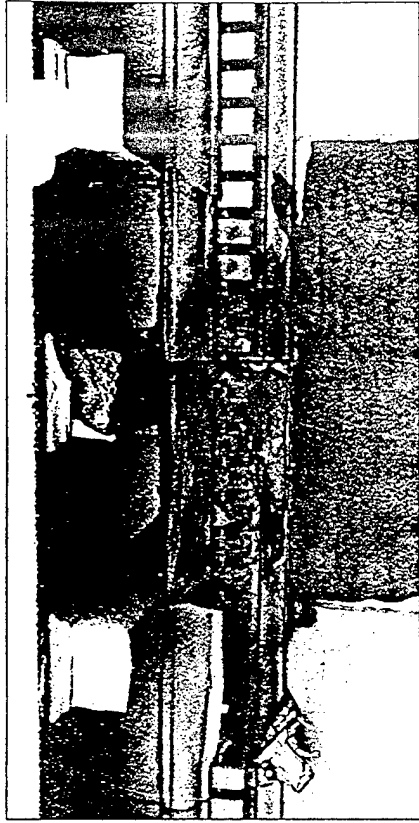
Moisture from a faulty roof and drainage system has been trapped inside this limestone cornice by a waterproof coating, causing severe damage to the stone.

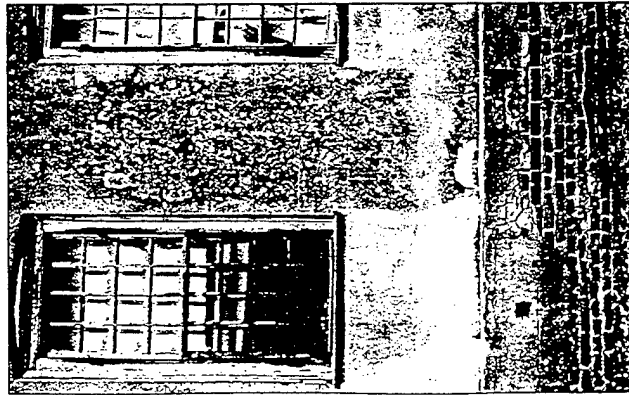
Photo: Jack E. Boucher, HABS

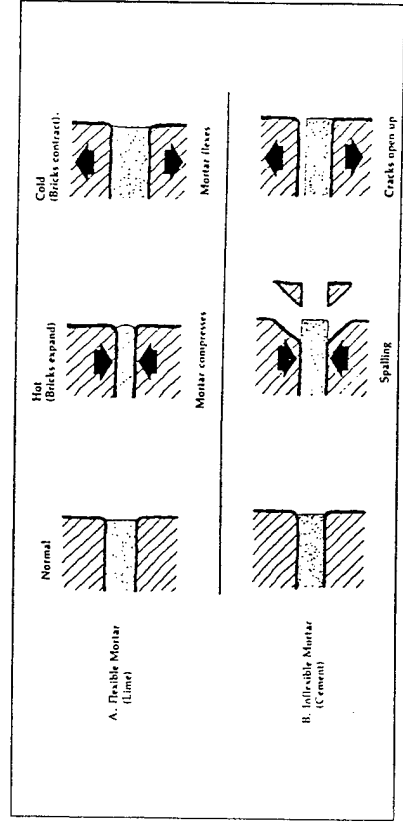
Flexible mortar expands and contracts with temperature changes. Bricks bonded by inflexible mortar tend to spall at the edges in hot weather and separate from the mortar when it is cold. Temperature fluctuations result in cracks which permit water to enter, causing additional deterioration.

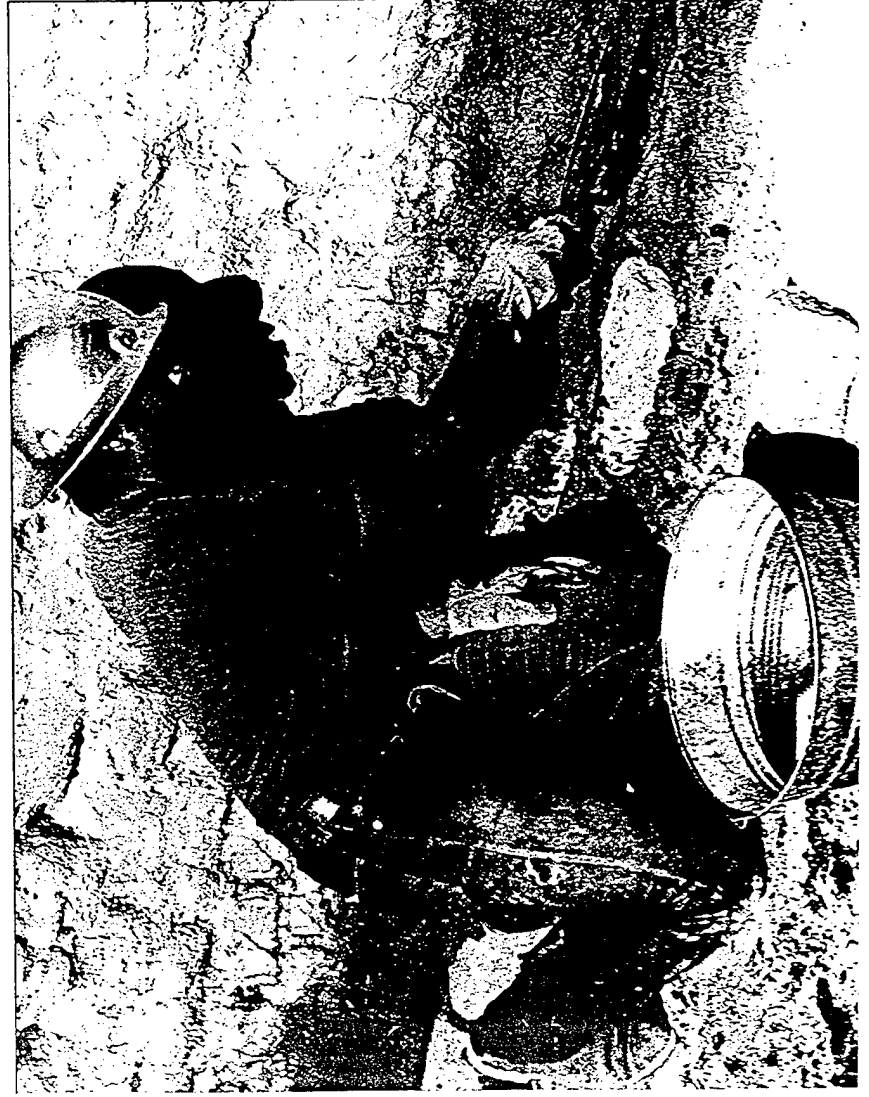
Coving—the hollowing out of an adobe wall just above grade—may be caused by standing rainwater, rainwater splash-up from the ground, or by salts deposited in the adobe by moisture evaporation. This adobe wall is being patched in the traditional manner with adobe mud.

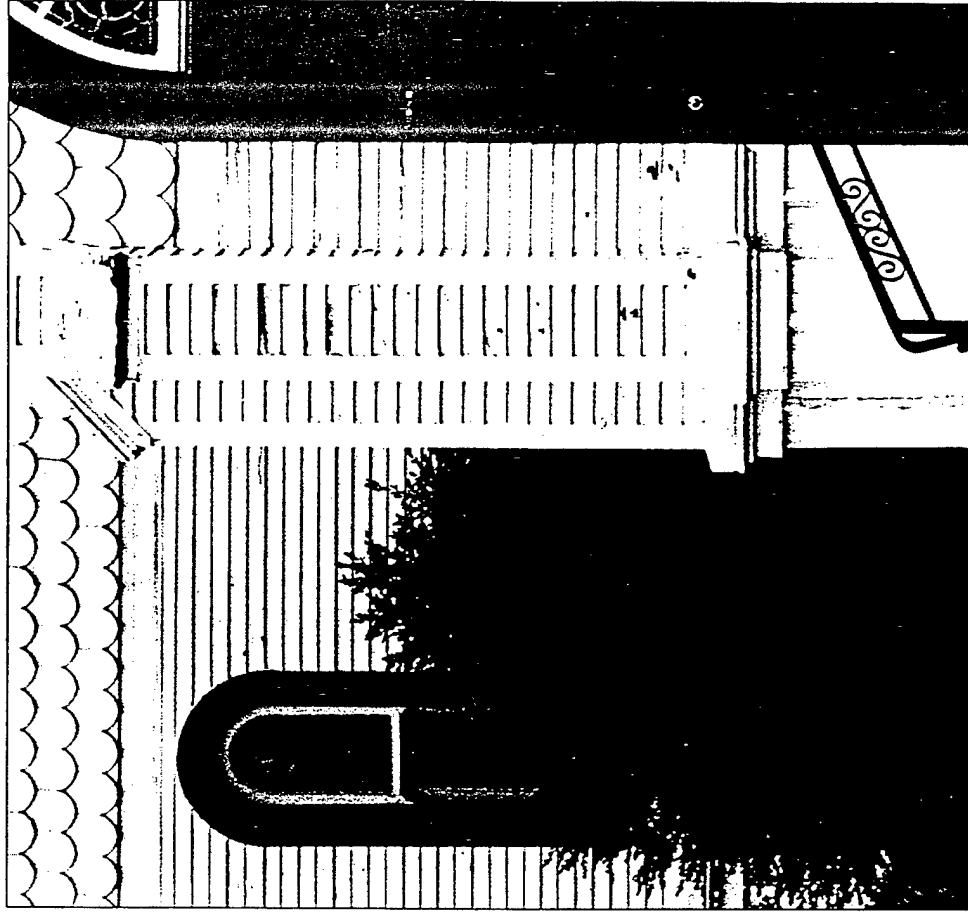
Wood has played a central role in American buildings during every period and in every style. Whether as structural membering, exterior cladding, roofing, interior finishes, or decorative features, wood is frequently an essential component of historic and older buildings.

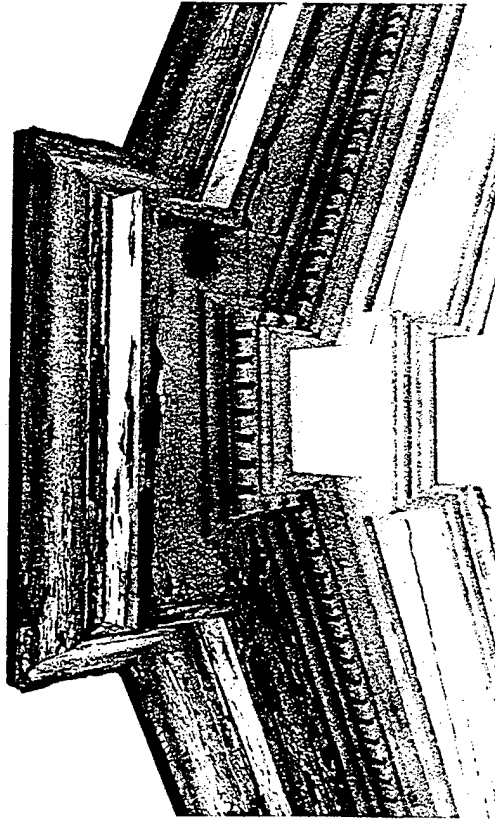
Protect and maintain

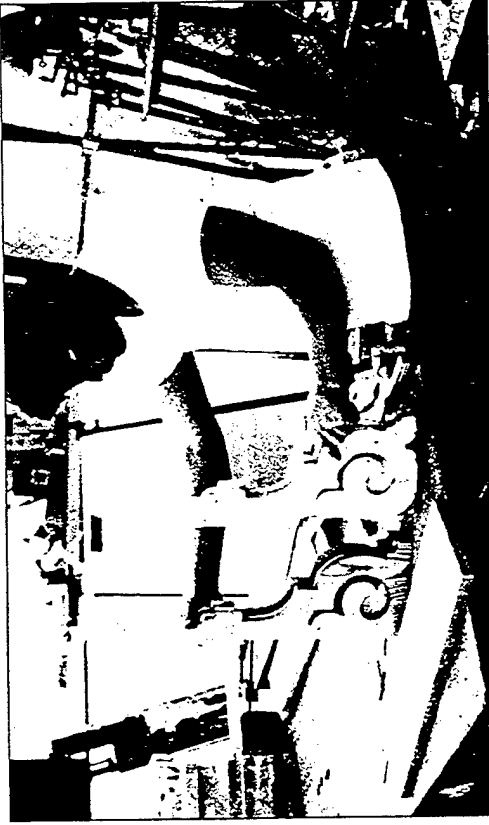
If a character-defining feature is missing, it should be replaced with a matching feature. This shop artisan used traditional tools to replicate a missing porch bracket; after the new bracket is painted, both original and duplicate will be installed on-site.

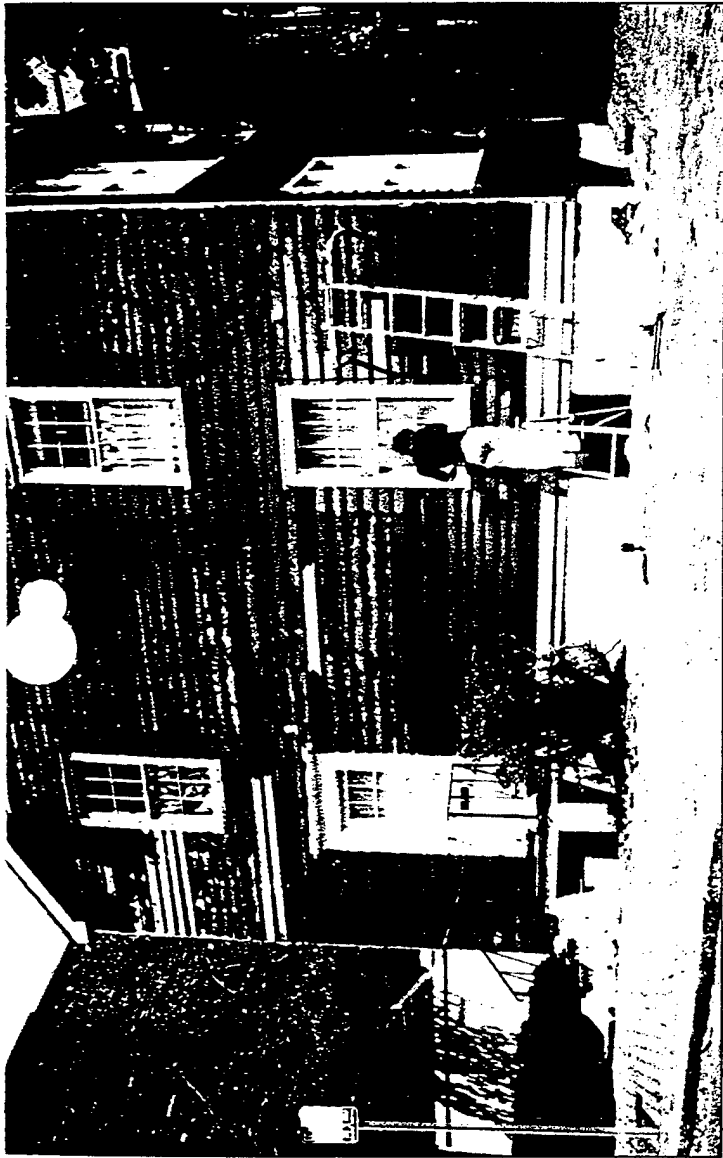
Deteriorated clapboards are being selectively replaced, thereby maximizing retention of the historic siding.

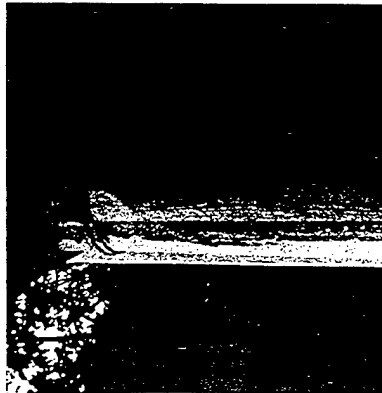
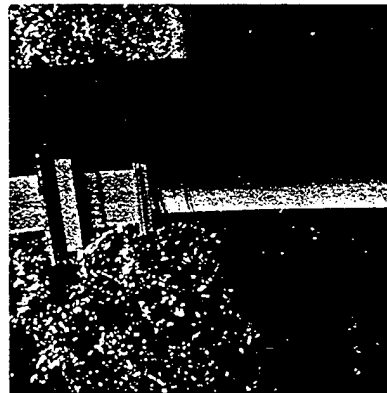
To replace deteriorated portions of the column, strips of new wood were milled to conform to the shape and appearance of the old column framework, glued in place, then back-primed and painted.

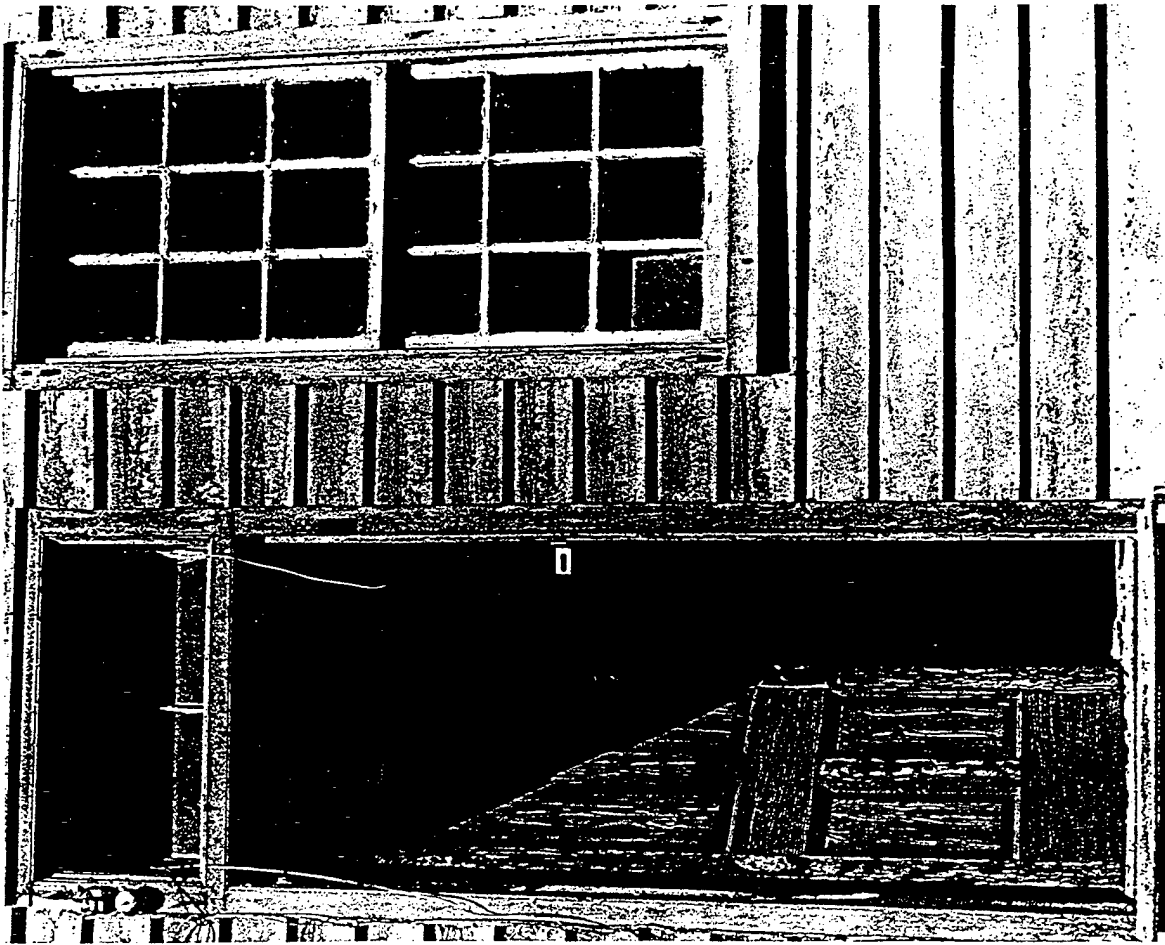
Design for Missing Historic Features

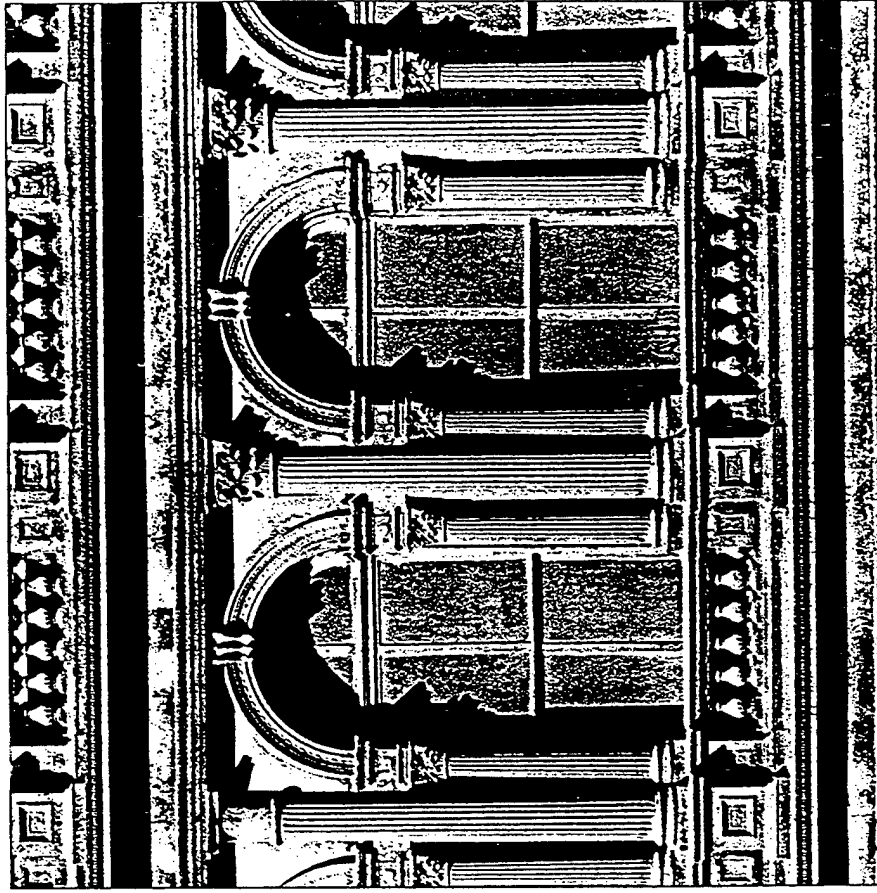
Metals commonly used in historic buildings include lead, tin, zinc, copper, bronze, brass, iron, steel, and to a lesser extent, nickel alloys, stainless steel and aluminum. Historic metal building components were often created by highly skilled, local artisans, and by the late 19th century, many of these components were prefabricated and readily available from catalogs in standardized sizes and designs.

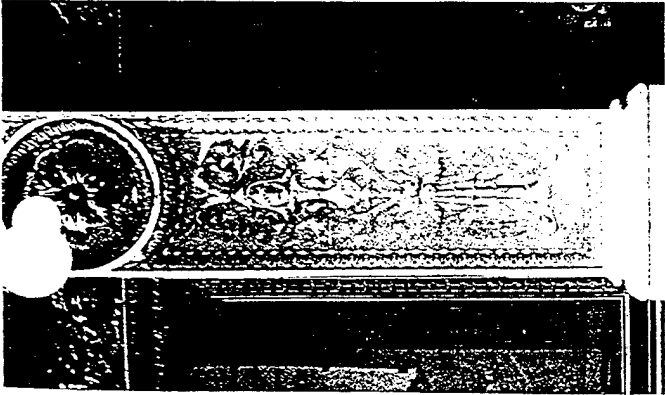
The decorative cast-iron storefront column was sandblasted in order to remove flaking paint and rust prior to repainting. Unlike soft metals such as copper and tin, which are damaged by abrasive cleaning, sandblasting is an appropriate method for cleaning cast iron, a very hard metal.

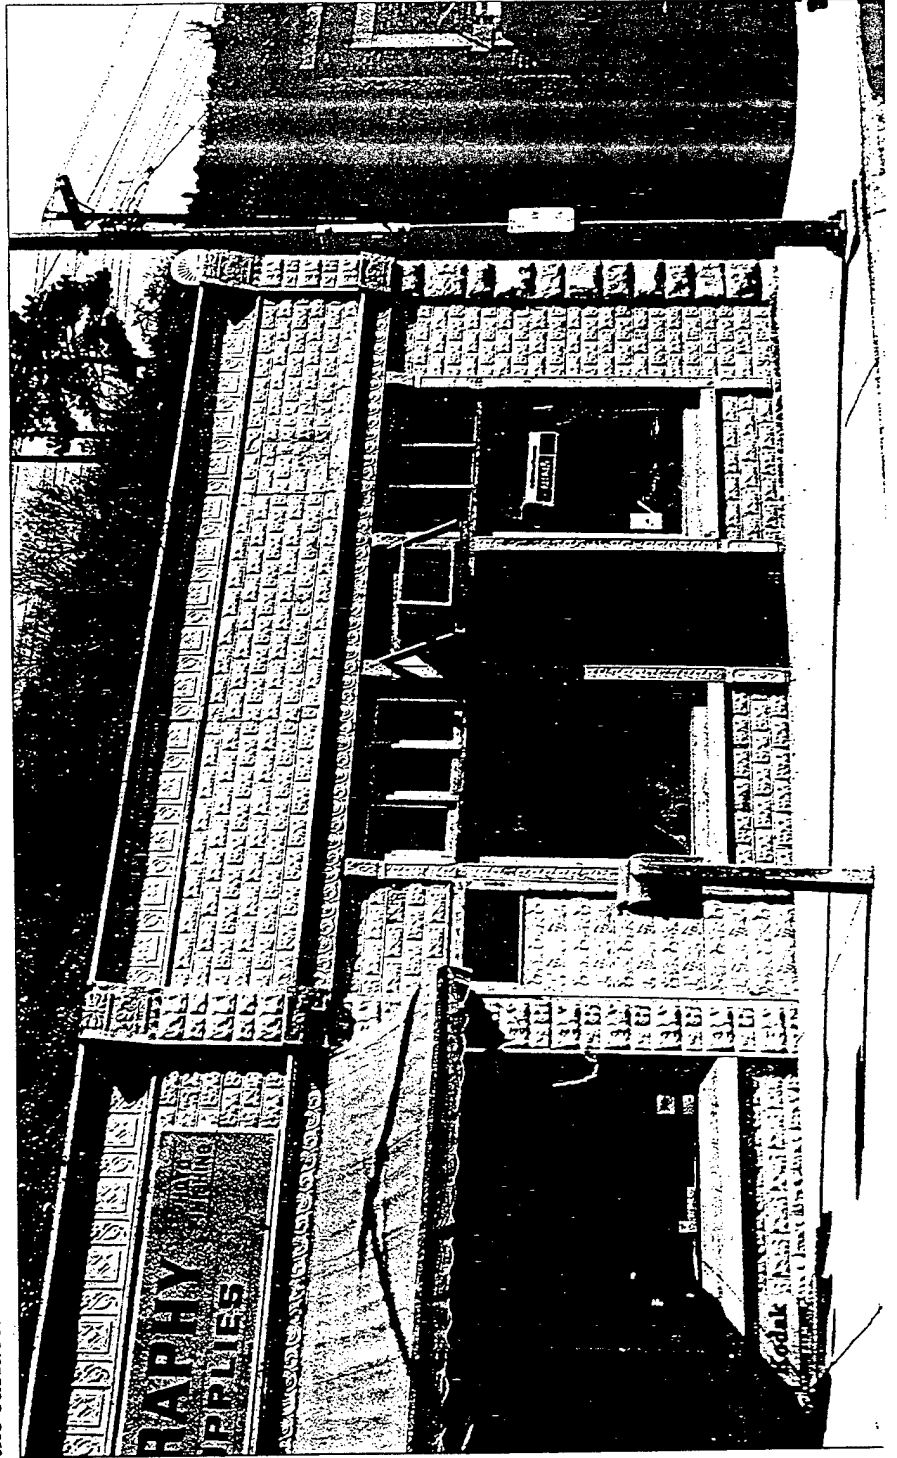
Although these pressed metal storefronts have been well maintained over the years, gaps in the seams between the metal sheets above the door and slight stains along the cornice line indicate a possible roof leak. The roof should be investigated and repaired before the moisture results in rust and more severe metal deterioration.

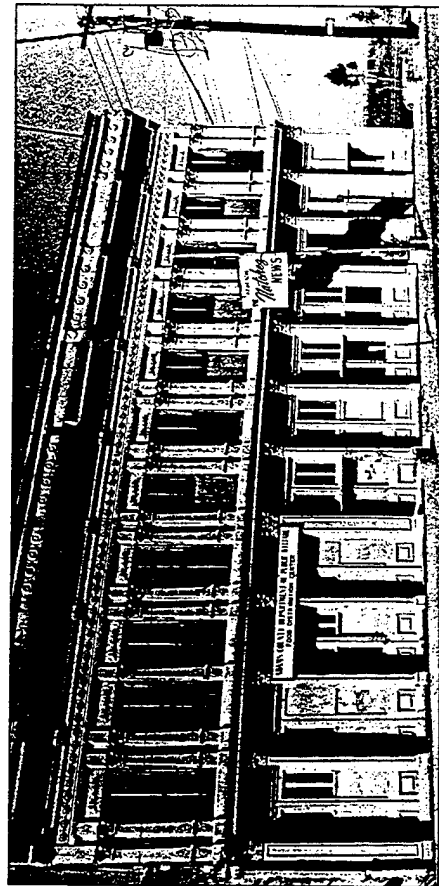
Deteriorated portions of the decorative pressed metal cornice have been inappropriately replaced with non-matching, plain metal sheets, adversely affecting the historic character of this building.

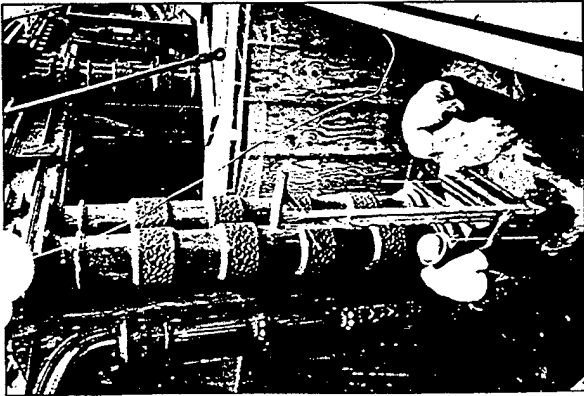
The cast-iron columns of this theater are being repaired during rehabilitation. Some of the cast iron elements such as the smaller, non-structural columns missing from the bay on the right will be replaced with a lightweight substitute material such as cast aluminum, an acceptable alternative according to the Standards.

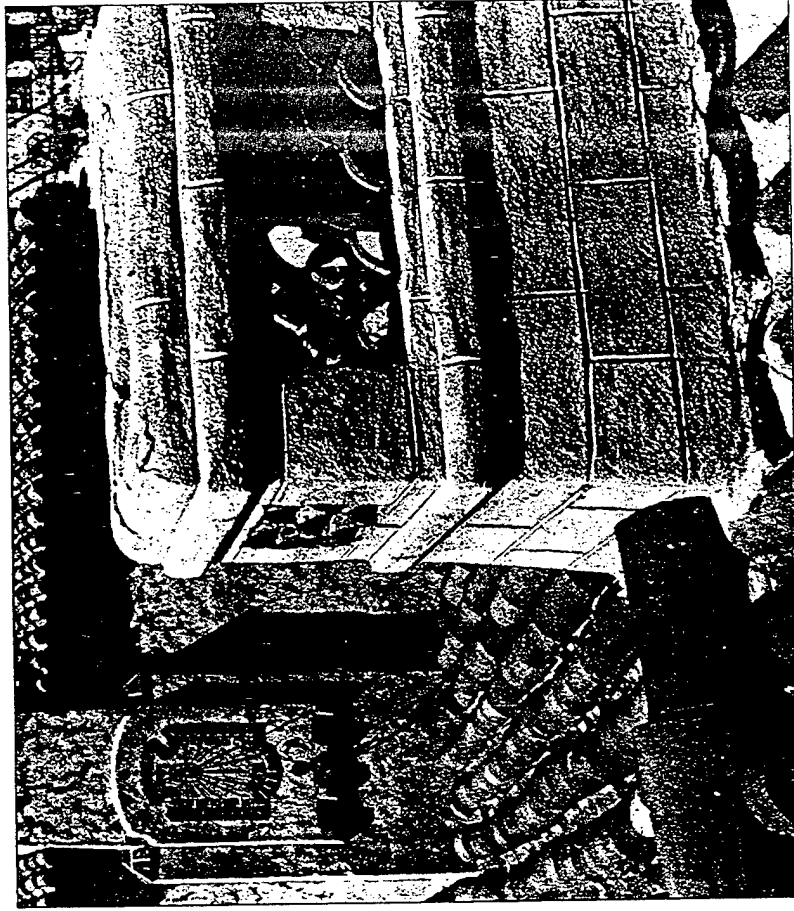
of slate for roofing dates from the mid-17th century. Slate has remained popular for its durability, fireproof qualities, and decorative applications. The use of metals for roofing and roof features dates from the 18th century, and includes the use of sheet iron, corrugated iron, galvanized metal, tinplate, copper, lead and zinc. Awareness of these and other traditions of roofing materials and their detailing will contribute to more sensitive treatment.

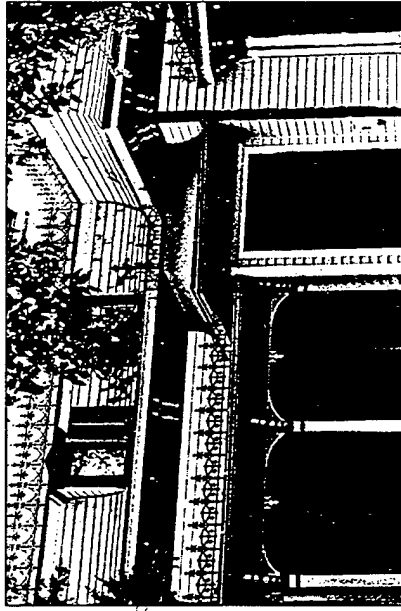
This well-maintained mansard roof displays its handsome and varied decorative detailing—cast-iron cresting, wood shingles, and pedimented dormers.

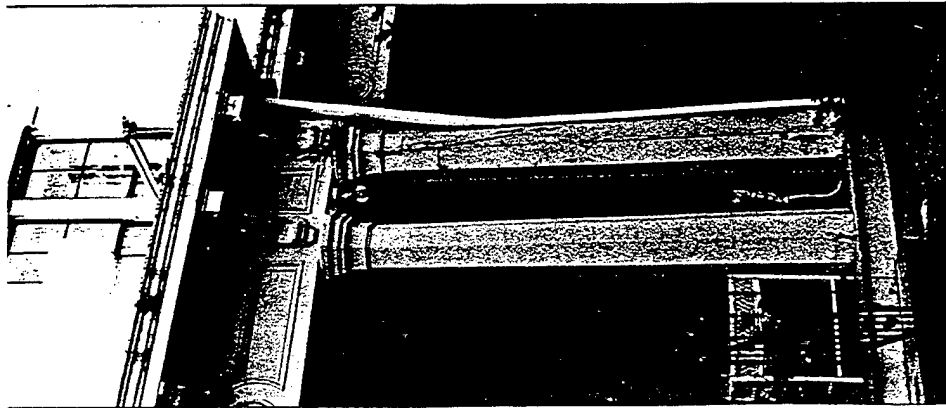
The roof drainage system has been neglected for such a long time that, as a result, the wood cornice and a porch column are both severely deteriorated.

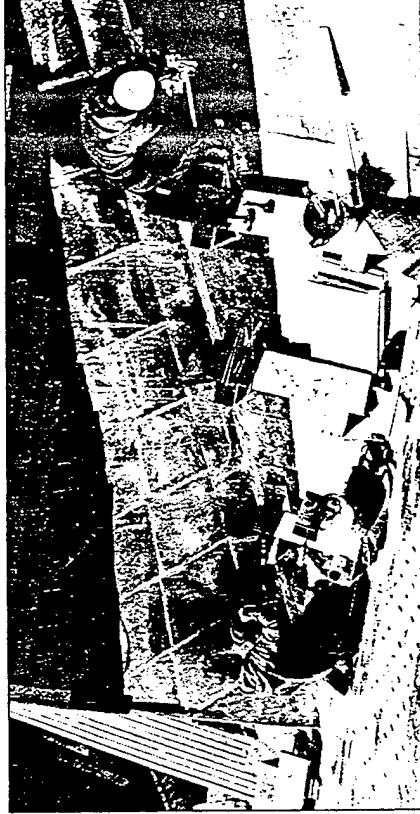
New copper valley flashing is installed as part of overall repairs to the historic slate roof and its drainage system.

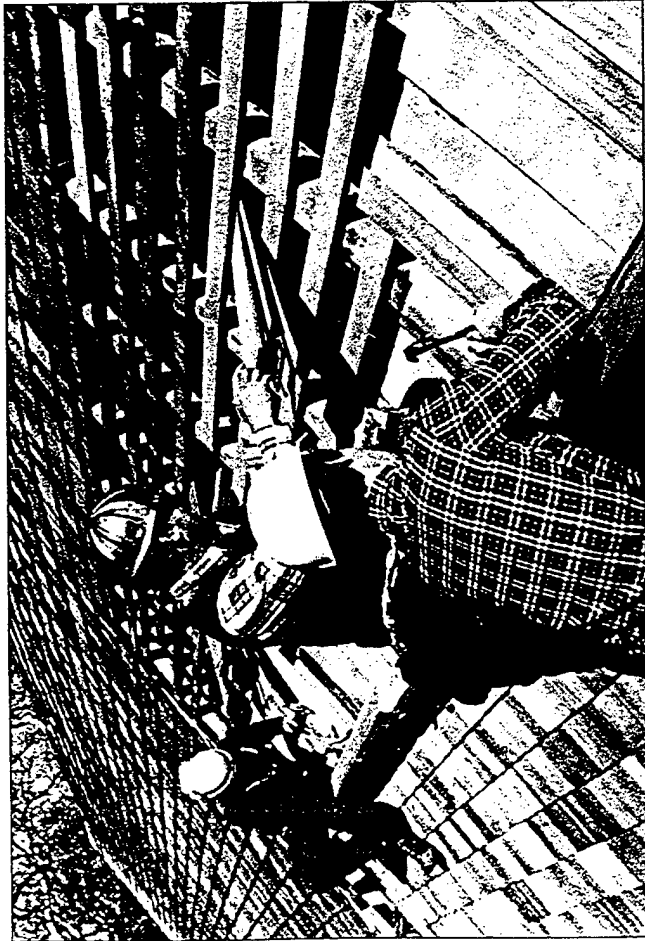
The size, shape, and detailing of the historic shingles as well as the method of fabrication and installation were carefully researched prior to selecting this new wood-shingle roofing.

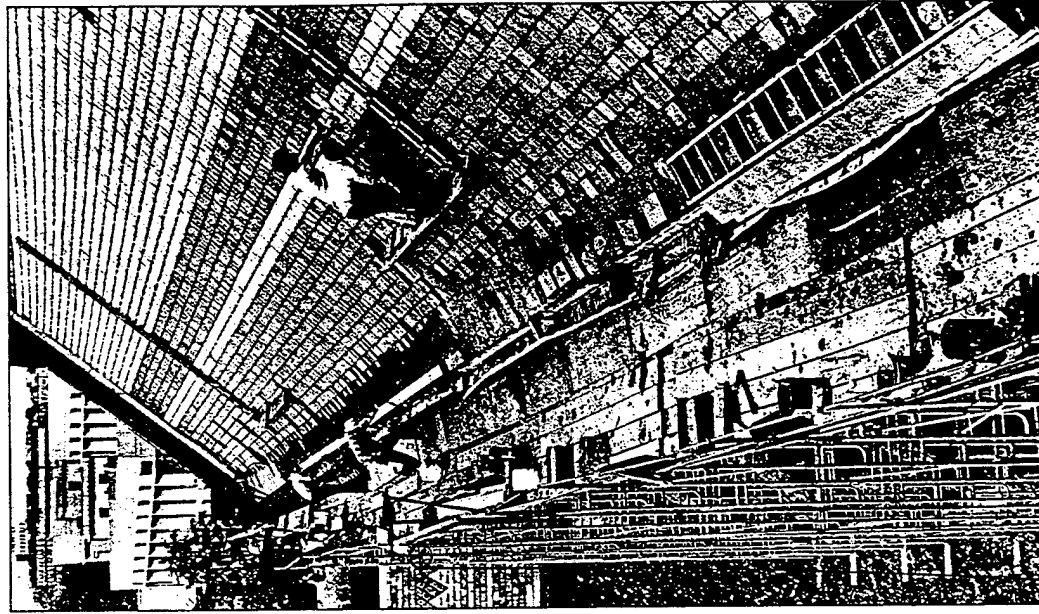
Workmen are in the process of removing deteriorated roofing slates and replacing them with new matching slates.

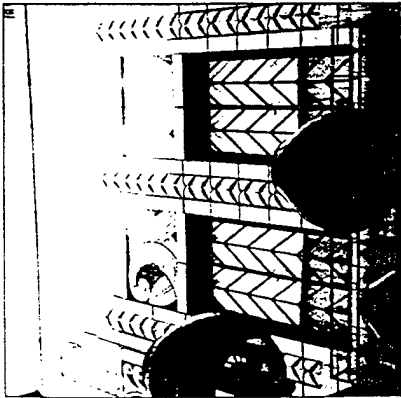
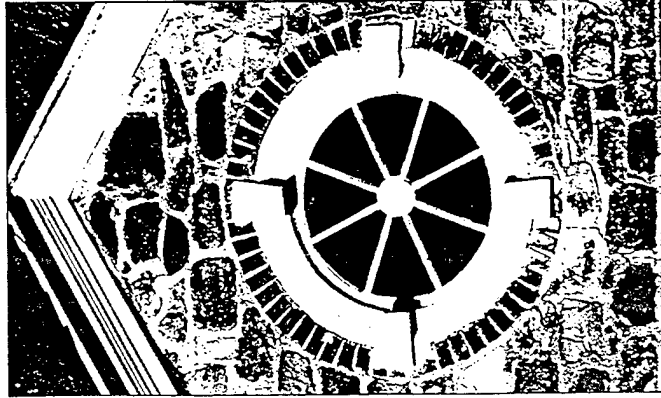
The distinctive shape and decorative detailing of a building's windows often help establish its architectural style and character.

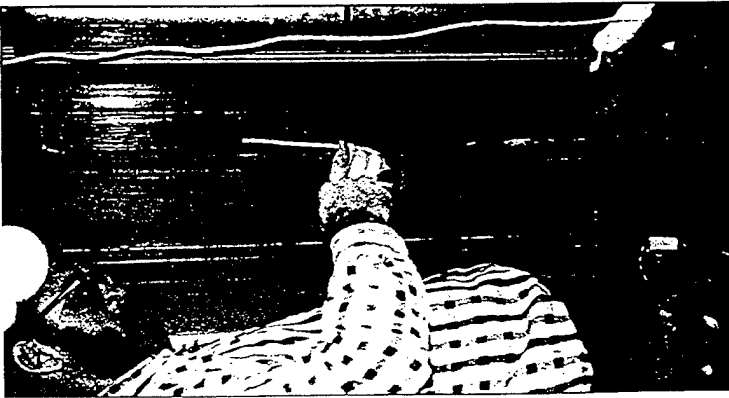
Maintaining a historic window may include work as basic as replacing a sash cord.

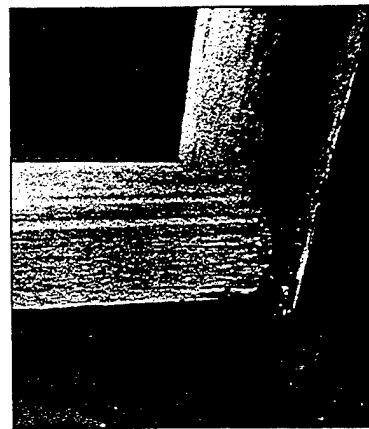
Deterioration of poorly maintained windows usually begins on horizontal surfaces where water collects. Problem areas on this sill are clearly indicated by paint failure due to moisture.

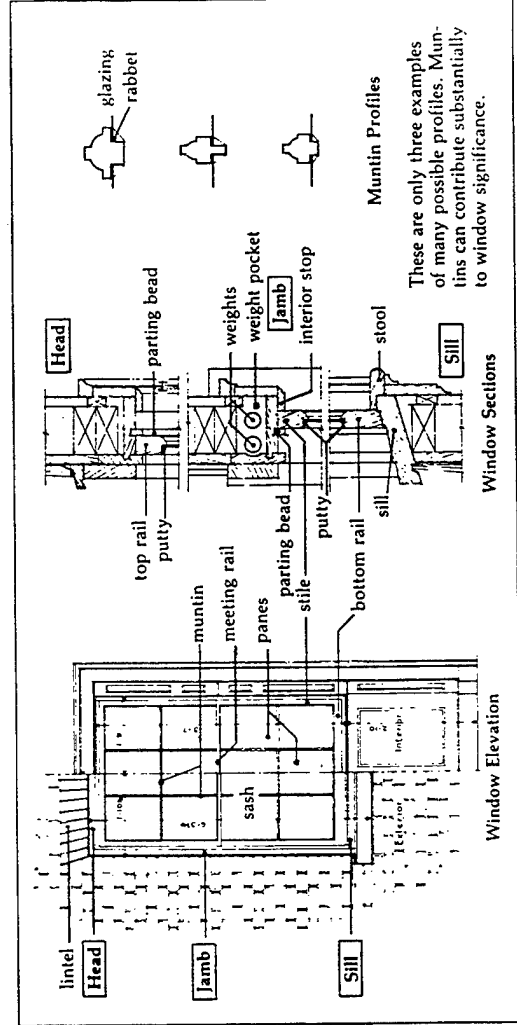
These drawings identify individual parts and fabrication details of a historic wooden double-hung window.

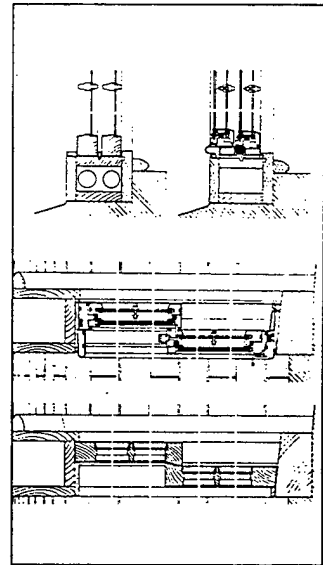
For some larger buildings, it may be appropriate to replace seriously deteriorated windows with new ones that replicate most of the historic visual qualities. This two-part drawing shows the original windows in a mill and the rehabilitation solution that retained the wood frames, then utilized an aluminum sash with true divided lights and a piggyback interior storm panel.

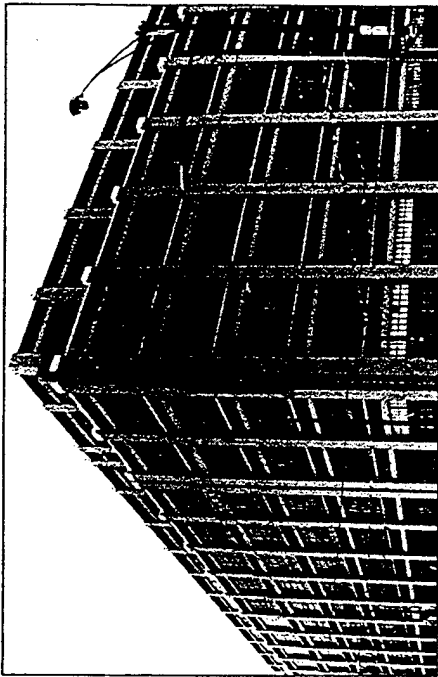
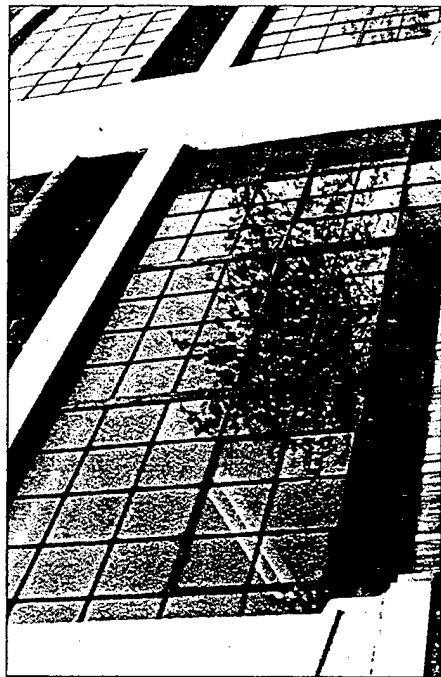
The steel pivot windows in this historic manufacturing building were replaced with new windows which matched the multi-lighted originals.

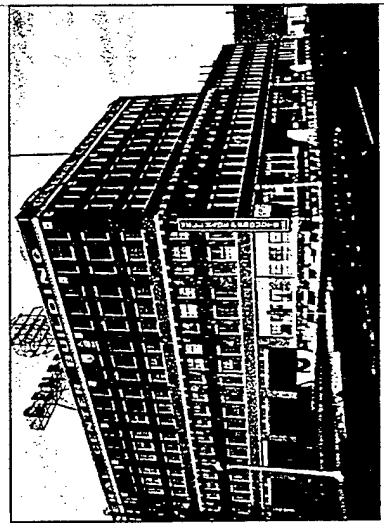
Providing a setback in the design of dropped ceilings when they are required for the new use to allow for the full height of the window openings.

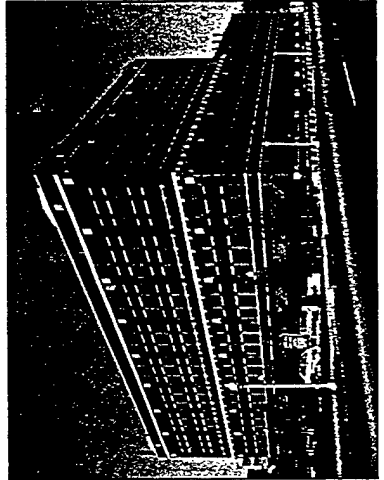
Building
Exterior
*Entrances
and Porches*

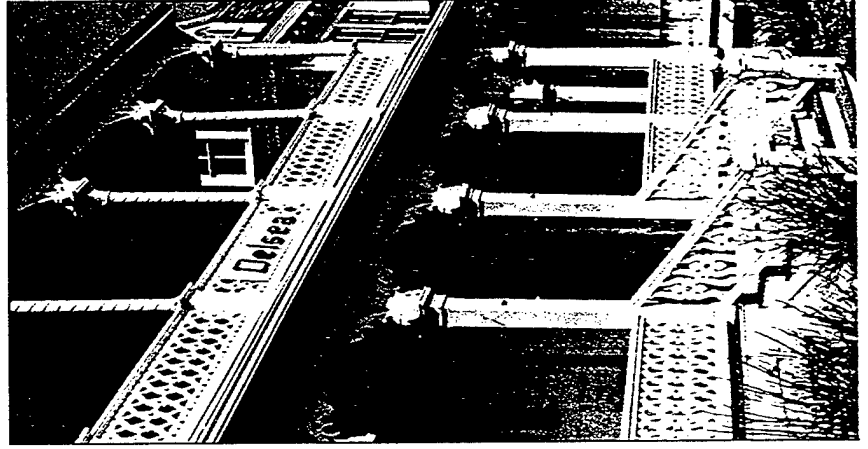
ments. Porches were particularly prominent features of Eastlake and Stick Style houses; porch posts, railings, and balusters were characterized by a massive and robust quality, with members turned on a lathe. Porches of bungalows of the early 20th century were characterized by tapered porch posts, exposed post and beams, and low pitched roofs with wide overhangs. Art Deco commercial buildings were entered through stylized glass and stainless steel doors.

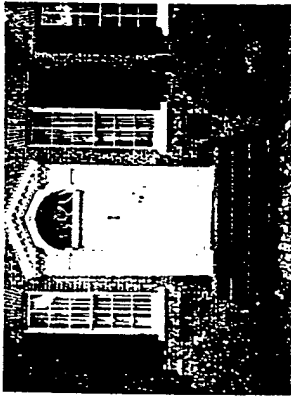
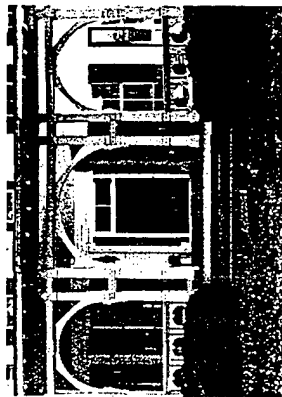
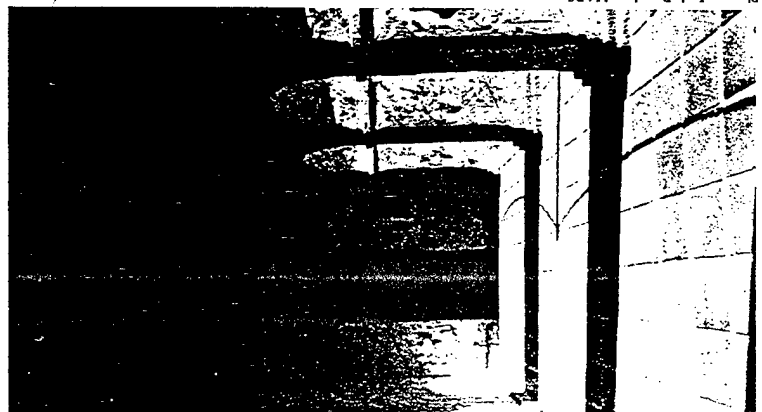
Photos: Jack Boucher, HABS.

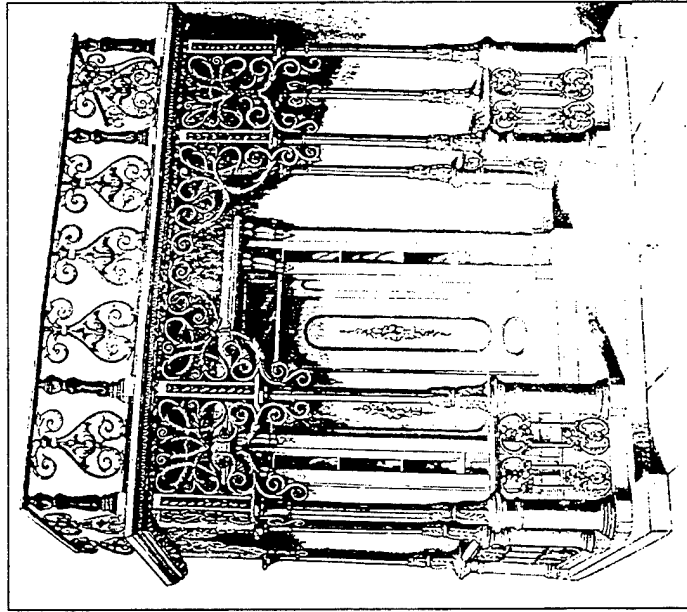
In the 19th century some cast-iron porches could be purchased by mail, such as this made-to-order veranda which was featured in an 1870 foundry catalog.

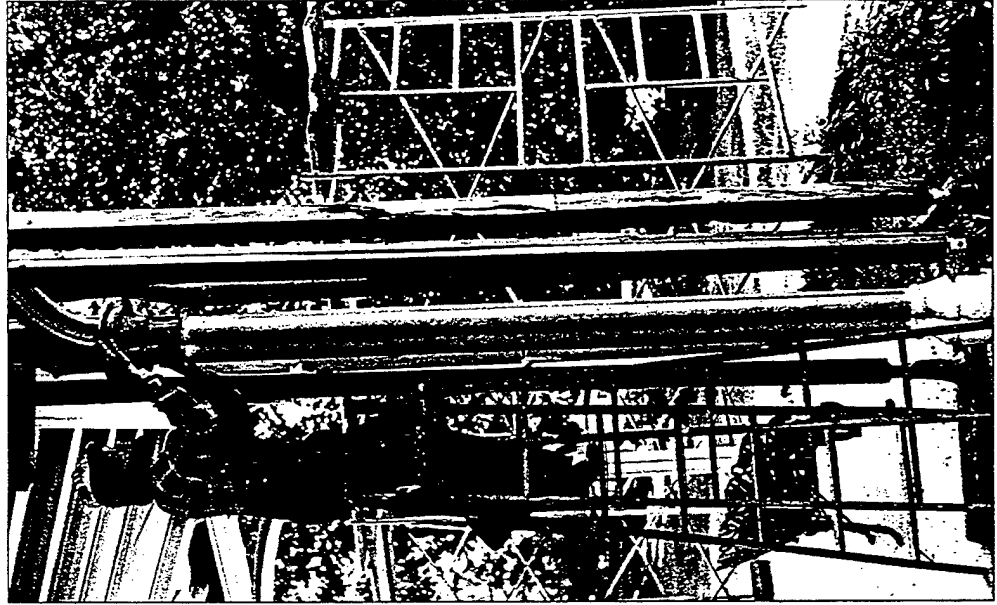
Careful inspection of porch features such as these column capitals is necessary before initiating a rehabilitation project.

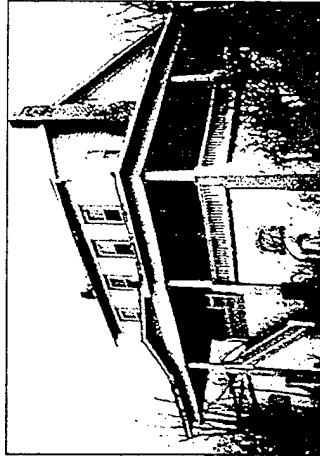
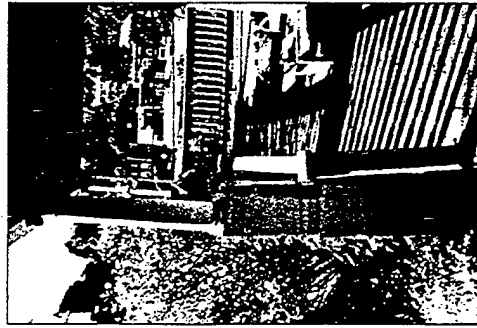
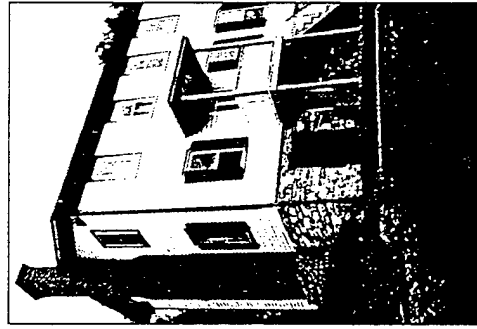
Replacing in kind an entire entrance or porch that is too deteriorated to repair—if the form and detailing are still evident—using the physical evidence as a model to reproduce the feature. If using the same kind of material is not technically or economically feasible, then a compatible substitute material may be considered.

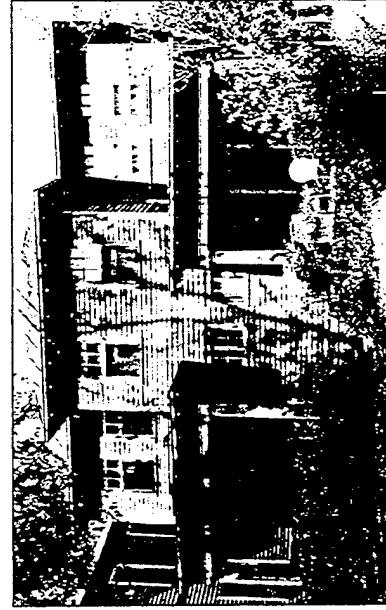
This rehabilitation connected two separate porches, resulting in the creation of a large continuous porch that obscures the historic twin porch design; it is thus incompatible with the historic character of the house.

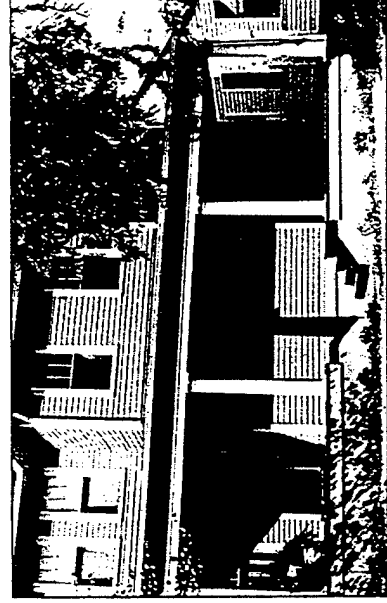
Installing secondary service entrances and porches that are incompatible in size and scale with the historic building or obscure, damage, or destroy character-defining features.
