Management and Maintenance Manual
The Old Hospital Complex
Fort Carson, Colorado
(5EP1778)

James Schneck

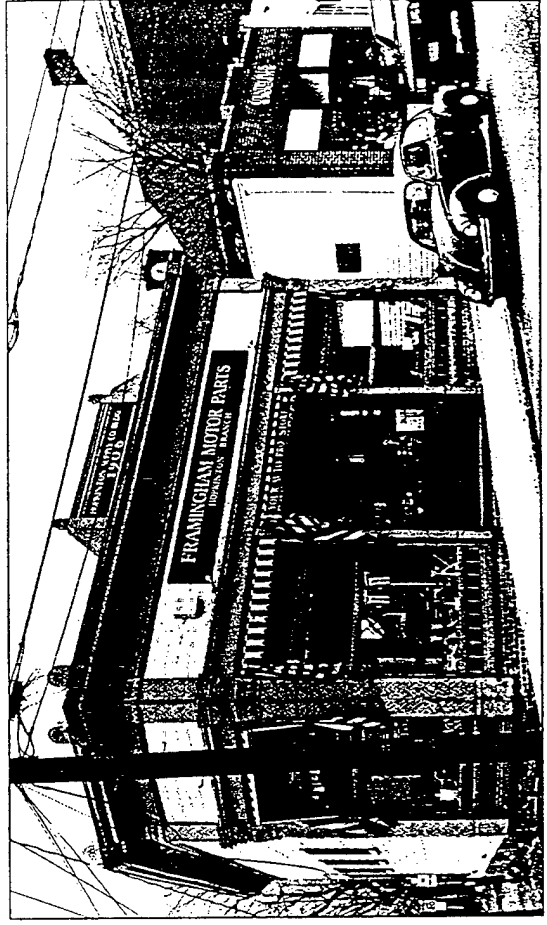
as plate glass became available in increasingly larger units. The use of cast iron columns and lintels at ground floor level permitted structural members to be reduced in size. Recessed entrances provided shelter for sidewalk patrons and further enlarged display areas. In the 1920s and 1930s, aluminum, colored structural glass, stainless steel, glass block, neon, and other new materials were introduced to create Art Deco storefronts.

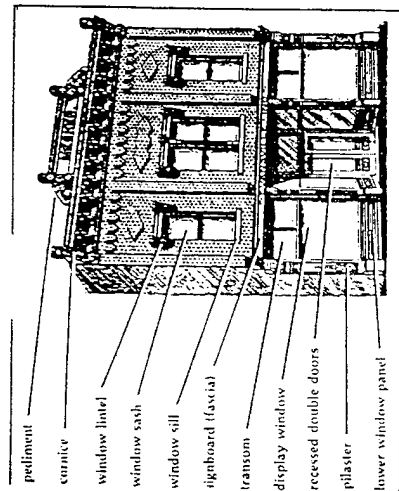
These architectural details are typical of historic commercial buildings (this particular one is No. 4016 in the George L. Mesker and Company catalog of 1905). The design utilized both cast and galvanized iron.

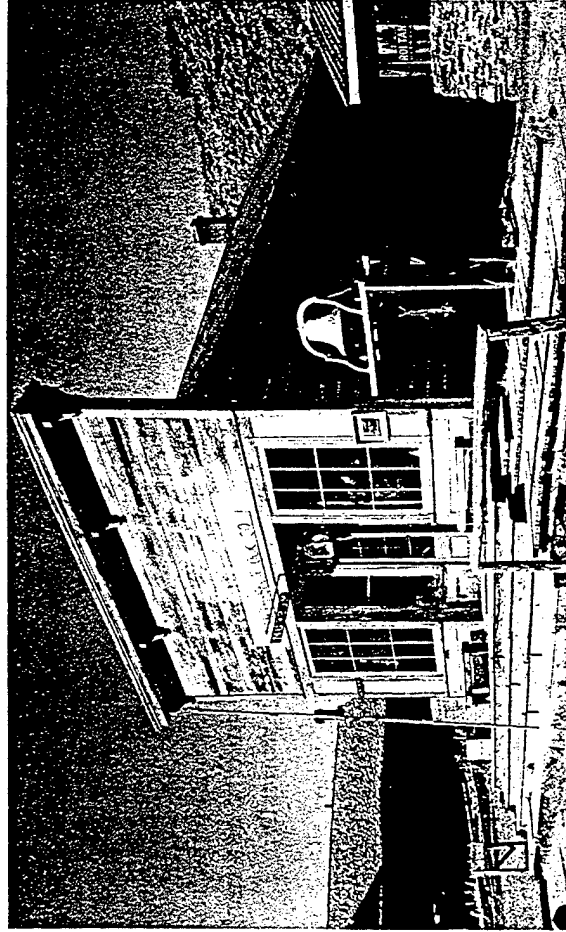
Photo: Jack E. Boucher, HABS.

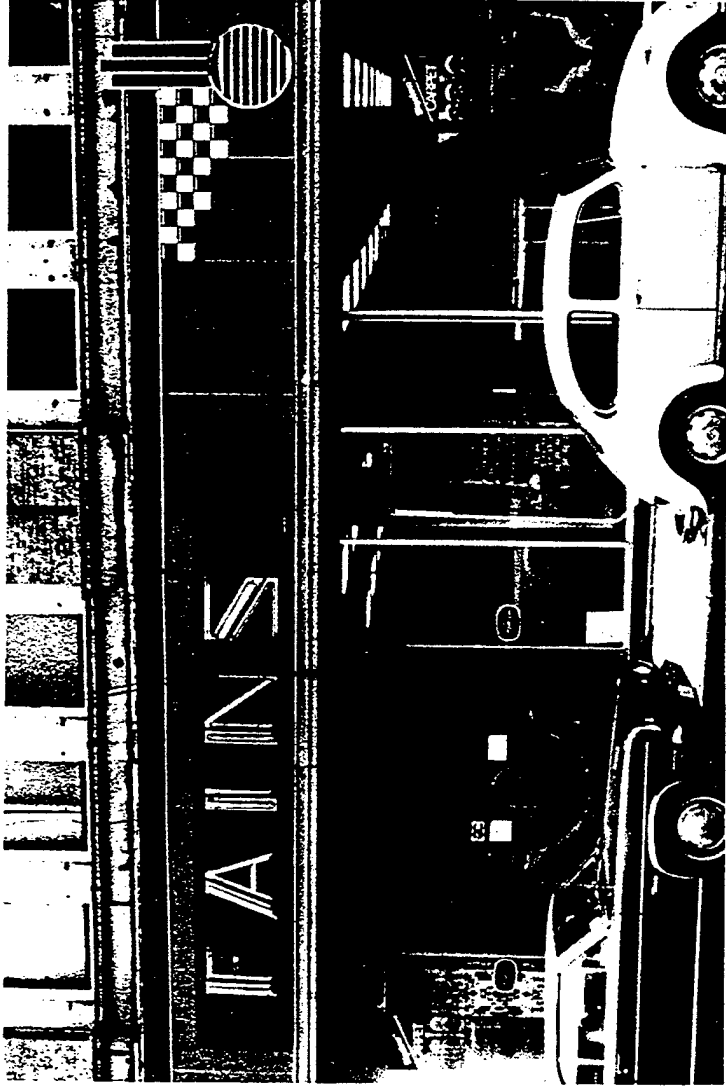
This sleek red and black Moderne storefront was added to a more staid late-19th century commercial building in the 1930s—both are now in need of repair. According to the Standards, later storefronts that have acquired significance over time should generally be retained in rehabilitation.

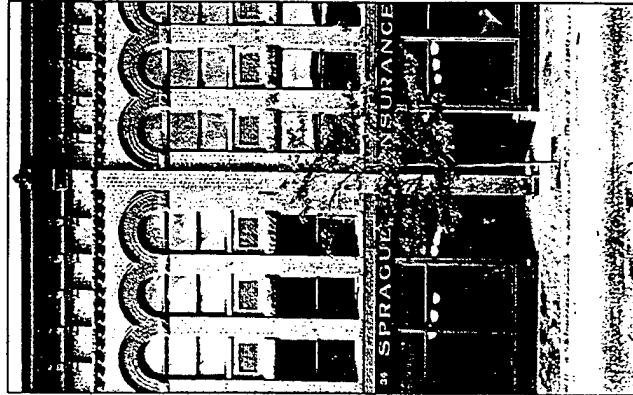
This appropriate new storefront replaces an old one that was too deteriorated to save. It features a recessed doorway based on the historic design and respects the scale and proportion of the existing building.

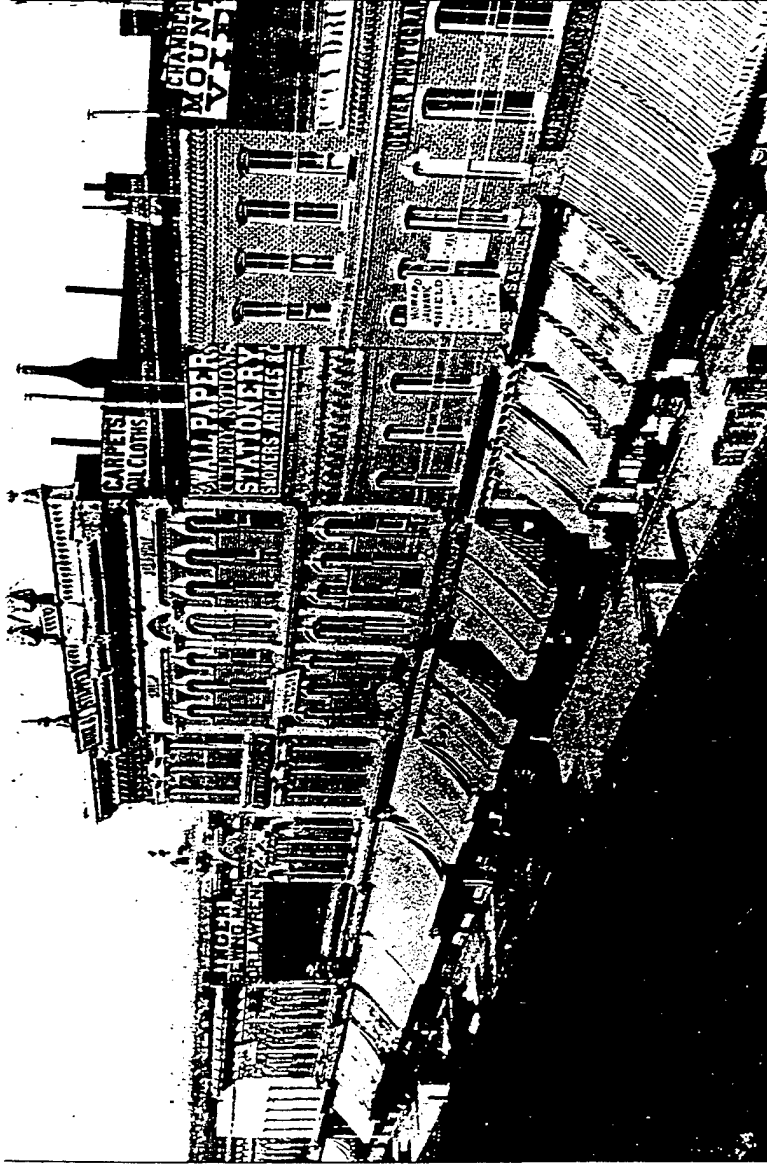
The following work is highlighted to indicate that it represents the particularly complex technical or design aspects of rehabilitation projects and should only be considered after the preservation concerns listed above have been addressed.

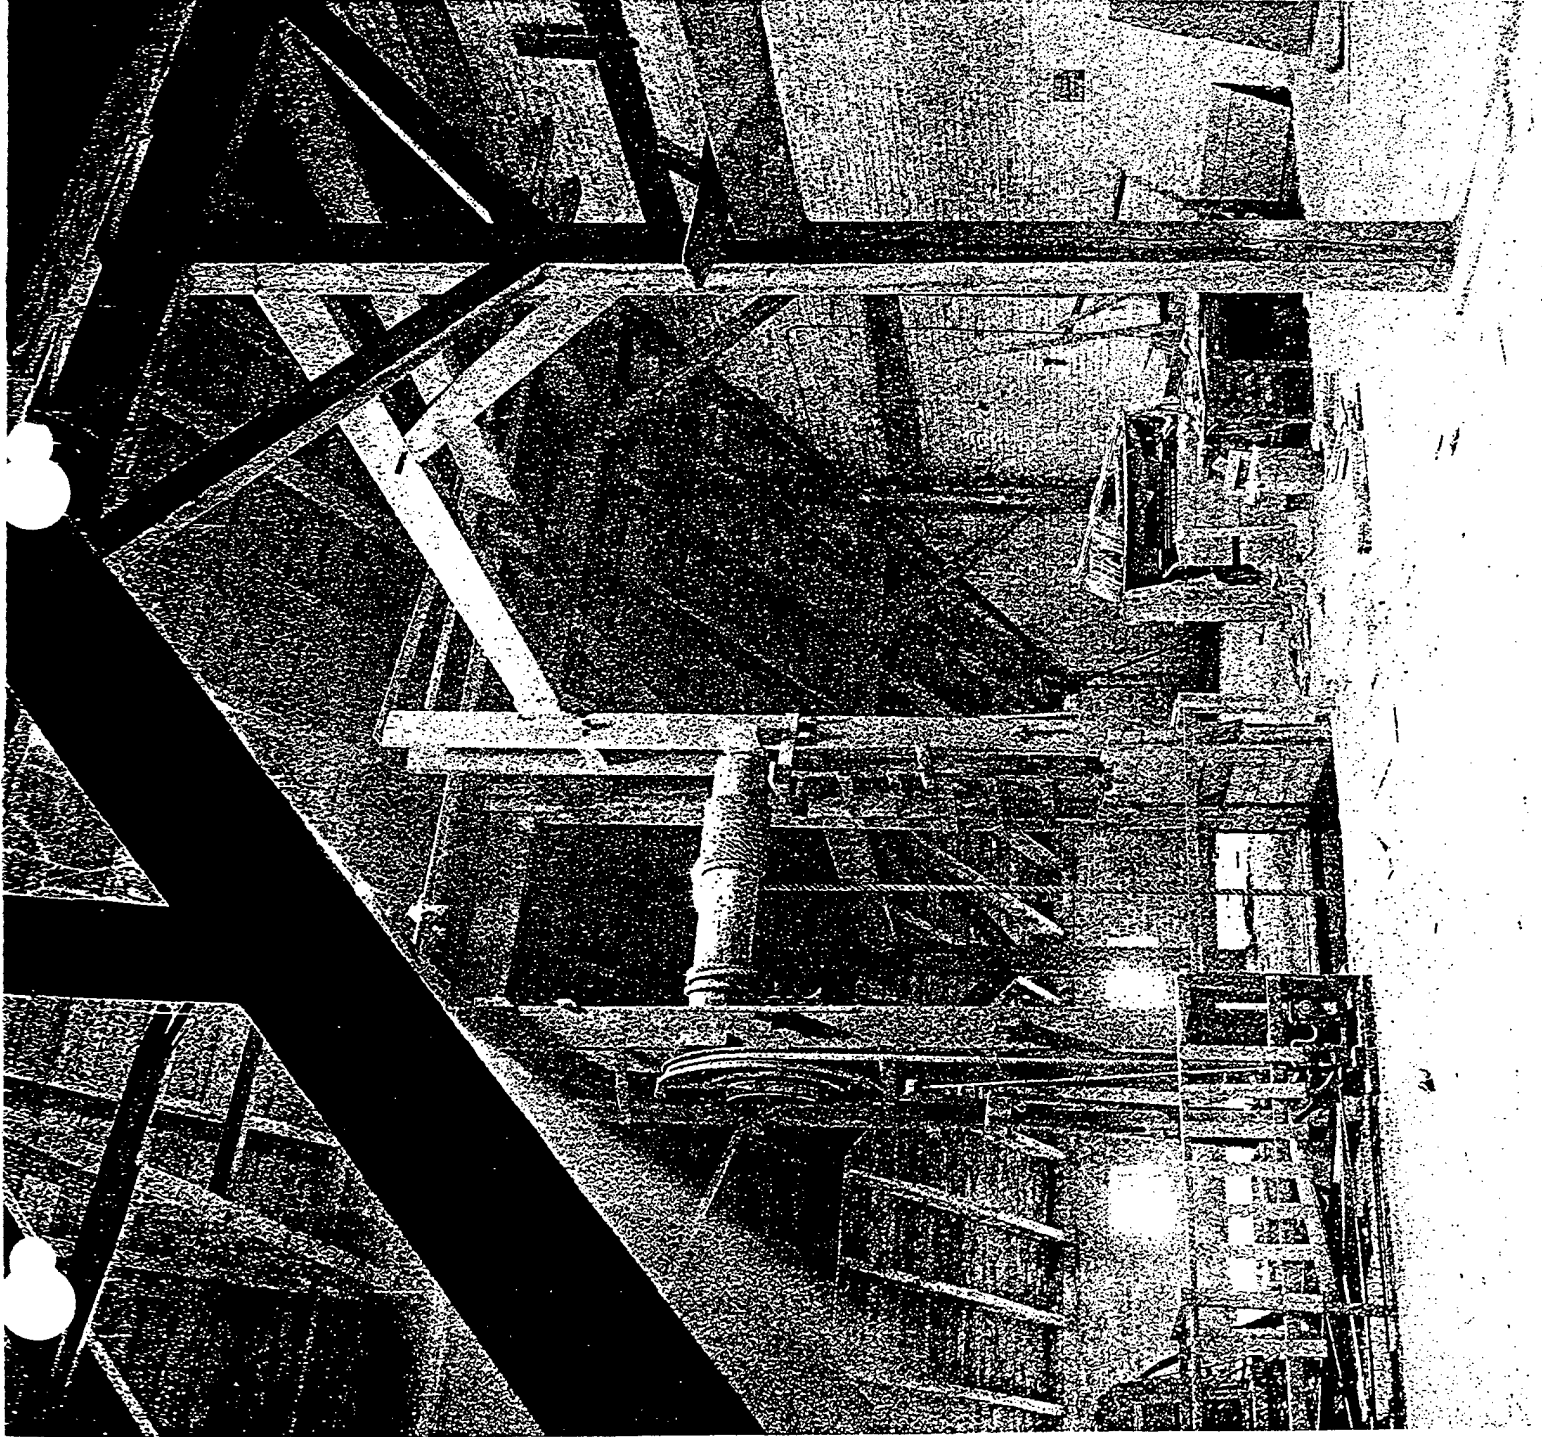
Building Interior *Structural Systems*

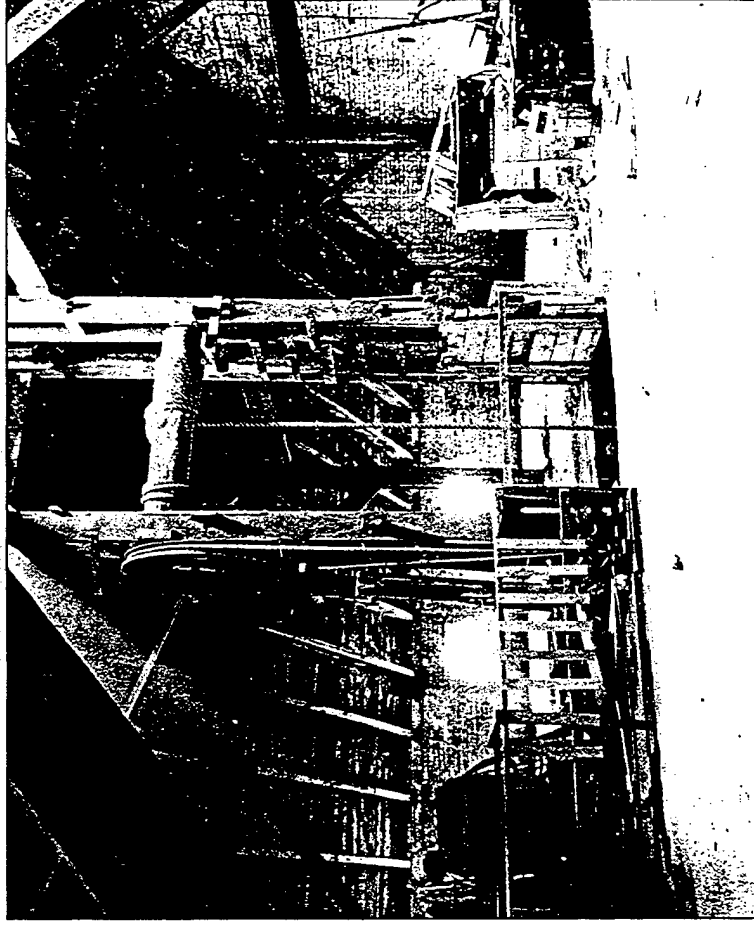
following: wooden frame construction (17th c.), balloon frame construction (19th c.), load-bearing masonry construction (18th c.), brick cavity wall construction (19th c.), heavy timber post and beam industrial construction (19th c.), fireproof iron construction (19th c.), heavy masonry and steel construction (19th c.), skeletal steel construction (19th c.), and concrete slab and post construction (20th c.).

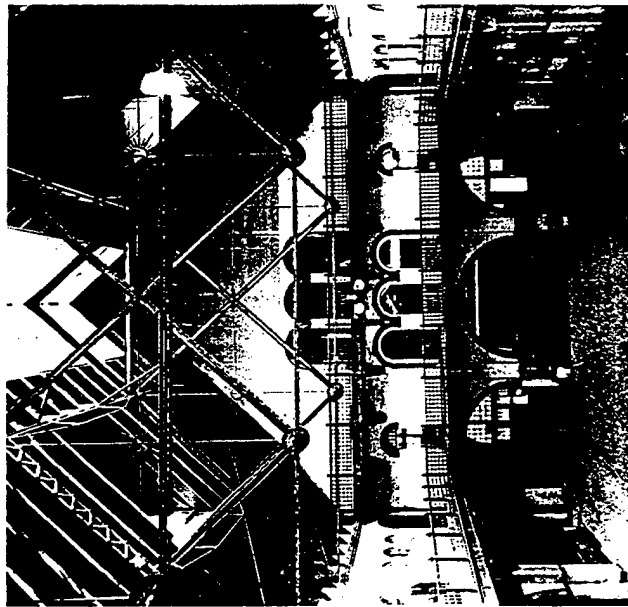
The exposed metal roof-truss system of this waiting room not only provides structural support, but is also important in defining the interior character of the train station.

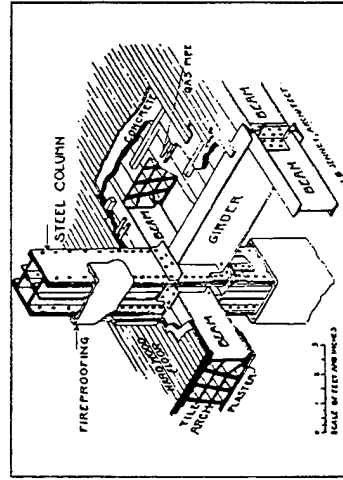
Detail of a column and girder connection and floor construction, The Fair Store, Chicago, Illinois, 1892 (Jenney and Mundie, architects). This type of connection was used in many iron and steel buildings; "fireproofing" was provided by terra-cotta tile and plaster.

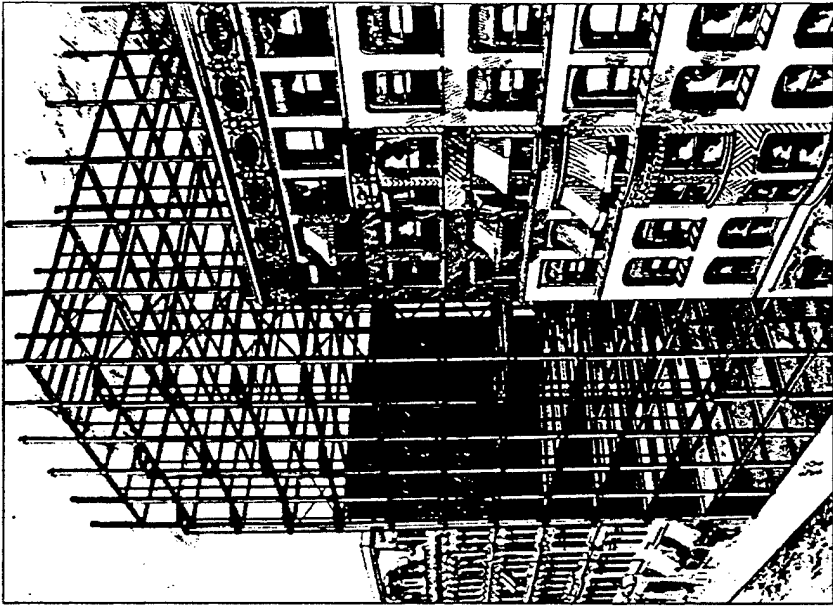
In 1889, James L. Watson, architect, designed the Unity Building, Chicago, Illinois, 1891-1892 (Clinton J. Warren, architect). The development of the skeleton frame was pioneered by architects of the "Chicago School" in the late-19th century. With this method the weight of the building is carried on the frame, not the walls, allowing the construction of taller buildings without increasing the wall thickness.

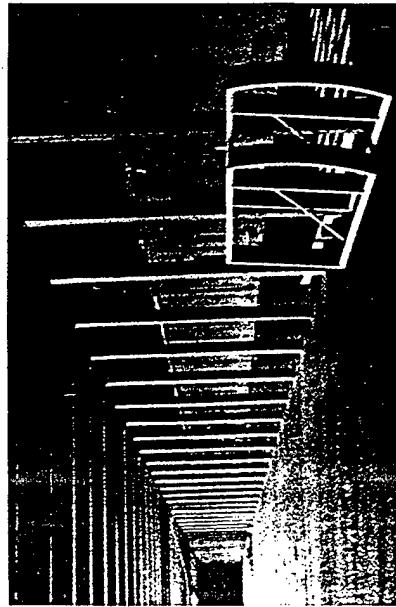
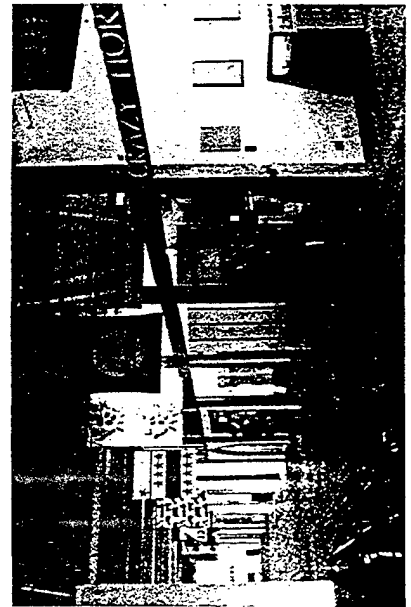
These before and after rehabilitation photographs offer a good example of a project that took into account, and respected, the unique industrial structural character of this mill building in its conversion to a shopping mall.

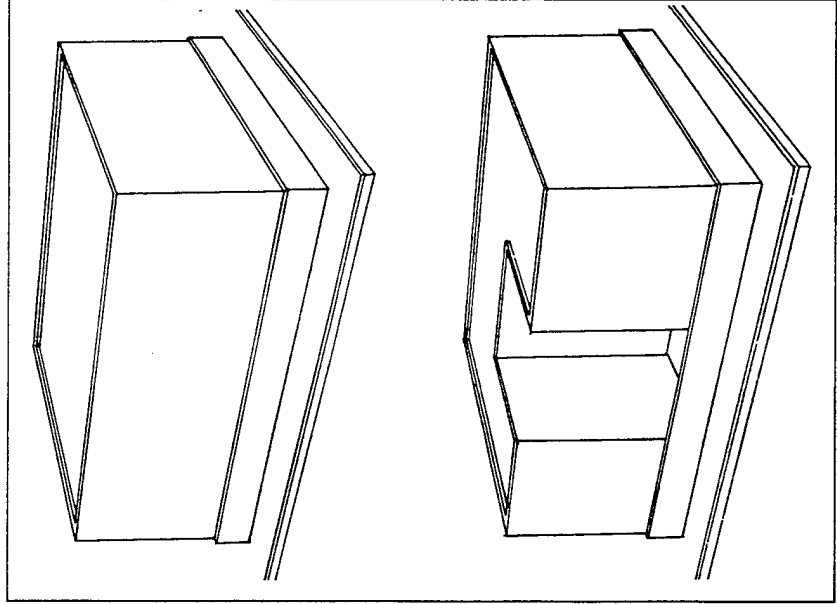
A rehabilitation proposal to convert a historic waterfront warehouse into a residential apartment building called for cutting out a large section of the rectangular-shaped historic building. The new "U" shape would provide more apartments with a waterfront view. This schematic drawing shows the drastic change that would result to the structure and character of the historic building if a portion had been removed as proposed (the project was denied because it did not meet the Standards).

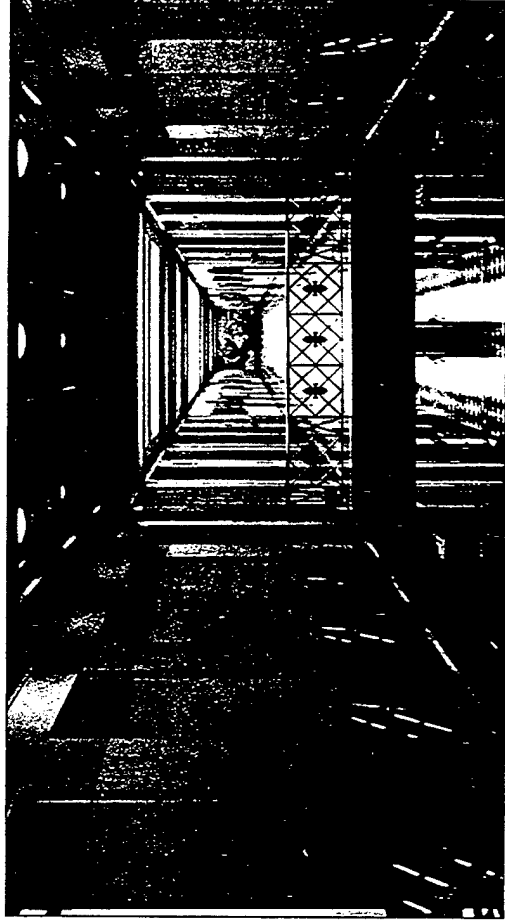
Secondary spaces include areas and rooms that “service” the primary spaces and may include kitchens, bathrooms, mail rooms, utility spaces, hallways, fire stairs and work spaces in a commercial or office building. Extensive changes can often be made in these less important areas without having a detrimental effect on the overall historic character.

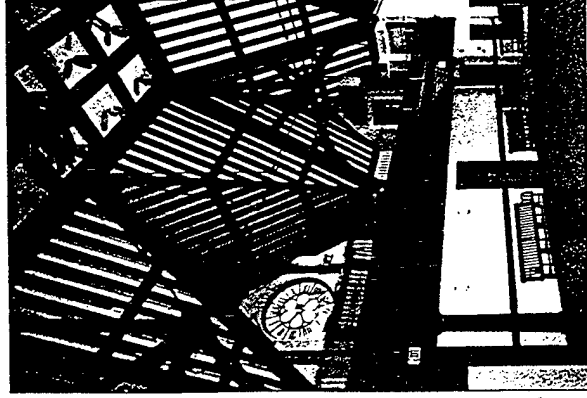
These photographs suggest the richness and diversity of public building spaces, features, and finishes.

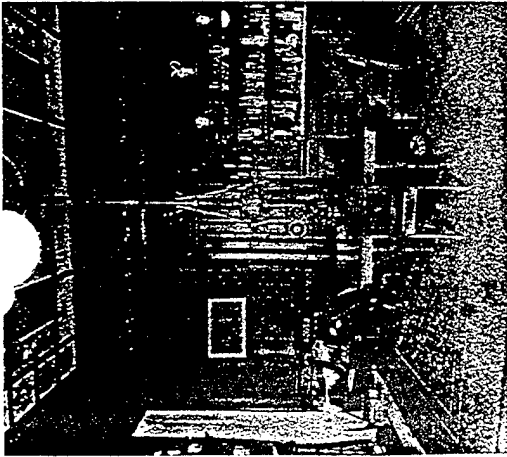
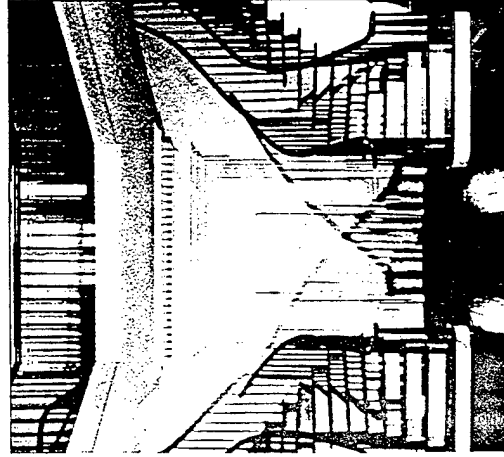
Photo: Jack E. Boucher, HAIBS.

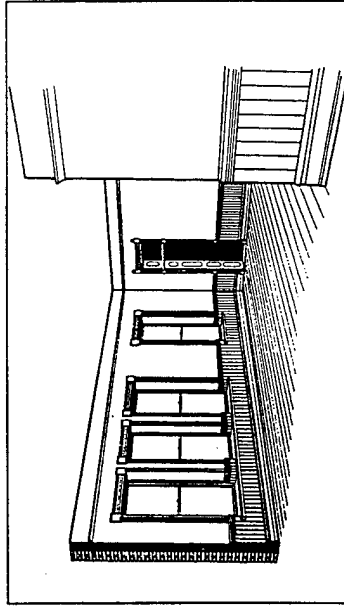
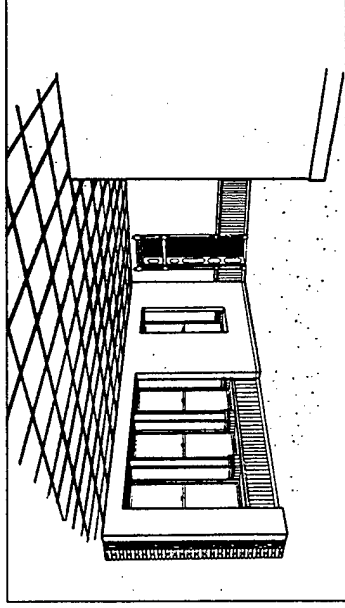
Furring out exterior walls to add insulation and suspending new ceilings to hide ductwork and wiring can change a room's proportions and can also destroy or obscure significant decorative detailing.

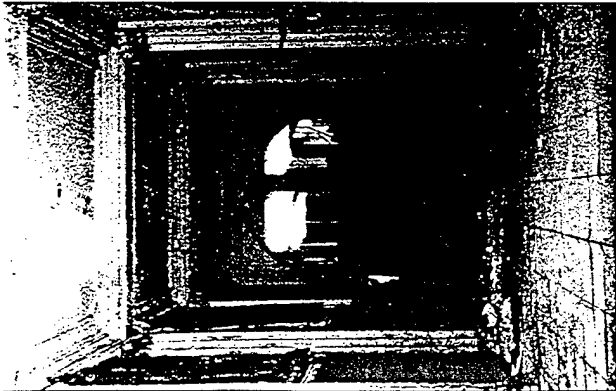
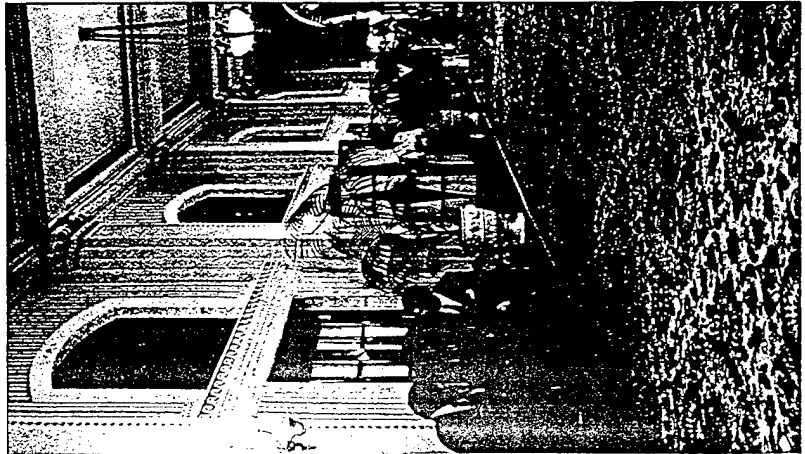
Before and after: Prior to rehabilitation of this hotel, water intrusion and freeze-thaw cycles had caused extensive efflorescence and plaster failure. The ornamental plaster was almost fully re-manufactured, then gilded. Light fixtures and other detailing were also carefully replicated.

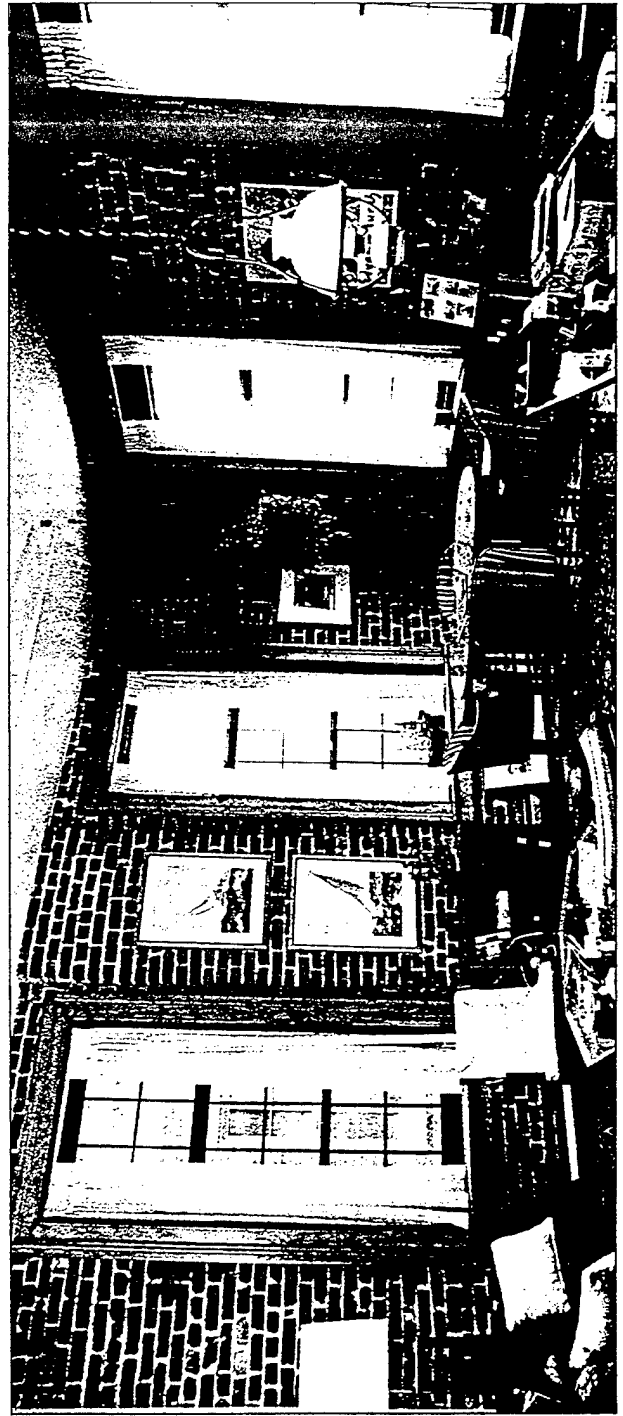
The following work is highlighted to indicate that it represents the particularly complex technical or design aspects of rehabilitation projects and should only be considered after the preservation concerns listed above have been addressed.

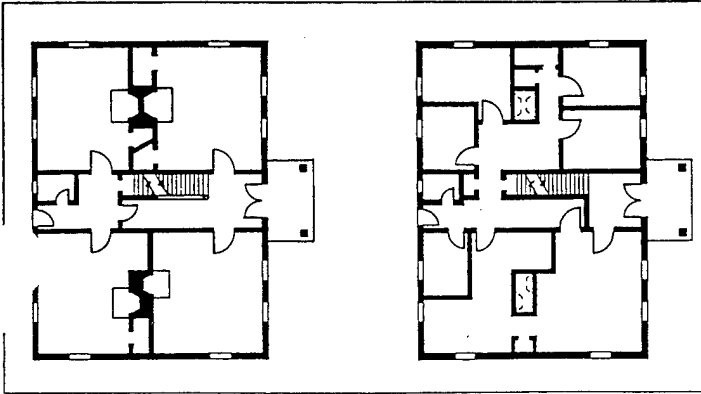
Adding several new rooms to a distinctive interior space may radically change its historic character. Before (top): The original plan was a central hall with four large, equally-sized rooms around it. Each room had a fireplace with a mantel and decorative trim. After (bottom): During rehabilitation, numerous small rooms were added; the open stair was also replaced with a boxed-in stair and the original trim and fireplaces were removed.

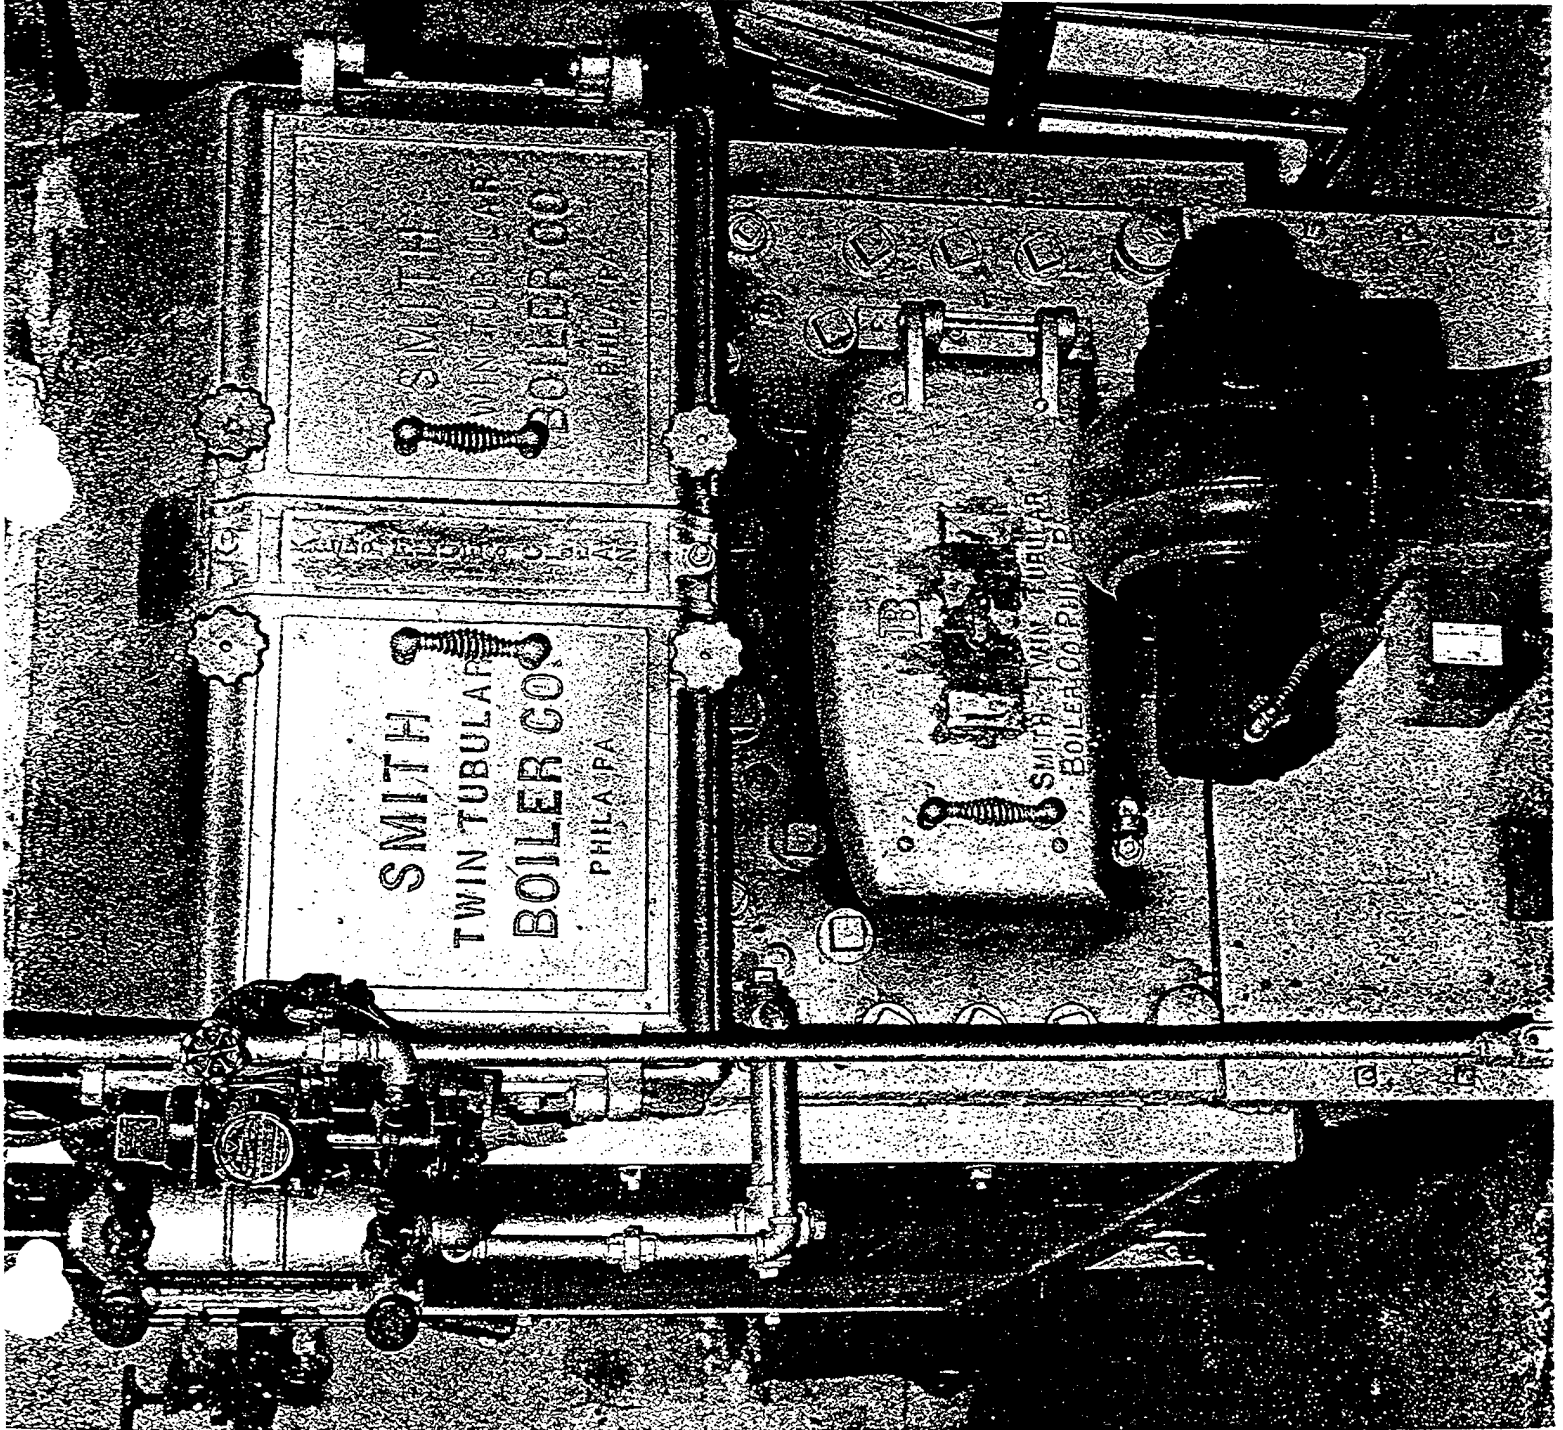
HEATING
AIR CONDITIONING
ELECTRICAL
AND PLUMBING

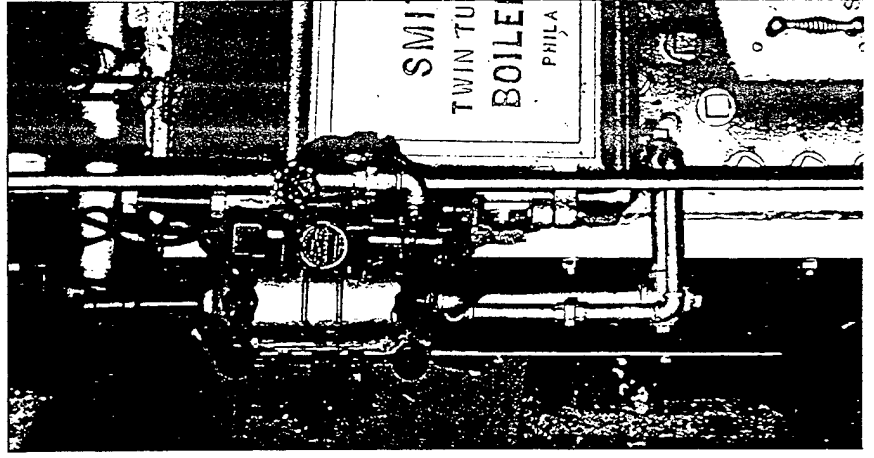
The visible decorative features of historic mechanical systems such as grilles, lighting fixtures, and ornamental switchplates may contribute to the overall historic character of the building and should thus be retained and repaired, whenever possible. Their identification needs to take place together with an evaluation of their physical condition early in project planning. On the other hand, the functioning parts of many older systems, such as compressors and their ductwork, and wiring and pipes may often need to be upgraded or entirely replaced in order to accommodate the new use and to meet code requirements.

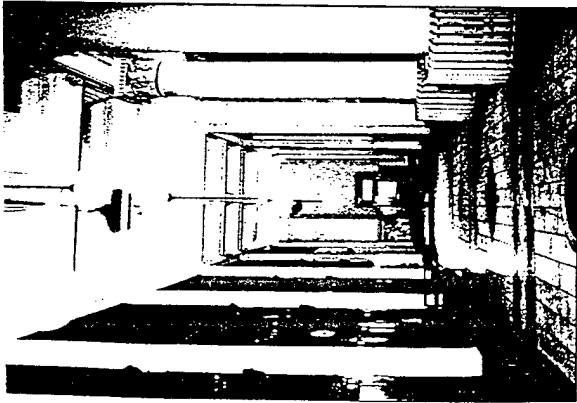
The visible features of historic mechanical systems, such as heating, lighting, and plumbing, may sometimes help define the overall character of an interior.

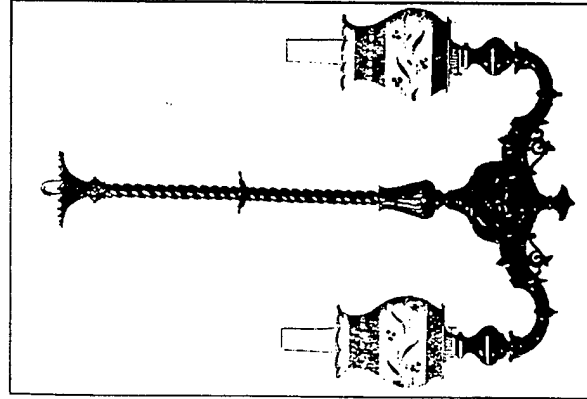
A gaslight may be converted for electrical use to extend its functional and decorative life.

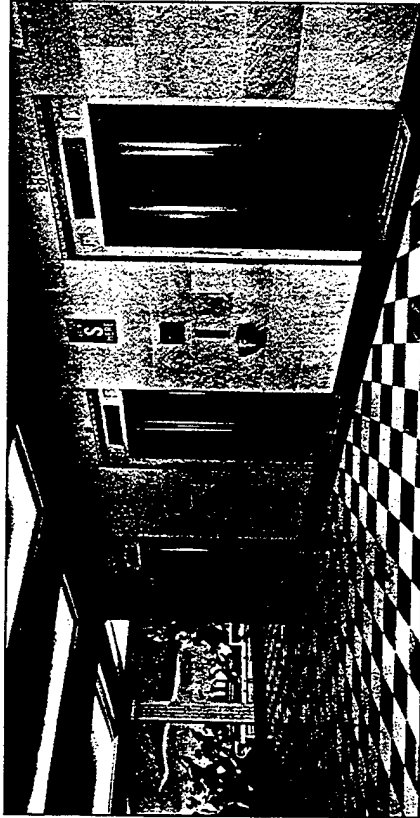
The bronze elevator doors and light coffers play an important decorative role in this early-20th century administrative building.

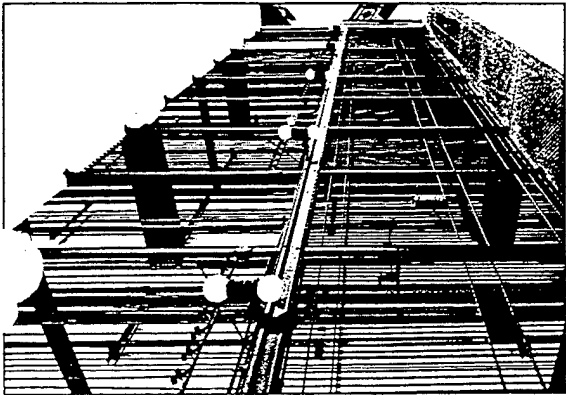
Photo: Richard Nickel

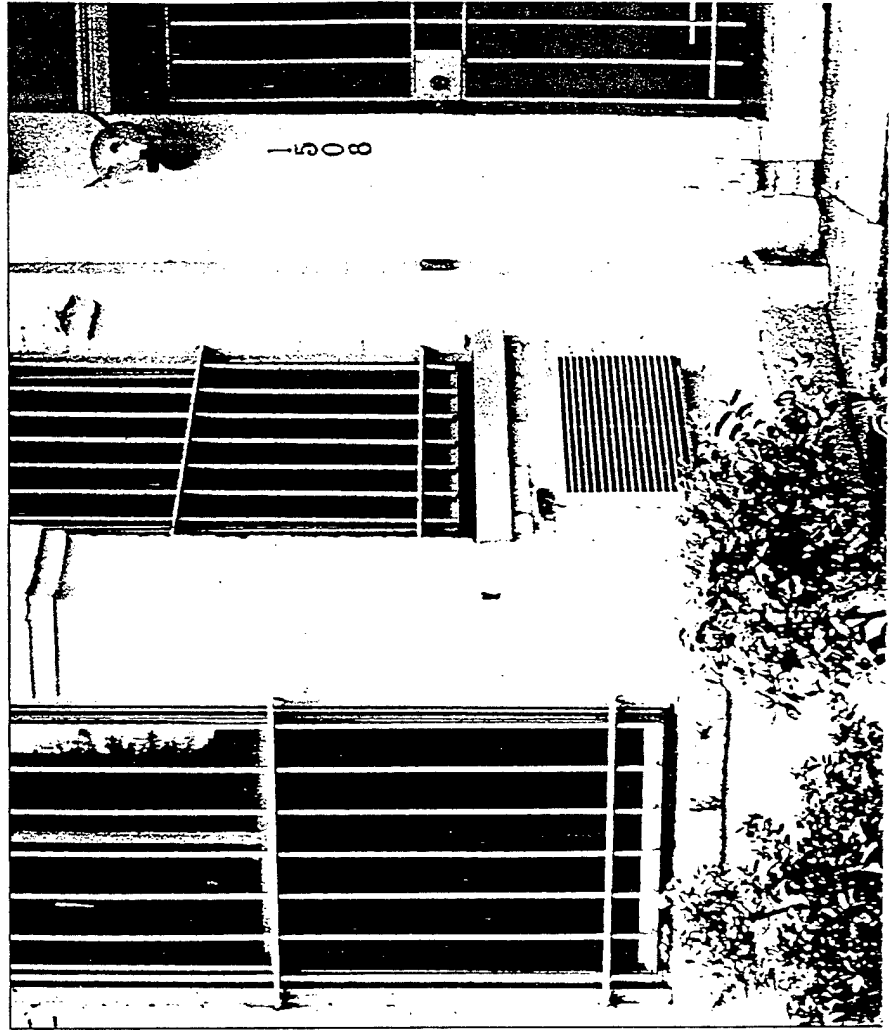
The historic window on a primary facade has been shortened and the area below it filled in with brick in order to install a through-the-wall air conditioning unit. In addition to changing the window size and destroying the sill, the unit itself is visually obtrusive.

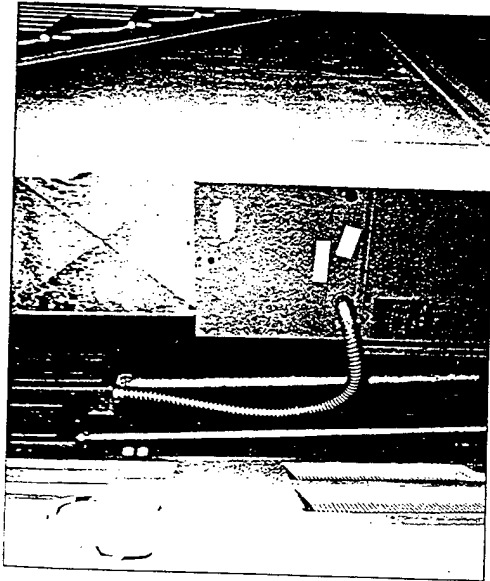
When a late-19th century single-family house was converted to four rental units, the new HVAC system was installed under the central stair. When the door is closed, only the vents indicate its presence.

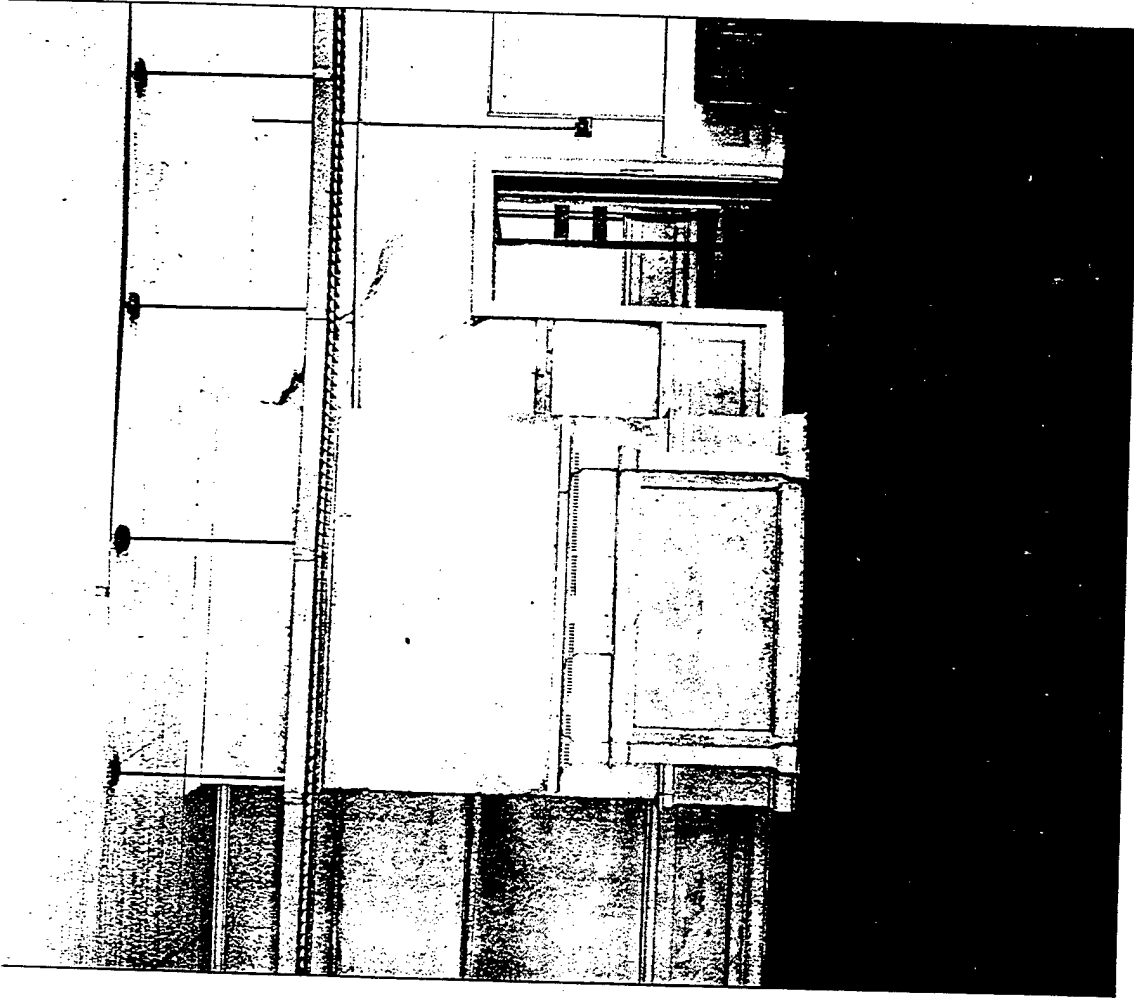
This row of hanging fluorescent lights installed in an earlier renovation mars an otherwise classically detailed interior. They have also caused the historic beaded ceiling to pull away from the joists.

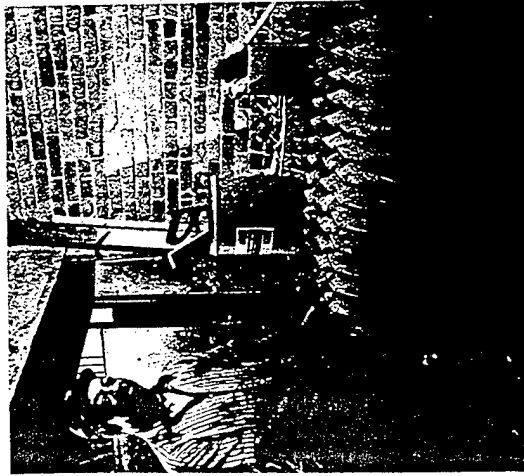
Radically changing the appearance of the historic building or damaging or destroying windows by installing heating/air conditioning units in historic window frames.

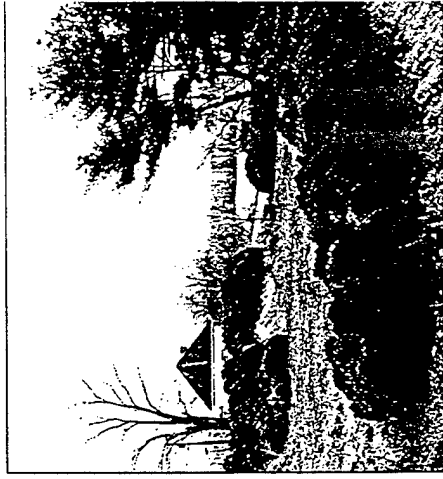
plants, creates an appearance that is constantly changing, both seasonally and annually. Since most plant material is adapted to specific environments, the character of landscapes varies dramatically in different climates, elevations and regions.

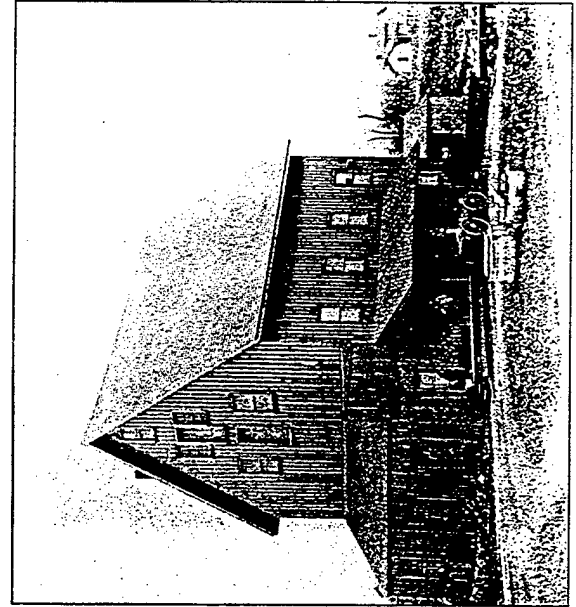
Retaining the historic relationship between buildings and the landscape.

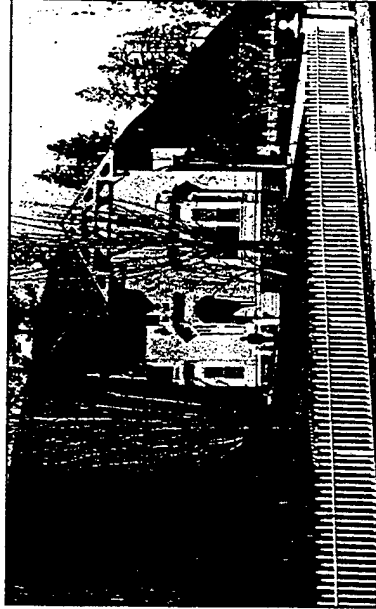
Landscape features that are important in defining the historic character of a building site may include fences, walks, and small outbuildings, as well as trees, bushes and topography that may be unique, such as the hill behind the house.

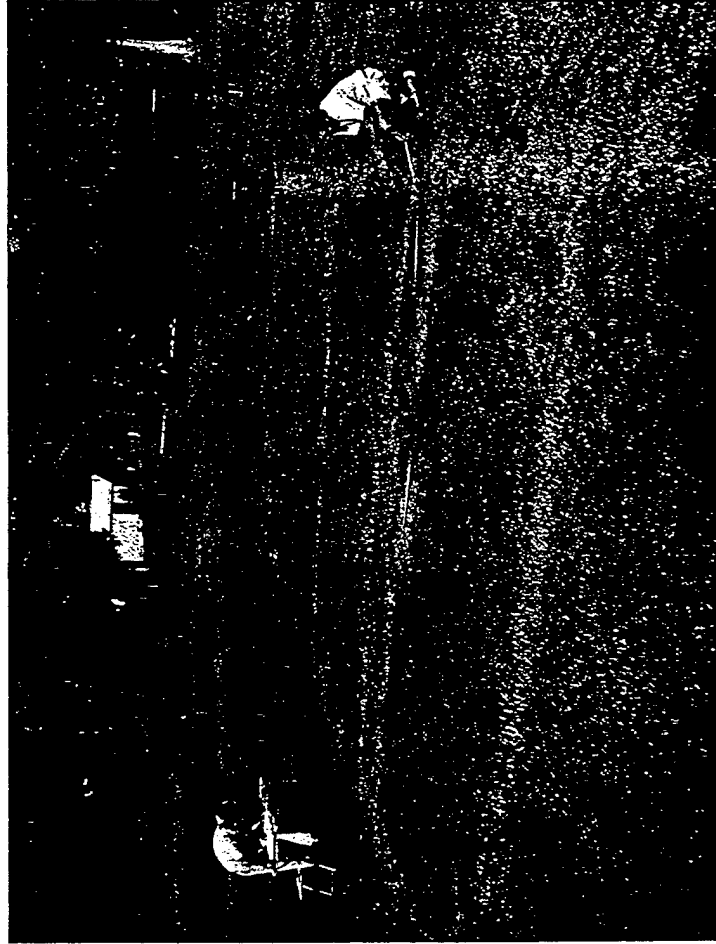
Whenever possible, non-destructive techniques should be used to inventory and evaluate archeological resources to ensure their protection.

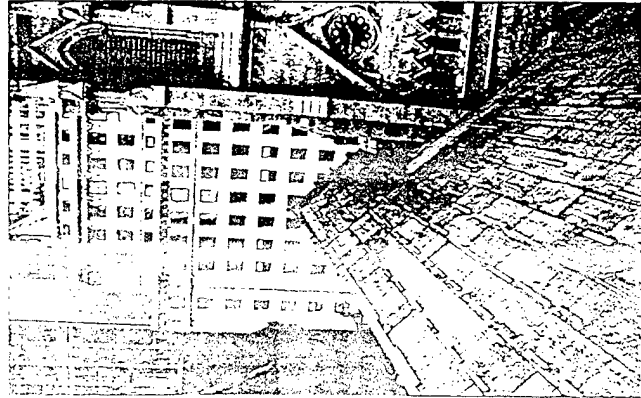
▲ The roof and stained glass windows of this historic church have been appropriately covered with plywood as a protective measure during construction of a new building on an adjacent lot.

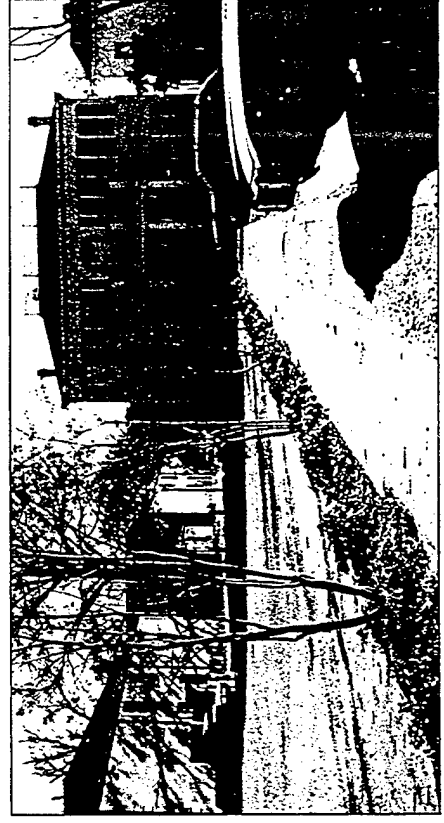
Park-like settings surrounding many historic mansions are important in defining their historic character. However, the relationship between building and site was destroyed by an inappropriate rehabilitation when this house was converted into offices, and the formally landscaped grounds in front of the house were bulldozed to provide a parking lot.

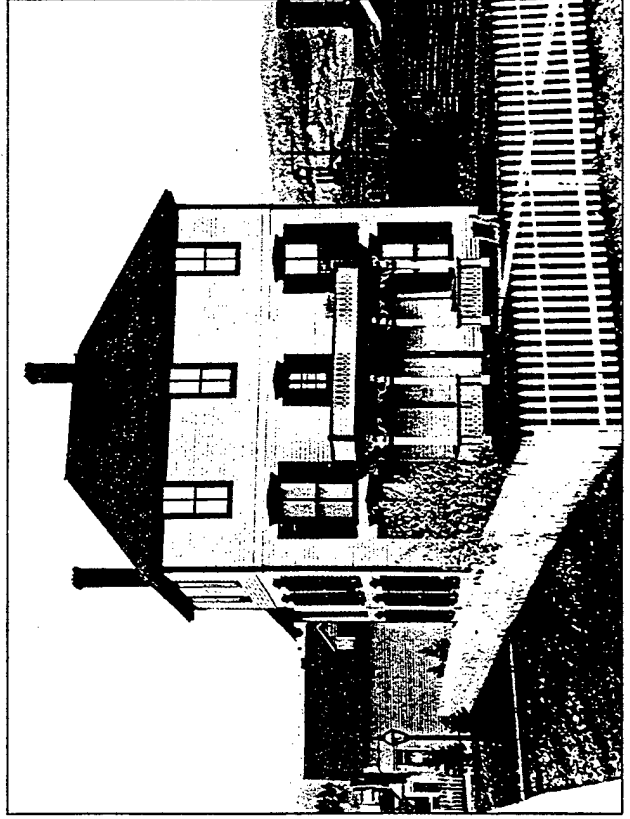
Photo: Library, The State Historical Society of Colorado
