Management and Maintenance Manual
The Old Hospital Complex
Fort Carson, Colorado
(5EP1778)

James Schneck

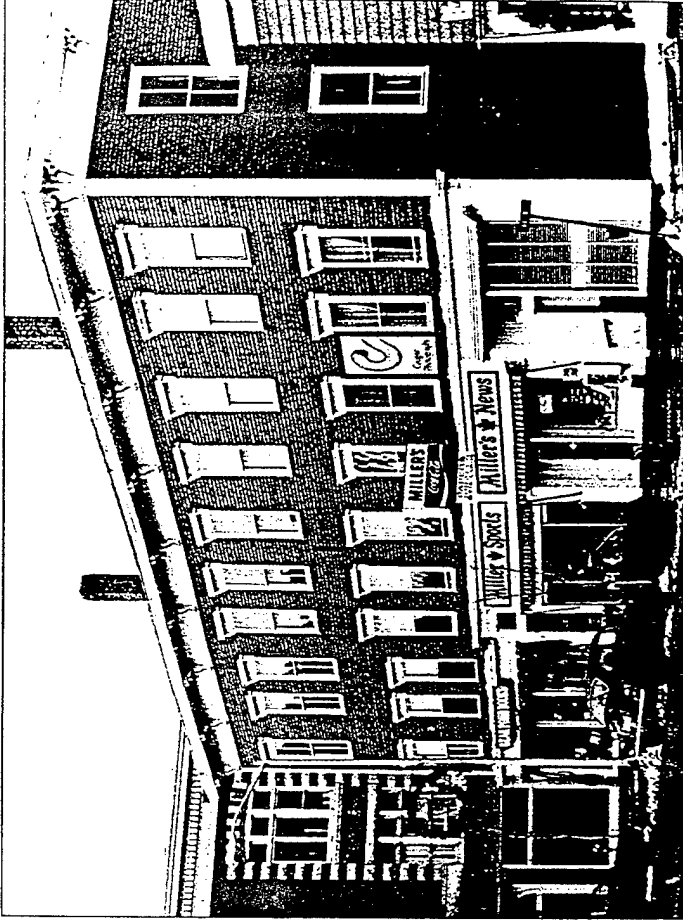
The setting is the area or environment in which a historic property is found. It may be an urban or suburban neighborhood or a natural landscape in which a building has been constructed. The elements of setting, such as the relationship of buildings to each other, setbacks, fence patterns, views, driveways and walkways, and street trees together create the character of a district or neighborhood. In some instances, many individual building sites may form a neighborhood or setting. In rural environments, agricultural or natural landscapes may form the setting for an individual property.

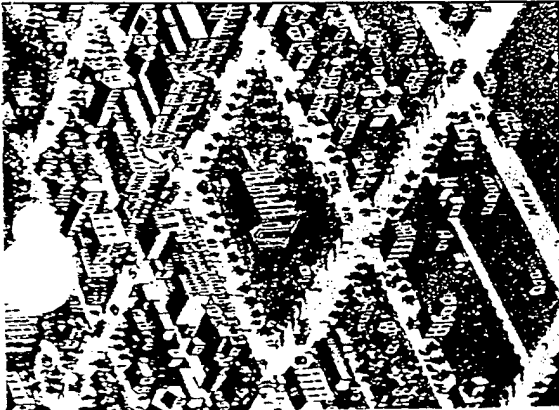
In an urban historic district, the alignment and width of roads, the relationship between buildings and yards, and the repetition of trees lining the streets help define its historic character.

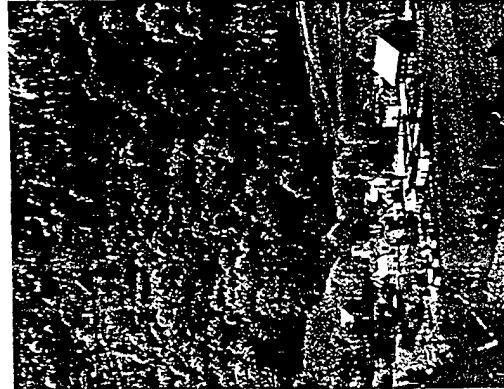
The setting is an important aspect of a historic district. In a rural historic district, the natural topography and landscape features, agricultural field patterns, roads, and the organization of buildings and structures all contribute to its character.

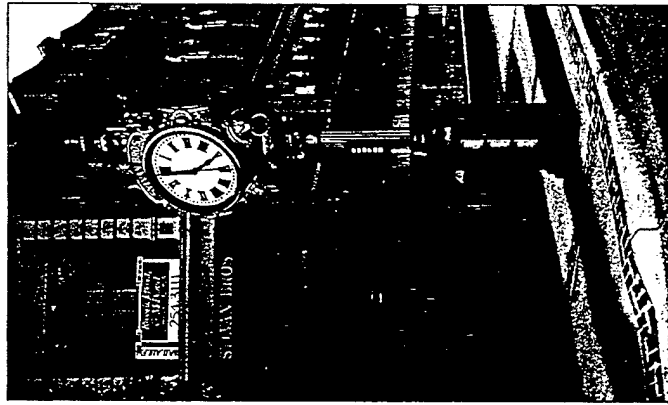
Photo: Jack E. Boucher, HABS.

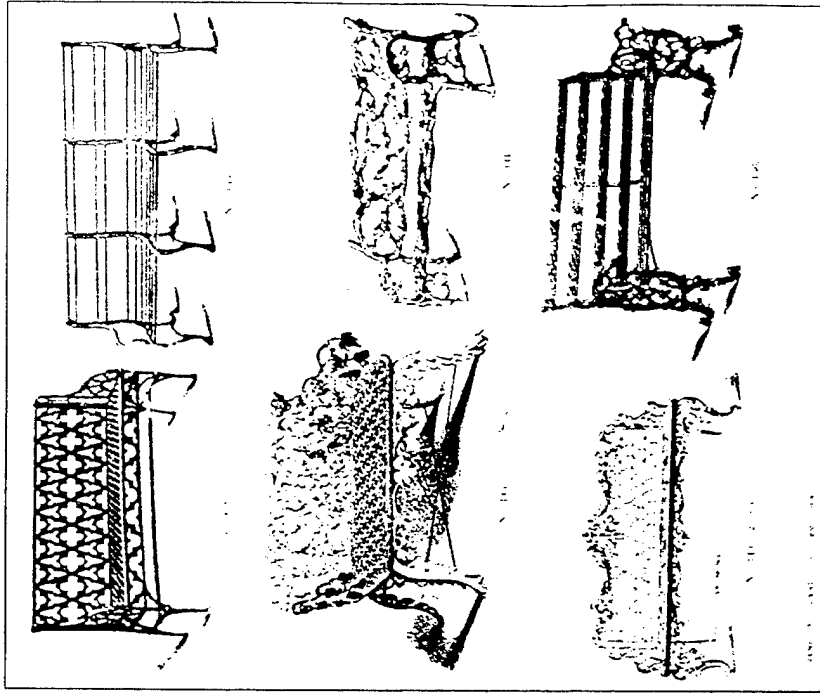
Cast Iron Benches, illustrated in Catalogue of Ornamental Iron Works, James, Kirtland & Co., 1870. Benches can be important features both in defining an urban streetscape as well as a more rural landscape.

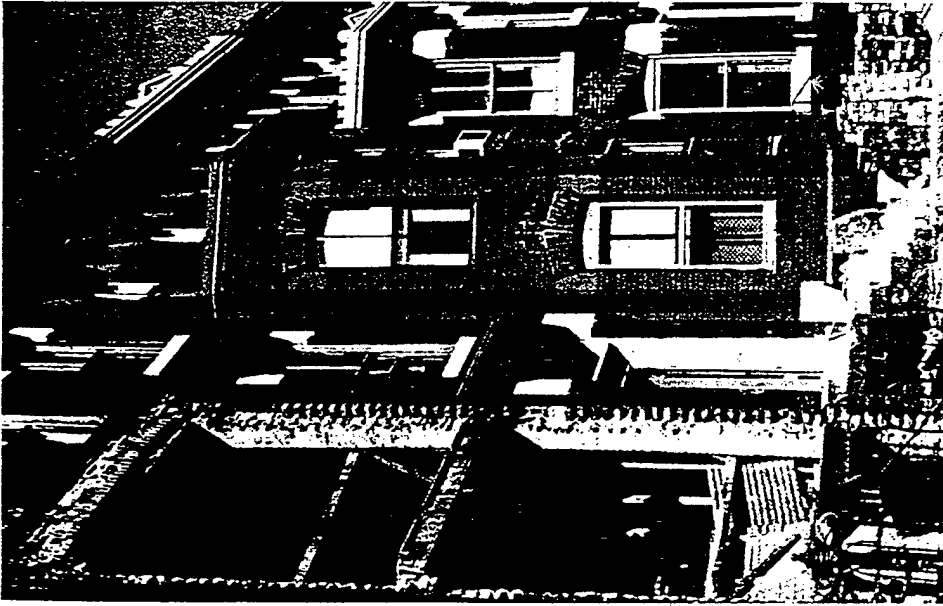
This late-19th century residential historic district is characterized by brick row-houses with two-storied bays. A street-scapes visual continuity can be marred by an insensitive rehabilitation such as the one shown here. The original two-story brick bay of one of the houses was removed and replaced with a three-story bay that is incompatible in size, materials, and detailing.

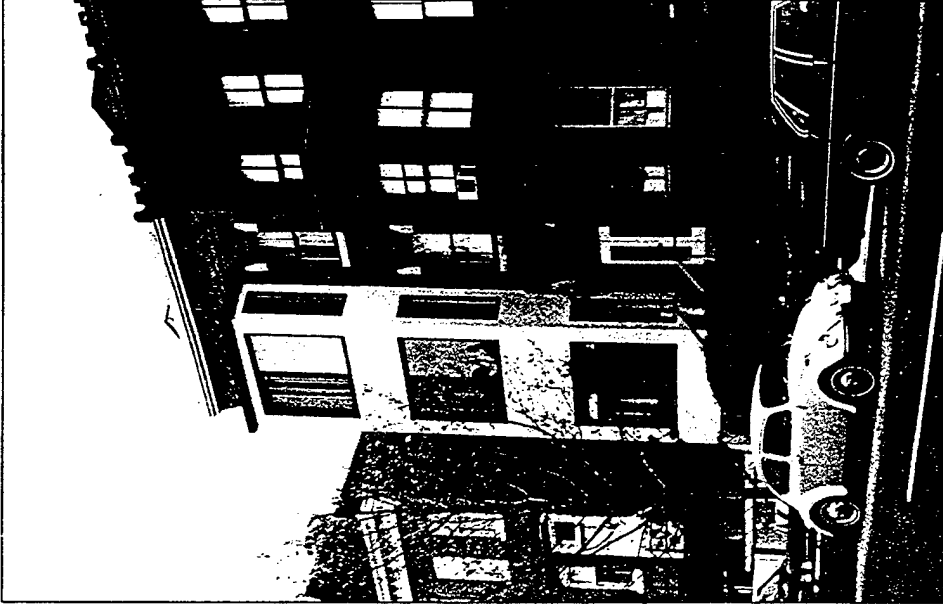
Replacing in kind an entire feature of the building or landscape that is too deteriorated to repair — when the overall form and detailing are still evident — using the physical evidence as a model to guide the new work. If using the same kind of material is not technically or economically feasible, then a compatible substitute material may be considered.

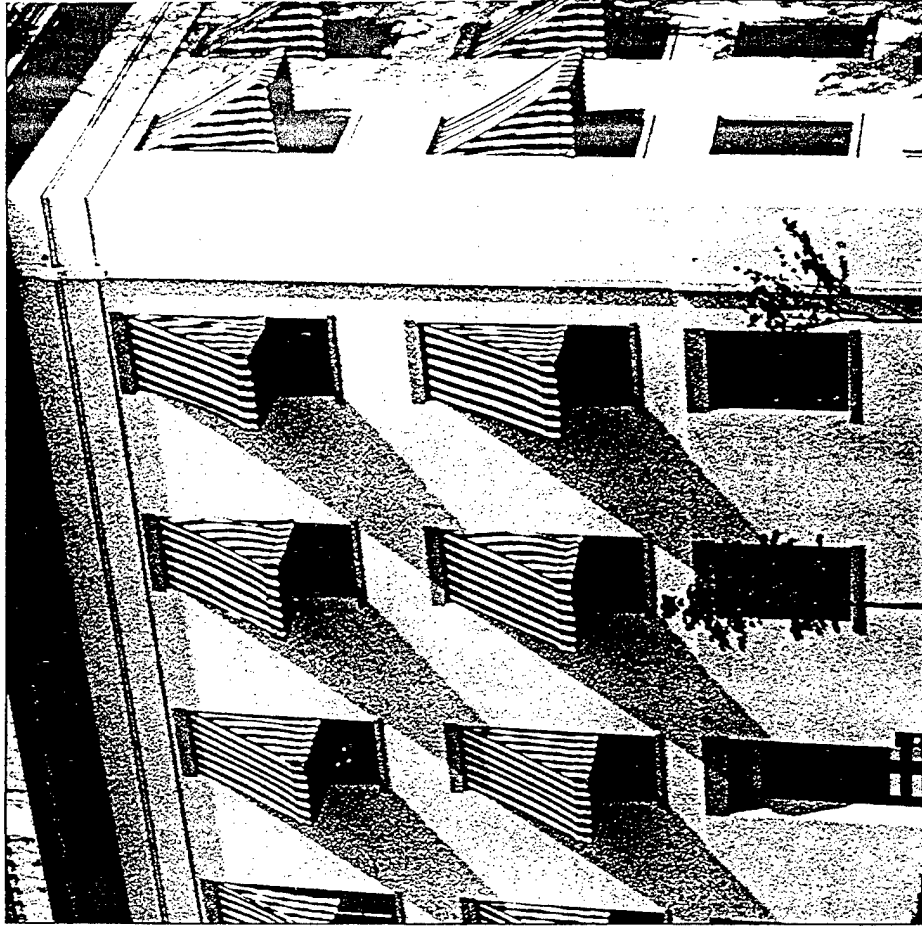
Therefore, prior to retrofitting historic buildings to make them more energy efficient, the first step should always be to identify and evaluate the existing historic features to assess their inherent energy-conserving potential. If it is determined that retrofitting measures are necessary, then such work needs to be carried out with particular care to insure that the building's historic character is preserved in the process of rehabilitation.

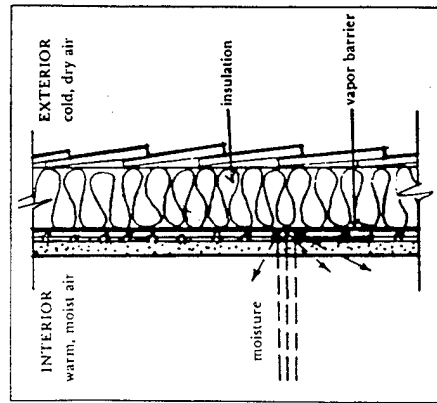
When installing insulation in the wall cavity of a historic wood-frame building, a vapor barrier must be placed facing in toward the heated side of the wall. The vapor barrier prevents moisture from passing from the warm interior to the cold exterior, thus keeping the insulation and adjacent building materials dry.

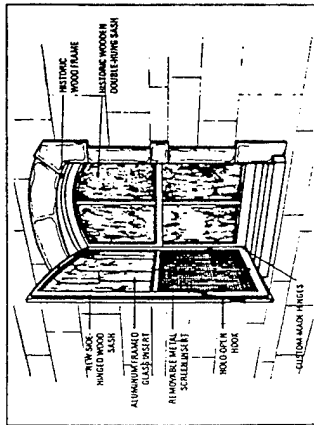
Historic residential window — appropriate storm window retrofit. The single casement, wooden storm window has two removable panels for screen and glass inserts. It is designed to minimize visual changes to the historic building.

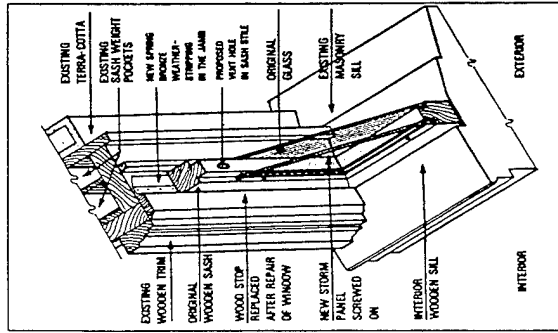
Historic commercial window — appropriate storm window retrofit. This cutaway view shows how the historic sash would receive a recessed storm panel through routing or cutting an inside rabbet.

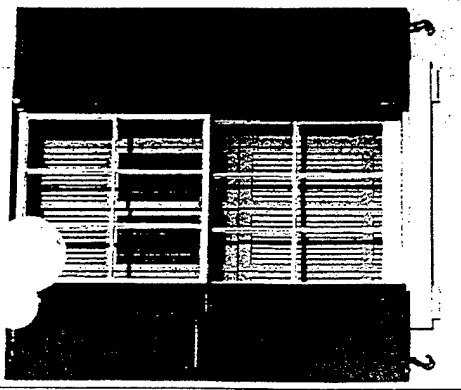
Shutters were used to minimize temperature extremes. If interior or exterior shutters are present, they should be retained, preserved, and used as they were historically.

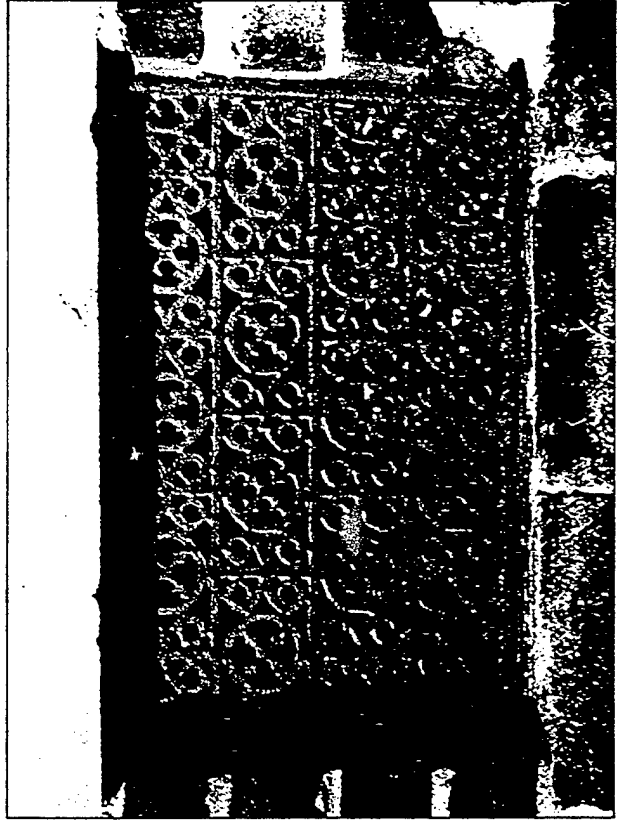
New Additions to Historic Buildings

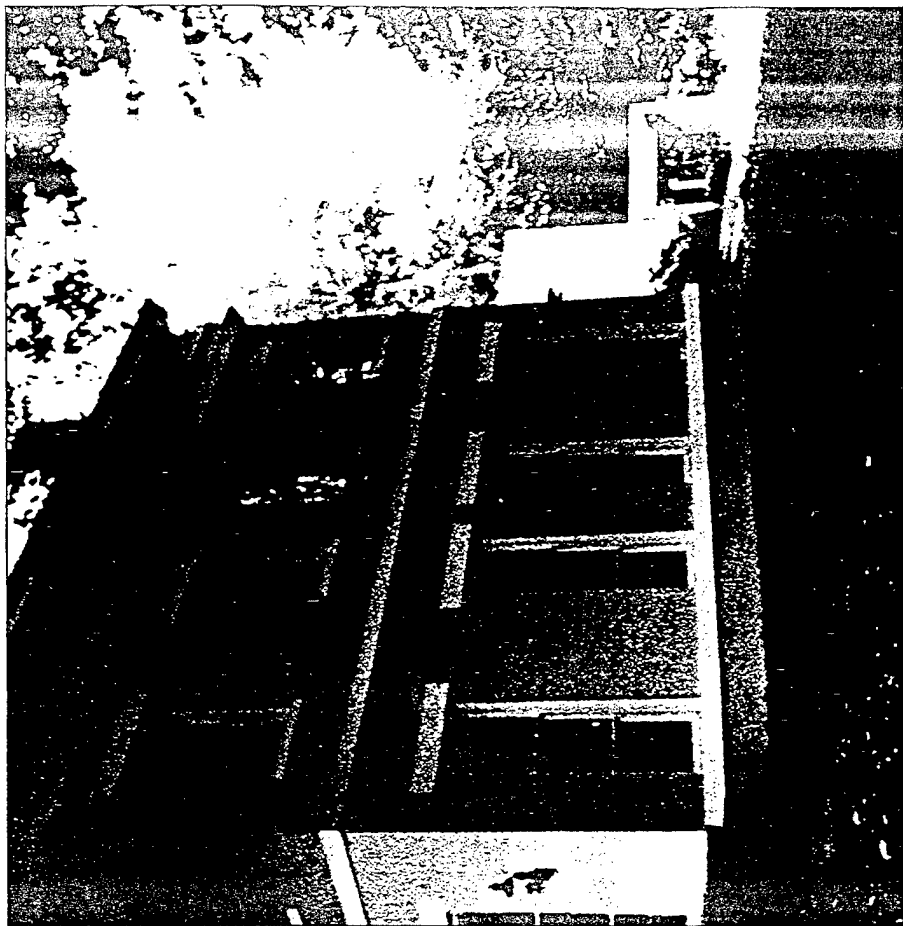
An attached exterior addition to a historic building expands its "outer limits" to create a new profile. Because such expansion has the capability to radically change the historic appearance, an exterior addition should be considered only after it has been determined that the new use cannot be successfully met by altering non-character-defining interior spaces. If the new use cannot be met in this way, then an attached exterior addition is usually an acceptable alternative. New additions should be designed and constructed so that the character-defining features of the historic building are not radically changed, obscured, damaged, or destroyed in the process of rehabilitation. New design should always be clearly differentiated so that the addition does not appear to be part of the historic resource.

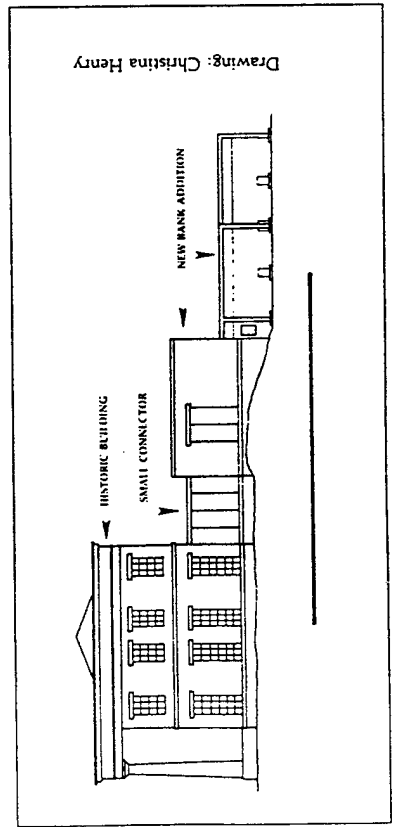
An 1847 residence was successfully converted into a bank, with the construction of a low-scale addition. The drawing shows how the three-unit addition has been stepped down the hill, each unit set further back from the historic structure as it extends horizontally. As a result, the new addition is only partially visible from the historic "approach." The small connector was sensitively designed to minimize loss of historic building materials.

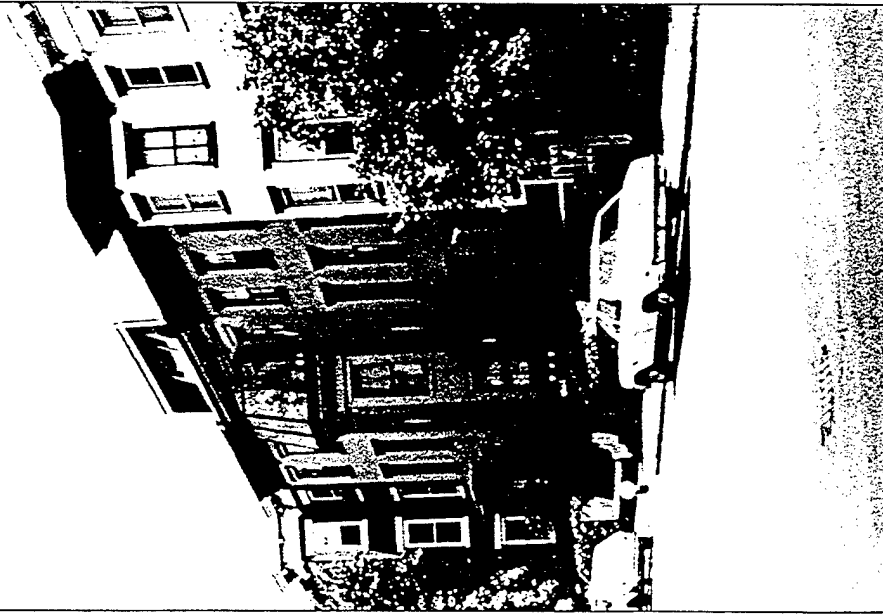
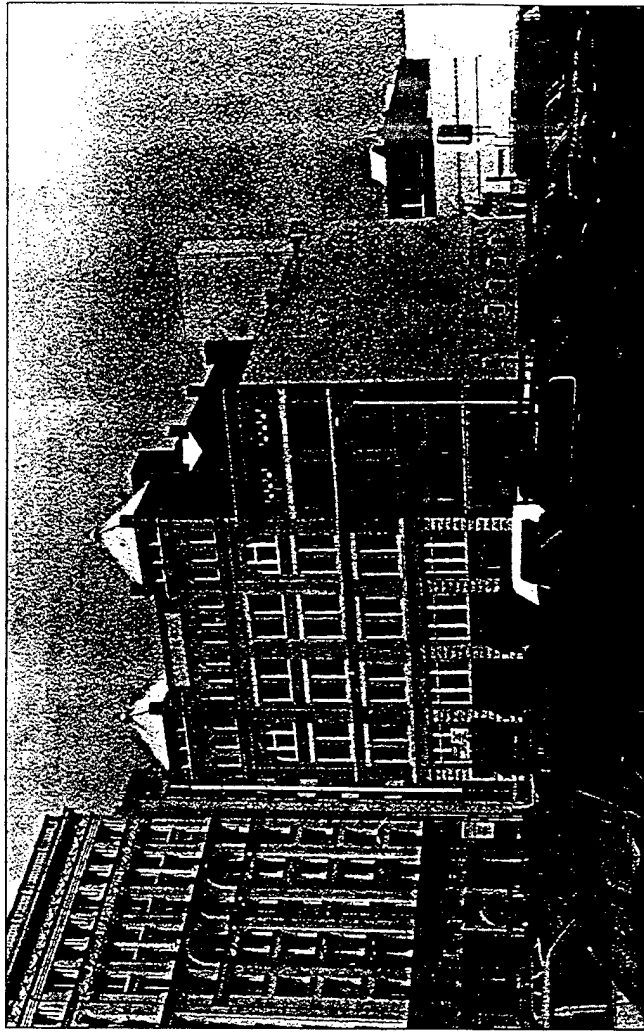
Left: This top addition has substantially altered the historic profile and proportions of a three-story row house; more important, it has interrupted the uniform roof height of the block. The greenhouse is also a jarring element in an otherwise intact 19th century streetscape. Below: A sizeable employee lounge was added atop this four-story historic commercial building. Because the rooftop addition has been set back from both the front and side roof edges against a party wall, the historic character of the building and the district have been preserved.

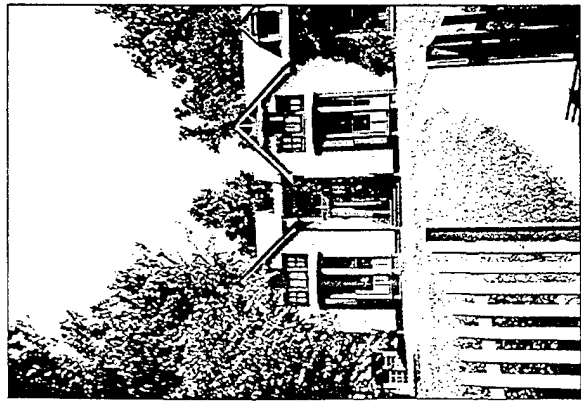
The historic residence is on the right. By copying the decorative gable and three-part window in the new addition, the old and new portions are virtually indistinguishable. This approach violates the Standards for Rehabilitation.

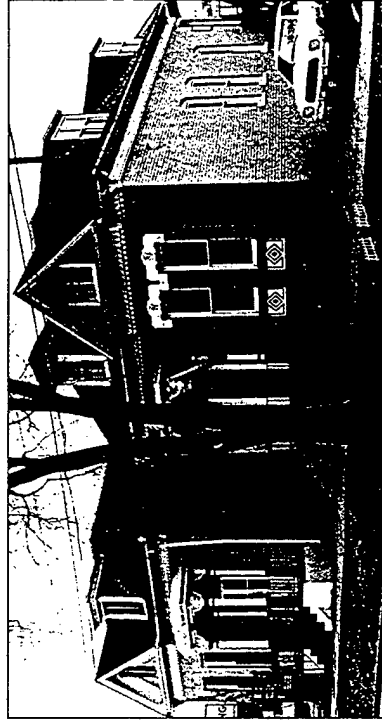
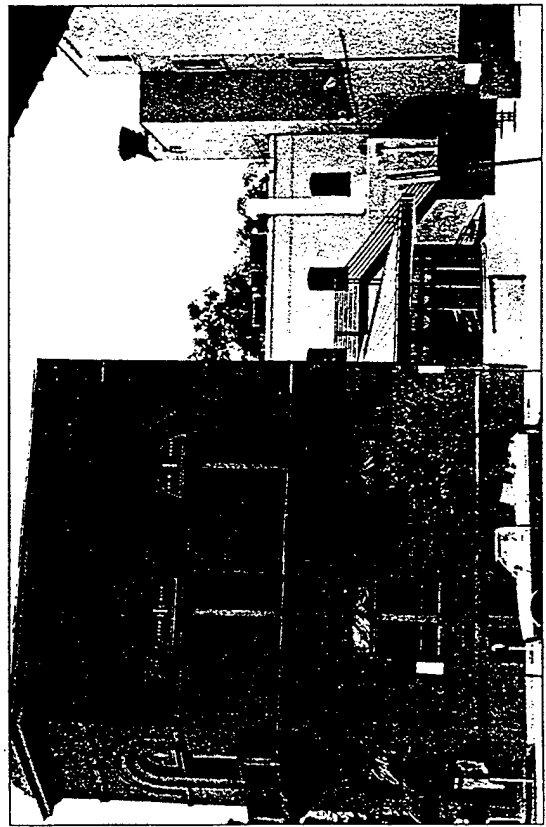
In rehabilitating a historic bank for a new use, a small restaurant addition was built on the rear. The new addition is compatible with the historic building primarily because of its scale and location.

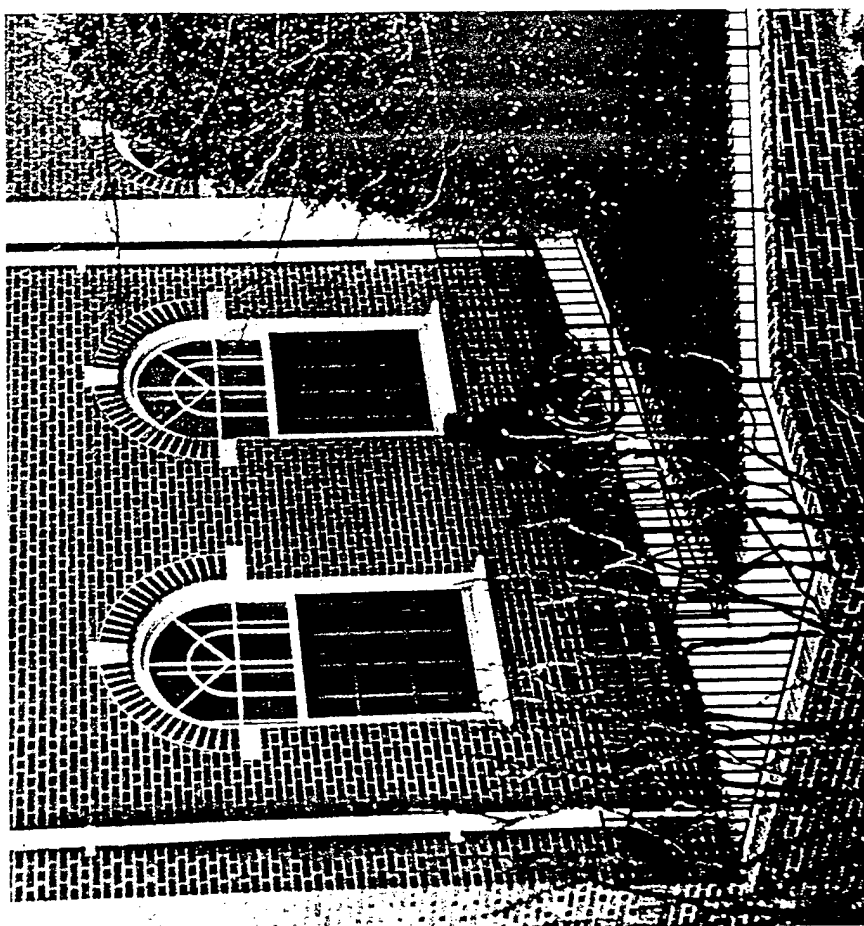
it to meet both accessibility and historic preservation requirements. Thus, work must be carefully planned and undertaken so that it does not result in a loss of character-defining spaces, features, and finishes. The goal is to provide the highest level of access with the lowest level of impact.

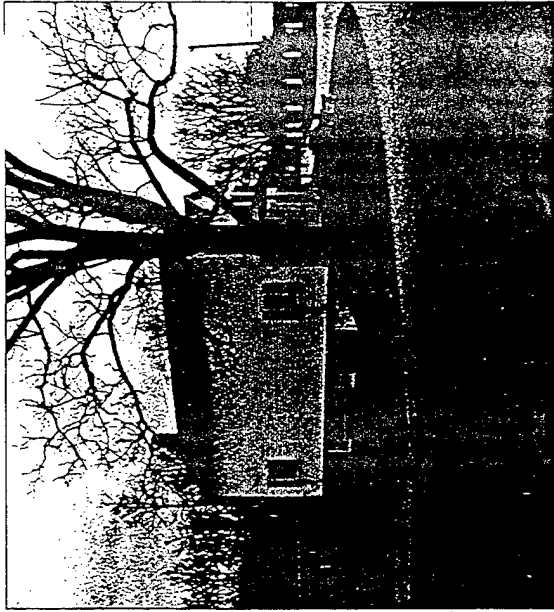
Photo: Cuyahoga Valley National Recreation Area, NPS

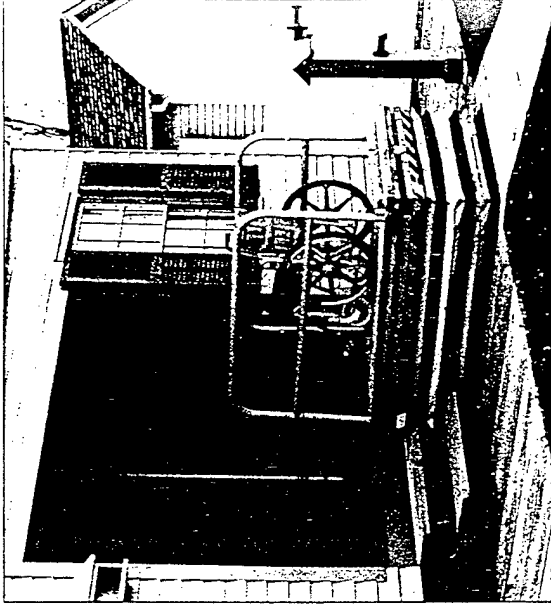
An air-condition-type platform lift that retracts to ground level when not in use has been installed to make this historic house accessible.

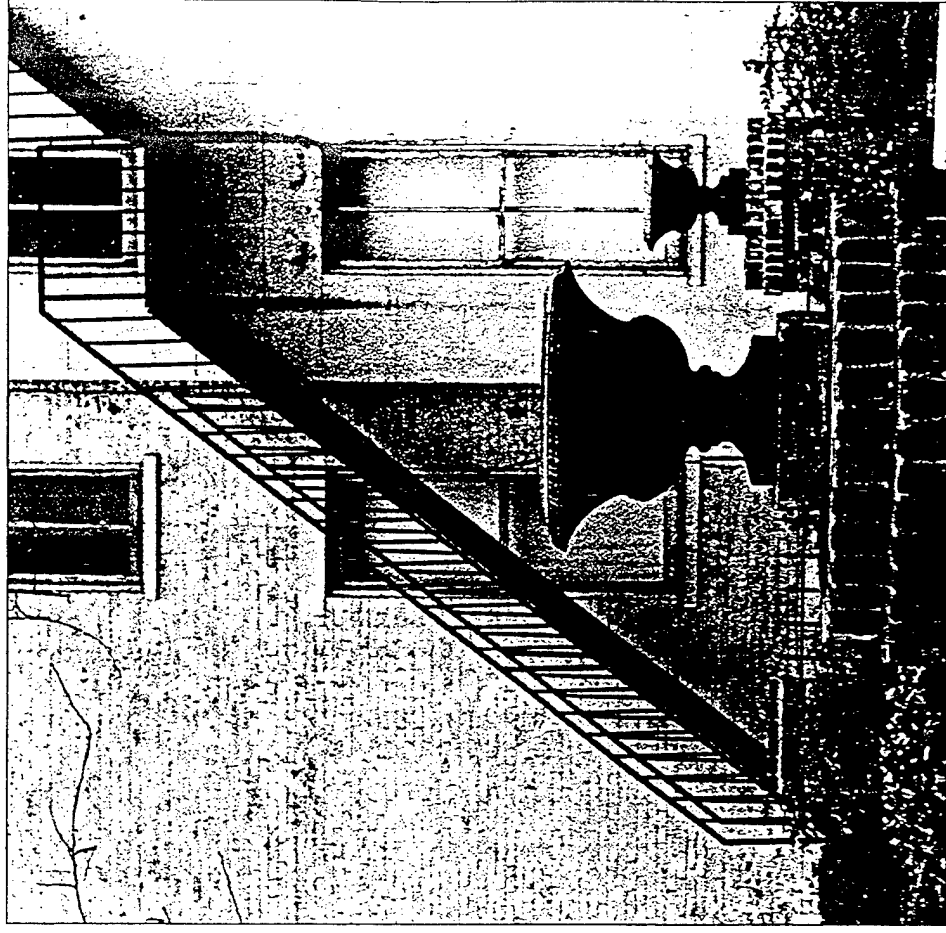
should wear proper personal protective equipment. Finally, preventive and routine maintenance programs for historic structures known to contain such materials should also be developed to include proper warnings and precautions.

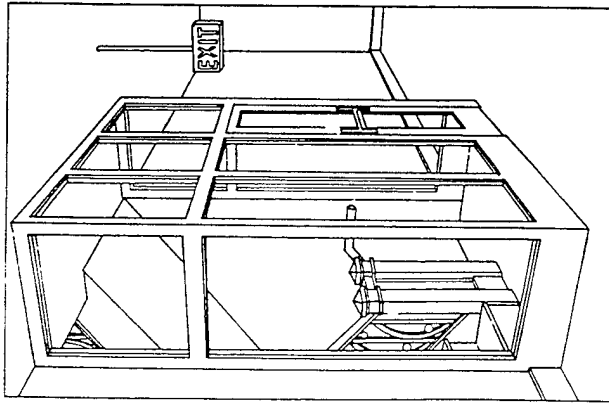
Existing decorative staircases in historic buildings may meet safety requirements if enclosed with safety glass. This enclosure preserves the stairs while providing a secure means of egress.

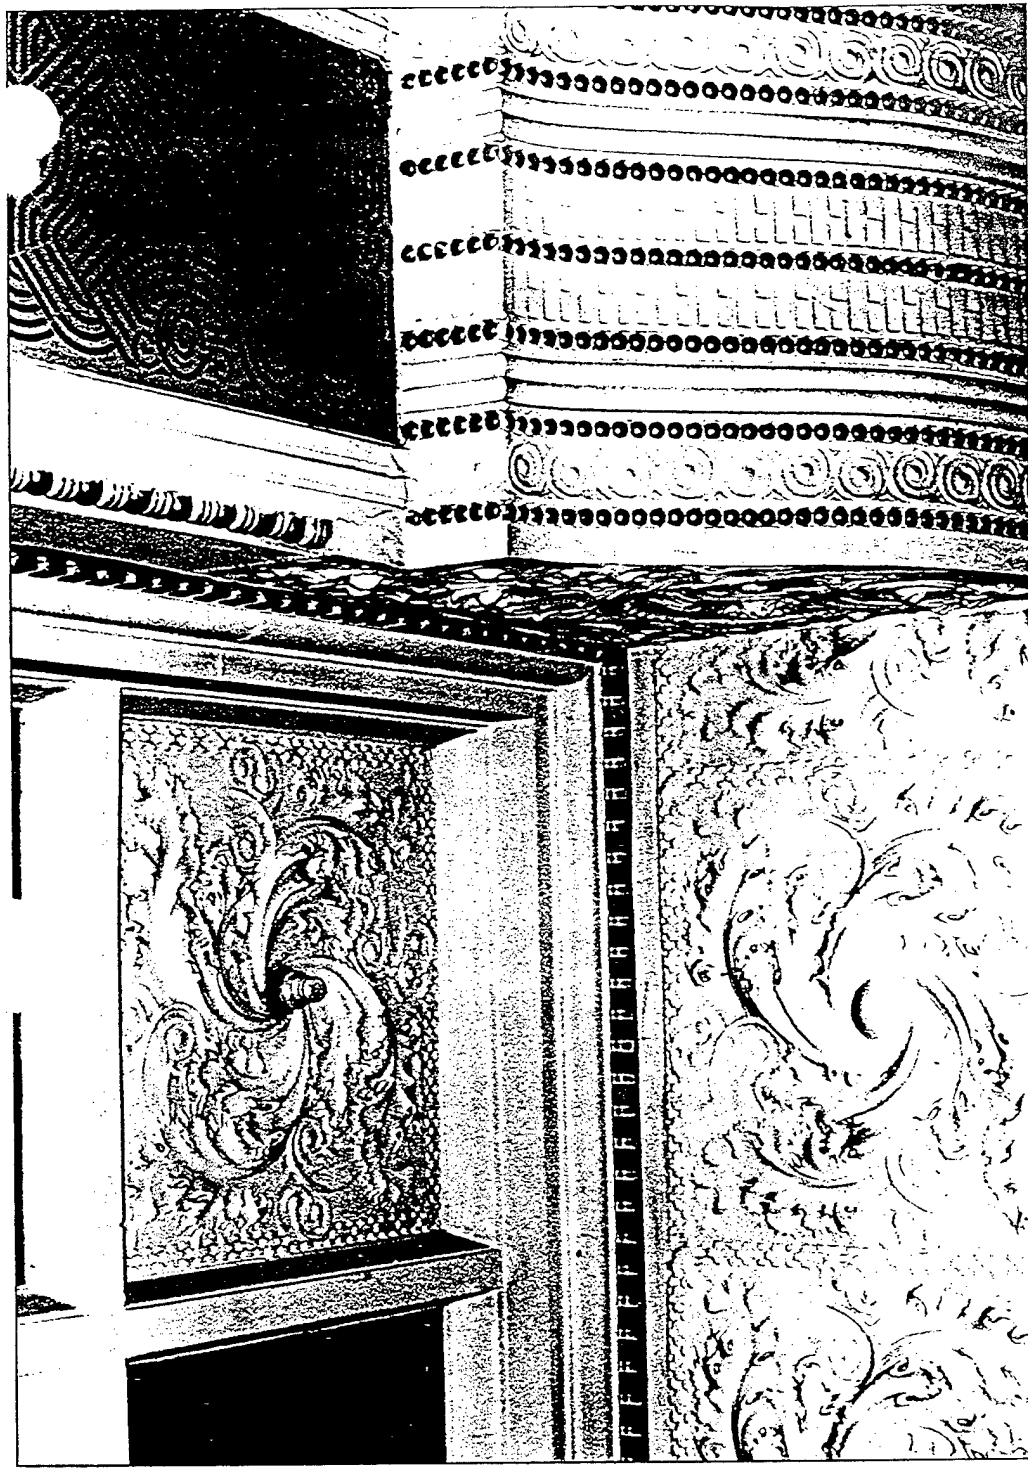
A sprinkler has been sensitively installed in this highly ornamental plaster ceiling during the building's rehabilitation. Sprinkler heads have been unobtrusively located in the center of the decorative plaster relief.

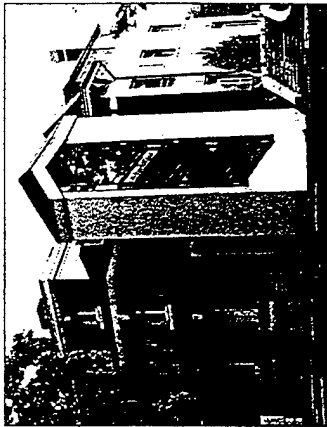
In buildings such as this historic courthouse, where old lead-based paint is essentially intact and covered with a lead-free topcoat, removing the historic paint because of potential toxicity may not be necessary. Historic paint can provide valuable documentation about the evolution of a building and should be retained, whenever possible.

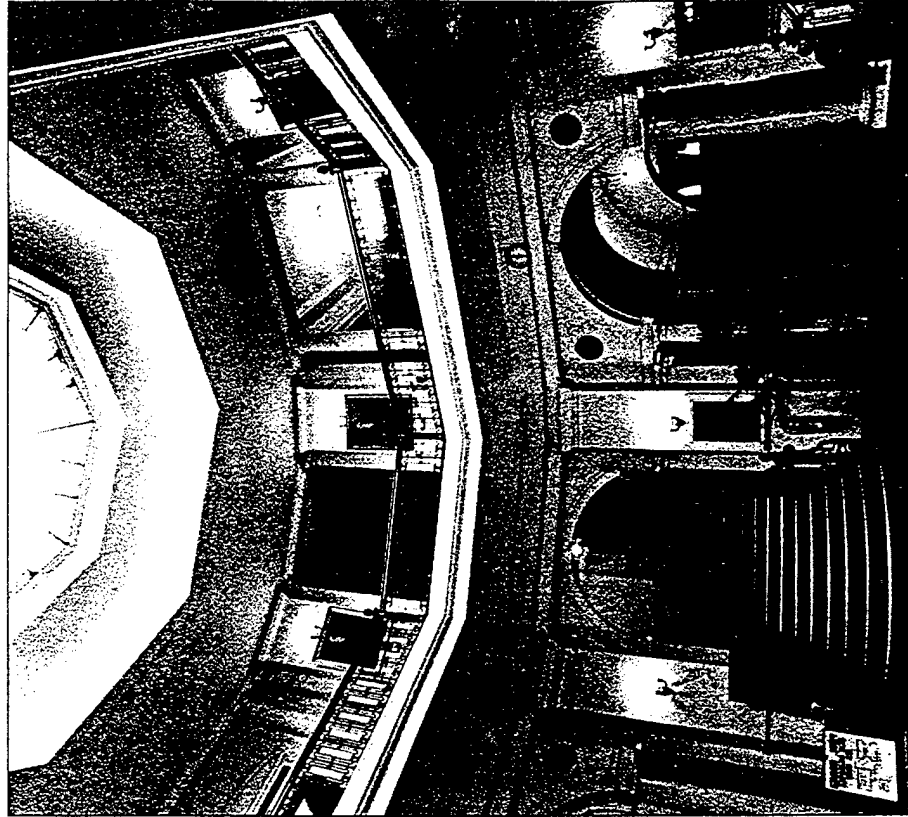
Technical
Guidance
Publications

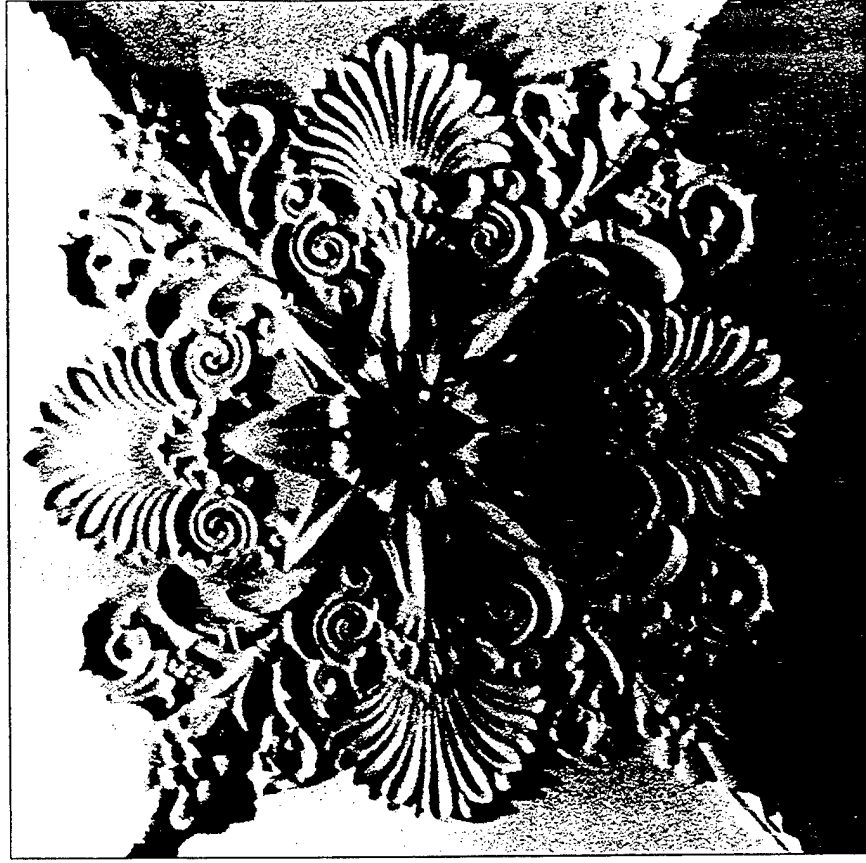
Office, National Technical Information Service, American Association for State and Local History, and Historic Preservation Education Foundation. A Catalog of Historic Preservation Publications with stock numbers, prices, and ordering information may be obtained by writing: National Park Service, Preservation Assistance Division, P.O. Box 37127, Washington, D.C. 20013-7127.

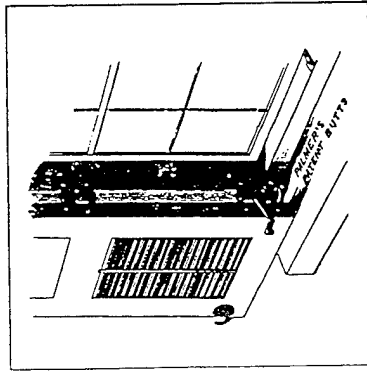
of the 20th century. Explains steps for cleaning and repairing damaged steel windows; also provides information on appropriate methods of weatherstripping and options for storm panels or the installation of thermal glass. 12 pages. 10 illustrations. 1984.

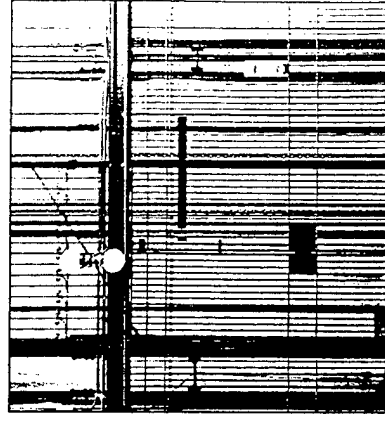
Photo: Richard Nickel, HAHS

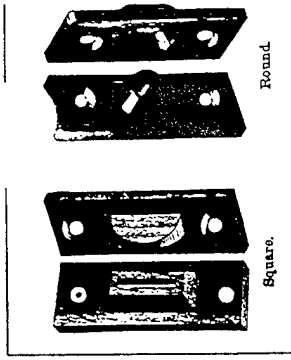
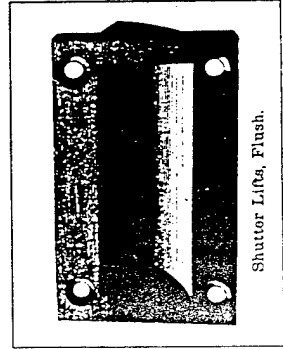
ing and repairing architectural cast iron within rehabilitation projects. 14 pages. 25 illustrations. September, 1991.

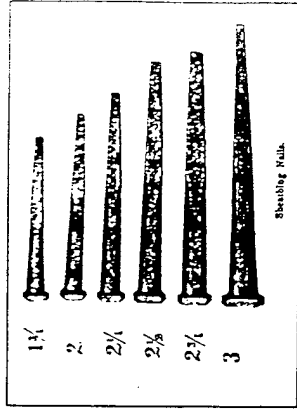
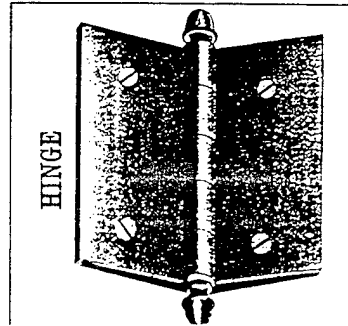
cleaners and removal techniques. 45 pages. 35 illustrations. Bibliography.

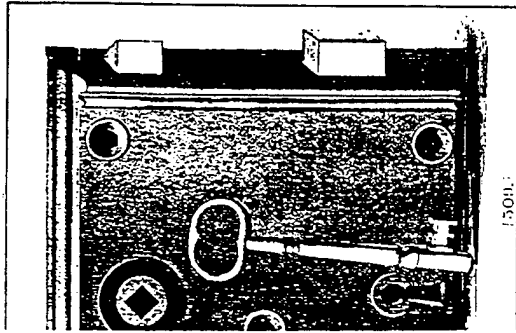
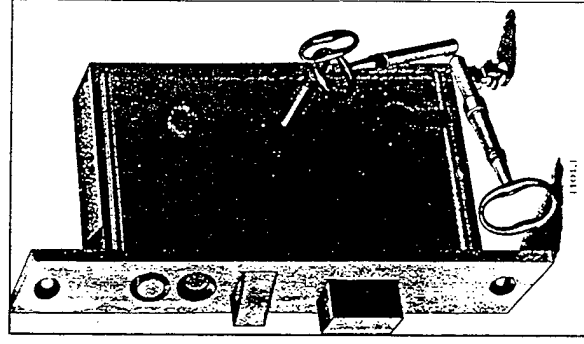
flashing, and painting. 58 pages. 15 illustrations. Secretary of the Interior's Standards as Appendix. 1979.

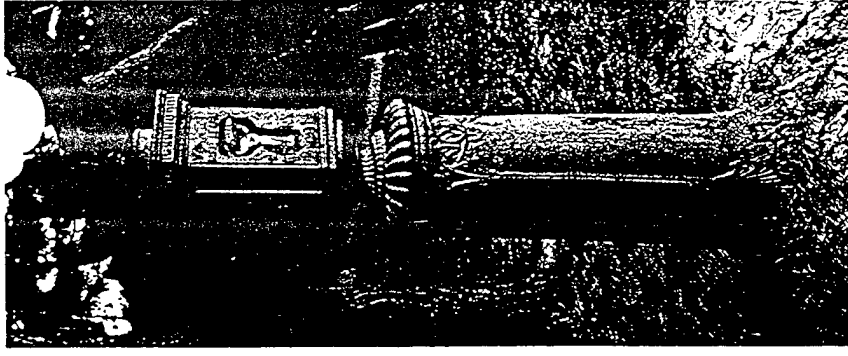
Photo: Jack E. Boucher.

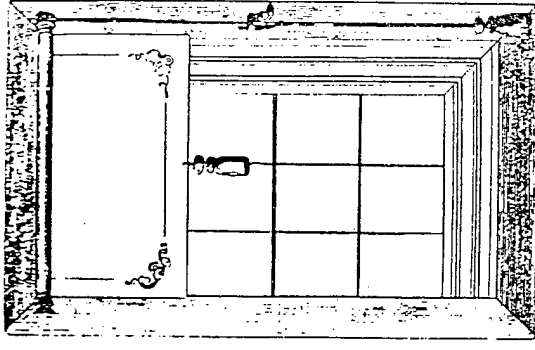
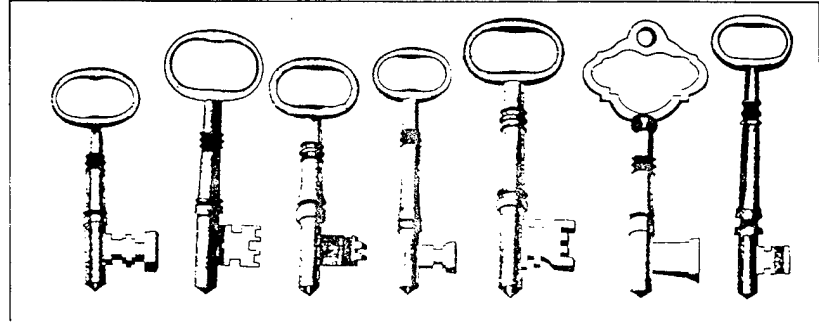
PTN 24 Mechanical Systems(1): Replicating Historic Elevator Enclosures by Marilyn E. Kaplan, AIA. June, 1989.

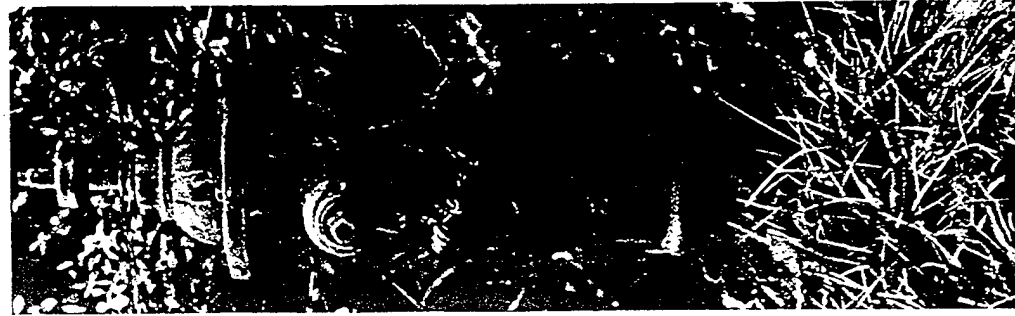
PTN 36 Windows(19): Aluminum Replacement With True Divided Lights, Interior Piggyback Storms, and Exposed Historic Wooden Frames by Charles Parrott. October, 1991.

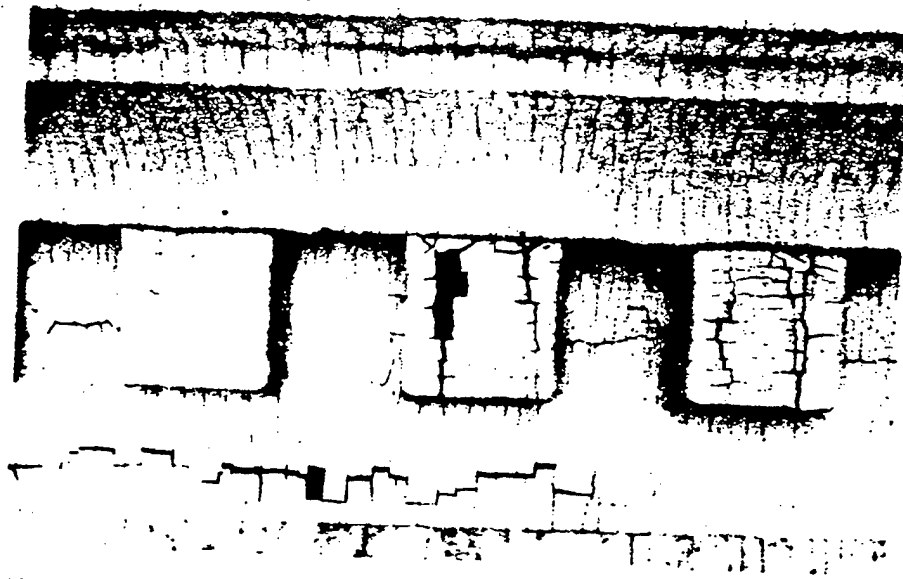
Figure 1. Detail of a cornice dentil shows the severe cracking and failure of paint finish. Photo: Alan O'Bright

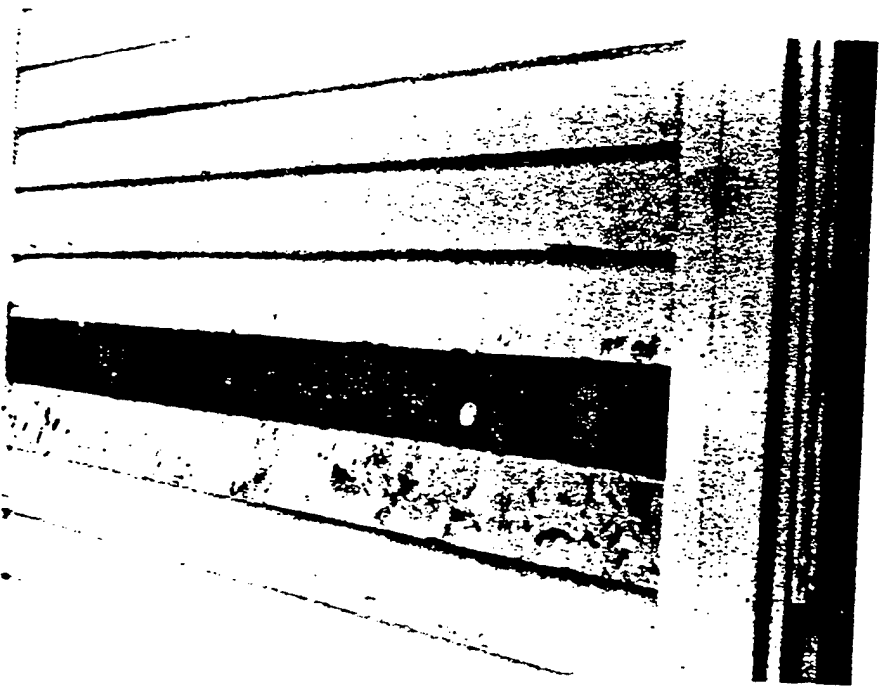
Figure 2. In assessing the safety of using thermal heat to remove paint from the siding, an investigation was performed to determine wall construction and condition. In this portion of the structure, there was no sheathing backing the siding but brick nogging extended from the foundation to the soffit. Photo: Alan O'Bright

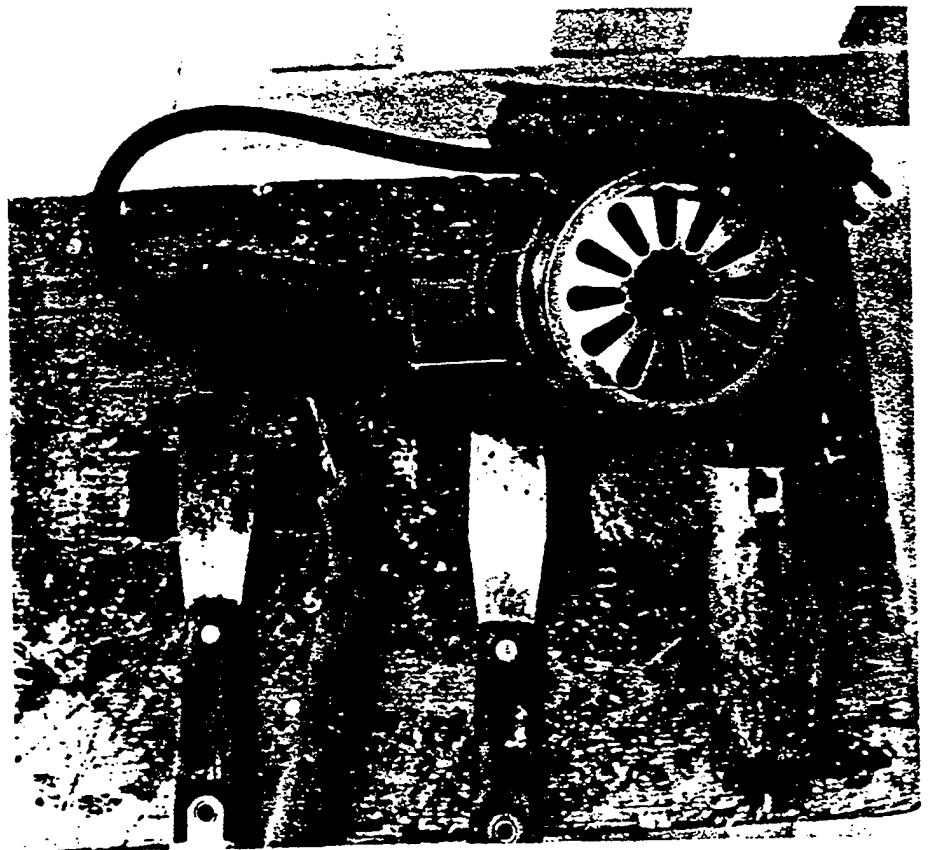
Figure 3. Heat guns, putty knives with corners rounded, and paint scrapers were used in paint removal. Photo: Michael Lee

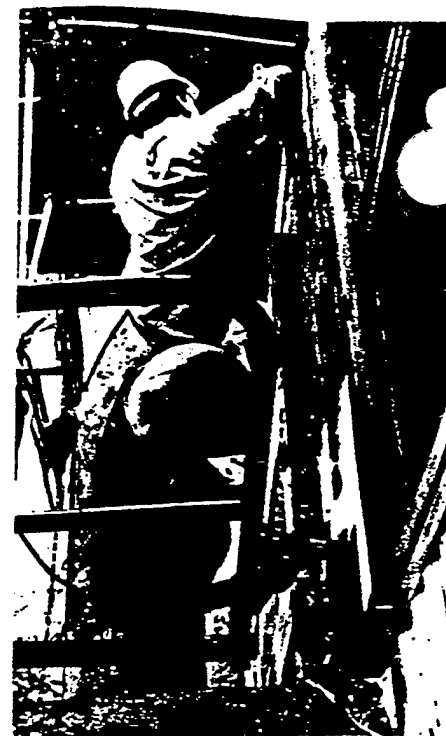
Figure 5. Using scaffolding, workers remove the paint with heat guns. Cracked or deteriorated siding was repaired or replaced. Photo: Alan O'Bright

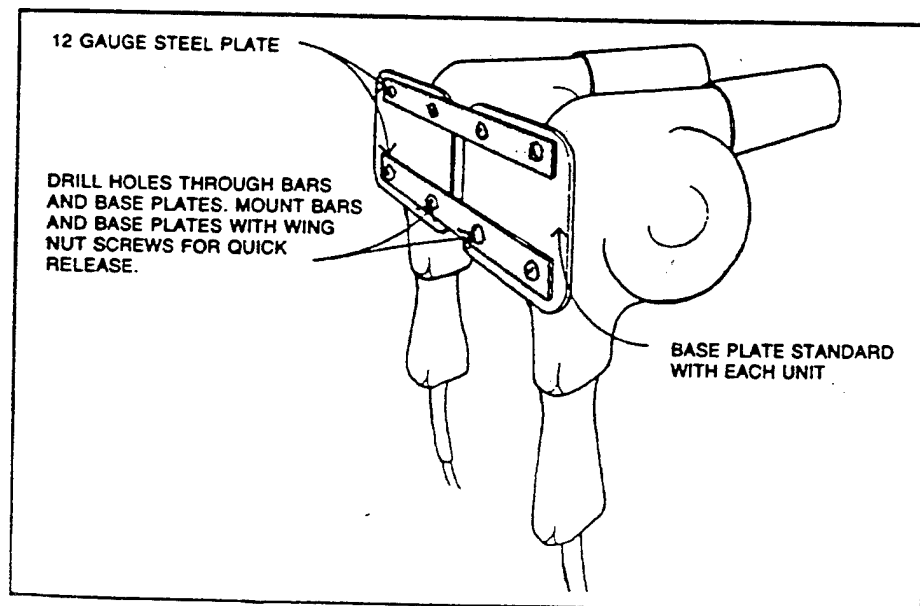
Figure 4. Method used to join two heat guns for simultaneous use. Drawing: Alan O'Bright

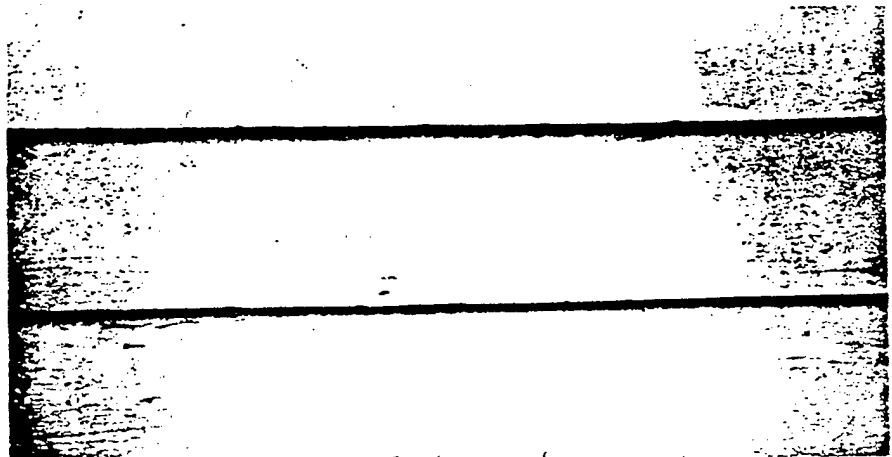
Figure 6. A typical section of the finish painted siding shows that little damage was done in removing the paint. Photo: Michael Lee

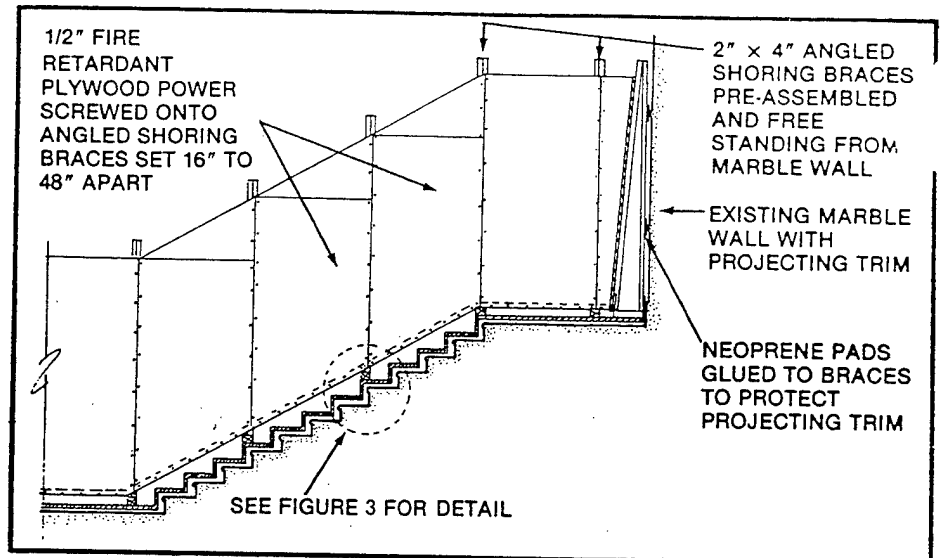
Figure 1. The Villard Houses include stairways ranging from very elegant (seen here) to quite simple. All could have been damaged if not protected during the extensive rehabilitation work. Photo: Steven Zane, HABS Collection.
