Management and Maintenance Manual
The Old Hospital Complex
Fort Carson, Colorado
(5EP1778)

James Schneck

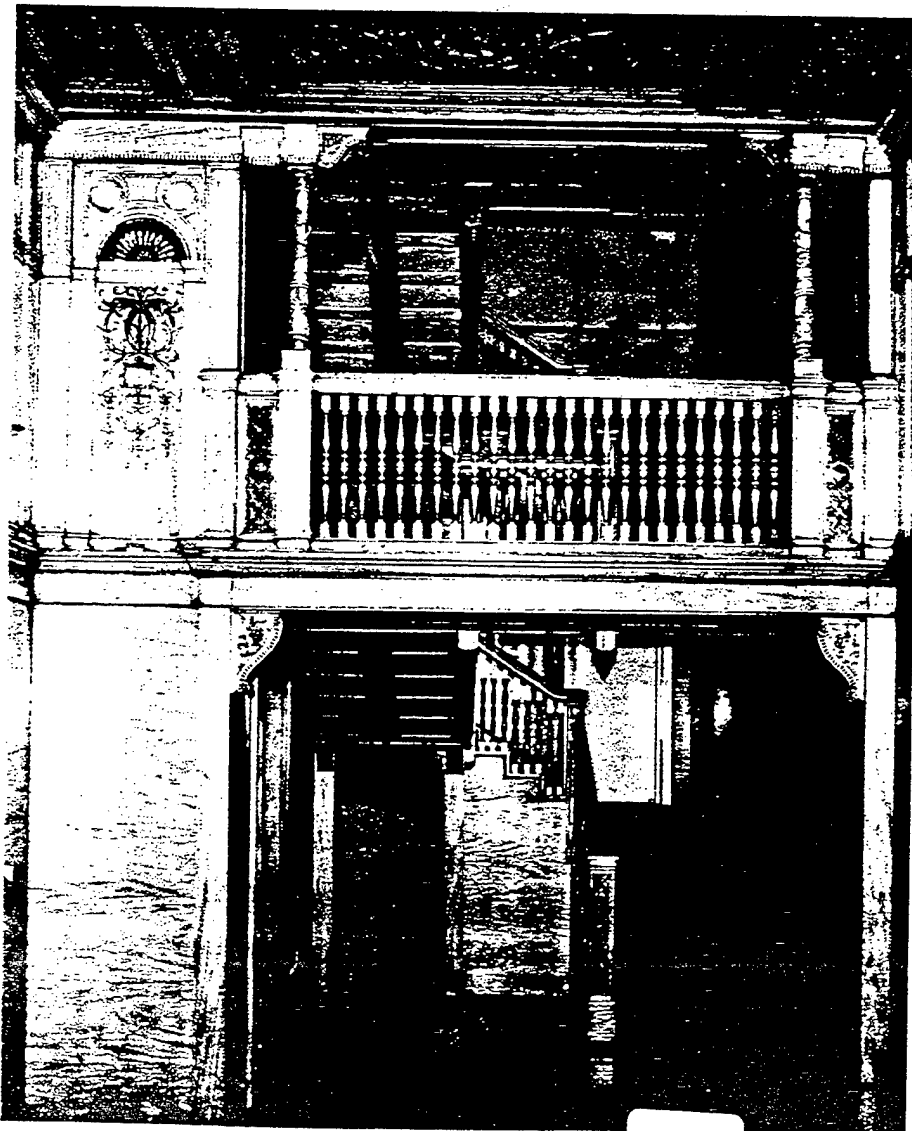
Figure 2. A system for protecting the decorative staircases was drawn and specified by the project architect. Drawing: Christina Henry.

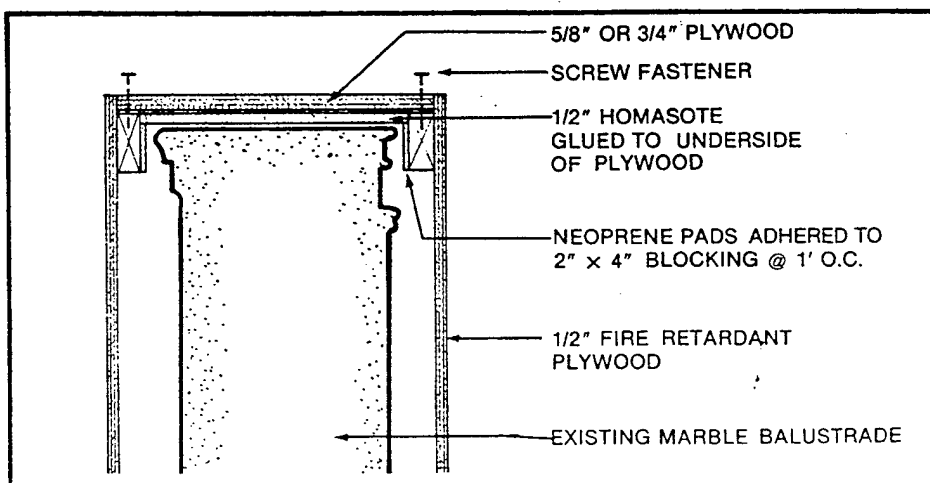
Figure 5. As with the step detailing, the temporary protection over the balustrade and hand railing used plywood padding, blocking, and screw fasteners to minimize possible damage. Drawing: Christina Henry.

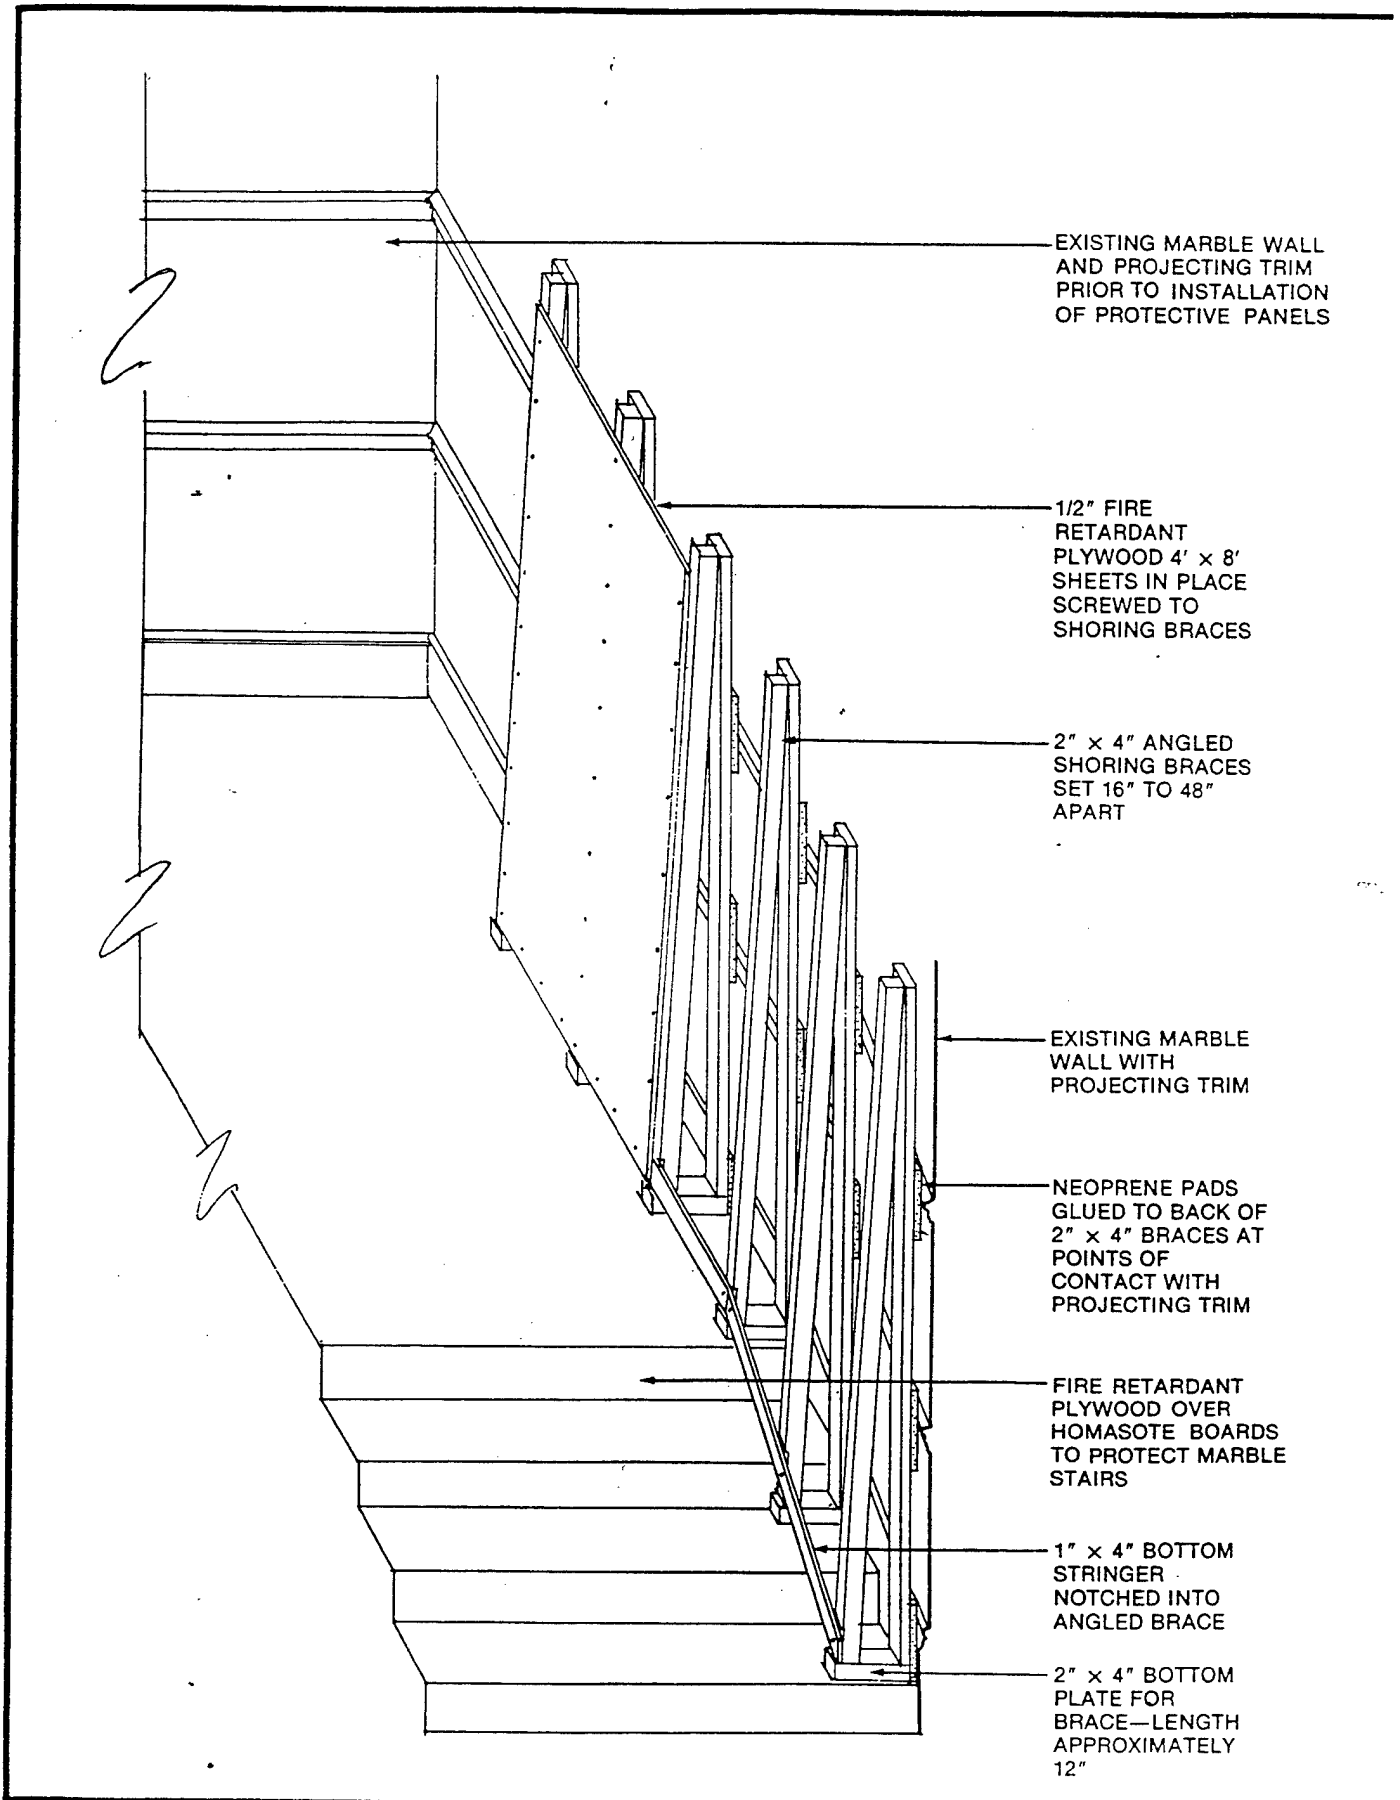
4 Figure 7. The temporary wall covering going up the stairs consisted of plywood mounted on a wooden frame. Neoprene padding was used where the frame abutted the historic walls. The method shown here requires no fasteners to be used, avoiding possible damage to the decorative walls. Drawing: Sharon Park, A.I.A.

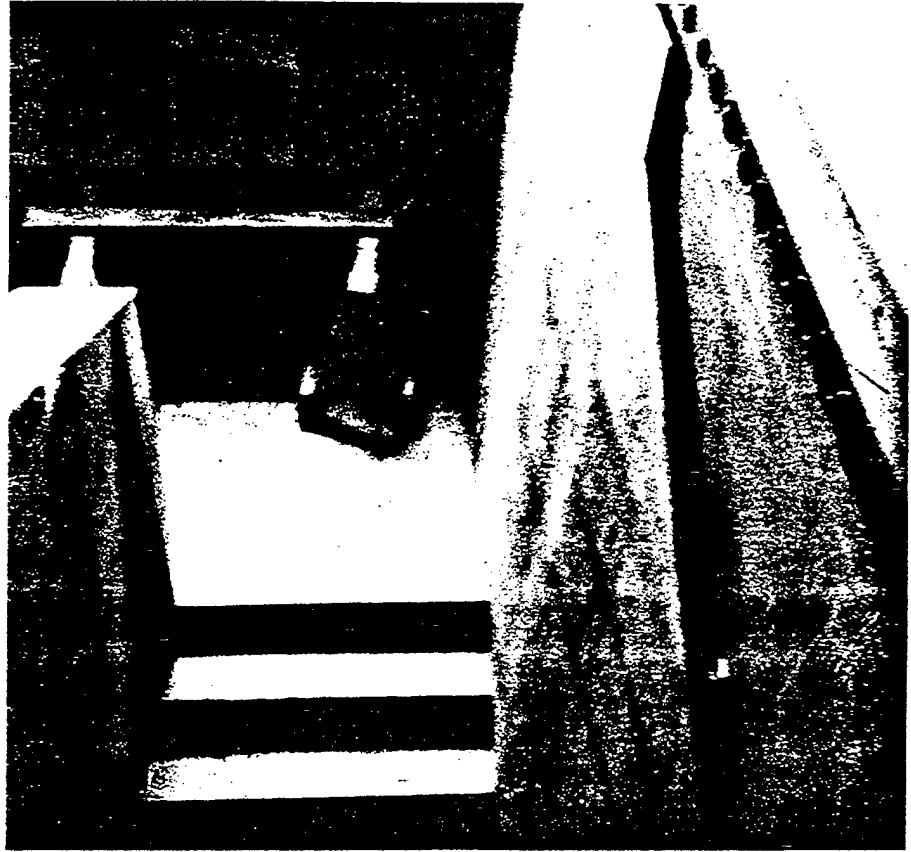
Figure 6. The balustrade on the left side of the photograph has been entirely encased in plywood to protect it from damage. Note that the kick-out at the end is due to the protrusion of the newel post. Photo: Charles Fisher.

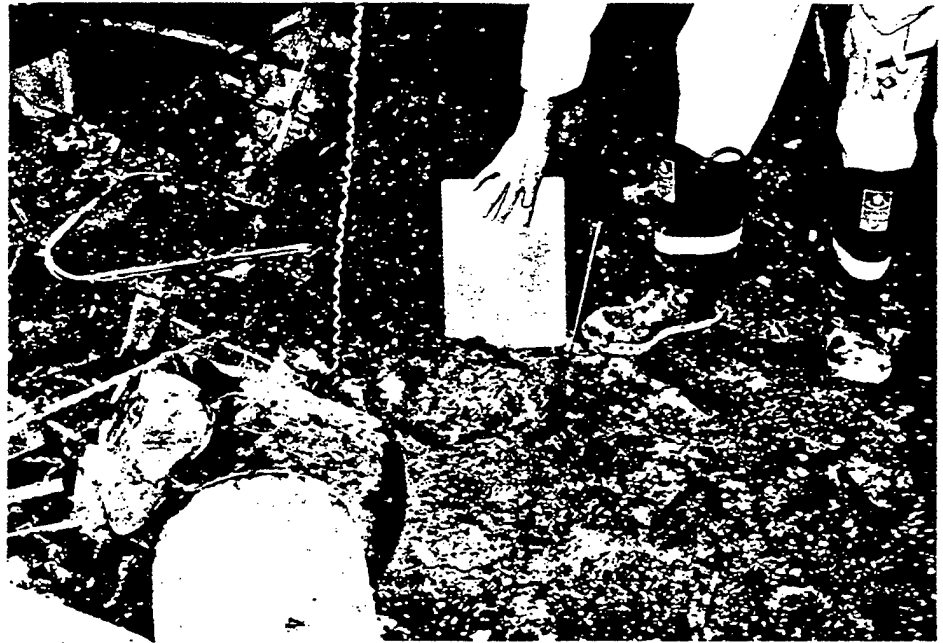
Figure 1. The spontaneous combustion of cloth rags that had been used in applying a common finishing wax caused over \$1 million damage to a historic government office building in 1991. Remains of the trash can where the rags had been stored overnight is indicated by the fireman's notepad. After the cause of the fire was determined, a standard specification provision was developed for future contracts requiring the contractor to remove all material contaminated with finishing products from the site at the end of the day.

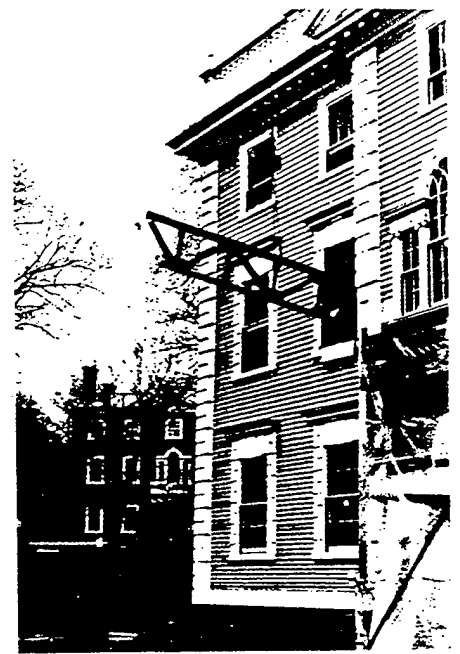
Figure 2. Because of the fire risks, open flame cutting and welding deserves careful attention both in the preparation of specifications and during the work. As much welding as possible should be done off site. For example, at the Nightingale-Brown House, several large trusses were assembled off site, then carefully hoisted through a window for installation. Photo: Irving B. Haynes and Associates.

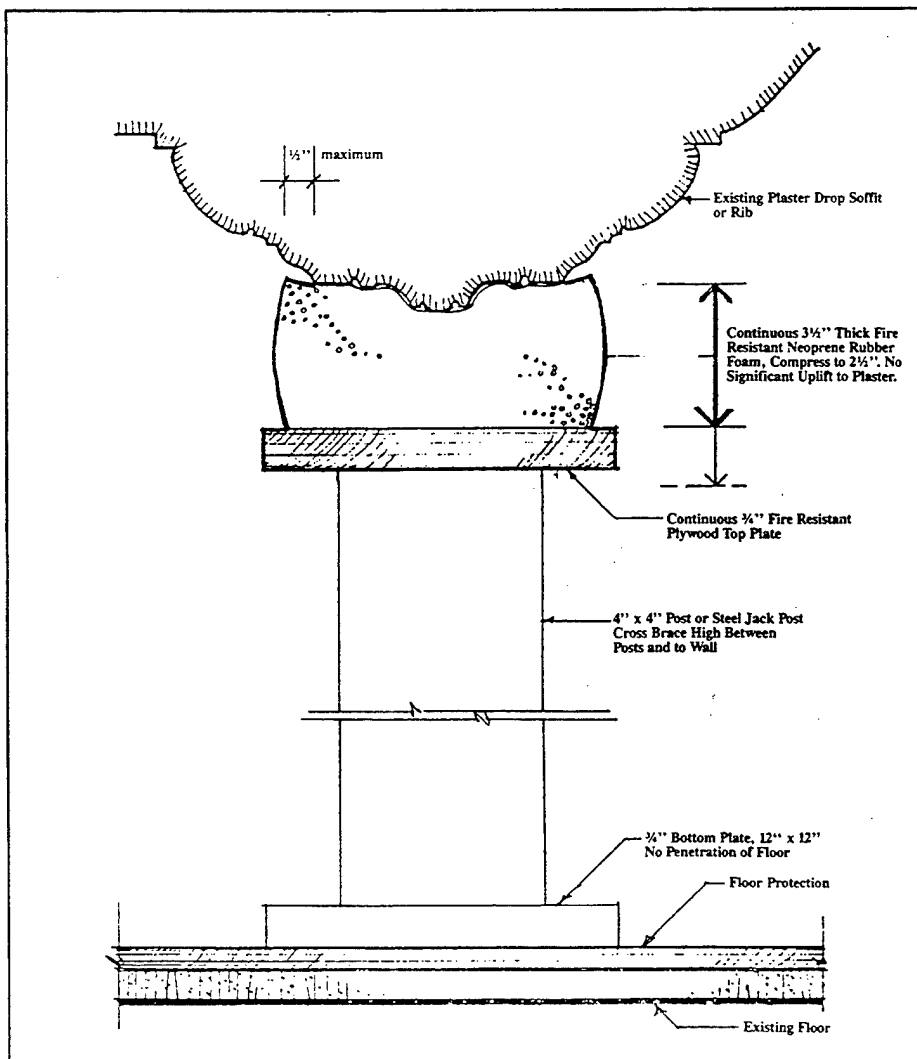
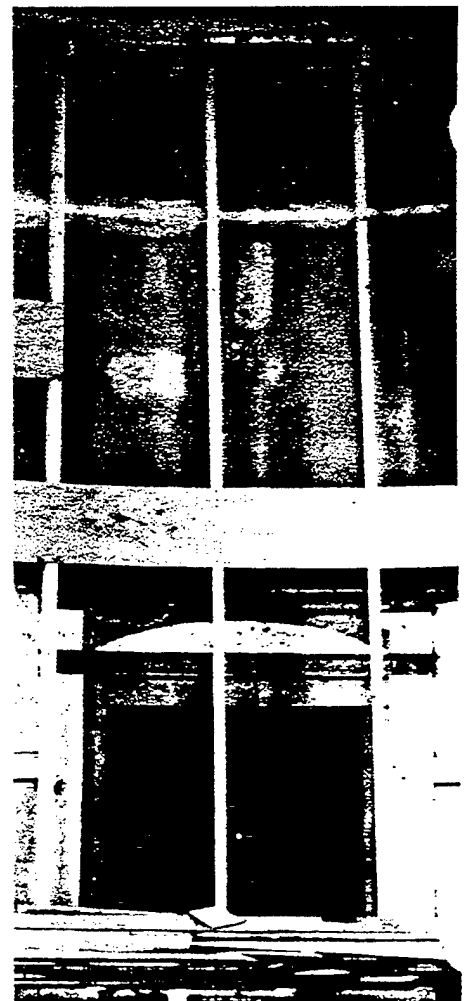
Figure 3. Vibrations generated during construction may necessitate the installation of temporary support for such fragile features as plaster ceiling cornices and soffits. Drawing: Villard Houses — courtesy of Emery Roth & Sons Architects. P.C. Photo: The Octagon, Lonnie Hovey, AIA.

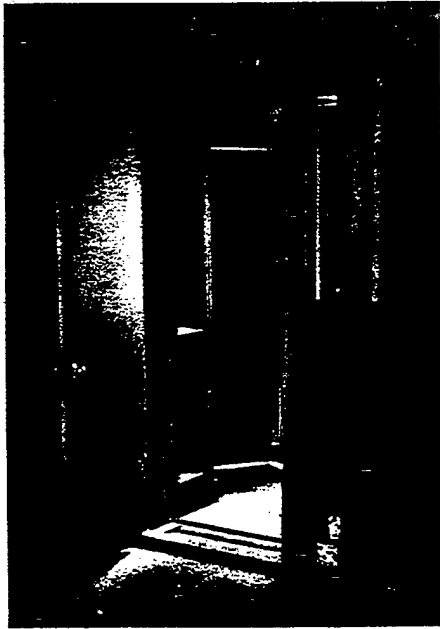
Figure 4. Temporary protection during construction can involve covering historic features, such as floors and walls, as well as using temporary doors to control the passage of workers and the inevitable dust and dirt. Prominently located fire extinguishers are mandatory. Photo: Lonnie Hovey, AIA, The Octagon.

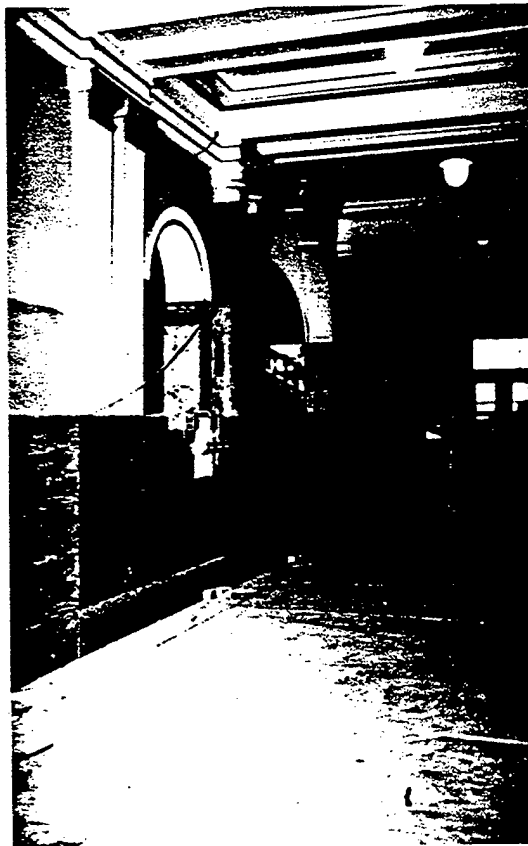
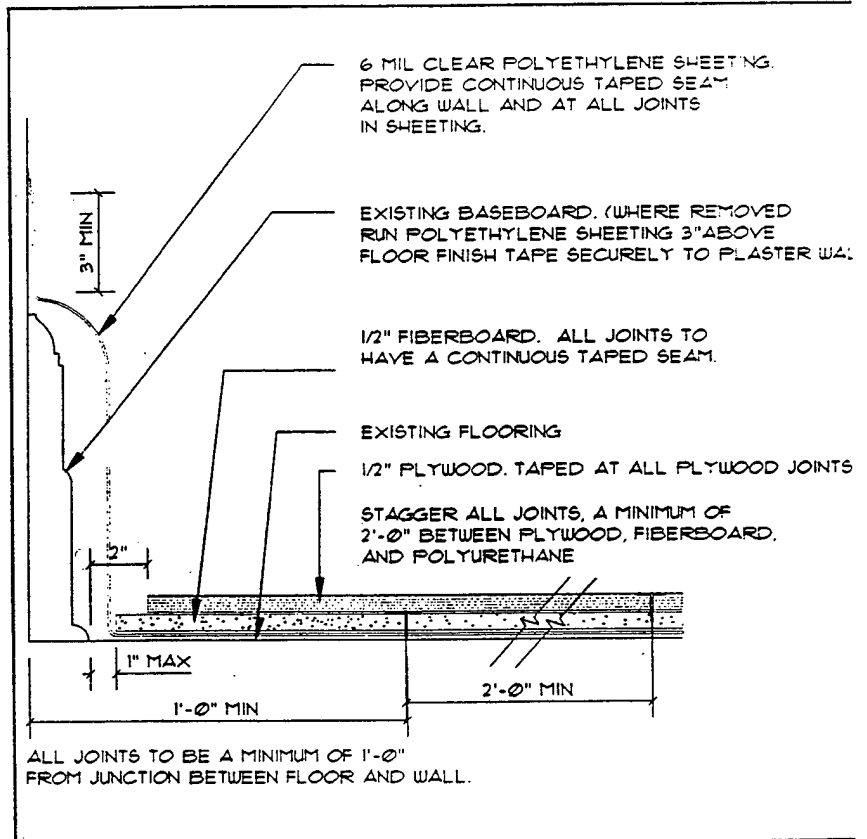
Figure 5. To provide for adequate floor protection in the New Jersey State Capitol, this area was swept clean, then covered with polyethylene sheeting to protect against spills and dirt abrasion. Fiberboard (1/2" thick) was placed over floors and the joints sealed with tape. Finally 1/2" plywood was laid with all joints taped. This floor protection system has been successful over many years of use and is recommended in major construction areas, and where tile, marble, parquet wood, or other historic flooring is involved. Photo and drawing: Ford Farewell Mills and Gatsch Architects.

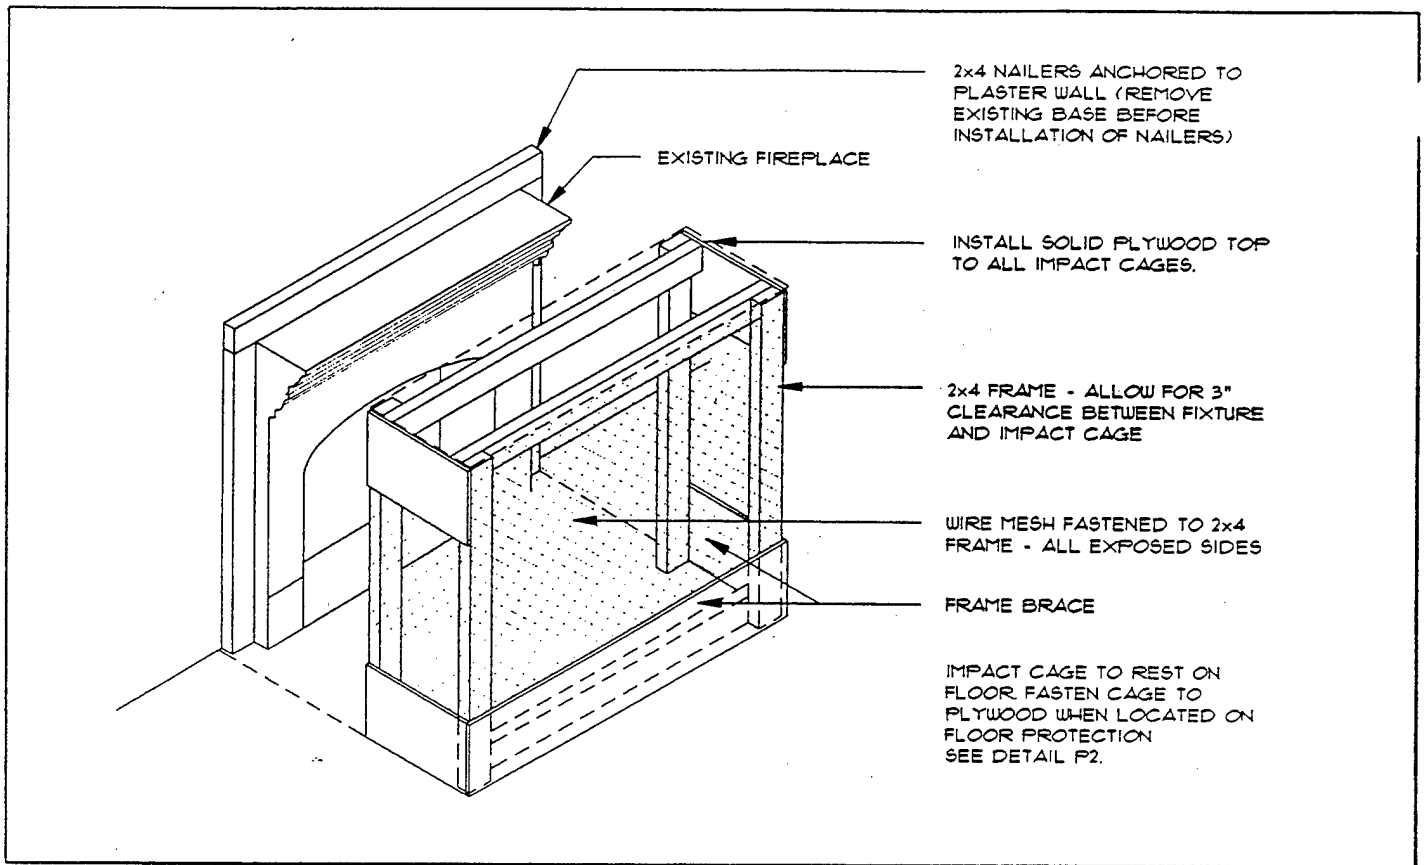
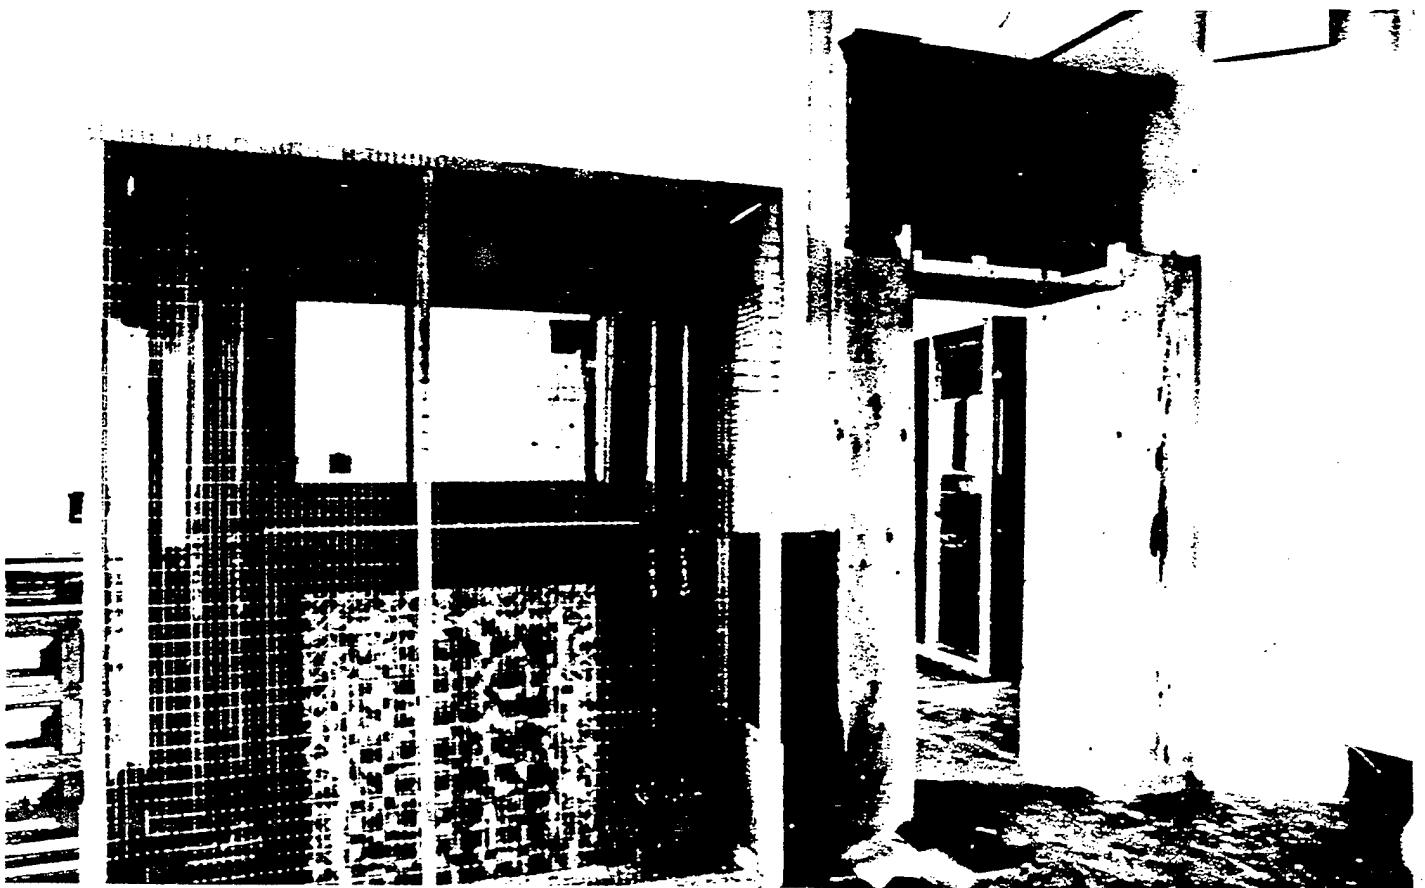
Figure 6. A self-supporting impact cage utilizing wood and wire mesh protects the fireplace. In this project, the long construction process required bidders to have visible access to features such as the fireplace. The wire mesh also facilitated monitoring during the lengthy construction. Photo and drawing: Ford Farewell Mills and Gatsch Architects.

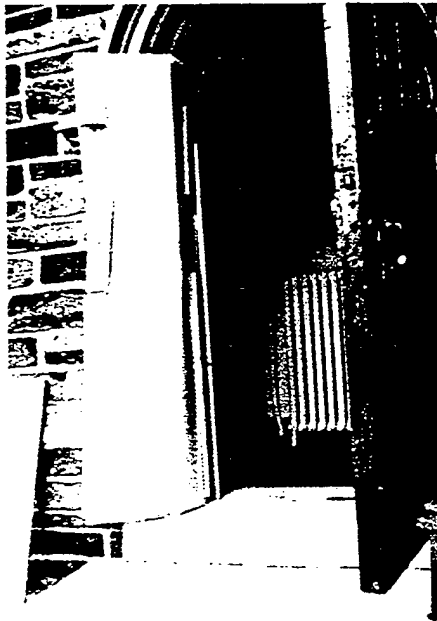
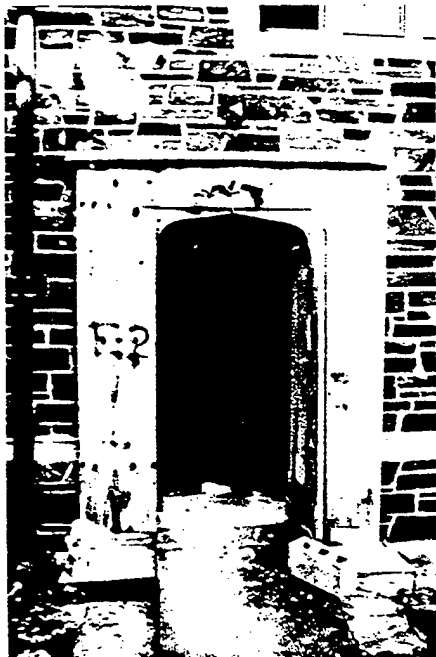
Figure 7. A contractor's solution to protecting the limestone door surround consisted of thin foam sheeting, secured with wood nailed to the masonry. This protection was rejected as inadequate by the architect, and a full plywood enclosure constructed. In the architect's solution, it should be noted that a temporary door is used while the original door is stored for safe keeping during construction. Photo: Ford Farewell Mills and Gatsch Architects.

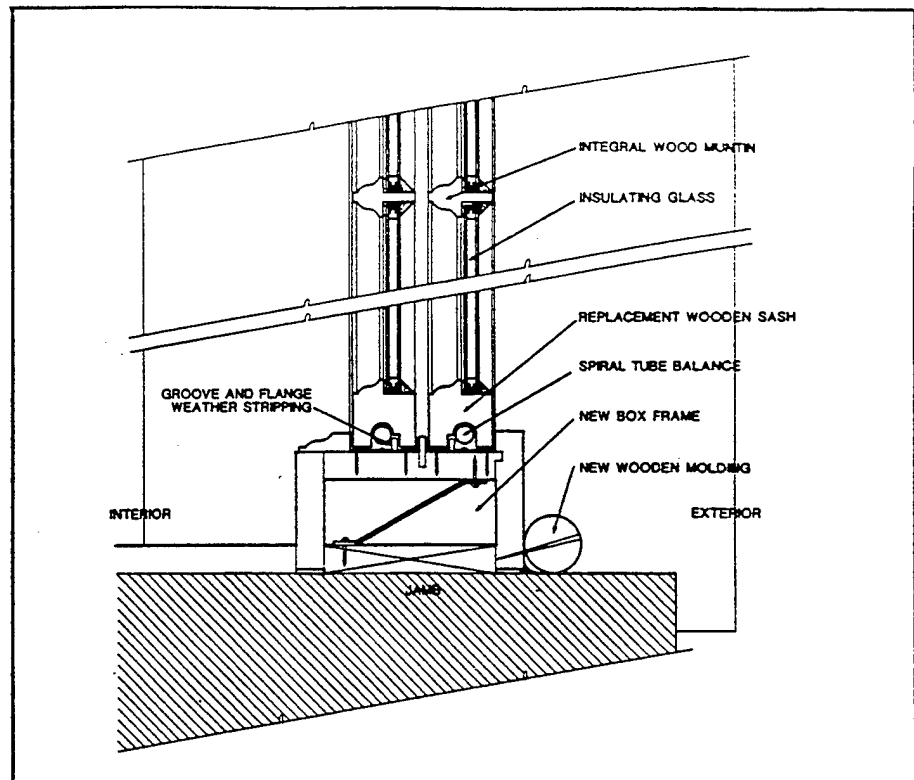
Figure 1. The wooden replacement windows had two individual lights of insulating glass in each sash with an integral (as opposed to "fake") muntin. Drawing: Penelope S. Watson

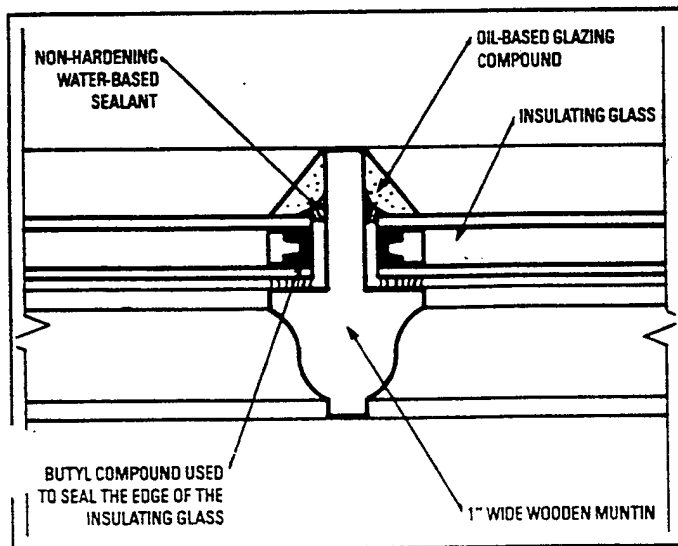
Figure 3. Glazing detail shows how the non-hardening water-based glazing sealant was used to separate the butyl compound (used to seal the insulating glass) from the oil-based glazing compound. Drawing: Penelope S. Watson

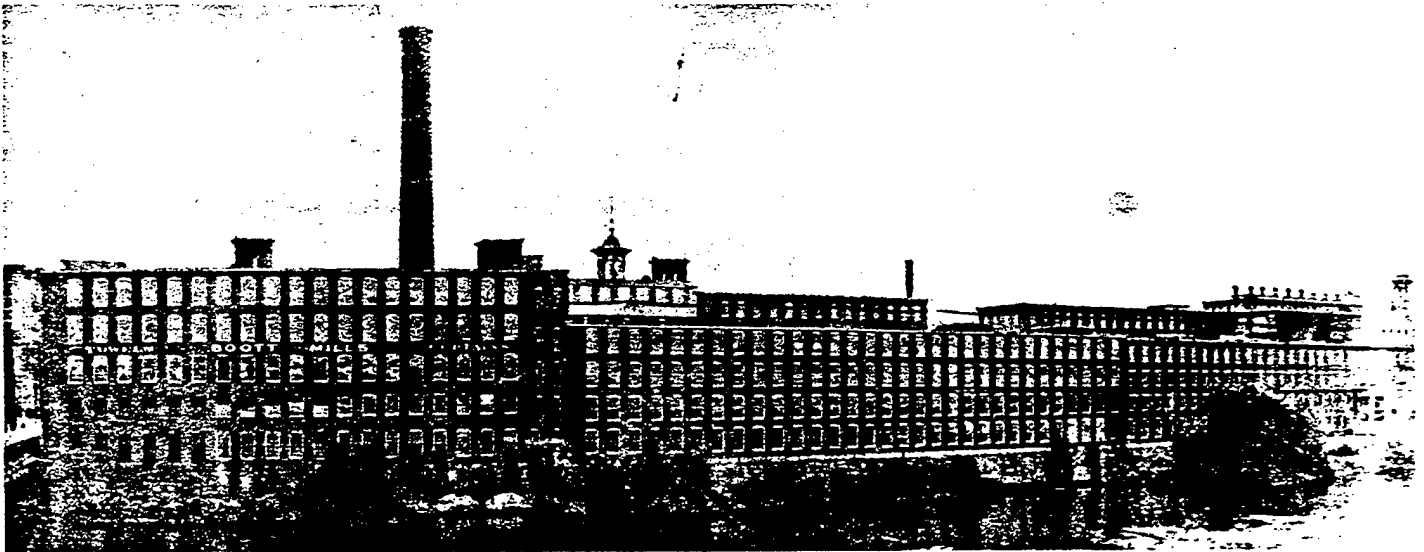
Figure 1. The windows are the dominant element of detail and decoration in the Boott Cotton Mills. Photo: Courtesy of the Center for Lowell History

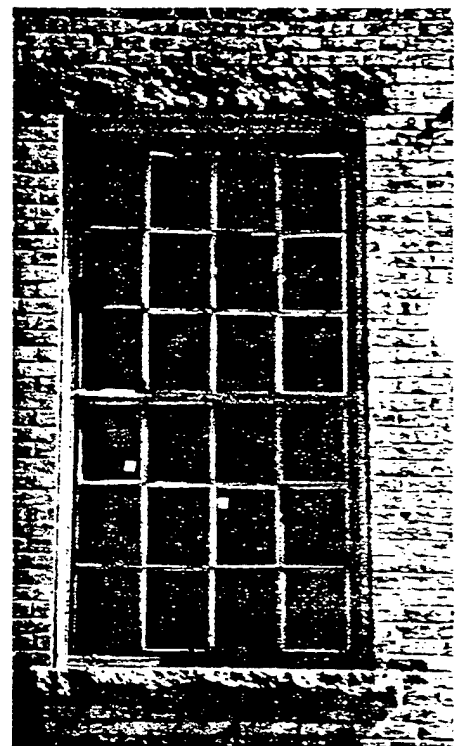
Figure 2. Because of the historic character and significance of the complex, replacement sash needed to have true divided lights and the dimensions and profiles of visible elements needed to be close copies of the originals. Photo: Courtesy of Huygens DiMella Shaffer

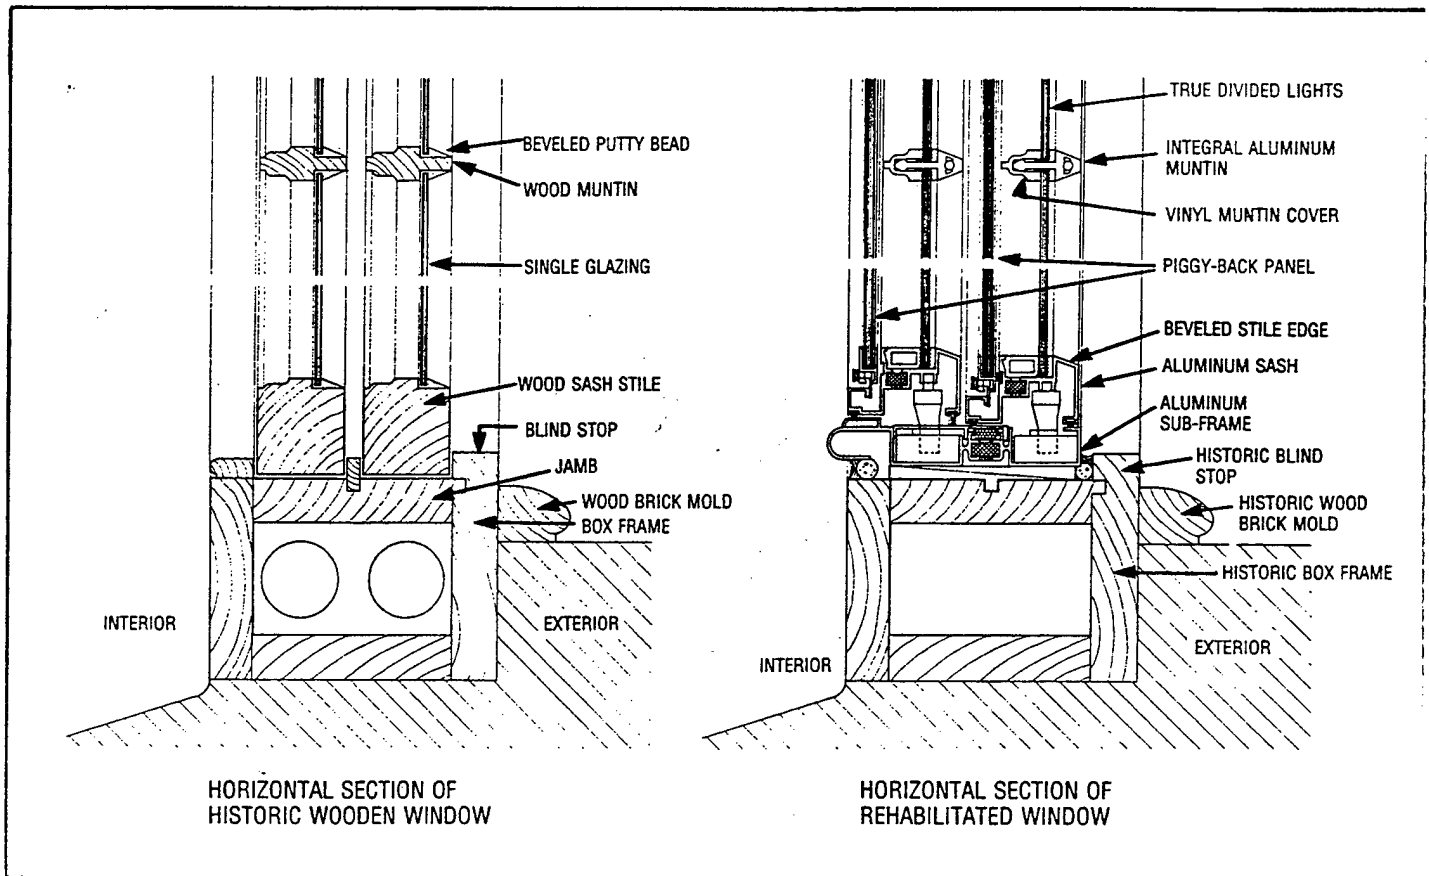
Figure 3. Horizontal section of the window shown with old and new sash. Drawing: Timothy Buehner

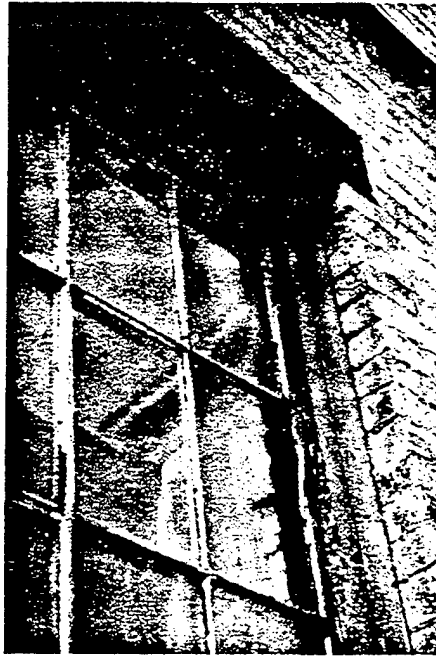
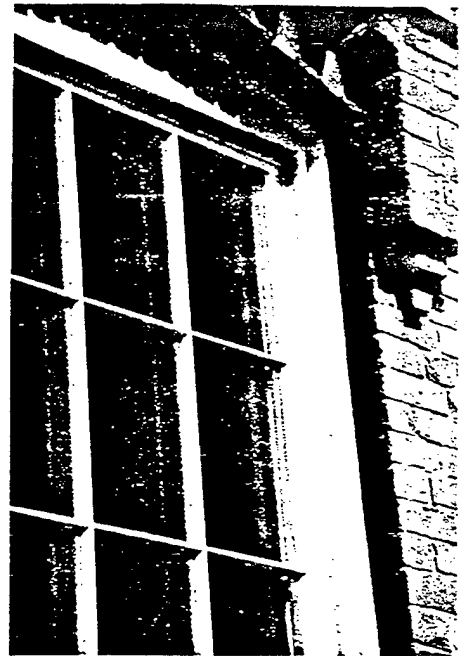
Figure 4. The decision to use an integral muntin for the outer glazing and a piggy-back interior glazing panel was an important component of the successful window solution. Sash shown before and after rehabilitation. Photos: Charles Parrott

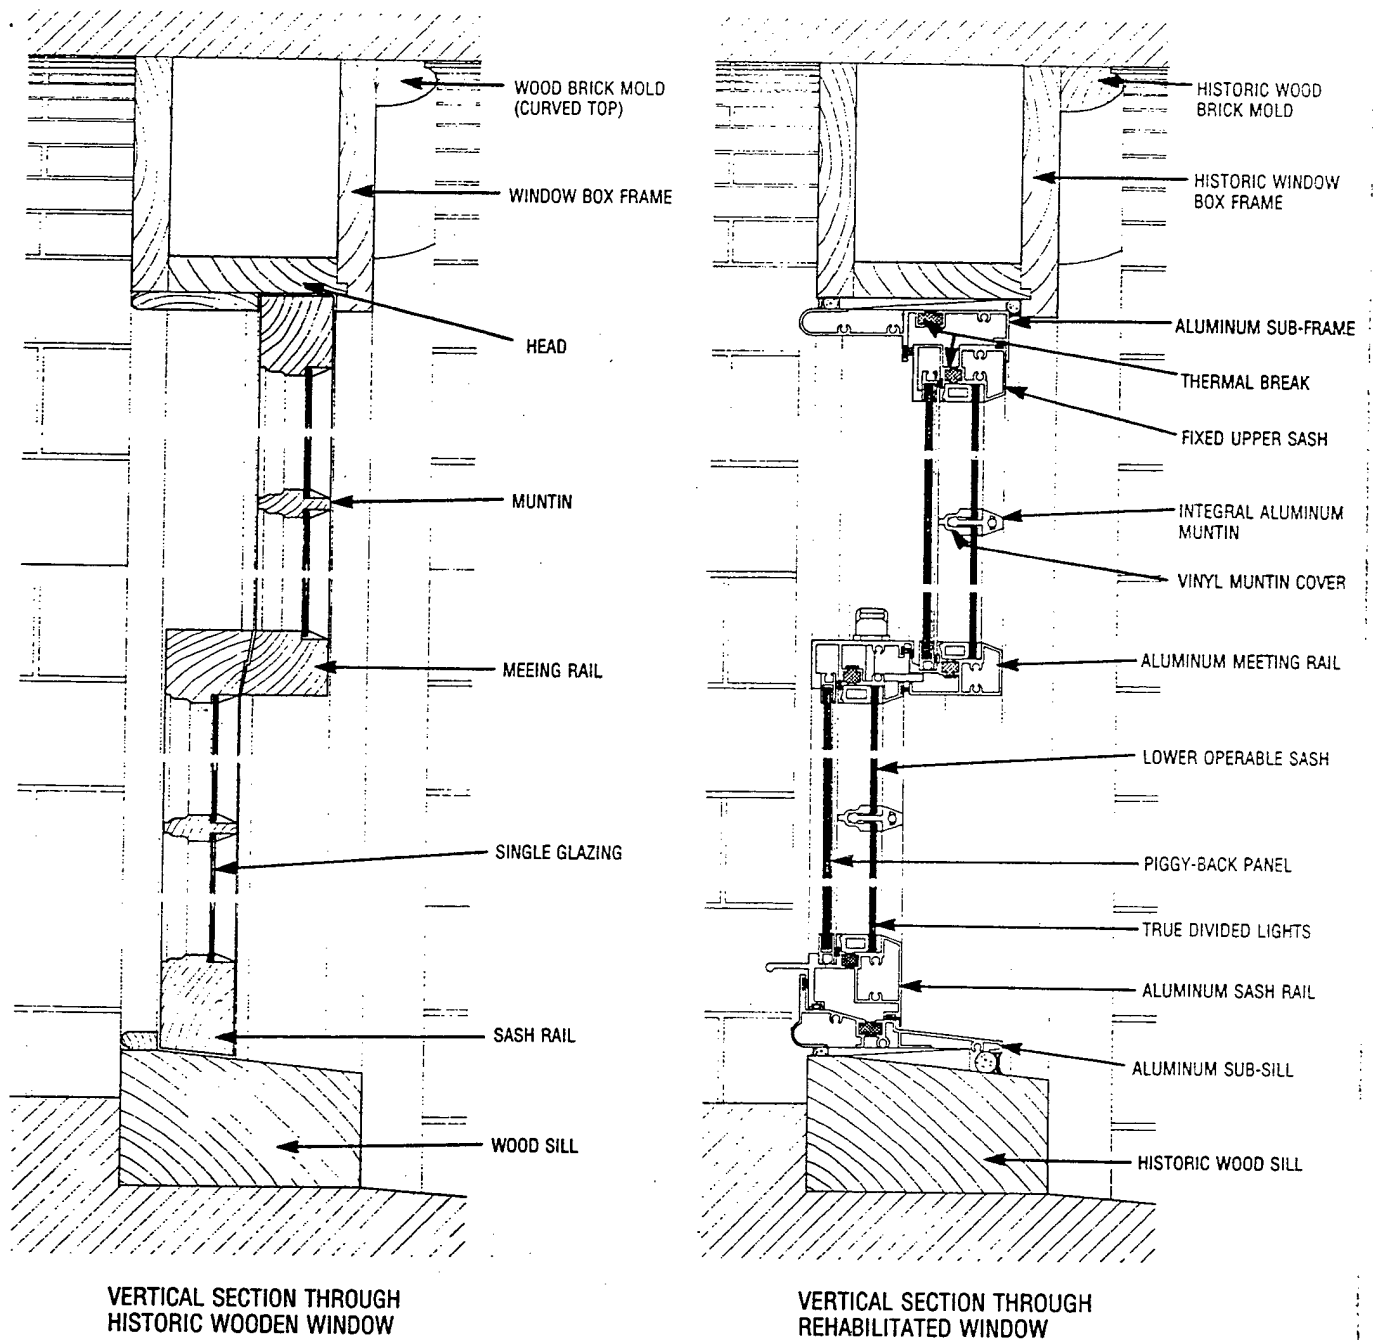
Figure 5. Vertical section of the window shown with old and new sash. Drawing: Timothy Buehner

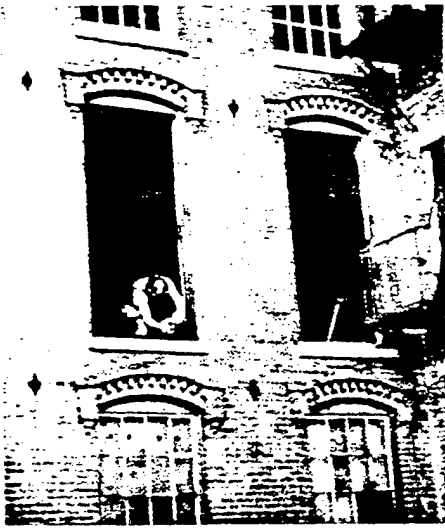
Figure 6. Work on the frames consisted largely of making dutchman repairs to the pulley stiles where required; renailing or replacing brick moldings; replacing some sills; and surface preparation. Photo: Charles Fisher

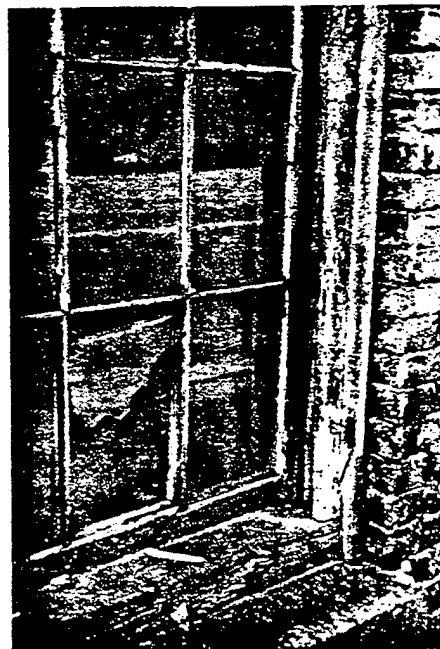
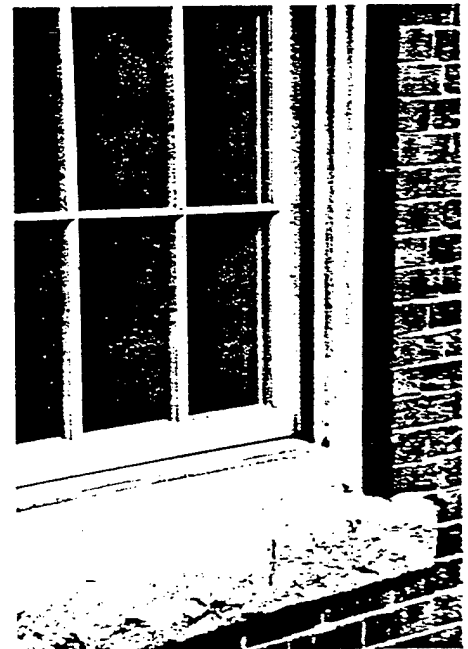
Figure 7. The retention of the exposed outer face of the historic wooden frame and the sill detailing were important qualities of the window treatment. Before and after photos: Charles Parrott

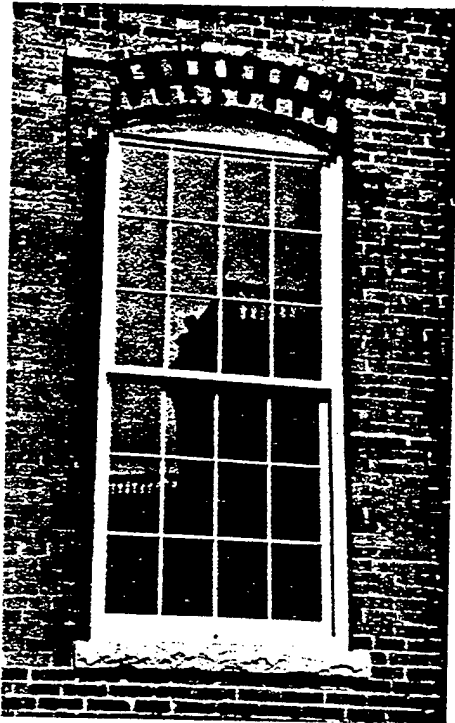
Figure 8. Replacement window sash after installation. Photo: Charles Parrott

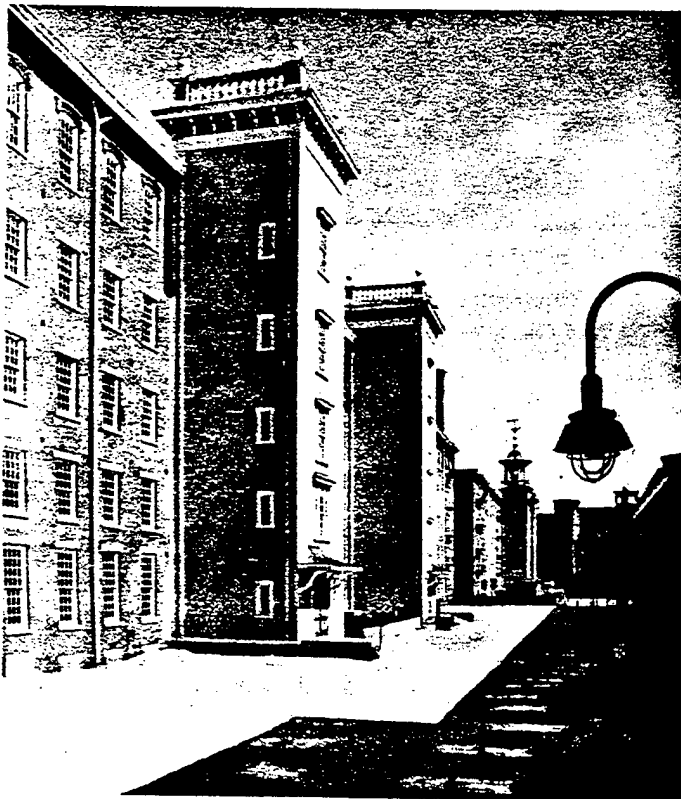
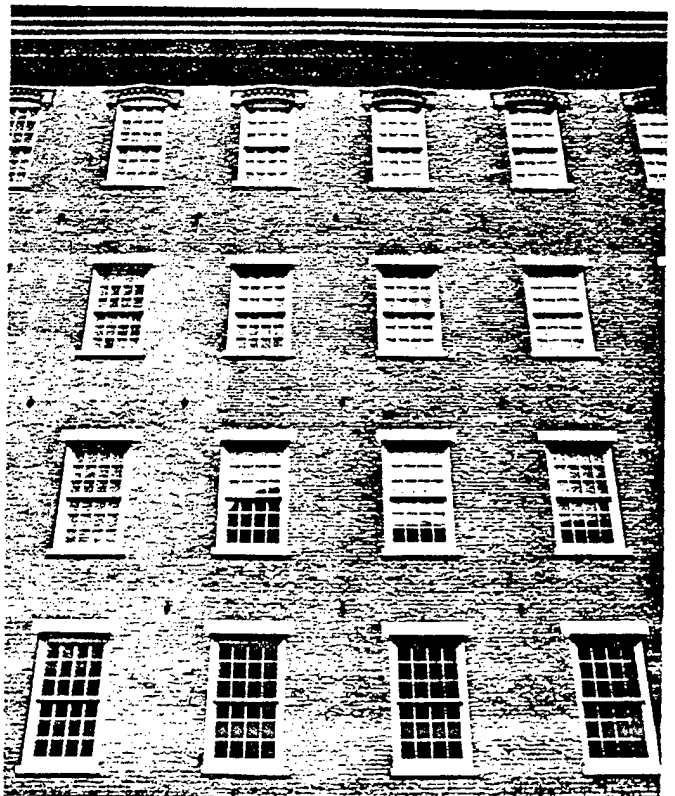
Figure 9. The window solution represents an important advance in the way in which aluminum windows can be designed to capture more fully the appearance of historic windows in larger buildings. Right photo shows wood sash in bottom row and aluminum in the upper three rows. Photos: Jim Higgins ©

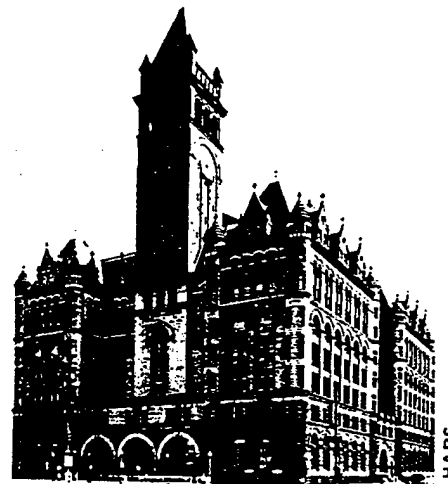
U.S. Department of the Interior National Park Service
Preservation Assistance Division Technical Preservation Services

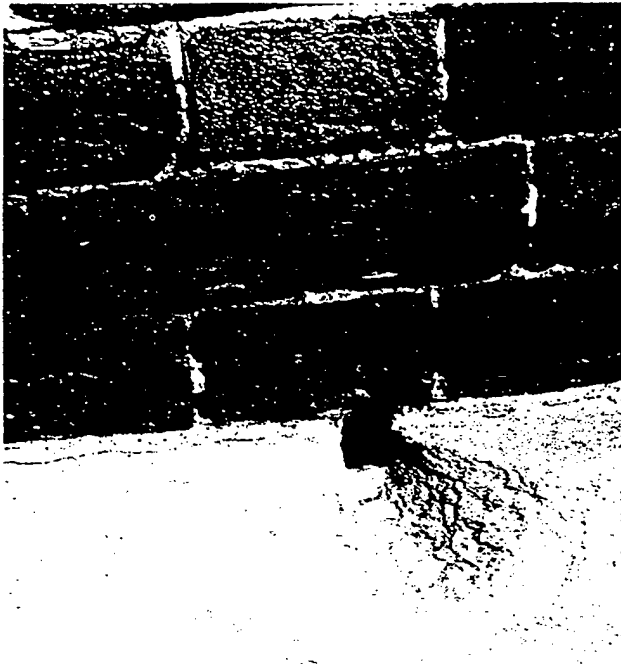
Figure 1. The iron anchor shown here originally was hidden from view. An increase in volume due to rusting created internal pressures on the stone and brick, causing spalling. Careful study of the building construction can result in the identification of these potential problem areas and they can be taken into consideration while planning a cleaning project.

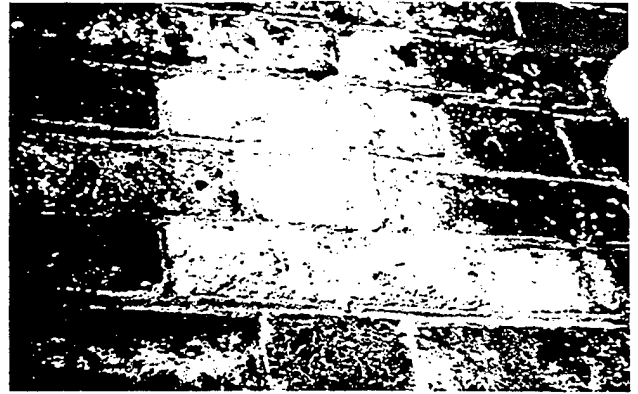
Figure 2. The white deposits are efflorescence, soluble salts deposited on the surface of the masonry. These salts usually originate in the masonry or mortar, migrate from the ground below through capillary action, or are brought in by air pollution. The salts also may be the result of chemical reactions resulting from selection of an improper cleaner.

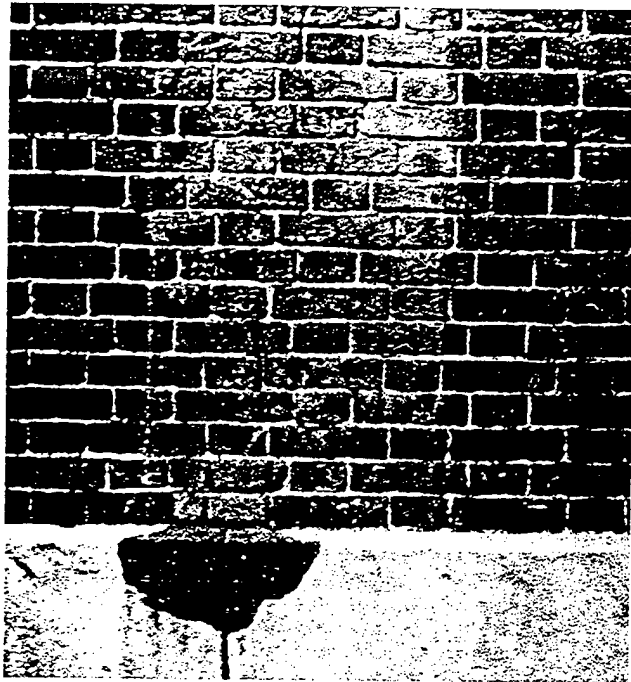
Figure 3. The hazy appearance of a portion of the brick is caused by a residue resulting from cleaning. This film occurred in spite of thorough rinsing. Test patches such as this should always be allowed to weather prior to continuing with the cleaning.
