Management and Maintenance Manual
The Old Hospital Complex
Fort Carson, Colorado
(5EP1778)

James Schneck

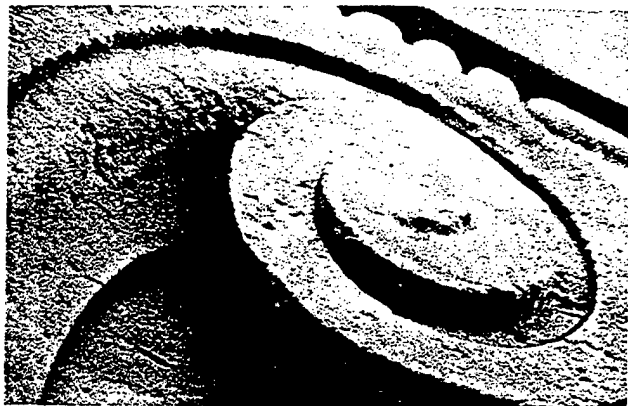
Figure 4. Sandblasting has rounded the corners of this marble capital and pitted the formerly smooth surface. Not only is the stone harmed visually, the increased roughness of the surface also will collect new dirt more quickly than smooth stone.

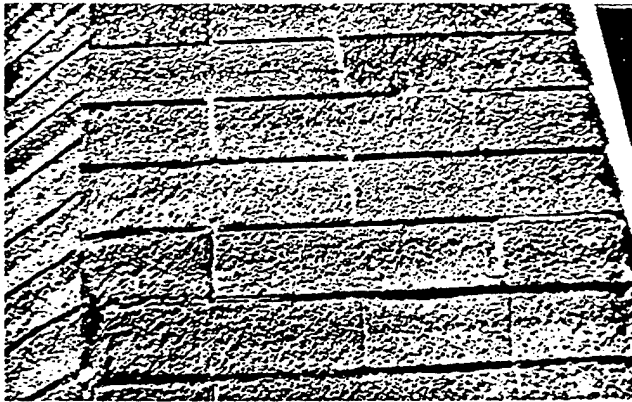
Figure 5. This brickwork was sandblasted to remove paint. Note the severe erosion which has occurred, especially in the softer center sections of this "hard burned" late 19th-century brick. Although this is a severe example, the same problem of increased roughness and porosity will occur even on more skillfully performed jobs where the effect is less evident visually.

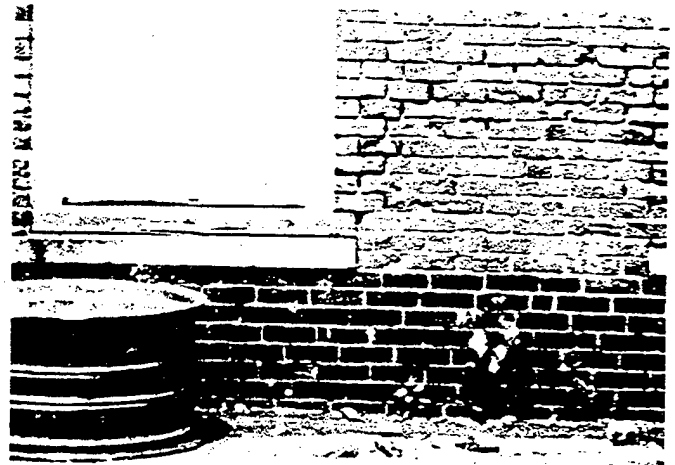
Figure 1. All buildings and building materials are in a constant process of deterioration, such as the brick masonry seen here. Through repointing, the deteriorated mortar joints which might otherwise lead to serious damage, can be renewed and thus preserve the historic character and integrity of the brickwork. Photo: Baird M. Smith.

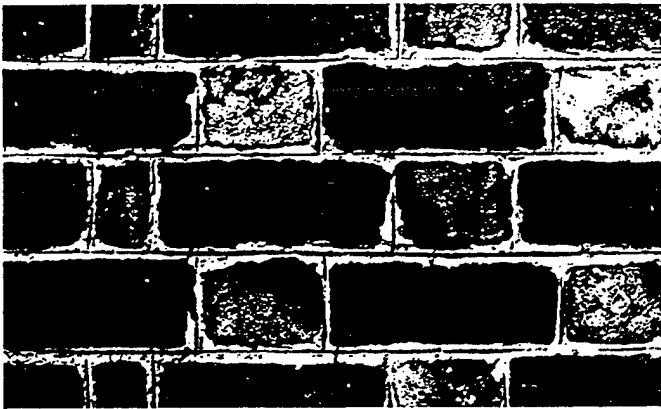
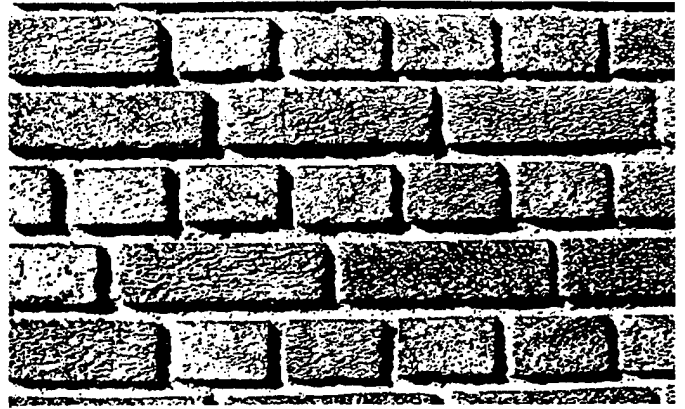
Figure 2. Joint styles and bonding patterns give a rich, divergent, and varied character to historic masonry walls as is apparent in these two examples. The sample on the left is an 18th century (c. 1720) Flemish bond struck with a grapevine joint; the example on the right, an early 20th century English bond with a raked joint. Successfully recreating the historically correct joint size and profile is of paramount importance in the appropriate repointing of historic brick walls. Photos: Calder Loth.

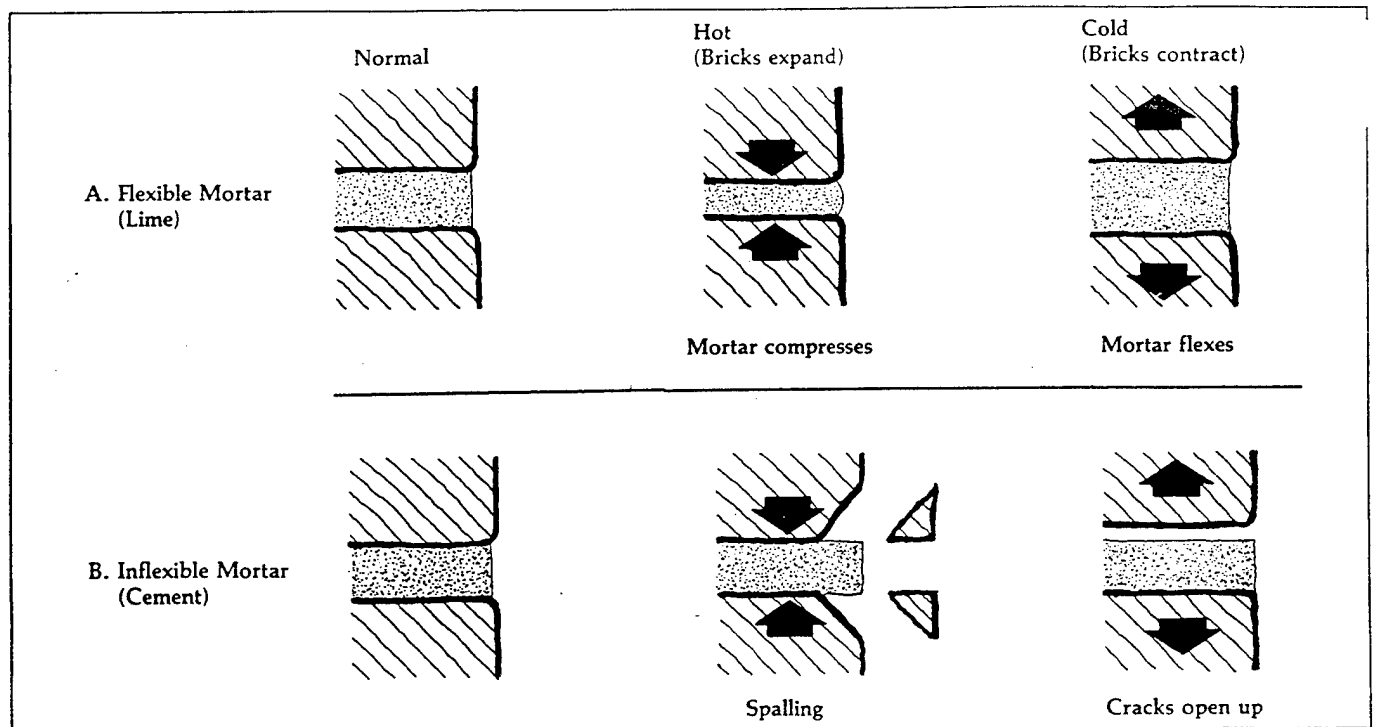
Figure 3. Diagrammatic sketches showing effects of temperature change upon masonry. Flexible mortar (A) expands and contracts with temperature changes. Bricks bonded by inflexible mortar (B) tend to spall at the edges (the area of greatest stress) in hot weather and separate from the mortar when it is cold. This latter condition opens cracks, permitting the entry of water and causing additional deterioration. Adapted from Maintenance of Old Buildings, Document D10; National Swedish Institute for Building Research, Stockholm, 1975.

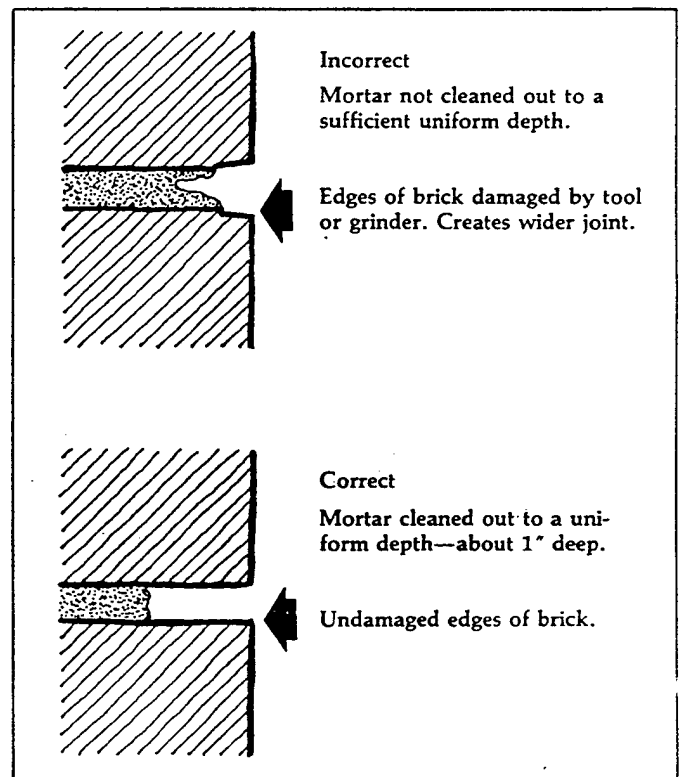
Figure 4. Comparison of incorrect and correct preparation of mortar joints for repointing. Drawing: Robert C. Mack and David W. Look.

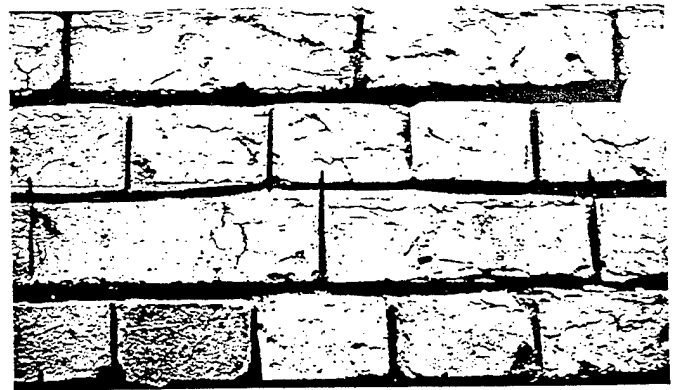
Figure 5. The damage to these bricks was caused by using a power saw with a carbide blade to rake out the mortar joints. Note the overcutting of the joint into the brick above the vertical joint. Careful hand work is required to prevent such damage to the brick during joint preparation. Photo: John Myers.

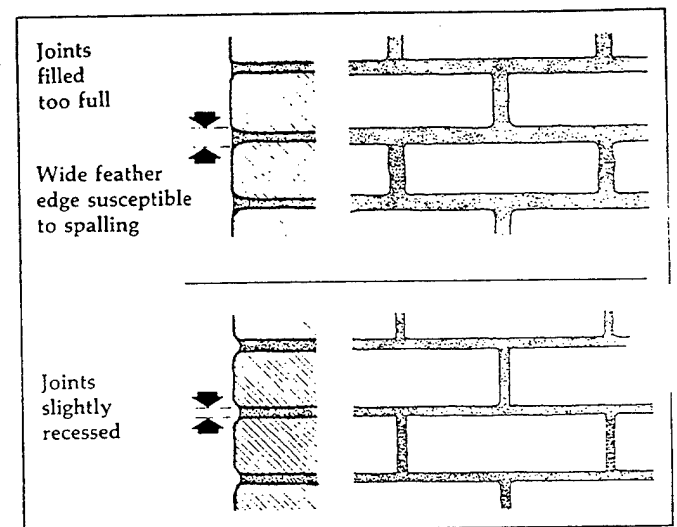
Figure 6. Comparison of visual effect of full mortar joints vs slightly recessed joints. Filling joints too full hides the actual joint thickness and changes the character of the original brickwork.

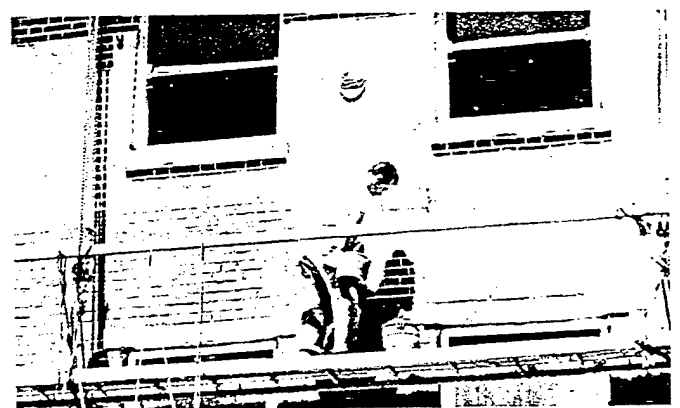
Figure 7. This photograph shows the significant visual change which can result from improper re-pointing procedures. Note the increased thickness of the joints, the color variation, and the difference in the method of tooling—all noticeable even from a distance. Photo: Ler Nelson.

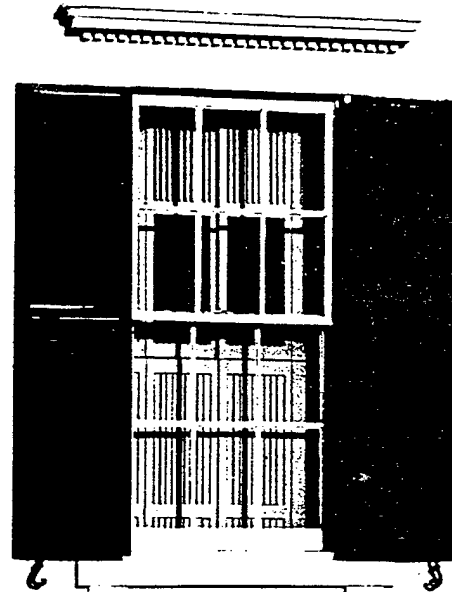
Figure 2. Shutters can be used to minimize the problem of summer heat gain by shading the windows. If operable shutters are in place, their use will help reduce the summer cooling load. (Photo: Baird Smith)

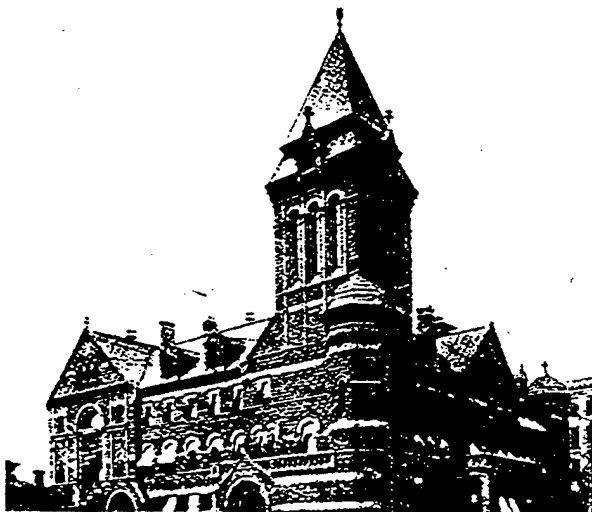
Figure 1. This 1891 Courthouse and Post Office in Rochester, New York, has built-in energy conserving features such as, heavy masonry walls, operable windows, an interior skylighted atrium which provides light and ventilation, and roof-top ventilators which keep the building cooler in the summer. Also note the presence of awnings in this old photograph.

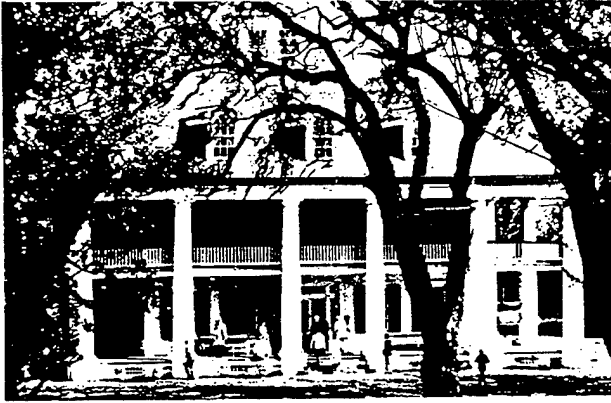
Figure 3. Southern mansions typify climate conscious design. The wide roof overhangs, exterior porches, shade trees, heavy masonry walls (painted white), and living quarters on the second floor (to catch evening breezes and escape the radiant heat from the earth's surface) all are energy saving characteristics which provide reasonably comfortable living spaces without mechanical air conditioning. (Photo: Marcia Axtmann Smith)

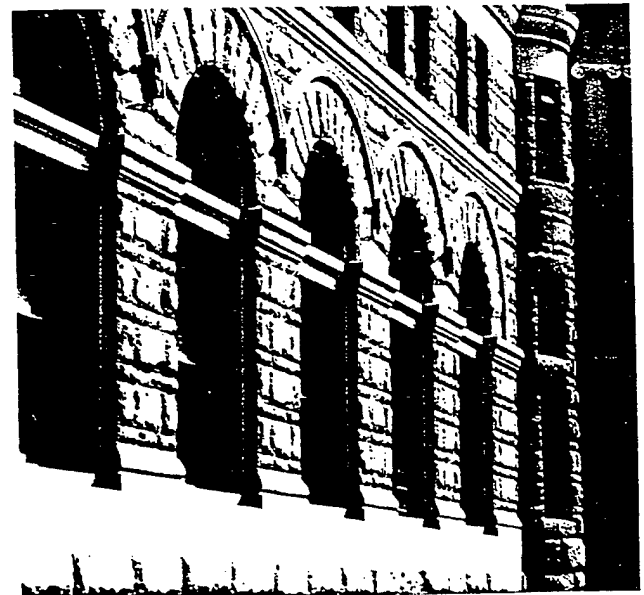
Figure 4. Heavy masonry walls in office buildings dramatically reduce the need for summer cooling because the thermal inertia (M factor) of the massive wall increases its thermal resistance (R factor), thus delaying the heat transfer into the building until late afternoon when the office workers have gone home. (Photo: Baird Smith)

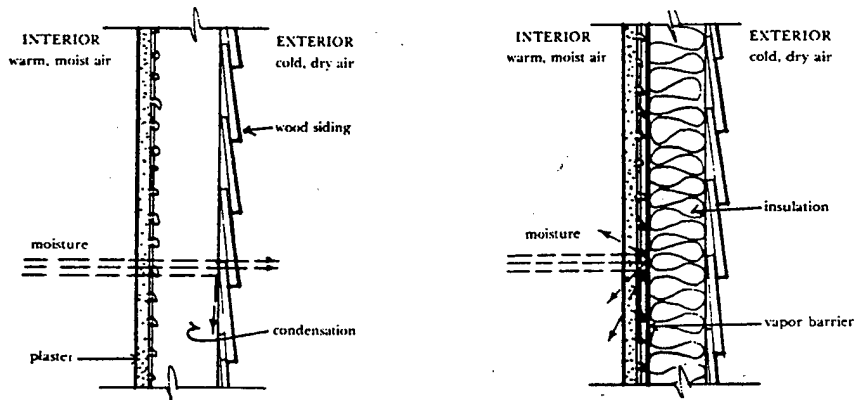
The passive measures outlined above can save as much as 30% of the energy used in a building. They should be the first undertakings to save energy in any existing building and are particularly appropriate for historic buildings because they do not necessitate building alterations or the introduction of new materials that may cause damage. Passive measures make energy sense, common sense, and preservation sense!

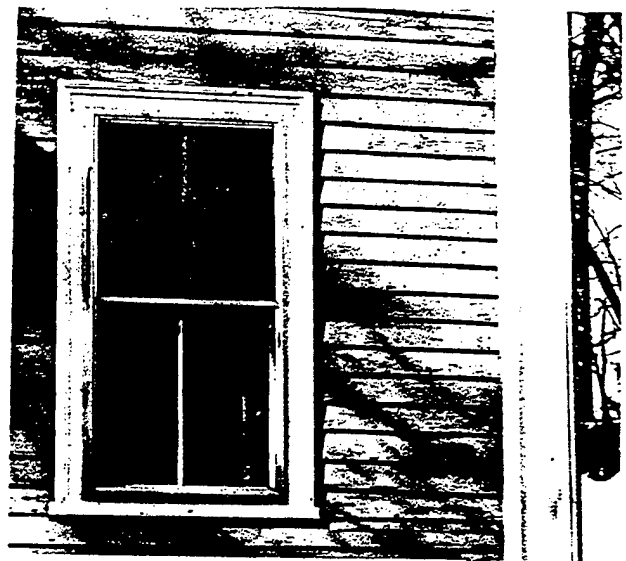
Figure 6. The addition of triple track storm windows, as shown here, greatly improves the thermal performance of existing window assemblies, with a minimal impact on the appearance of the building. (Photo: Baird Smith)

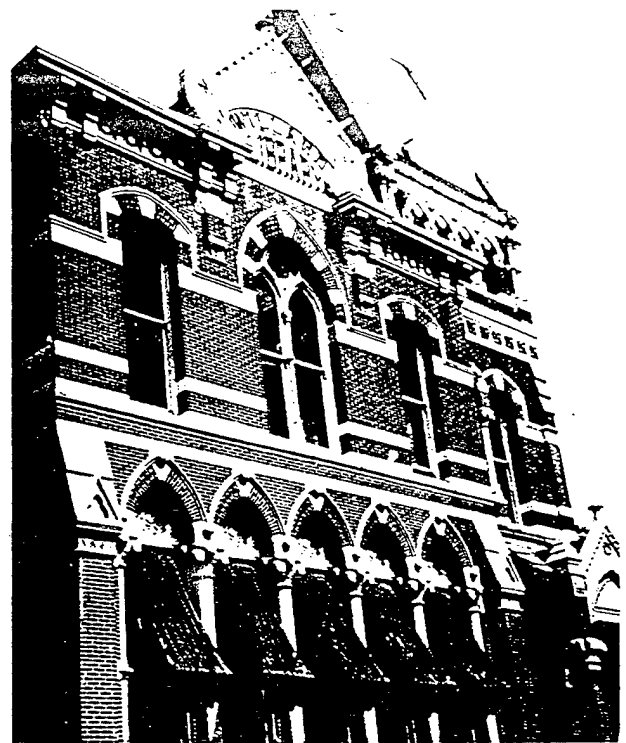
Figure 7. The awnings on the Willard Library in Evansville, Indiana, reduce heat gain in the summer and, when they are raised in the winter, radiant heat from the sun provides free supplementary heat. (Photo: Lee H. Nelson)

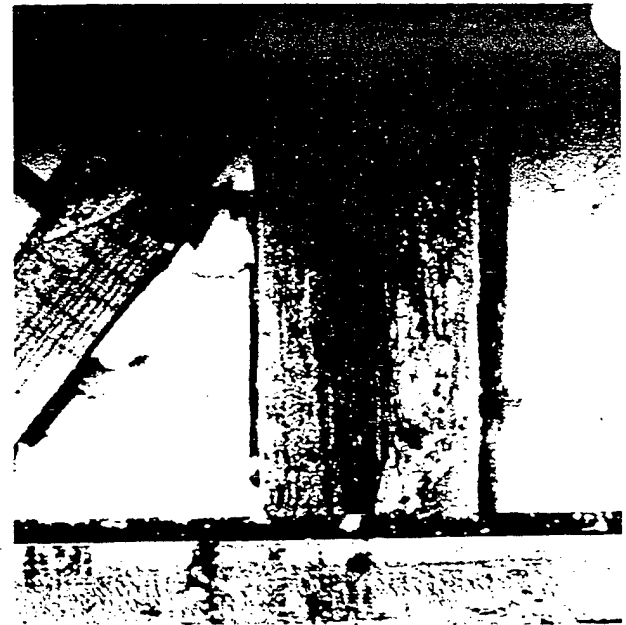
Figure 8. The white material seen between the wooden wall studs is urea-formaldehyde foam. It is injected into the wall cavity wet, and as it cures, large quantities of moisture are given off creating the potential for serious deterioration of adjacent materials and may cause paint to blister on interior and exterior wall surfaces. Additionally, foam can shrink as much as that shown here (about 7% by volume), thus reducing the predicted insulating performance. Until some of the technical problems are corrected, its use is not recommended in historic structures. (Photo: B. Smith)

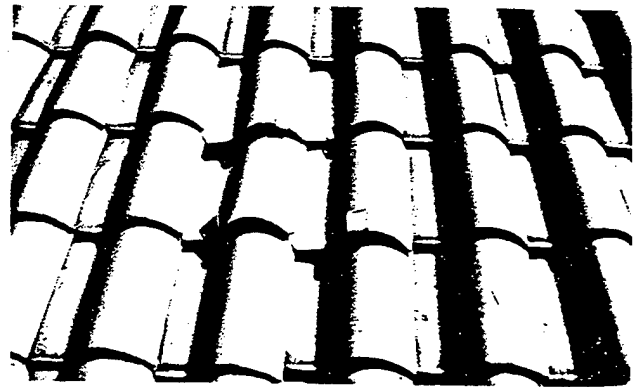
Repairs on this pantile roof were made with new tiles held in place with metal hangers. (Main Building, Ellis Island, New York)

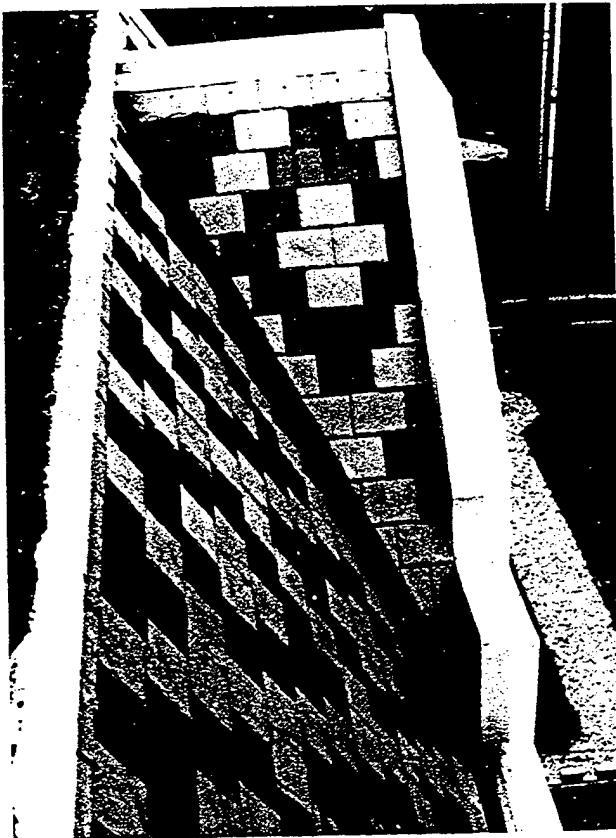
The Victorians loved to use different colored slates to create decorative patterns on their roofs, an effect which cannot be easily duplicated by substitute materials. Before any repair work on a roof such as this, the slate sizes, colors, and position of the patterning should be carefully recorded to assure proper replacement. (Ebenezer Maxwell Mansion, Philadelphia, Pennsylvania, photo courtesy of William D. Hershey)

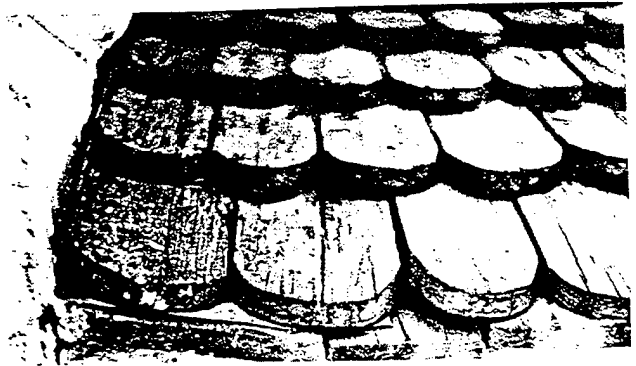
Replacement of particular historic details is important to the individual historic character of a roof, such as the treatment at the eaves of this rounded butt wood shingle roof. Also note that the surface of the roof was carefully sloped to drain water away from the side of the dormer. In the restoration, this function was augmented with the addition of carefully concealed modern metal flashing. (Mount Vernon, Virginia)

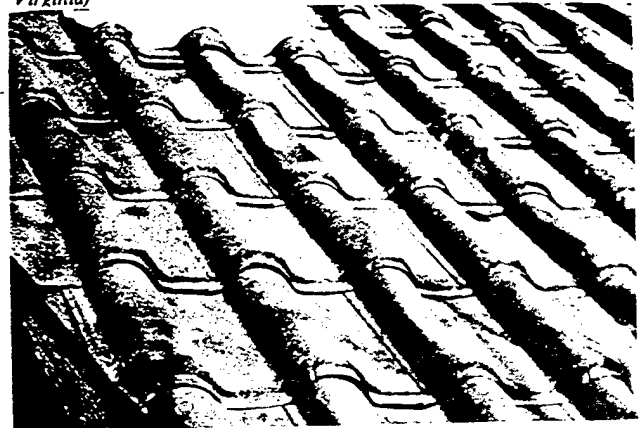
Galvanized sheet-metal shingles imitating the appearance of pantiles remained popular from the second half of the 19th century into the 20th century. (Episcopal Church, now the Jerome Historical Society Building, Jerome, Arizona, 1927)

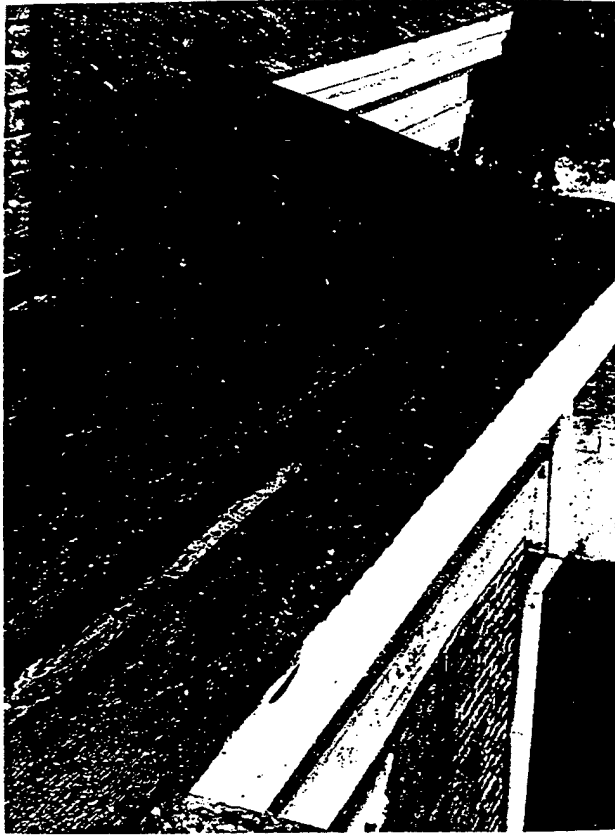
Repeated repair with asphalt, which cracks as it hardens, has created a blistered surface on this sheet-metal roof and built-in gutter, which will retain water. Repairs could be made by carefully heating and scraping the surface clean, repairing the holes in the metal with a flexible mastic compound or a metal patch, and coating the surface with a fibre paint. (Roane County Courthouse, Kingston, Tennessee, photo courtesy of Building Conservation Technology, Inc.)

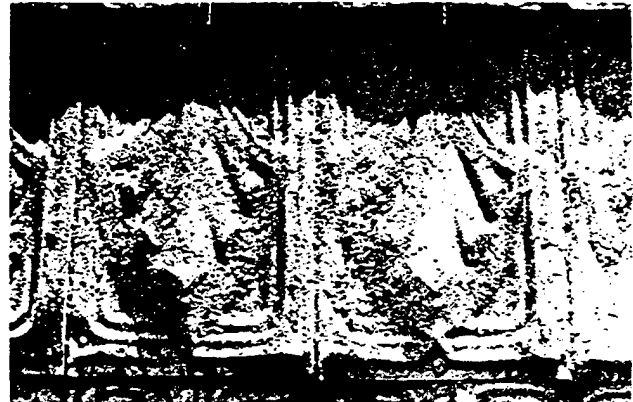
Tin shingles, commonly embossed to imitate wood or tile, or with a decorative design, were popular as an inexpensive, textured roofing material. These shingles 8¹/₈ inch by 12¹/₂ inch on the exposed surface were designed with interlocking edges, but they have been repaired by surface nailing, which may cause future leakage. (Ballard House, Yorktown, Virginia, photo by Gordie Whittington, National Park Service)

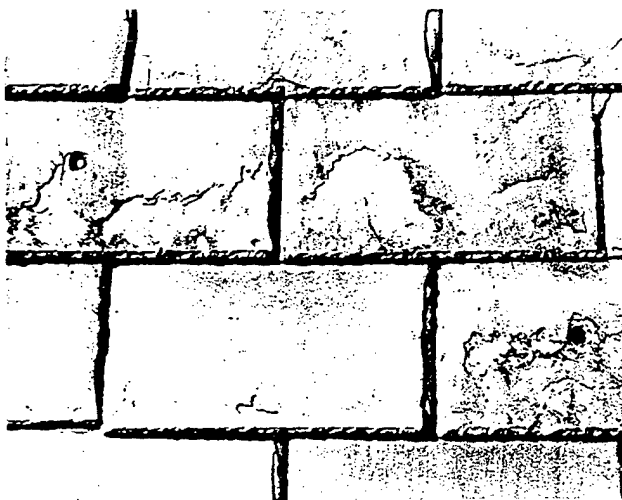
This detail shows slate delamination caused by a combination of weathering and pollution. In addition, the slates have eroded around the repair nails, incorrectly placed in the exposed surface of the slates. (Lower Pontalba Building, New Orleans, photo courtesy of Building Conservation Technology, Inc.)

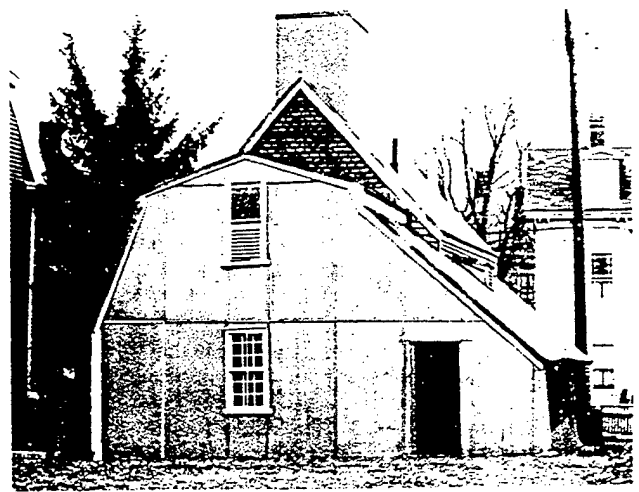
Temporary stabilization or "mothballing" with materials such as plywood and building paper can protect the roof of a project until it can be properly repaired or replaced. (Narbonne House, Salem, Massachusetts)

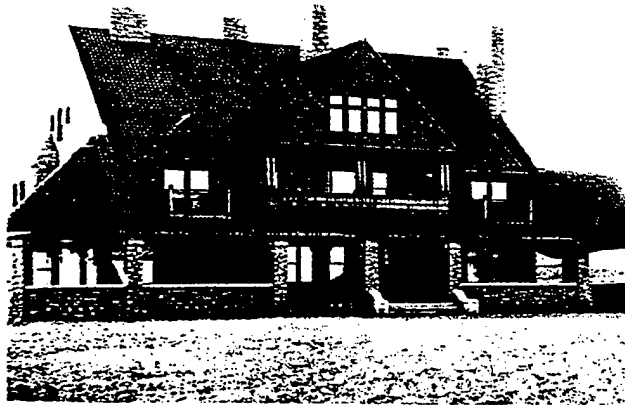
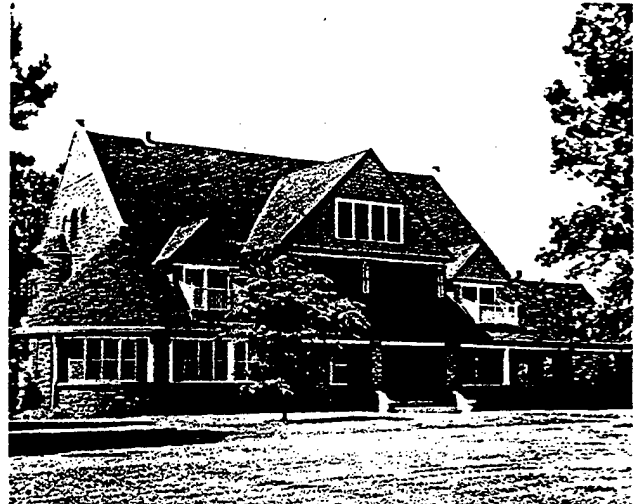
These two views of the same house demonstrate how the use of a substitute material can drastically affect the overall character of a structure. The textural interest of the original tile roof was lost with the use of asphalt shingles. Recent preservation efforts are replacing the tile roof. (Frank House, Kearney, Nebraska, photo courtesy of the Nebraska State Historical Society, Lincoln, Nebraska)

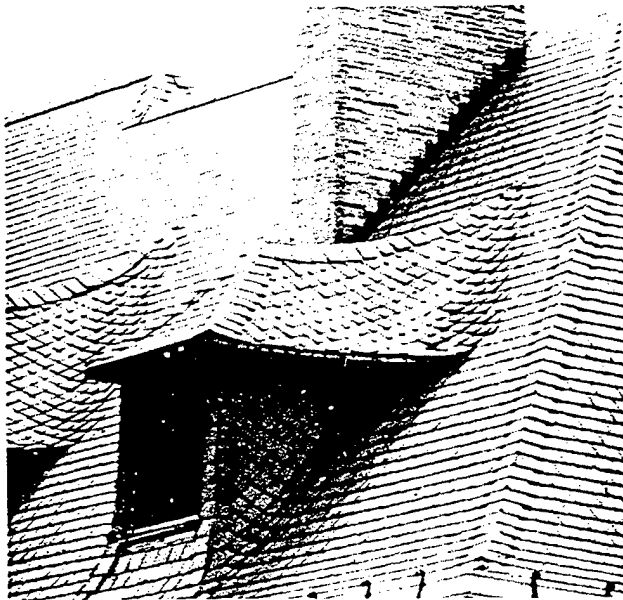
Because of the roof's visibility, the slate detailing around the dormers is important to the character of this structure. Note how the slates swirl from a horizontal pattern on the main roof to a diamond pattern on the dormer roofs and side walls. (18th and Que Streets, NW, Washington, D.C.)

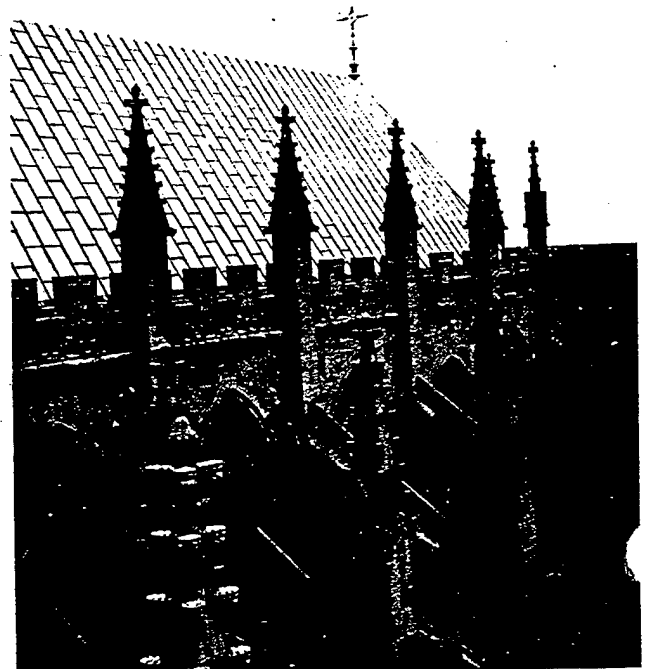
Good design and quality materials for the roof surface, fastenings, and flashing minimize roofing failures. This is essential on roofs such as on the National Cathedral where a thorough maintenance inspection and minor repairs cannot be done easily without special scaffolding. However, the success of the roof on any structure depends on frequent cleaning and repair of the gutter system. (Washington, D.C., photo courtesy of John Burns, A.I.A.)

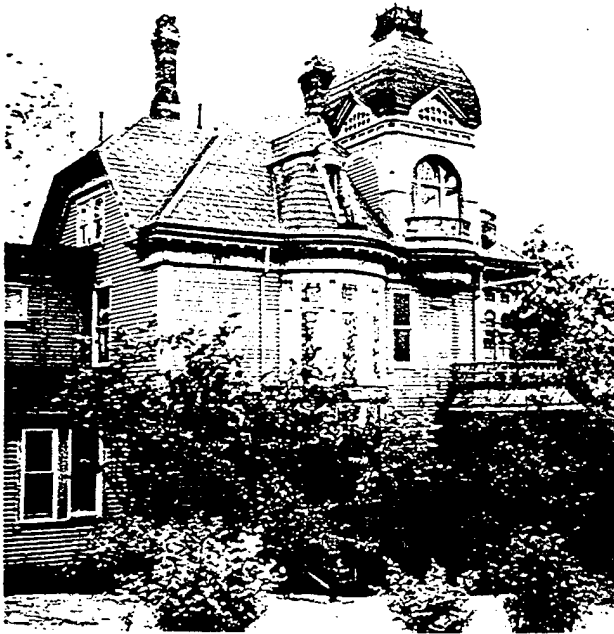
Special problems inherent in the design of an elaborate historic roof can be controlled through the use of good materials and regular maintenance. The shape and detailing are essential elements of the building's historic character, and should not be modified, despite the use of alternative surface materials. (Gamwell House, Bellingham, Washington)

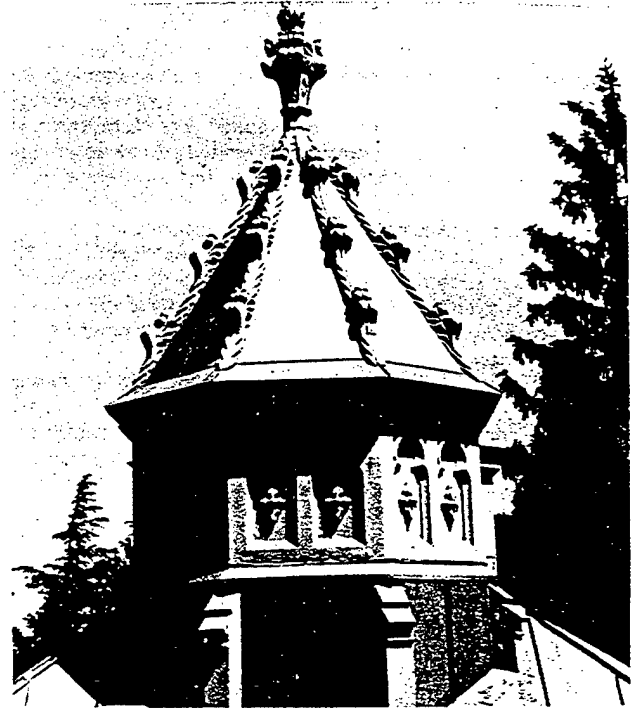
Decorative features such as cupolas require extra maintenance. The flashing is carefully detailed to promote run-off, and the wooden ribbing must be kept well-painted. This roof surface, which was originally tin plate, has been replaced with lead-coated copper for maintenance purposes. (Lyndhurst, Tarrytown, New York, photo courtesy of the National Trust for Historic Preservation)

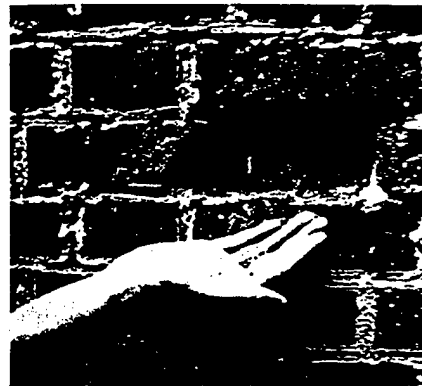
U.S. Department of the Interior National Park Service
Preservation Assistance Division Technical Preservation Services

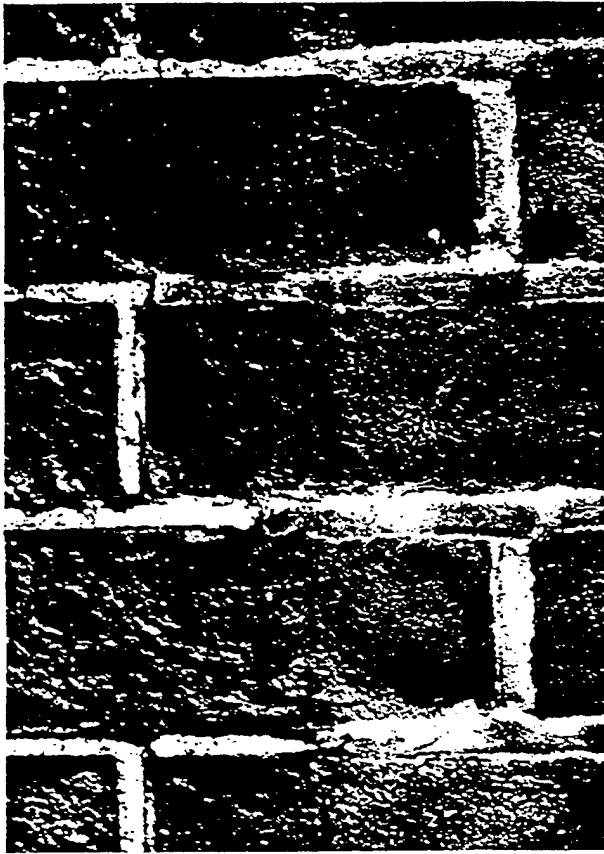
Abrasively Cleaned vs. Untouched Brick. Two brick rowhouses with a common façade provide an excellent point of comparison when only one of the houses has been sandblasted. It is clear that abrasive blasting, by removing the outer surface, has left the brickwork on the left rough and pitted, while that on the right still exhibits an undamaged and relatively smooth surface. Note that the abrasive cleaning has also removed a considerable portion of the mortar from the joints of the brick on the left side, which will require repointing.

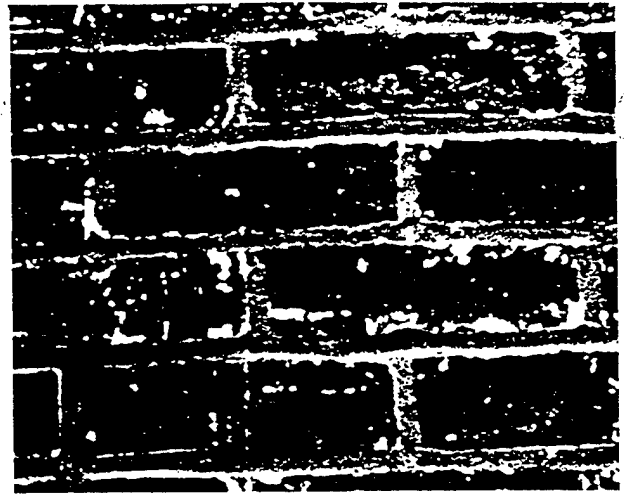
Abrading the Surface without Removing the Paint. Even though the entire outer surface layer of the brick has been sandblasted off, spots of paint still cling to the masonry. Sandblasting or other similarly abrasive methods are not always a successful means of removing paint.

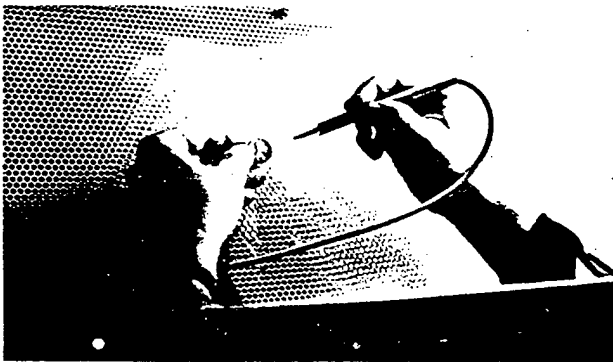
Micro-Abrasive Cleaning. This small, pencil-sized micro-abrasive unit is used by some museum conservators to clean small objects. This particular micro-abrasive unit is operated within the confines of a box (approximately 2 cubic feet of space), but a similar and slightly larger unit may be used for cleaning larger pieces of sculpture, or areas of architectural detailing on a building. Even a pressure cleaning unit this small is capable of eroding a surface, and must be carefully controlled.

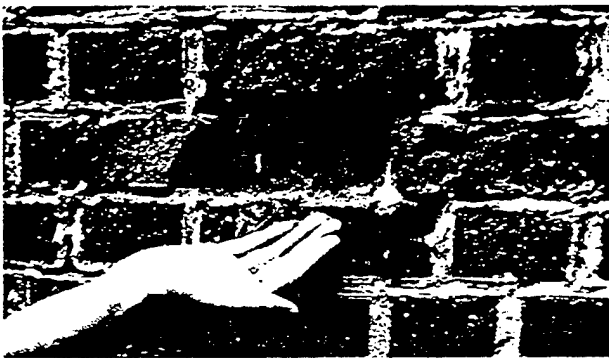
Spalling Brick. This soft, early 19th-century brick was sandblasted in the 1960s; consequently, severe spalling has resulted. Some bricks have almost totally disintegrated, and will eventually have to be replaced. (Robert S. Gamble)

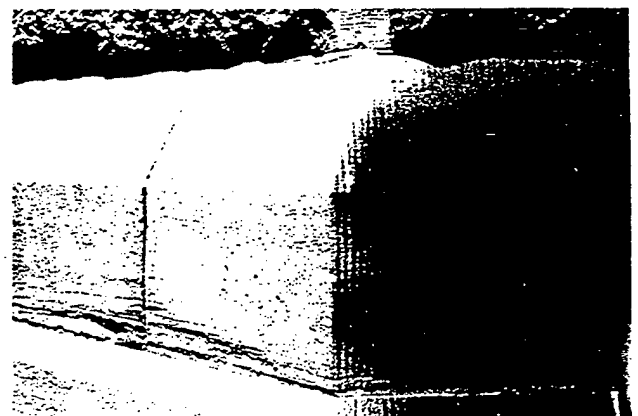
Abrasive Cleaning of Tooled Granite. Even this carefully controlled, "wet grit" blasting has erased vertical tooling marks in the cut granite blocks on the left. Not only has the tooling been destroyed, but damaged stone surface is now more susceptible to accelerated weathering.

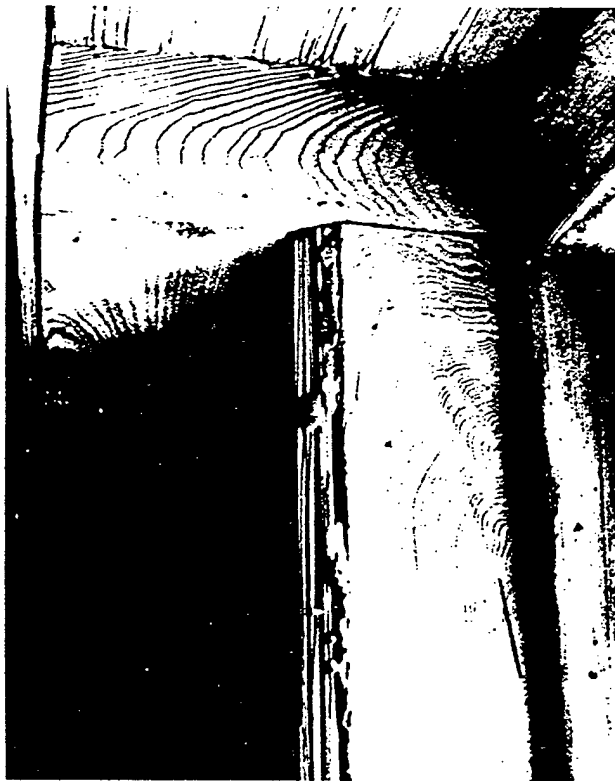
Abrasive Cleaning of Wood. This wooden windowsill, molding and paneling have been sandblasted to remove layers of paint in the rehabilitation of this commercial building. Not only is some paint still embedded in cracks and crevices of the woodwork, but more importantly, grit blasting has actually eroded the summer wood, in effect raising the grain, and resulting in a rough surface.

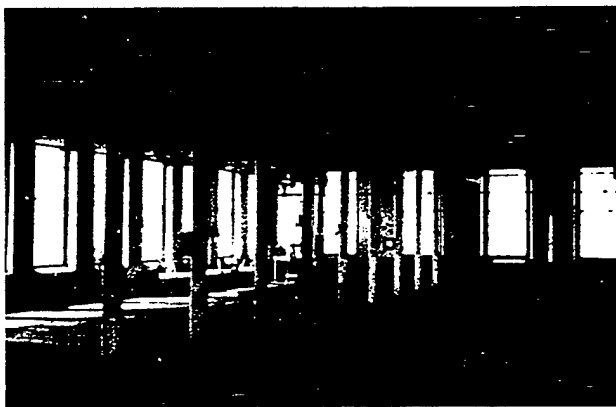
Permissible Abrasive Cleaning. In accordance with the Secretary of the Interior's Guidelines for Rehabilitation Projects, it may be acceptable to use abrasive techniques to clean an industrial interior space such as that illustrated here, because the masonry surfaces do not have significant design, detailing, tooling or finish, and the wooden architectural features are not finished, molded, beaded or worked by hand.

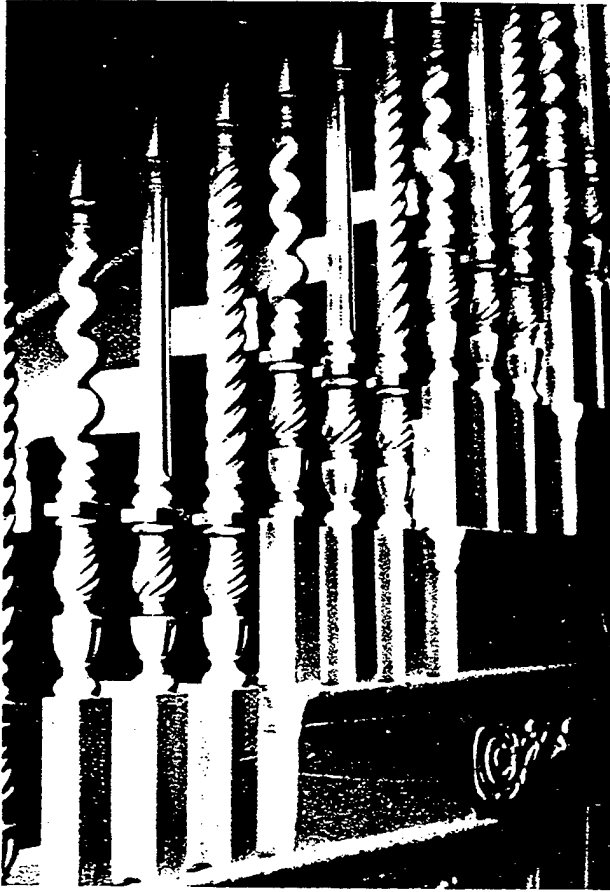
Do not Abrasively Clean these Interiors. Most historic residential and some commercial interior spaces contain finished plaster and wooden elements such as this stair balustrade and paneling which contribute to the historic and architectural character of the structure. Such interiors should not be subjected to abrasive techniques for the purpose of removing paint, dirt, discoloration or plaster.

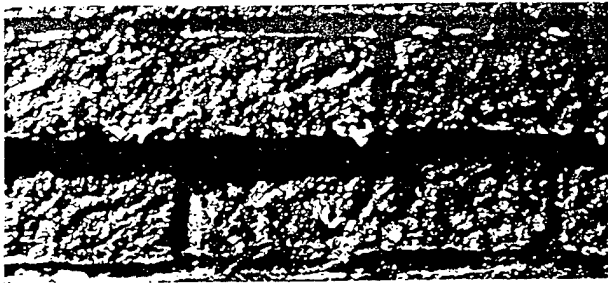
Hazards of Sandblasting and Surface Coating. In order to "protect" this heavily sandblasted brick, a clear surface coating or sealer was applied. Because the air temperature was too cold at the time of application, the sealer failed to dry properly, dripping in places, and giving the brick surface a cloudy appearance.

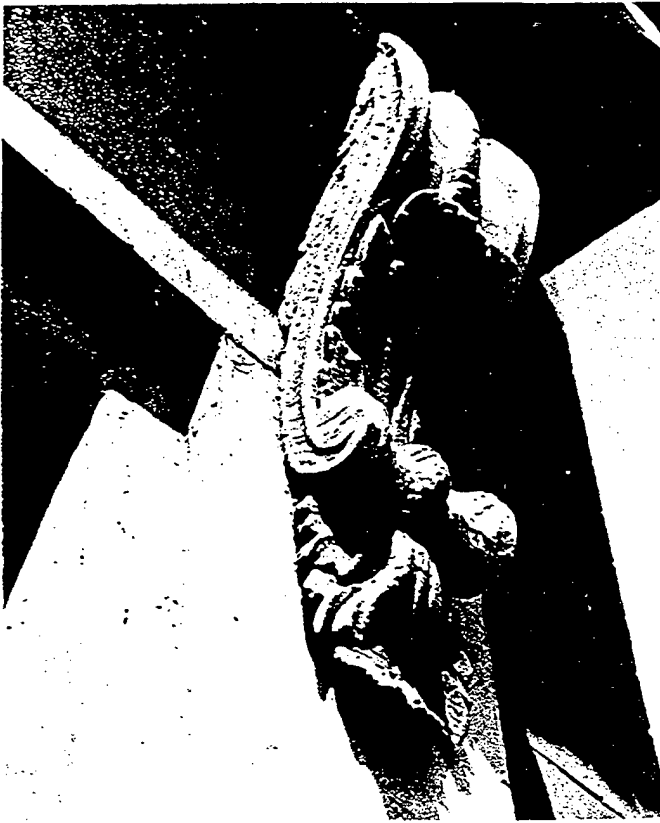
Fig. 1 Excessive paint build-up on architectural details such as this ornamental bracket does not in itself justify total paint removal. If paint is cracked and peeling down to bare wood, however, it should be removed using the gentlest means possible. Photo: David W. Look, AIA.

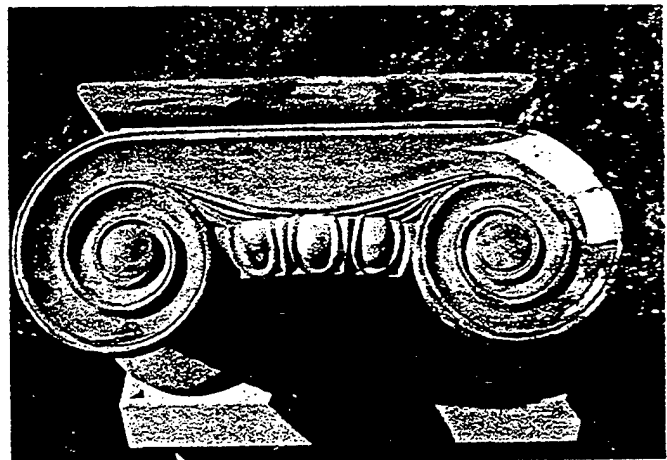
Fig. 3 If damage to parts of a wooden element is severe, new sections of wood will need to be pieced-in. When such piecing is required, paint on the adjacent woodwork should be removed so that the old and new woods will make a smooth profile when joined. After repainting, the repair should be virtually impossible to detect. Photo: Morgan W. Phillips.

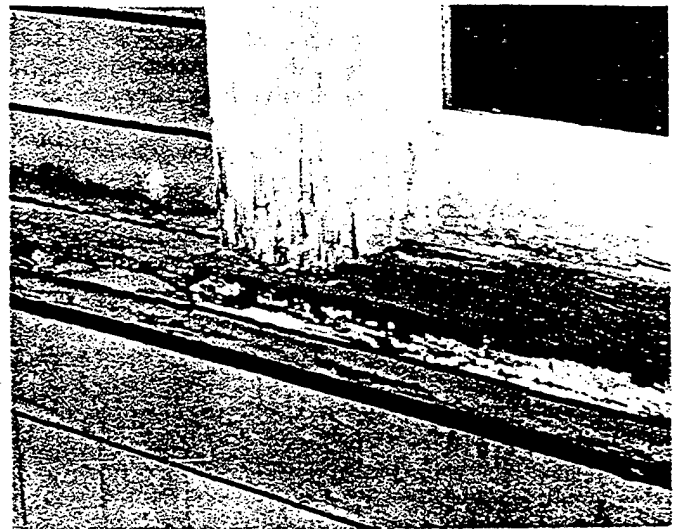
Staining of paint coatings usually results from excess

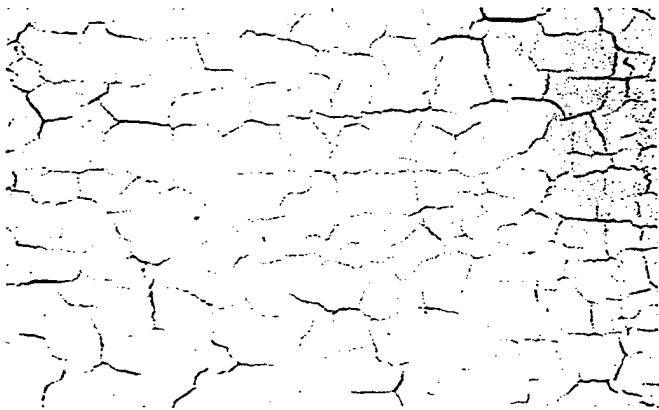
Fig. 5 Crazing—or surface cracking—is an exterior surface condition which can be successfully treated by sanding and painting. Photo: Courtesy, National Decorating Products Association.

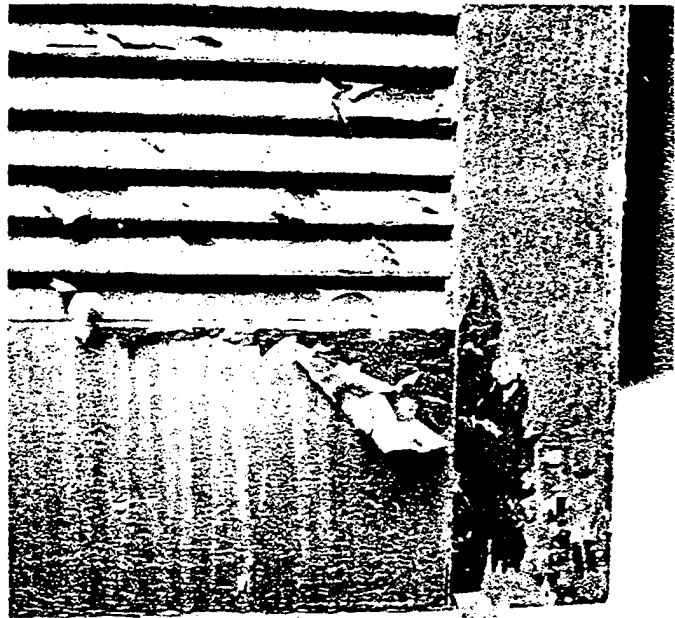
Fig. 6 This is an example of intercoat peeling. A latex top coat was applied directly over old oil paint and, as a result, the latex paint was unable to adhere. If latex is being used over oil, an oil-base primer should be applied first. Although much of the peeling latex paint can be scraped off, in this case, the best solution may be to chemically dip strip the entire shutter to remove all of the paint down to bare wood, rinse thoroughly, then repaint. Photo: Mary L. Oehrlein, AIA.

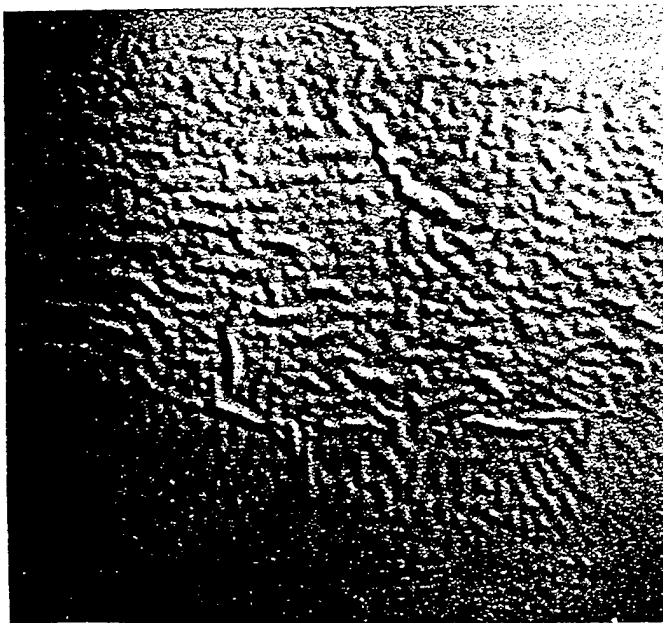
Fig. 7 Wrinkled layers can generally be removed by scraping and sanding as opposed to total paint removal. Following manufacturers' application instructions is the best way to avoid this surface condition. Photo: Courtesy, National Decorating Products Association.

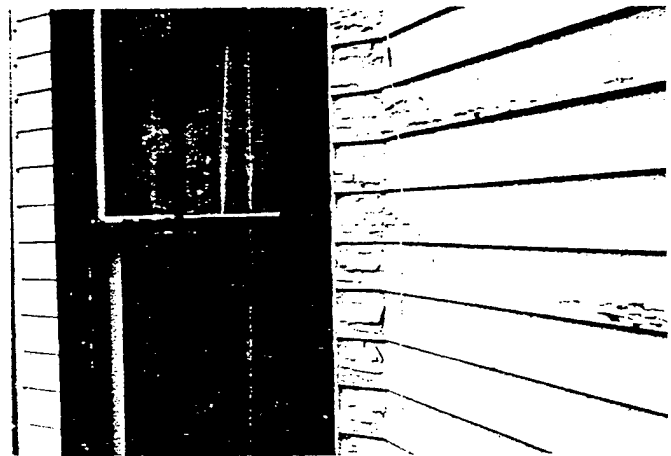
Fig. 8 Peeling to bare wood—one of the most common types of paint failure—is usually caused by an interior or exterior moisture problem. Photo: Anne E. Grimmer.

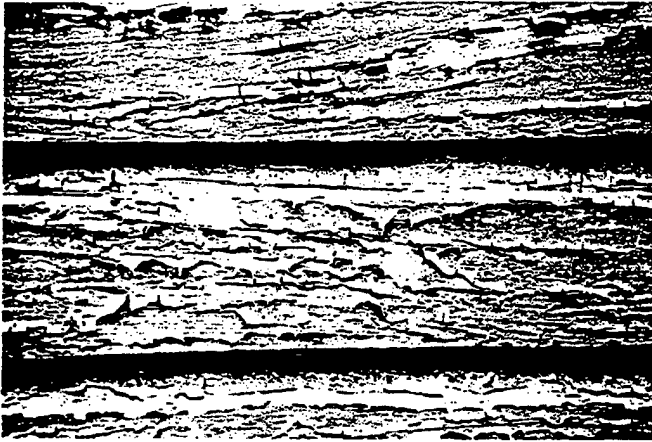
Fig. 9 Cracking, alligating, and flaking are evidence of long-term neglect of painted surfaces. The remaining paint on the clapboard shown here can be removed with an electric heat plate and wide-bladed scraper. In addition, unsound wood should be replaced and moisture problems corrected before primer and top coats of paint are applied. Photo: David W. Look, AIA.

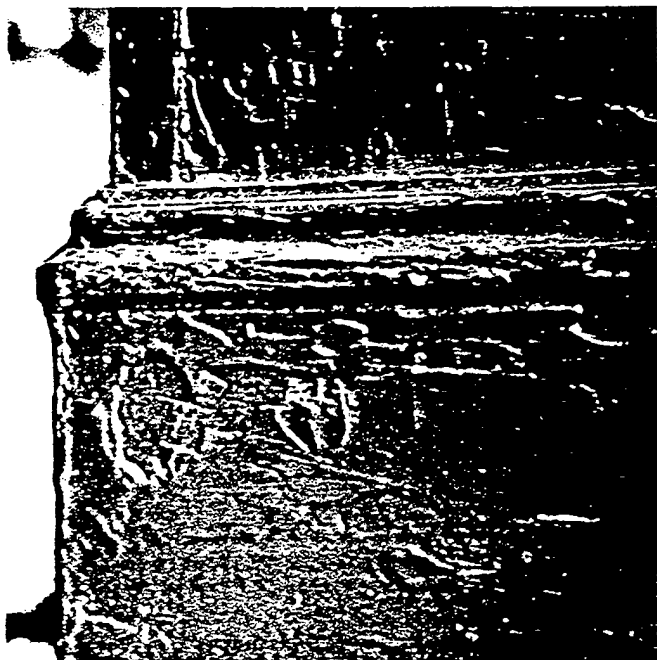
Fig. 10 An excellent example of inadequate scraping before repainting, the problems here are far more than cosmetic. This improperly prepared surface will permit moisture to get behind the paint film which, in turn, will result in chipping and peeling. Photo: Baird M. Smith, AIA.
