Management and Maintenance Manual
The Old Hospital Complex
Fort Carson, Colorado
(5EP1778)

James Schneck

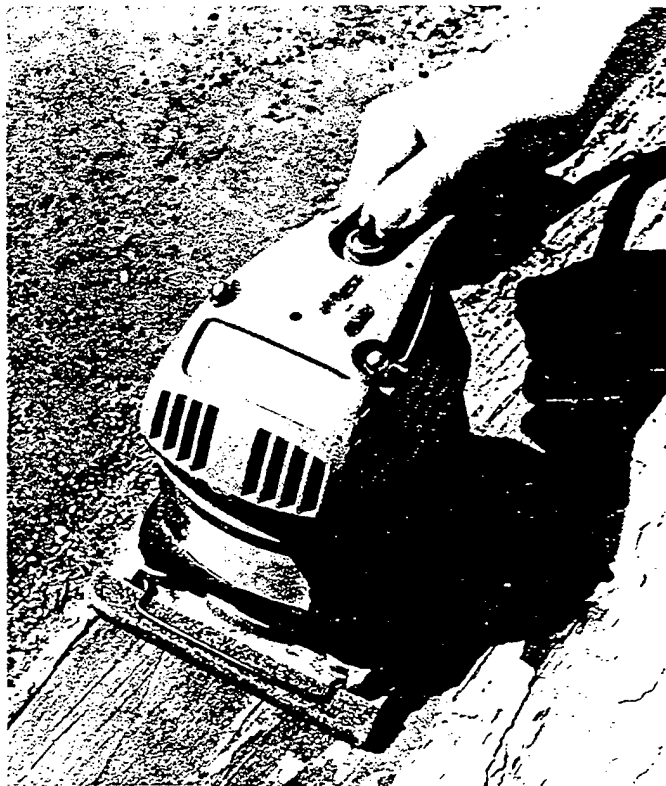
Fig. 11 The orbital sander can be used for limited paint removal, i.e., for smoothing flat surfaces after the majority of deteriorated paint has already been scraped off. Photo: Charles E. Fisher, III.

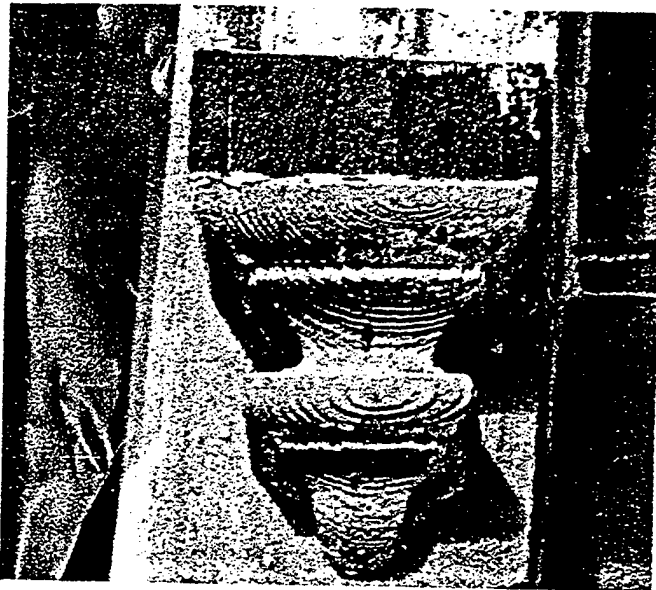
Fig. 12 Sandblasting has permanently damaged this ornamental bracket. Even paint will not be able to hide the deep erosion of the wood. Photo: David W. Look, AIA.

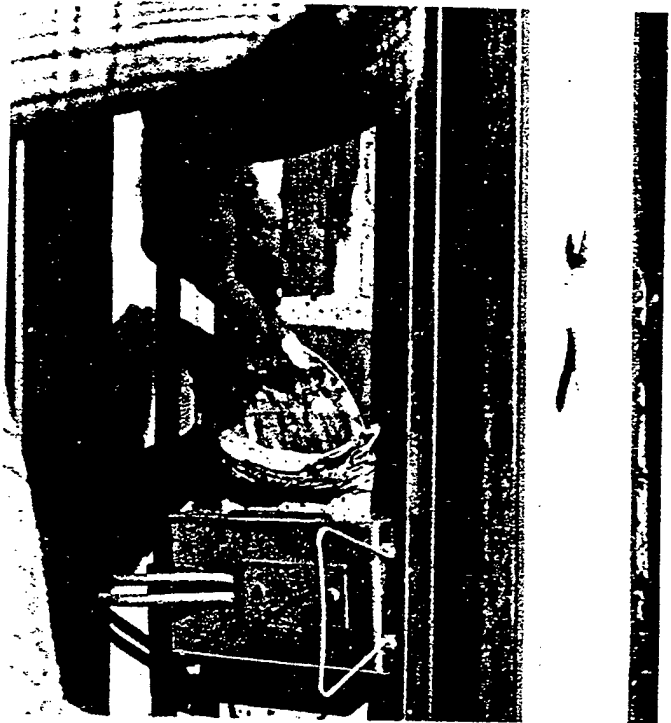
Fig. 13 The electric heat plate (with paint scraper) is particularly useful for removing paint down to bare wood on flat surfaces such as doors, window frames, and siding. After scraping, some light sanding will probably be necessary to smooth the surface prior to application of primer and top coats. Photo: David W. Look, AIA.

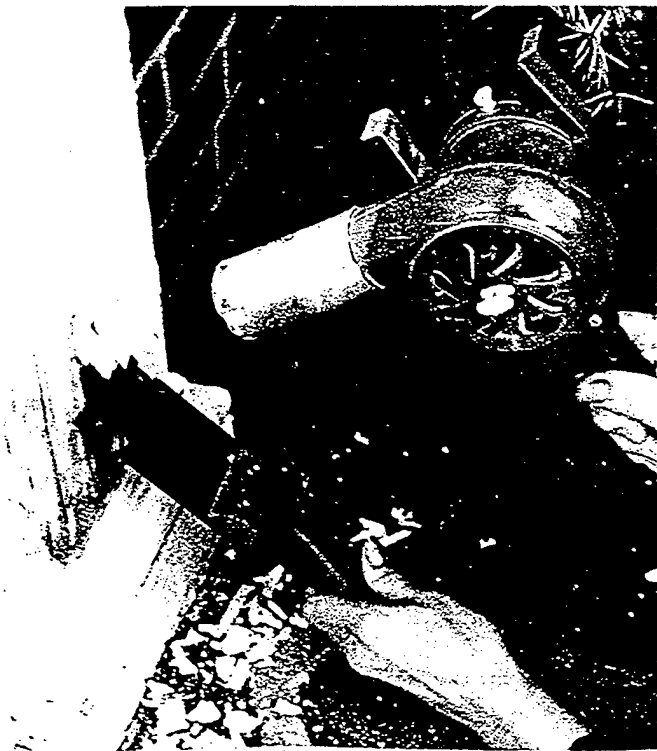
Fig. 14 The nozzle on the electric heat gun permits hot air to be aimed into cavities on solid decorative elements such as this applied column. After the paint has been sufficiently softened, it can be removed with a profiled scraper. Photo: Charles E. Fisher, III.

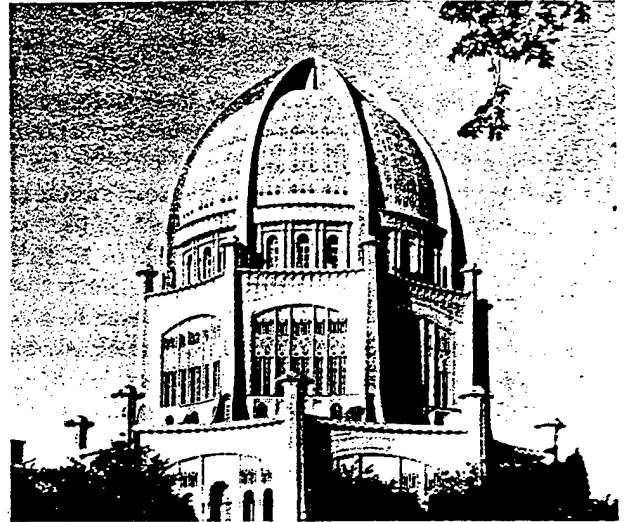
The Secretary of the Interior's "Standards for Rehabilitation" require that deteriorated architectural features shall be repaired rather than replaced. When the severity of deterioration requires removal of historic material, its replacement should match the material being replaced in composition, design, color, texture, and other visual qualities.

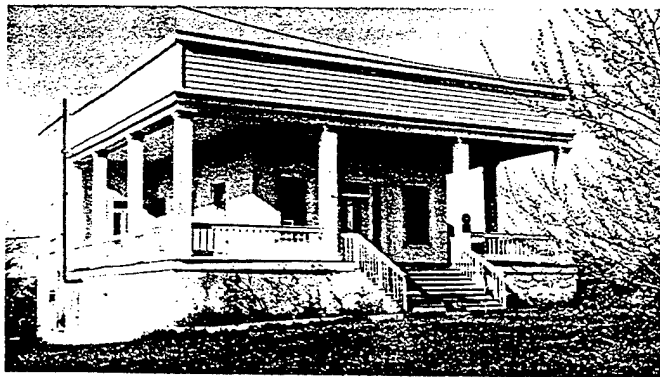
Fig. 2. Sebastopol House, Seguin, Texas (1856). This Greek Revival dwelling is one of the few remaining poured-in-place concrete structures in this Texas town noted for its construction of over 90 concrete buildings in the mid-nineteenth century. The high parapets surrounding the flat roof were lined and served as a water reservoir to cool the house. Photo: Texas Historical Commission.

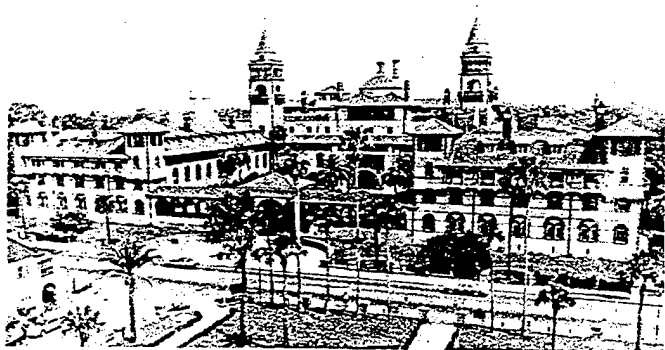
Fig. 3. Ponce de Leon Hotel, St. Augustine, Florida (1885-87). An example of unreinforced concrete used on a grand scale, this Spanish Colonial Revival hotel was designed by Carrere and Hastings and commissioned by railroad magnate Henry Flagler. The building now serves as the main campus hall for Flagler College. Photo: Flagler College.

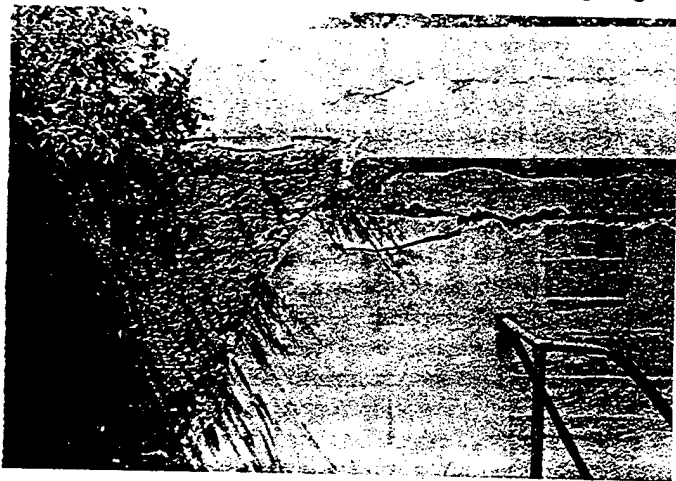
Fig. 6. Battery Fortifications, Ft. Washington, Maryland (1891-97). This unreinforced concrete fortification exhibits several kinds of deterioration: the diagonal structural crack due to uneven settlement, the long horizontal crack at the cold joint, the spalling of the concrete surface coating, and vegetative growth. Photo: Sharon C. Park, AIA.

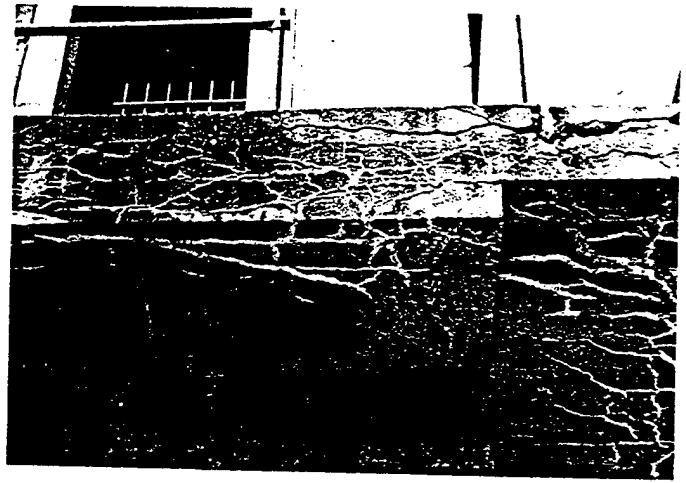
Fig. 7. Battery Commander's Station, Ft. Washington, Maryland (1904). This reinforced concrete tower with a cantilevered balcony is showing serious deterioration. Water has penetrated the slab, causing freeze-thaw spalling around the posts and corrosion of the reinforcing bars. This internal corrosion is causing expansion inside the slab and creating major horizontal cracks in the concrete. Under the balcony can be seen the network of hardened white calcified deposits, which have exuded through cracks in the concrete as a result of alkali-aggregate reaction. Photo: Lee H. Nelson, FAIA.

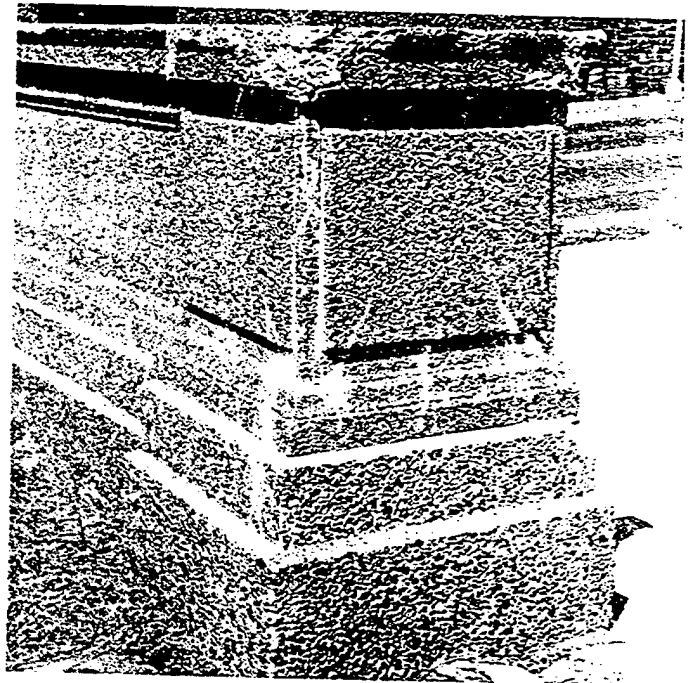
Fig. 8. Meridian Hill, Washington, D.C. (1934). This reinforced concrete pier has lost much of its projecting molding partly from accidental impact and partly from spalling induced by freeze-thaw action. Evidence of moisture leaching out from the interior through cracks is seen as white deposits on the surface of this exposed aggregate concrete. Photo: Lee H. Nelson, FAIA.

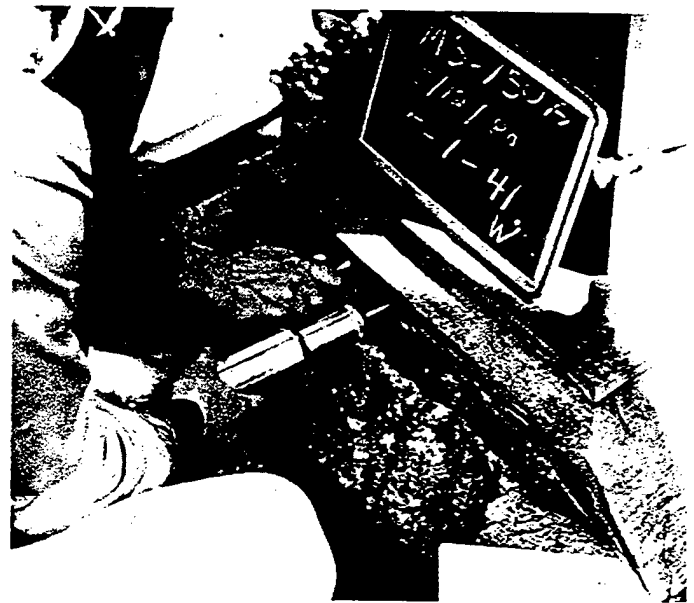
Fig. 9. Nondestructive sonic tests are one way of determining the location and soundness of internal reinforcing bars and the hardness of the concrete. There are a variety of other nondestructive tests provided by professional consultants that will help in the evaluation of the structural integrity of concrete prior to major repair work. Photo: Feld, Kaminetzky and Cohen and American Concrete Institute.

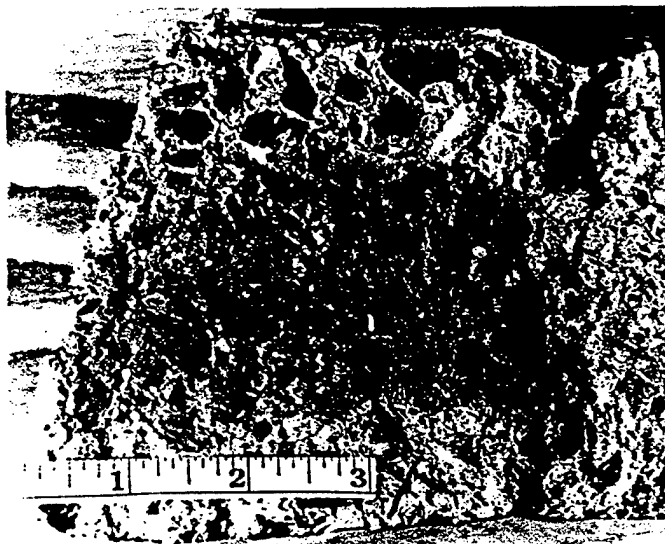
Fig. 10. Testing of actual samples of concrete in the lab may be necessary to determine the strength and condition of the concrete. In this sample, the surface, which is lighter than the sound concrete core, shows that carbonation has taken place. Carbonation reduces the alkalinity in concrete and may hasten corrosion of reinforcing bars close to the surface. Photo: Stella L. Marusin.

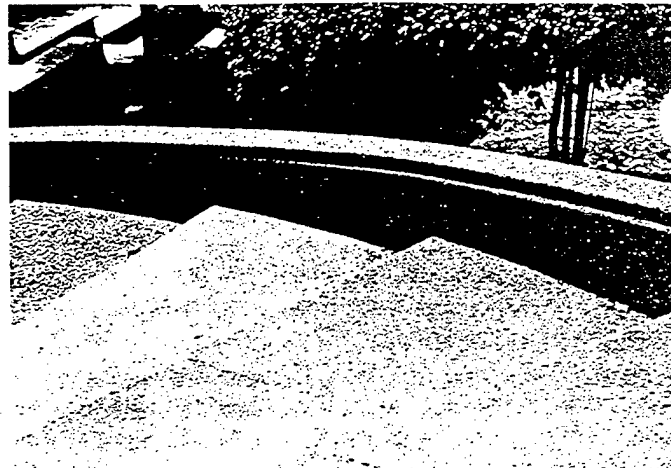
Fig. 11. Meridian Hill, Washington, D.C. (1934). It is important to match the visual qualities, such as color and texture, when repairs or replacement sections are undertaken. In this case, the new replacement step, located second from the left, matches the original pebble-finish surface of the adjacent historic steps. Photo: Sharon C. Park, AIA.

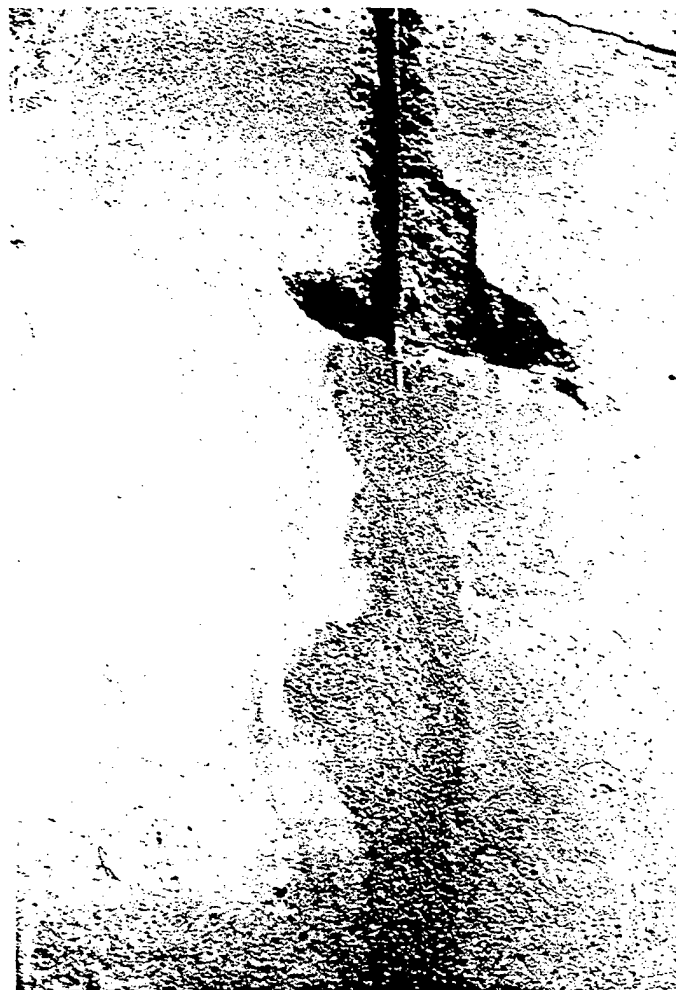
Fig. 12. Without proper preparation and correction of a pre-existing problem, repairs will fail. Insufficient concrete at the surface caused this patch around a reinforcing bar to fail within a year. In this case, a structural engineer should have assessed the need for this rod so close to the surface. Redundant rods are often cut out prior to patching. Photo: Alonzo White.

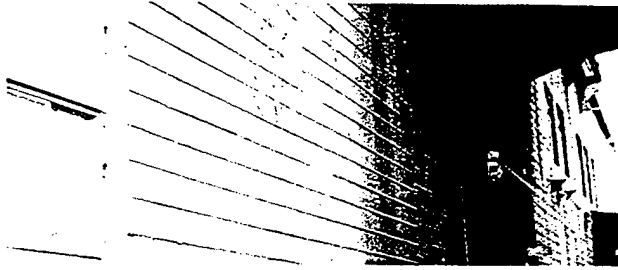
Fig. 13a. Buckling concrete under a painted surface indicates underlying deterioration. It is often difficult to assess the amount of deterioration until the area has been cleaned and examined closely.

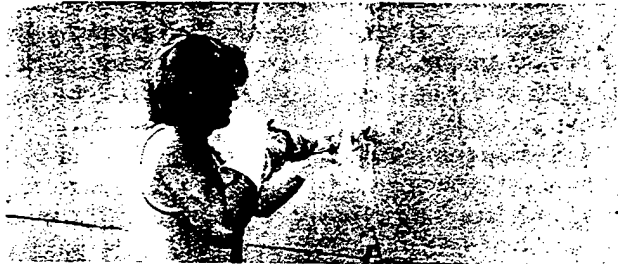
Fig. 13c. Narrow cracks often need to be widened to receive concrete patches. Here a pneumatic chisel is being used.

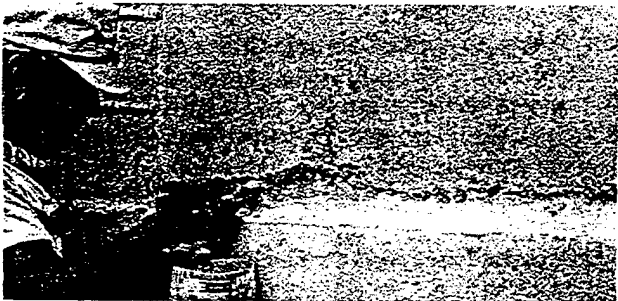
Fig. 13e. A spalled area of concrete has been cleaned back to a sound surface, and is being coated with a bonding agent to increase adherence of the new concrete patch.

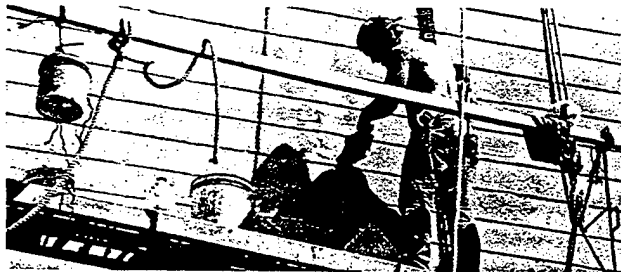
Fig. 13g. A soft brush is used to smooth the patch and to blend it with the adjacent historic concrete.

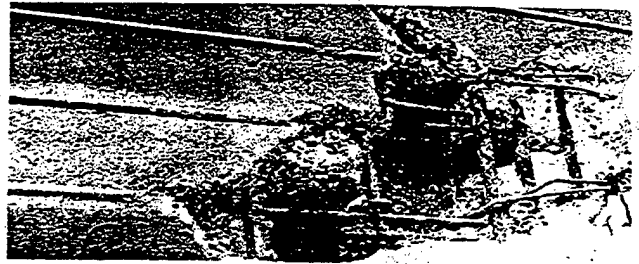
Fig. 13b. Upon removal of the deteriorated surface, a pocket of poorly mixed concrete (mostly sand and gravel) was easily chiseled out. The reinforcing rods were in good condition.

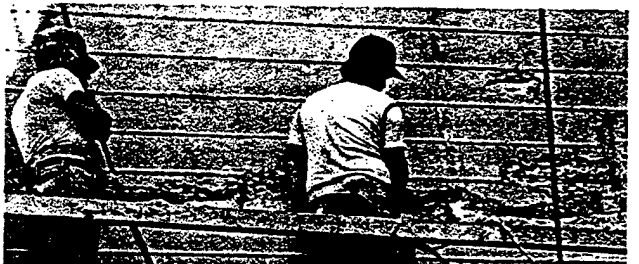
Fig. 13d. Deteriorated or redundant reinforcing bars are removed after evaluation by a structural engineer. An acetylene torch is being used to cut out the bars.

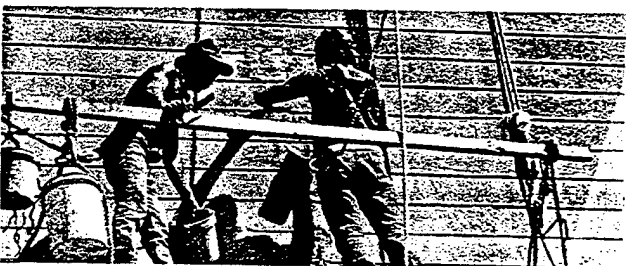
Fig. 13f. Workmen are applying patching concrete and using a trowel to form ridges to match the appearance of the historic concrete ridges that were originally created by the form boards.

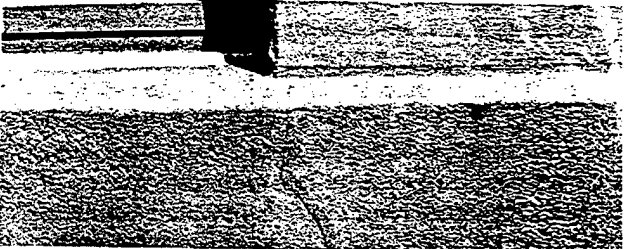
Fig. 13h. This active crack at a window sill and in the foundation wall has been filled with a flexible sealant. This area was subsequently painted with a masonry paint compatible with the sealant.

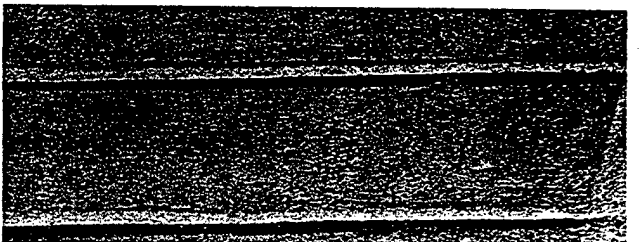
Fig. 13i. Upon completion of all repairs, the building was painted. The finished repair of the deterioration seen in 13a and b is shown in this photograph. The patch matches the texture and detailing of the historic concrete.

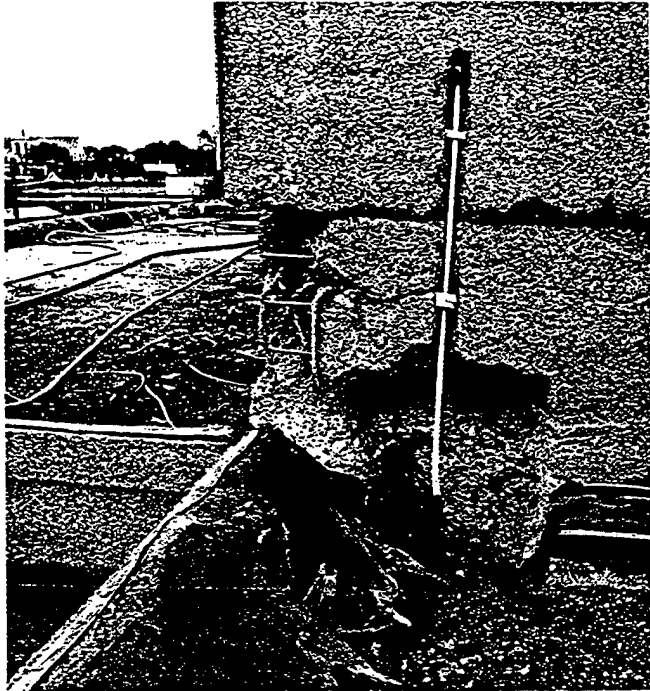
Fig. 14a. Spalled concrete was most noticeable at locations of concentrated rebars. Deteriorated concrete, the 1960s stucco finish, and corrosion were removed by grit-blasting. Photo: Robert Bell.

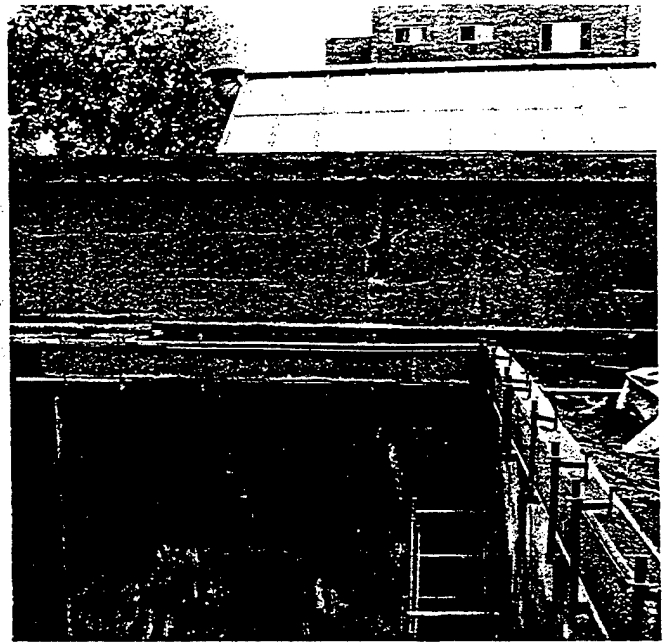
Fig. 14b. Board screeds were attached to the building to recreate the sharp edges of the original detail. Photo: Robert Bell.

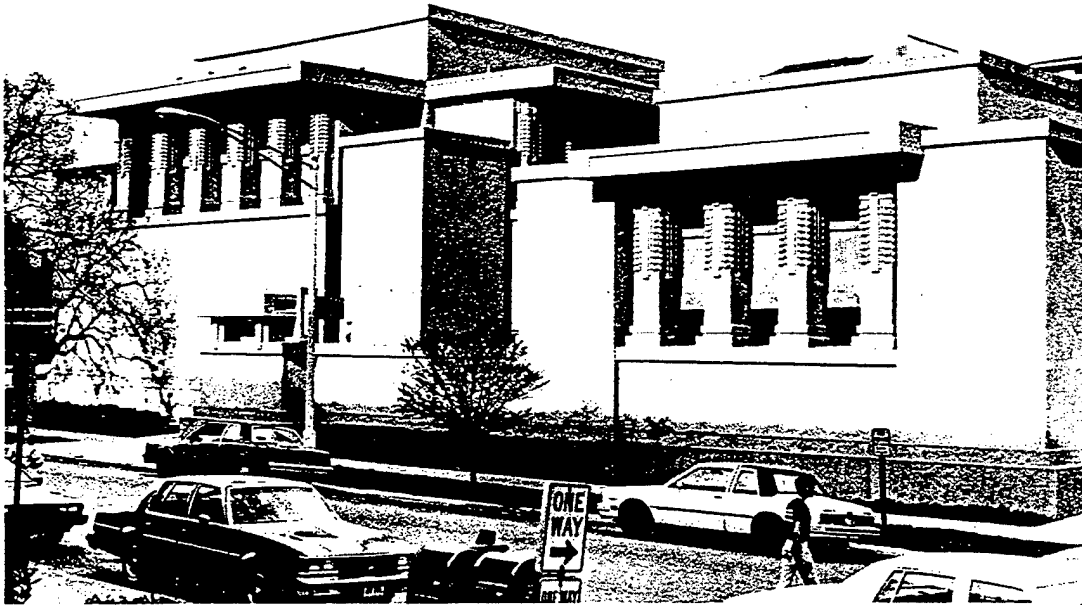
Fig. 14c. Once the repair work was complete, the entire building was sprayed with a concrete mixture consisting of pea-gravel, cement, and sand, which was then hand-

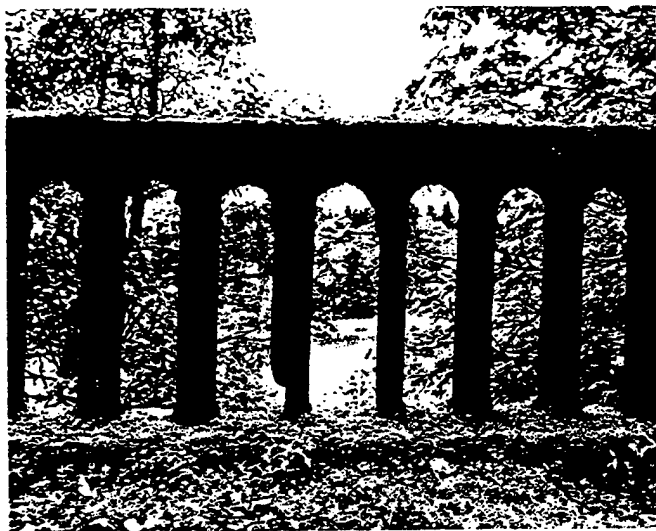
Fig. 15a. The spindle-type railings were deteriorated beyond repair. The concrete was cracked or broken and the center reinforcing rods were exposed and badly rusted.

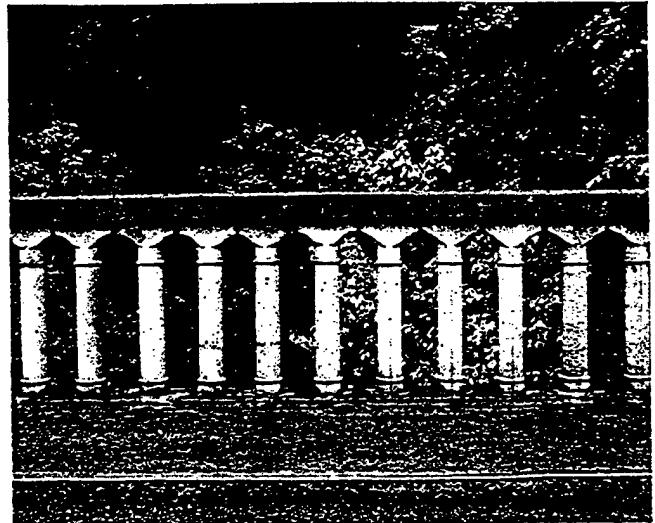
Fig. 15b. Deteriorated spindles were removed. The original 1914 molds were still available and used in casting new concrete spindles, but had they not been available, new molds could have been made to match the originals.

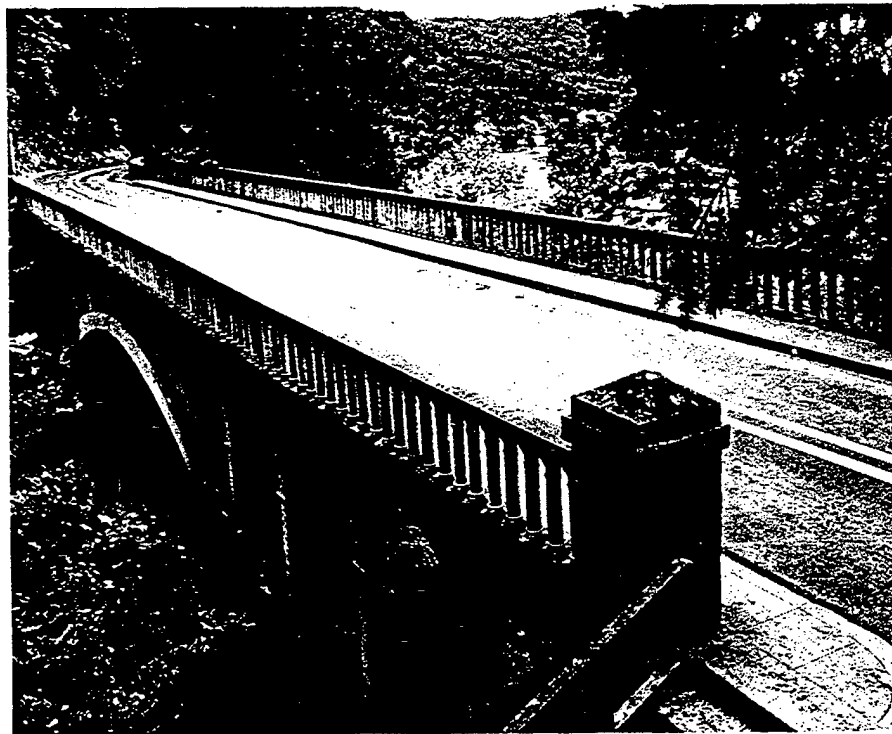
Fig.15c. The new concrete spindles have been installed. This sensitive renovation reused the historic concrete cap railing and stone piers, as they were still in sound condition.

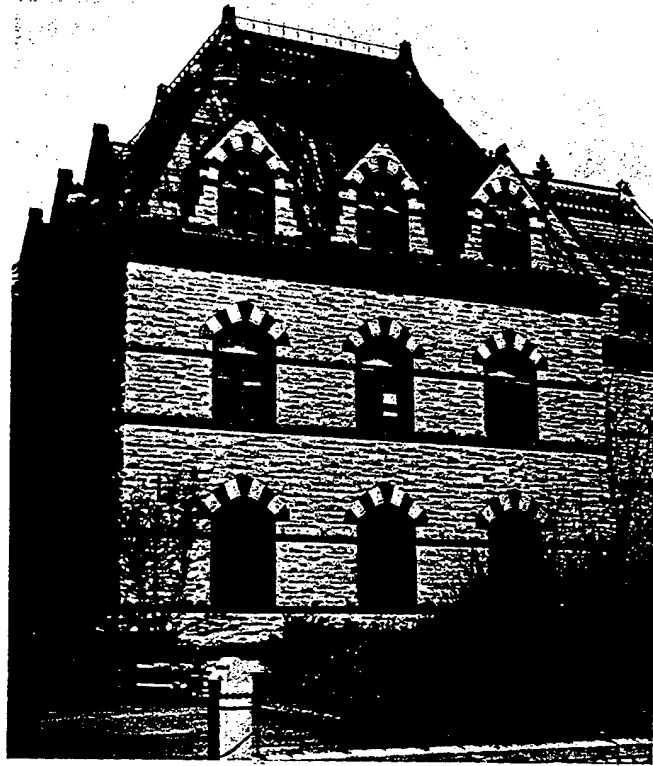
Overall Visual Character: Roof and Related Features

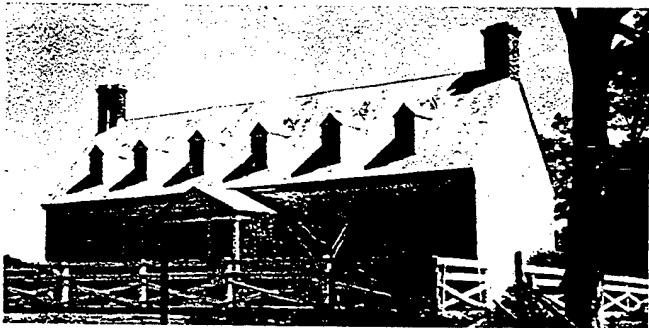
Overall Visual Character: Roof and Related Features

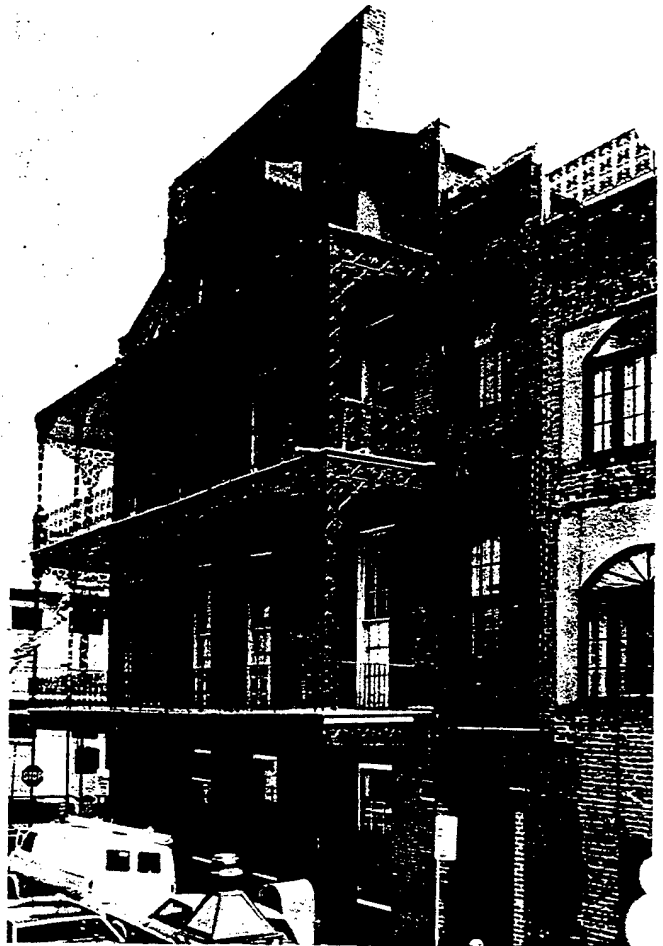
Overall Visual Character: Projections

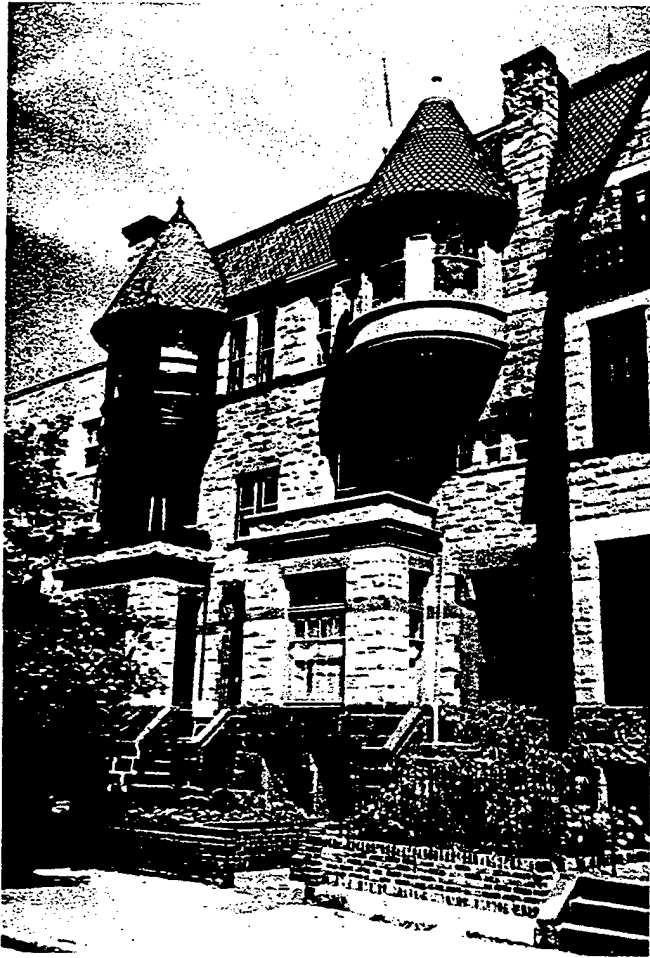
Overall Visual Character: Projections

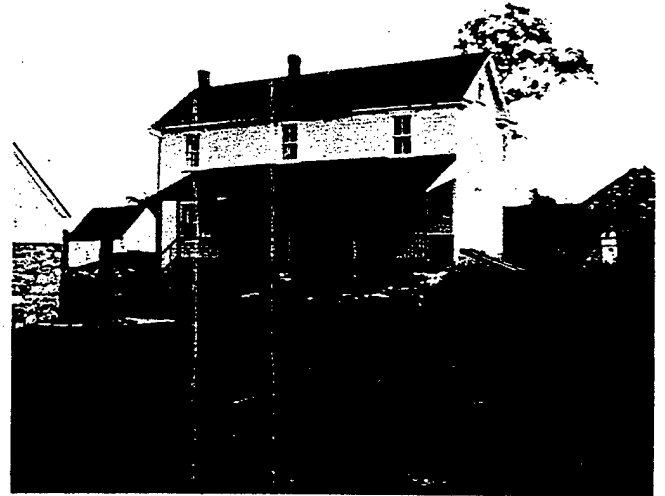
Overall Visual Character: Projections

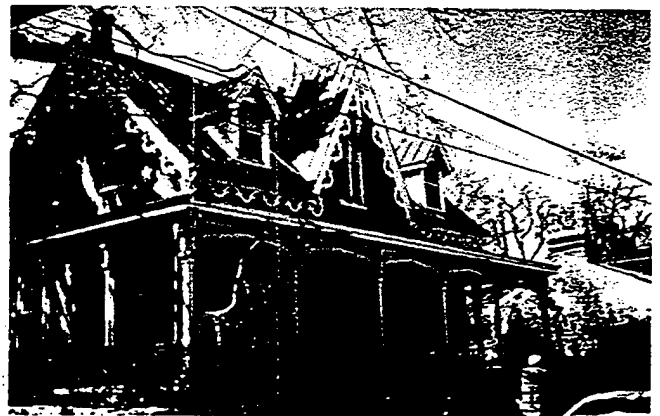
Overall Visual Character: Trim

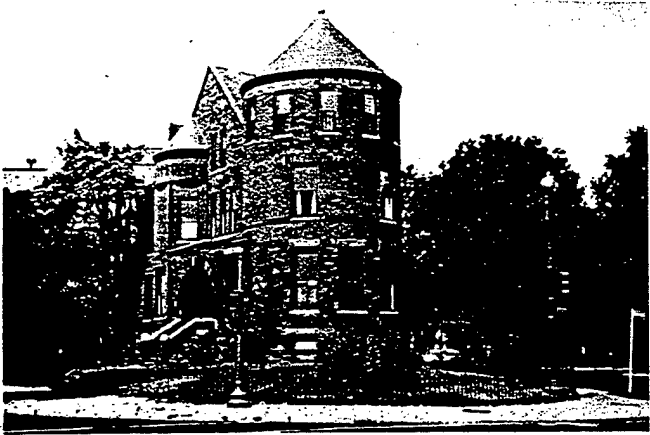
Overall Visual Character: Setting

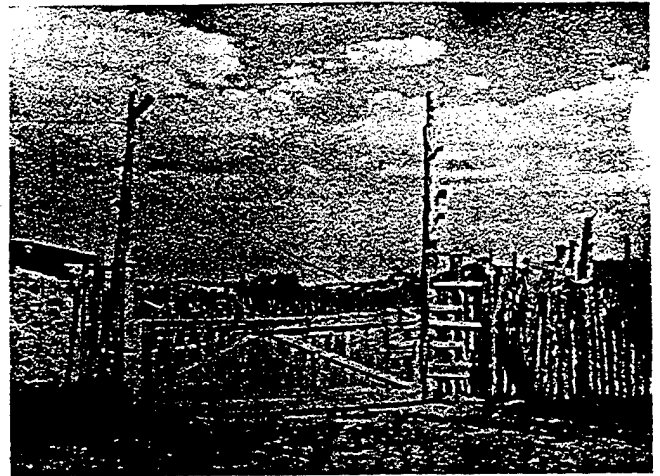
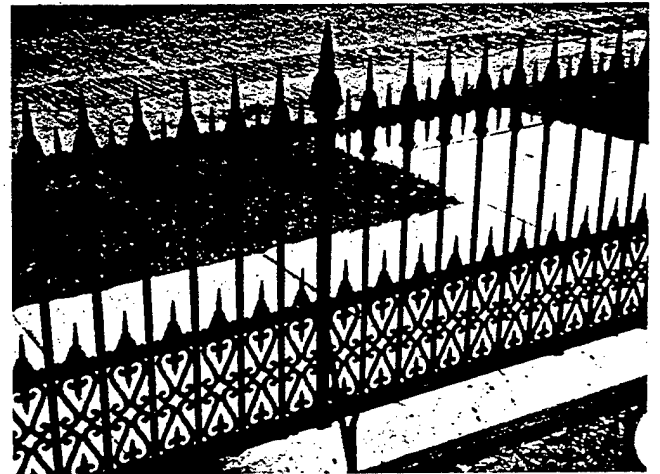
Overall Visual Character: Setting

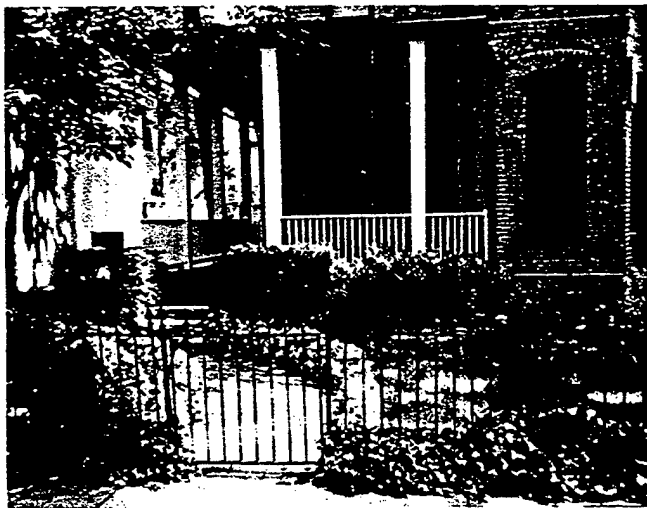
Overall Visual Character: Setting

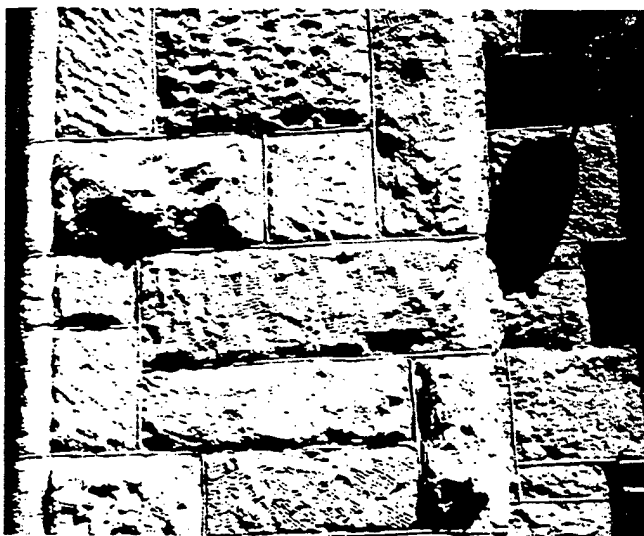
Arm's Length Visual Character: Craft Details

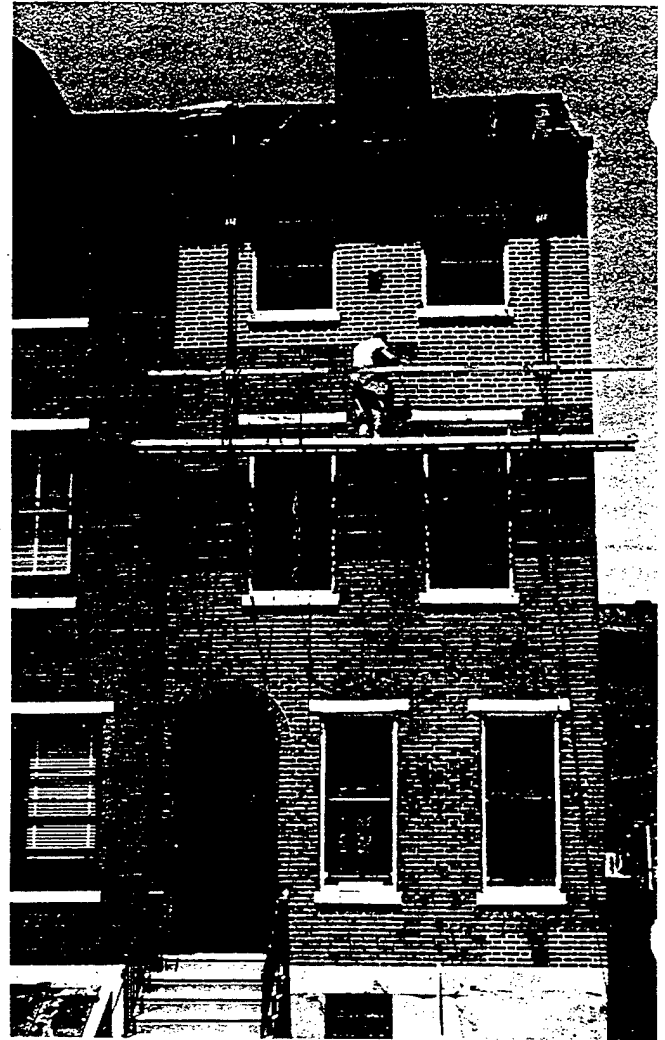
Fragility of A Building's Visual Character

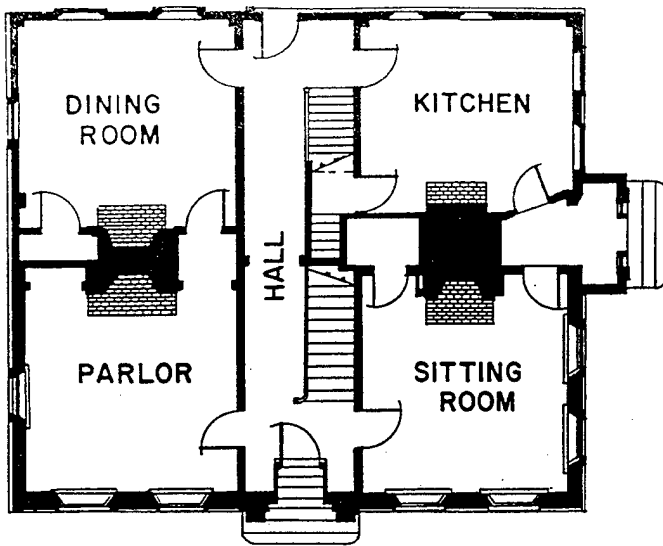
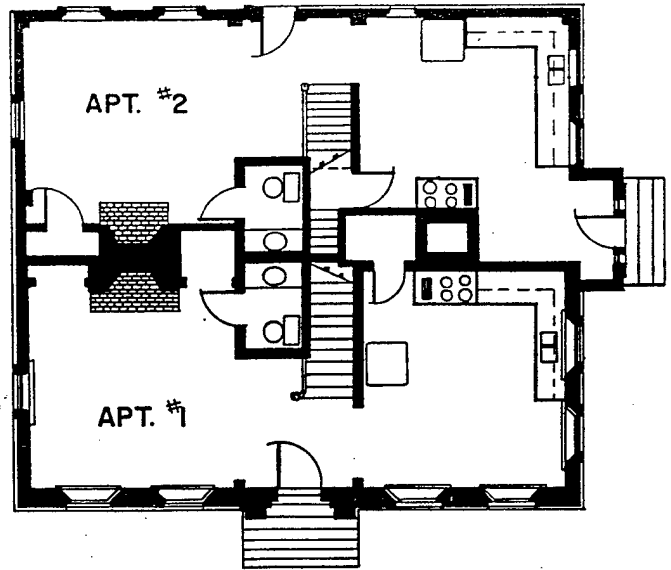
Figure 3. The floor plan at left is characteristic of many 19th century Greek Revival houses, with large rooms flanking a central hall. In the process of rehabilitation, the plan (at right) was drastically altered to accommodate two duplex apartments. The open stair was replaced with one that is enclosed, two fireplaces were eliminated, and Greek Revival trim around windows and doors was removed. The symmetry of the rooms themselves was destroyed with the insertion of bathrooms and kitchens. Few vestiges of the 19th century interior survived the rehabilitation. Drawing by Neal A. Vogel

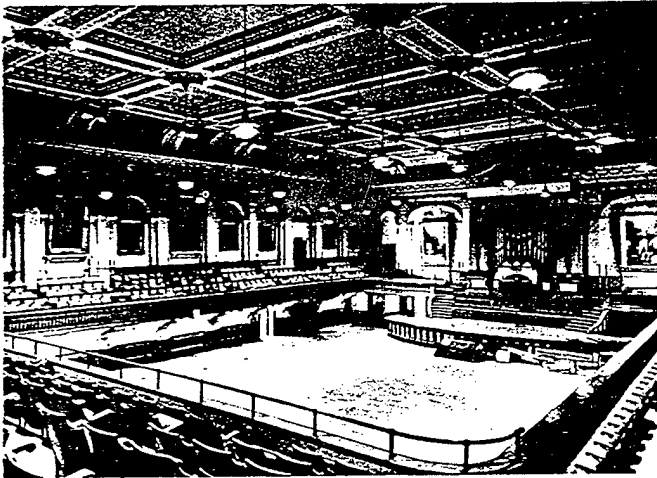
Figure 4. Many institutional buildings possess distinctive spaces or floor plans that are important in conveying the significance of the property. Finding new compatible uses for these buildings and preserving the buildings' historic character can be a difficult, if not impossible, task. One such case is Mechanics Hall in Worcester, Massachusetts, constructed between 1855 and 1857. This grand hall, which occupies the entire third floor of the building, could not be subdivided without destroying the integrity of the space.

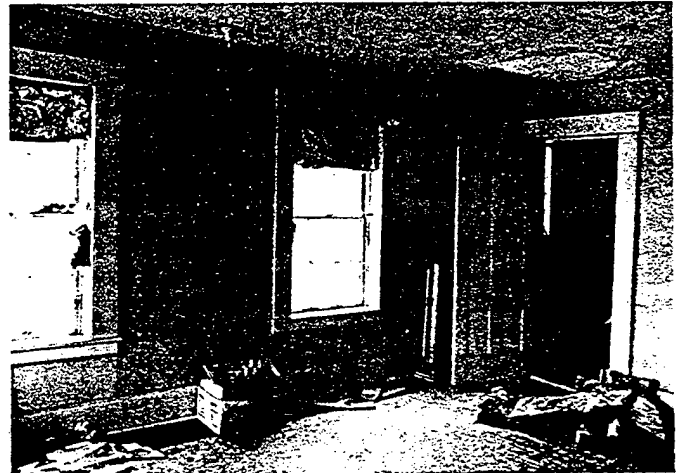
Figure 5. The interior of a simply detailed worker's house of the 19th century may be as important historically as the richly ornamented interior seen in figure 1. Although the interior of this house has not been properly maintained, the wide baseboards, flat window trim, and four-panel door are characteristic of workers' housing during this period and deserve retention during rehabilitation.

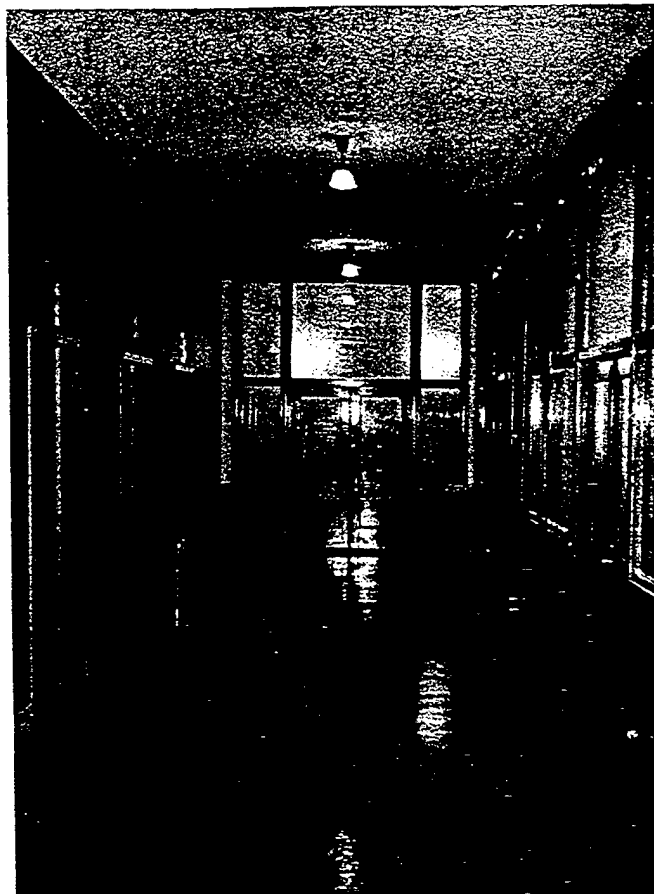
Figure 6. This corridor, located in the historic Monadnock Building in Chicago, has glazed walls, oak trim, and marble wainscotting, and is typical of those found in late 19th and early 20th century office buildings. Despite the simplicity of the features, a careful attention to detail can be noted in the patterned tile floor, bronze mail chute, and door hardware. The retention of corridors like this one should be a priority in rehabilitation projects involving commercial buildings.

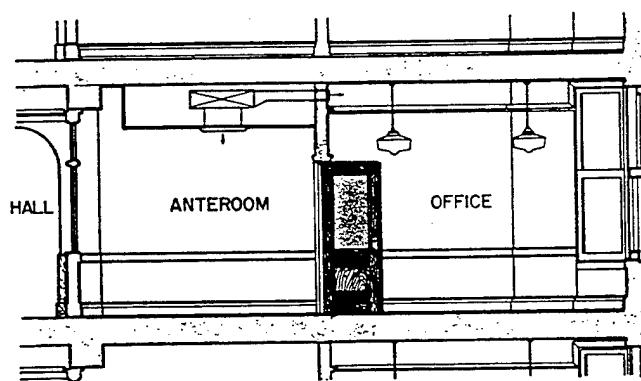
Figure 7. When the Monadnock Building was rehabilitated, architects retained the basic floor plan on the upper floors consisting of a double-loaded corridor with offices opening onto it. The original floor-to-ceiling height in the corridors and outside offices—the most important spaces—was maintained by installing needed air conditioning ductwork in the less important anterooms. In this way, the most significant interior spaces were preserved intact. Drawing by Neal A. Vogel

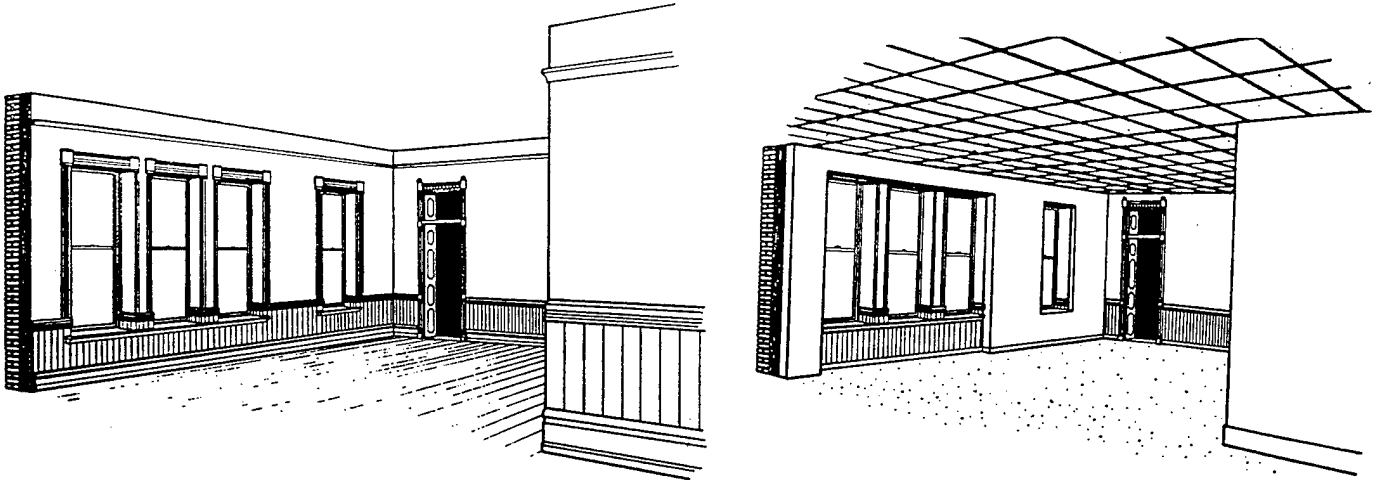
10. Avoid using destructive methods—propane and butane torches or sandblasting—to remove paint or other coatings from historic features. Avoid harsh cleaning agents that can change the appearance of wood. (For more information regarding appropriate cleaning methods, consult Preservation Brief 6, "Dangers of Abrasive Cleaning to Historic Buildings.")

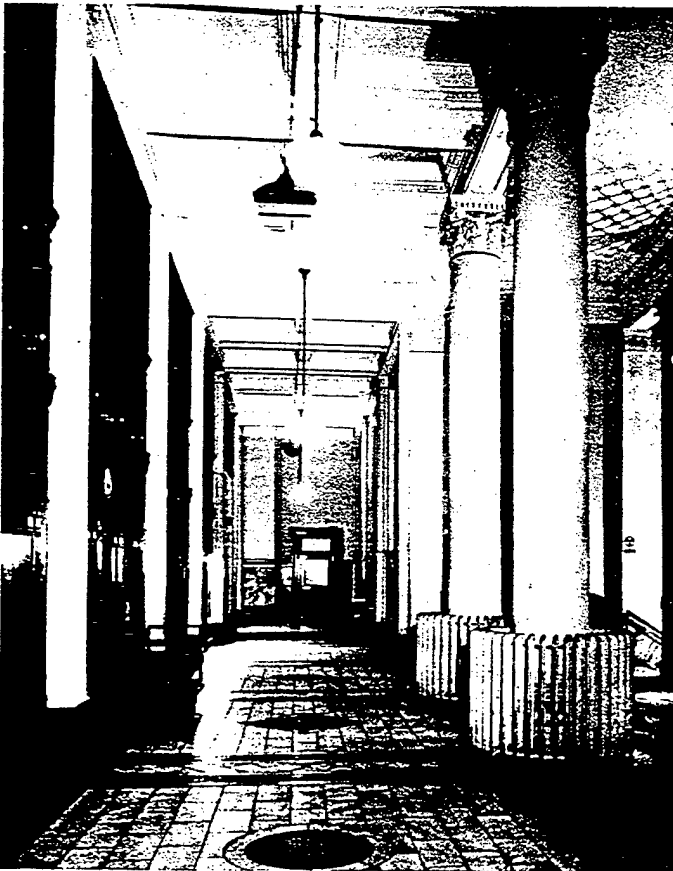
Figure 9. The tangible reminders of early mechanical systems can be worth saving. In this example, in the Old Post Office in Washington, D.C., radiators encircle Corinthian columns in a decorative manner. Note, too, the period light fixtures. These features were retained when the building was rehabilitated as retail and office space. Photo: Historic American Buildings Survey

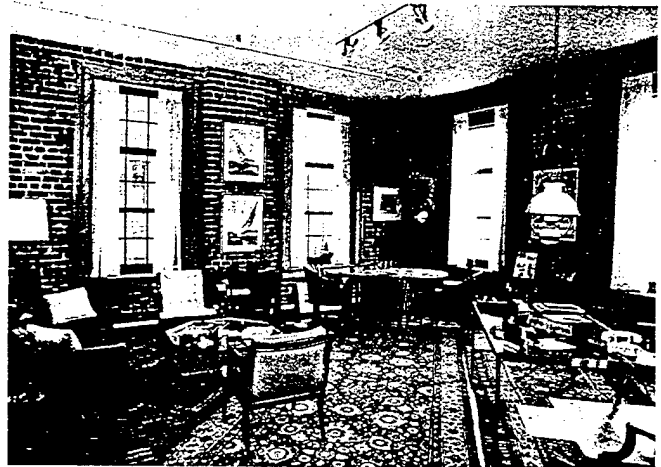
Figure 10. In this case plaster has been removed from perimeter walls, leaving brick exposed. In removing finishes from historic masonry walls, not only is there a loss of historic finish, but raw, unfinished walls are exposed, giving the interior an appearance it never had. Here, the exposed brick is of poor quality and the mortar joints are wide and badly struck. Plaster should have been retained and repaired, as necessary.

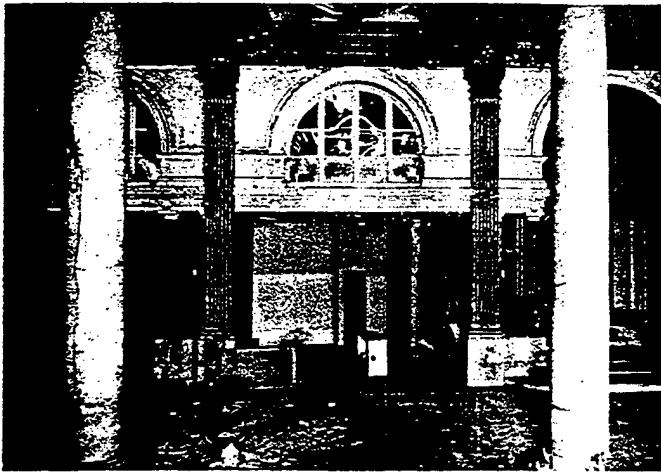
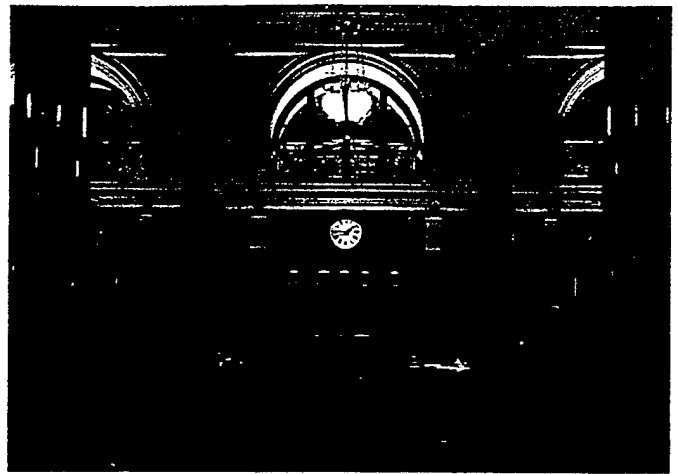
Figure 11. These dramatic "before" and "after" photographs show a severely deteriorated space restored to its original elegance: plaster has been repaired and painted, the scagliola columns have been restored to match marble using traditional craft techniques, and missing decorative metalwork has been re-installed in front of the windows. Although some reorganization of the space took place, notably the relocation of the front desk, the overall historic character of the space has been preserved. These views are of the lobby in the Willard Hotel, Washington, D.C. Credit: Commercial Photographers (left); Carol M. Highsmith (right)

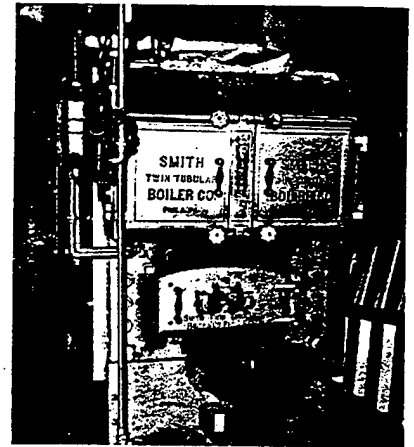
U.S. Department of the Interior
National Park Service
Cultural Resources
Preservation Assistance
