Management and Maintenance Manual
The Old Hospital Complex
Fort Carson, Colorado
(5EP1778)

James Schneck

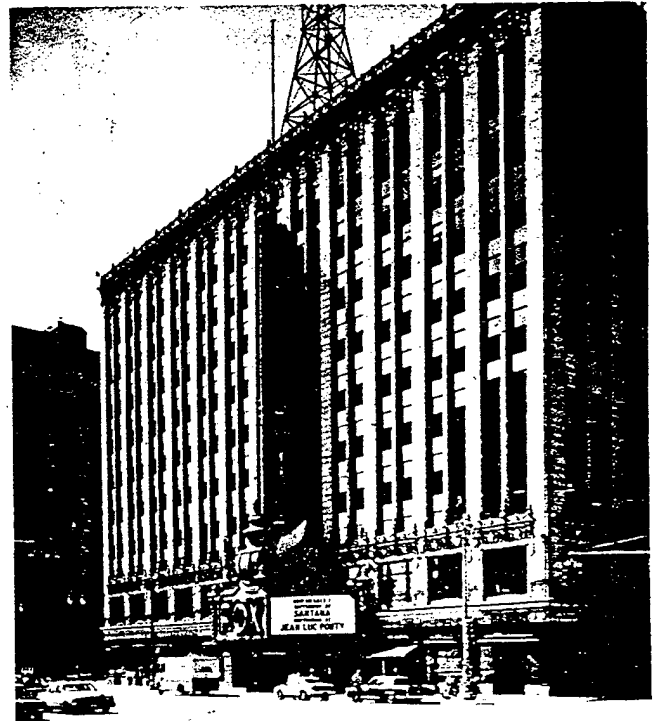
3. The circa 1928 Fox Theater in Detroit, designed by C. Howard Crane, was one of the earliest twentieth century buildings to provide air conditioning to its patrons. The early water-cooled system was recently restored. Commercial and highrise buildings of the twentieth century were able, mostly through electrical power, to provide sophisticated systems that integrated many building services. Photo: William Kessler and Associates, Architects.

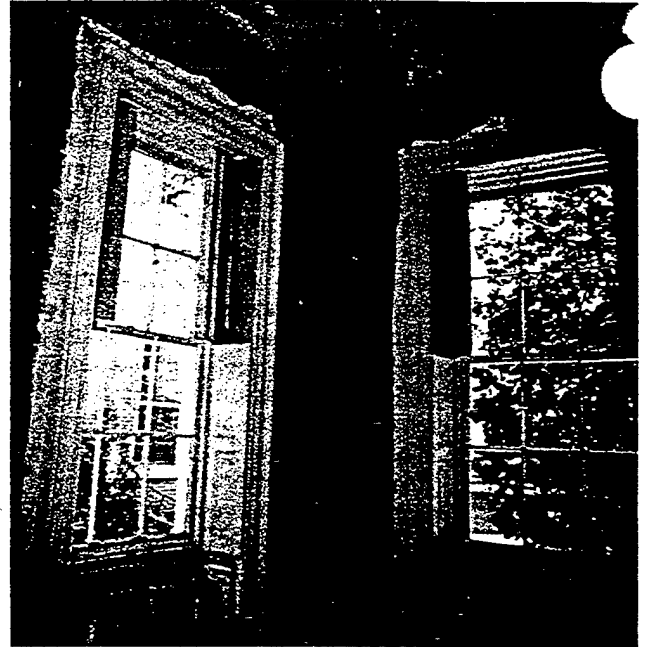
5. The installation of vapor retarders in walls of historic buildings in an effort to contain interior moisture can cause serious damage to historic finishes as shown here. In this example, all the wall plaster and lath have been stripped in preparation for a vapor barrier prior to replastering. Controlling interior temperature and relative humidity can be more effective than adding insulation and vapor barriers to historic perimeter walls. Photo: Ernest A. Conrad, P.E.

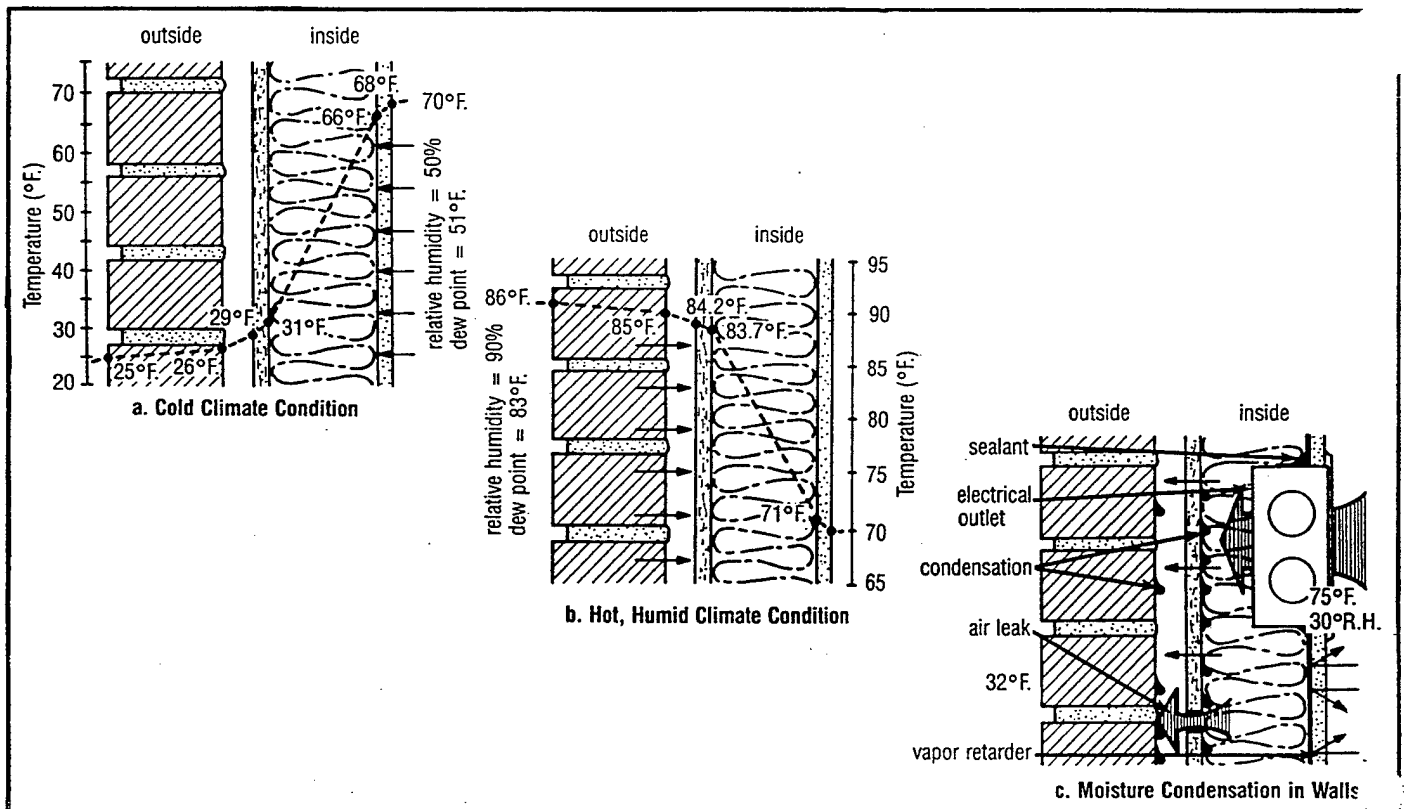
4. Mechanical heating and cooling systems change the interior climate of a building. Moisture in the air will dissipate from the warmer area of a building the colder area and can cause serious deterioration of historic materials. Condensation can form if the dew point occurs within the building wall, particularly one that has been insulated (see a and b). Even when vapor retarders are installed (c), any non-continuous areas will provide spaces for moisture to pass. Wall Section Drawings: NPS files

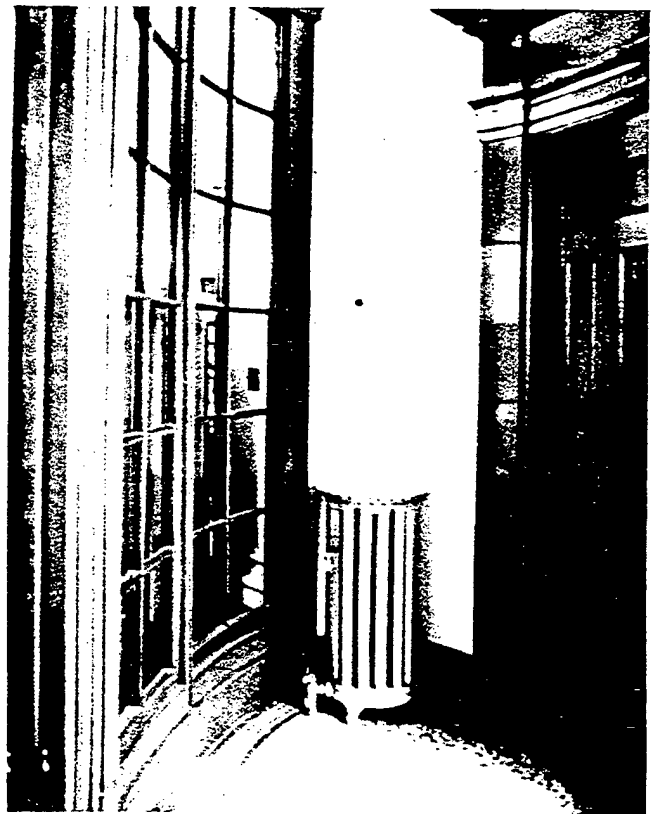
6. A condition assessment during the planning stage would identify this round radiator in a small oval-shaped vestibule as a significant element of the historic heating system. In upgrading the mechanical system, the radiator should be retained. Photo: Michael C. Henry, P.E., AIA.

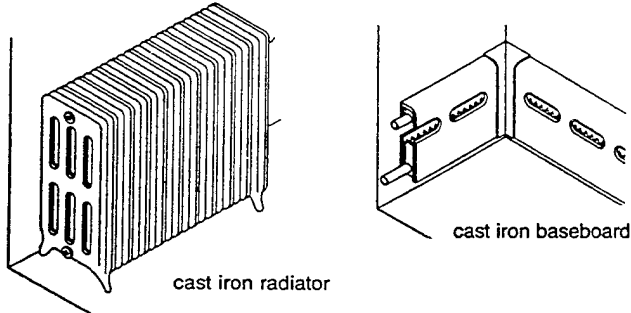
Fan Coil Units: Fan coil systems use terminal cabinets in each room serviced by 2, 3, or 4 pipes approximately 1-1/2" each in diameter. A fan blows air over the coils which are serviced by hot or chilled water. Each fan coil cabinet can be individually controlled. Four-pipe fan coils can provide both heating and cooling all year long. Most piping is steel. Non-cabinet units may be concealed in closets or custom cabinetry, such as benches, can be built.

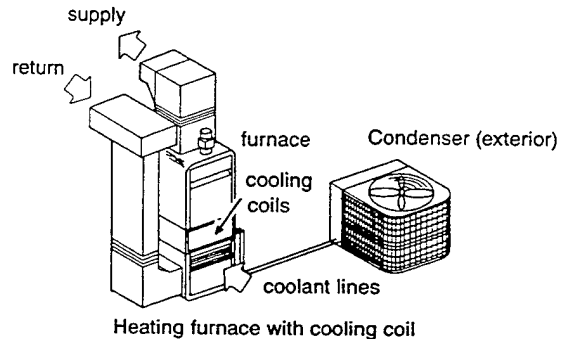
Basic Heat Pump/Air System: The heat pump is a basic HVAC system as described above except for the method of generating hot and cold air. The system operates on the basic refrigeration cycle where latent heat is extracted from the ambient air and is used to evaporate refrigerant vapor under pressure. Functions of the condenser and evaporator switch when heating is needed. Heat pumps, somewhat less efficient in cold climates, can be fitted with electric resistance coil.

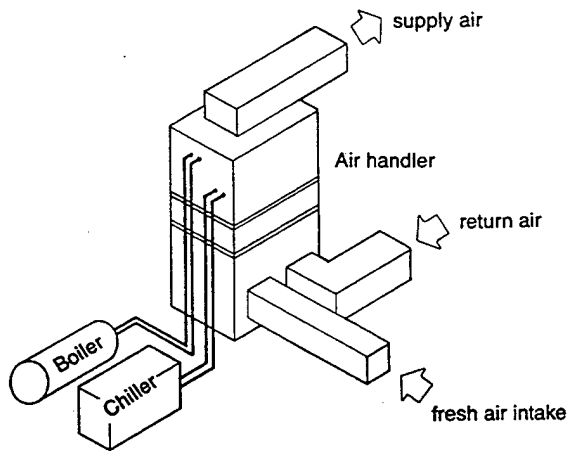
Typical Systems Layout:

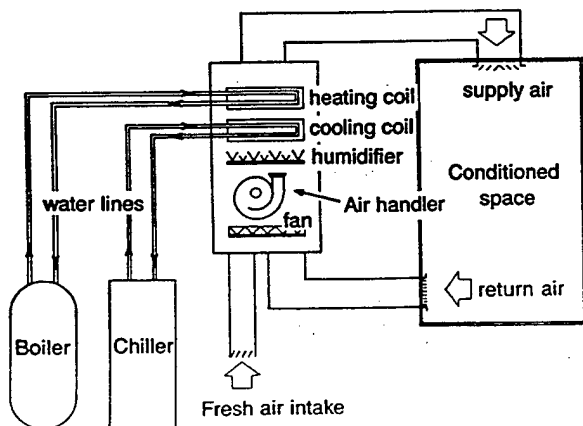
OTHER SYSTEM COMPONENTS

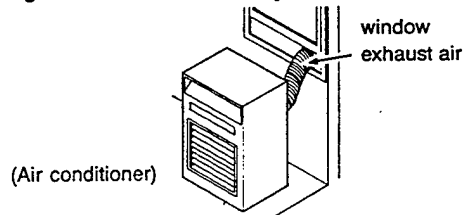
Fans: Fans should be considered in most properties to improve ventilation. Fans can be located in attics, at the top of stairs, or in individual rooms. In moderate climates, fans may eliminate the need to install central air systems.

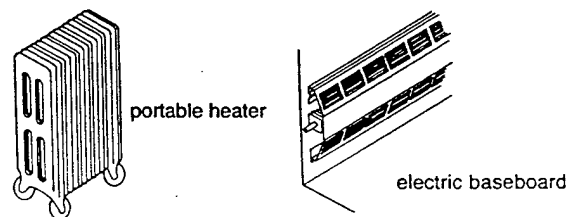
4. Prioritize architecturally significant spaces, finishes, and features to be preserved. Significant architectural spaces, finishes and features should be identified and evaluated at the outset to ensure their preservation. This includes significant existing mechanical systems or elements such as hot water radiators, decorative grilles, elaborate switchplates, and non-mechanical architectural features such as cupolas, transoms, or porches. Identify non-significant spaces where mechanical equipment can be placed and secondary spaces where equipment and distribution runs on both a horizontal and vertical basis can be located. Appropriate secondary spaces for housing equipment might include attics, basements, penthouses, mezzanines, false ceiling or floor cavities, vertical chases, stair towers, closets, or exterior below-grade vaults (see figure 8).

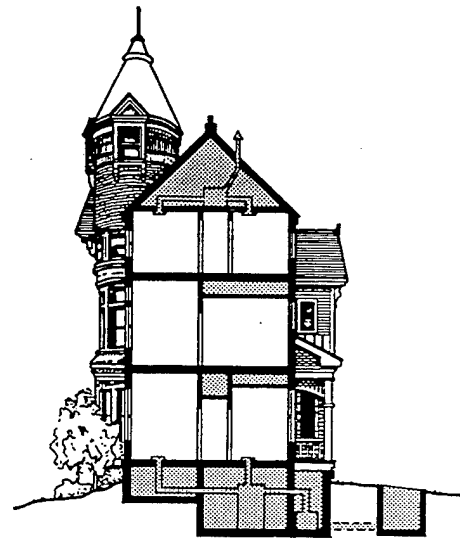
8. In considering options for new systems, existing spaces should be evaluated for their ability to house new equipment. This sketch shows several areas where new mechanical equipment could be located to avoid damaging significant spaces. Sketch: NPS files

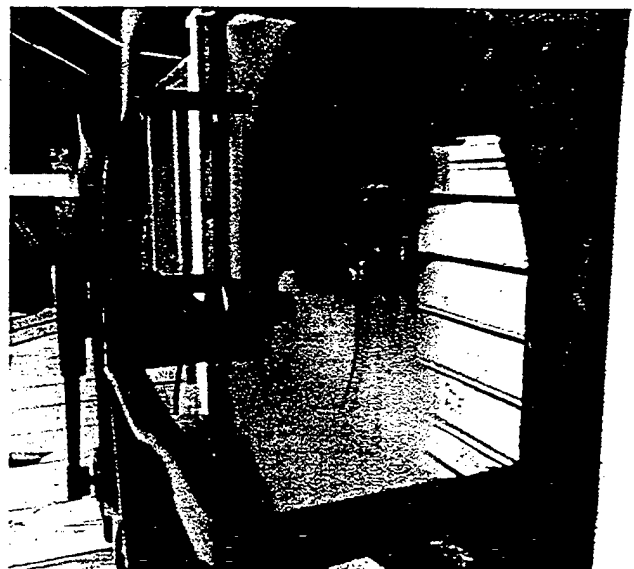
9. Improving ventilation through traditional means should not be overlooked in planning new or upgraded HVAC systems. In mild climates, good exhaust fans can often eliminate the need for air conditioning or can reduce equipment size by reducing cooling loads. Photo: Ernest A. Conrad, P.E.

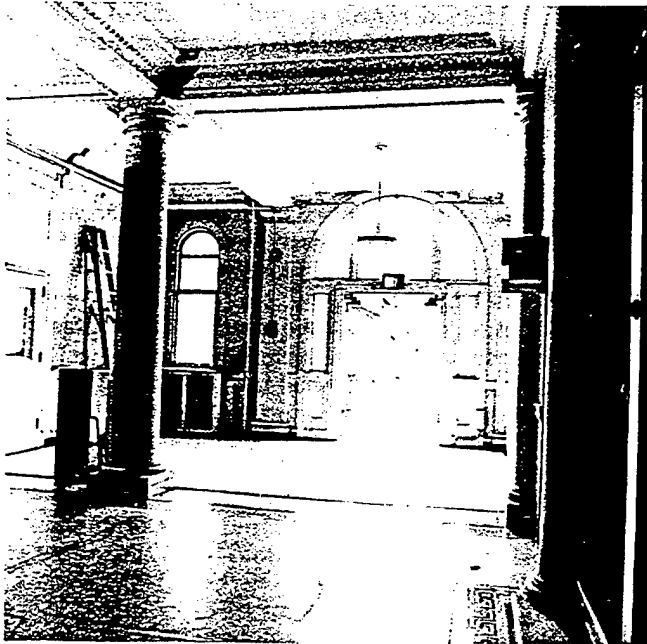
10. The following photographs illustrate recent preservation projects where careful planning and design retained the historic character of the resources.

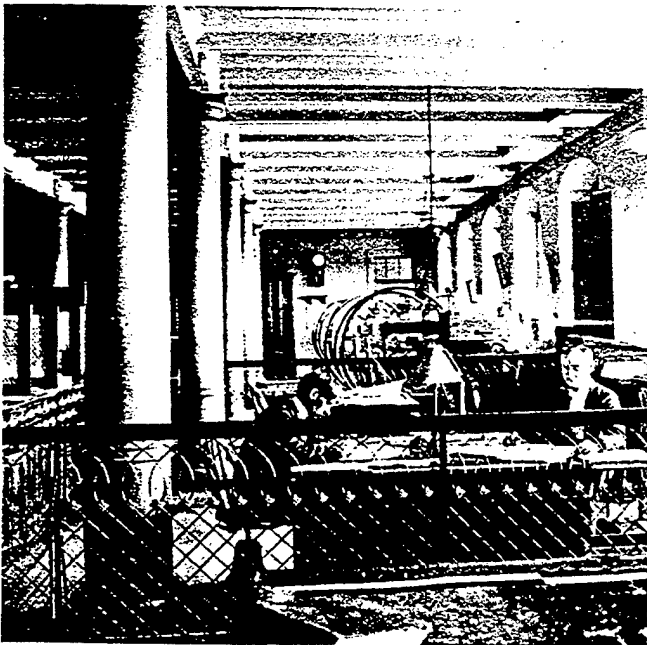
a. Before and after of a circa 1900 school entrance. The radiators have been replaced with a two-pipe fan coil system built into bench seats. The ceiling was preserved and no exposed elements were required to add air conditioning. Piping runs are under the benches and there was no damage to the masonry walls. Photos: Notter Finegold + Alexander Inc. and Lautman Photography, Washington.

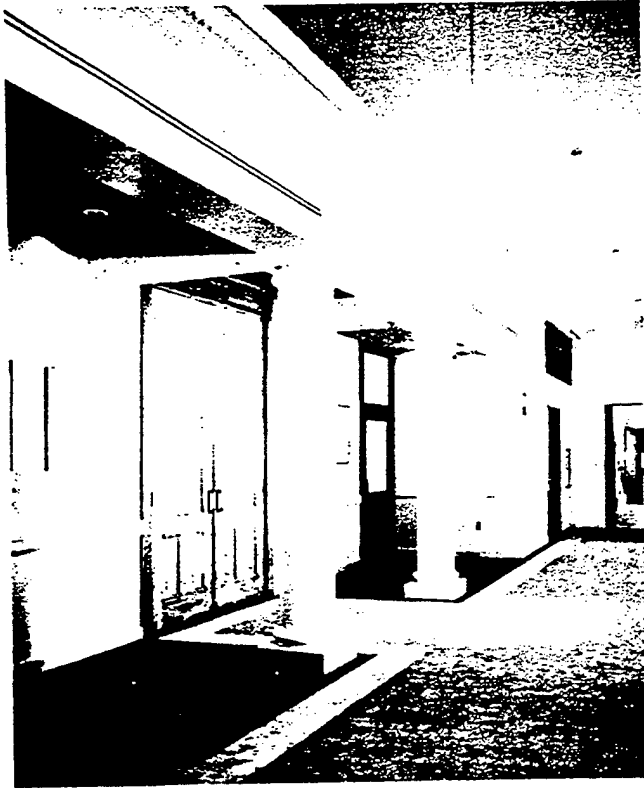
b. Central air conditioning was installed in the corridors of this circa 1900 school building by adding an air handler over the entrance from a vestibule. The custom-designed slot registers provide linear diffusers without detracting from the architecture of the space. Photo: Lautman Photography courtesy of Notter Finegold + Alexander Inc.

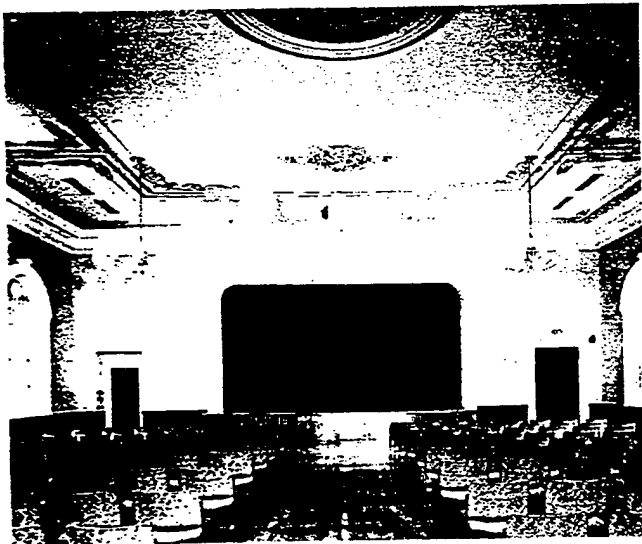
e. Town Hall, Andover, MA. The upstairs auditorium was restored and new mechanical systems were installed. Perimeter baseboard radiation provides heat and air handlers, located in the attic space provide air conditioning. The cast iron ceiling grille was adapted for return air and the supply registers were installed in a symmetrical and regular manner to minimize impact on the historic ceiling. Photo: David Hewitt/Anne Garrison for Ann Beha Associates.

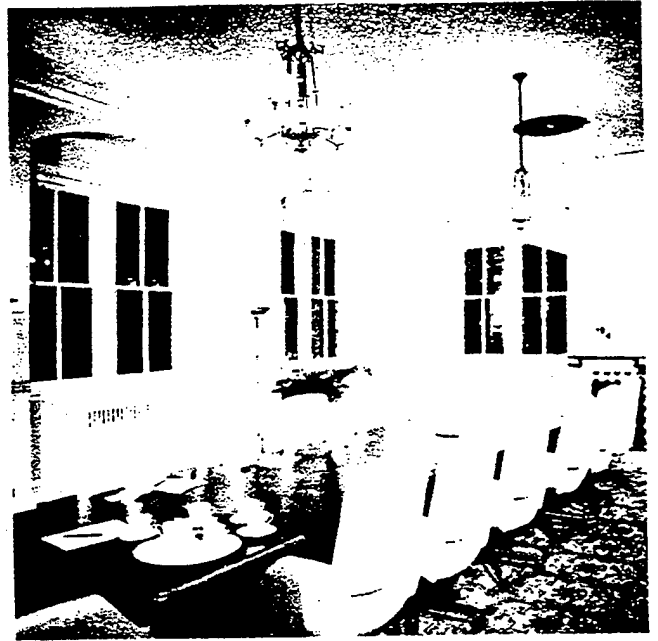
c. Conference room, Auditors Building, Washington, D.C. The historic steam radiators were retained for heating. The cast iron ceiling register was retained as a decorative element, but made inoperable to meet fire codes. Photo: Kenneth Wyner Photography courtesy of Notter Finegold + Alexander Inc.

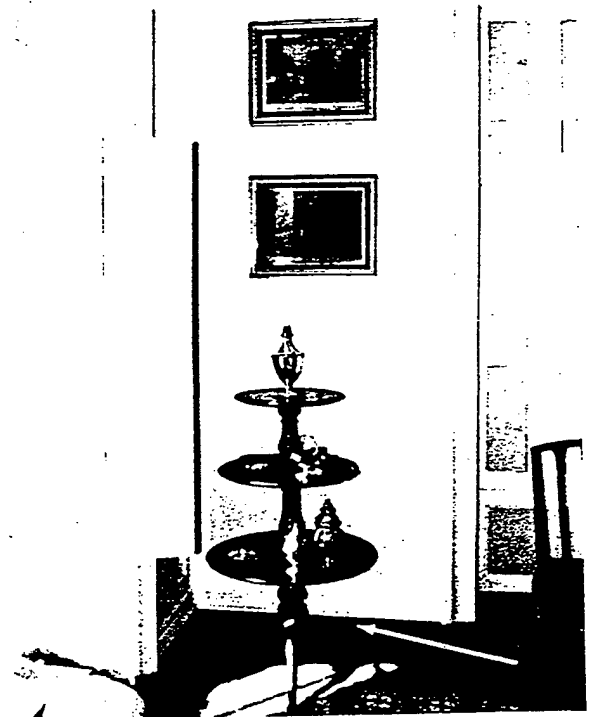
f. Homewood, Baltimore, MD. This elegant circa 1806 residence is now a house museum. The registers for the forced air ducted system seen behind the table legs, are grained to blend with the historic baseboards. The HVAC system uses a water/air system where chilled water and steam heat are converted to conditioned air. Photo: Courtesy Homewood Museum, Johns Hopkins University.

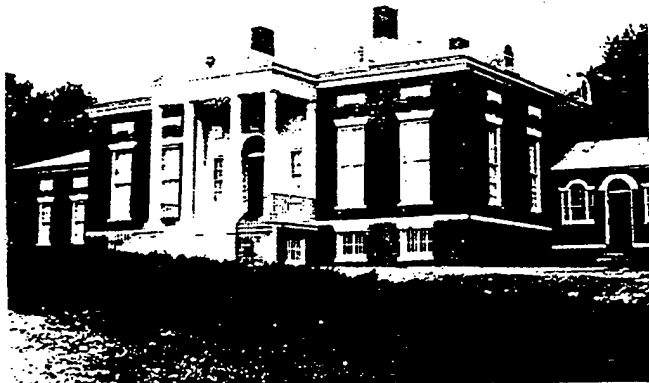
Too often the presumed climate needs of the occupants or collections can be detrimental to the long-term preservation of the building. With a careful balance between the preservation needs of the building and the interior temperature and humidity needs of the occupants, a successful project can result.

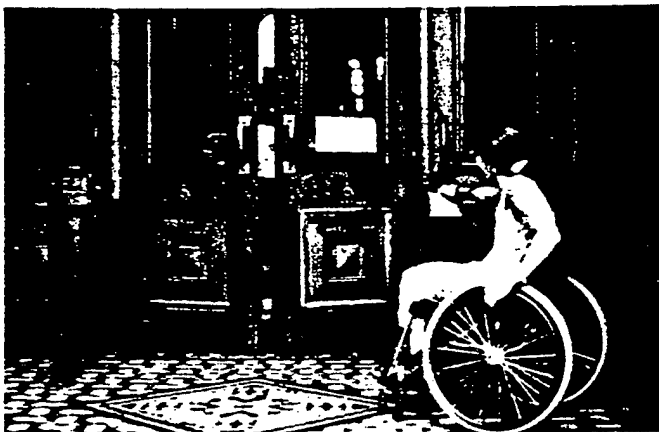
Figure 5. A universal access symbol clearly marks the Arts and Industries Building in Washington, D.C., and a push plate (right) engages the automatic door-opener. Photo: Thomas Jester.

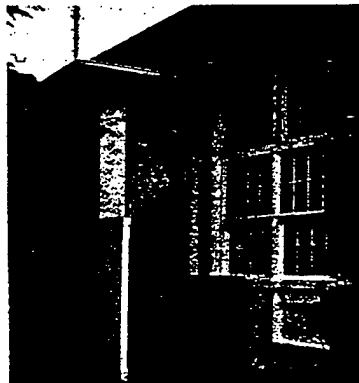
Figure 13. Platform lifts like the one used on this building require minimal space and can be removed without damaging historic materials. Shielded with lattice work, this lift is also protected by the roof eaves. Approach path should be stable, firm, and slip resistant. Photo: Sharon Park.

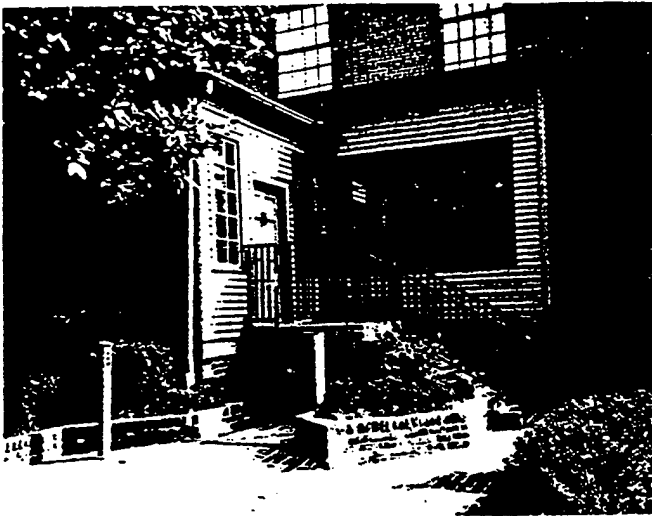
Figure 14. At the Lieutenant Governor's Mansion in Frankfort, Kentucky, a retracting lift (b) was installed to minimize the visual effect on this historic building when not in use (a). Photos: Aging Technology Incorporated.

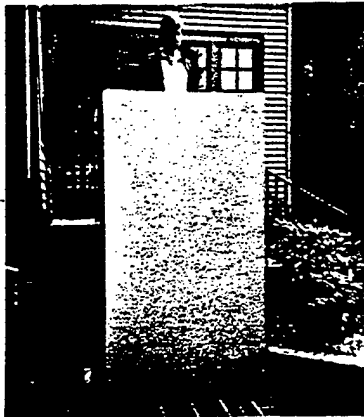
Figure 15. A new entrance to the elevator lobby replaces a window at Faneuil Hall in Boston, Massachusetts. The new entrance is appropriately differentiated from the historic design. Photo: Paul Holtz.

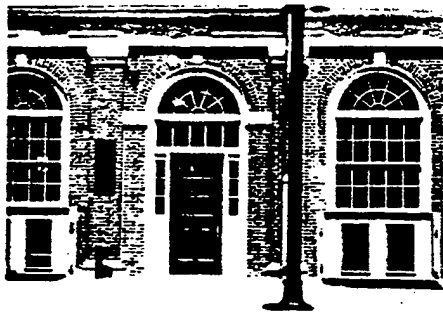
(operated by push buttons, mats, or electronic eyes) and power-assisted door openers can eliminate or reduce door pressures that are accessibility barriers, and make single or double-leaf doors fully operational (See Figure 16).

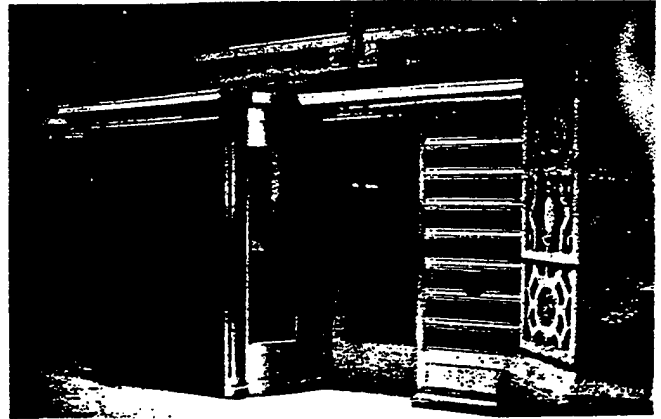
Figure 16. During the rehabilitation of the Rookery in Chicago, the original entrance was modified to create an accessible entrance. Two revolving doors were replaced with a new one flanked by new doors, one of which is operated with a push-plate door opener. Photo: Thomas Jester.

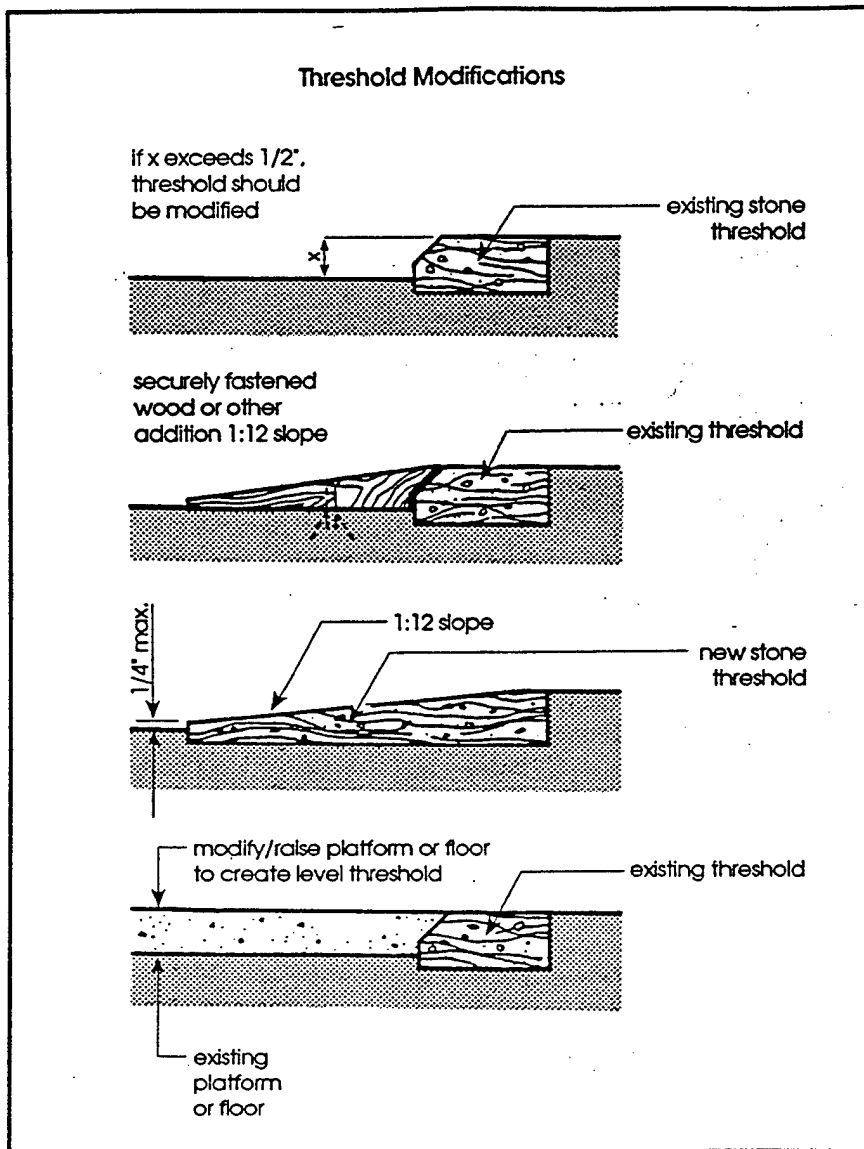
Figure 17. Thresholds that exceed allowable heights can be modified several ways to increase accessibility. Source: Uniform Federal Accessibility Standard (UFAS) Retrofit Manual.

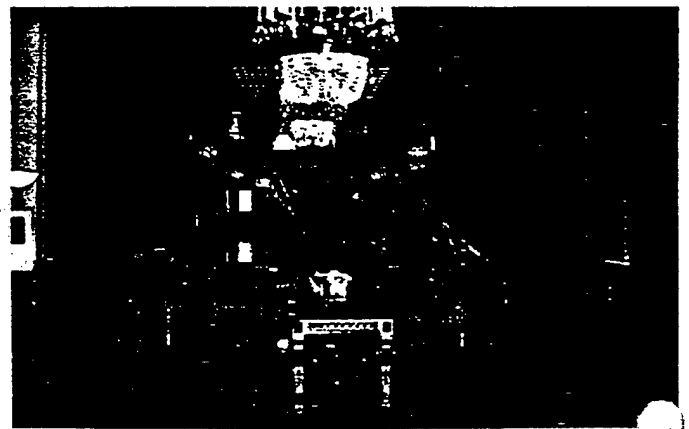
Figure 18. Symmetrical ramps at the Mayflower Hotel in Washington D.C., provide access to the hotel's lower level. The design for the ramps respects the historic character of this landmark building. Photo: Thomas Jester.

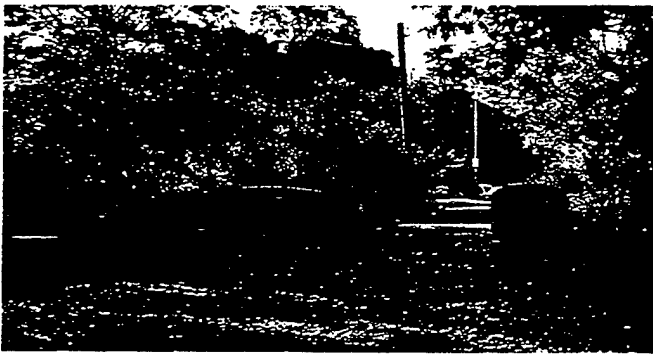
(a.) To improve accessibility in Boston's Emerald Necklace Parks, standard asphalt paving was replaced in selected areas with an imbedded aggregate surface that is more in keeping with the landscape's historic appearance. Photo: Charles Birnbaum.

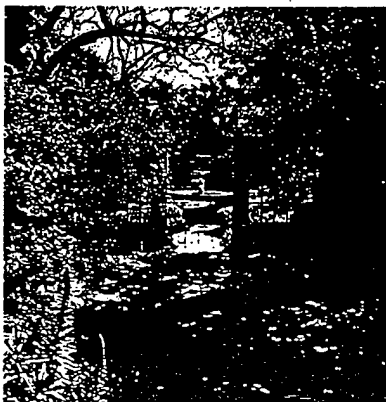
(b.) The Friendly Garden at Ranchos Los Alamitos, a historic estate with designed gardens in southern California, was made accessible with limited widening of its existing approach path. Photo: Ranchos Los Alamitos Foundation.

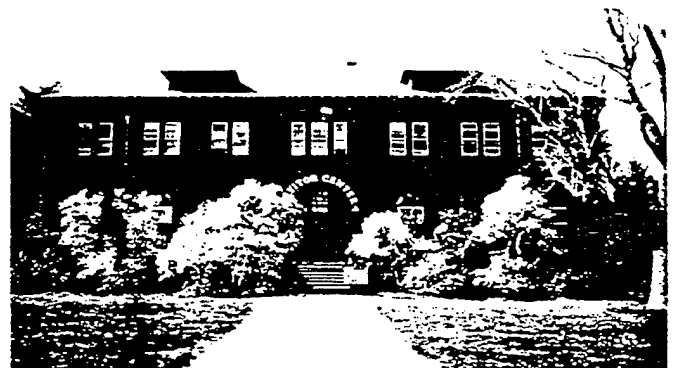
(c.) Hunnewell Visitor's Center before rehabilitation, revealing the altered landscapes. Photo: Jennifer Jones, Carol R. Johnson and associates.

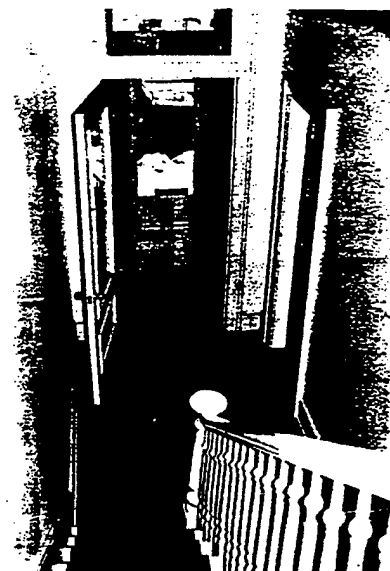
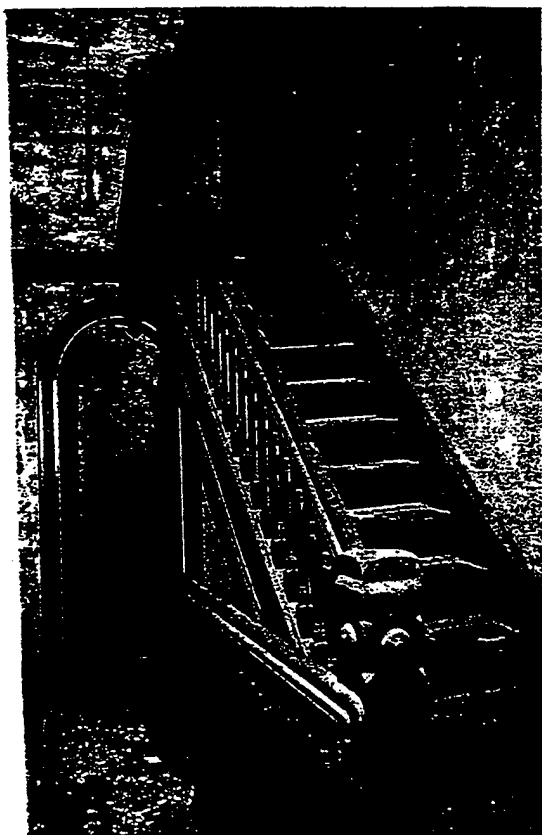
The premise of this Preservation Brief is that historic housing can be made lead-safe for children without removing significant decorative features and finishes, or architectural trimwork that may contribute to the building's historic character (see fig. 1). *Historic housing* — encompassing private dwellings and all types of rental units—is necessarily the focus of this Brief because federal and state laws primarily address the hazards of lead and

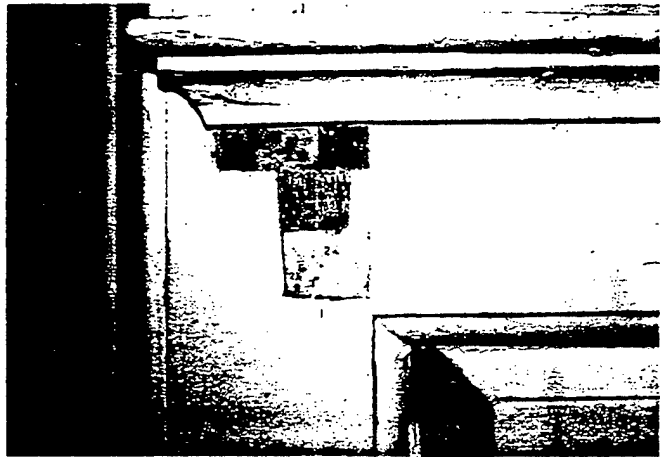
Figure 2. The paint chronology of this mantel, seen in the exposed paint layers in the left corner, proved it had been relocated from another room in the house. To remove a significant feature's paint history and the evidence of its original sequence of color by stripping off all the paint is inappropriate — and unnecessary — as part of a lead hazard reduction project. Careful surface preparation and repainting with lead-free top coats is recommended. Photo: NPS Files.

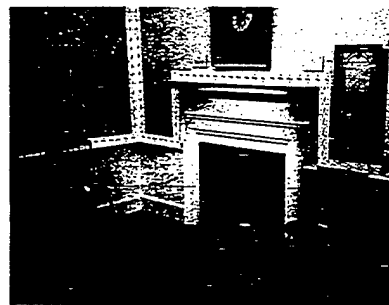
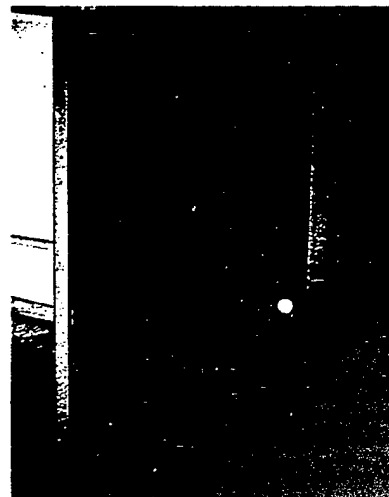
Figure 3. Significant architectural features and their finishes should not be removed during a project incorporating lead hazard controls. If the decorative stencilling above, or hand grained doors below, or painted murals need repair, then a paint conservator should be consulted. Once loose paint is consolidated or otherwise stabilized, a clear finish or other reversible clear protective surface or coating can be added to areas subject to impact or abrasion. Photos: NPS Files.

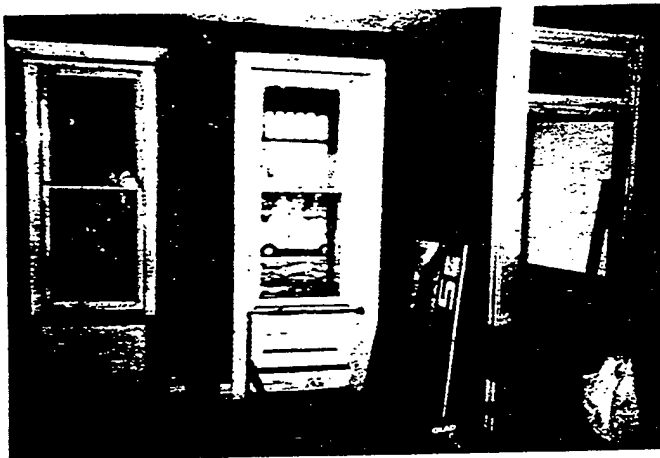
The historical significance, integrity, and architectural character of the building always need to be assessed before work is undertaken that might adversely affect them. An owner may need to enlist the help of a preservation architect, building conservator or historian. The State Historic Preservation Office (SHPO) may be able to provide a list of knowledgeable preservation professionals who could assist with this evaluation.

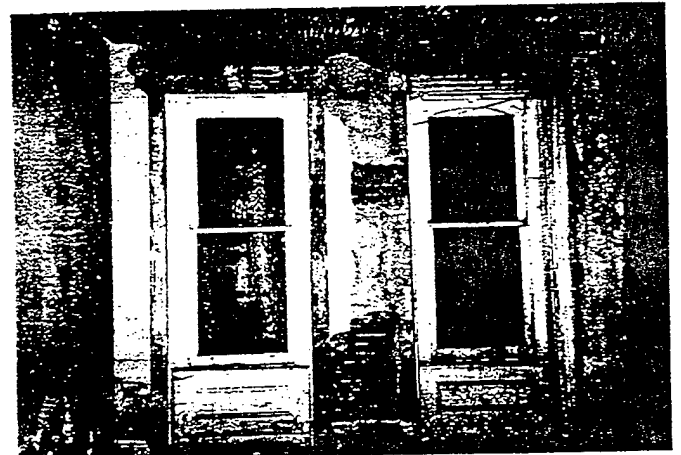
Figure 4. The typical method for abating lead-based paint through substrate removal is not consistent with the Standards for Rehabilitation. In this project, all the historic trim, base panels, and the transom were removed. While the unit is lead-safe, its character has been severely altered. Figure 5 shows a similar, but successful, balance of historic preservation and lead hazard control work. Photo: NPS Files.

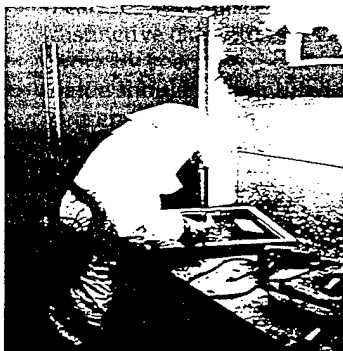
Low-level heat guns can be used to remove lead-based paint from significant historic windows and trimwork, but a worker exposed to lead dust over an extended period of time must be protected from the hazards created during the process of paint removal. Photo: Williamsport Preservation Training Center.

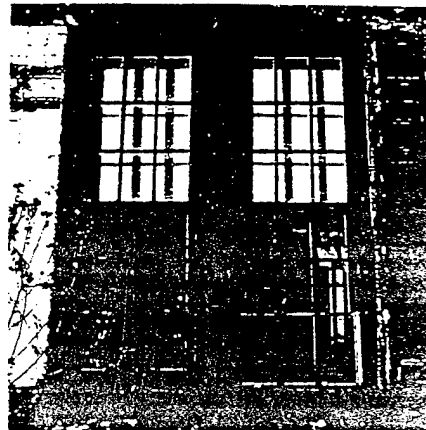
Figure 7. Chalking exterior paint can cause dangerous lead levels in soil around a house. Lead levels are usually highest in the one foot wide area adjacent to the building foundation. In these cases, the existing soil should be replaced with new soil or sod. This is particularly important if children and small pets play in contaminated areas, then inadvertently track the dirt inside.

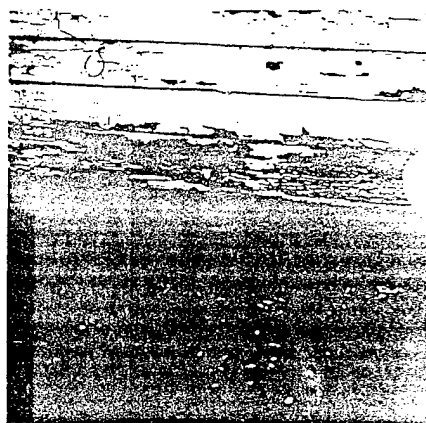
Finally, features and finishes that characterize simple, vernacular buildings should be retained and preserved; in the process of removing hazards, there are usually reasonable options for their protection. Wholesale removal of historic trim, and other seemingly less important historic material, undermines a building's overall character and integrity and, thus, is never recommended.

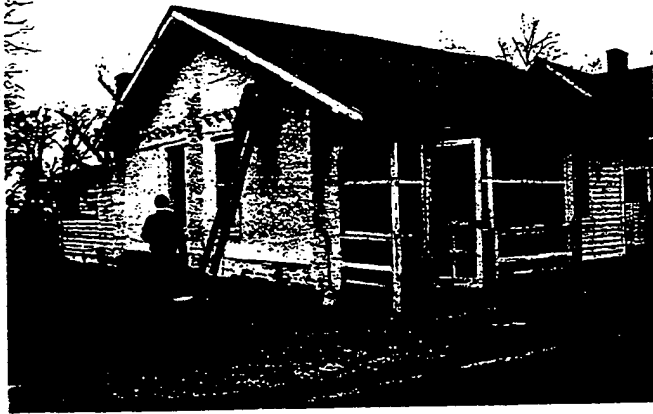
This hierarchy gives an owner a working guide for making decisions about appropriate methods of removing lead-based paint.

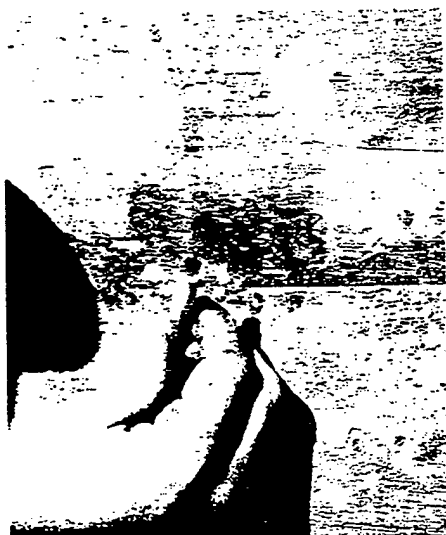
- the paint's location
- the paint's condition
- lead content of paint and soil
- the type of surface (friction; accessible to children for chewing; impact)
- how much lead dust is actively present
- how the family uses and cares for the house
- the age of the occupants who might come into contact with lead paint.

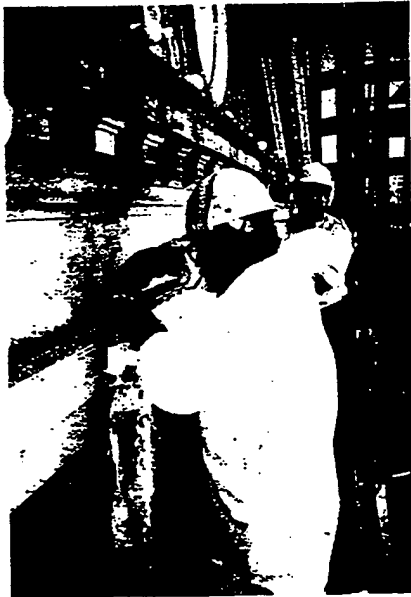
Figure 10. The choice of paint removal method will trigger various environmental controls and worker protection. The chemical poultice-type paint remover uses a paper backing that keeps the lead waste contained for proper disposal. The worker is adequately protected by a suit and gloves; for this work a respirator was not required. Local laws required containment and neutralization of any after-wash water run off. Photo: NPS Files.

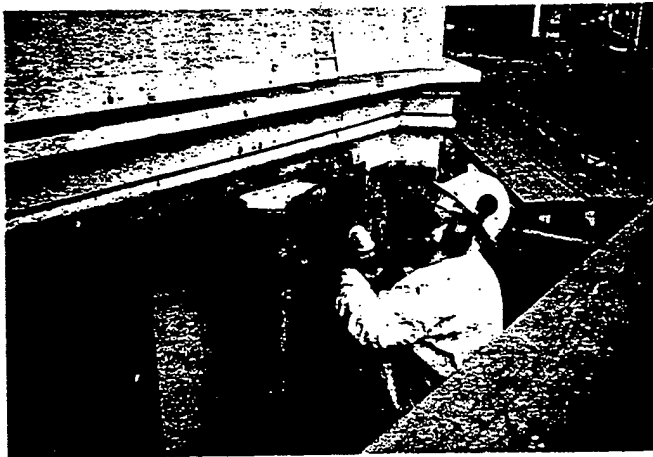
Figure 11. New methods are being developed or adapted to safely remove lead-based paint from various substrates. On this cast iron building undergoing rehabilitation for apartment units, multiple layers of lead-based paint were removed with pneumatic needle guns with vacuum attachments. Paint chips and waste containing lead-based paint were placed in 55 gallon drums for transport to a special waste site, and the workers were fully protected. The cleaned metal was primed and repainted. Photo: Building Conservation Associates, Inc.

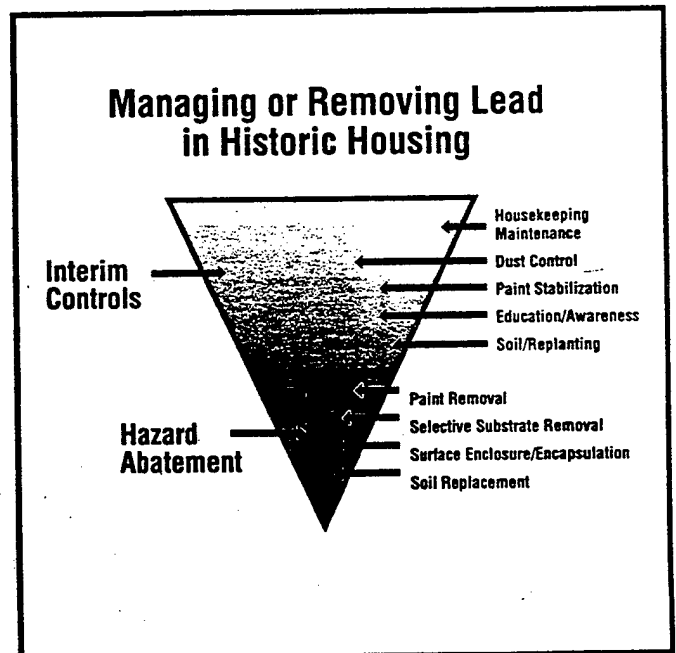
Figure 12. An inverted triangle makes the point that most of the nation's housing can be made lead-safe using interim control methods, such as dust control, paint stabilization, and good housekeeping. Shaded from light to dark, the lighter interim controls will generally not harm the historic materials. The darker, more aggressive controls, can be implemented with rehabilitation projects where paint removal, selective replacement of deteriorated elements, and encapsulation or enclosure are incorporated into other work.

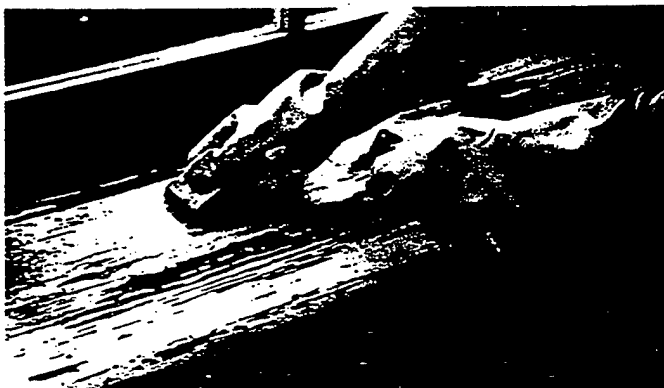
Figure 15. Wet sanding of interior surfaces will keep dust levels down, reduce the need for workers' protection, and provide a sound surface for repainting. Priming and repainting with oil/alkyd, latex or latex acrylic should be undertaken according to manufacturers' instructions.

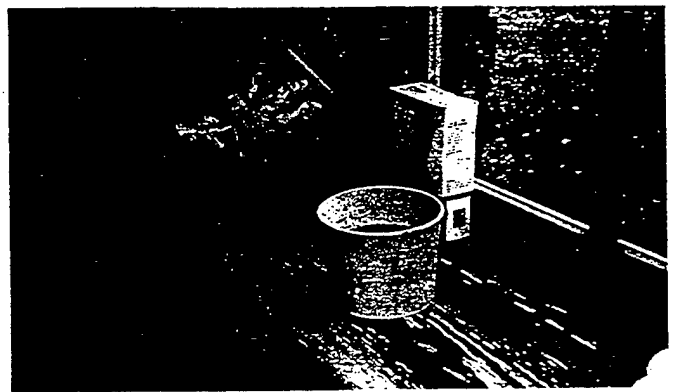
Figure 16. Washing windows and cleaning debris from window well, a periodic basis can substantially reduce lead dust. Using water and tri-sodium phosphate (TSP or equivalent) will remove loose paint, and, after rinsing, the surface can be repainted with latex, oil/alkyd, or latex acrylic paints.

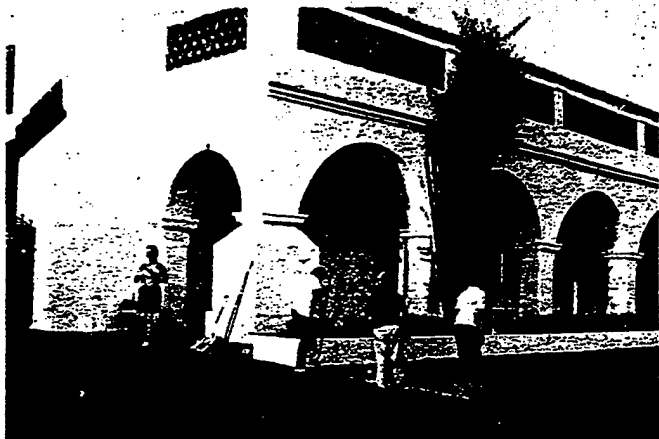
Figure 17. When historic sites are found to contain high levels of lead in bare soil — particularly around foundations — it is important to reduce the hazard without destroying significant landscapes. In many cases, contaminated soil can be removed from the foundation area and appropriate plantings or ground covers replanted in new soil. Photo: Charles A. Birnbaum, ASLA.

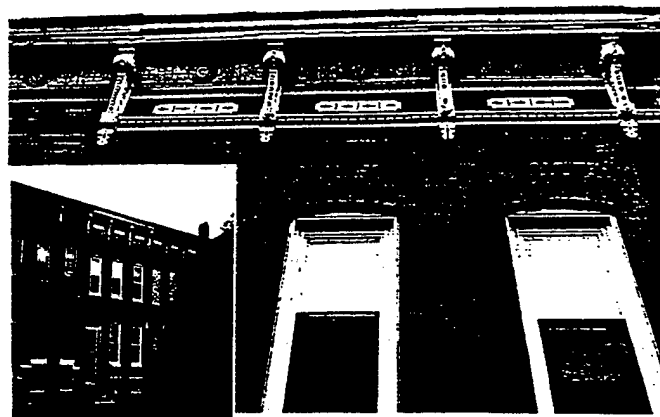
Figure 18. As part of an urban housing grant program, the exterior of this row house was successfully made lead-safe and met the Secretary of the Interior's Standards for Rehabilitation. The exterior was washed, then repainted with exterior grade alkyd paint. The decorative roof brackets and cornice were repainted; not removed or covered as is often recommended in typical abatement guidelines. The previously altered, deteriorated window sash were replaced with new sash and jamb liners set within the historic frames. Photos: Deborah Birch.

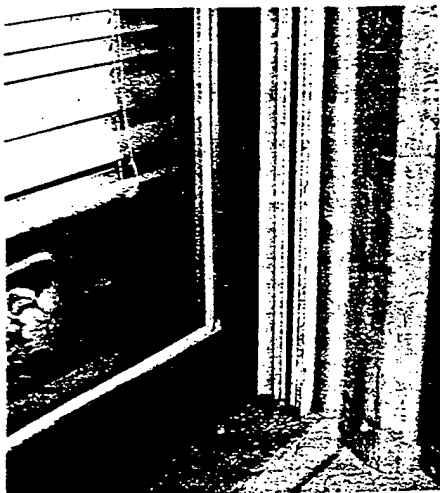
Figure 20. Operable windows have friction surfaces between the sash and the frames, which can be a source of fine lead dust. In this case, the deteriorated sash was replaced, but the historic frame remains in place, successfully isolated from the sash with a simple vinyl jamb liner that is part of the new sash operation.

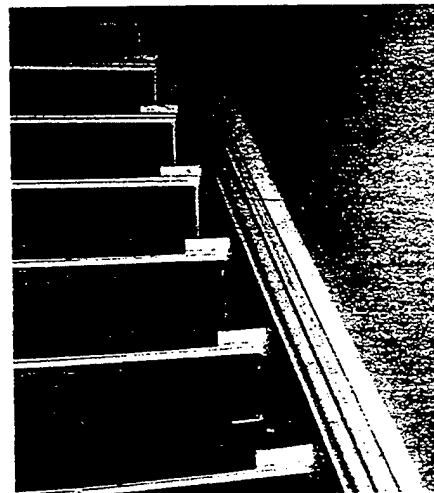
Figure 21. Painted stairs and floors can cause a problem because lead dust settles between the wooden boards. In this case, the steps were sanded, repainted, and covered with rubber stair treads. The floors could not be effectively cleaned and sealed so they were isolated with a new subflooring, and a washable tile finish installed.

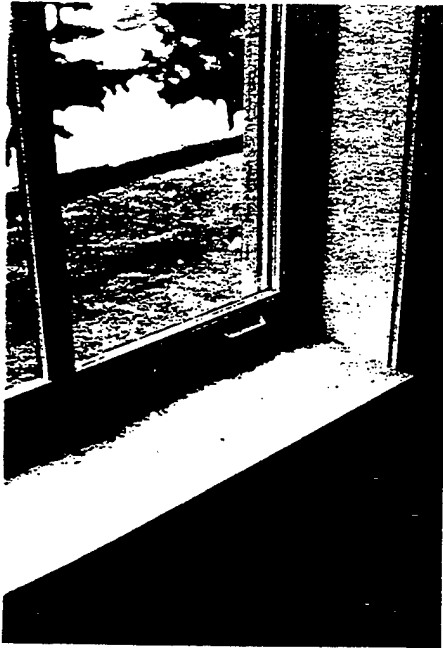
Figure 22. Research has shown that some small children will chew on projecting window sills while teething. As part of a lead hazard control project, the edge of the sill can be stripped to bare wood or an encapsulating paint applied. In this case, a new window sill was installed as part of a window upgrade that retained the historic trim and frame.

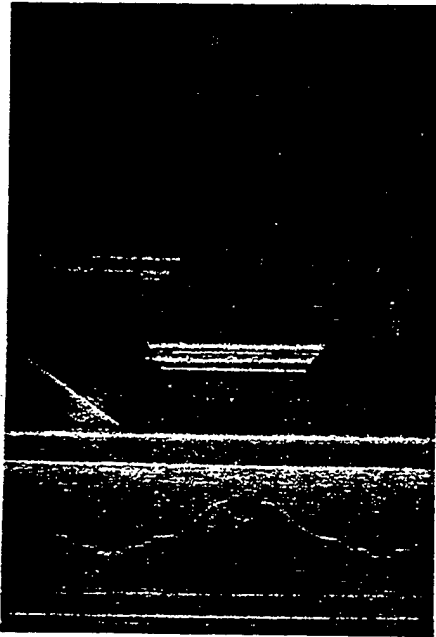
Impact Surfaces. Painted surfaces near doorways and along corridors tend to become chipped and scraped simply because of their location. This is particularly true of baseboards, which were designed to protect wall surfaces, and also for doorjamb. Owners should avoid hitting painted impact surfaces with vacuums, brooms, baby carriages, or wheeled toys. Adding new shoe moldings can give greater protection to some baseboards. In most cases, stabilizing loose paint and repainting with a high quality interior paint will provide a durable surface. Clear panels or shields can be installed at narrow doorways, if abrasion continues, or these areas can be stripped of paint and repainted. Features in poor condition may need to be replaced with new, matching materials (see fig. 24).

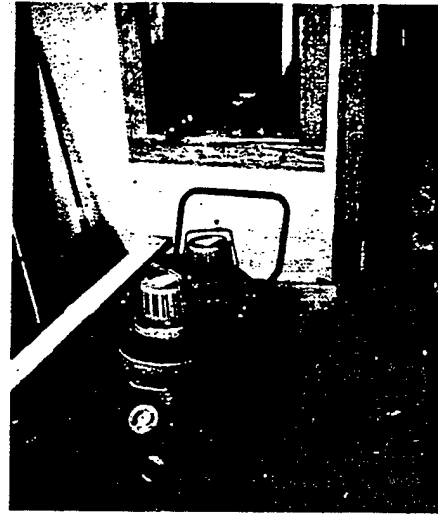
Figure 24. Historic baseboards are often bumped by brooms and vacuum cleaners, causing lead-based paint chips to fall on the floor. Shoe moldings can be added or replaced to increase protection to the baseboard itself. In this case, because the condition of the interior warranted substantial repair, simple historic board trim was replaced with new matching trim. Note the HEPA filter vacuum in the foreground. Photo: NPS file.

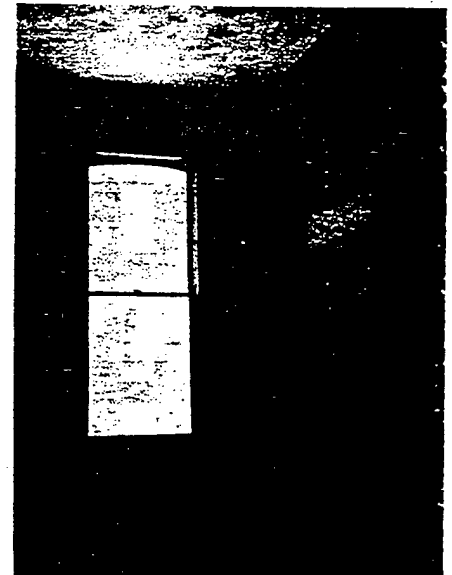
If a new drywall surface needs to be applied, care should be taken that the historic relationship of wall to trim is not lost. Also, if there are significant features, such as crown moldings or ceiling medallions, they should always be retained and repaired (see fig. 26).

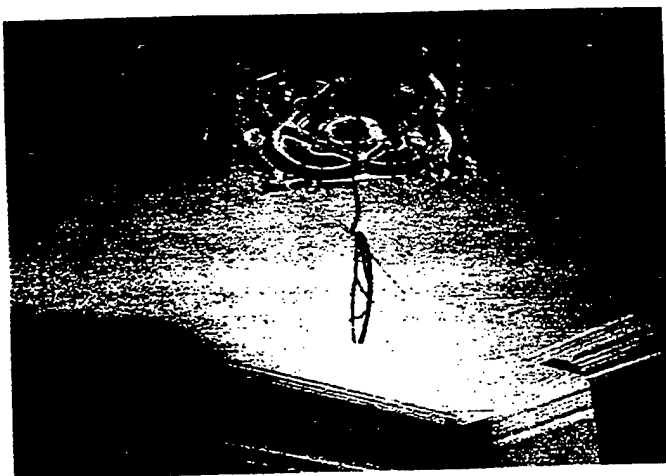
Figure 26. Deteriorated ceiling plaster was removed and a new drywall ceiling installed. The historic ceiling medallion was preserved, and the plaster cornices repaired in place. Photo: Landmarks Design Associates.

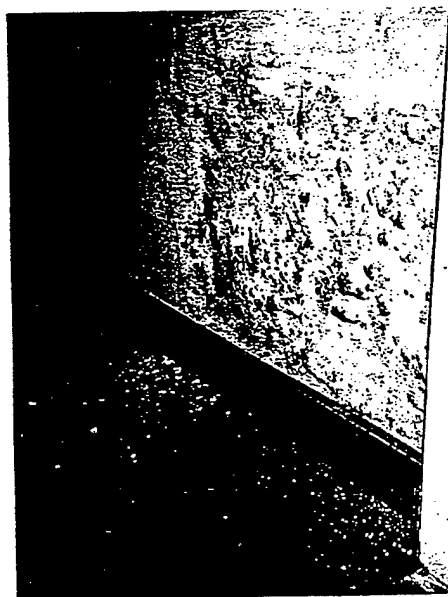
Figure 27. Wall leaks can cause historic surfaces to deteriorate, thereby exposing underlayers of lead-based paint. If painted surfaces show signs of deterioration, they should be repaired as soon as possible.
