Management and Maintenance Manual
The Old Hospital Complex
Fort Carson, Colorado
(5EP1778)

James Schneck

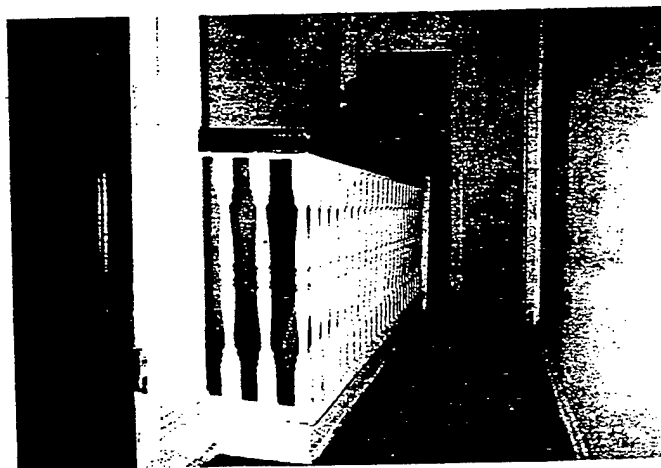
Figure 28. This recently completed housing, which is now lead-safe, could become re-contaminated from lead if safe conditions are not maintained. Damp mopping floor surfaces and regular dusting to keep the house clean will ensure its continuing safety.

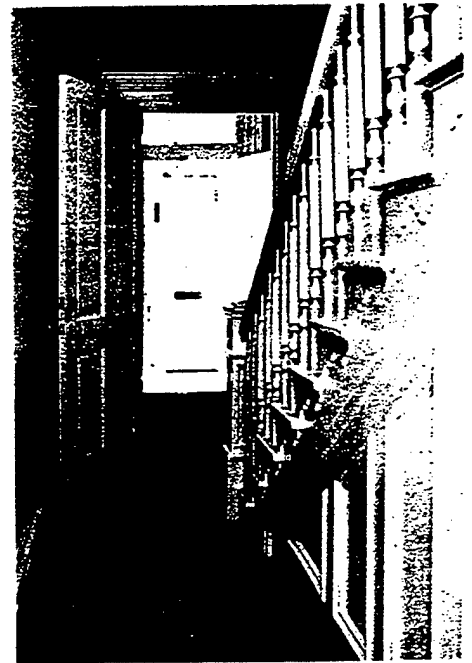
Photographs courtesy of the authors unless identified.
