REPORT NO. NADC-80021-60

NATURAL EXPOSURE OF SELECTED GRAPHITE/EPOXY
COMPOSITE MATERIAL SYSTEMS

R. E. TRABOCCO
Aircraft and Crew Systems Technology Directorate
NAVAL AIR DEVELOPMENT CENTER
Warminster, Pennsylvania 18974

31 JULY 1980

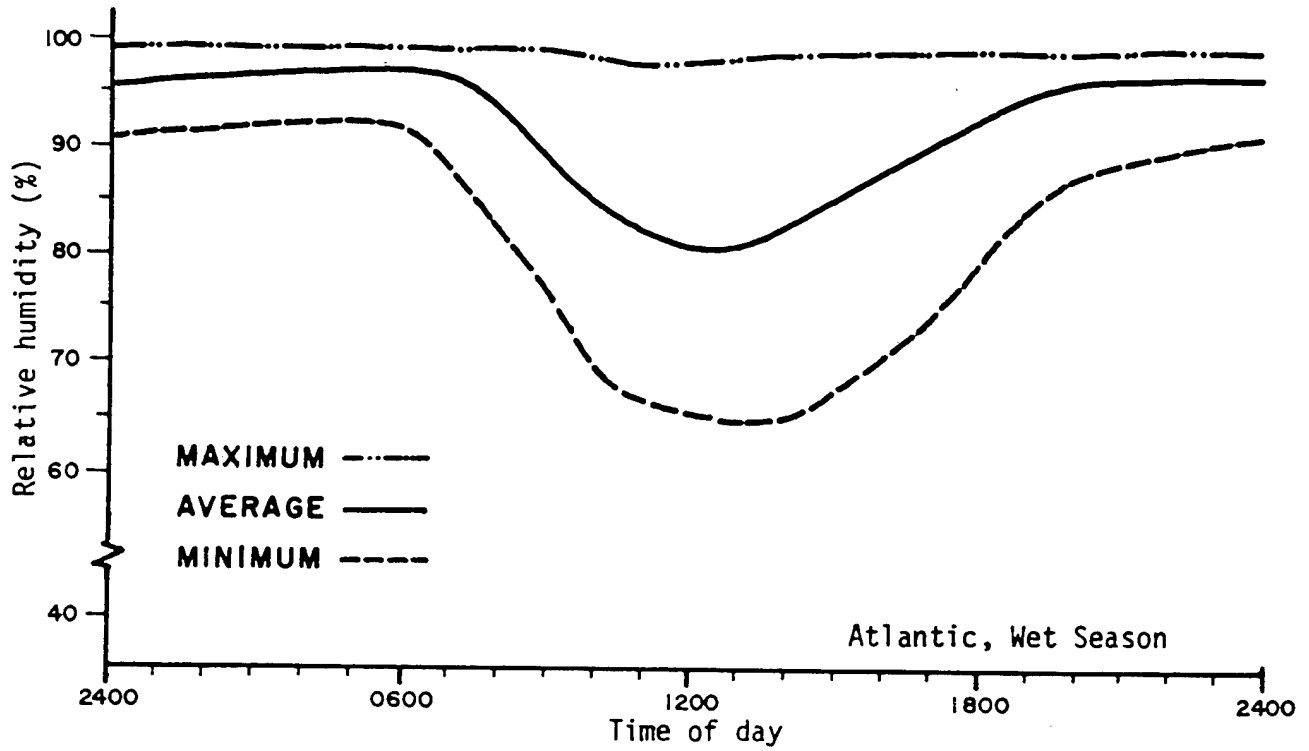
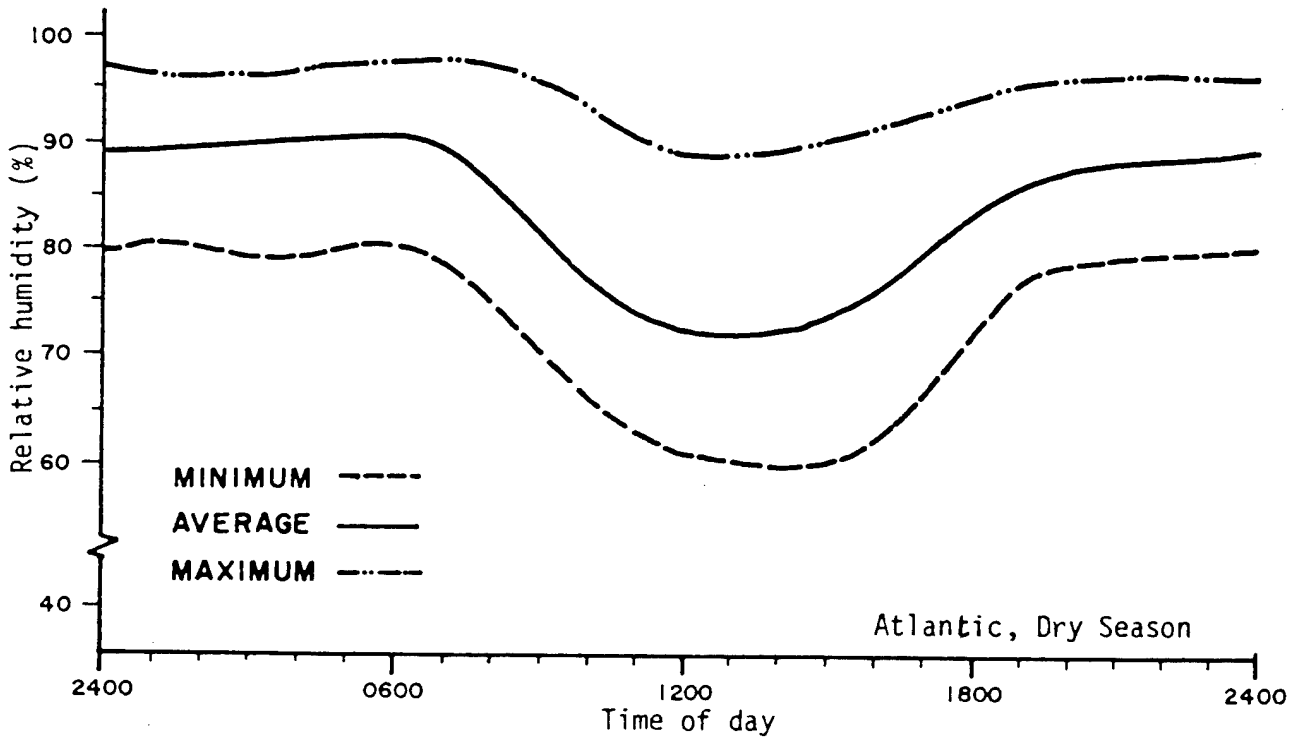
FIGURE 1 RELATIVE HUMIDITY - ATLANTIC AREA OF CANAL ZONE

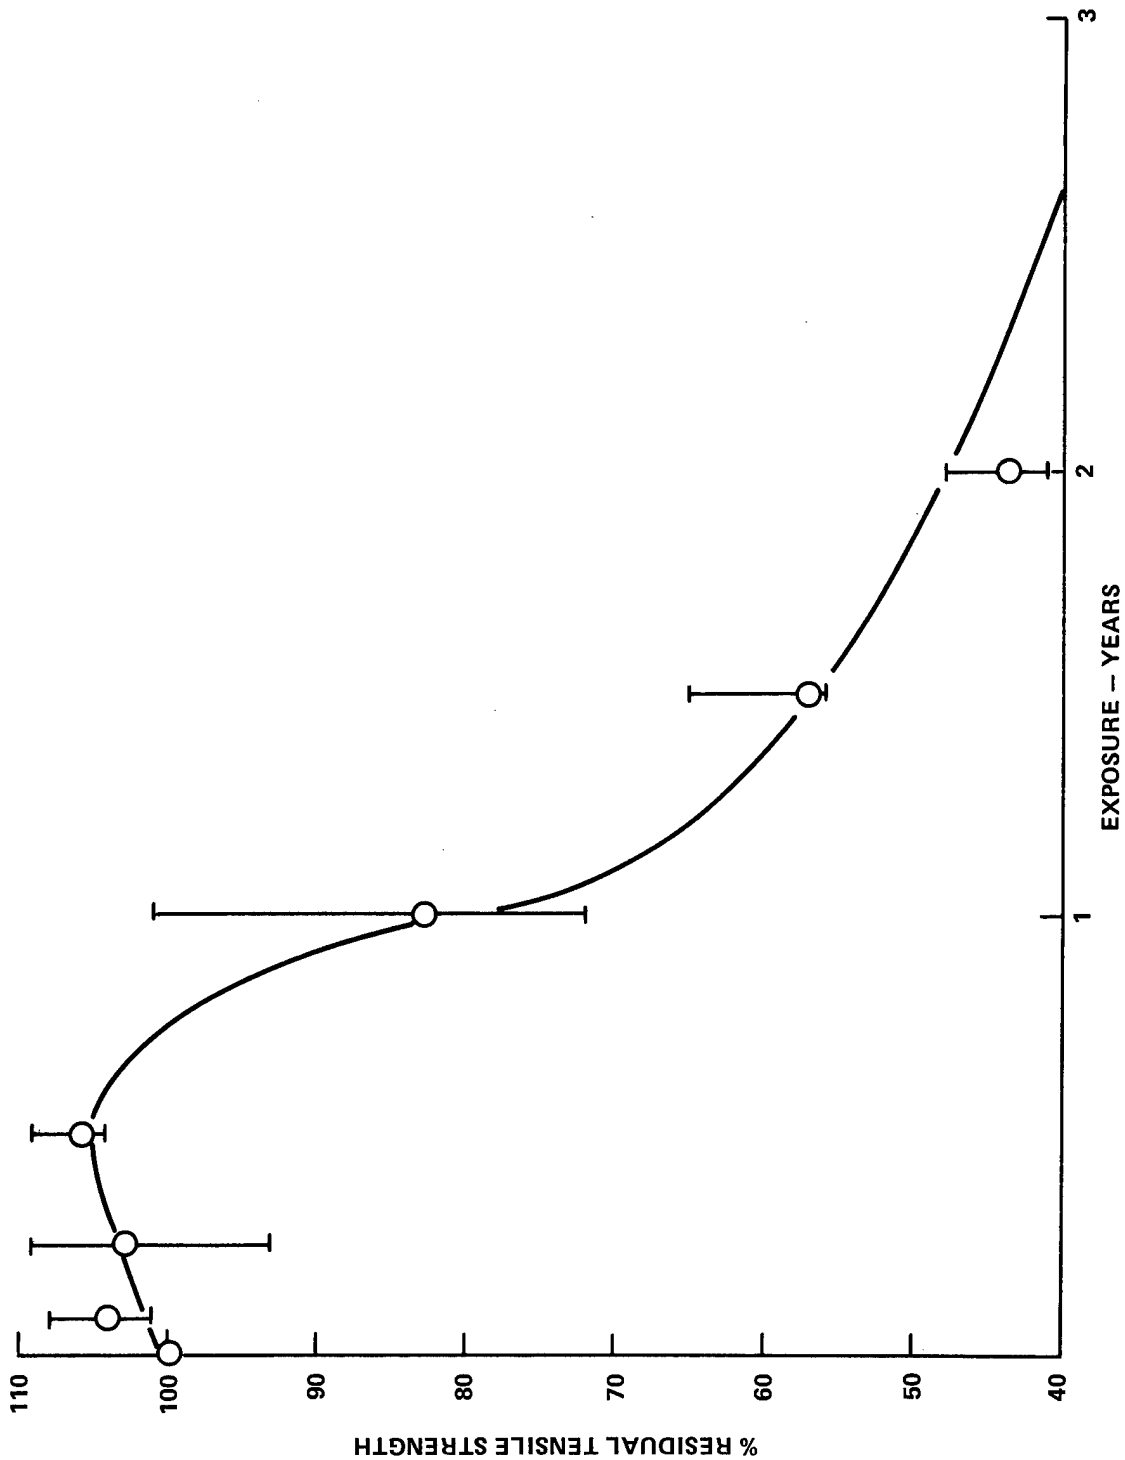
FIGURE 5 THE VARIATION IN RESIDUAL TENSILE STRENGTH VERSUS EXPOSURE TIME IN PANAMA (200 SERIES UNCOATED)

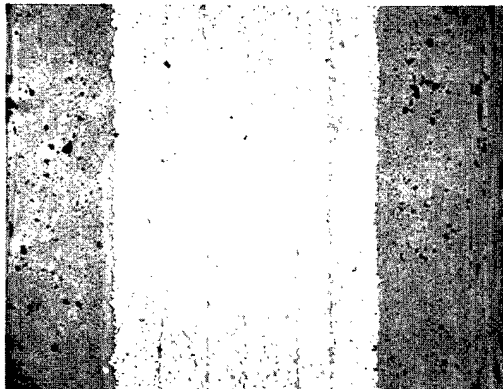
FIGURE 37 A COMPARISON OF UNCOATED EXPOSED AND UNEXPOSED LAMINATE MICROSTRUCTURES (35X)

In order to obtain a thorough analysis of the state of deterioration for various samples, sections were removed, mounted, polished, and examined. Cross sections of specific samples are shown in Figures 36 through 40. The representative exposed sections are shown with their unexposed counterparts. The effects of exposure on uncoated specimens were manifested in removal or thinning of the exposed 0° ply with cracking and or delamination. Any deterioration of coated sections would be evident in a much more subtle fashion principally through coating thinning.

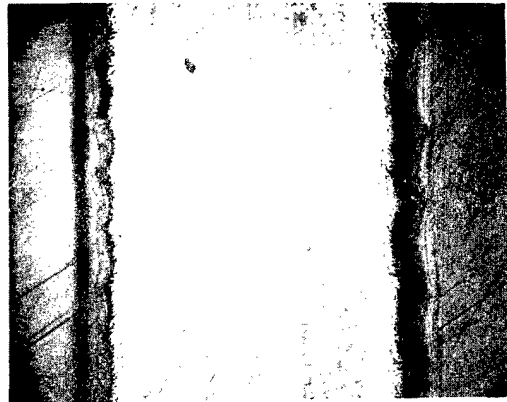
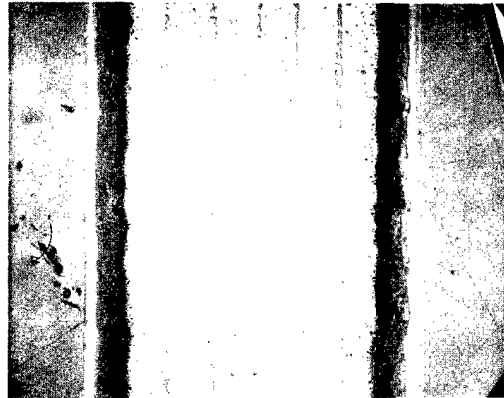
FIGURE 39 A COMPARISON OF COATED EXPOSED AND UNEXPOSED LAMINATE MICROSTRUCTURES (35X)

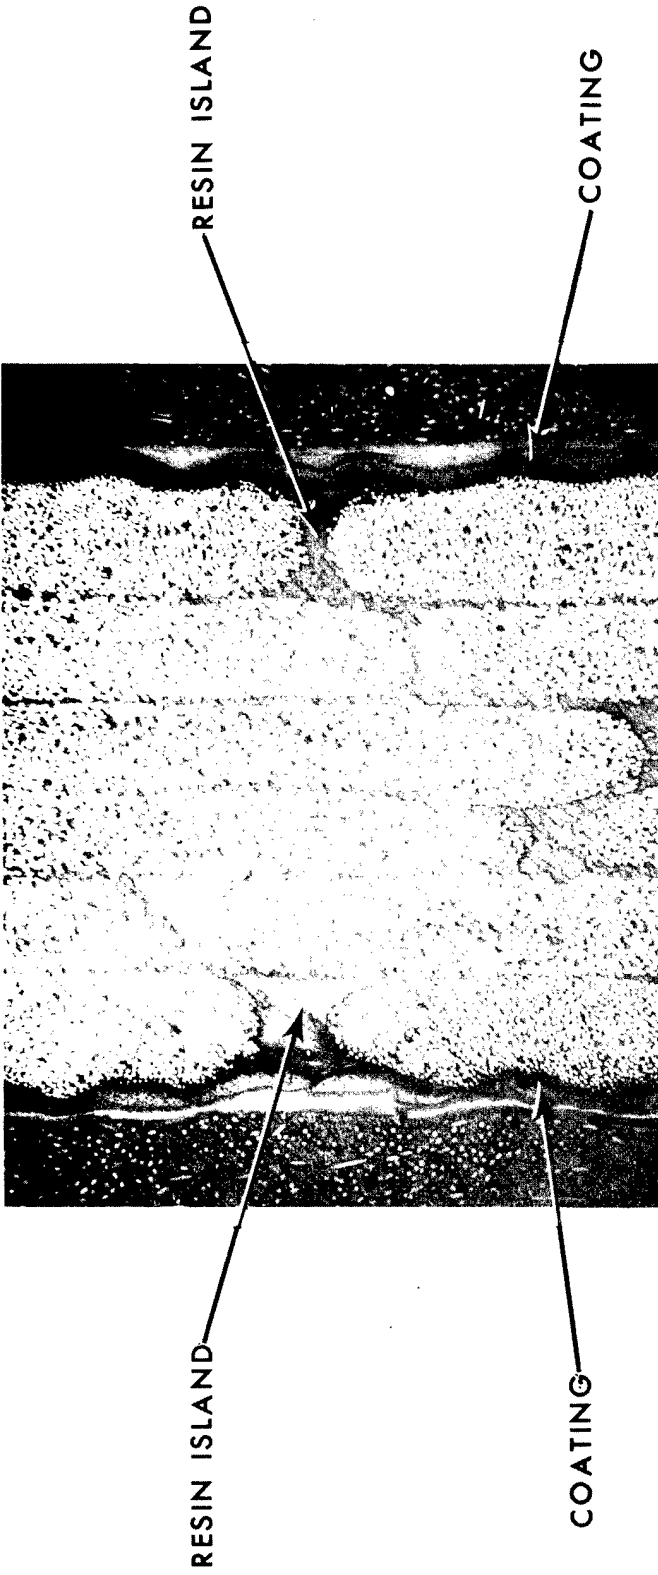
FIGURE 40 A PHOTO MICROGRAPH DEPICTING THE LARGE RESIN RICH AREAS COMPLETELY BRIDGING THE 0° PLYS IN 200 SERIES MATERIAL EXPOSED FOR 24 MONTHS IN PANAMA
