DSTO-TN-0086

A Review of Australian and New Zealand Investigations on Aeronautical Fatigue During the Period April 1995 to March 1997

Colin Martin

**Airframes and Engines Division  
Aeronautical and Maritime Research Laboratory**

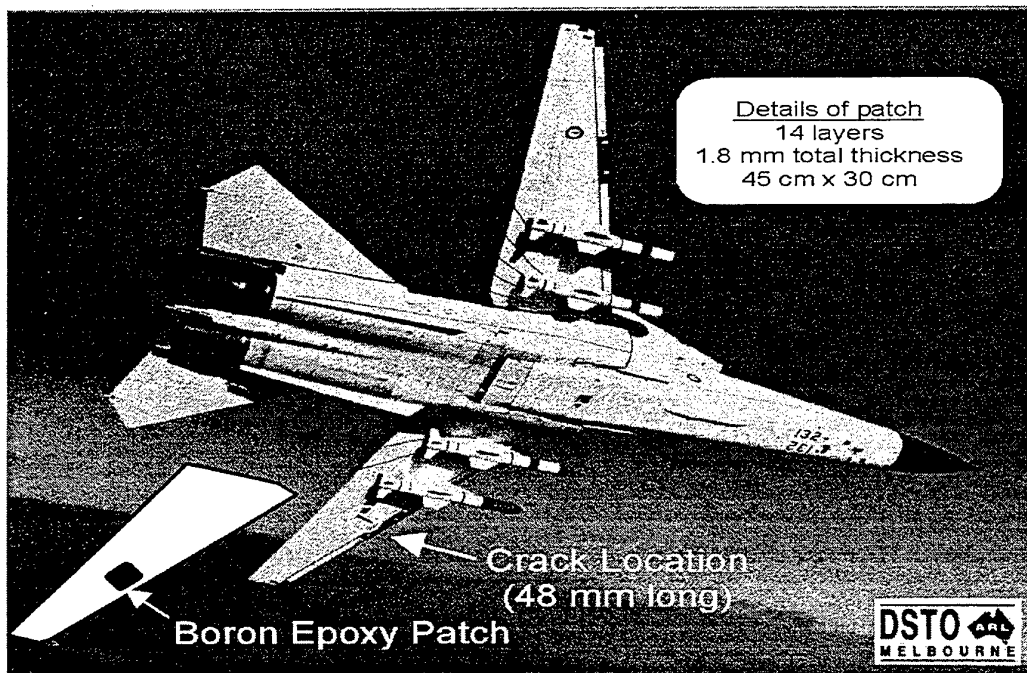
Figure 2. Boron Epoxy Patch Repair to RAAF F-111

A bonded composite repair to a critical fatigue crack in the lower wing skin of an RAAF F-111 aircraft has been fully substantiated. The crack was located in the lower wing skin at approximately 2/3 semi span (Figure 2). The crack had reduced the residual strength of the wing to below design limit load. The repair consisted of a 14 layer boron epoxy laminate patch which was bonded to the outer surface using FM-73 structural film adhesive. This is thought to be the most critical bonded repair yet undertaken anywhere in the world. The repair was designed and applied according to a RAAF document known as RAAF Standard Engineering C5033. A comprehensive substantiation program including testing of representative specimens and Finite Element Analysis was undertaken and has been successfully completed.

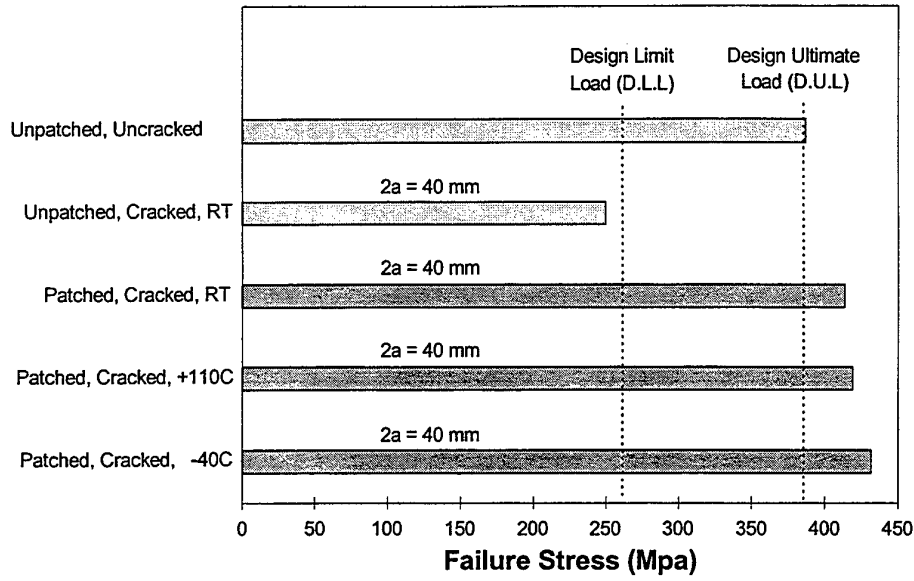
Figure 3. Residual Strength Test Results, F-111 Bonded Repair

The Finite Element Analysis (Reference 19) included a calibrated three dimensional model which was subjected to structural and thermal loads. The analysis verified the adequacy of the original design which was performed using simplified equations based on 2-D lap joint theory. A comprehensive testing program (Reference 20) using representative cracked and patched specimens demonstrated the repair to be airworthy. The results of static load tests on representative specimens are shown in Figure 3. The tests show that the original crack had reduced the residual strength to below design limit, and that the repair restores static strength to design ultimate load capability, even at extremes of temperature. Spectrum loading tests were also performed on cracked and patched specimens. The crack continues to grow under the patch but the crack growth rate is reduced to an acceptable level as shown by the results for a range of patched and unpatched panels in Figure 4.

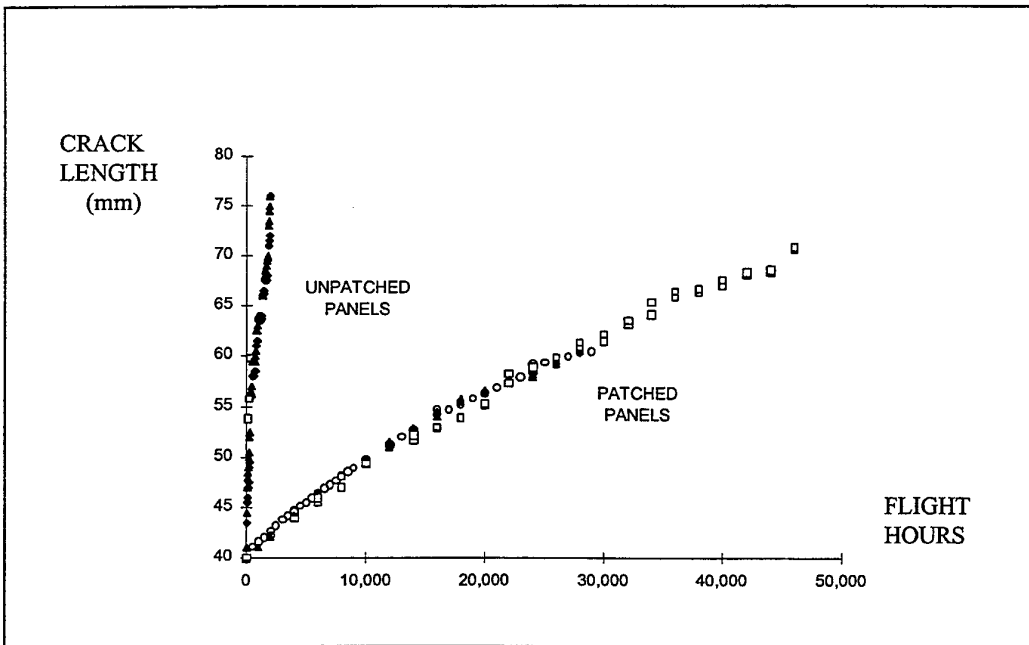
Figure 4. Spectrum Load Crack Growth Results, F-111 Bonded Repair

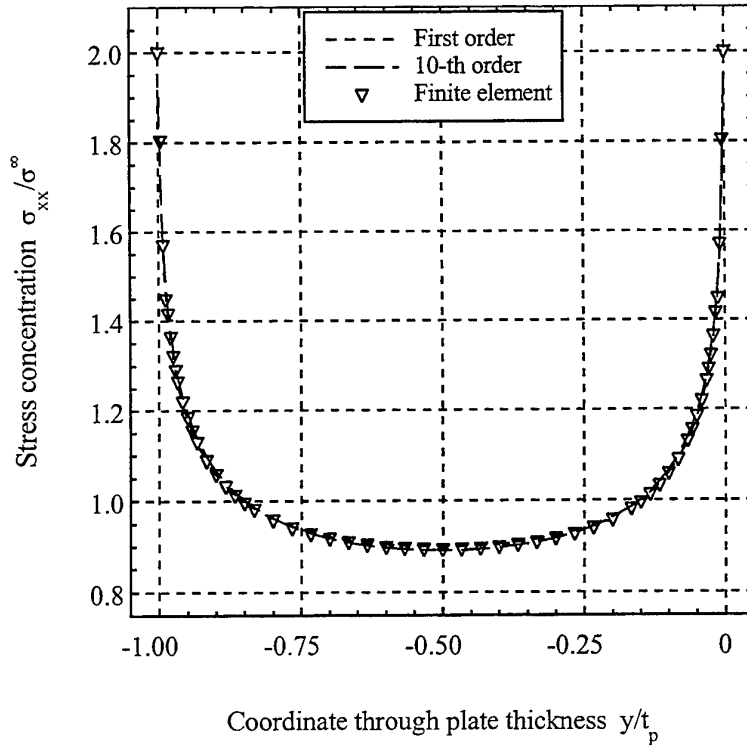
Figure 5. Through thickness stress concentration in the inner adherend of double lap joint

The problem of the stress concentration in adherends of adhesively bonded joints has been analysed using a successive boundary stress correction method [29]. Joints with a square-edged adhesive layer or with a spew fillet near the ends of the overlap have been considered. It is shown that the main cause of the stress concentration stems from the adhesive shear stress which acts on the adherends; the adhesive peel stress has little effect. In the case of square-edged adhesive layer, an eigenfunction solution has been derived for the adhesive shear stress distribution near the end of overlap, which satisfies the free surface condition. Based on the improved adhesive shear stress solution, an approximate formulas has been obtained for the stress concentration factor, which is shown in Figure 5 to be in close agreement with finite element analysis. Finally strategies to reduce stress concentrations have been discussed.

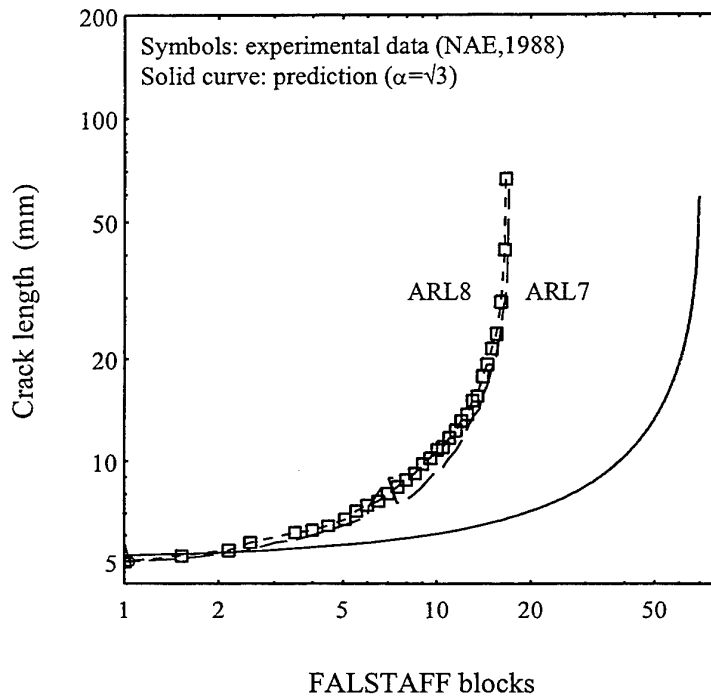
Figure 6. Unpatched Al sheets with honeycomb core

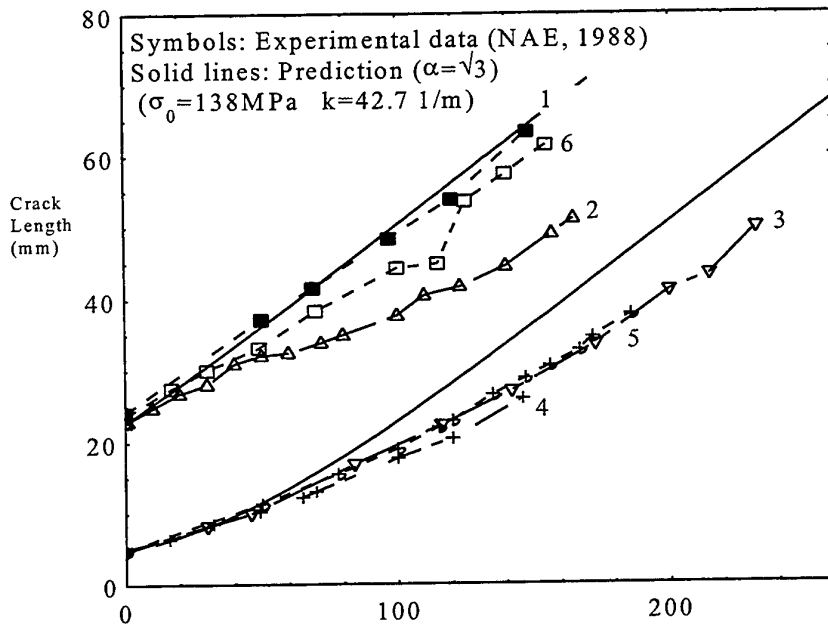
Figure 7. Crack growth in patched panels

It has been found that FASTRAN does not have the capability of dealing with patched cracks. Work has since been undertaken at AMRL to develop a crack closure model for patched cracks. As shown in Fig.7, the prediction based on the new model is in good agreement with the experimental results.
