**INSTALLATION RESTORATION PROGRAM  
CLOSURE INVESTIGATION REPORT  
SITE 1 - FORMER BASE LANDFILL**

**STEWART AIR NATIONAL GUARD BASE  
NEWBURGH, NEW YORK**

**APRIL 1997**

**ANEPTEK CORPORATION  
209 West Central Street  
Natick, Massachusetts 01760  
(508) 650-1048**

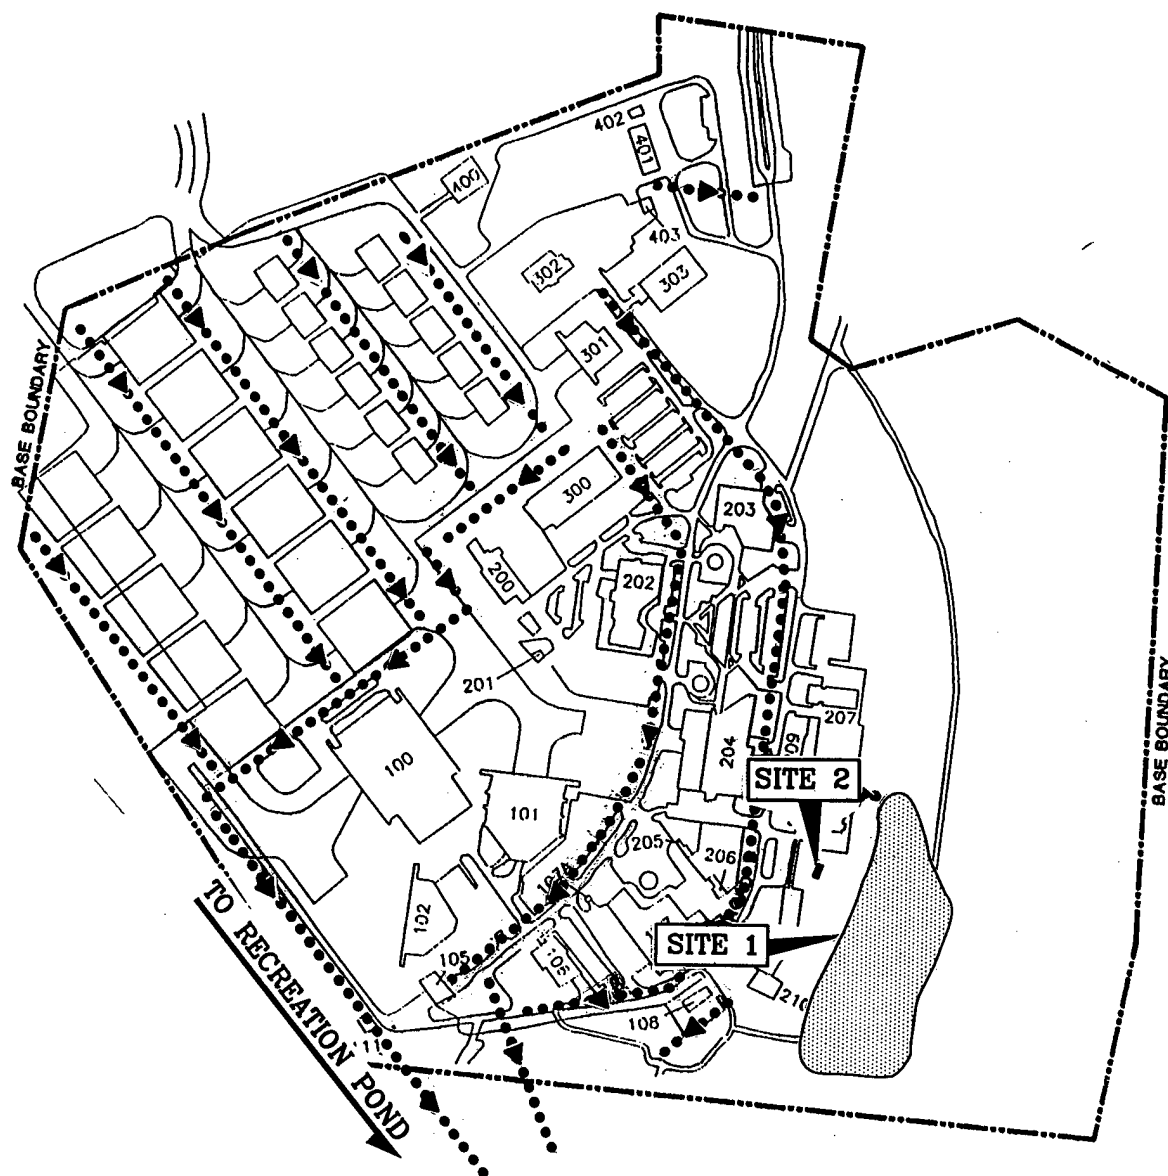
FIGURE 3-6  
BASE STORMWATER DRAINAGE MAP

- Base Boundary
- Building/Building Number
- Aircraft Parking Area
- Base Drainage Flow

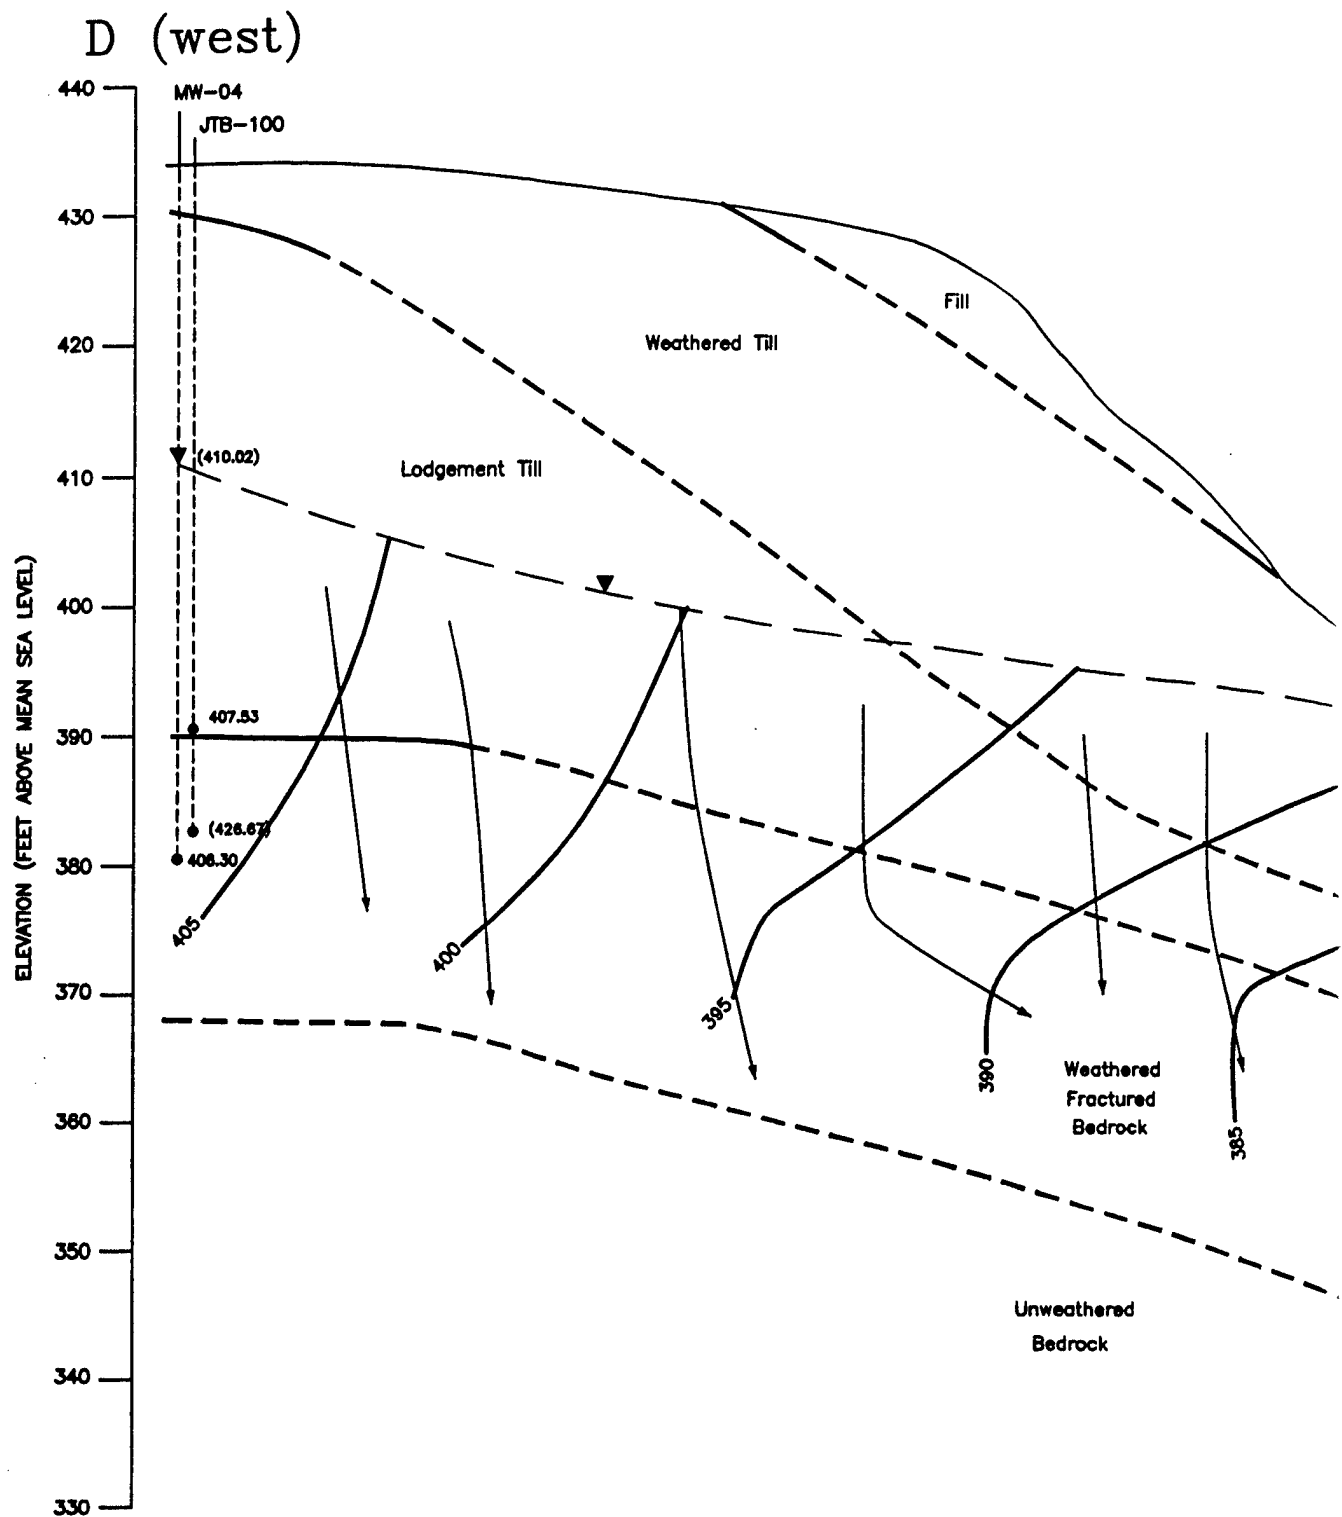
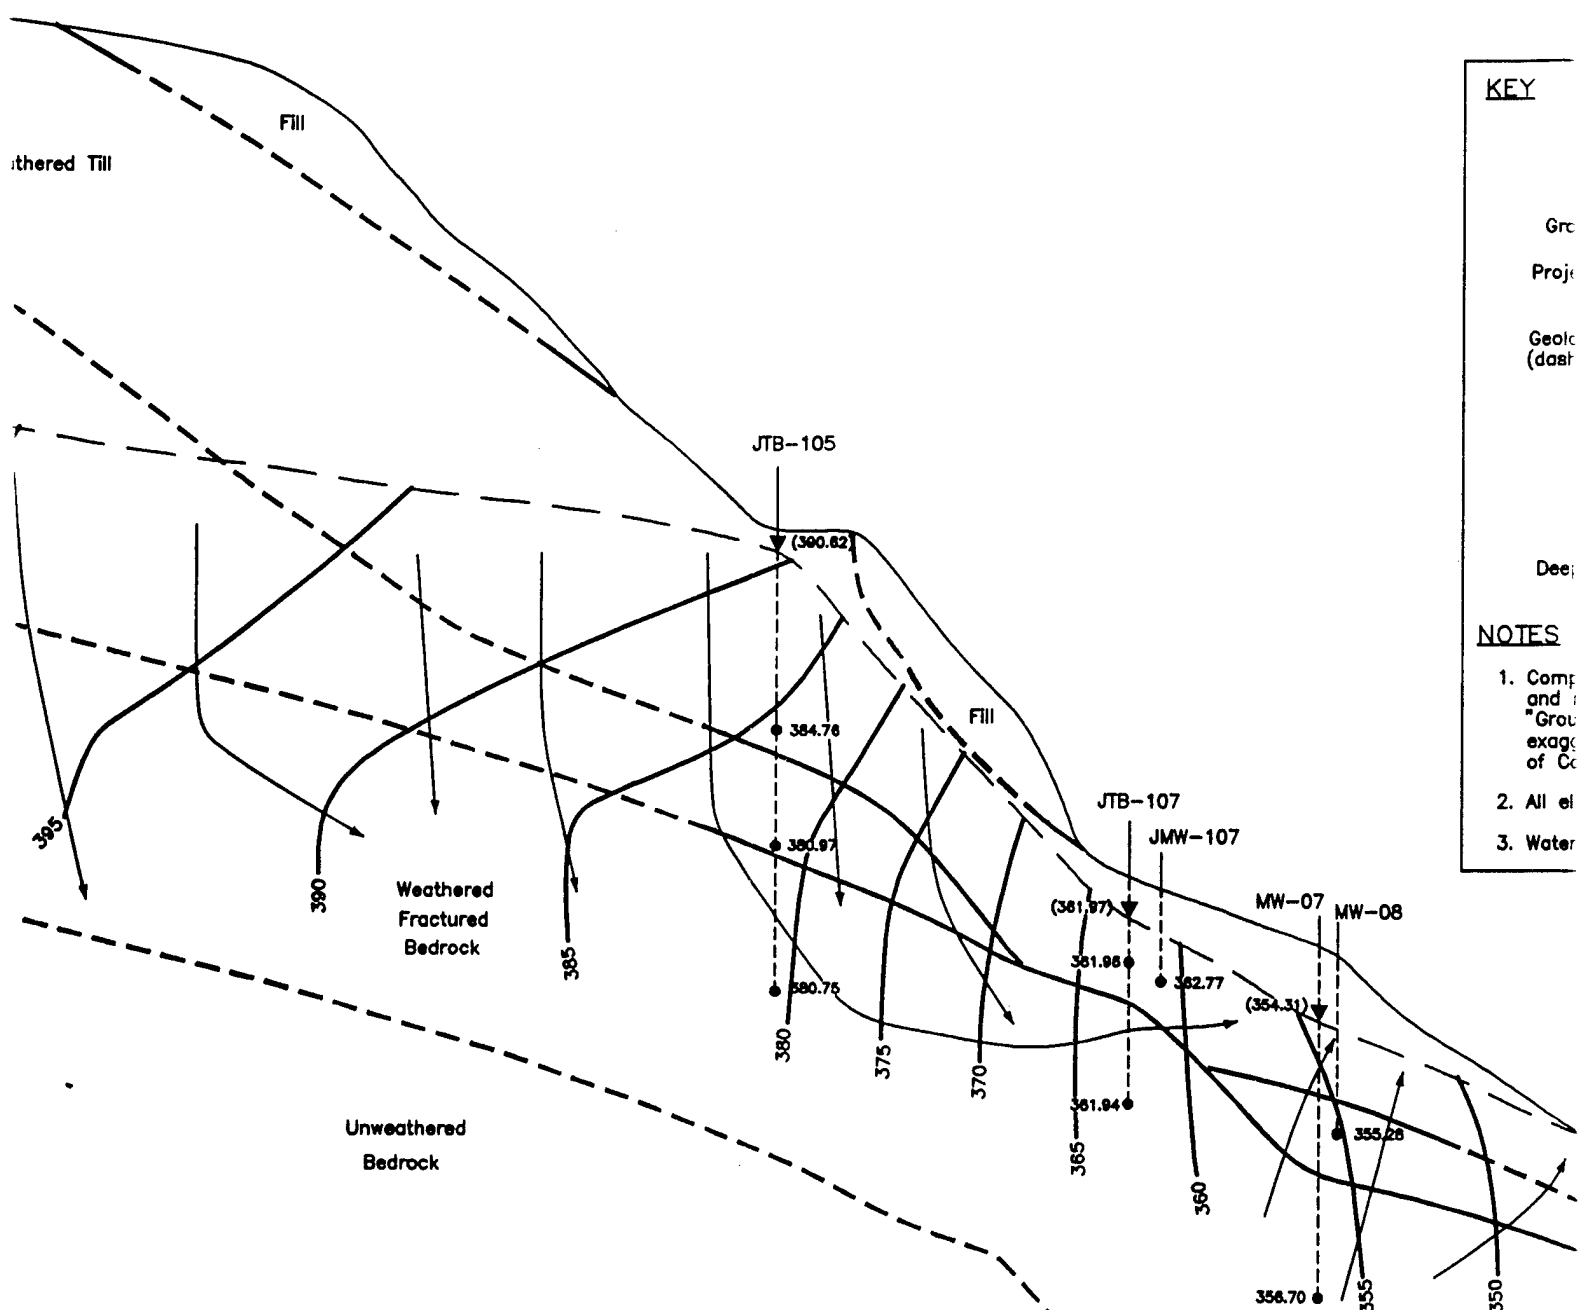
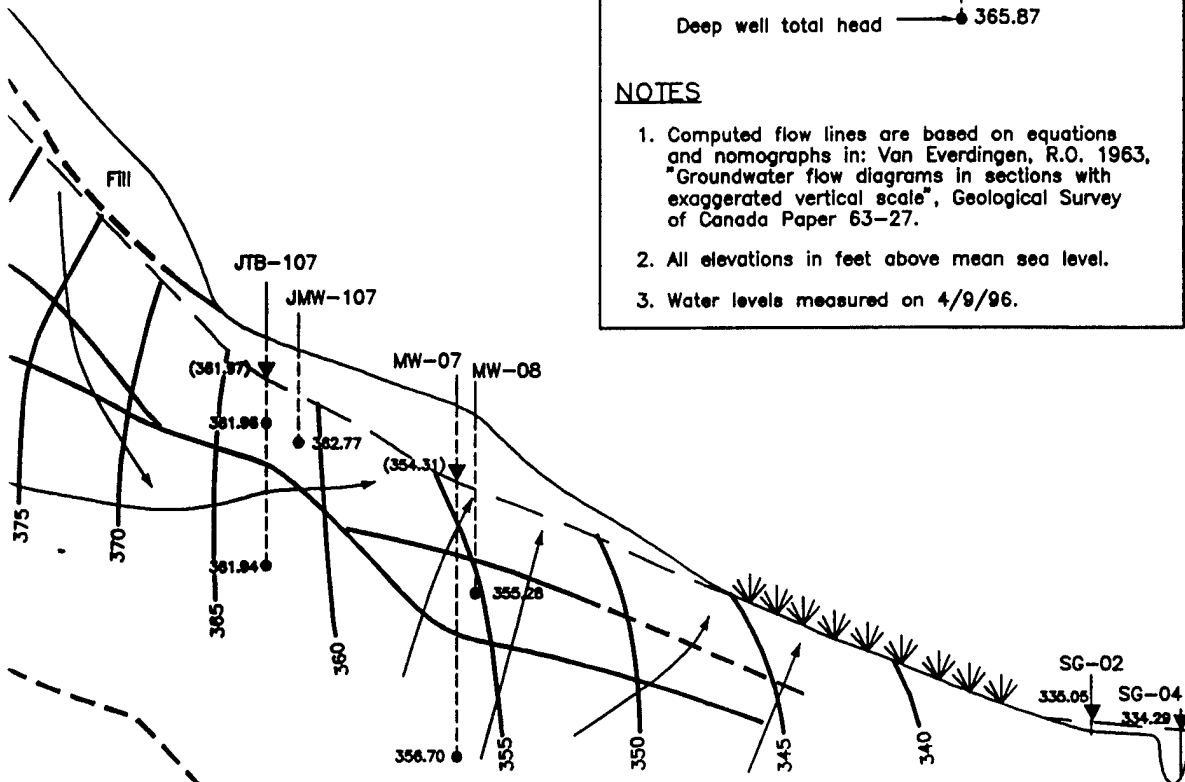
| <p><b>ANEPTEK CORPORATION</b><br/>Analytic, Environmental<br/>and Process Technologies<br/>208 West Central Street, Natick, MA 01760</p> | | <p><b>FIGURE 5-13</b><br/><b>FLOW NET CROSS SECTION D - D'</b><br/><b>STEWART AIR NATIONAL GUARD BASE</b><br/><b>NEWBURGH, NEW YORK</b></p> | |

1. Computed flow lines are based on equations and nomographs in: Van Everdingen, R.O. 1963, "Groundwater flow diagrams in sections with exaggerated vertical scale", Geological Survey of Canada Paper 63-27.
2. All elevations in feet above mean sea level.
3. Water levels measured on 4/9/96.

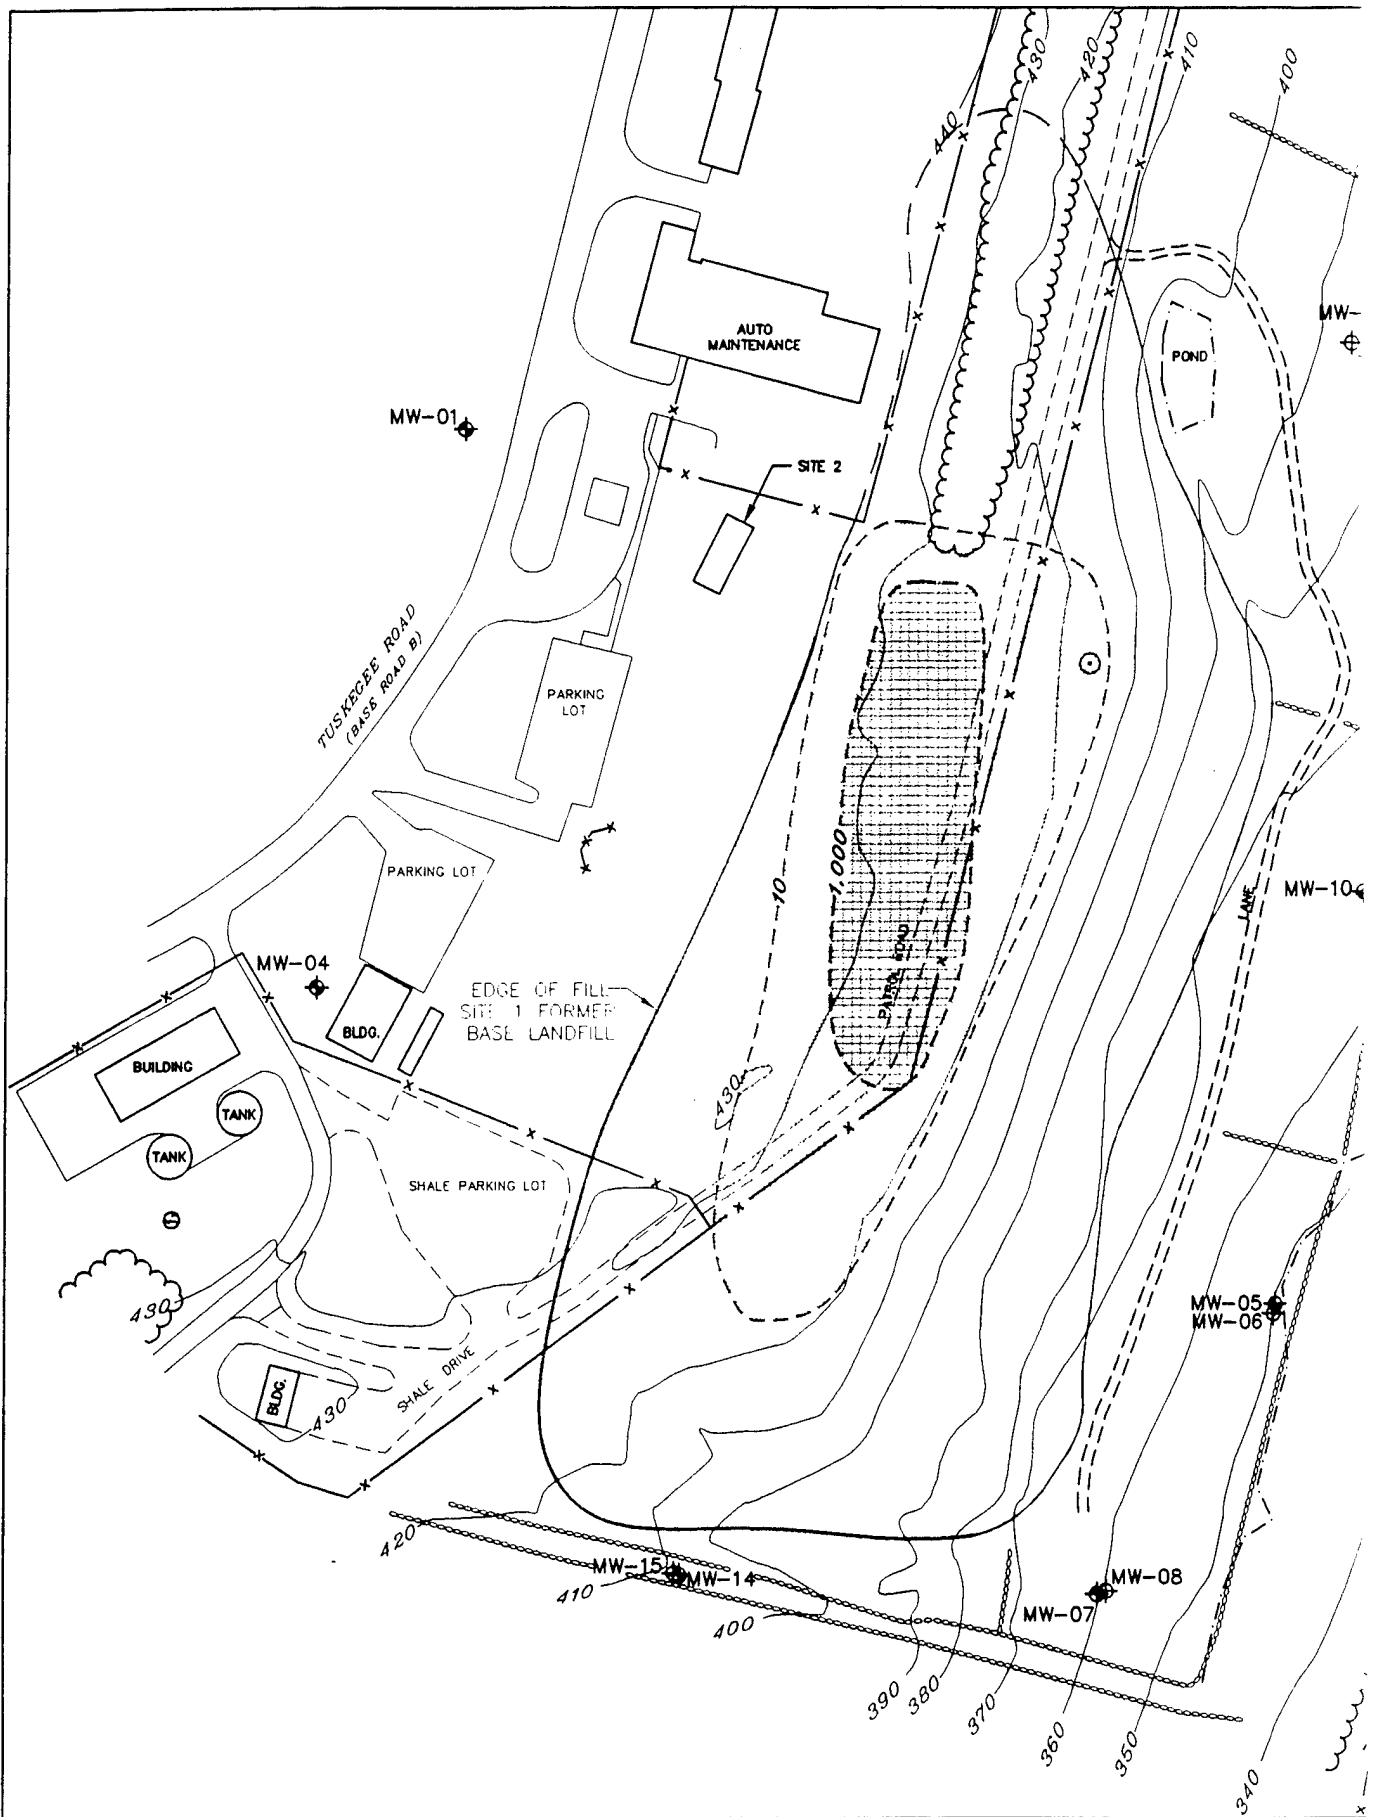
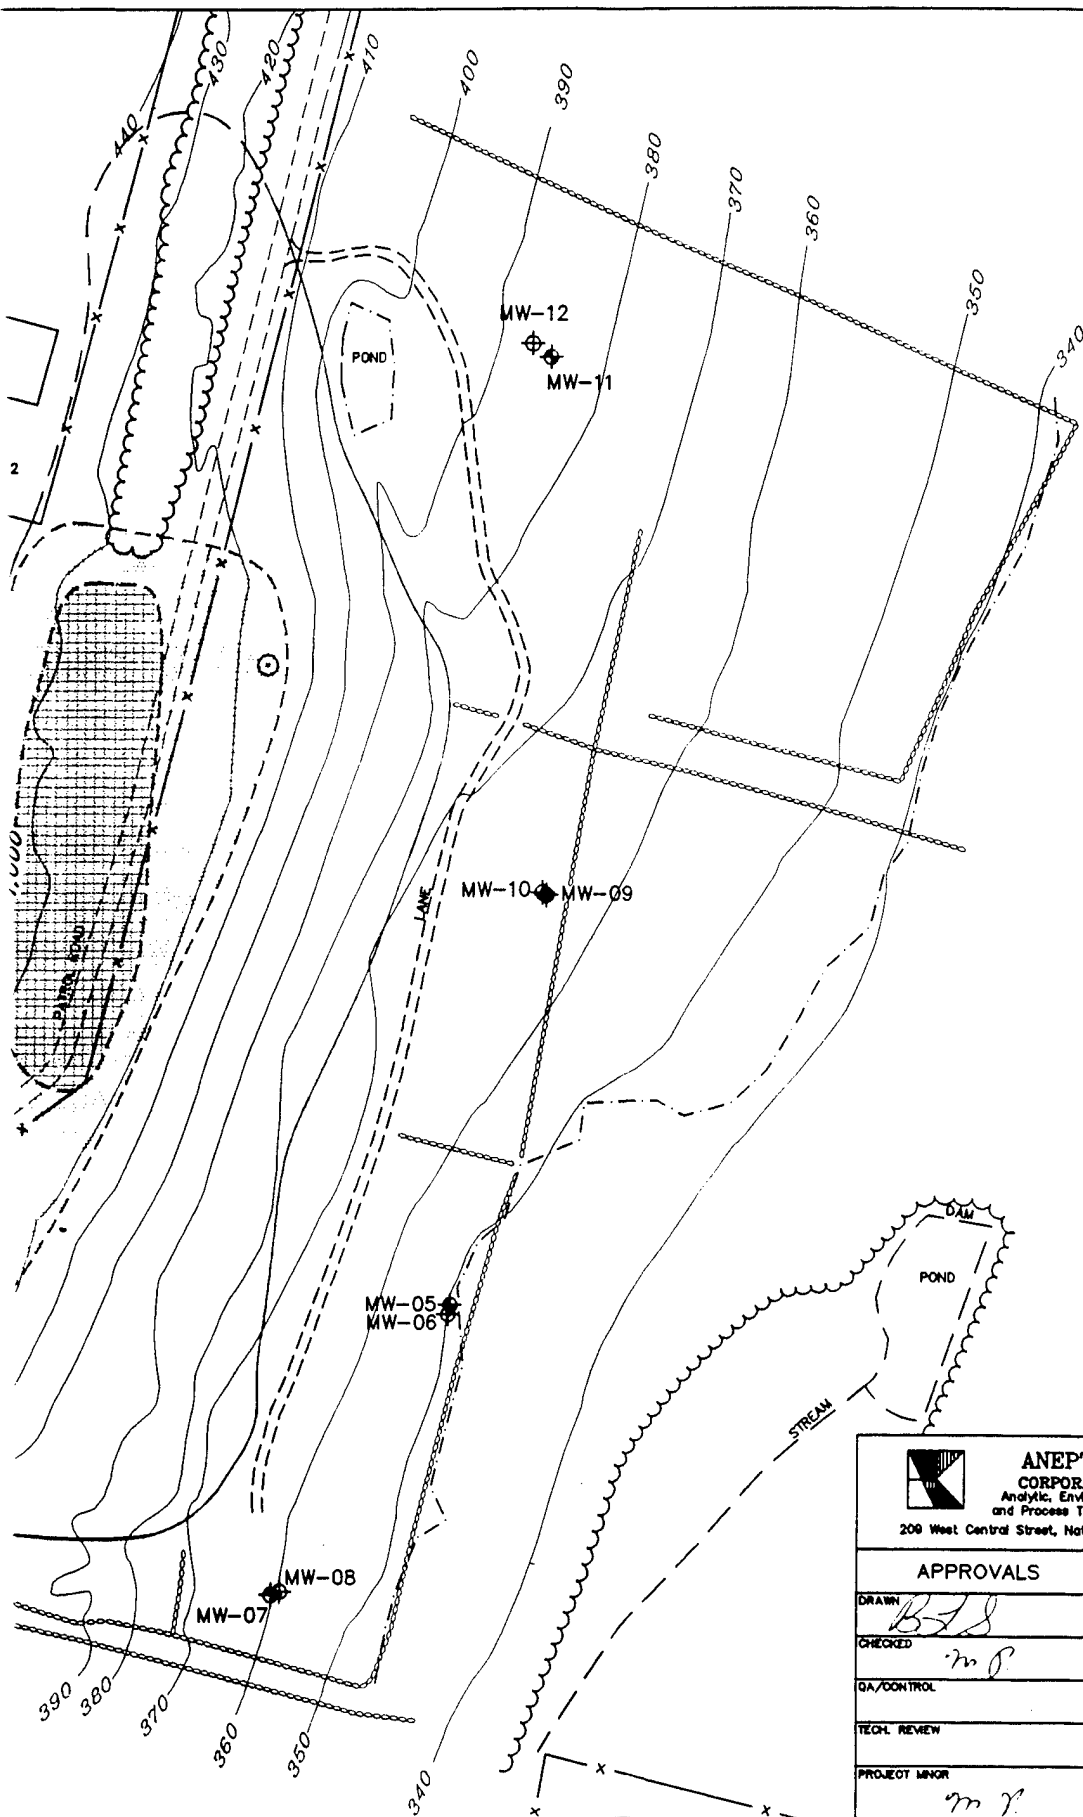
- Approximate location >1,000ppm on FID during testing
- ▨ Approximate extent >1,000ppm on FID during testing
- Approximate extent >10ppm on FID during testing
- ⊕ Monitoring Well Location (screened in overburden)
- ⊙ Monitoring Well Location (screened in bedrock)
- x-x- Chain Link Fence
- ∞ Stone Wall
- - - Wetland Boundary
- ~~~~~ Edge of woods

Generation and migration of explosive gas does not appear to be a significant problem at the Site 1 landfill. Only one of three rounds of gas measurements confirmed the presence of explosive gasses. The identified area was found to be limited in areal extent, as the relatively dense subsurface soils beneath the waste fill prevent subsurface gas migration to the west of the landfill. The less compacted, vegetated side slope may also be allowing gas generated to vent to the atmosphere, preventing build up of hazardous concentrations of such gas.

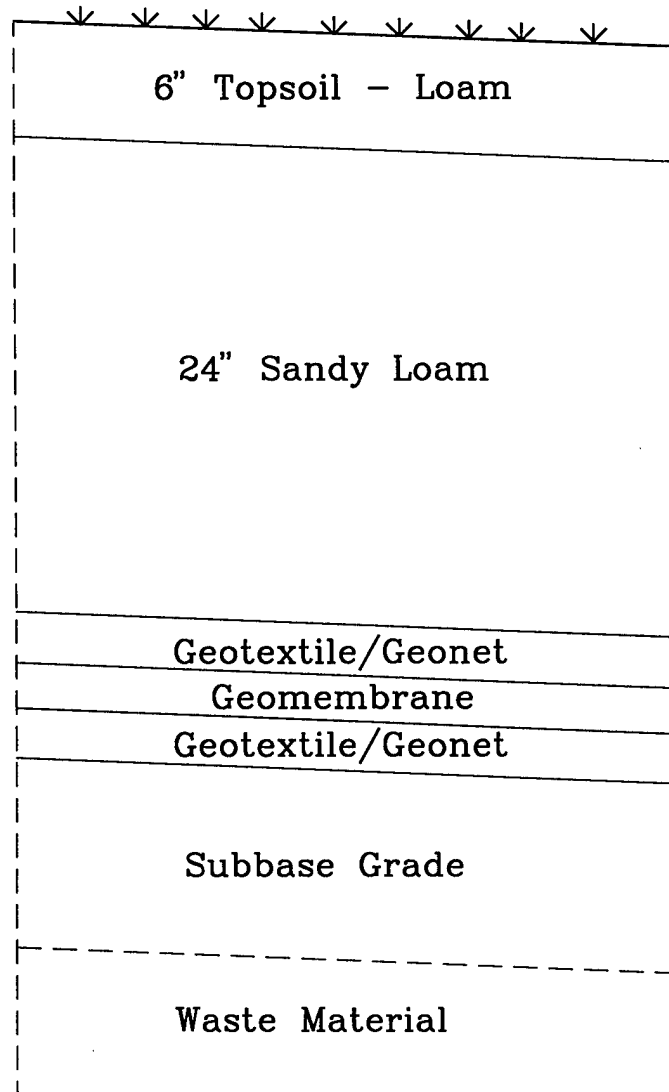
Slope:  
Min. = 4.0%  
Max. = 25.0%
