**TRI-SERVICE
CONFERENCE
ON CORROSION**

Fracture Toughness and Stress Corrosion Resistance of U-0.75 wt% Ti

Dr. Chester V. Zabielski* and Mr. Milton Levy
U.S. Army Research Laboratory.
Watertown, Massachusetts 02172-001

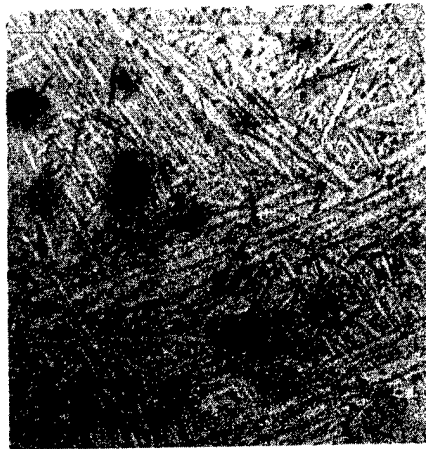
(see Figure 3) and at the tail, or rear, portion of the bar which entered the water last (see Figure 4). The microstructure in Figure 3 is essentially martensitic with evidence of incipient slack quench at the grain boundaries and small voids, particularly in the central area are observed. The tail or rear, views show a more pronounced slack quench and even larger voids, particularly in the central areas (see Figure 4).

Figure 4. U-0.75 wt% Ti (RF) tail section - solution treated at 800°C for two hours, 850°C for one-half hour, vertically water quenched 18 inches per minute; aged (lead bath) for 16 hours at 350°C. Mag. 100X

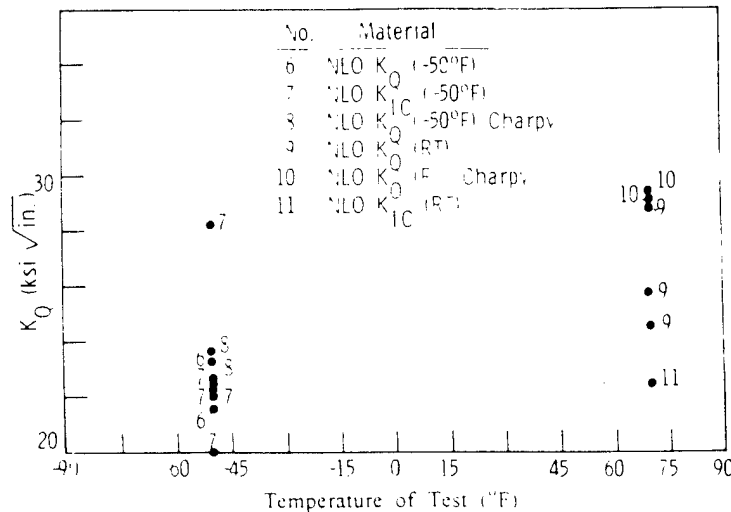
Figure 5 compares fracture toughness data for the failed NLO penetrator material obtained from the two types of specimens employed. The data was designated K_{IC} if all the conditions of ASTM E 399-74 were met; otherwise, the values were designated K_Q .

Figure 5. Fracture toughness of aged U-0.75 wt% Ti NLO penetrators versus temperature of test.

All K_{IC} and K_Q values were below 30 $ksi\sqrt{in.}$, regardless of test temperature. The K_{IC} and K_Q values were in fair agreement. The average value at -50°F was 22 $ksi\sqrt{in.}$, and at 75°F, 27 $ksi\sqrt{in.}$

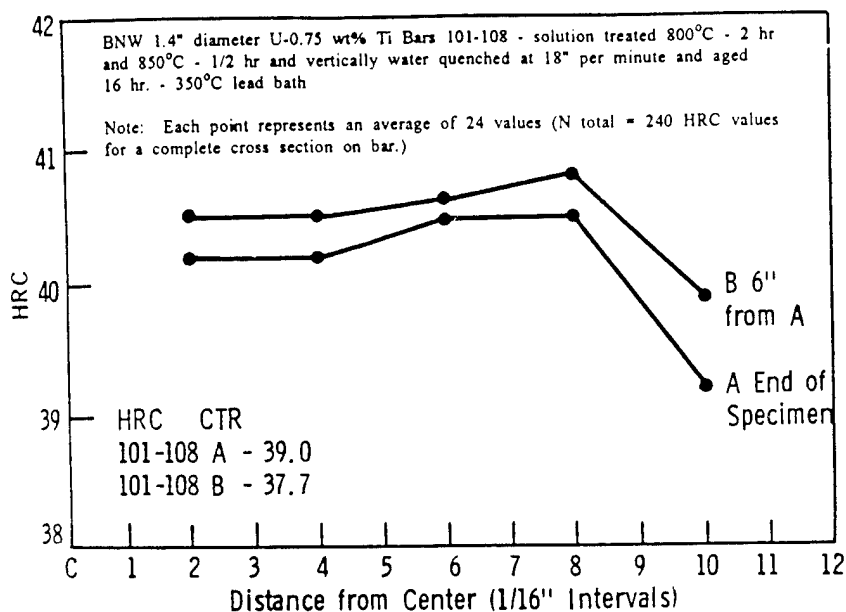
Figure 9 summarizes HRC traverse data taken across the diameter of transverse sections for six bars at 45° angles at the vertically water quenched end, marked A (first hits H₂O), and 6 in. from the end, marked B. The bars at position B were slightly harder than at position A. The central areas of the bars were quite uniform in hardness and slightly softer.

Figure 9. Transverse Rockwell C Hardness versus distance from center.

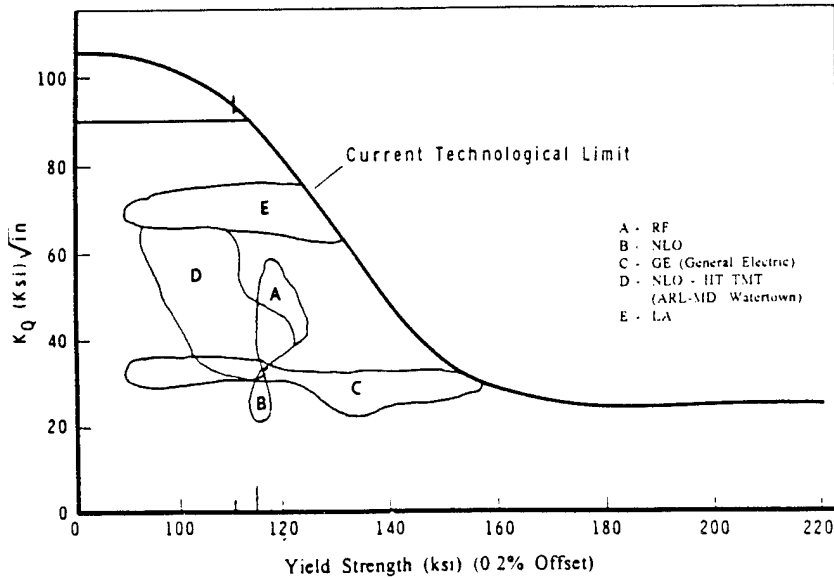
Figure 11 contains the RAD constructed for the U-0.75 wt% Ti alloy (6-8). The envelope "B" encompasses fracture toughness data obtained for the NLO processed alloy which are representative of the failed (low temperature launch) penetrator lots. The material was molten salt solution treated, quenched in oil, and aged; it also contained high hydrogen (>1 ppm). Envelopes "A" and "D" contain data for penetrators which were vacuum solution treated, vertically water quenched, and aged with a low hydrogen content (<1 ppm).

The data shows that the fracture toughness of the alloy is highly sensitive to variations in heat treatment and concomitant interstitial content and microstructure. Under optimum conditions a fracture toughness of $80 \text{ ksi}\sqrt{\text{in.}}$ has been reported for the U-0.75 wt% Ti alloy at a YS of 115 ksi. Further processing improvements and alloy development may raise this current limit to $90 \text{ ksi}\sqrt{\text{in.}}$

Figure 11. RAD for U-0.75 wt% Ti K_Q versus YS (0.2%).
