**TRI-SERVICE
CONFERENCE
ON CORROSION**

21-23 JUNE 1994

**Rapid Inspection of
Tubing and Piping Due to
Corrosion-Related Problems**

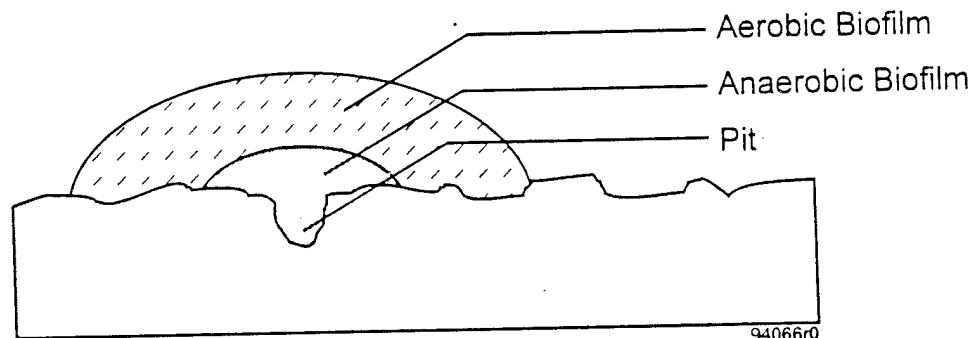
Figure 1. Biofilm Over Pitting Corrosion

Crevice corrosion is another localized form of pitting corrosion. Crevice corrosion typically occurs under deposits or in crevices between mating surfaces, such as gasketed flanged connections. Often it occurs on film-protected (passive) metal surfaces, such as austenitic stainless steels. Some instances of MIC may be considered a form of crevice corrosion when the exopolymer film formed by the microorganisms creates a "living crevice", as shown in Figure 1. The role of organisms relates to the influence of differential aeration cells forming under a biological deposit where a pit initiates and tubercle forms.¹

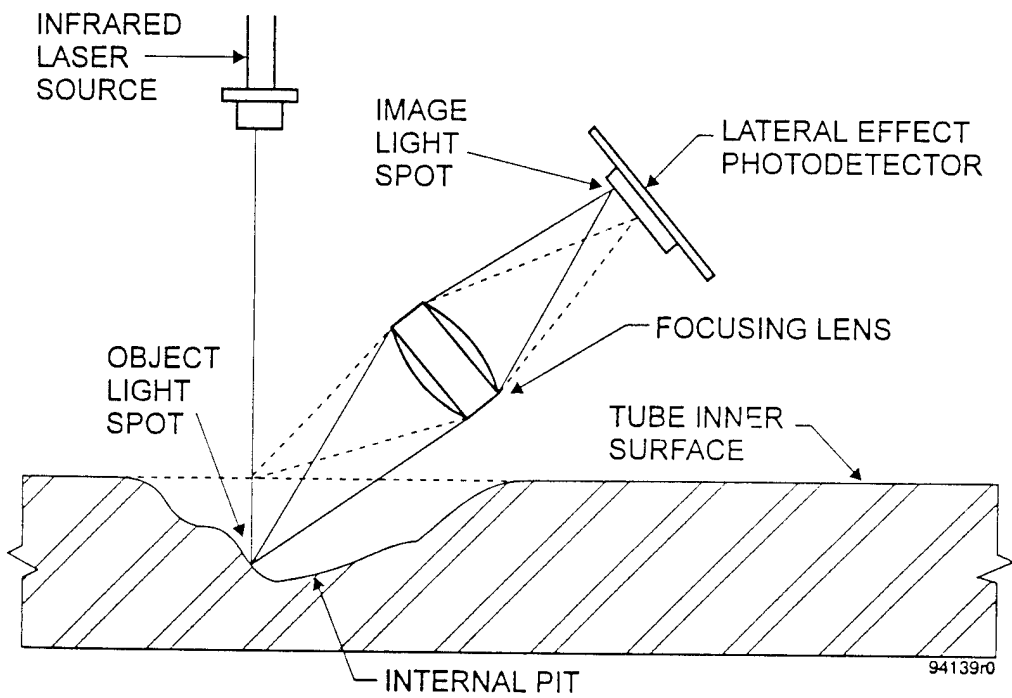
Figure 2a. Operation of Laser Scanner

Laser profilometry, such as the LOTIS™ technique developed by Quest Integrated, Inc., of Kent, Washington, uses a laser source, optic, and a photodetector in the front section of the probe for internal inspection of tubing.¹¹ Doyle discusses how this is useful for inspection systems that can rapidly scan the full length of a marine boiler tube, generate a quantitative topographic map of the tube surface, and tabulate a summary of the results (Figure 2). Internal corrosion and pitting are the primary mechanisms of degradation the system was designed to examine. It provides a high degree of precision and accuracy and distinguishes between cracks, pits and other defects. LOTIS is now being used to inspect heat exchanger and condenser tubes in both military and civilian applications.

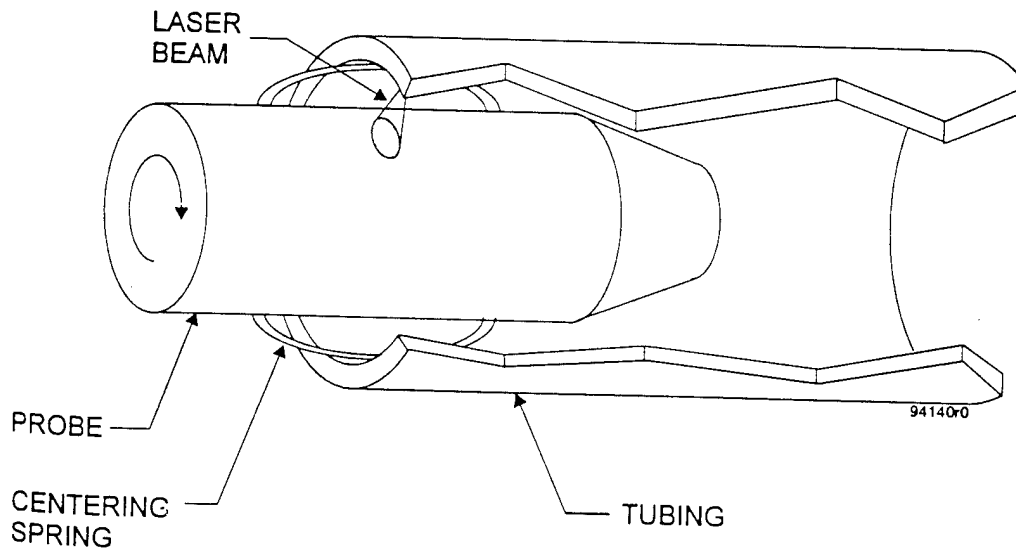
Figure 2b. Optics Housing of LOTIS™ Generates a Helical Map of Tube 1D

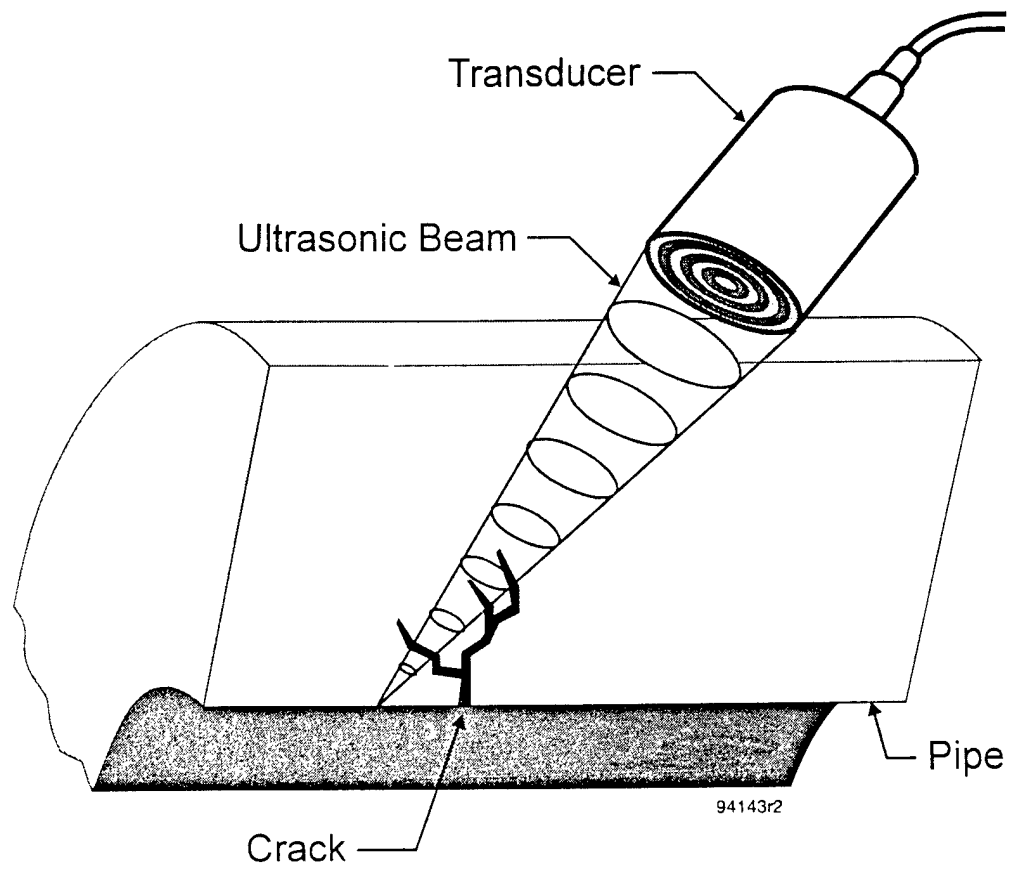
Figure 3 Focused Ultrasonic Beam Using Multiple Transducers

FATS (Focused Array Transducer System) developed by Infometrics of Silver Spring, MD, is a UT system that improves the performance of ultrasonic examinations. Conventional UT techniques can be improved by using a focused transducer, made up of phased arrays of transducers and sophisticated electronics (Figure 3). In addition, the technique can be partnered with TestPro, also developed by Infometrics. TestPro is a data acquisition system with enhancement features.
