**TRI-SERVICE  
CONFERENCE  
ON CORROSION**

**21-23 JUNE 1994**

## Topographic Radioscopic Metrology for Corrosion Mapping

John C. Brausch  
Wright Laboratory, Materials Directorate  
Wright Patterson A.F.B.

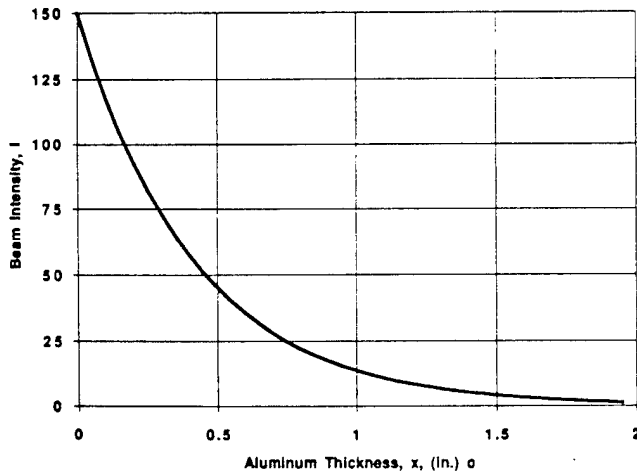
Figure 2. Plot of transmitted beam intensity versus material thickness for aluminum.

Where  $I_0$  is the incident intensity,  $I$  is the transmitted intensity,  $x$  is the thickness of the material, and  $u$  is a factor called the linear attenuation coefficient. The value of  $u$  depends on the energy of the incident photons and the elemental composition of the material. For aluminum at an incident energy of .05 MeV the value for  $u$  is  $2.448 \text{ in}^{-1}$  ( $0.964 \text{ cm}^{-1}$ )<sup>4</sup>. The transmitted intensity vs. material thickness for aluminum is plotted in Figure 2. As expected the transmitted intensity rises exponentially as the material thickness goes to zero. Over thickness ranges of less than 0.25 inches (0.635 cm) aluminum the curve can be assumed linear.

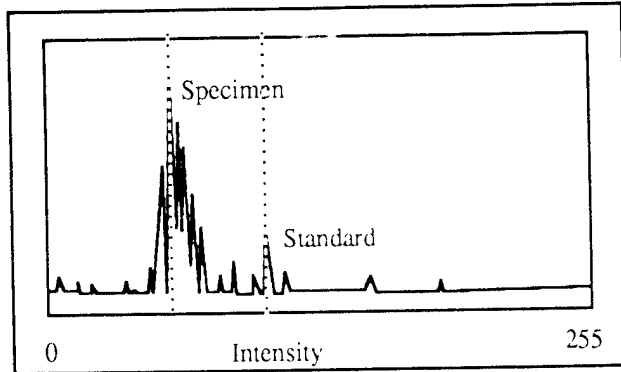
Figure 9: Representative histogram of radioscopic image.

A radioscopic image of a corroded region (Figure 7) on a 0.040 inch (1.016 mm) 7075-T6 aluminum fuselage lap-joint specimen and a 0.03009 inch (0.764 mm) thickness standard was acquired with an x-ray exposure of 47 kV at 1.0 mA. The image was digitally corrected for x-ray beam non-uniformity (Figure 8). Figure 9 represents the histogram of the image of the specimen.

Measuring average pixel intensities for the thickest and thinnest regions (uncorroded base material and thickness standard respectively), provides end points for histogram contrast expansion. The primary peak represents the corrosion specimen and the secondary peak represents the thickness standard. The peaks of these spikes are selected and the data between these peaks are chopped and stretched to fit the TN-8502's full dynamic range of 0 and 256. Colorization of the image is accomplished by dividing the dynamic range by 24 percent (thickness standard) resulting in a 10.4 point intensity change for a 1 percent change in material thickness. Assuming a linear relationship between material thickness and image intensity, the image's histogram is scaled and color banded accordingly. A colorized histogram will appear similar to Figure 10 with the resulting image as shown in Figure 11.

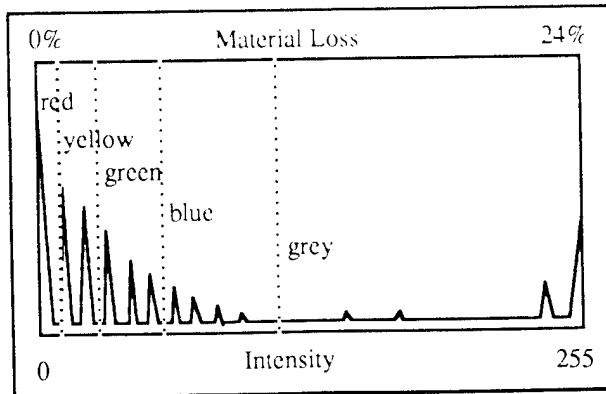
Figure 10. Resulting histogram after expansion and color scaling.
