4. TITLE AND SUBTITLE Surface Treatment of High Performance Marine Alloys to Enhance Crevice Corrosion Resistance in Critical Seawater Applications	5. FUNDING NUMBERS C N000144-95C-001
--	--

6. AUTHOR(S) Robert M. Kain

7. PERFORMING ORGANIZATION NAME(S) AND ADDRESS(ES) LaQue Center for Corrosion Technology, Inc. 702 Causeway Drive, Post Office Box 656 Wrightsville Beach, North Carolina 28480	8. PERFORMING ORGANIZATION REPORT NUMBER
--	--

**SURFACE TREATMENT OF HIGH PERFORMANCE
MARINE ALLOYS TO ENHANCE CREVICE CORROSION
RESISTANCE IN CRITICAL SEAWATER APPLICATIONS**

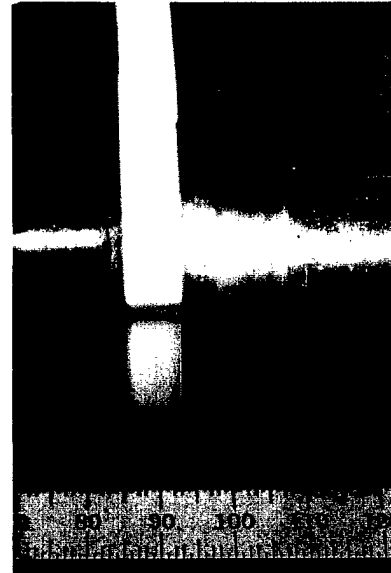
Figure 9. Progression of crevice corrosion for as-produced pipe specimen (No. 002) during 180-day exposure to chlorinated seawater with vinyl sleeve crevice formers.

In addition to the in-situ views shown in Figure 9, several post-test views of affected specimens are shown in Figures 13 to 15. Table 10 compares the crevice corrosion behavior of specimens exposed with vinyl sleeves and rubber gland compression fittings in a 180 day chlorinated seawater test. In this case the seawater temperature was 19.8°C at test initiation, but increased with seasonally warmer temperatures. As can be seen, all eight crevice sites on the as-produced material incurred attack, but with minimal depth of propagation. In contrast, the electropolished specimens were resistant except for a small 2 mm² area of superficial attack beneath one of the rubber glands. Both the cerium A and cerium B treated material were more resistant than the as-produced controls.

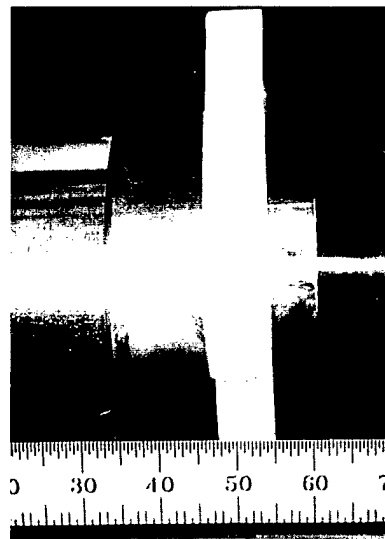
Figure 11. In-situ views showing crevice corrosion incurred by two as-produced pipe specimens, l) No. 017 and r) No. 018, during a 180-day exposure to cold, natural seawater with vinyl sleeve crevice formers.

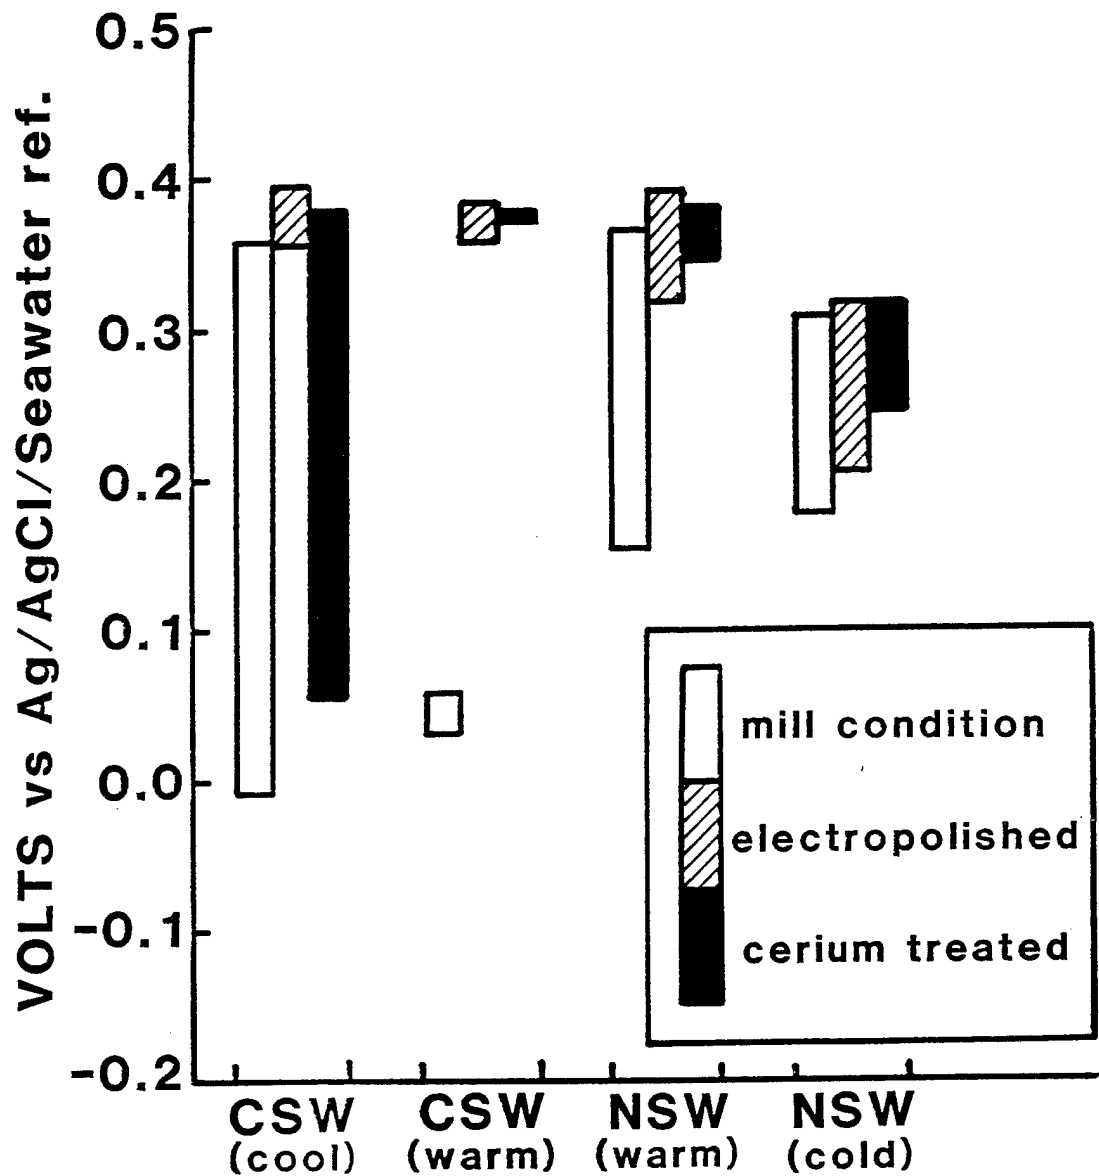
Figure 16. Range of corrosion potentials for various specimen groups after 1000 hours exposure in chlorinated (CSW) and natural (NSW) seawater tests commencing at different times of the year (left - Spring, center - Summer, and right - Winter).

The bar graph in Figure 16 shows the range of corrosion potentials measured for specimens representing the three groups of materials after 1,000 hours in the four indicated tests. These data include potentials for vinyl sleeve and compression fitting assembled specimens having scheduled removals after 60 and/or 180 days. In this analysis, data for the cerium treated (A and B) and the electropolished (OD and OD/ID) specimens have been consolidated, respectively. The potentials shown in Figure 16 (and later in Tables 12 and 13) are mixed potentials indicative of anodic and cathodic reactions taking place on the boldly exposed pipe ID surfaces, as well as those within the crevice on the pipe OD. Results show respectively narrower ranges of potentials for the electropolished and cerium treated specimens, as compared with the as-produced material. Generally, the least variation among materials is noted for the tests commencing in cold natural seawater. As-produced and cerium treated specimens exhibited their greatest variability in the chlorinated seawater test which commenced in early spring. The greatest variation in potential among elec-

The reverse scan low current region shown in Figure 22 for the electropolished material approximates that of the corrosion potentials for electropolished N06625 pipe in the natural and chlorinated seawater as describes in Figure 16 and Tables 12 and 13. Thus, under freely corroding conditions, crevices capable of generating an anolyte pH of 0.2, and perhaps lower, would remain resistant, or corrode at an exceedingly low rate.

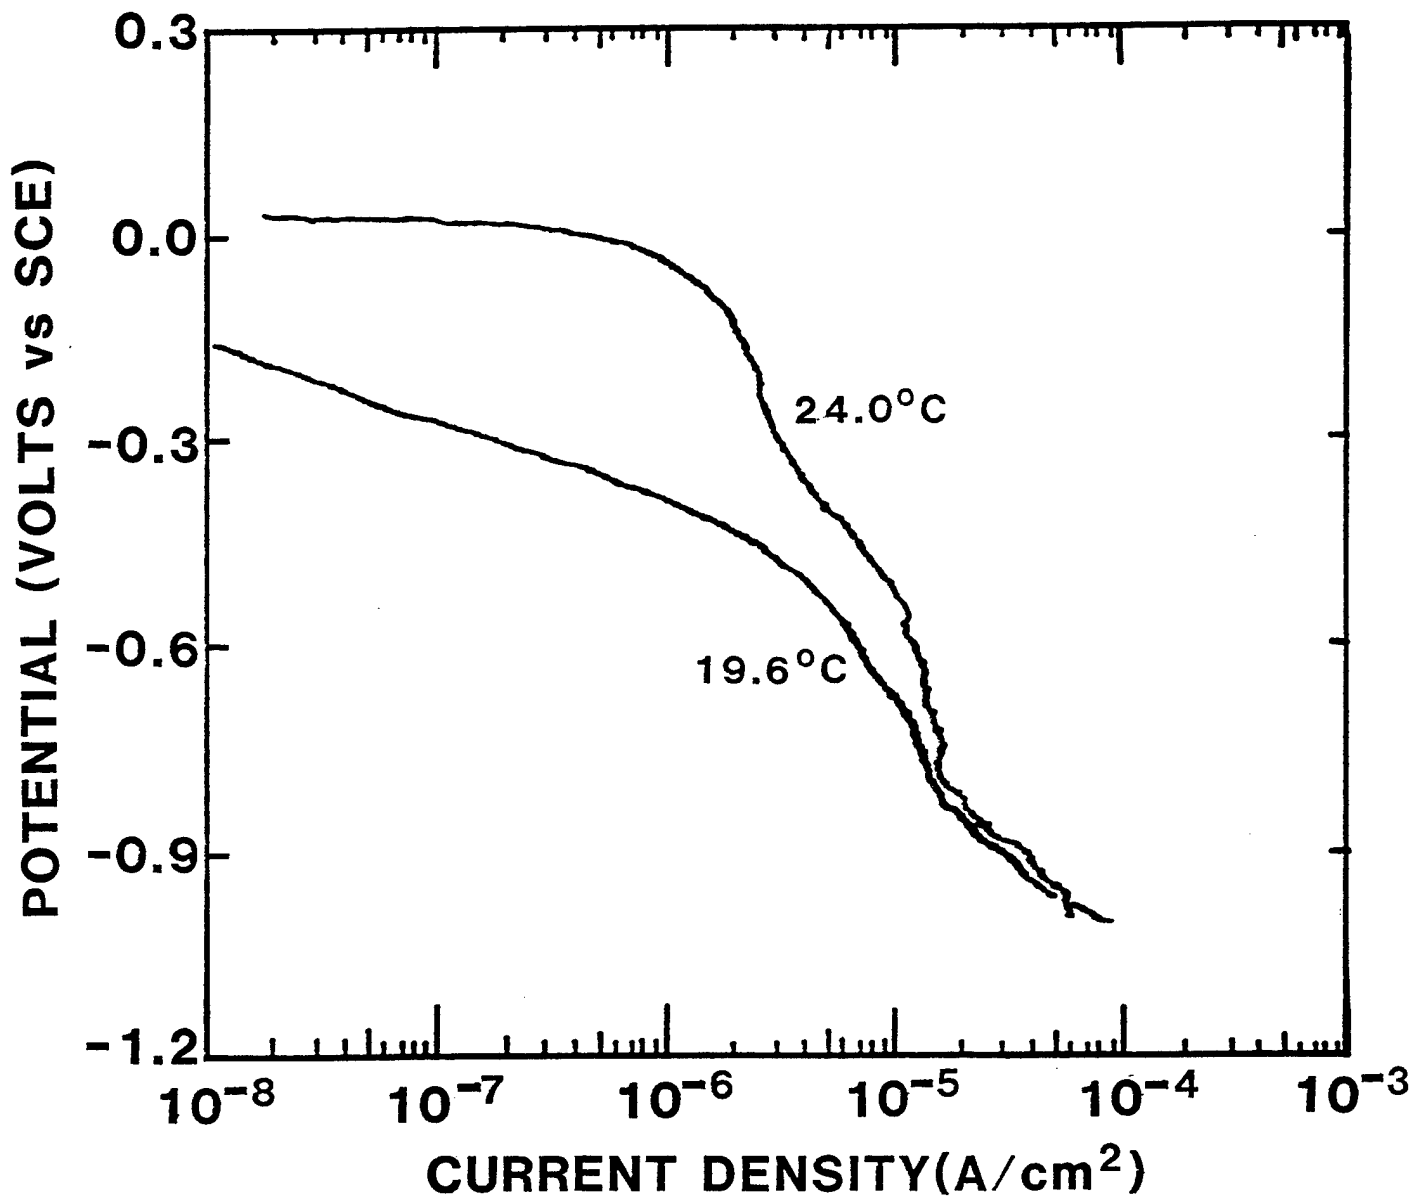
Figure 17. Cathodic polarization behavior for as-produced N06625 pipe pre-exposed to ambient temperature seawater for 12 days.

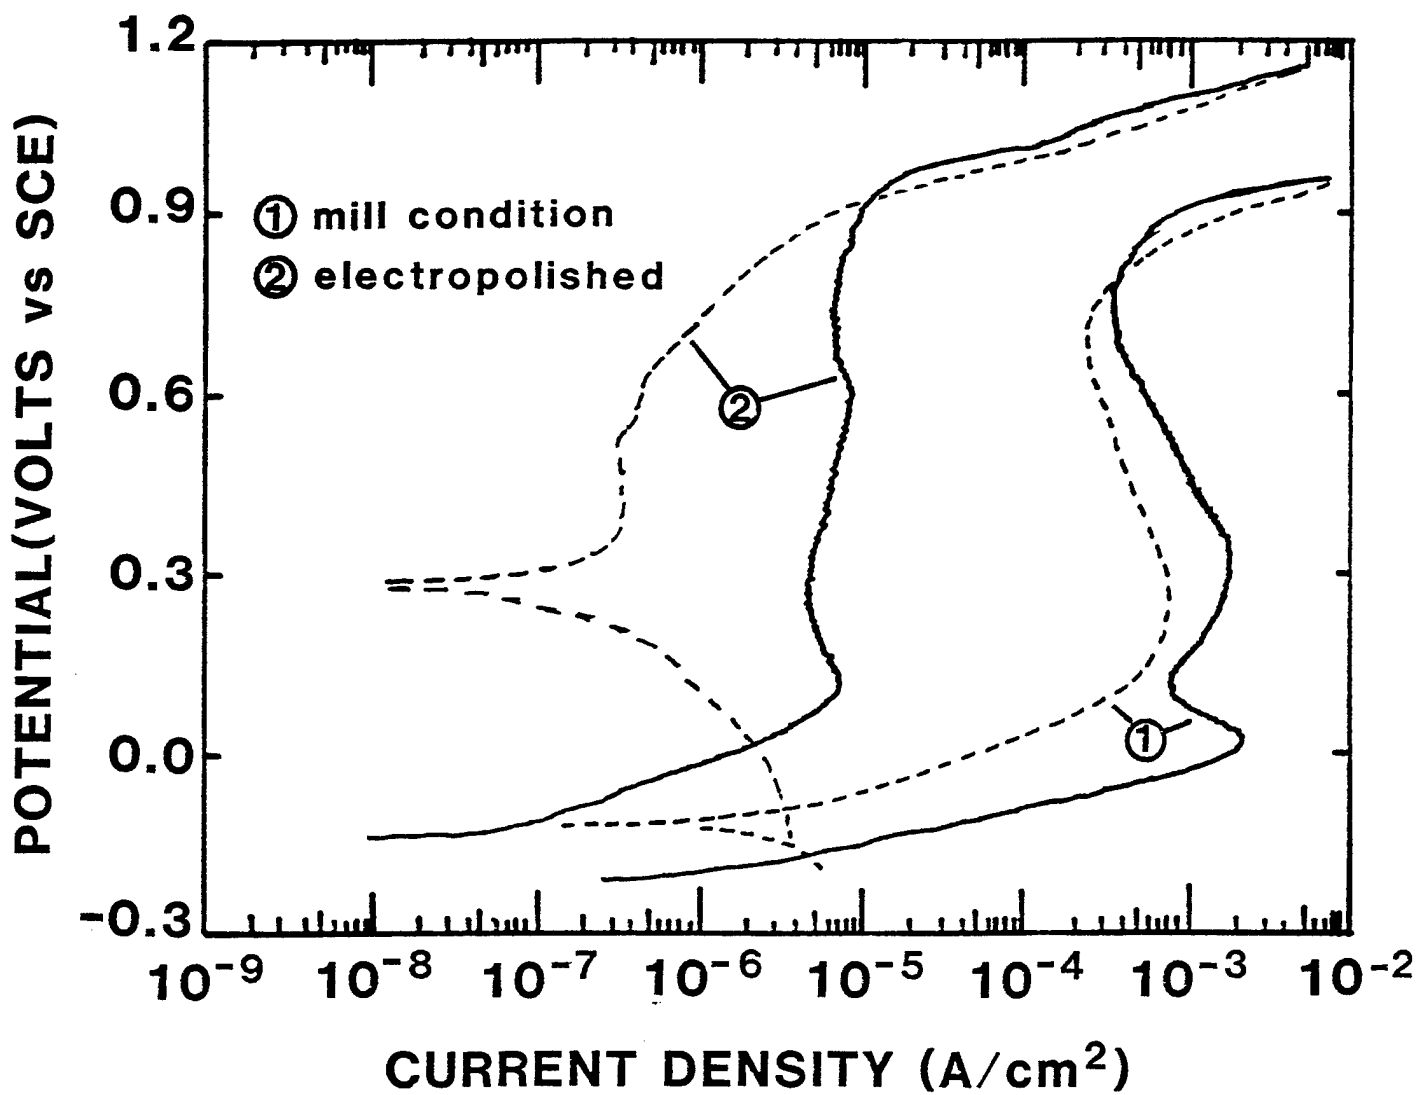
Figure 22. Cyclic forward (solid) and reverse (dashed) scan polarization curves for as-produced and electropolished N06625 pipe in deaerated, simulated crevice solution at pH = 0.2 (scan rate = 17 mV/min.).

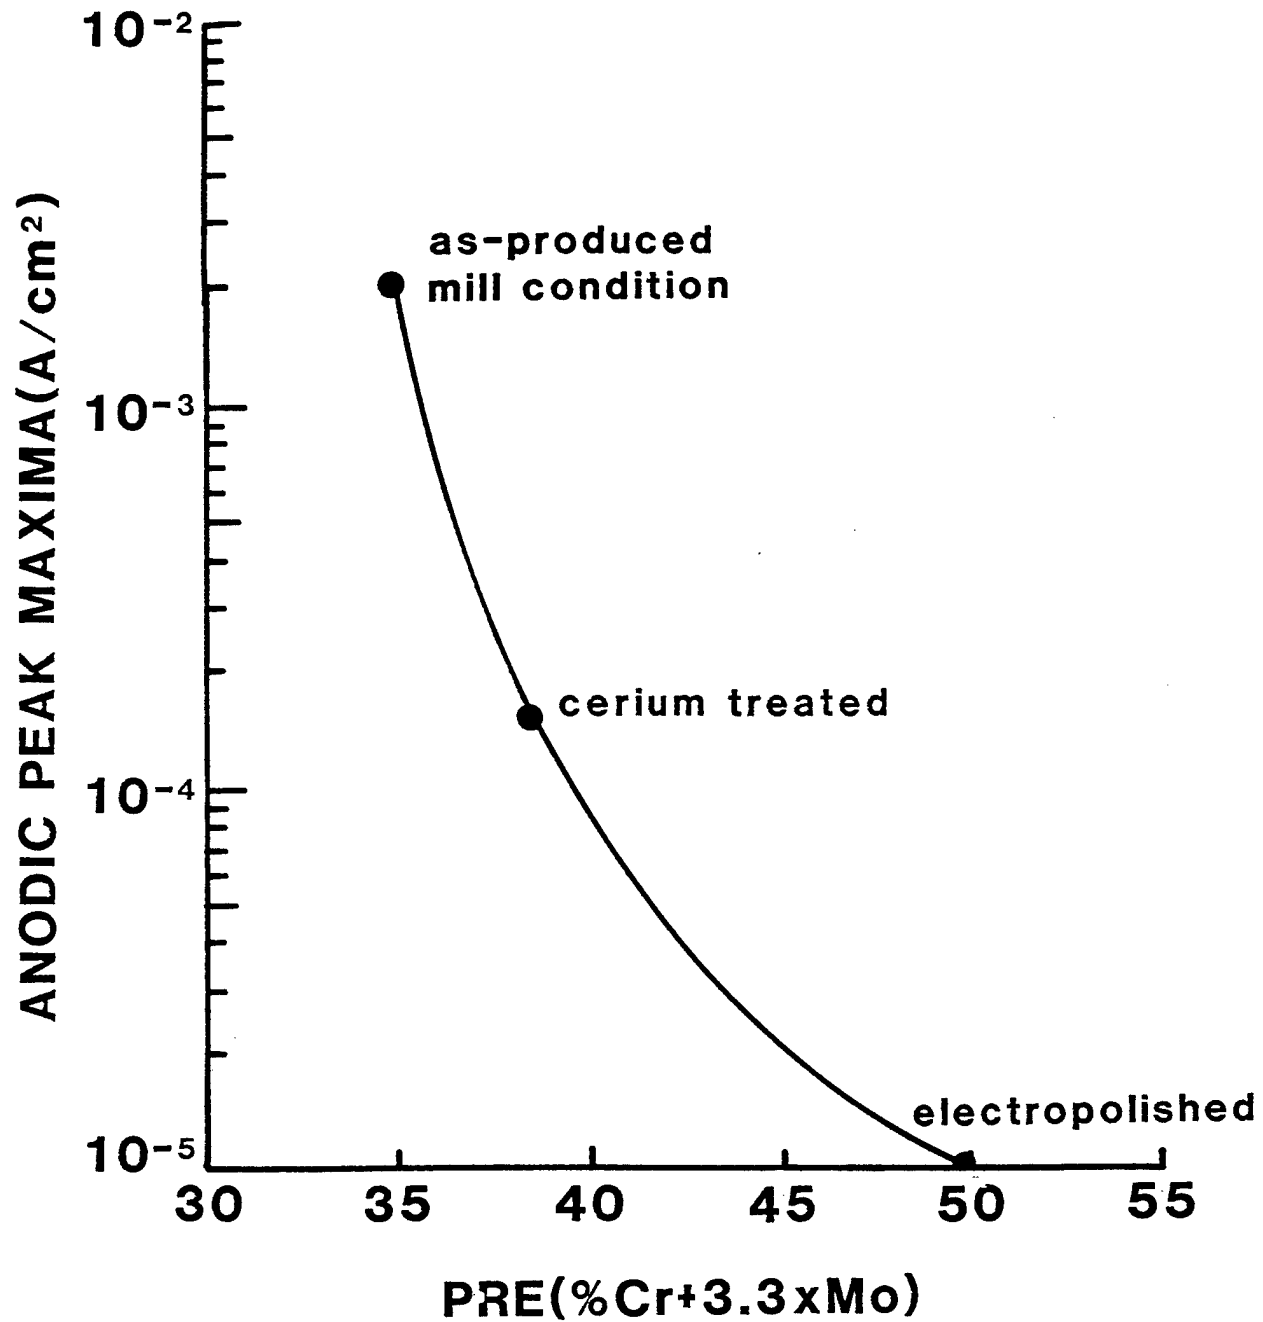
Figure 25. Relationship between N06625 surface PRE value and anodic current maxima determined in deaerated, simulated crevice solution at pH=0.2.

Figure 24 provides a plot showing the relationship between the calculated PREN values, from adjusted EDS data, and the total number of affected crevice sites in all natural and chlorinated seawater tests discussed earlier in this report. For this example, results for cerium A and cerium B treated material have been averaged, as were those for the two series of electropolished pipes. As can be seen, the propensity for crevice corrosion initiation decreased with an increase in the value of PREN, as would be expected for similar comparisons of alloys with different bulk analyses. While the greatest benefit was associated with electropolishing, the influence of the applied cerium treatments was also substantial. The enhanced resistance provided by both the cerium (A and B) treatments and electropolishing in terms of crevice corrosion initiation can be related to the resistance of the respective materials in aggressive crevice electrolytes. Figure 25, for example, shows a plot of the

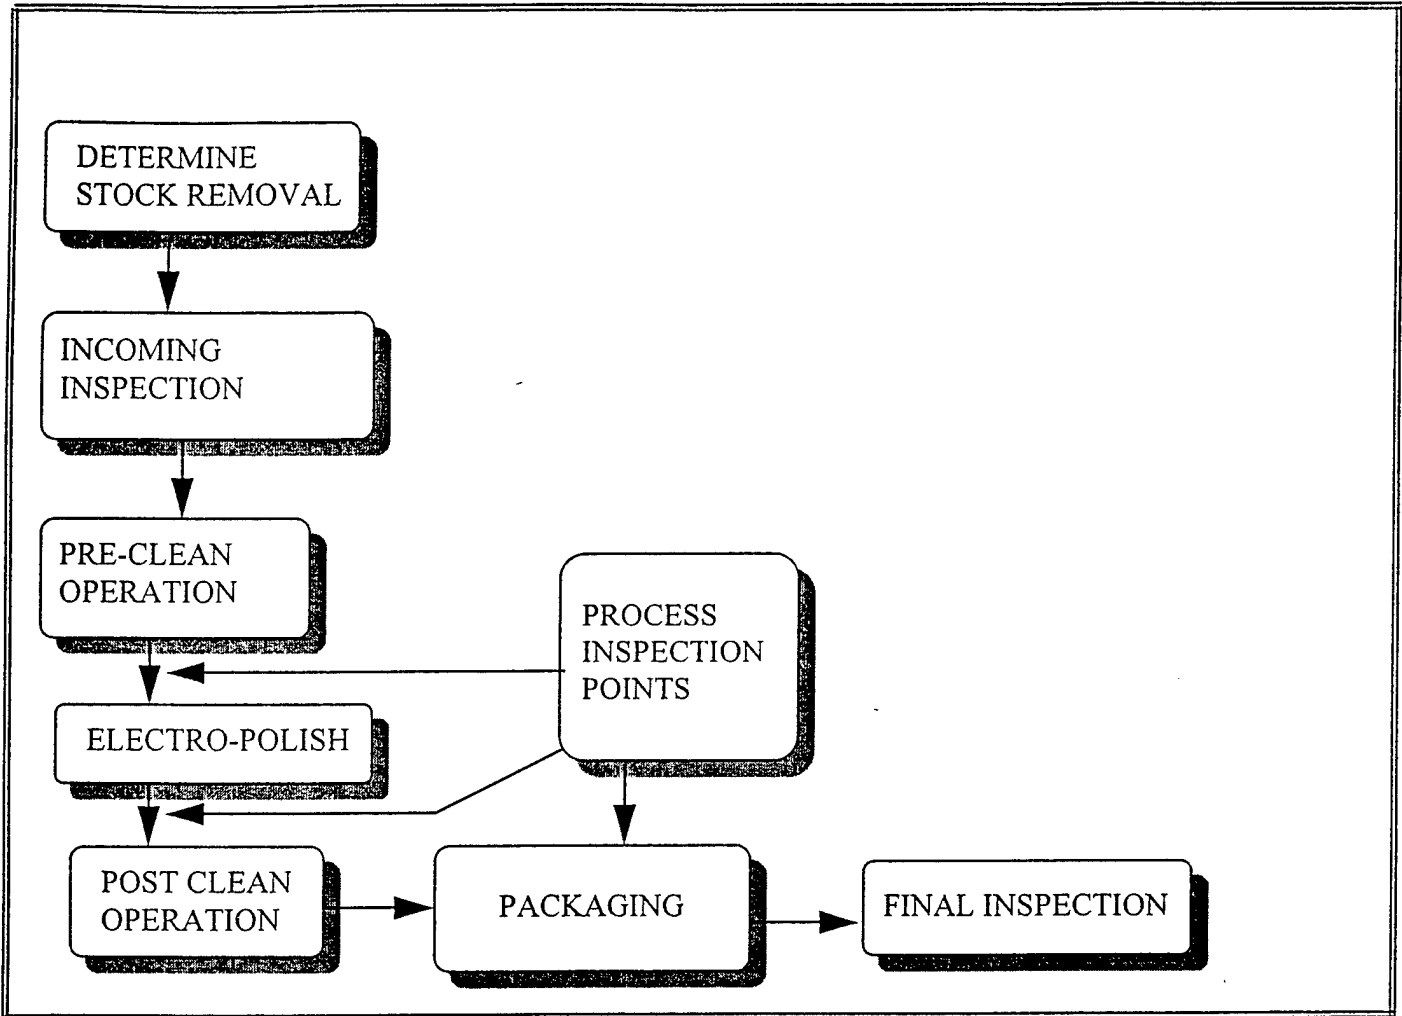
The above flow chart illustrates the process control procedures as performed by Able Electro-Polishing. Detailed procedures follow in this document.

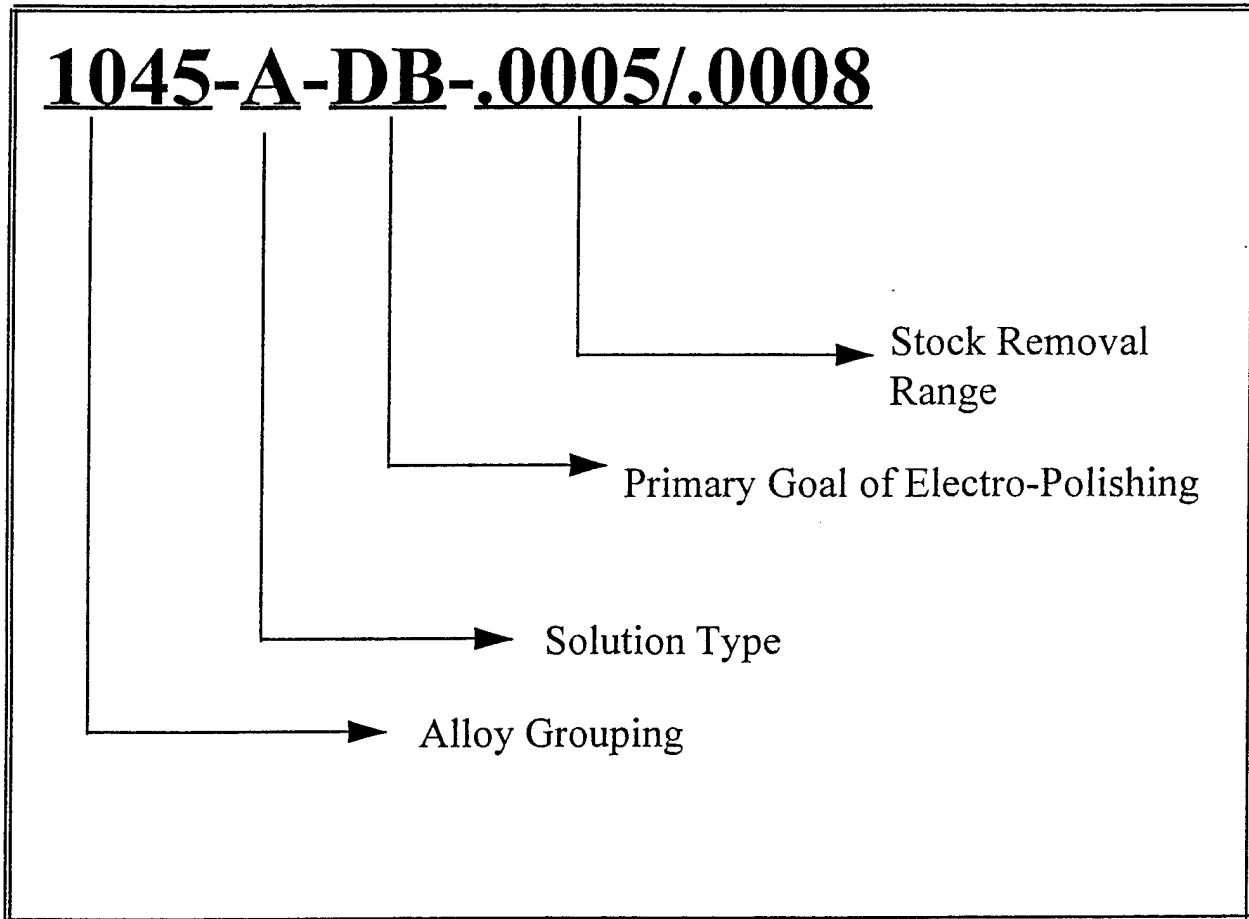
A specification numbering process has been developed. As the above illustration depicts, the numbering format has four distinct parts indicating the alloy of metal, polishing solution, primary process goal and stock removal range.
