Annual Technical Progress Report:
**E-BEAM TESTING AND
EVALUATION OF
SUPERPOLISHED HIGH
QUALITY DEVELOPMENTAL
MIRRORS**

Covering the Period:
21 November 1989 - 21 November 1990

Submitted Under:
Contract No. DASG60-90-C-0002

Corporate Author or Publisher: Spire Corporation, Bedford, MA 01730

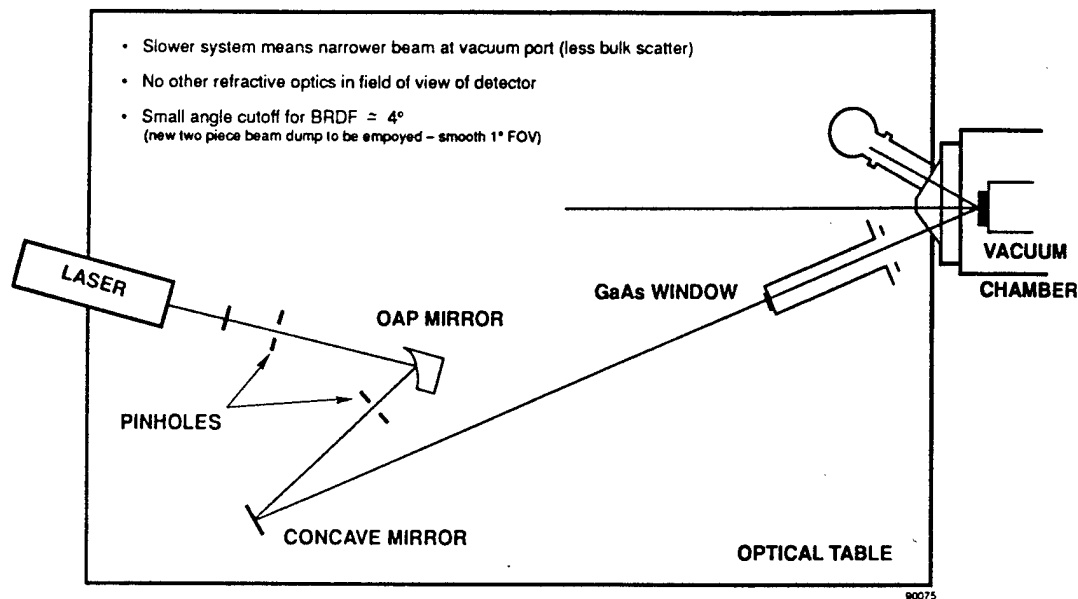
FIGURE 6. SCHEMATIC OF SCATTEROMETER OPTICS.

All necessary optics and mounting hardware were ordered, and the scatterometer was scheduled to be operational by the end of February 1990. Once assembled, it will be tested and qualified. Design calculations estimate that, with a good low-scatter vacuum window in place, the system scatter profile should be insignificant past 1.5° off-specular.

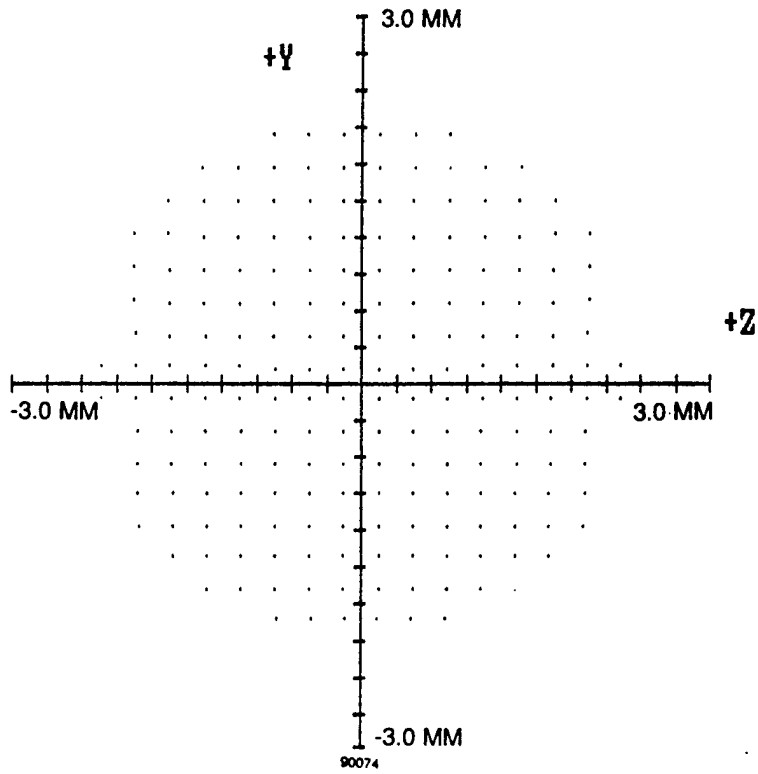
FIGURE 7. SPOT DIAGRAM AT TEST MIRROR.

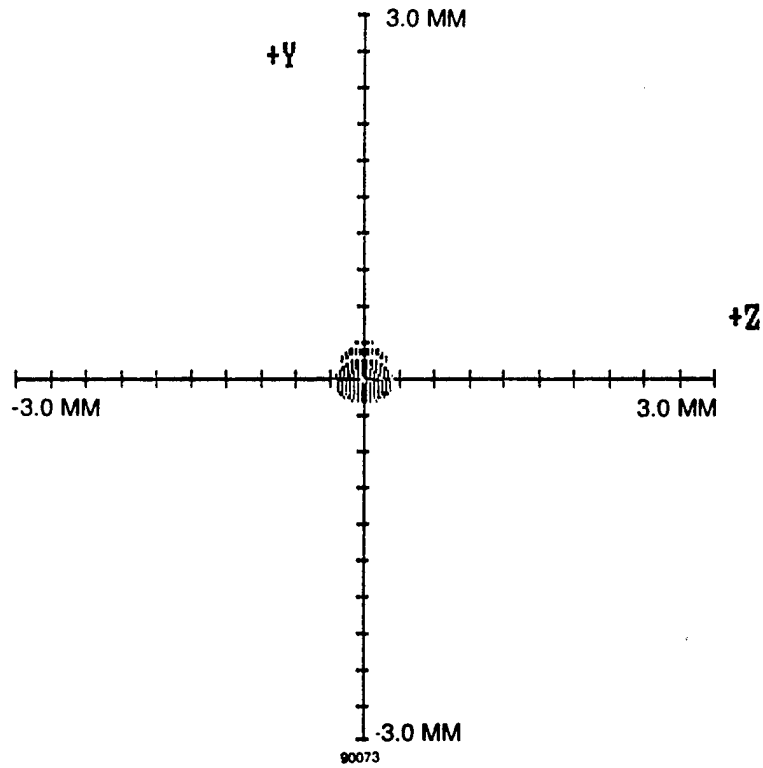
FIGURE 8. SPOT DIAGRAM AT DETECTOR.

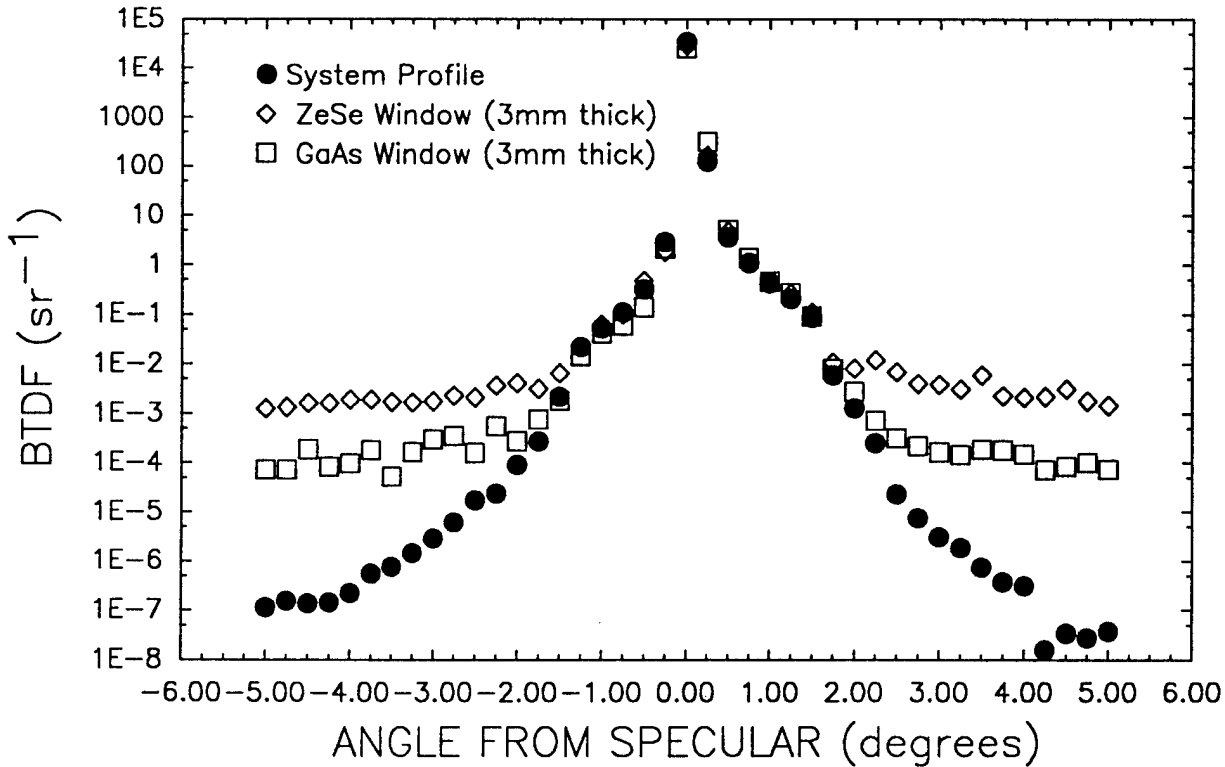
FIGURE 9. BRDF MEASUREMENTS OF ZnSe AND GaAs - BOTH WINDOWS WERE 3 mm THICK AND Ar-COATED ON BOTH SIDES. Note the lower scatter levels produced by GaAs past 1.5°.

BTDF is similar to BRDF except that it measures light that is scattered in transmission rather than reflection. These initial tests show that GaAs outperforms ZnSe in the near specular range as close as 1.5 degrees from specular. Figure 9 shows BTDF plots for both materials along with the scatterometer system profile. This figure shows that ZnSe produces scattered light at

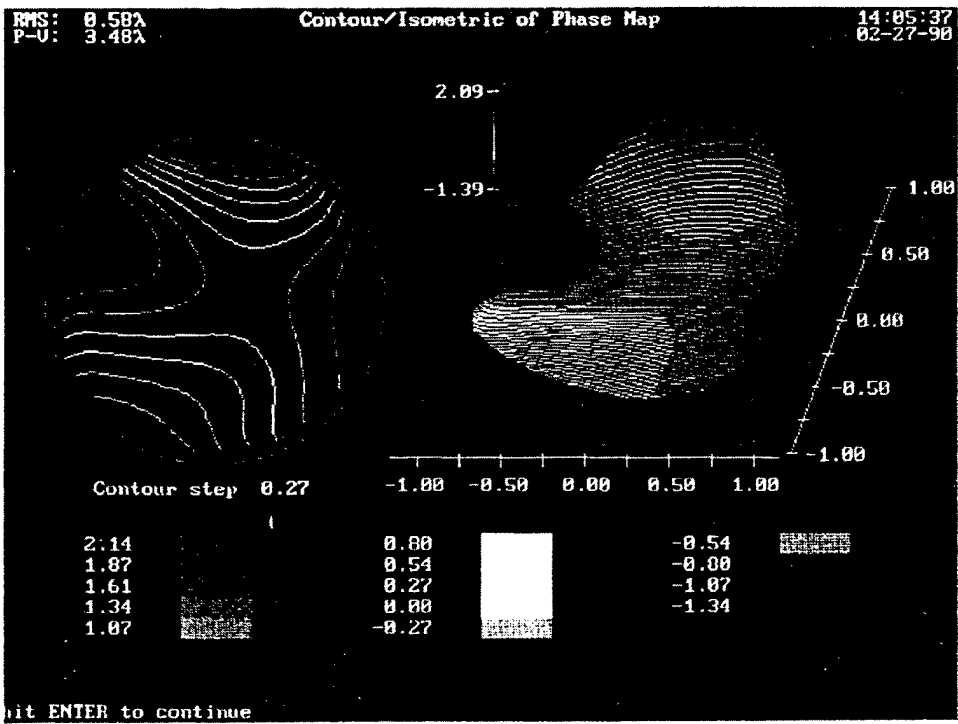
FIGURE 11. INTERFEROMETRY TEST AT 2000 Hz CAMERA RATE.

The camera demonstrated that it could capture interferometric figures accurately while the camera was set at 4000 Hz or faster. Slower speed produced blurred pictures that could not be considered accurate. Operation of this camera at 4000 Hz or 10000 Hz will allow for interferometric studies in-situ on mirrors while under regular testing conditions without further isolating the apparatus from mechanical vibrations. Zygo recommended, however, that the camera be used within the MARK-II model interferometer because of the limited space available within the PTI model and the need for a camera with sufficient imaging resolution for testing seven-inch mirrors.

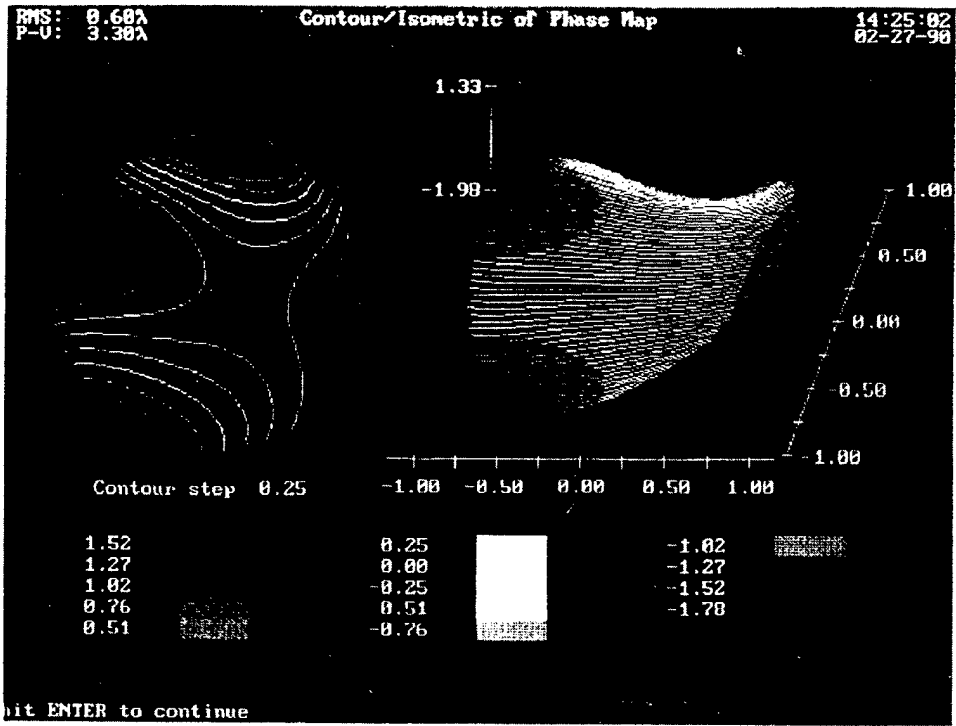
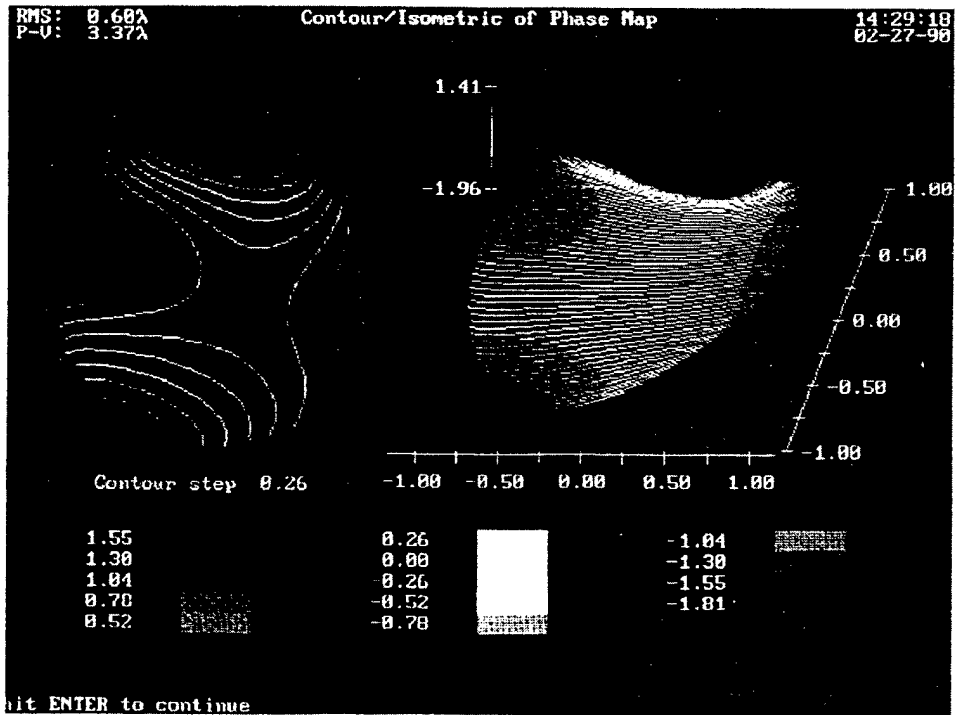
FIGURE 12. INTERFEROMETRY TEST AT 4000 Hz CAMERA RATE.

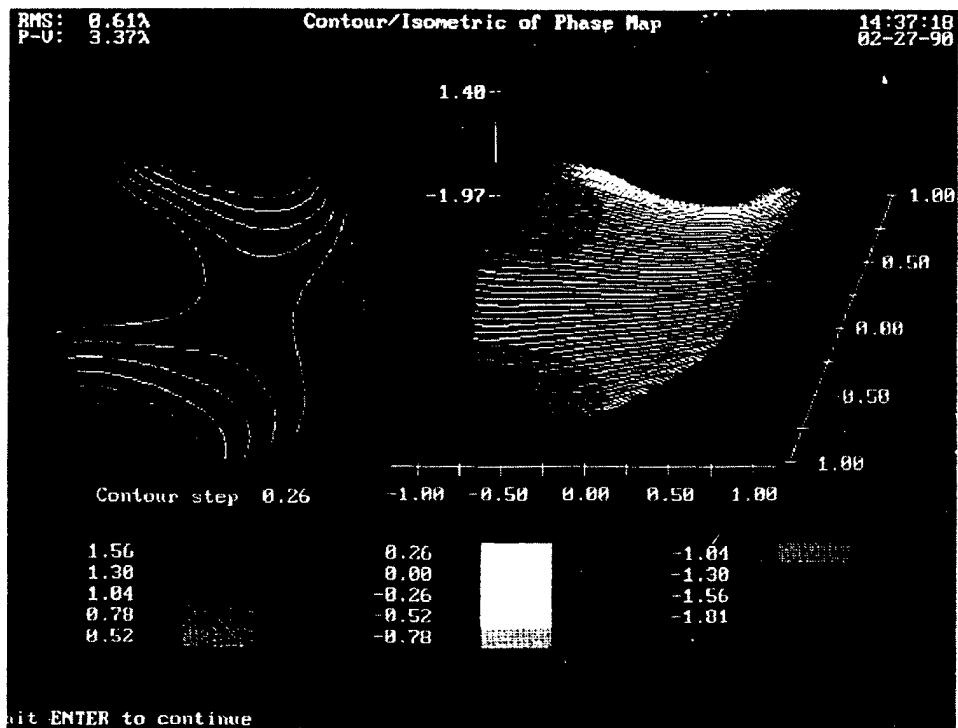
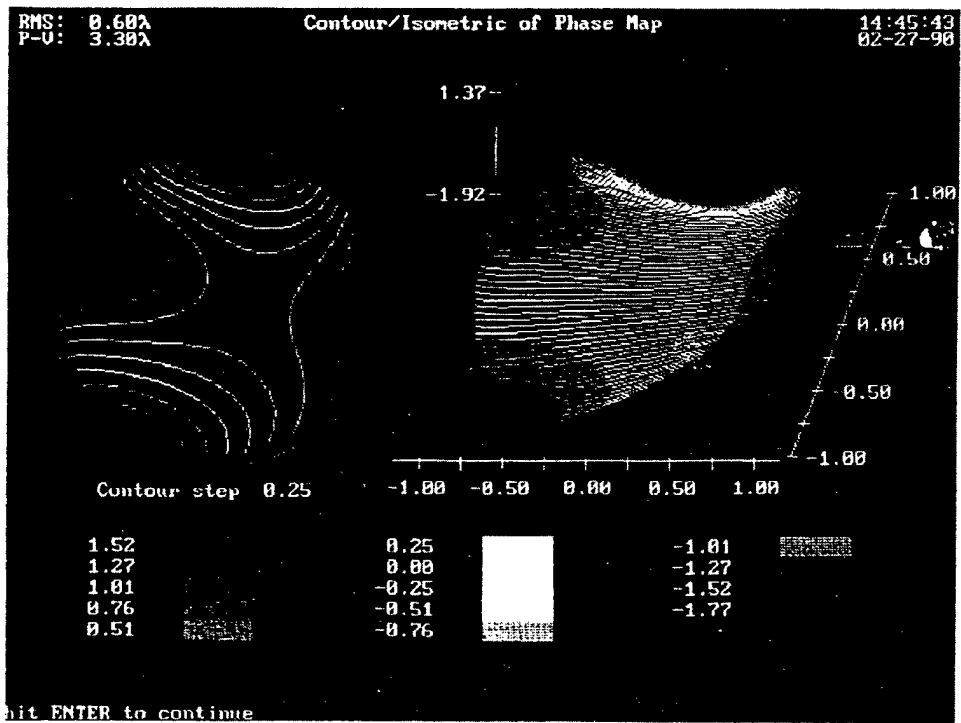
FIGURE 13. INTERFEROMETRY TEST AT 10,000 Hz CAMERA RATE. Interferograms (a) and (b) taken at approximately 10 minute intervals.

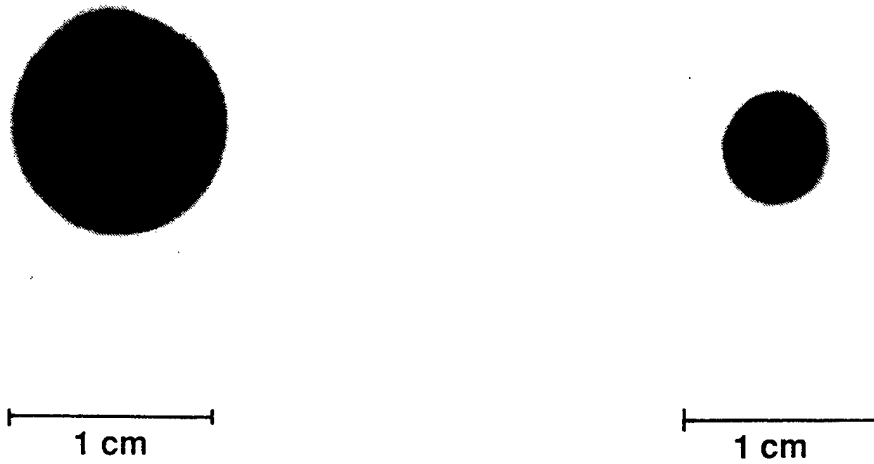
FIGURE 15. CO₂ LASER SPOT IMAGES. Left: After collimation; Right: At test mirror.

To compare computer predictions with system performance, a straightforward method of beam characterization was used. Thermal imaging, or "burn," paper was placed in the beam path at selected positions and exposed to the beam energy. The paper is capable of significant resolution and is a helpful tool in general IR alignment procedures. The high power density at the plane of the detector, where the beam focuses, required the use of ordinary paper to provide a "beam" footprint.

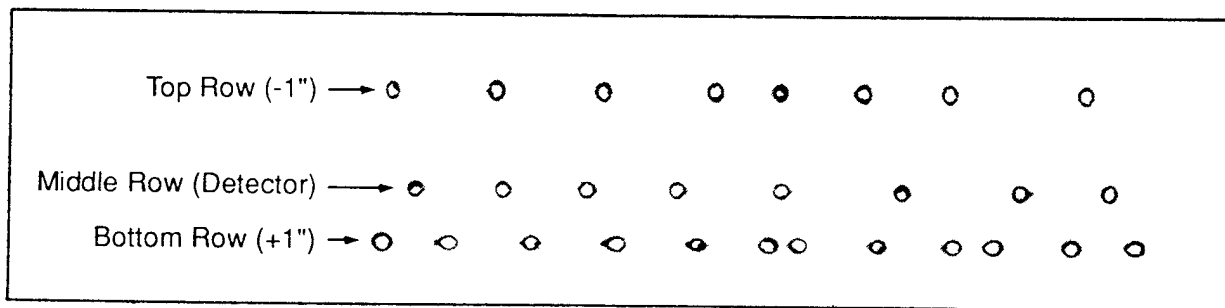
FIGURE 16. LASER BURN SPOTS NEAR DETECTOR PLANE.

The hole pattern shown in Figure 16 represents three series of burn hole measurements at the detector plane and at one inch on each side of the detector plane. The top row of holes was made with the paper located one inch in front of the detector plane and show a slightly oval shape in the vertical axis. The middle row of holes was made at the detector plane itself and appear circular. The lower row of holes was made one inch behind the detector plane and show an oval horizontal shape. This shift from oval vertical to circular to oval horizontal is due to the

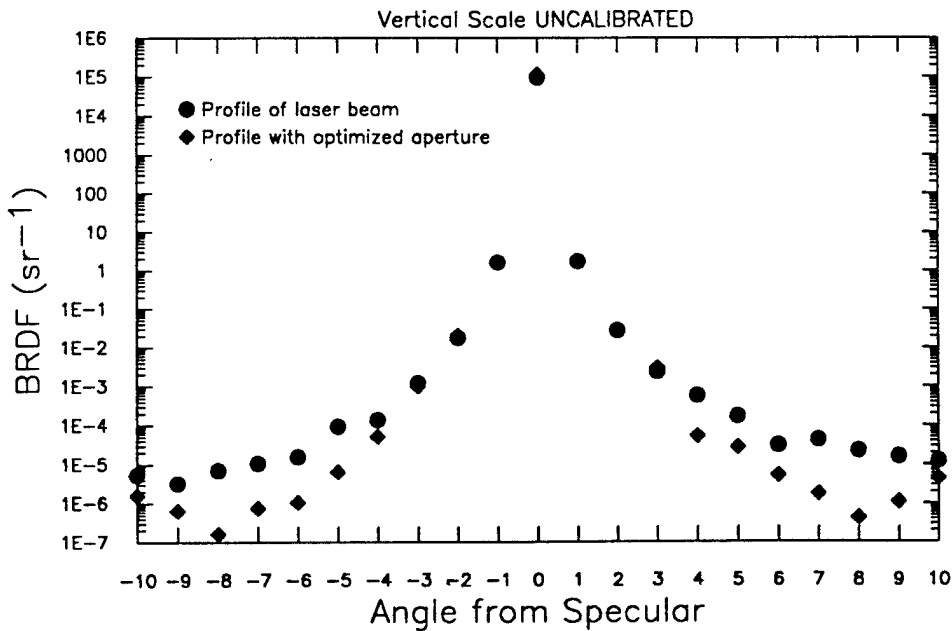
FIGURE 18. SYSTEM PROFILE WITH 0.75-INCH FIELD STOP (No GaAs Window).

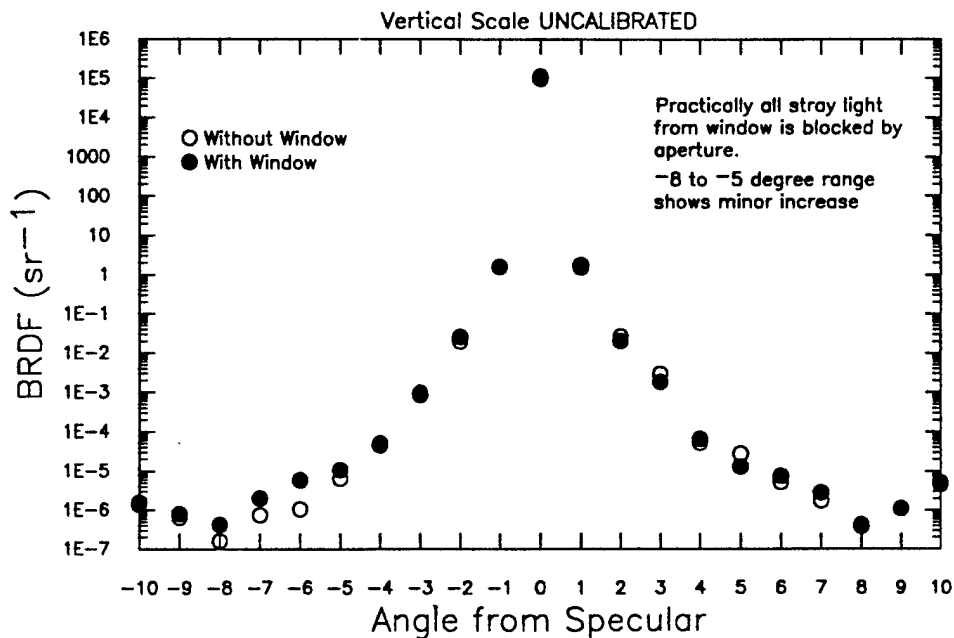
FIGURE 19. SYSTEM PROFILE WITH FINAL BEAM STOP AND GaAs WINDOW IN PLACE.

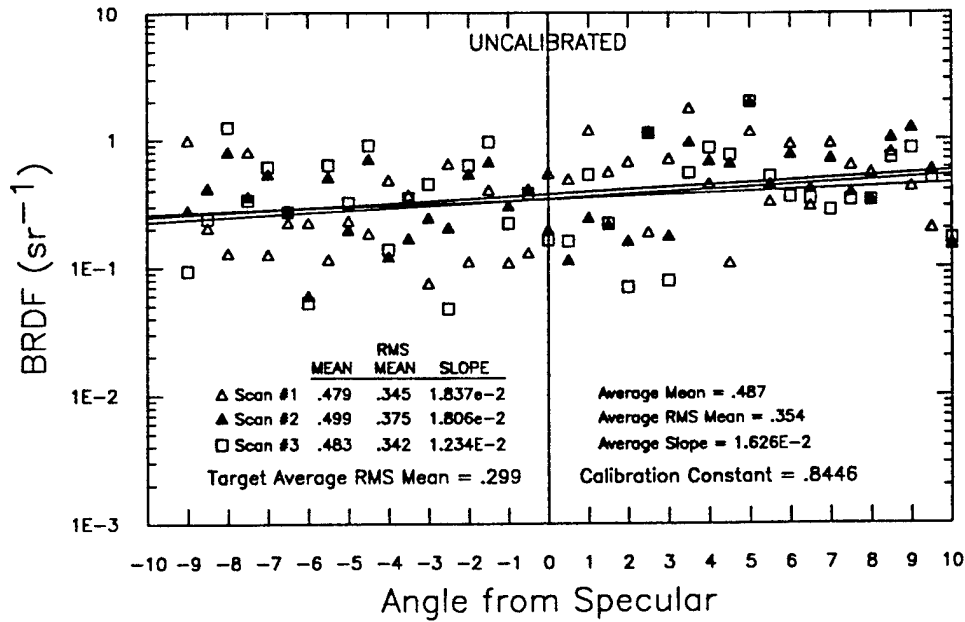
FIGURE 20. UNCALIBRATED BRDF MEASUREMENTS ON IR REFLECTANCE STANDARD.

The BRDF of the diffuse reference sample used to calibrate the CRYOSCAT was also measured on FASCAT. This machine has its own diffuse reflectance standard mounted within the system. It is measured before each run to establish its own CC. Measurements of the Labsphere reference by this instrument produced an average RMS BRDF of 0.389, which is well above the maximum value allowed by theory for a 100% reflective diffuse sample (0.318). These data are indicative of differences between the two scatterometers and the two reference samples.

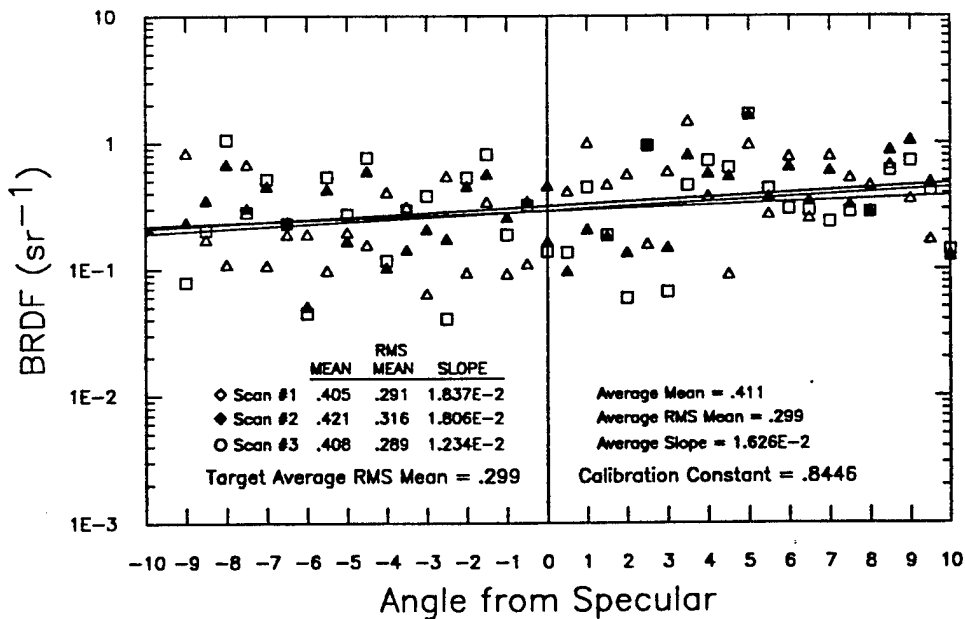
FIGURE 21. BRDF MEASUREMENTS CALIBRATED TO IR REFLECTANCE STANDARD.

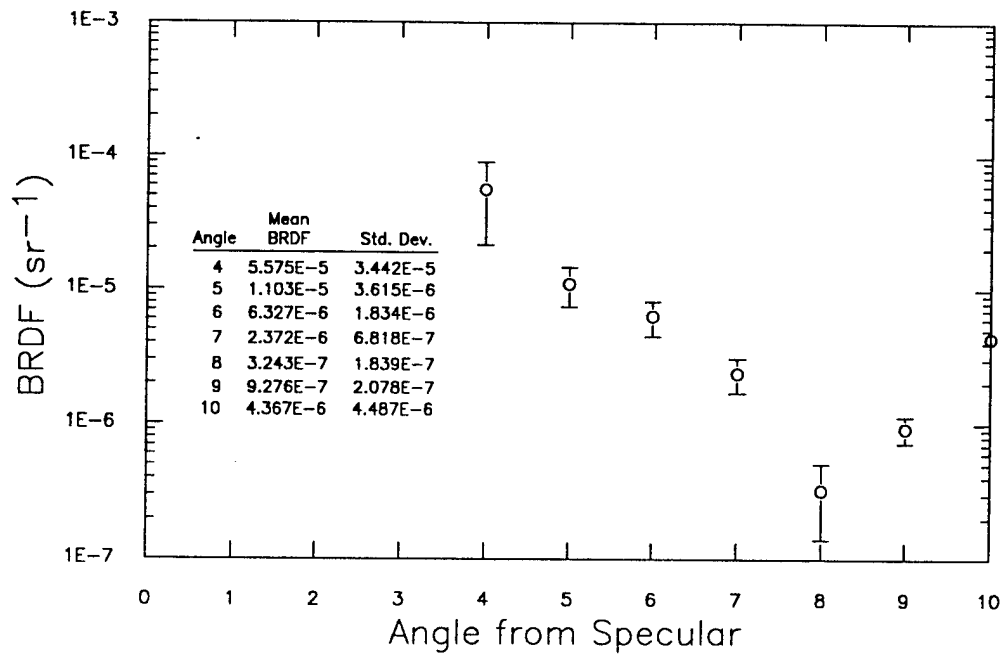
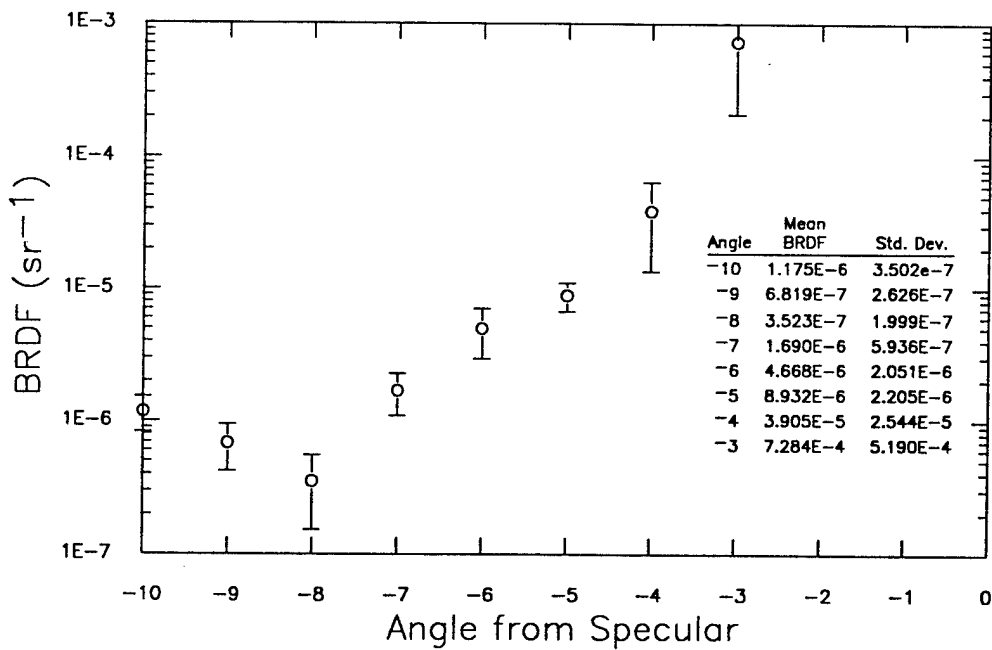
FIGURE 22. CALIBRATED CRYOSCAT SYSTEM PROFILE. (a) Forward scatter; (b) Backscatter.

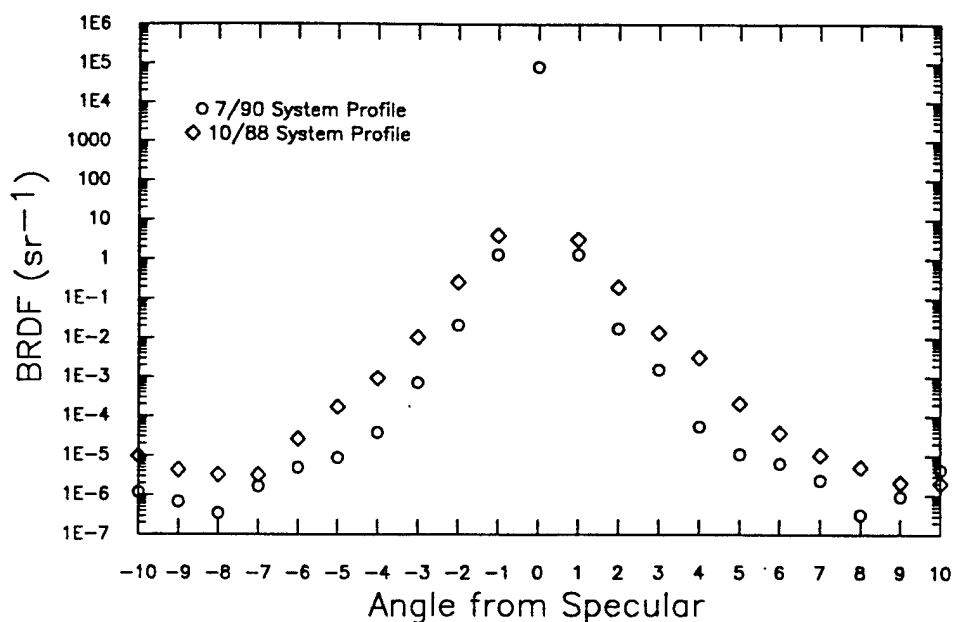
FIGURE 23. COMPARISON OF NEW REFLECTIVE SYSTEM PROFILE TO OLD REFRACTIVE OPTICAL SYSTEM.

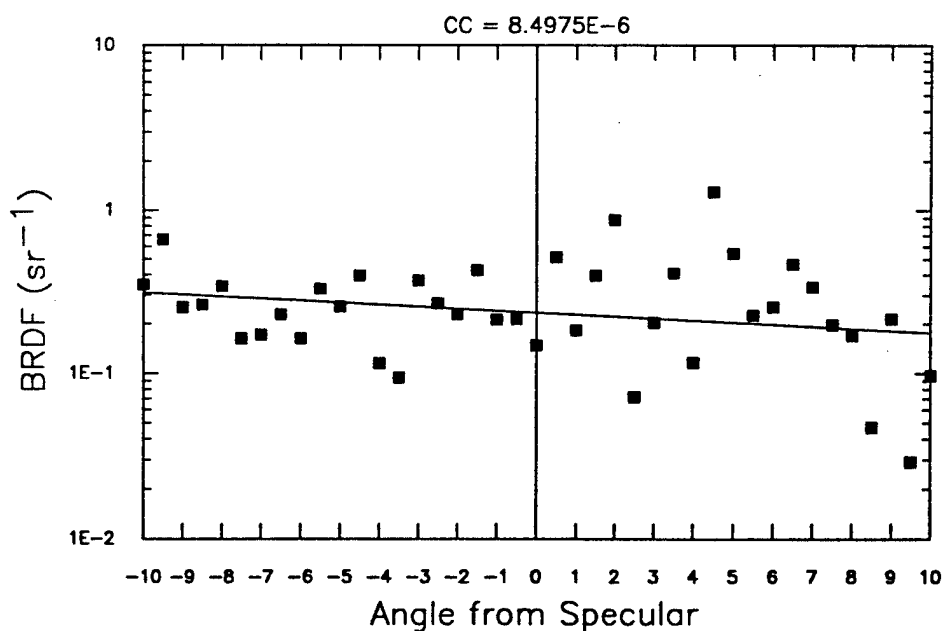
FIGURE 24. BRDF MEASUREMENT OF REFLECTANCE STANDARD ON FASCAT SCATTEROMETER.

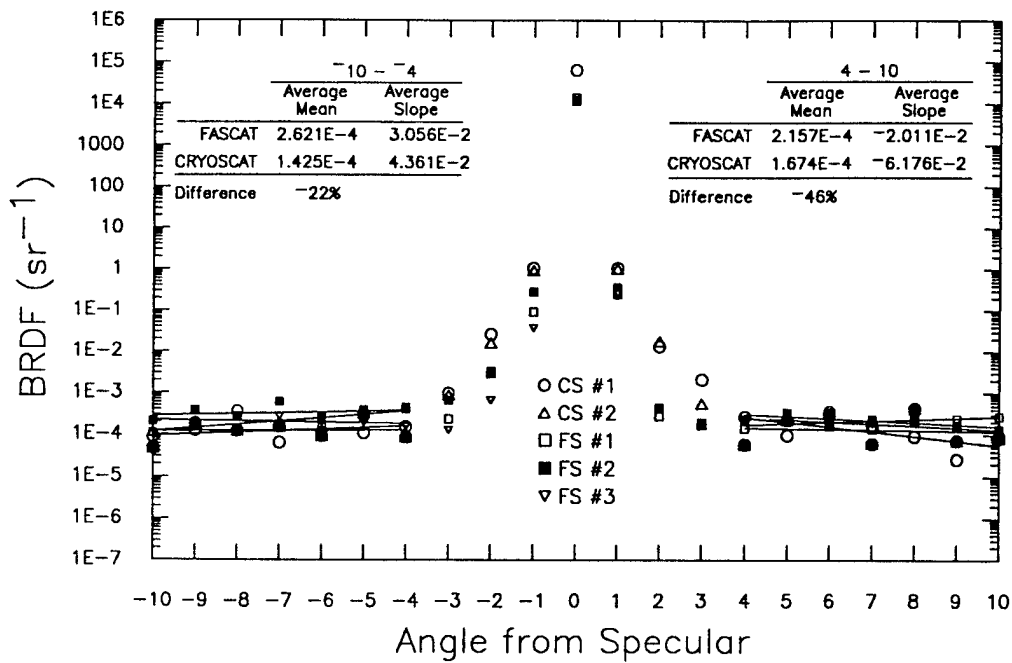
FIGURE 25. COMPARISON OF CRYOSCAT AND FASCAT BRDF MEASUREMENTS ON ROCKWELL RI 94 MIRROR.

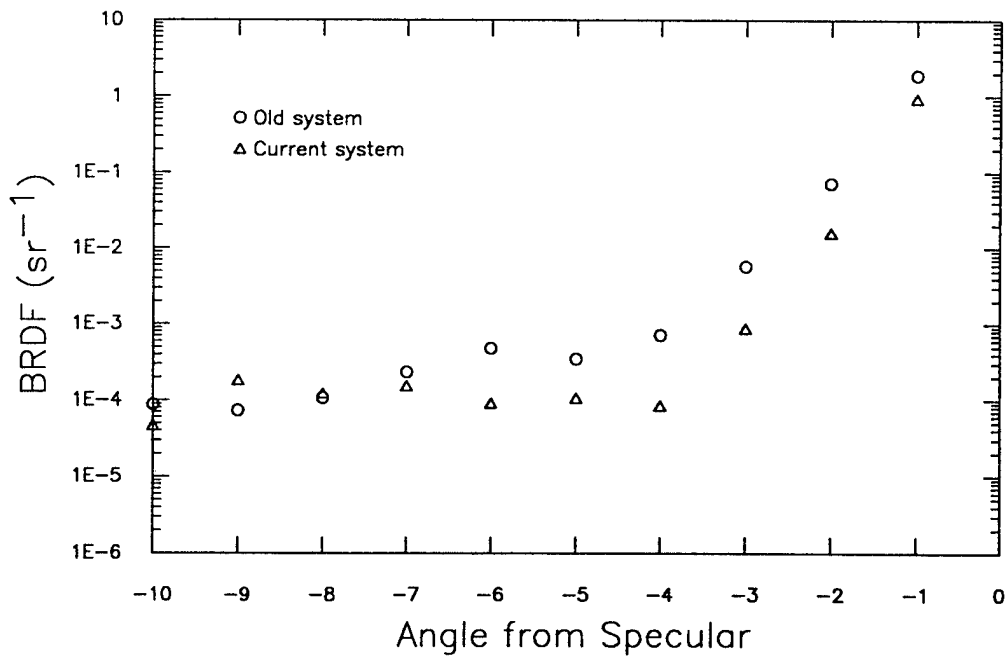
FIGURE 26. COMPARISON OF CURRENT AND OLD SYSTEM BRDF MEASUREMENTS ON RI 94 MIRROR.

As a final test of system performance a comparison was made of current measurements of mirror RI94 and measurements taken by CRYOSCAT in 1988. Figure 26 shows that the new system has a considerably lower system profile for angles less than 7° from specular and, at the same time, closely reproduces the older system's data at larger angles.

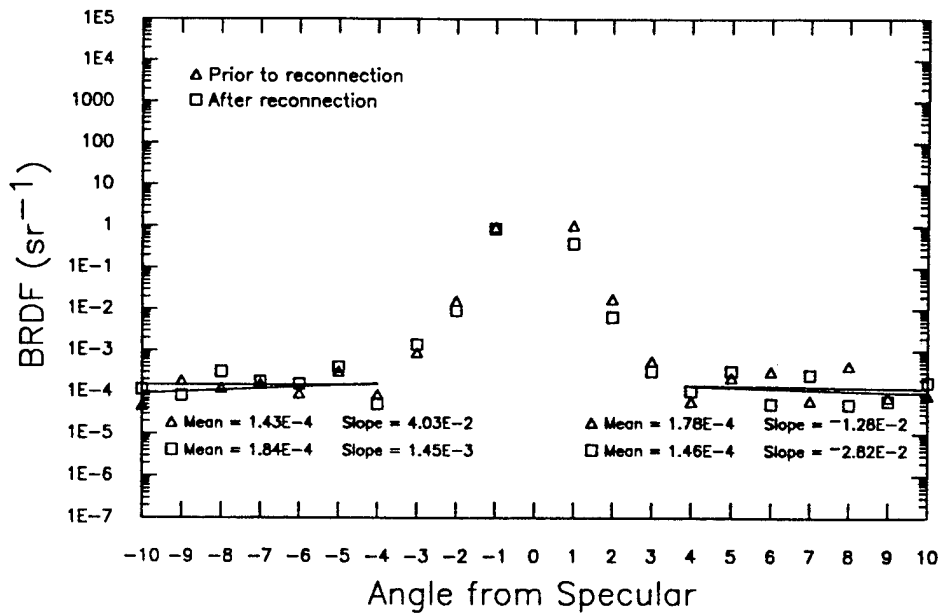
FIGURE 28. BRDF MEASUREMENTS ON MIRROR RI 94 FROM FULLY ASSEMBLED CRYOSCAT SYSTEM.

Figure 28 presents data taken on RI 94 (center) before and after reconnecting CRYOSCAT to the vacuum chamber. A mean value is calculated and presented for each scan on both sides of specular. The range of data used for this calculation is ± 4 to 10 degrees. The lines drawn through the data plots represent the first order regression to determine the slope of the plots.

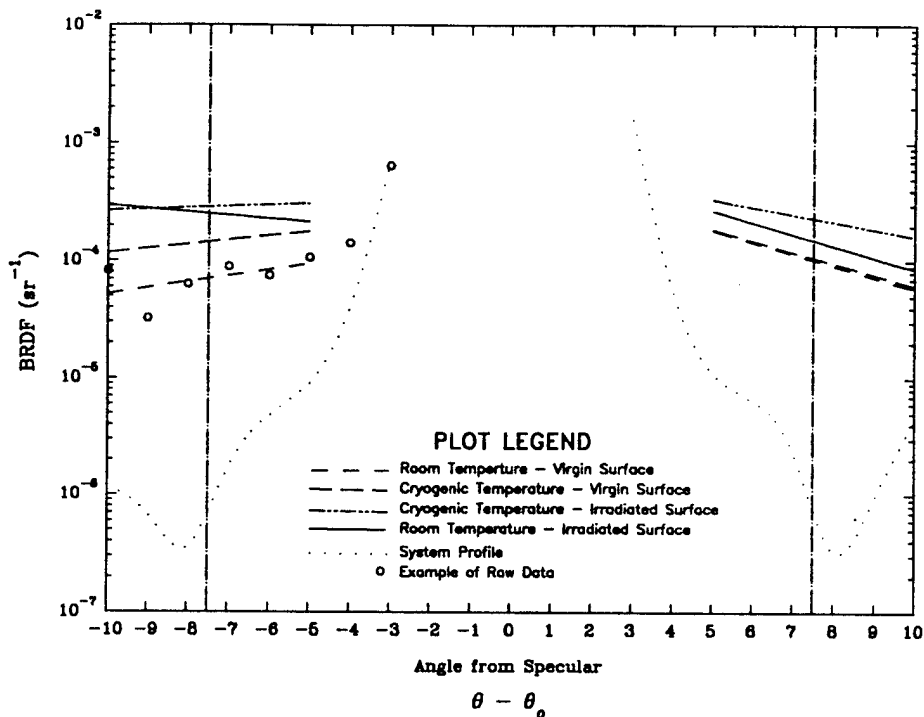
FIGURE 30. BRDF MEASUREMENTS ON MIRROR Be O50-01 AT SITE A (0.17 cal/cm² e-BEAM IRRADIATION).

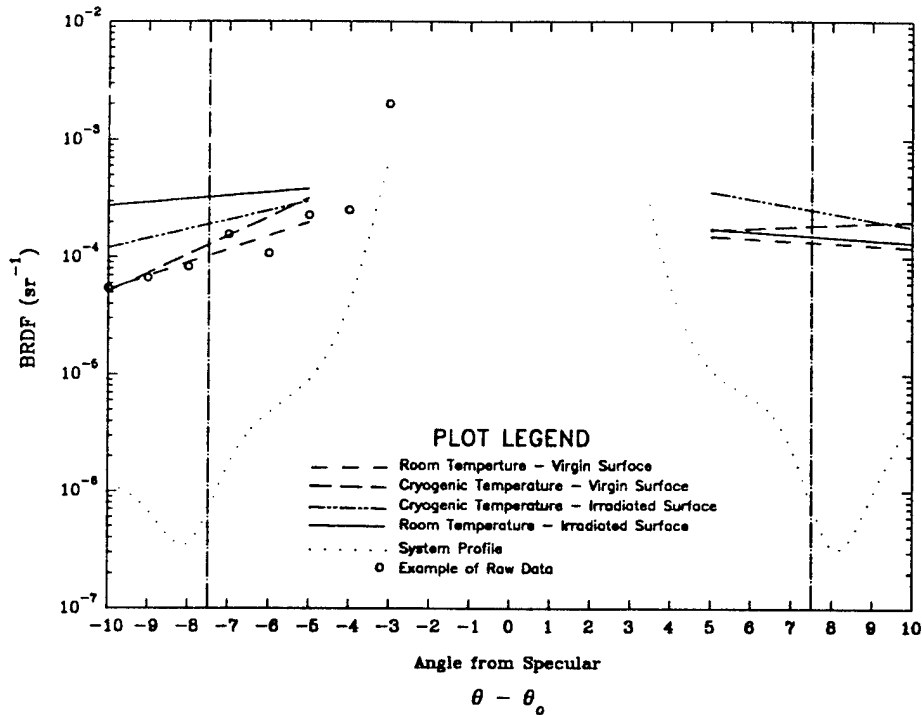
FIGURE 31. BRDF MEASUREMENTS OF MIRROR Be O50-01 AT SITE B (0.28 cal/cm² e-BEAM IRRADIATION).

Site B was irradiated by a higher fluence of 0.28 cal/cm^2 . Figure 31 presents the BRDF plots; data at $\pm 7.5^\circ$ scattering angle is presented in Table 3. This fluence produced similar response as at 0.17 cal/cm^2 , while the mirror remained cold. Backscatter response was 0.50, while forward scatter response was 0.38. After warming to room temperature, there is an overall response of 2.18 on the backscatter side of specular and an overall response of 0.13 on the forward scatter side.

This mirror responded very similarly to both fluence levels. The response of the mirror, while cold, to both fluence levels was a small increase in scatter on both sides of specular. After warming, however, a marked increase in scatter on the backscatter side of specular was observed for both fluence levels, while forward scatter remained virtually unchanged after irradiation and thermal cycling.

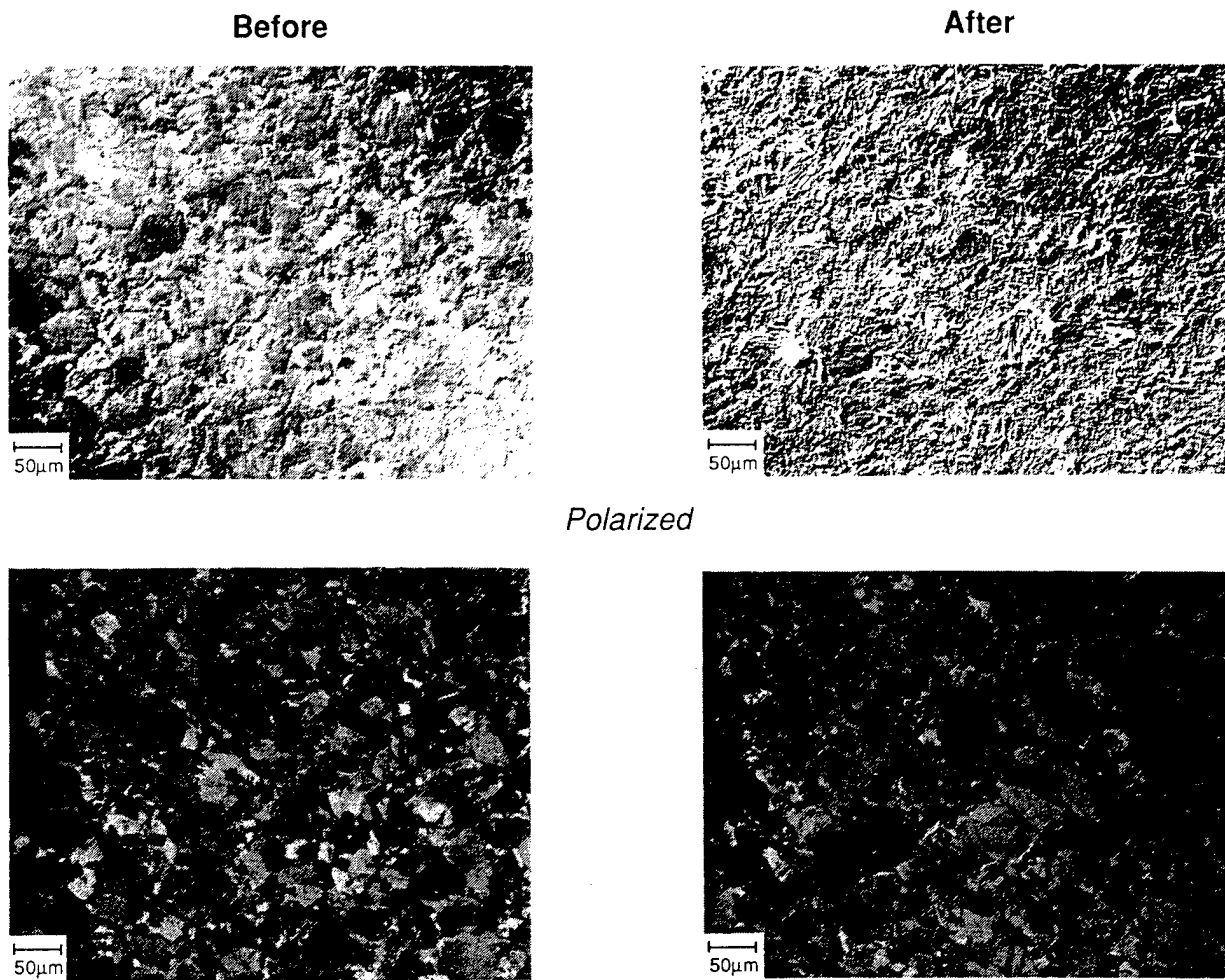
FIGURE 33. NOMARSKI PHOTOMICROGRAPHS OF MIRROR Be O50-01 AT SITE B (0.28 cal/cm² e-BEAM FLUENCE).

After the test was completed, the mirror was removed from the test chamber and Nomarski photomicrographs were taken of the two test sites again. These photomicrographs are presented along side the virgin surface photomicrographs in Figures 32 and 33. The observed physical change in the surface of the mirror appears to be roughly proportional to the fluence

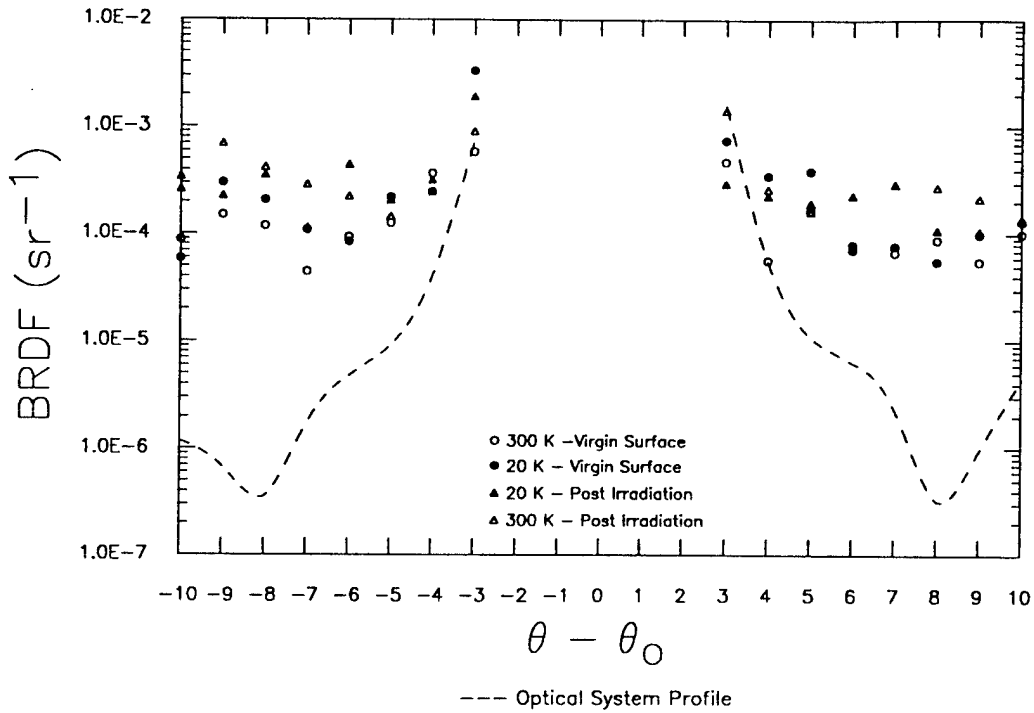
FIGURE 34. BRDF MEASUREMENTS OF MIRROR Be O50-04 AT SITE A (0.28 cal/cm² e-BEAM FLUENCE).

The mirror's response to 0.28 cal/cm^2 , while cold, was found to be 0.75 (backscatter) and 0.56 (forward scatter). The overall response of the mirror due to 0.28 cal/cm^2 and thermal cycling was measured to be 2.24 (backscatter) and 1.02 (forward scatter). While the mirror remained cold, the response due to e-beam alone produced a small increase in scatter on both sides of specular. After warming the mirror to room temperature, there was an overall increase in scatter of 2.24 on the backscatter side of specular, and forward scatter showed an increase of 1.02. This compares well to the response observed on Be O50-01 - Site B, which was irradiated by the same fluence level. This time there was a noted overall increase in forward scatter which was not observed previously.

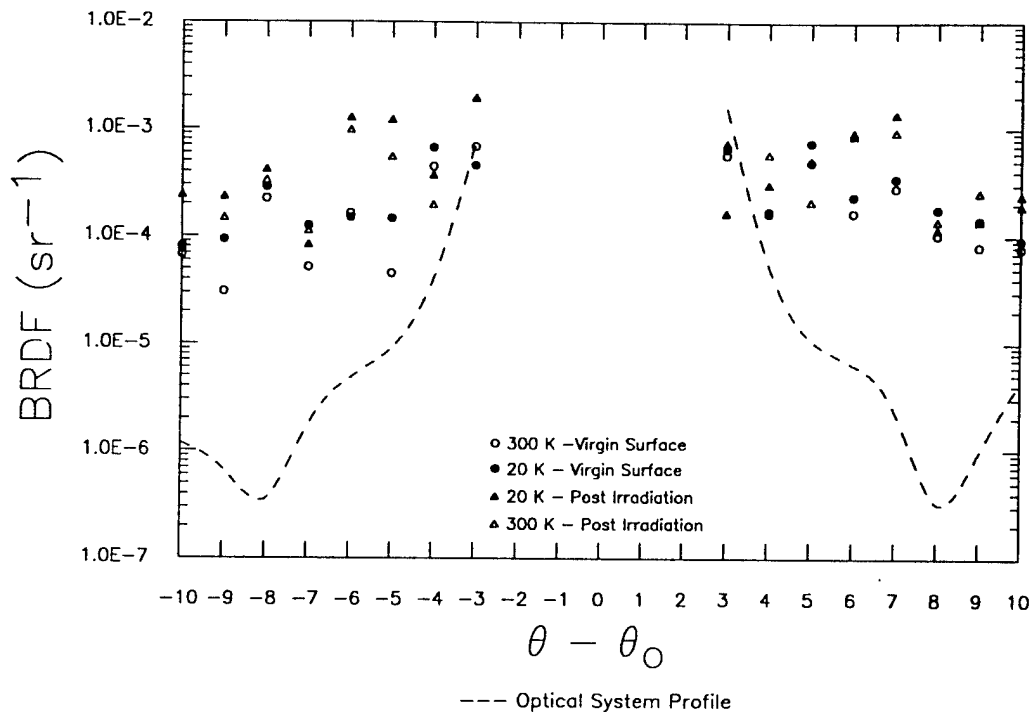
FIGURE 35. BRDF MEASUREMENTS OF MIRROR Be O50-04 AT SITE B (0.45 cal/cm² e-BEAM FLUENCE).

Site B was irradiated by a higher fluence of 0.45 cal/cm^2 . Figure 35 presents BRDF plots and the data are presented in Table 4. This fluence produced slightly higher response levels while the mirror remained cold. Backscatter response was 1.81 while forward scatter response

This mirror responded similarly to both fluence levels, although the higher 0.45 cal/cm² fluence produced a greater cold response in the backscatter direction. The response of the mirror, while cold, to 0.28 cal/cm² was a small increase in scatter on both sides of specular, which compares well to the results of Be O50-01 - Site B. After warming, however, a marked increase in scatter on the backscatter side of specular was observed for both fluence levels, while forward scatter was only slightly increased as a result of irradiation and thermal cycling.

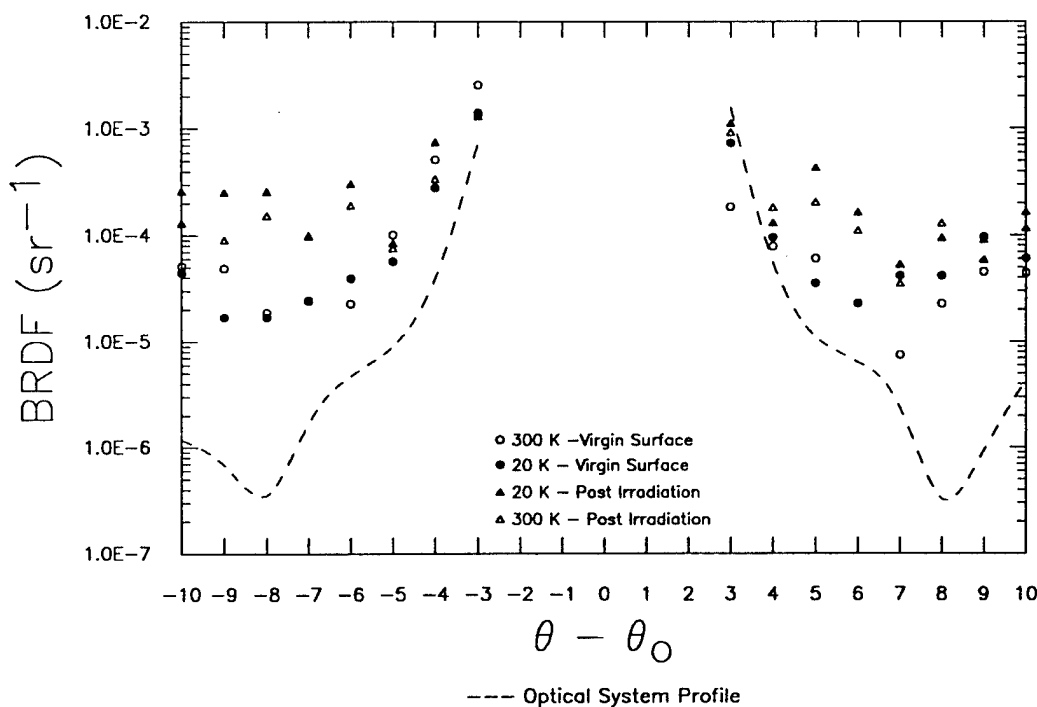
FIGURE 40. BRDF MEASUREMENTS OF MIRROR POCT 56-W1-M1-1 AT SITE C (0.45 cal/cm^2).

The overall and cold backscatter response increased with increased fluence. The forward scatter response (cold and overall) also increased with fluence up to 0.33 cal/cm^2 . After that, the response dropped as fluence increased to 0.45 cal/cm^2 , showing an overall increase favoring backscatter, as observed with the other mirrors tested and described above.

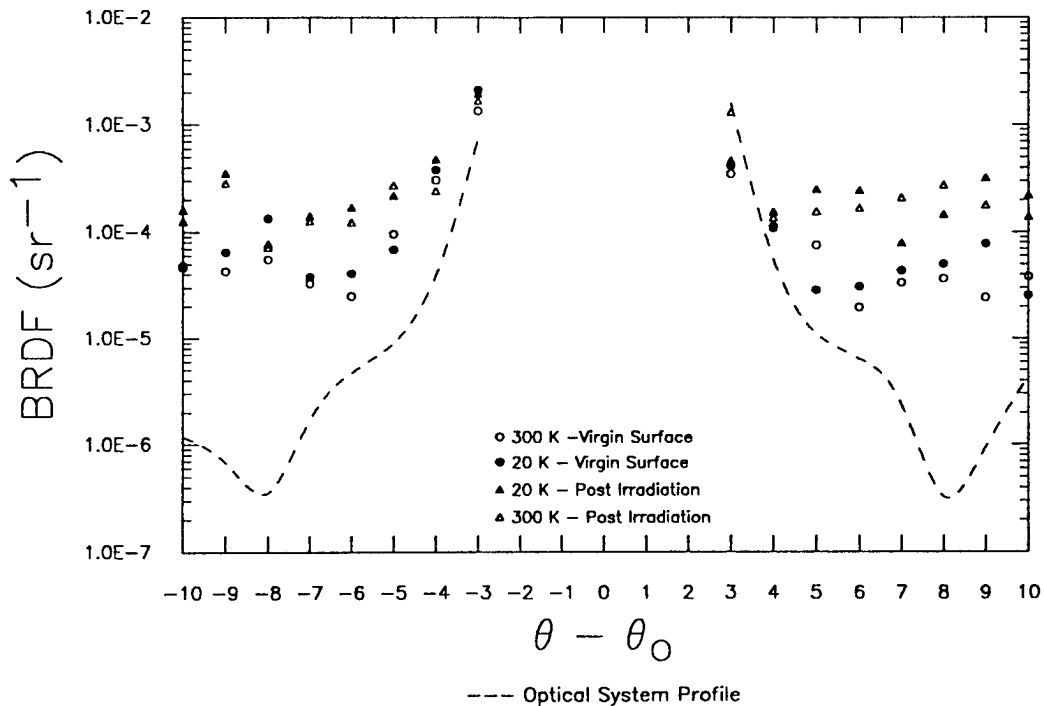
FIGURE 41. BRDF MEASUREMENTS OF MIRROR POCT 56-W1-M1-1 AT SITE D (central position receiving only indirect e-beam irradiation).

Site D (center) was not irradiated but was measured at each stage of the experiment. The close proximity of Site D to the other three sites suggests that residual effects may be observed as a result of the irradiation of those sites. Figure 41 shows the BRDF plots measured at Site D and Table 5 presents response data. Cold response to the indirect irradiation of the center of the mirror was 1.85 (backscatter) and 3.52 (forward scatter). Overall response was 2.29 (backscatter) and 4.73 (forward scatter). The center position of the mirror shows a significant increase in cold and overall scatter on both sides of specular. Forward scatter is greater than backscatter in this case. The type(s) of damage effecting scatter at this site are the result of three irradiations within close proximity of the site, rather than direct irradiation of a specific fluence.
