Annual Technical Progress Report:
**E-BEAM TESTING AND
EVALUATION OF
SUPERPOLISHED HIGH
QUALITY DEVELOPMENTAL
MIRRORS**

Covering the Period:
21 November 1989 - 21 November 1990

Submitted Under:
Contract No. DASG60-90-C-0002

Corporate Author or Publisher: Spire Corporation, Bedford, MA 01730

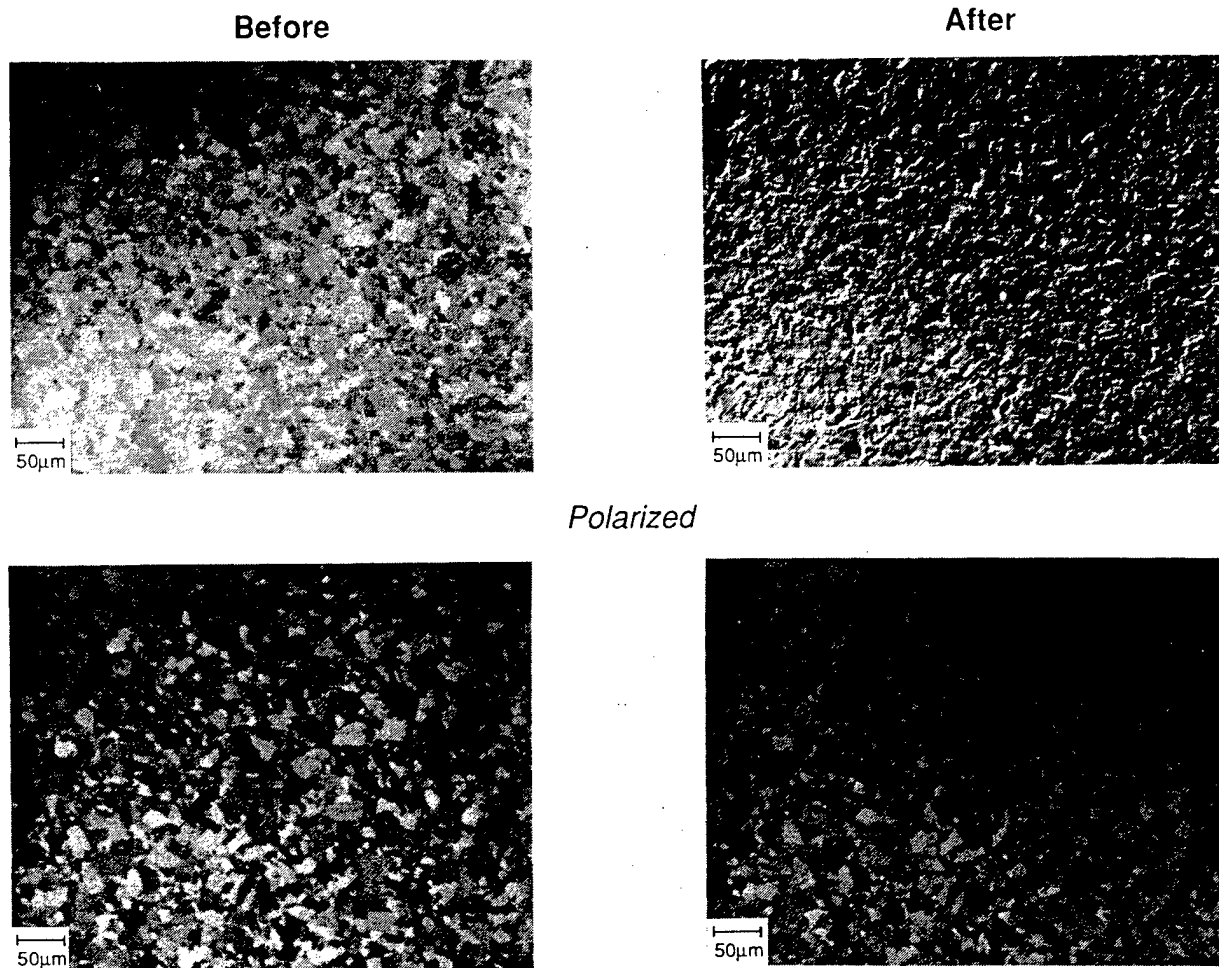
FIGURE 42. NOMARSKI PHOTOMICROGRAPH OF MIRROR POCT 56-W1-M1-1 AT SITE A (0.27 cal/cm²).

After the test was completed, the mirror was removed from the test chamber and Nomarski photomicrographs were taken of all test sites. These photomicrographs are presented alongside the virgin surface photomicrographs in Figures 42 through 45. The observed physical change on the mirror surface appears to be proportional to the e-beam irradiation fluence levels. The center position (Site D) shows little or no visible damage in the photomicrographs.

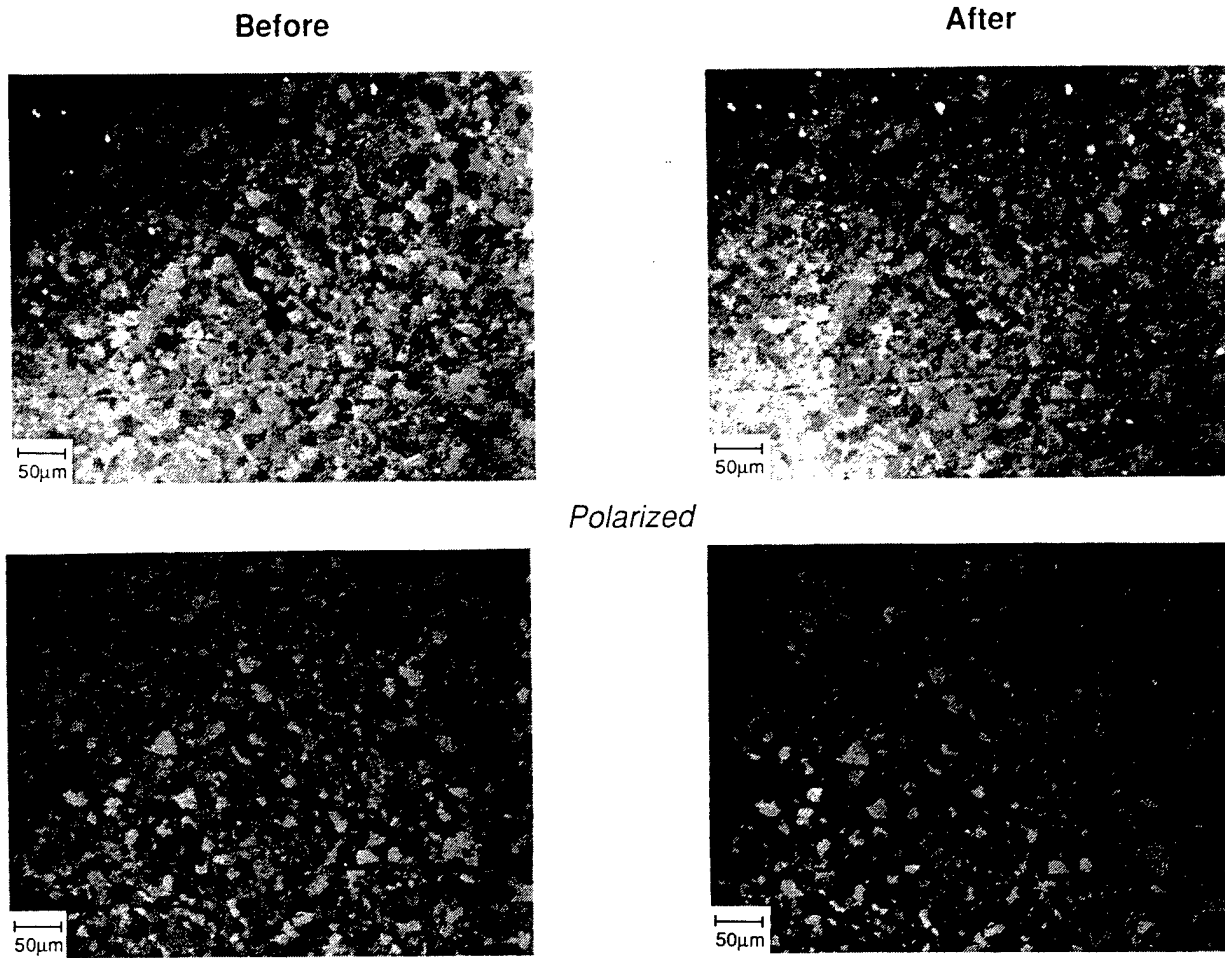
FIGURE 45. NOMARSKI PHOTOMICROGRAPH OF MIRROR POCT 56-W1-M1-1 AT SITE D (central position, no direct e-beam irradiation).

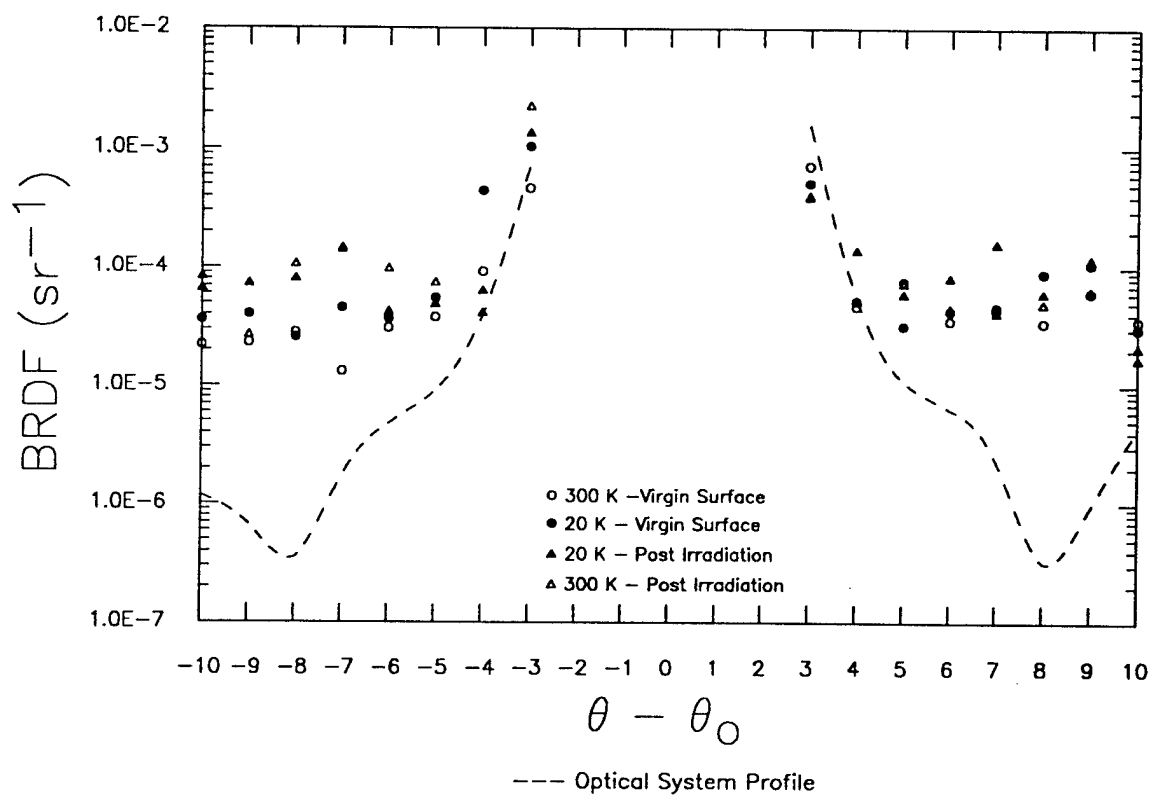
FIGURE 46. BRDF MEASUREMENTS ON MIRROR POCT 2V-A-67-A AT SITE A (0.27 cal/cm²).

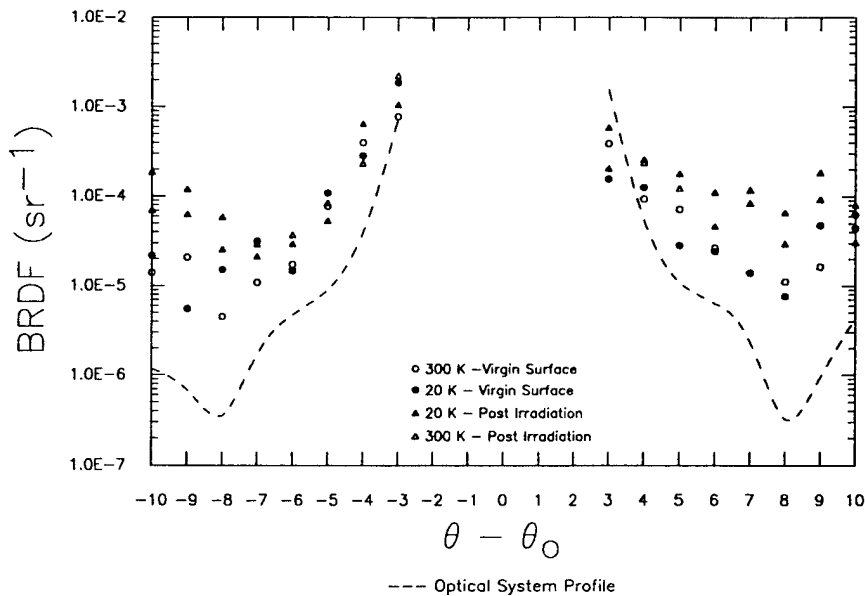
FIGURE 47. BRDF MEASUREMENTS ON MIRROR POCT 2V-A-67-A AT SITE B (0.37 cal/cm²).

Site B was irradiated by a higher fluence of 0.37 cal/cm^2 . Figure 47 shows BRDF plots and response data is presented in Table 6. This fluence produced significantly higher response levels while the mirror remained cold. Backscatter response was 1.19 while forward scatter response was 3.09. After warming the mirror to room temperature, there was an overall response of 2.63 on the backscatter side of specular and an overall response of 1.74 on the forward scatter side.

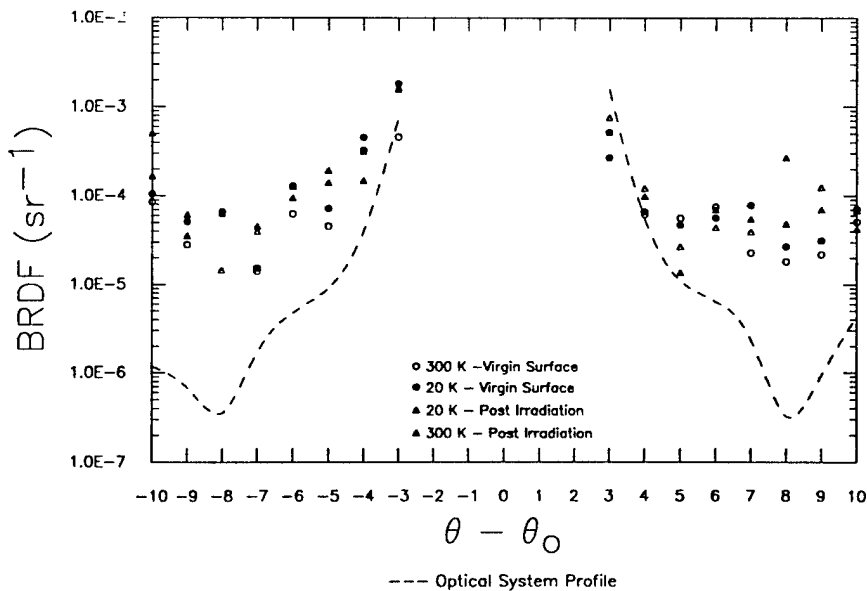
FIGURE 48. BRDF MEASUREMENTS ON MIRROR POCT 2V-A-67-A AT SITE C (0.45 cal/cm²).

Site C was irradiated by a still higher fluence of 0.45 cal/cm². Figure 48 presents the BRDF plots and response data is presented in Table 6. While the mirror remained cold, backscatter response was 0.70 while forward scatter response was 0.33. After warming the mirror to room temperature, there was an overall response of 0.53 on the backscatter side of specular and an overall response of 0.35 on the forward scatter side.

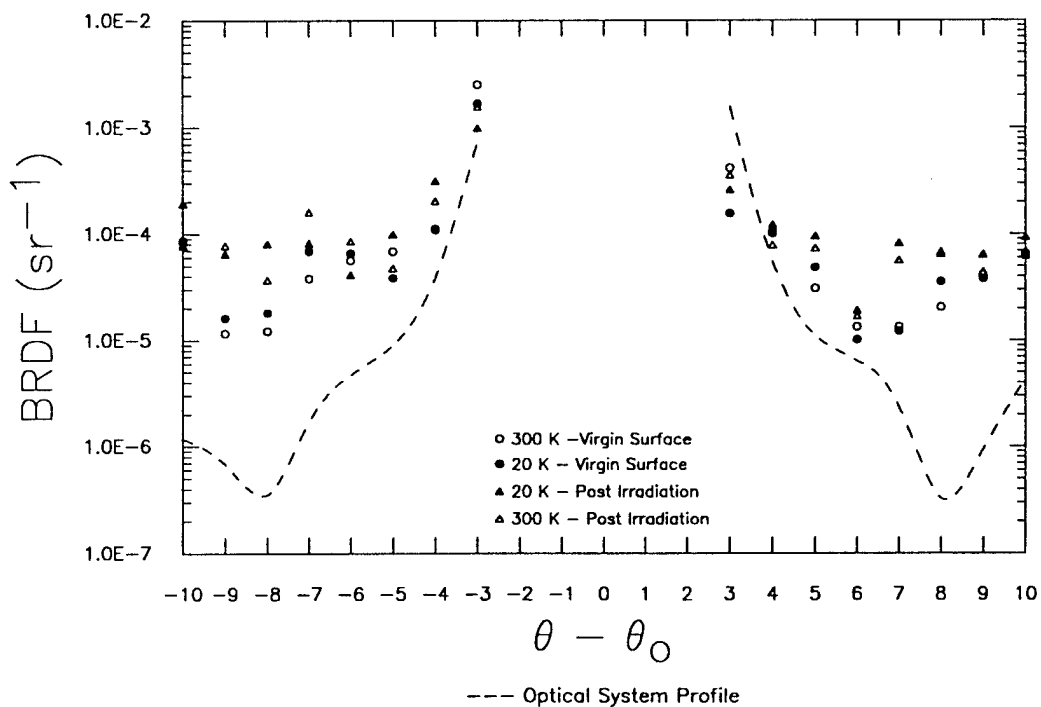
FIGURE 49. BRDF MEASUREMENTS ON MIRROR POCT 2V-A-67-A AT SITE D (central position, no direct irradiation).

Site D (center) was not irradiated but was measured at each stage of the experiment. Figure 49 shows BRDF plots measured at Site D and Table 6 presents response data. Cold response to indirect irradiation at the center of the mirror was 1.07 (backscatter) and 1.08 (forward scatter). Overall response was 1.07 (backscatter) and 0.99 (forward scatter). The center position of the mirror shows a minor increase in scatter on both sides of specular both while cold and overall. Neither forward scatter nor backscatter is favored in this case.

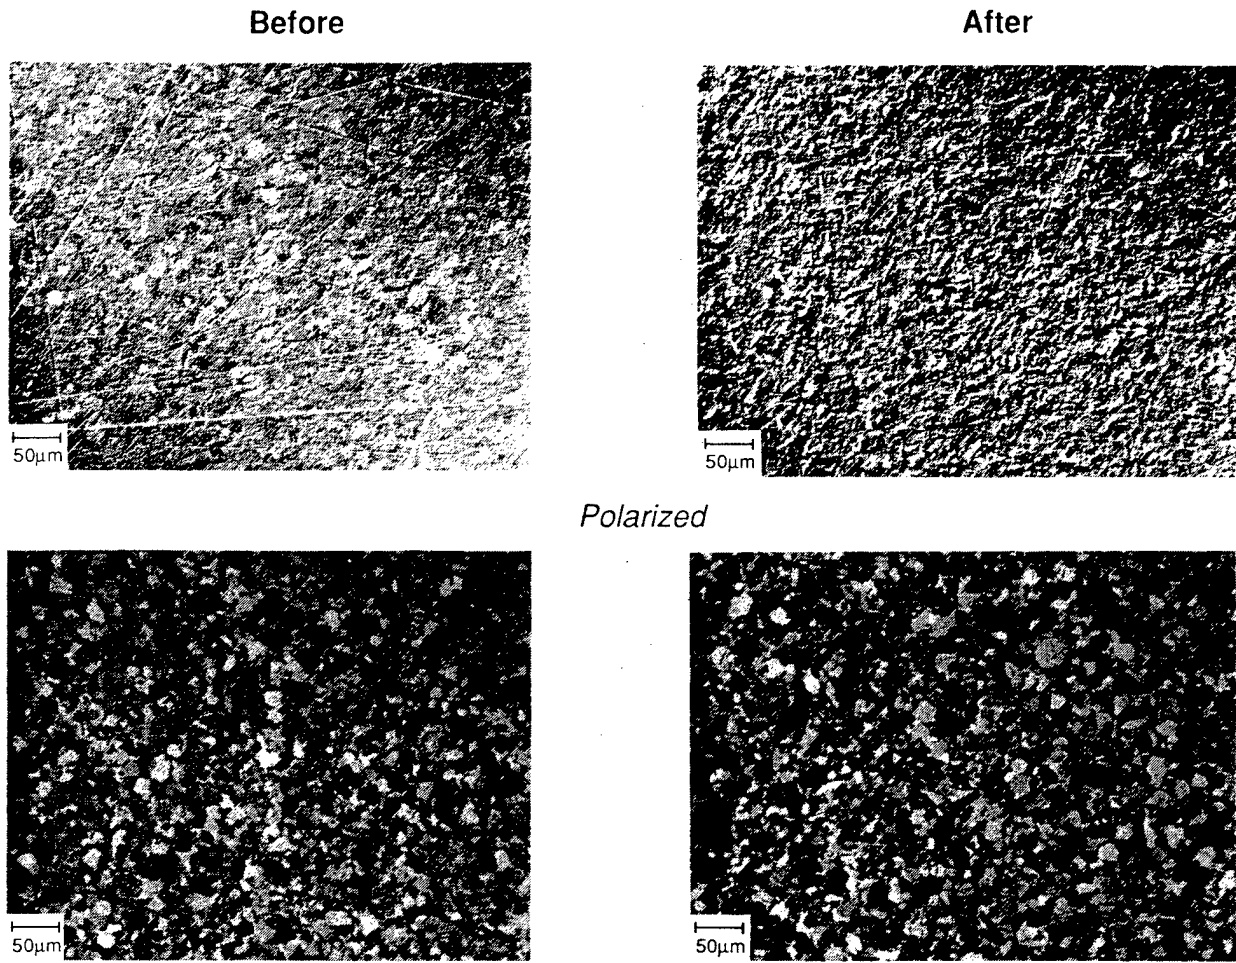
FIGURE 52. NOMARSKI PHOTOMICROGRAPHS OF MIRROR POCT 2V-A-67-A AT SITE C (0.45 cal/cm²).

After the test was completed, the mirror was removed from the test chamber and Nomarski photomicrographs were taken of two test sites. These photomicrographs are presented along side the virgin surface photomicrographs in Figures 50 through 53. The observed physical change in the surface of the mirror appears to be proportional to the fluence levels used to irradiate it. The center position (Site D) shows some damage in the photomicrographs.

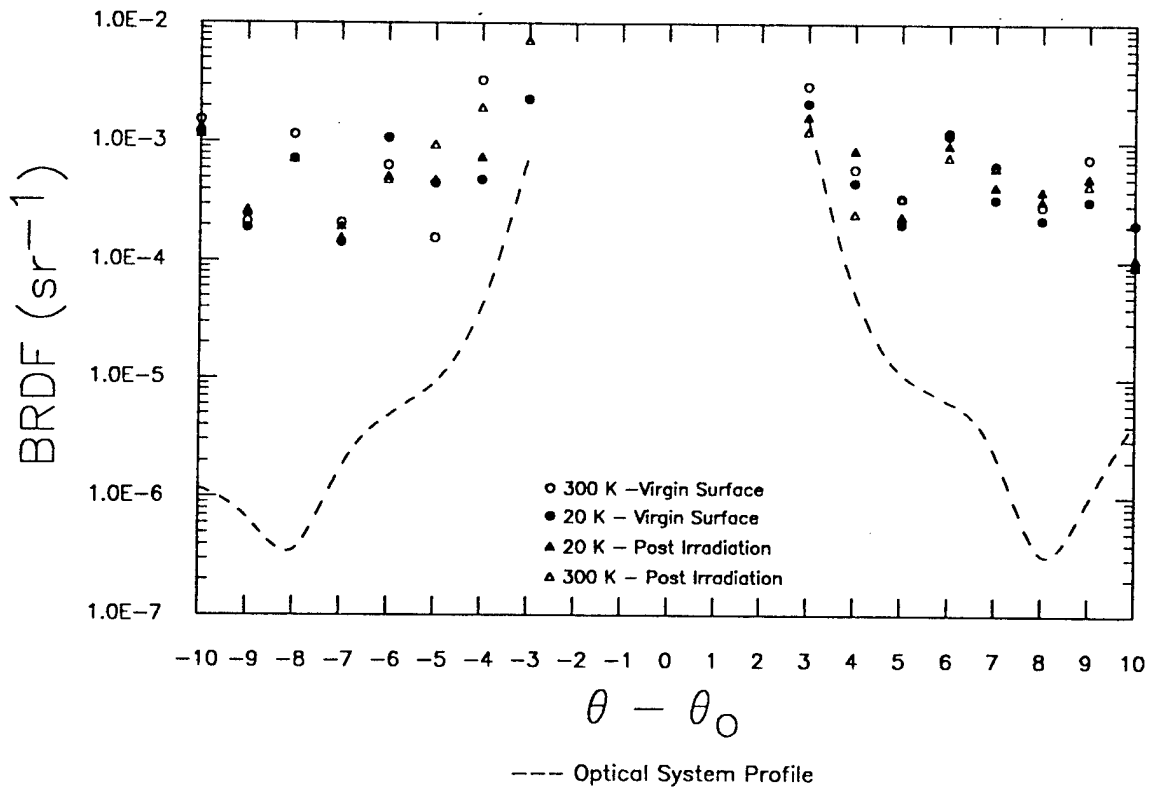
FIGURE 54. BRDF MEASUREMENTS ON MIRROR POCT 56-W1-M1-2 AT SITE A (0.27 cal/cm²).

The mirror's response to 0.27 cal/cm^2 , while cold, was measured to be 0.01 (backscatter) and 0.06 (forward scatter). The overall response of the mirror due to 0.27 cal/cm^2 and thermal cycling was measured to be 0.12 (backscatter) and -0.11 (forward scatter). The response due to e-beam irradiation alone and the overall response produced negligible change scatter for both directions. These small numbers (± 0.30) are considered to be within the reproducibility of the system and are considered to represent no measurable change.

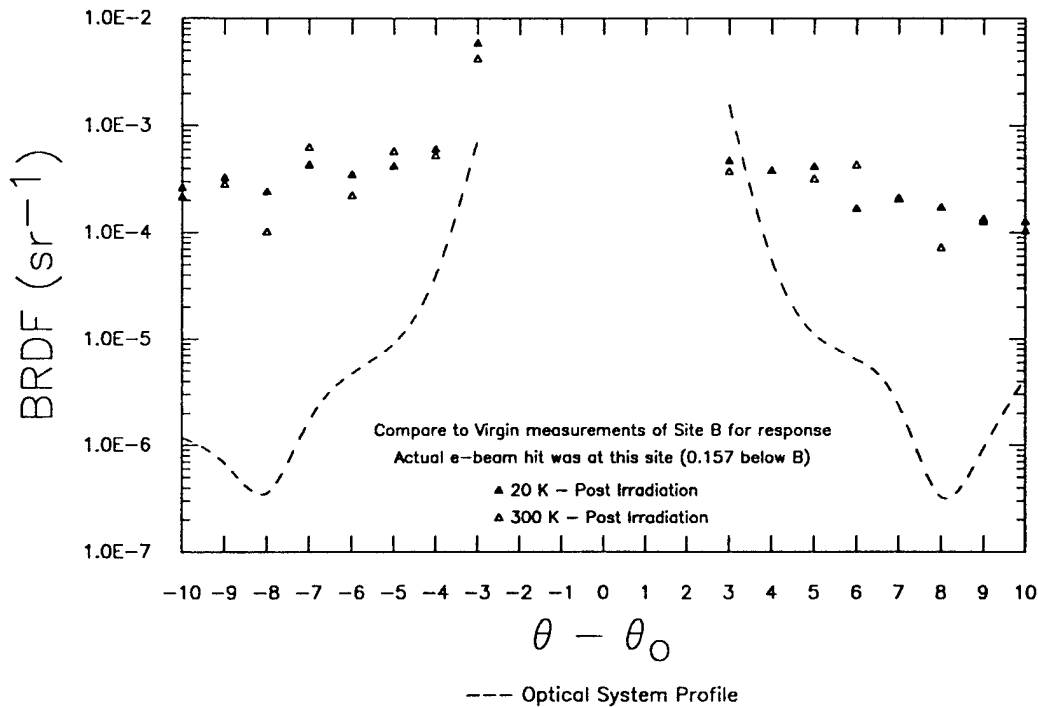
FIGURE 55. BRDF MEASUREMENTS ON MIRROR POCT 56-W1-M1-2 AT SITE B (0.37 cal/cm^2).

Site B was irradiated by a higher fluence of 0.37 cal/cm^2 . Figure 55 presents the BRDF plots and response data is presented in Table 7. This fluence produced noticeably higher response in the forward scatter direction while the mirror remained cold. Cold backscatter response was 0.36 while forward scatter response was 1.14. After warming the mirror to room temperature, there was an overall response of 0.44 on the backscatter side of specular and an overall response of 0.25 on the forward scatter side.

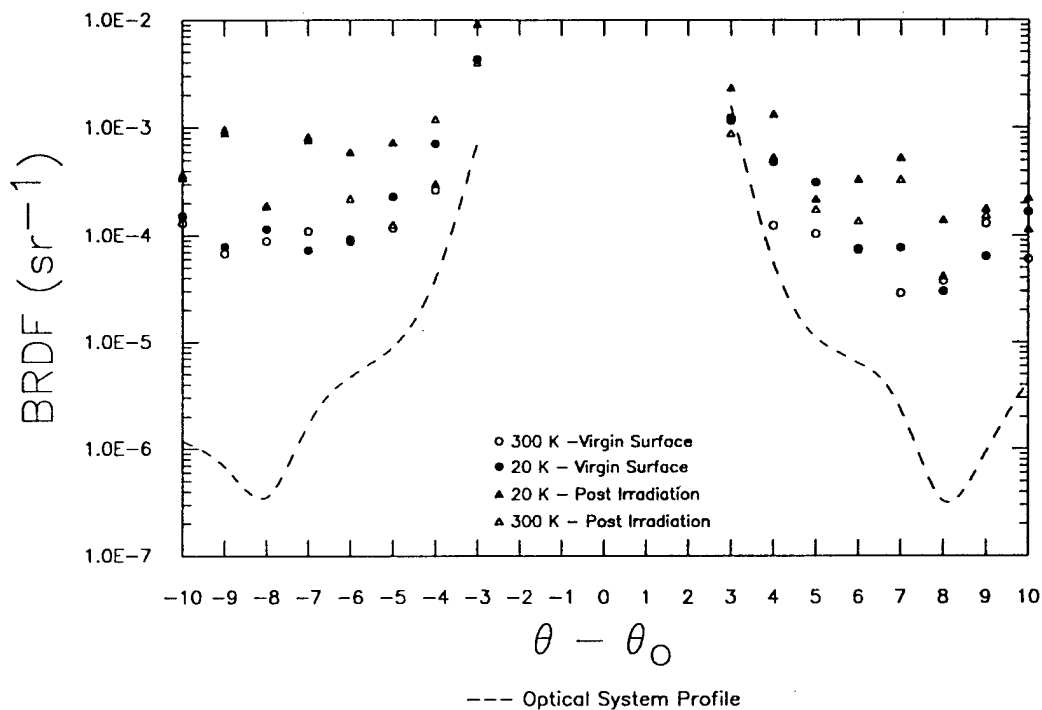
FIGURE 56. BRDF MEASUREMENTS ON MIRROR POCT 56-W1-M1-2 AT SITE C (0.45 cal/cm²).

Site C was irradiated by a higher fluence of 0.45 cal/cm^2 . Figure 56 shows BRDF plots and response data is presented in Table 7. While the mirror remained cold, backscatter response was 3.60 and forward scatter response was 1.69. After warming the mirror to room temperature, there was an overall response of 2.44 on the backscatter side of specular and an overall response of 1.14 on the forward scatter side.

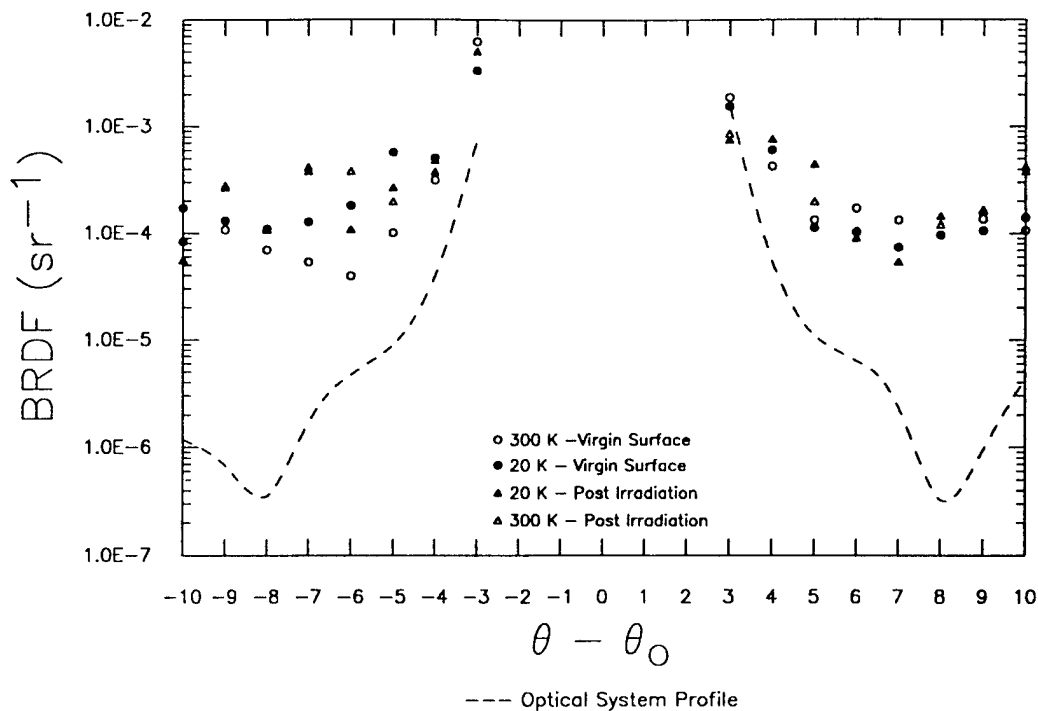
FIGURE 57. BRDF MEASUREMENTS ON MIRROR POCT 56-W1-M1-2 AT SITE D (center of mirror, no direct irradiation).

Site D (center) was not irradiated but was measured at each stage of the experiment. The close proximity of Site D to the other three sites means that there will be residual effects observed as a result of the irradiation of those sites. Figure 57 shows the BRDF plots measured at Site D and Table 7 presents response data. Cold response to the indirect irradiation of the center of the mirror was -0.02 (backscatter) and 0.61 (forward scatter). Overall response was 1.68 (backscatter) and 0.19 (forward scatter). The center position of the mirror showed negligible change in scatter on both sides of specular both while cold and overall for forward scatter. Overall backscatter increased by a notable amount. The damage affecting scatter at this site is the result of three irradiations within close proximity of the site, rather than direct e-beam irradiation.

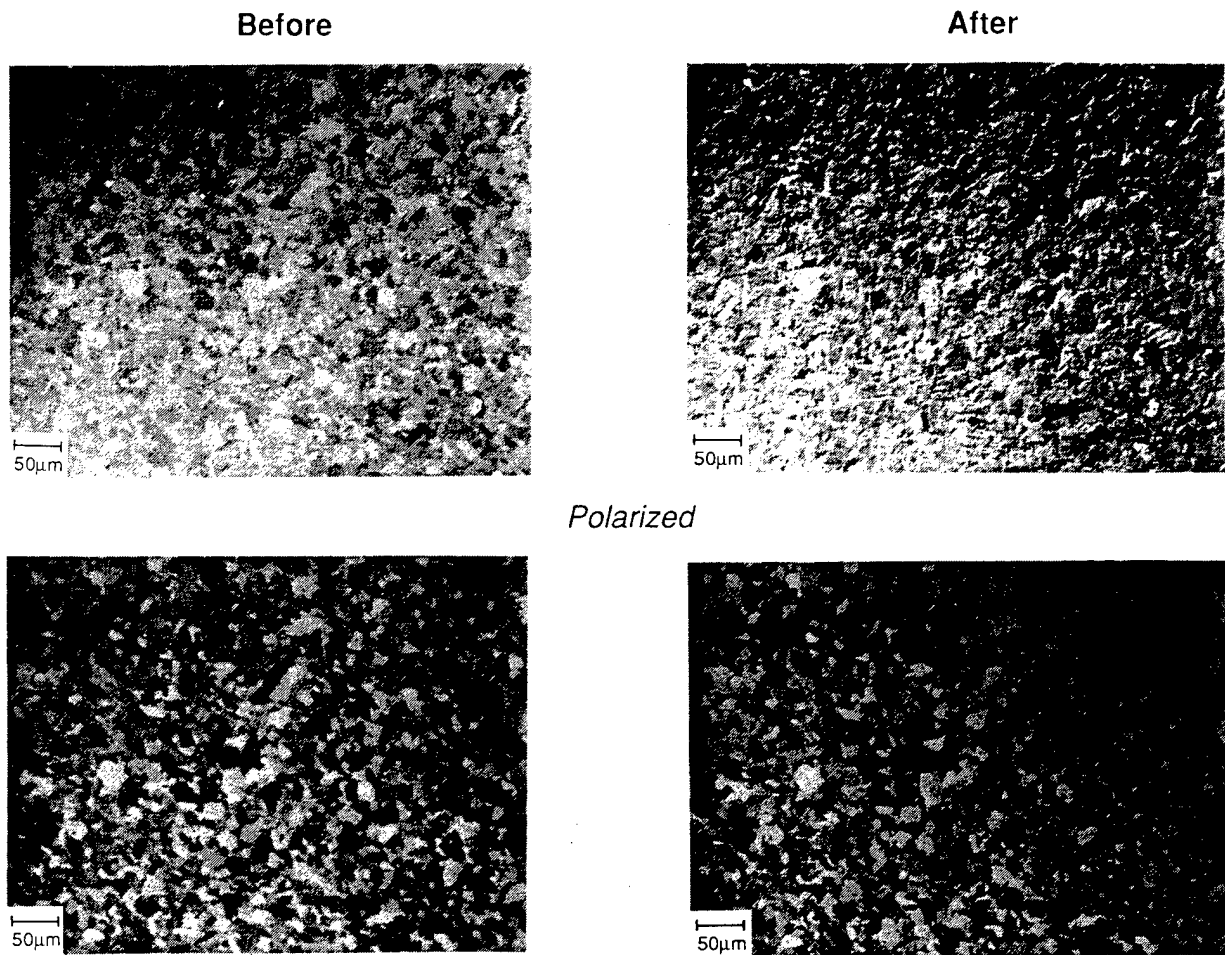
FIGURE 58. NOMARSKI PHOTOMICROGRAPHS OF MIRROR POCT 2V-A-67-A AT SITE A (0.27 cal/cm^2).

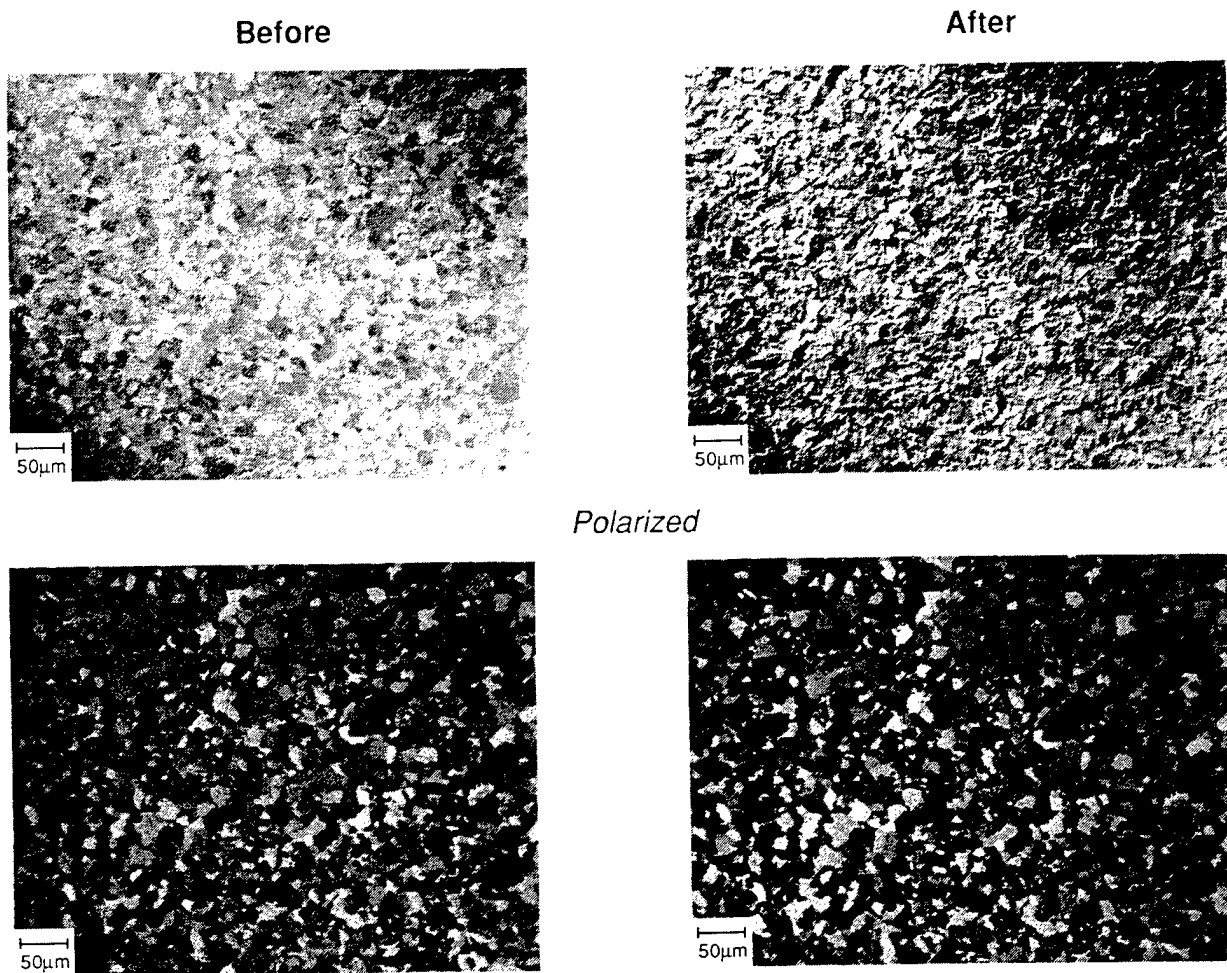
FIGURE 59. NOMARSKI PHOTOMICROGRAPHS OF MIRROR POCT 2V-A-67-A AT SITE B (0.37 cal/cm^2).

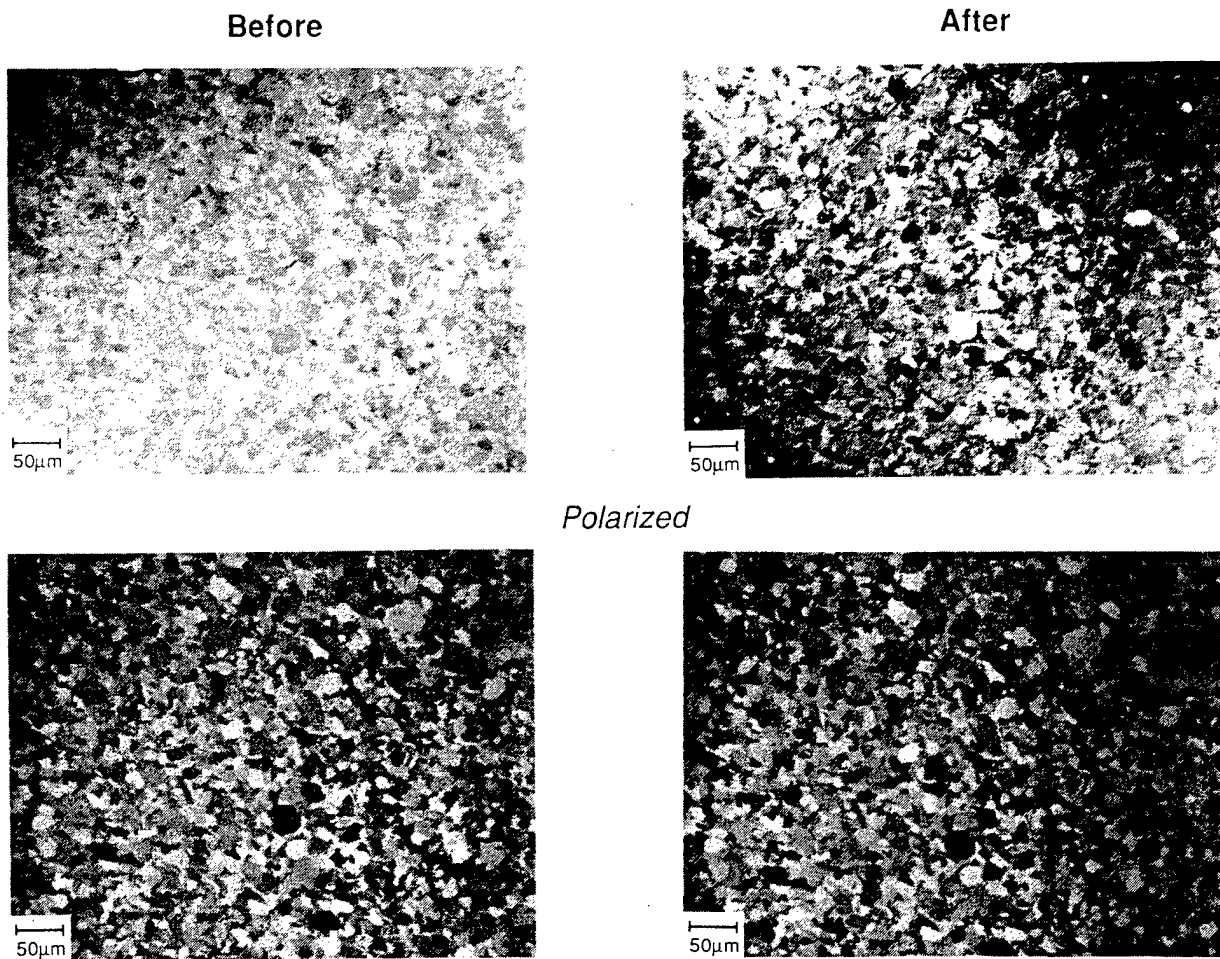
FIGURE 61. NOMARSKI PHOTOMICROGRAPHS OF MIRROR POCT 2V-A-67-A AT SITE D (center of mirror, no direct irradiation).

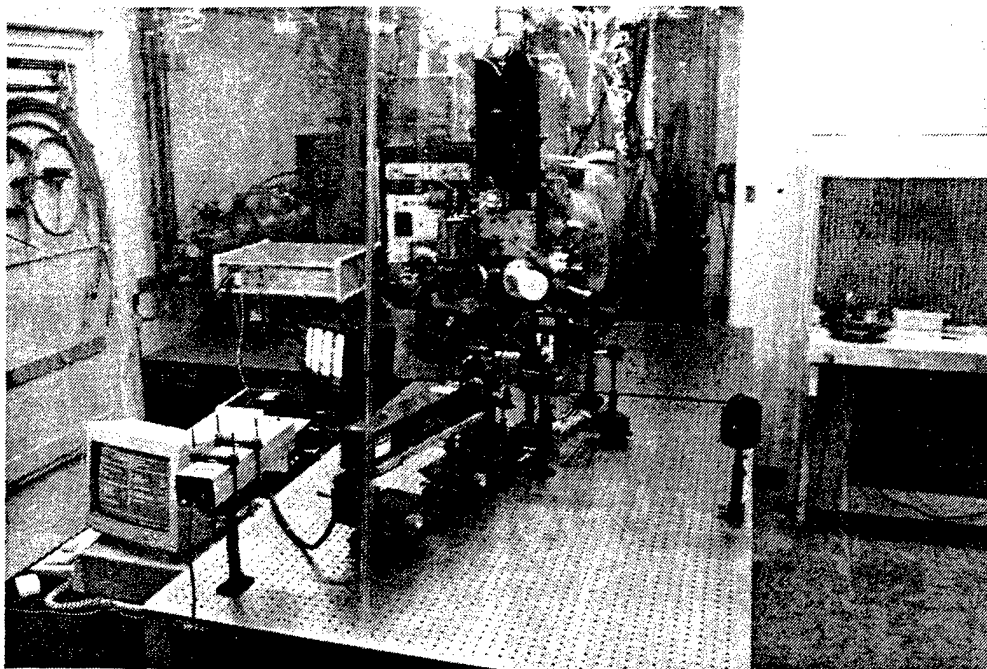
FIGURE 62. NEW SYSTEM COMPONENTS.
