ORNL/TM-10468

**OAK RIDGE  
NATIONAL  
LABORATORY**

## Analysis of Adhesion Test Methods and the Evaluation of Their Use for Ion-beam-mixed Metal/Ceramic Systems

CERAMIC TECHNOLOGY FOR  
ADVANCED HEAT ENGINES

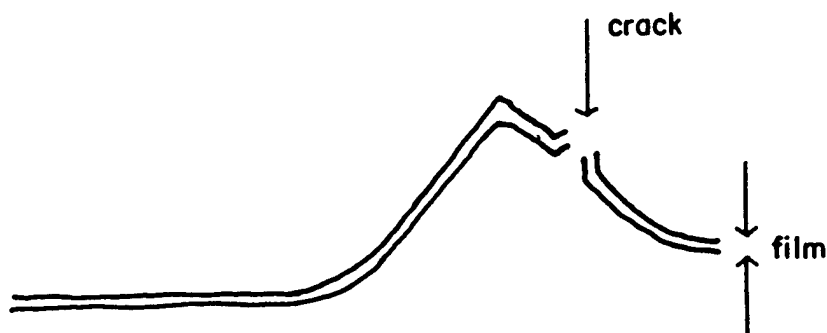
Fig. 7. Height profile across the end of the channel showing the crack formed ahead of the stylus. Scratching is from left to right. Source: Je, J. H., Gyarmati, E., and Naoumidis, A., "Scratch Adhesion Test of Reactively Sputtered TiN Coatings on a Soft Substrate," *Thin Solid Films* 136 (1986) 57.

Other researchers<sup>6,8</sup> also found that the edges of the channel were subjected to gross plastic deformation and that high walls developed. Extensive elastic recovery followed the passage of the stylus, and this may explain why the scratches were wider and shallower than the stylus geometry would indicate.<sup>8</sup> A typical scratch profile is shown in Fig. 5. Cracking of the coating at the lip of the channel,<sup>8,13</sup> as well as flaking of the coating ahead of the stylus,<sup>10</sup> has been noted. Detached fragments were pressed back onto the substrate in several cases.<sup>10,11</sup> Micrographs from the work of Je, Gyarmati, and Naoumidis<sup>11</sup> clearly show cracking ahead of the moving stylus (Fig. 6); a profile of the end revealed that the crack was not formed by bending (Fig. 7).

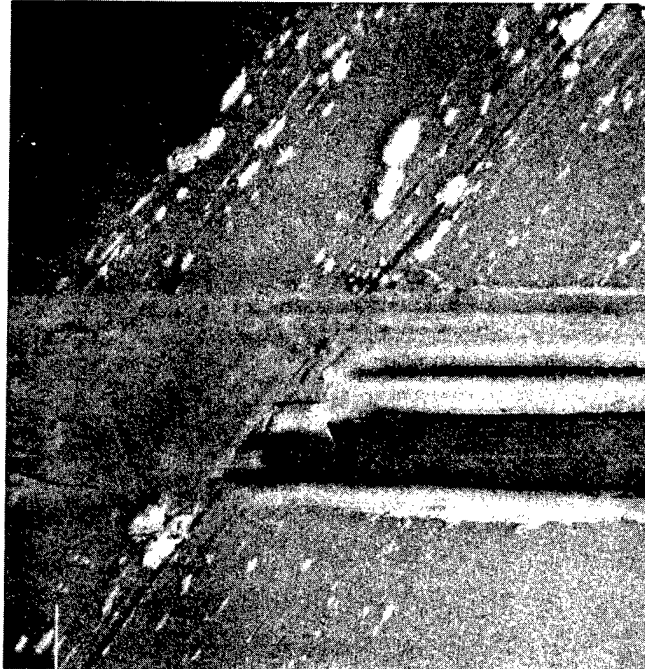
YP4804

Fig. 21. Effect of surface flaw on scratching of zirconium/sapphire system. Scratch direction is from left to right. Scanning electron metallograph. 1600X.

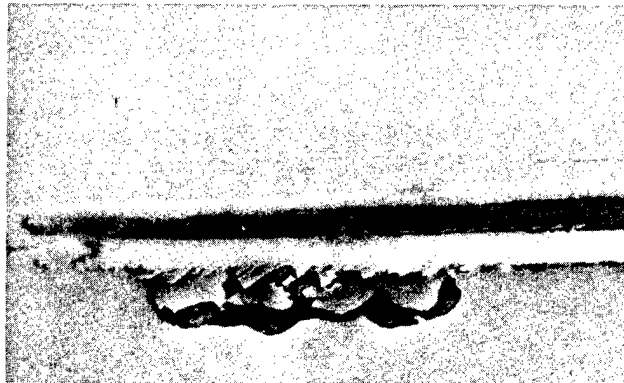
(a) Scanning electron micrograph. 1600X.

(b) Scanning electron micrograph. 1700X.

Fig. 25. Two regions of compressive failure caused by a 450-g normal load scratch on a zirconium/sapphire specimen. Scratch direction is from left to right.

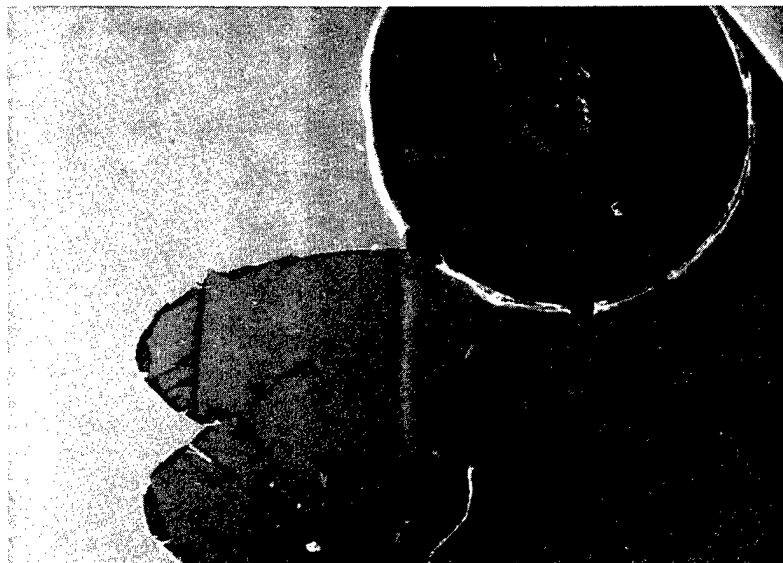
YP4807

Fig. 34. Zirconium on silicon carbide specimen surface, ion-beam mixed to a dose of  $2.0 \times 10^{16}$  ions/cm<sup>2</sup>. Scanning electron micrograph. 20X.

The interpretation of these pictures is as follows. The adhesion of the additional 500-nm zirconium to the original 30-nm zirconium was very good. However, large tensile stresses were developed in the additional layer during growth and cooling. The same stresses were present throughout the length of the specimens but had a different effect in the various regions because of differences in adhesion of the original layer. In areas that had not been ion beam mixed, the internal stresses were sufficient to cause de-adhesion of the entire 530-nm film. In regions that had been ion beam mixed, the adhesion of the original 30-nm film was generally adequate to prevent the film from de-adhering and curling up, especially at the higher doses. Only very small regions of de-adhesion are visible in the mixed films, and these are fewer in the higher-dosed region.

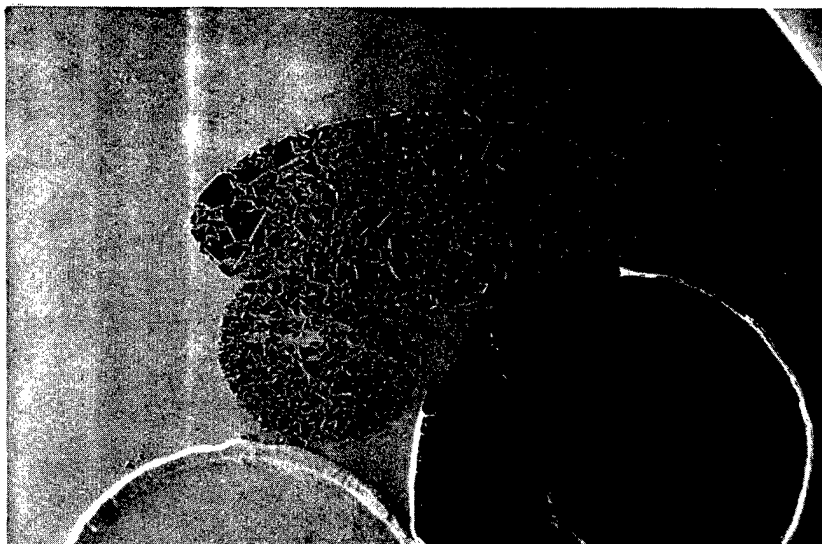
YP4809

Fig. 36. Zirconium (515 nm) on silicon nitride specimen surface in mixed region. Scanning electron micrograph. 20X.
