ORNL/Sub/84-47992/1

**High Temperature Coating Study  
to Reduce Contact Stress  
Damage of Ceramics**

**Final Report**

Prepared by  
Garrett Turbine Engine Company  
A Division of Garrett Corporation  
2739 East Washington Street  
P.O. Box 5217  
Phoenix, Arizona 85010  
Under Subcontract 86X-47992C

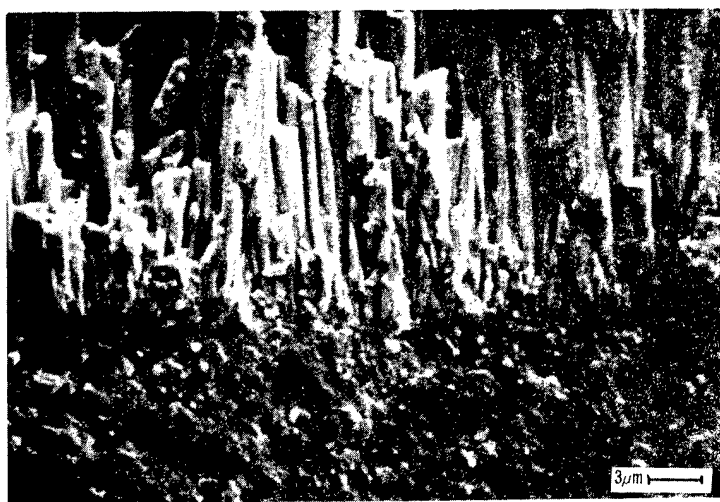
←  $\text{ZrO}_2$  COATING

← AS-MACHINED RBSN  
SUBSTRATE

← HEAVILY-PREOXIDIZED  
RBSN SUBSTRATE

← RBSN SUBSTRATE  
WITH SI INTERLAYER

Figure 5. As-coated zirconia remained adherent to RBSN substrates with various pretreatments through flexure testing.
