## HYDRIDING OF TITANIUM

Second Annual Report (1997)

Contract No. N00014-96-1-0272

Submitted by  
Clyde L. Briant, K. Sharvan Kumar, and Zhengfu Wang  
Division of Engineering  
Brown University  
Providence, RI 02912

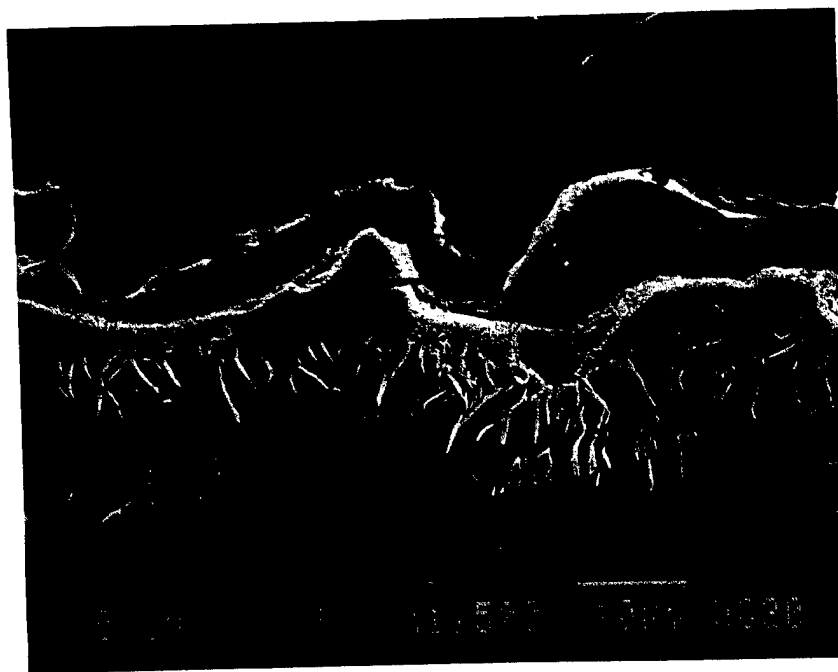
Figure 47 - Typical appearance of the fracture surface for grade 2 titanium at a potential of  $-700 \text{ mV}_{\text{SCE}}$ , showing slip bands.
