**TECHNICAL MEMORANDUM 97/258**  
December 1997

**ALUMINUM WIRE ROPE  
POLYETHYLENE SHEATHING FAILURE**

John A. Hiltz

# ALUMINUM WIRE ROPE POLYETHYLENE SHEATHING FAILURE

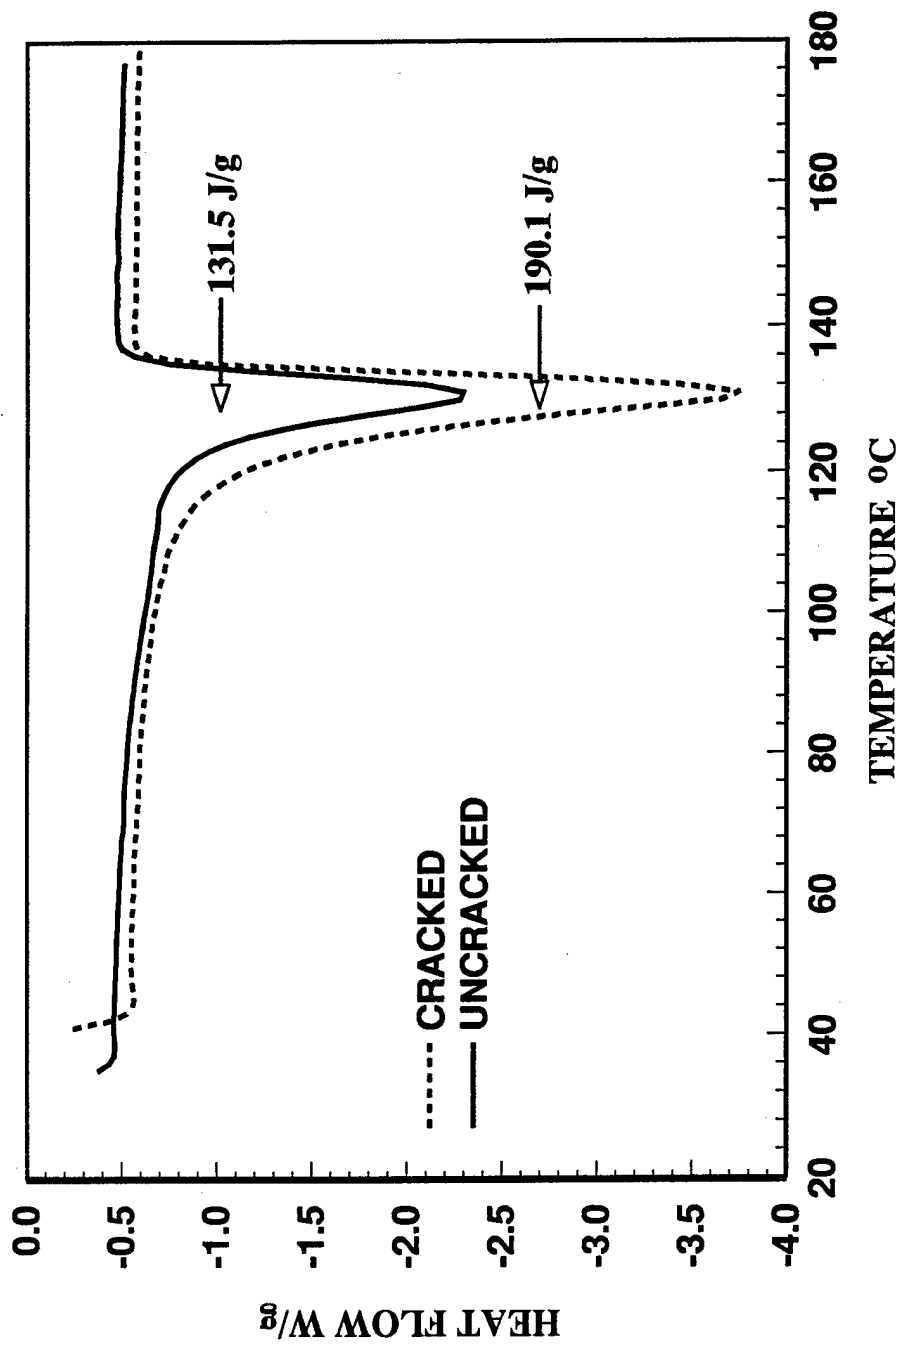
Typical plots of heat flow versus temperature for samples of cracked and uncracked cable sheathing are shown in Figure 1. The melting point, heat of fusion, and percentage crystallinity of samples of cracked and uncracked polyethylene cable sheathing are shown in Table 1.

Figure 1. DSC traces for samples of cracked polyethylene sheathing and uncracked polyethylene sheathing. The traces show heat flow versus temperature for the sample.

Although the melting points of the cracked and uncracked polyethylene were similar, 131.0°C and 129.9°C respectively, the heats of fusion and therefore the percentage crystallinity of the cracked and uncracked polyethylene were very different. The cracked sample had a heat of fusion of 191.2 J/g which corresponds to approximately 66 % crystallinity while the uncracked sample had a heat of fusion of 133.5 J/g and which corresponds to 46% crystallinity.

The results of the DSC and py-GC/MS analyses are more definitive. DSC indicated that there was a large difference in the percentage crystallinity of the two sheathing samples, 46% for the uncracked sample versus 65% for the cracked sample. The percentage crystallinities are consistent with low density (46% crystallinity) and medium density (65% crystallinity) PE. This is direct evidence of the difference in the structure of the samples.

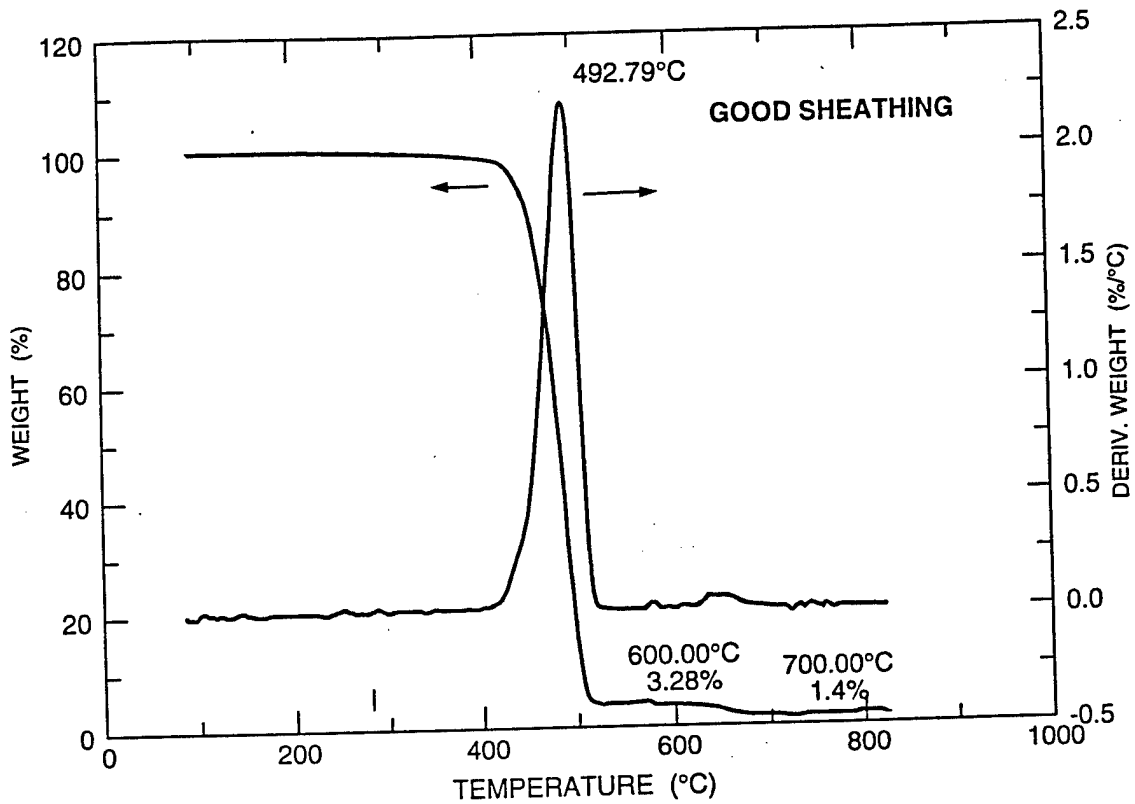
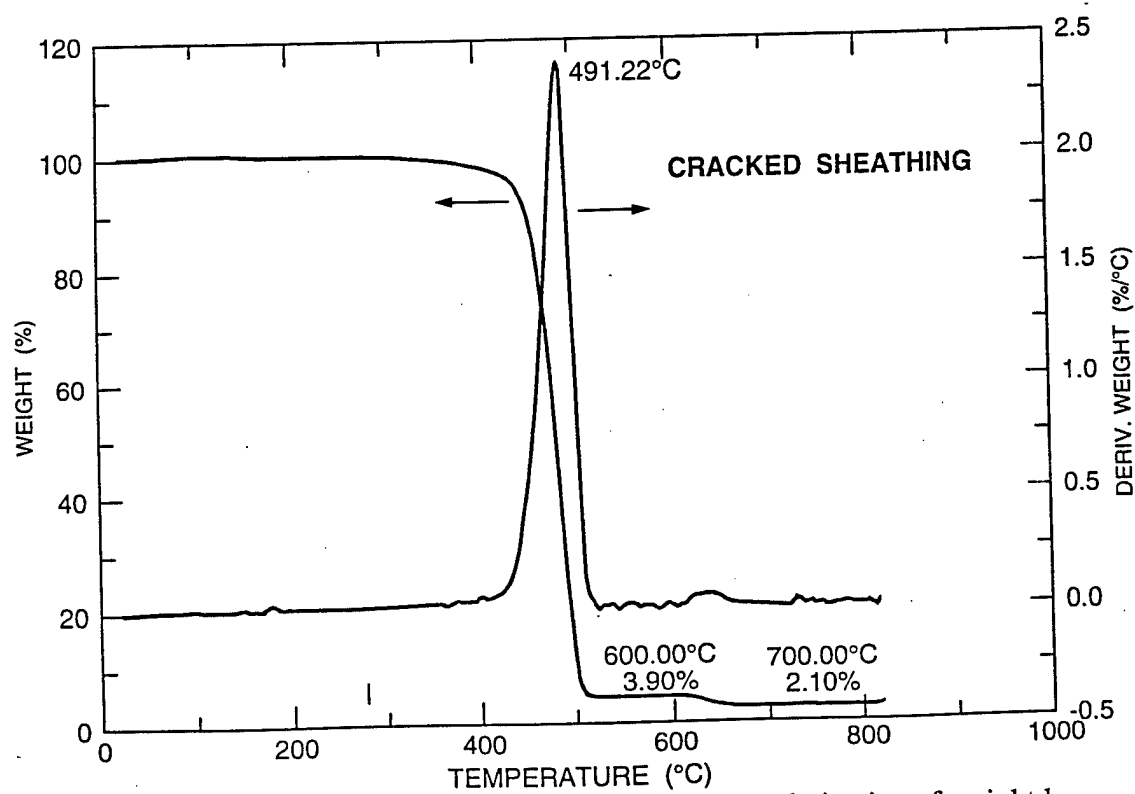
Plots of weight loss versus temperature and the first derivative of weight loss versus temperature for samples of the cracked and uncracked cable sheathing are shown in Figures 2a and 2b respectively. The weight loss versus temperature curves and the temperature of maximum weight loss were similar for the two samples. The cracked sample had a slightly higher residual weight at 600°C than the uncracked sample and a higher residual weight following heating in air to 800°C. However, the differences were small and might be expected for samples of similar types of PE from different suppliers. The differences cannot be used to explain the cracking of one sample of PE and not the other.

Figure 2 - Plot of weight loss versus temperature and the first derivative of weight loss versus temperature for samples of good (uncracked) and cracked polyethylene cable sheathing.

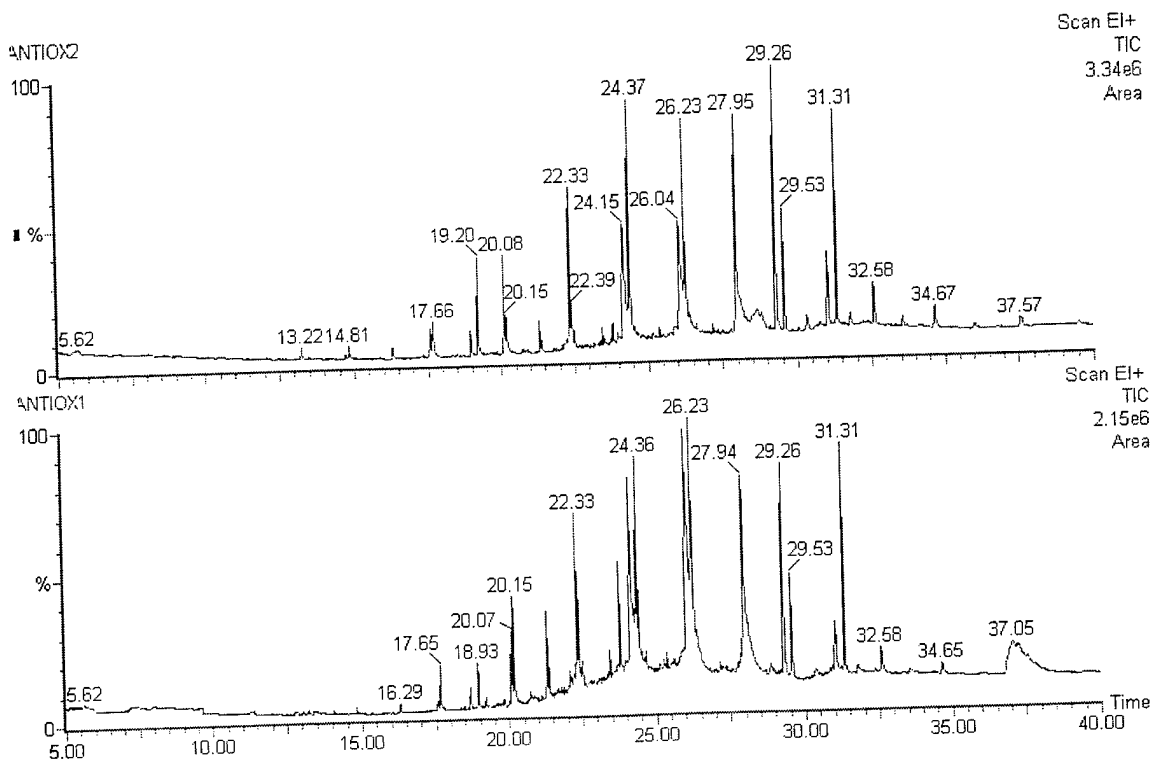
Chromatograms of extracts of the cracked and uncracked cable sheathing are shown in Figure 3. The chromatograms are similar. Butylated hydroxy toluene (19.2 min), hexadecanoic (24.1 min) and octadecanoic acids (26.0 min); dioctylphthalate (29.3 min) and a series of alkenes containing 14 (17.6 min), 16 (20.1 min), 18 (22.3 min), 20 (24.4 min), 22 (26.2 min), 24 (27.9 min) and 26 carbons (29.5 min) were found in both extracts. Butylated hydroxy toluene is a common antioxidant, while hexadecanoic acid and octadecanoic acid are commonly used processing aids<sup>3</sup>. Dioctylphthalate is a plasticizer and the alkenes arise from the synthesis of polyethylene.

Figure 3 - Chromatograms of extracts of samples of a) cracked and b) uncracked polyethylene

The sheathing extract analysis does not indicate that the cracked and uncracked sheathing samples are significantly different with respect to the type or concentration of additives, such as antioxidants or plasticizers.

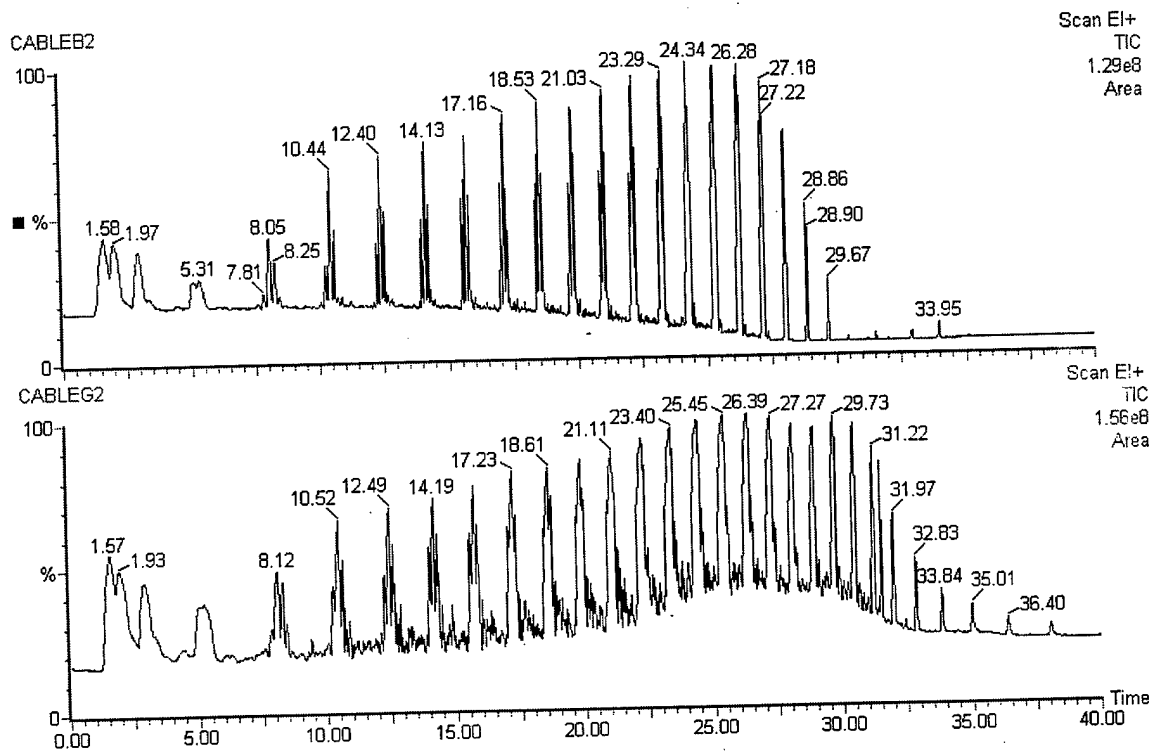
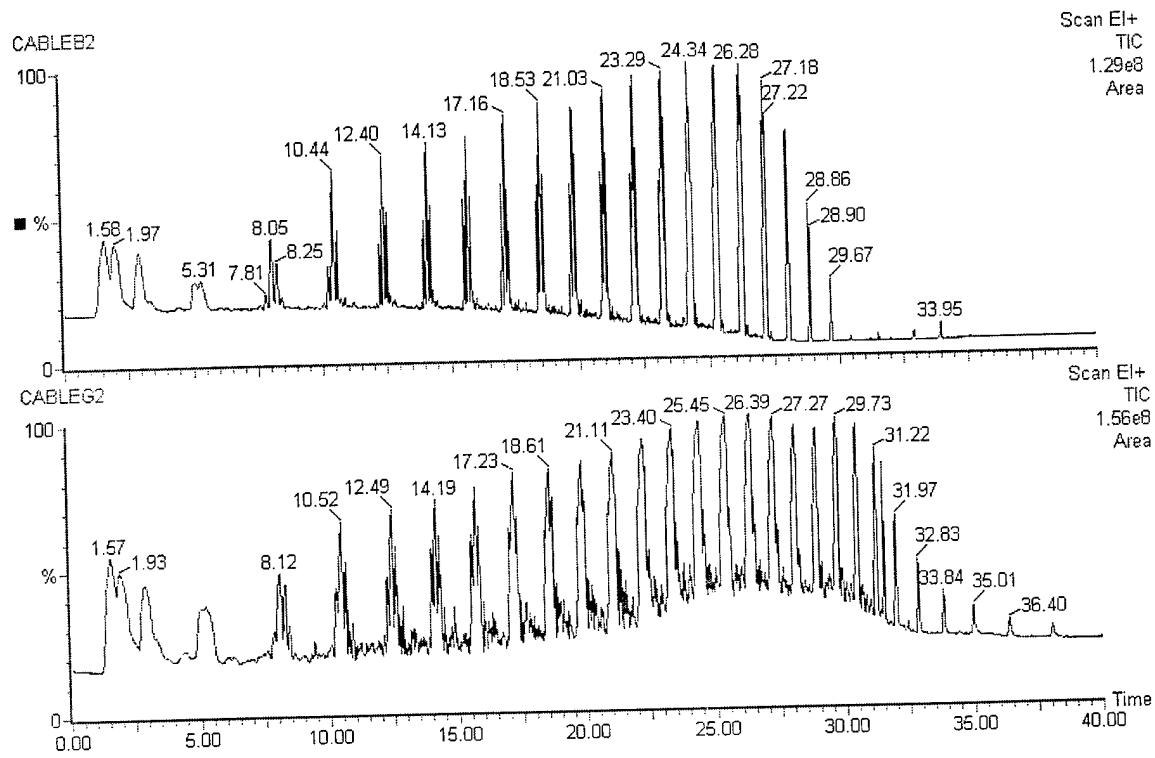
Pyrograms of samples of the cracked and uncracked cable sheathing are shown in Figures 4a and 4b respectively. The pyrograms of both samples are composed of a series of triplets. These triplets are characteristic of polyethylene<sup>4</sup>. For instance, in Figure 4a there are triplets centered at 10.43 minutes, 12.27 minutes, while Figure 4b has triplets centered at 10.52 minutes, 12.49 minutes. Mass spectral analysis indicated that the compounds giving rise to the peaks in each triplet were a diene, an alkene and an alkane containing the same number of carbons.

Figure 4 - Pyrograms of samples of a) cracked and b) uncracked polyethylene sheathing.

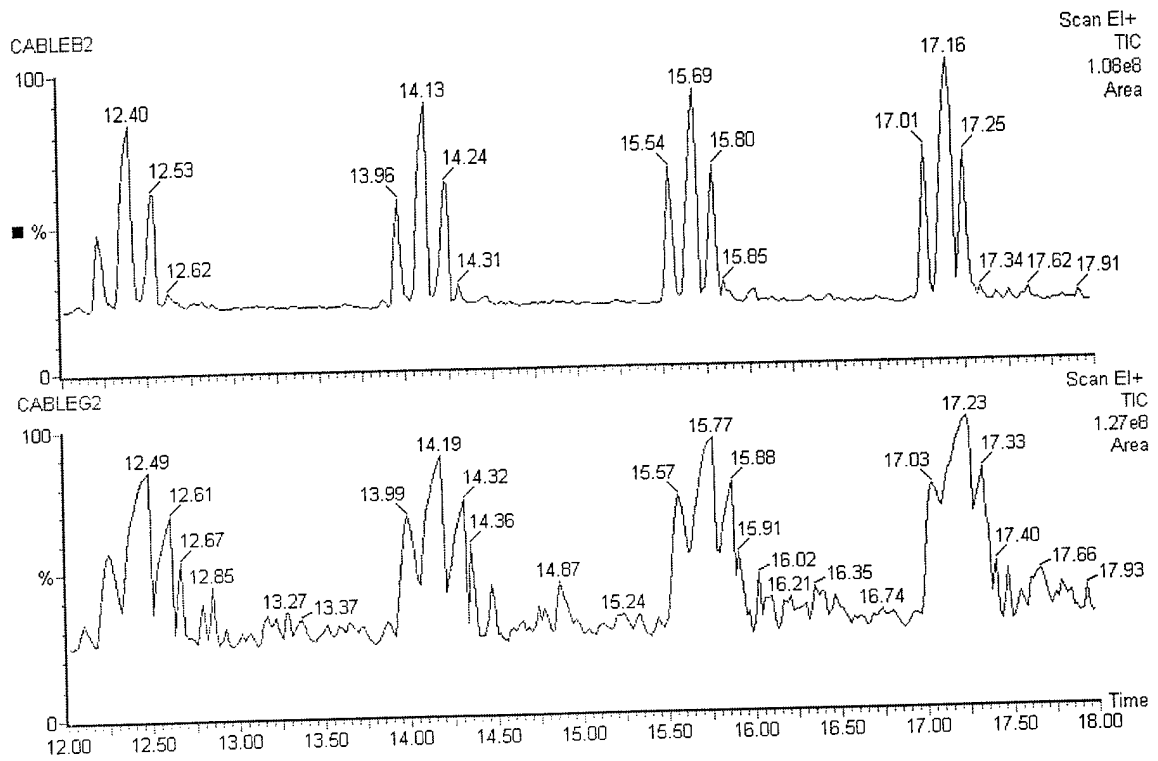
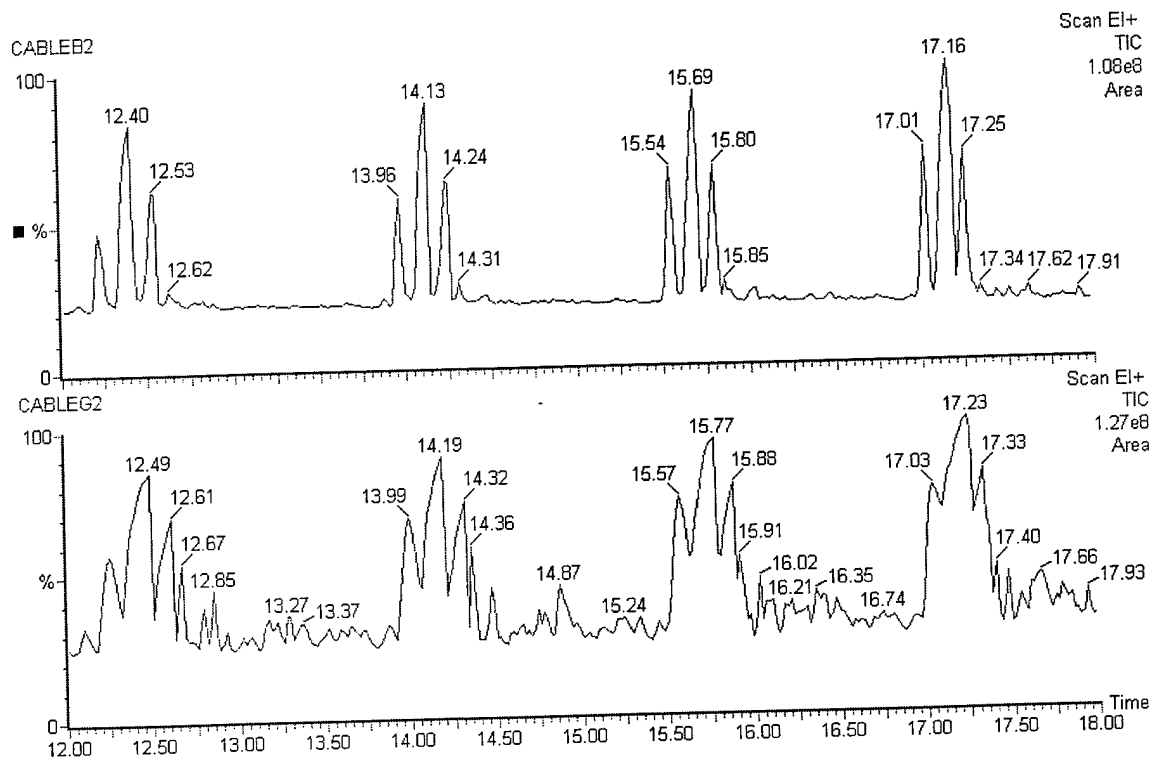
However, closer analysis of the pyrolytic degradation products does indicate that there were differences in the two PE sheathing samples. Expanded views of the pyrograms of the two samples are shown in Figure 5. It can be seen that the peaks in the pyrogram of the uncracked sheathing are broader than those in the pyrogram of the cracked sheathing. Also the pyrogram of the uncracked sample has a number of peaks between the triplets. A study<sup>5</sup> of the pyrolysis products of HDPE and LDPE samples found that the LDPE sample produced a number of peaks between the characteristic triplets that were not produced by the HDPE sample. These were attributed to methyl and ethyl substituted alkanes arising from the cleavage of the polymer chain in the vicinity of the branches in the LDPE chain. The presence of pyrolytic degradation compounds between the major triplets in the uncracked PE sheathing sample indicated that it is a LDPE.

Figure 5 - Expanded view of the pyrograms shown in Figure 7 (12 to 18 minutes retention time).

These differences are confirmed by the py-GC/MS results. The pyrolysis products of the uncracked (lower crystallinity) sample are similar to those that would be expected from LDPE while those of the cracked sample are consistent with the pyrolytic degradation of higher density PE samples.

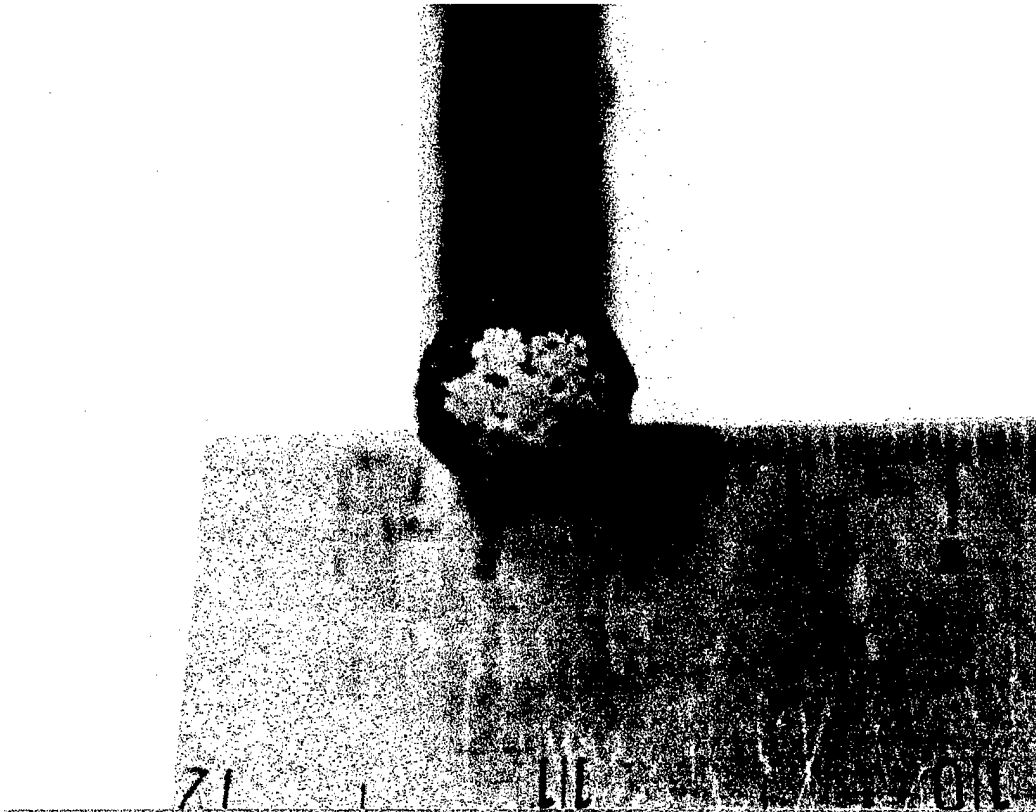
A cross section of the PE sheathed wire rope is shown in Figure 6. Side and top views of a crack in the failed polyethylene sheathing are shown in Figures 7a and 7b respectively. The cracks were normal to the long axis of the wire rope and did not progress all the way around the cable perimeter.

Figure 6 - Cross-sectional view of a sample of polyethylene sheathed wire rope.

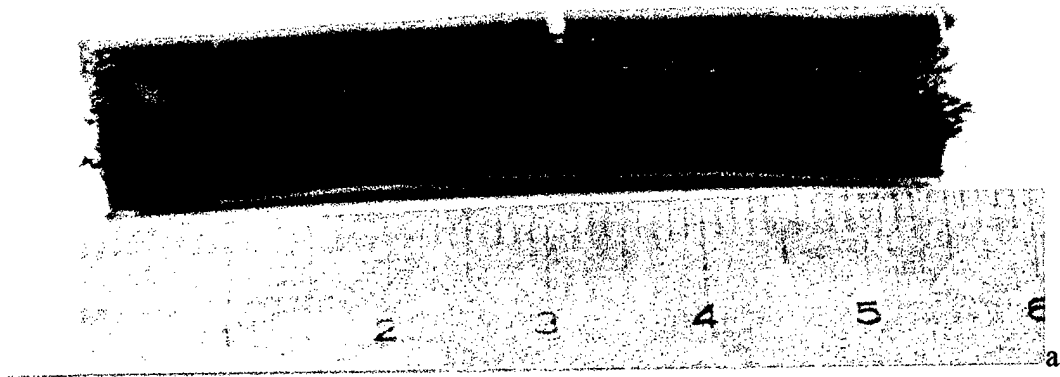
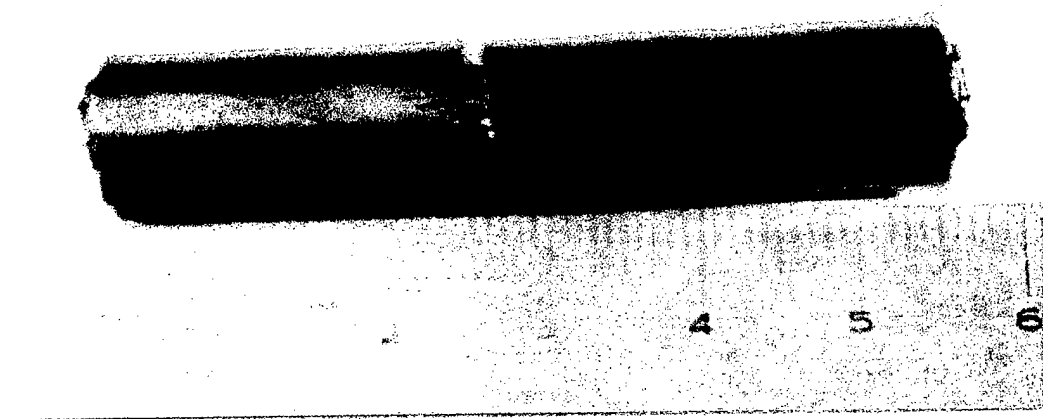
Figure 7 - A) Side and b) top views of a crack in a sample of polyethylene sheathed wire rope.

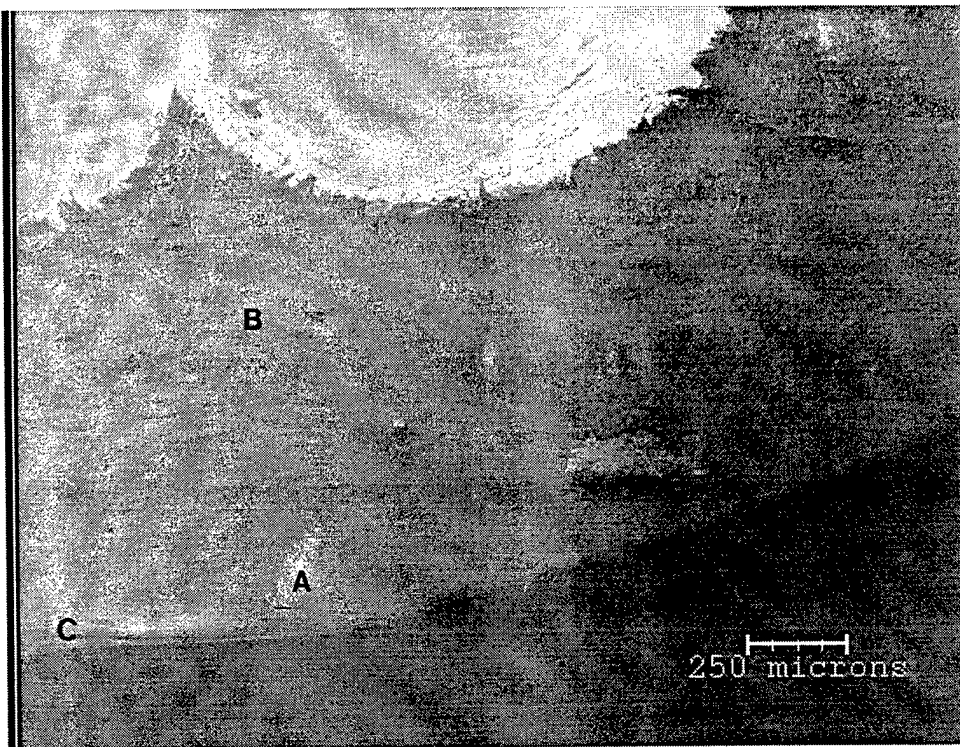
A series of electron micrographs of the failure surface are shown in Figures 8 through 13. A low magnification view of the fracture surface of the cable sheathing is shown in Figure 8. The edge of the sheathing that adjoined the aluminum wire rope is at the top of the picture. Visual analysis of the fracture surface indicated that it had dark and light areas. One of the dark areas was located at the outer edge of the cable (area A in Figure 8) while the lighter areas (area B in Figure 8) extended through the thickness of the sheathing to the sheathing/wire rope interface.

Figure 8 - Scanning electron micrograph of a polyethylene cable sheathing failure surface.

The scanning electron micrographs indicate that the failure initiated away from the outer edge of the sheathing, most likely adjacent to the aluminum wire rope. The crack grew slowly towards the outer edge of the sheathing until the remaining sheathing could not support the load and failed. The shear lip in Figure 12 is an area of final failure.

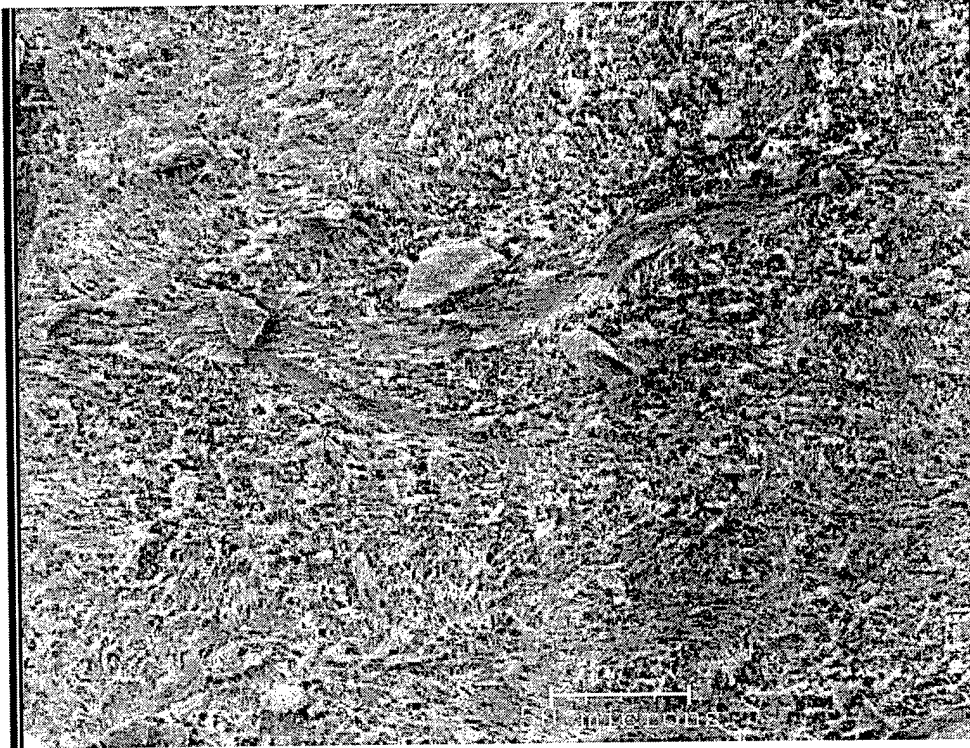
Higher magnifications of the dark area (area A in Figure 8) and area outside the dark area (area B in Figure 8) are shown in Figures 9 and 10 respectively. The morphologies of the fracture surfaces in these areas are significantly different. The fracture surface inside the dark area is relatively smooth while the fracture surface outside the dark area has a fibrillar morphology.

Figure 10 - Higher magnification of area B in Figure 8. Notice the fibrillar structure of the fracture surface.

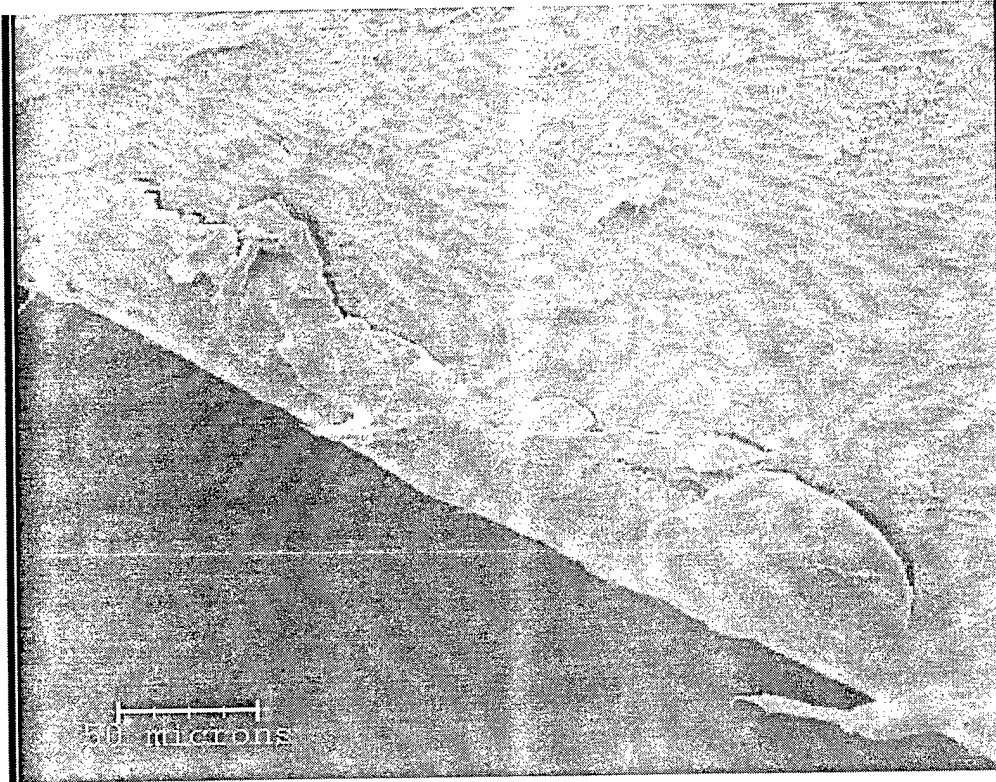
The outer edge of the failed sheathing is shown in Figure 11 (area C in Figure 8). A shear lip, characteristic of final failure, can be seen.

Figure 11 - Higher magnification of Area C in Figure 8. A shear is clearly visible on the outside edge of the cable sheathing.

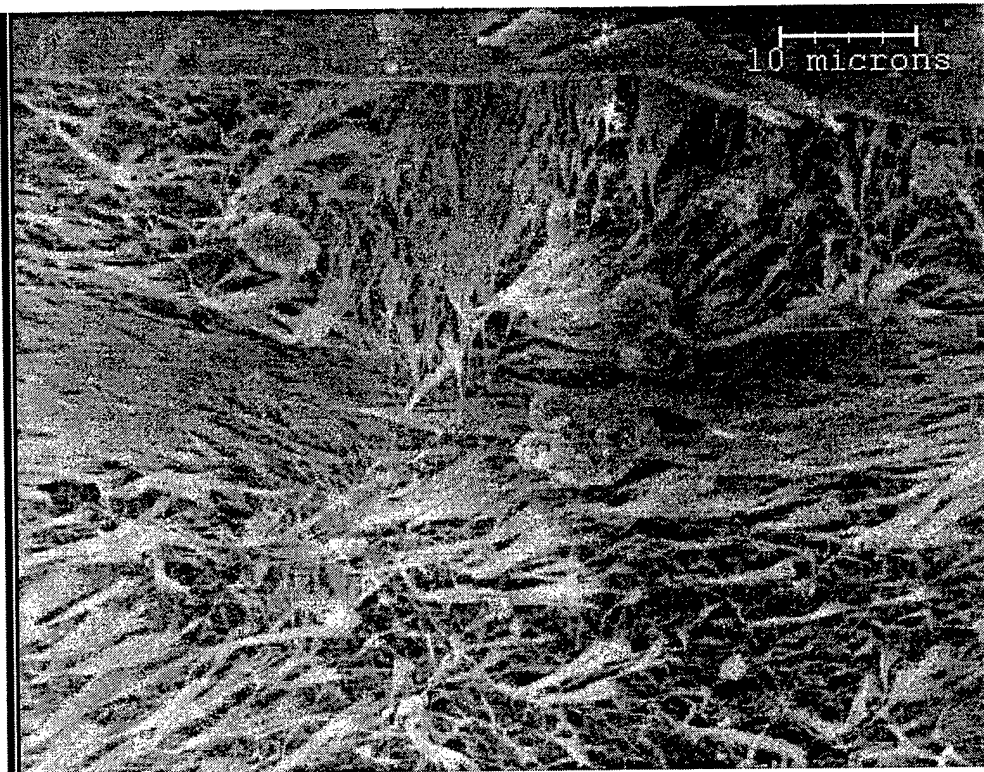
Figure 12 shows a higher magnification of the fracture surface in Area B of Figure 8. The fibrillar structure of the polymer at the fracture surface can be seen in this micrograph. This morphology is characteristic of slow crack growth brittle failures in polyethylene<sup>6</sup>. The fracture surface of a polyethylene sample that failed by a slow crack growth brittle fracture mechanism is shown in Figure 13 (page 327 in Reference 6) for comparison.

Figure 12 - High magnification of area B in Figure showing the fibrillar structure of the fracture surface.

Scanning electron microscopy indicated that the sheathing failed by a brittle-type slow crack growth mechanism. This behavior takes place at lower stress levels and over longer

periods of time than a ductile deformation. The stress responsible for the cracking arose from rereeling of the sheathed wire rope. Polyethylene is composed of crystalline lamellae and amorphous intercrystalline regions. The intercrystalline region contains a number of tie molecules, that is, polymer chains that begin and end in adjacent lamellae, polymer chain ends extending from a crystalline lamella into the intercrystalline region, and entangled polymer chains. Under a low load the tie molecules untangle to the point where the load cannot be supported by the remaining tie molecules. The polymer then fails by a brittle manner.

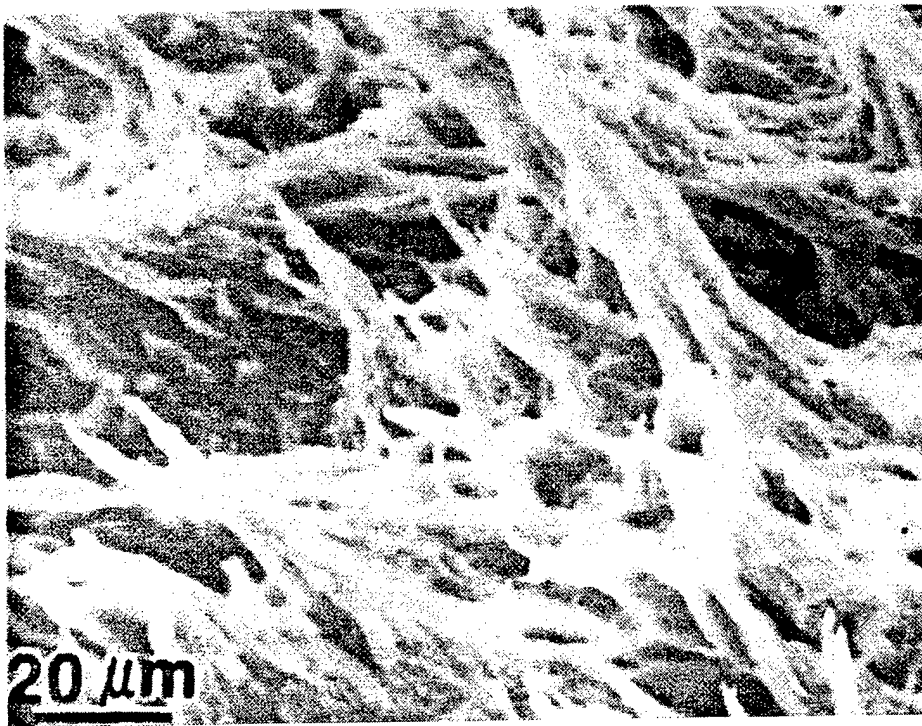
Figure 13 - Scanning electron micrograph of a polyethylene fracture surface after it failed by a brittle slow crack growth mechanism. Page 327 - A. Lustiger, 'Environmental Stress Cracking: The Phenomenon and its Utility', Chapter 16 in **Failure of Plastics**, edited by W. Brostow and R. D. Corneliussen, Hanser Publishers, New York, 1986.
