TNO-report  
98-CMC-R0328

## IMPACT ON A STEEL SONAR DOME

TNO Building and Construction  
Research

Date  
20 March 1998

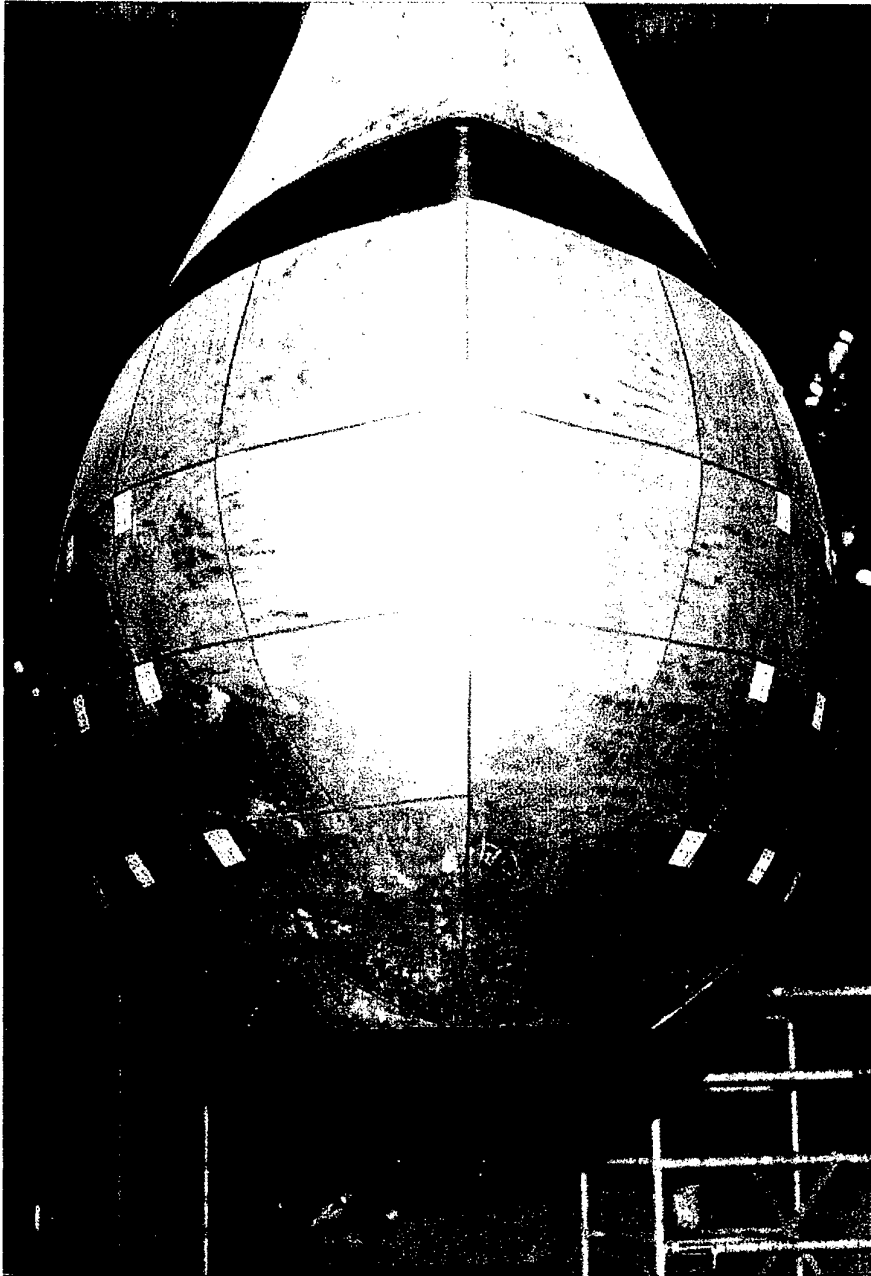
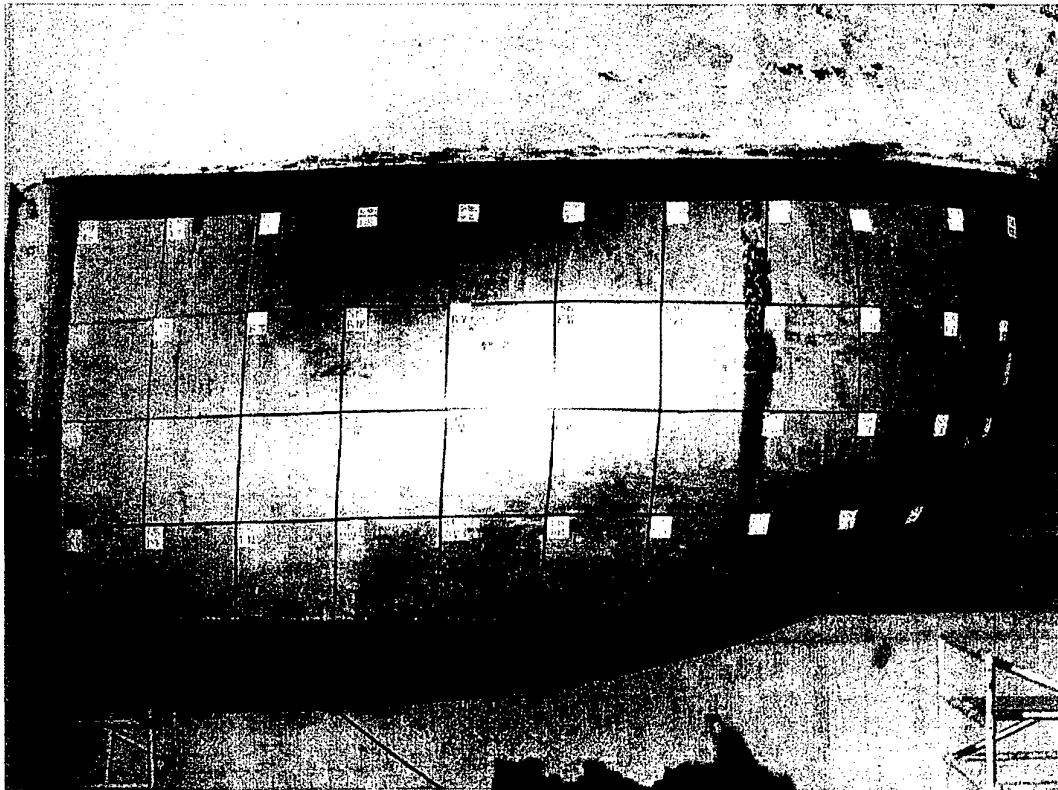
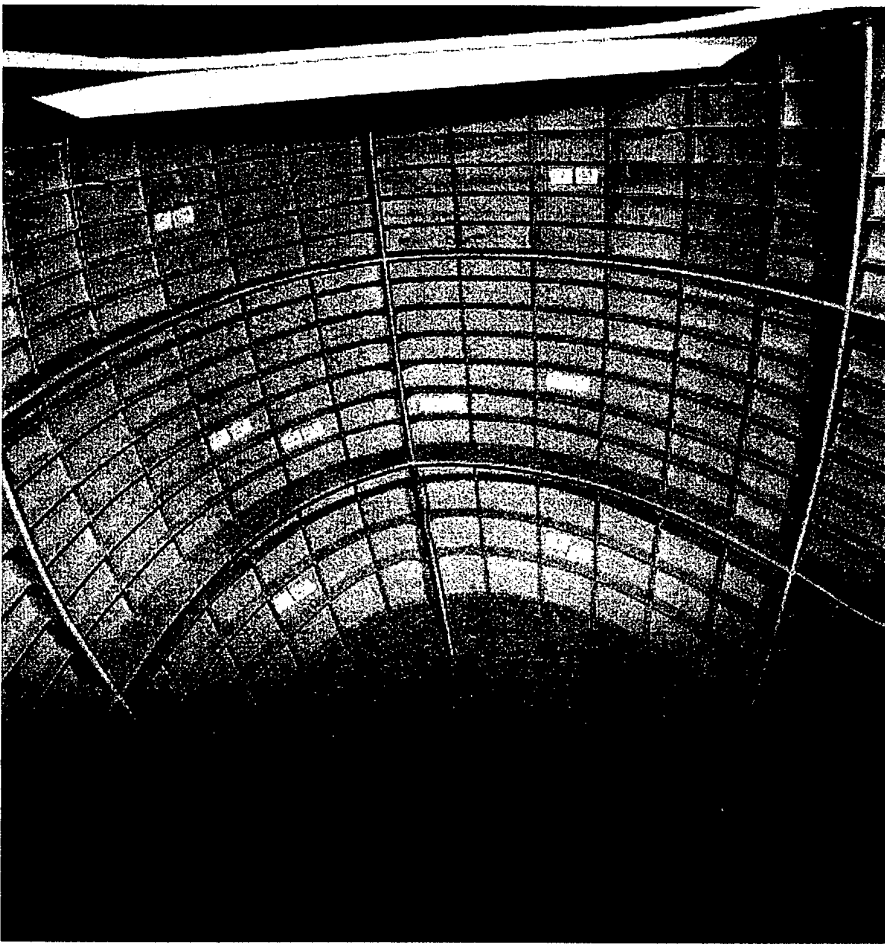
Photos of the undamaged dome are given in Figure 1-Figure 3. The thickness of the hull of the dome is 4 mm. There are primary frames (160 mm x 3 mm) and secondary frames (60 mm x 3 mm) on the inside of the dome in horizontal and vertical direction. On top of the primary frames are tubes with a radius of 7.5 mm. The horizontal frame distance between the vertical frames is maximal 375 mm. The vertical frame distance between the horizontal frames is 120 mm.

*Figure 1 Front view of the undamaged dome*

*Figure 2 View of starboard side of the undamaged dome (squares are numbered A to D from top to bottom and I to XI from left to right)*

*Figure 3 Inside front view of the undamaged dome*

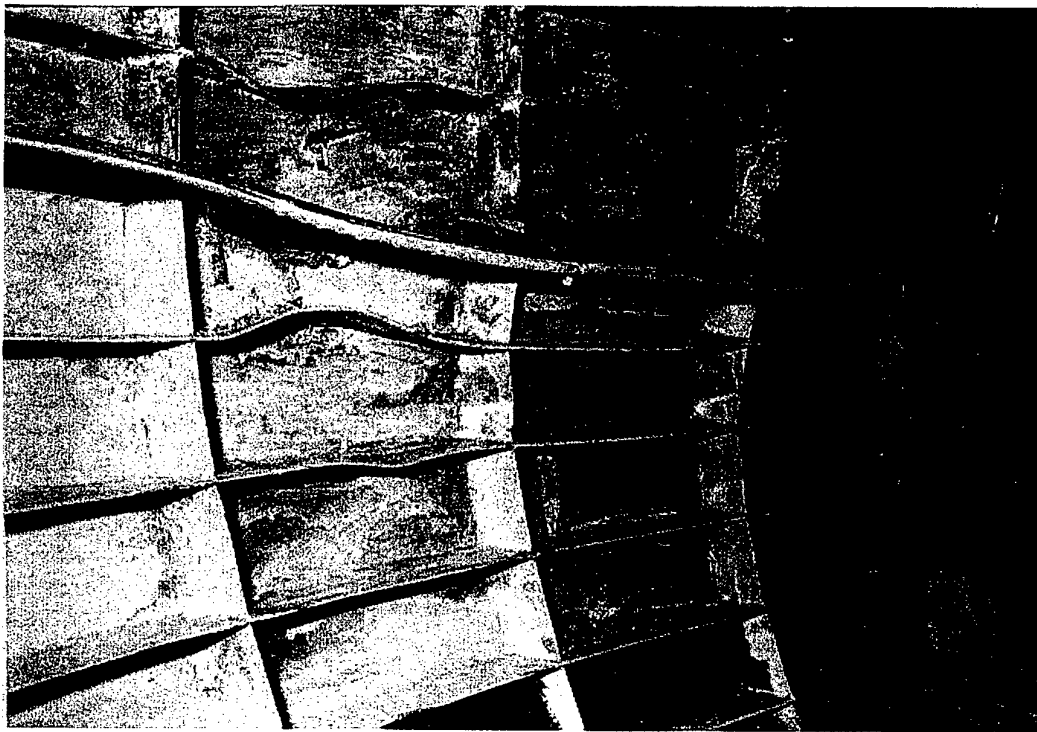
1. On the inside of the dome two large stiffeners are visible in the damaged area: a longitudinal stiffener and a transversal stiffener, see Figure 6.
2. The direction of impact is of influence.
3. The object which hit the dome had sharp edges.
4. A combination of the three hypotheses given above.

On the inside of the dome (Figure 6) we see tilting of the top horizontal primary stiffener over three vertical secondary stiffener distances. Also local buckling of secondary stiffeners is visible.

*Figure 6 Inside view of damage: tilting of horizontal primary stiffener and local buckling of horizontal secondary stiffeners*

Figure 15 and Figure 16 show the deformation of the inside of the dome at times  $t = 0.02$  s and  $t = 0.03$  s respectively. The deformation patterns at these two times are not significantly different. The upper horizontal primary stiffener is tilted over three vertical secondary stiffener distances. Secondary stiffeners buckle locally (especially the horizontal ones near the fourth vertical secondary stiffener). This deformation pattern corresponds remarkably well with the deformation pattern visible in Figure 6. The vertical primary stiffener is buckled near the lower horizontal primary stiffener.

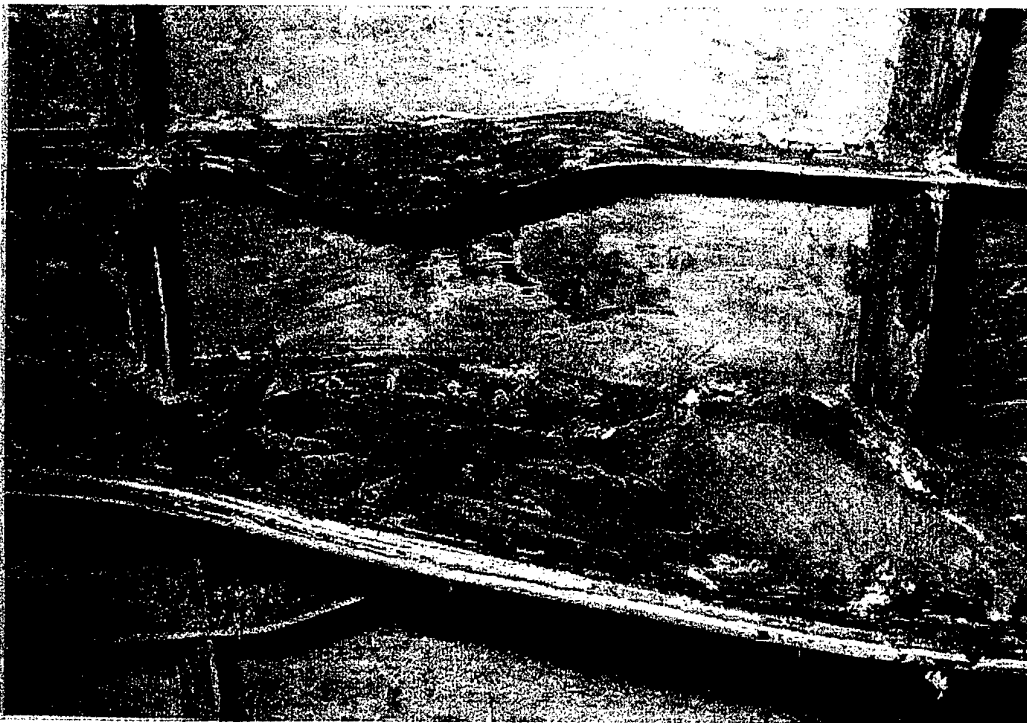
In Figure 7 and Figure 8 cracks are visible which are not predicted by the model. The real structure is chain welded. In the model continuous welding is assumed.

*Figure 7 Crack in connection between hull and longitudinal stiffener*

*Figure 8 Crack in stiffener connection*

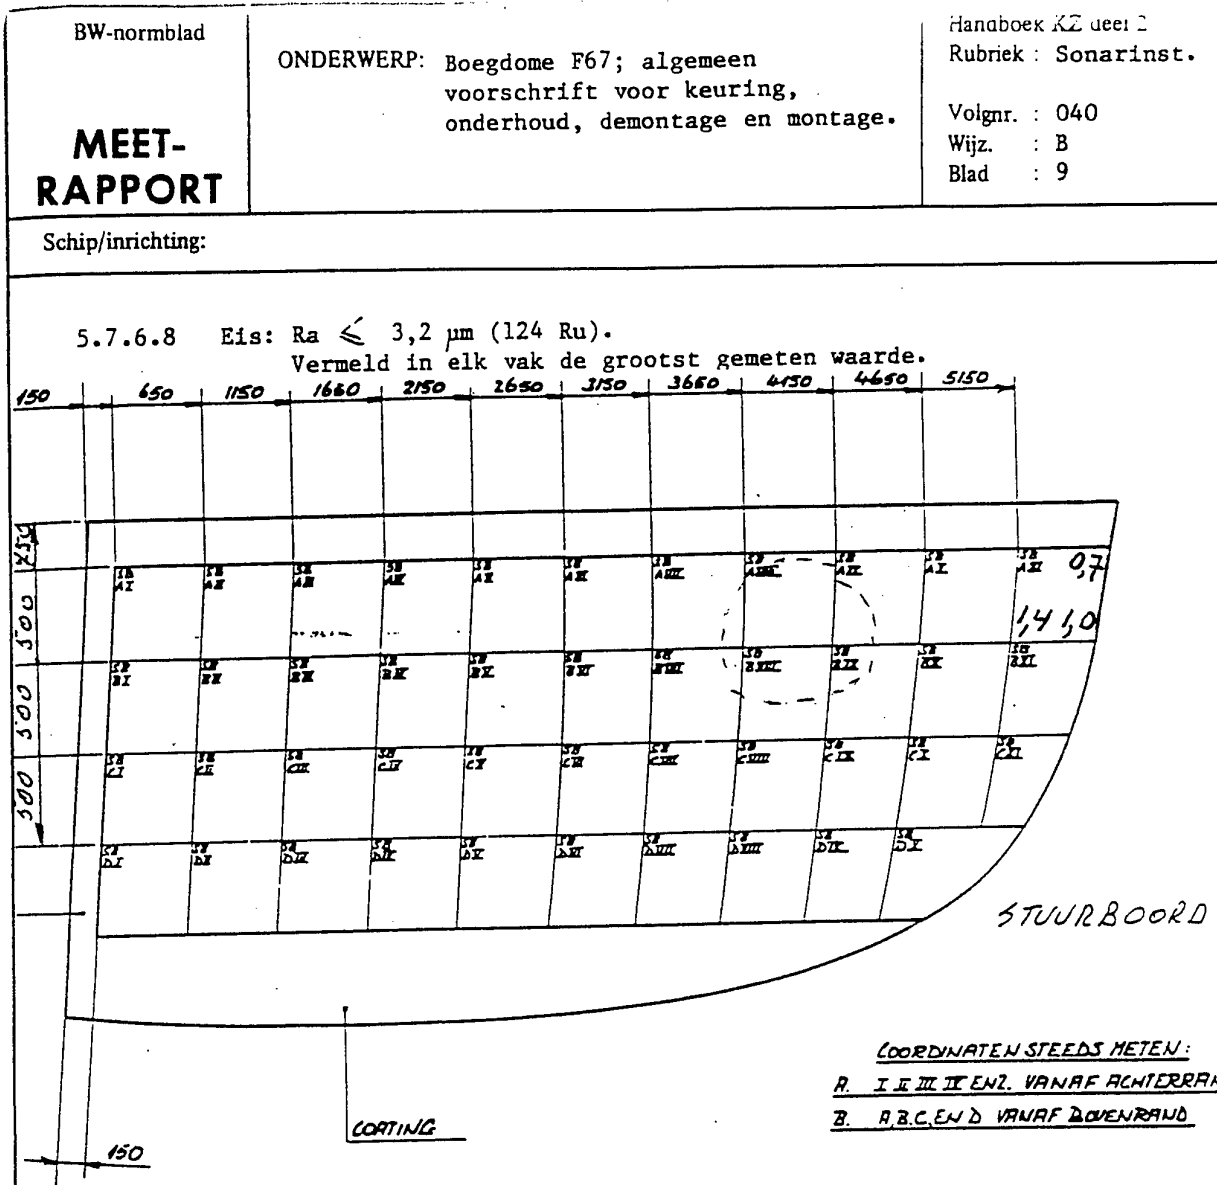
Because the damage to the dome is local, located on one side and relatively high, only the port side is modelled. Actually, the dome visible on the photos was hit on starboard side. This is not relevant for the analysis, however, because starboard and port side are symmetric. Figure 9 shows the place on the dome, which was damaged (marked by dotted curve).

Figure 9 Damaged region of the dome is marked by the dotted curve

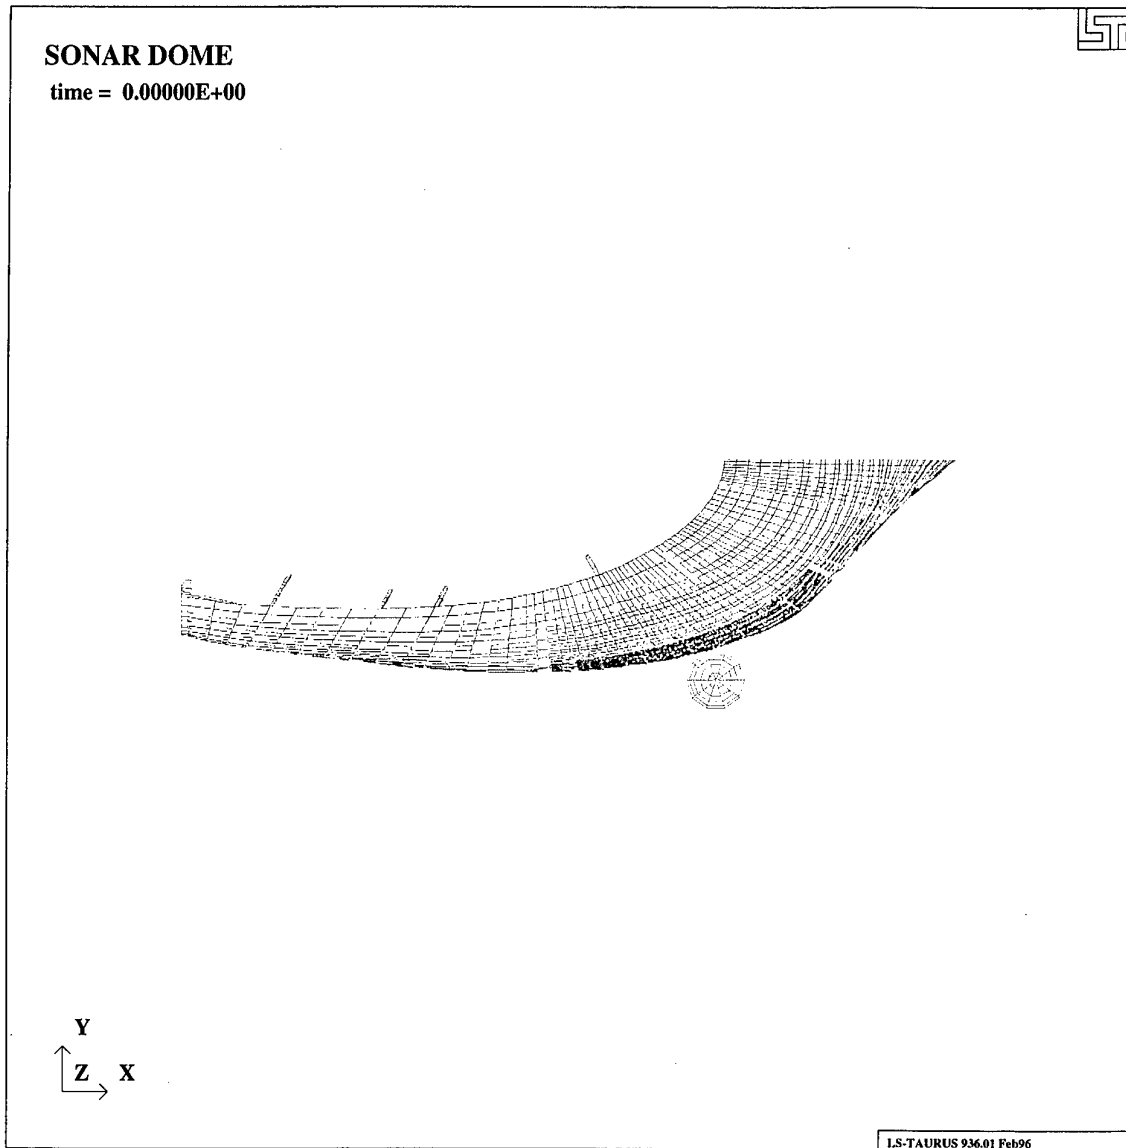
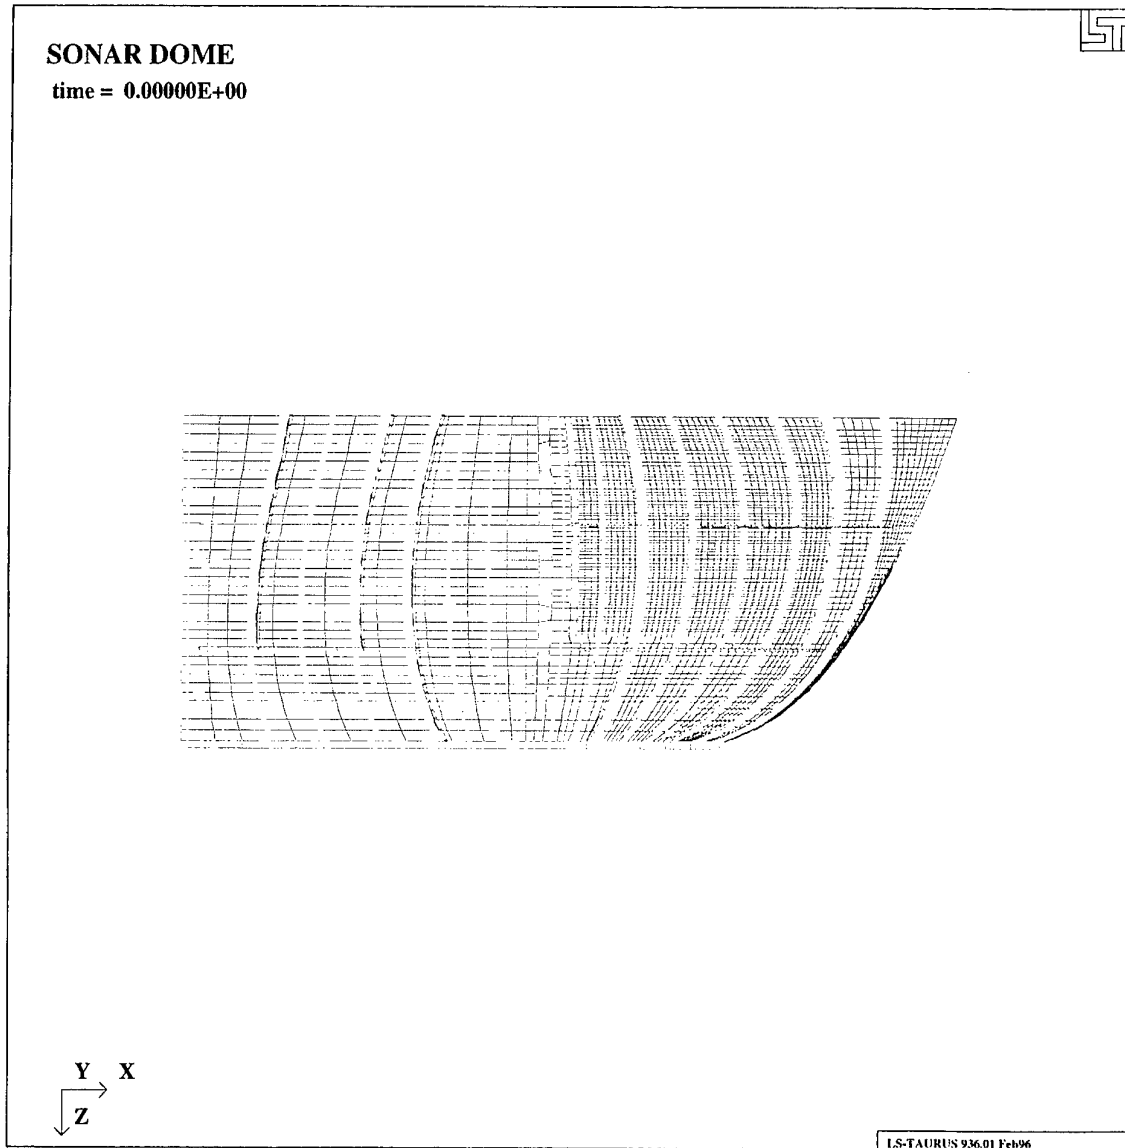
Figure 10-Figure 14 show the element mesh from different view points. The model consists of 11186 shell elements and 321 beam elements and has 10735 nodes. Near the location of impact the mesh has been refined. In this region 3 shell elements are used in the direction of their height for the secondary frames and 7 shell elements for the primary frames. The tube on top of the primary frames is modelled with beam elements. The minimal element length is 20 mm.

Figure 10 Mesh of the dome seen from the bottom in xy-plane (impacting sphere in blue)

Figure 11 Mesh of the dome seen from the aft in the yz-plane

Figure 12 Mesh of the dome seen from the inside in the xz-plane

Figure 13 Mesh of the dome seen from the inside near the region of impact

Figure 14 Further detail of the mesh of the dome near the region of impact

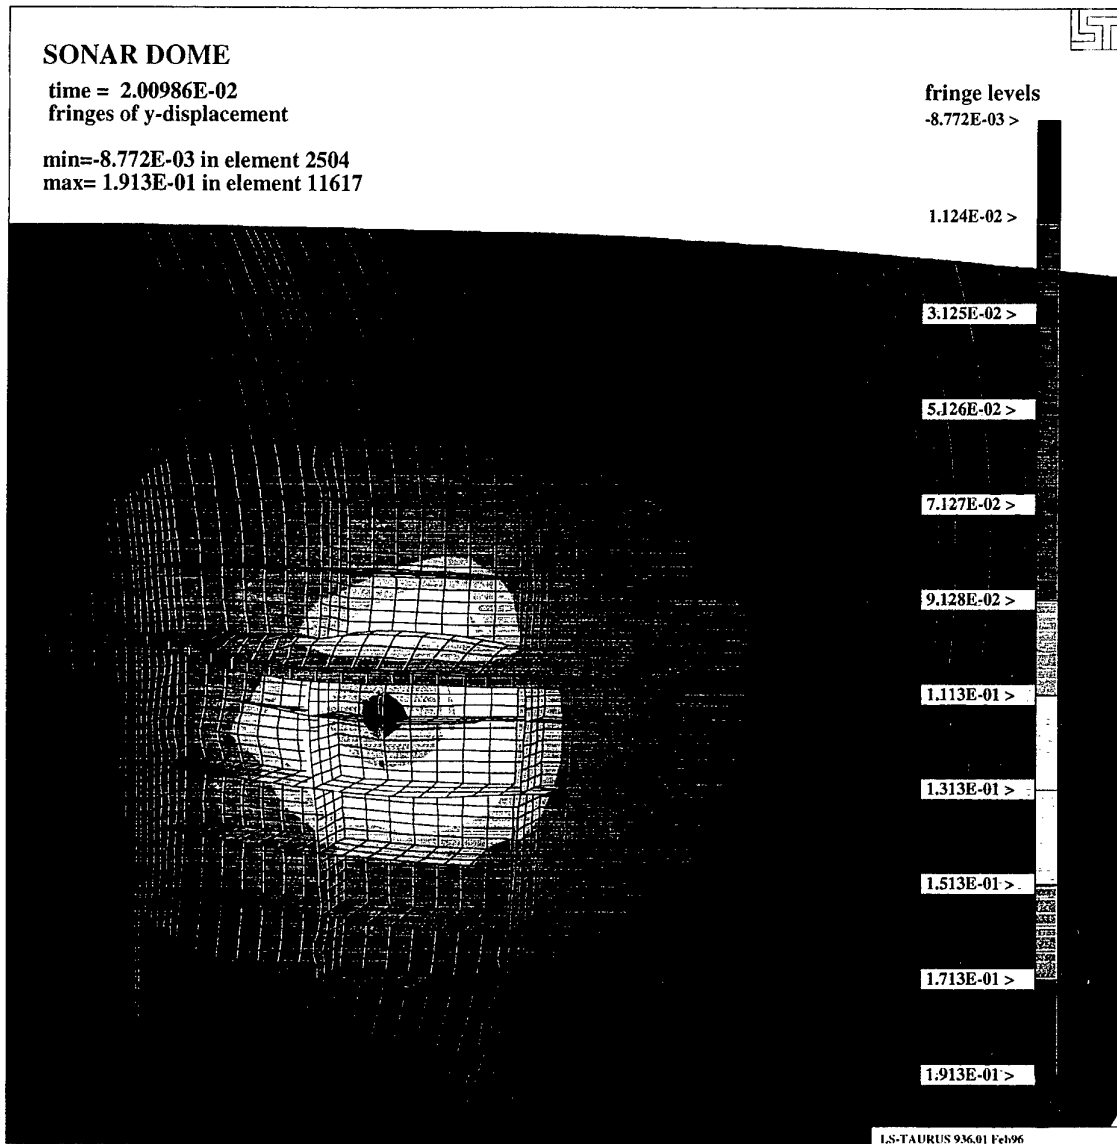
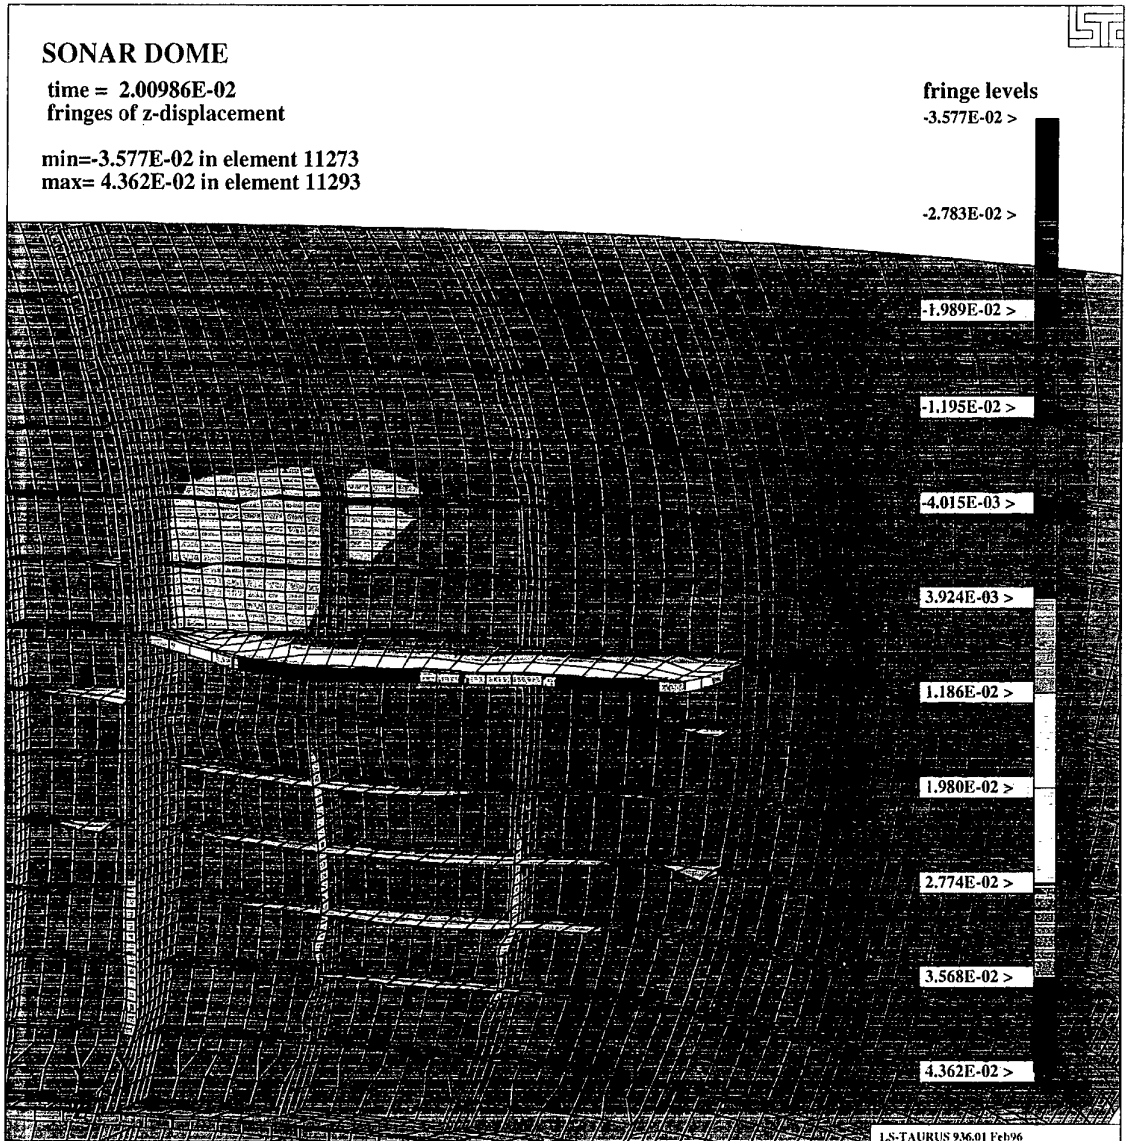
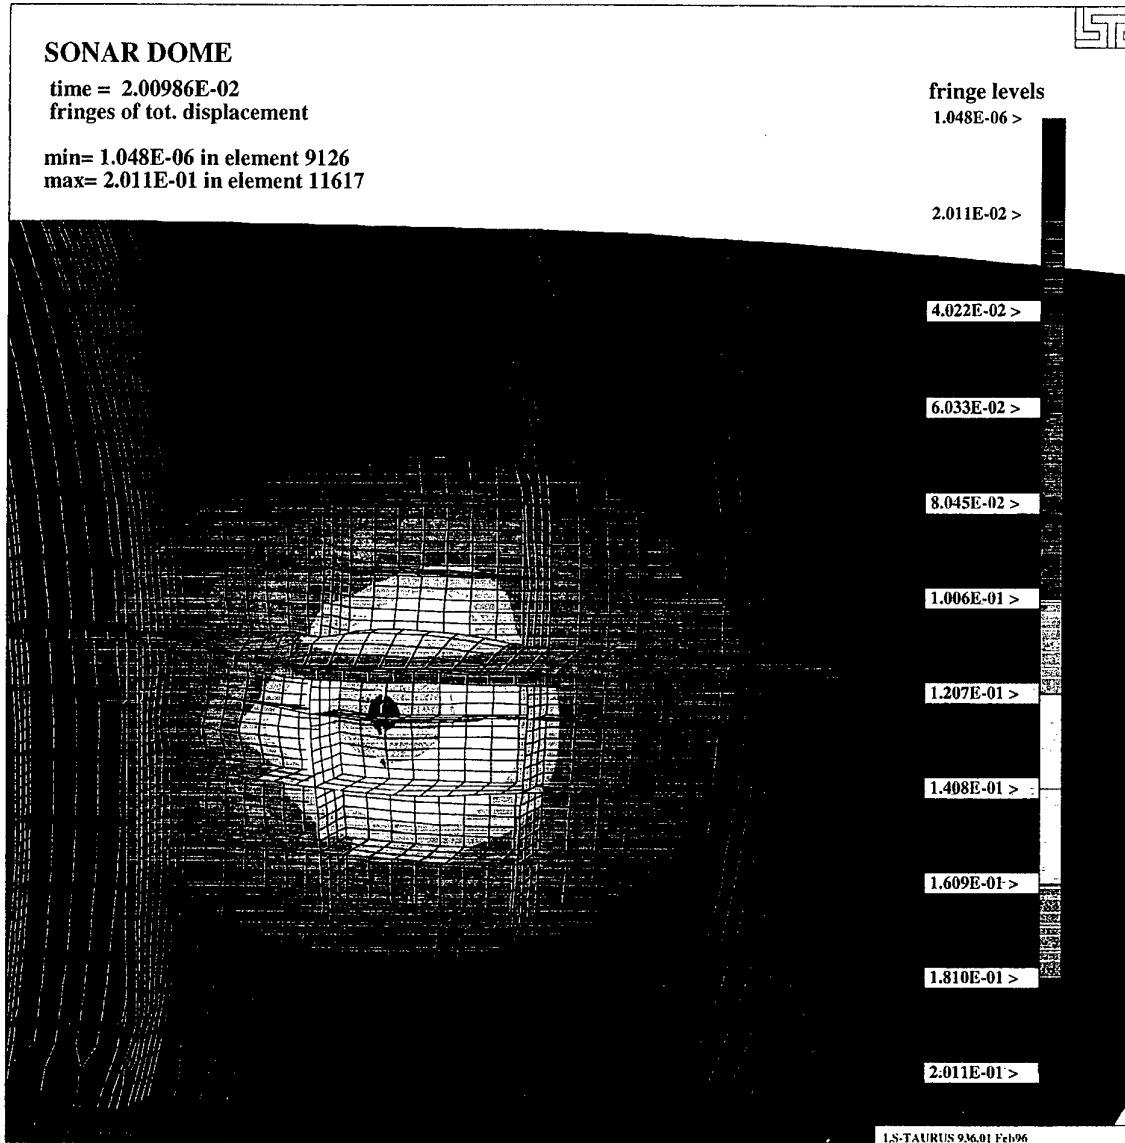
Figure 17-Figure 20 show the contour plots of the displacement in x, y and z-direction and the total displacement for  $t = 0.02$  s respectively. The damaged area is approximately circular with a radius of 0.4 m, which is the same radius as calculated from Figure 4. Therefore the situation at  $t = 0.02$  s will be investigated in detail. The centre of the damaged area has a maximum displacement of 0.2 m.

Figure 17 x-displacement [m] at t=0.02 s

Figure 18 y-displacement [m] at t=0.02 s

Figure 19 z-displacement [m] at t=0.02 s

Figure 20 Total displacement [m] at t=0.02 s

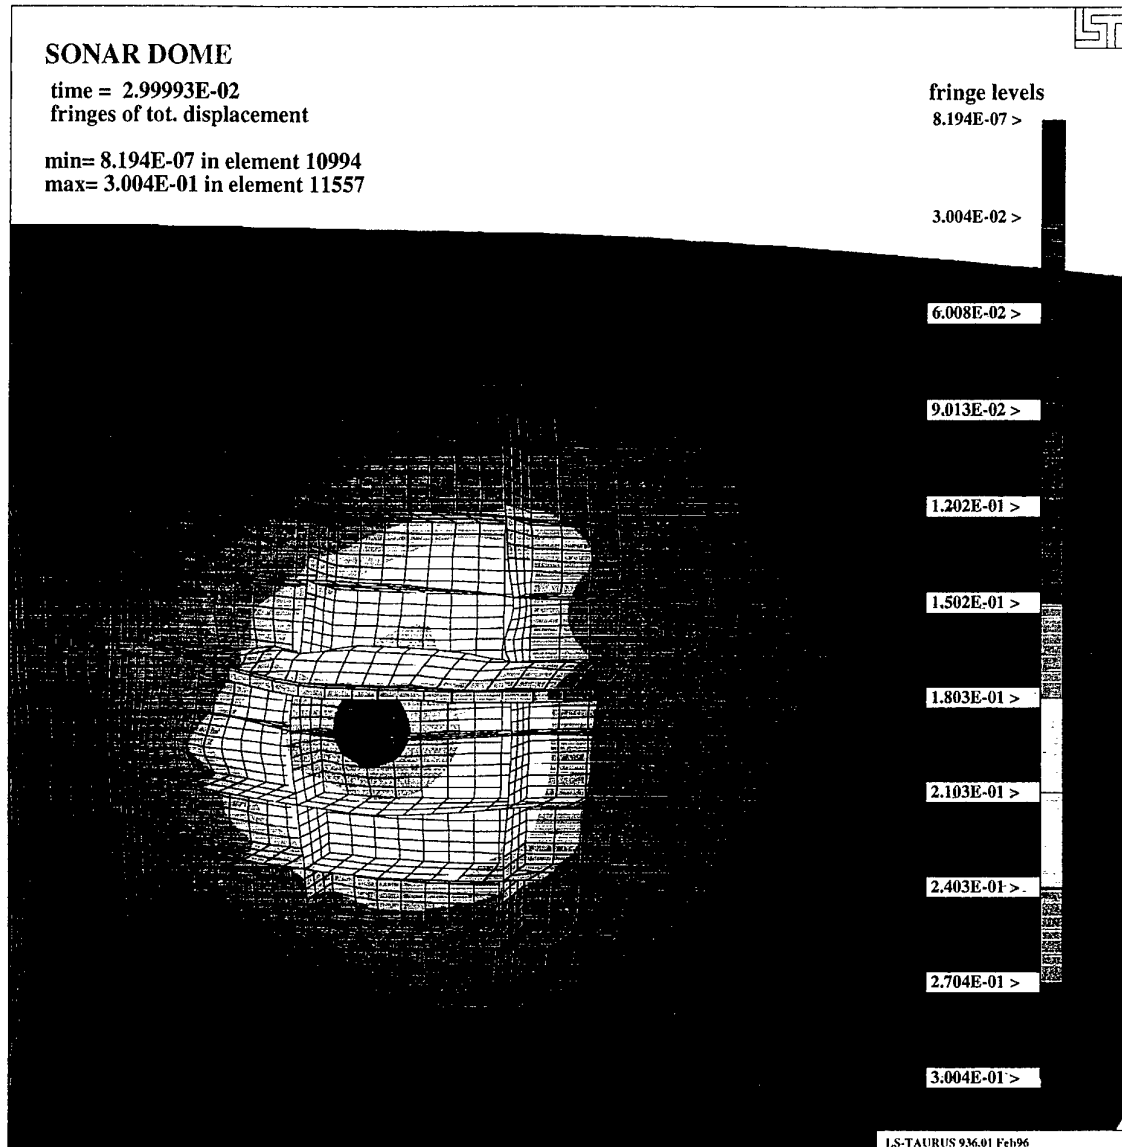
Figure 22 gives the total displacement for  $t = 0.03$  s.

Figure 22 Total displacement [m] at t=0.03 s

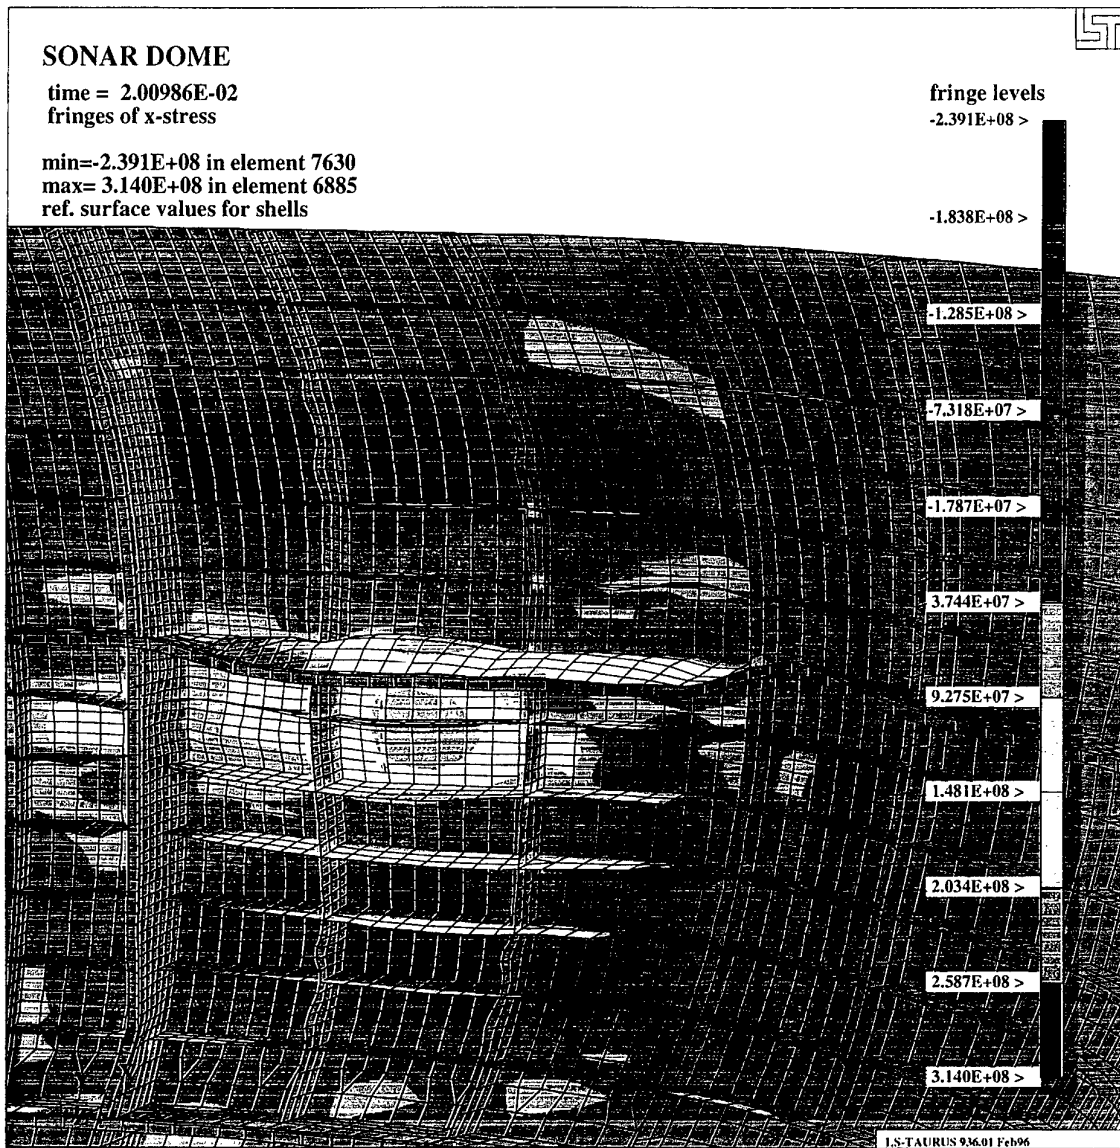
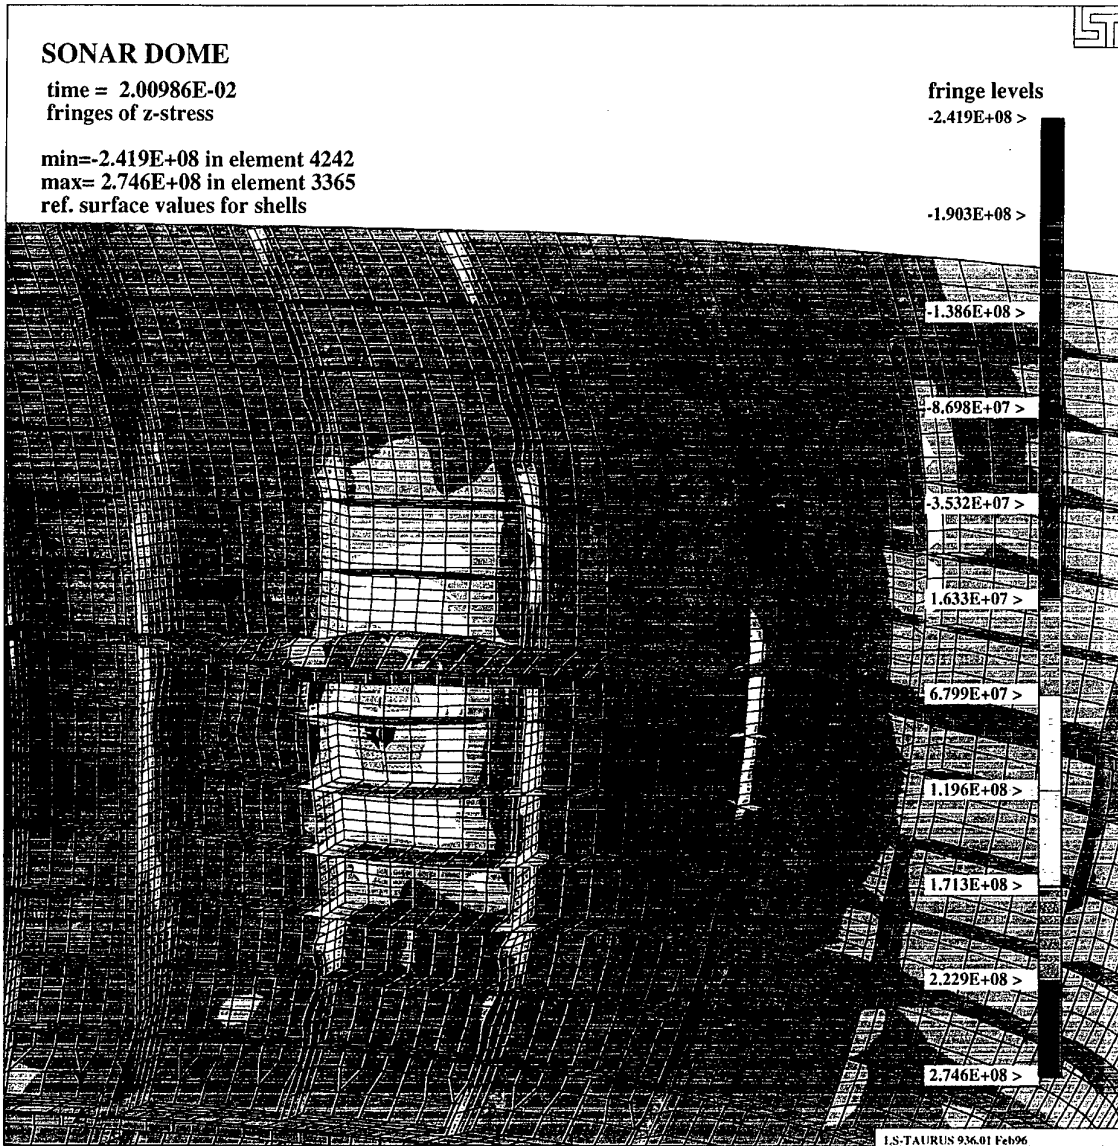
Figure 23-Figure 25 show the stresses in x, y and z-direction respectively for  $t = 0.02$  s. In the region where there is direct contact between the sphere and the dome we see tensile stresses up to 314 MPa. Just outside the region of contact we see compressive stresses up to -242 MPa.

Figure 23 x-stress [Pa] at t=0.02 s

Figure 24 y-stress [Pa] at t=0.02 s

Figure 25 z-stress [Pa] at t=0.02 s

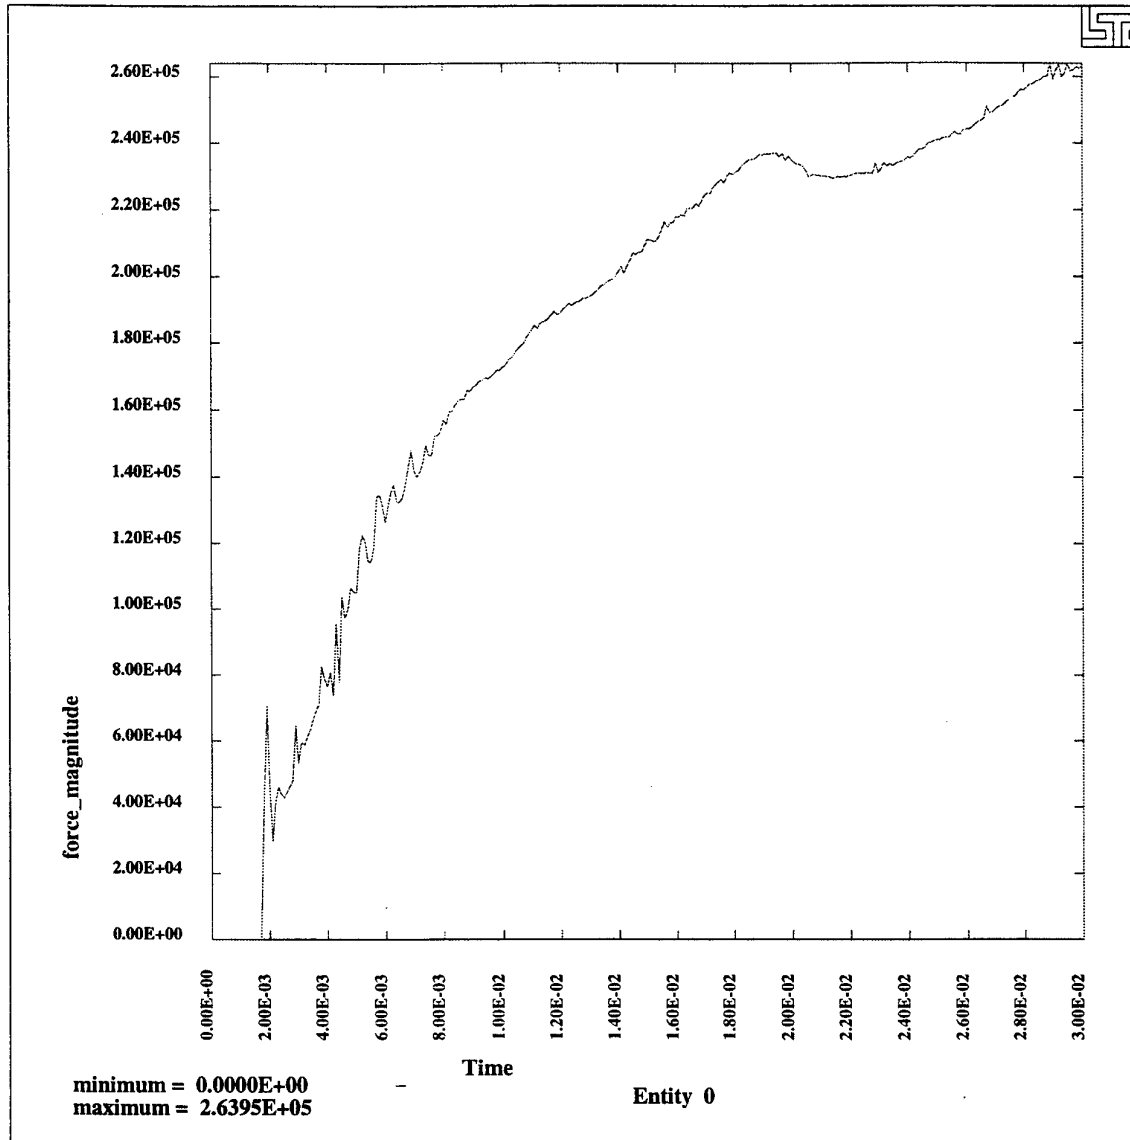
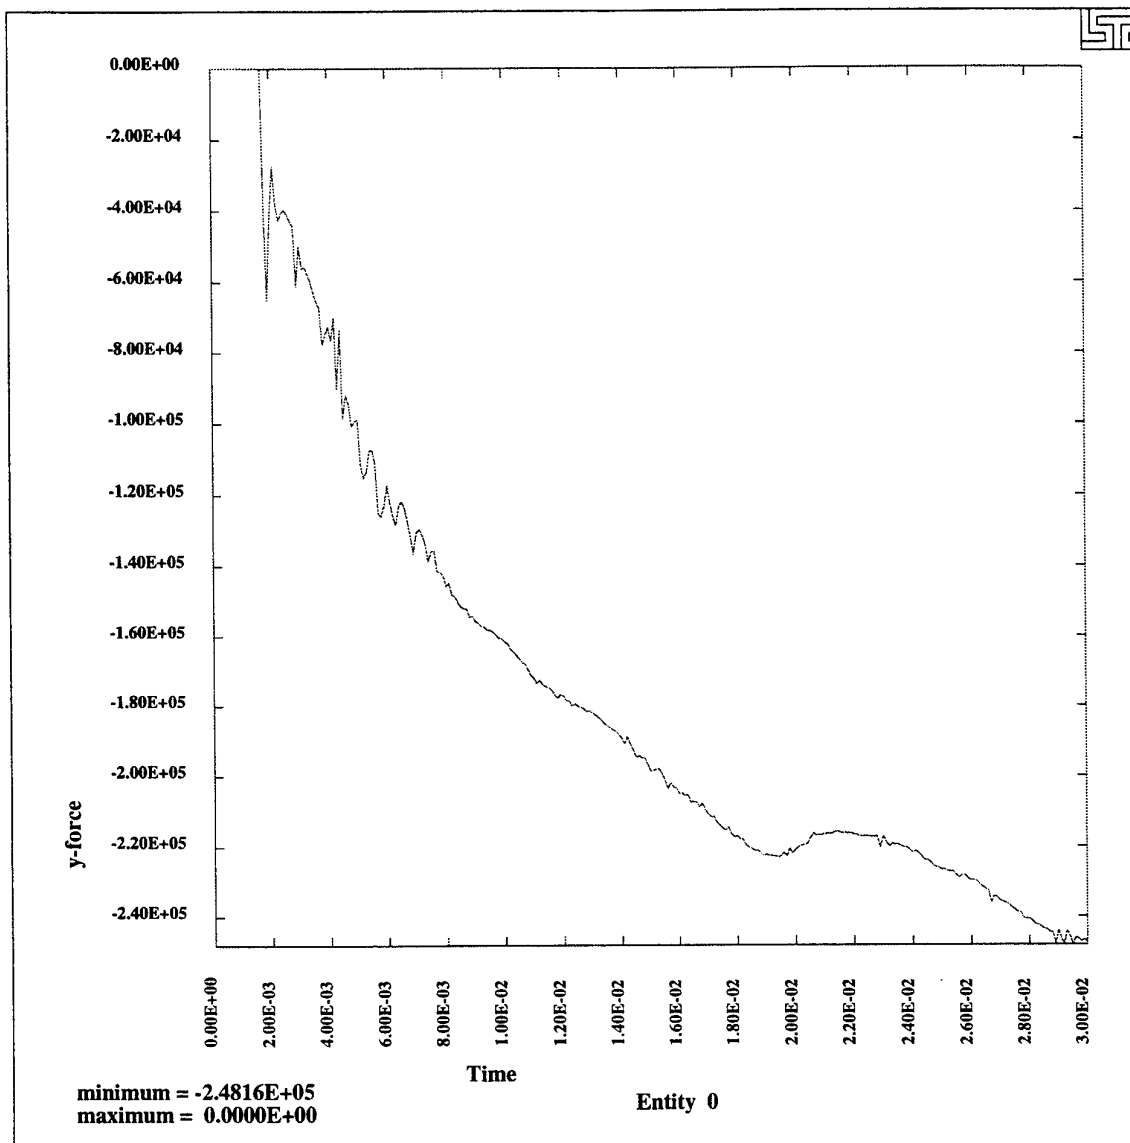
Figure 27 and Figure 28 show the force magnitude and the force in global y-direction as a function of time. From these figures it becomes clear that the force in global y-direction is dominant for the force magnitude. At  $t = 0.02 \text{ s}$  the penetration depth is about 0.2 m and the contact force is 230 kN, which is somewhat higher than but in the same order of magnitude as the forces following from Roark's formula and Lupker's formula. Probably it is somewhat higher because the bending stiffness of the stiffeners is underestimated in the formulas; moreover the primary stiffeners have been replaced by secondary stiffeners in the calculation of the equivalent thickness.

The force does not seem to increase much more at  $t = 0.03 \text{ s}$ .

Figure 27 Total contact force [N] versus time [s]

Figure 28 y-force [N] versus time [s]
